RTA 2 (O.N. 1290301)

Vessel Inspection Report

Prepared for: New Orleans RTA • New Orleans, LA

Ref: 19100-002-986-0 Rev. - December 10, 2019

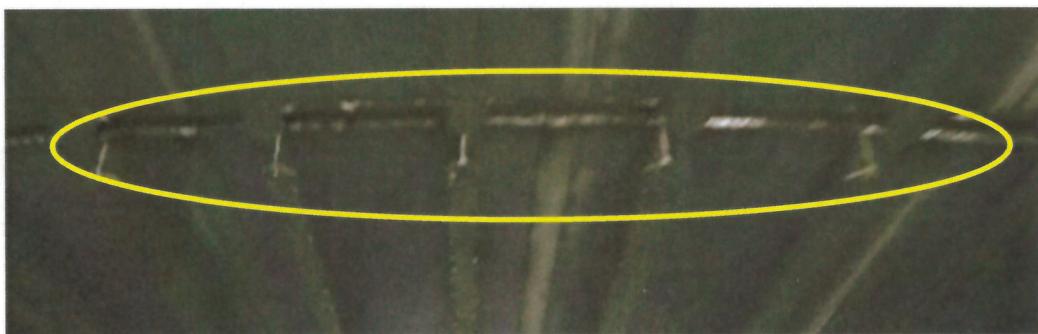
1. The "wet deck" is extruded plank rather than corrugated sheet as shown in, Ref. [1] Midship Section. The transverse seams appear to be continuously welded, Figure 1, protecting the wet deck void from water ingress.

Figure 1: Wet Deck Seam

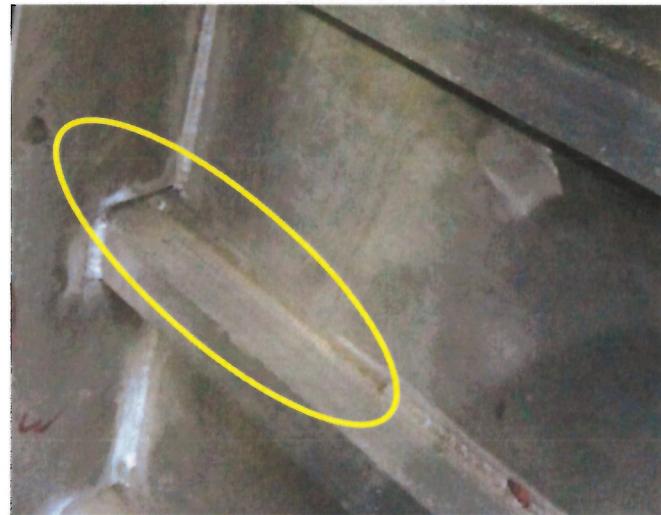
2. Longitudinal hull stiffeners do not have a matched pair of intermittent welds on each side of the transverse web frames as required in Refs. [2], [3] and [4], Figure 2.

Figure 2: Stiffeners at Web Frame

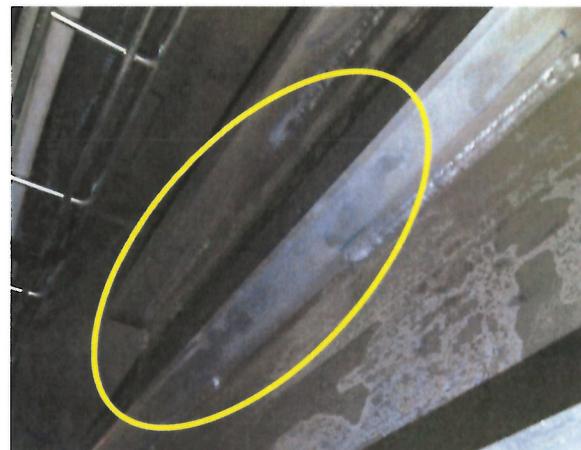
3. Limber holes shall be provided per Ref. [2] in non-tight structure to prevent the accumulation of liquids.
4. The first stiffener below the side shell and haunch knuckles, Figures 3 and 4, are to be welded double continuous (DC) per the Welding Arrangement, Ref. [3].

Figure 3: Stiffeners Below Sideshell Knuckle

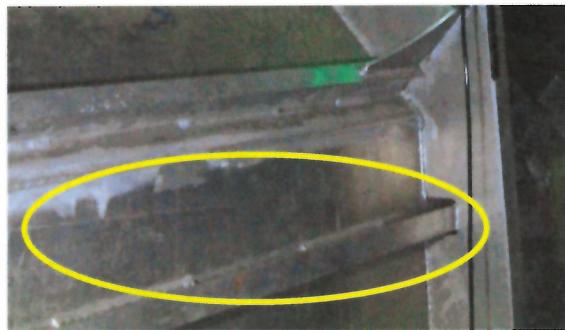
Figure 4: Stiffeners Below Haunch Knuckle

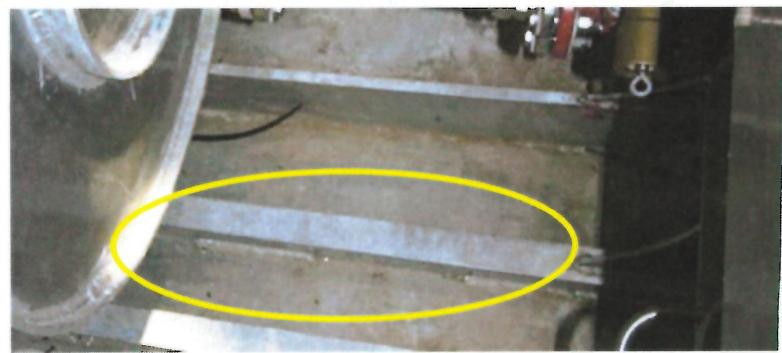
5. The first stiffeners adjacent to the keel bar, Figure 5, are to be welded DC per the Welding Arrangement, Ref. [3].

Figure 5: Stiffeners Adjacent to Keel

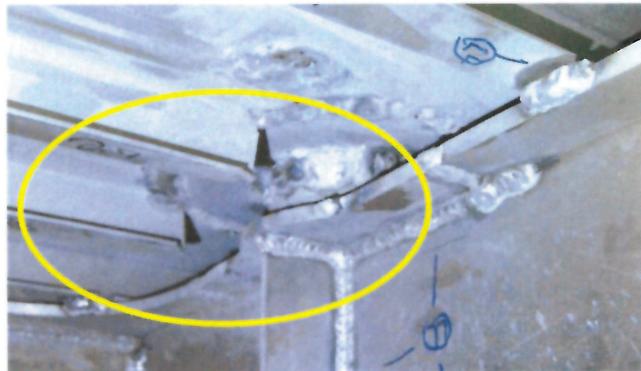
6. The deck planking stiffeners have been cut short and left unsupported in way of the pillar foundations, Figure 6.

Figure 6: Pillar Foundation

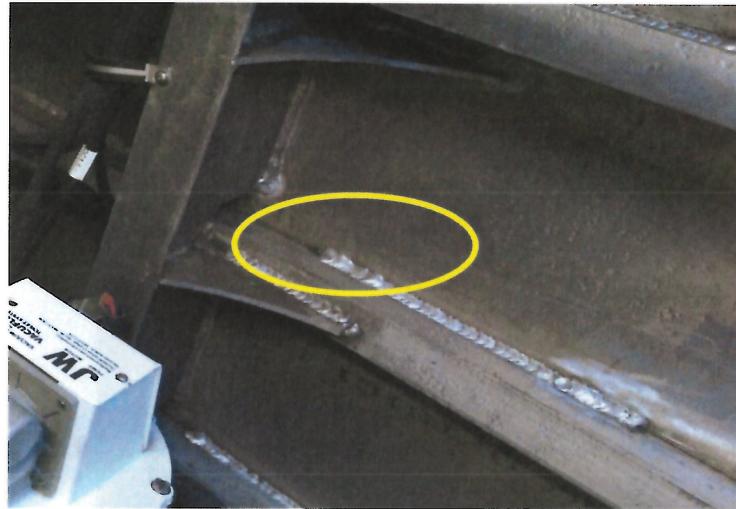
7. Weld crater, possible source of cracking, Figure 7.

Figure 7: Weld Crater

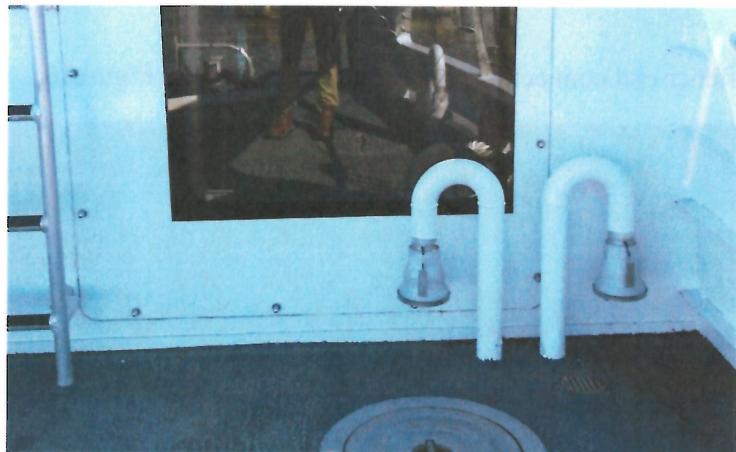
8. The 4'x5' tonnage opening is obstructed by the gooseneck vent as shown in Figure 8. Ref. [5], MTN 01-99 CH-9 69.117 (d)(2')(i), defines the "In the Clear Requirement" for End Openings.

Figure 8: Tonnage Opening Obstruction

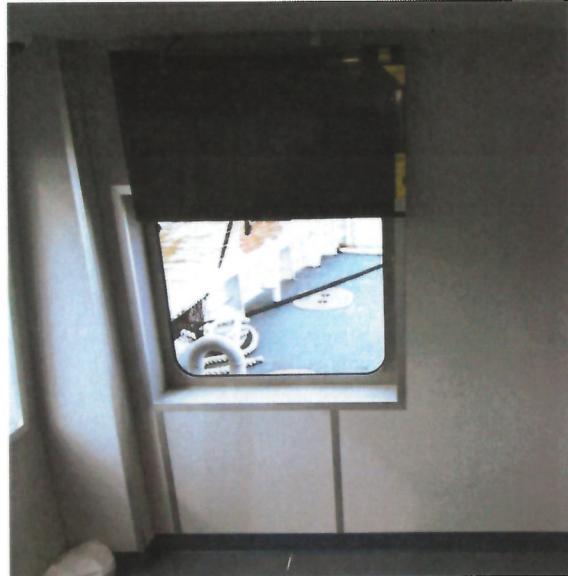
Ref. [5], MTN 01-99 CH-9 69.117 (d)(6')(ii) and (d)(6')(iii) defines the requirements for "Temporary Covers for Openings" which preclude the continuous joiner covering on the interior surface of the bulkhead, Figure 9.

Figure 9: Tonnage Opening Obstruction

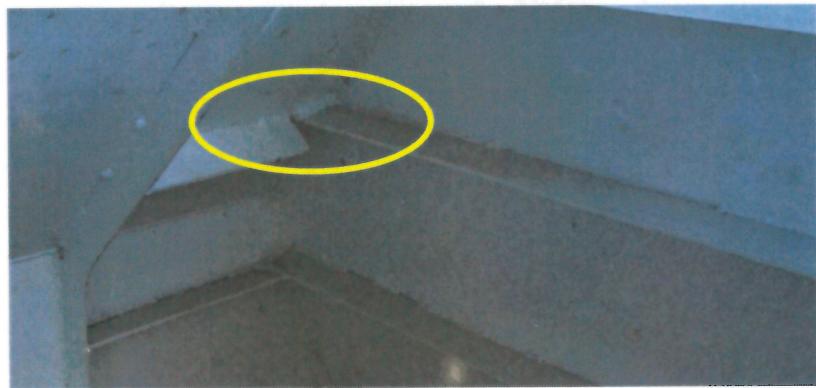
Bulwark stiffener end connections not aligned and welded, Figure 10.

Figure 10: Bulwarks Stiffener

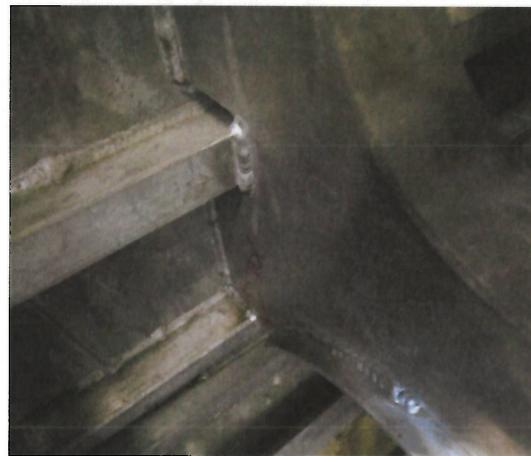
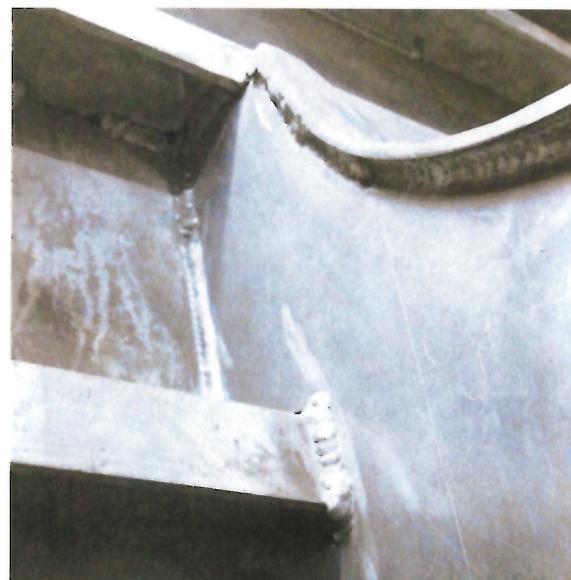
1. Black Water Tank foundation ends fully welded, Figures 11 and 12.

Figure 11: Black Water Tank Foundation

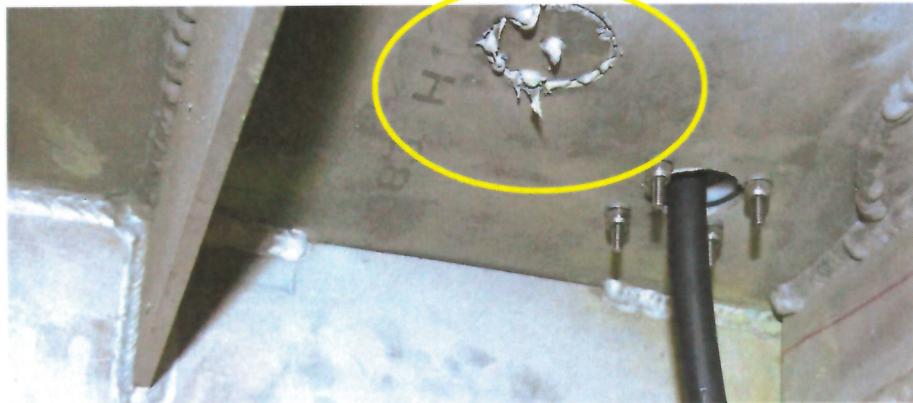
2. Main deck penetration patched and not fully welded, Figure 13.

Figure 13: Main Deck Penetration Patch

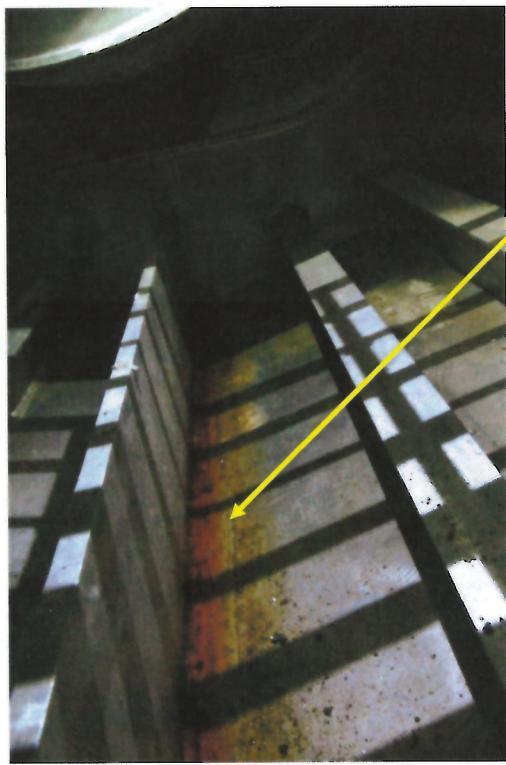
Compartment had diesel in the bilge and significant diesel fumes, so it was not safe for entry and was not inspected, Figure 14.

Figure 14: Starboard Tanks Compartment Bilge

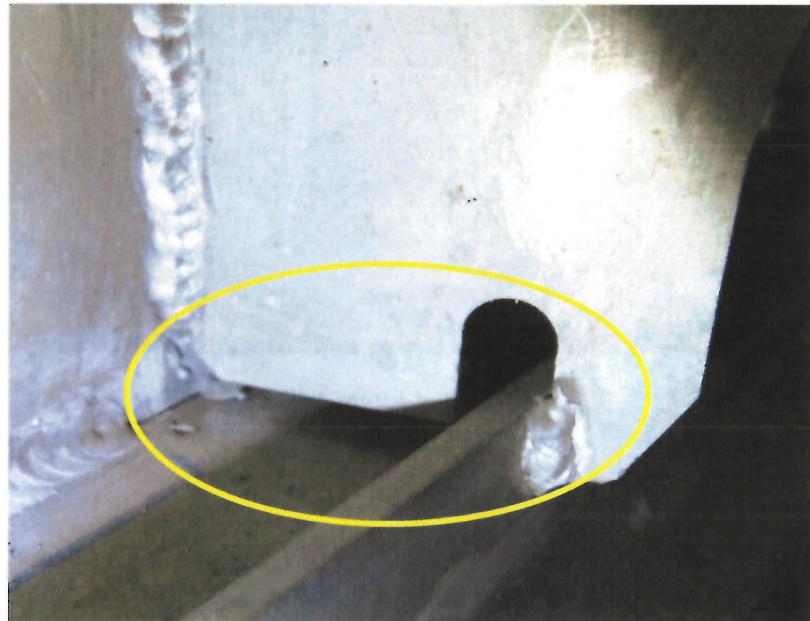
1. Deck edge bracket end connection not welded, Figure 15.

Figure 15: Deck Edge Bracket

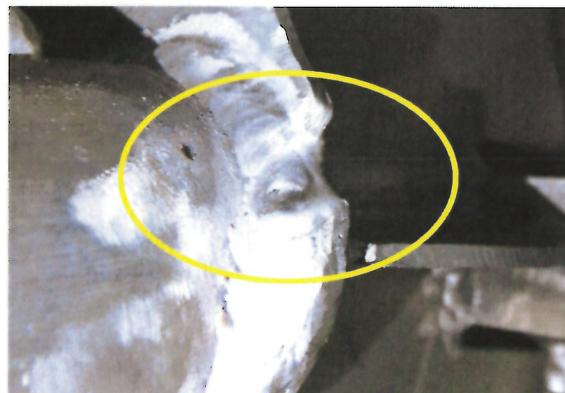
2. Weld burn through, Figure 16.

Figure 16: Weld Burn Through

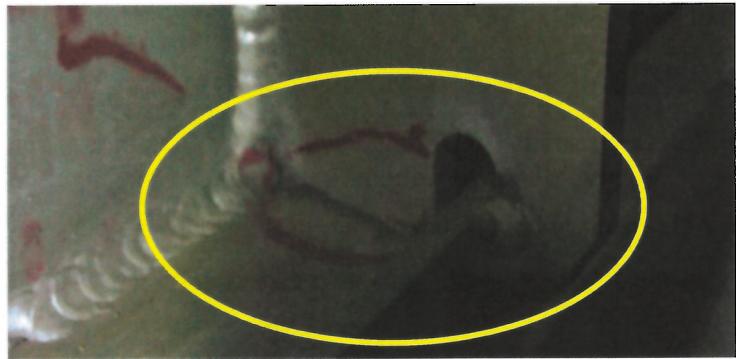
Deck edge brackets end connection not welded, Figure 17.

Figure 17: Weld Burn Through

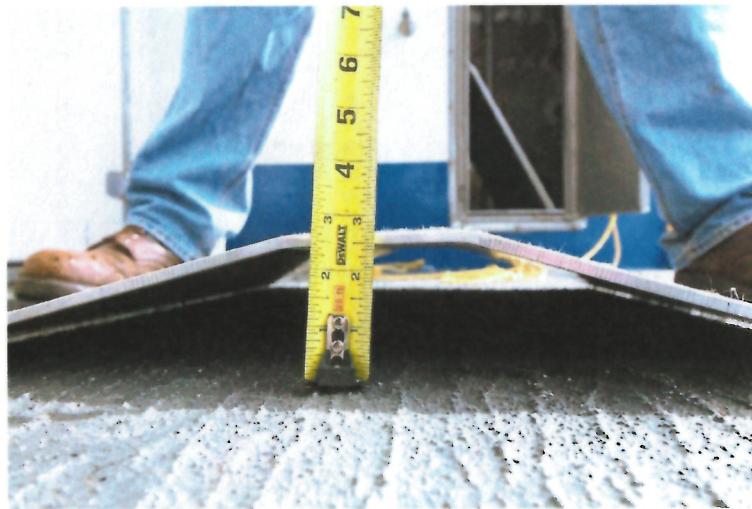
1. Wheelchair ramp not in compliance with ADA Chapter V4, Ref. [6]. Ramp rise shown in Figure 18 and ramp run-length shown in Figure 19.

Figure 18: Wheelchair Ramp Height

Recommended Resolution: Ramp to be redesigned to meet ADA requirements.

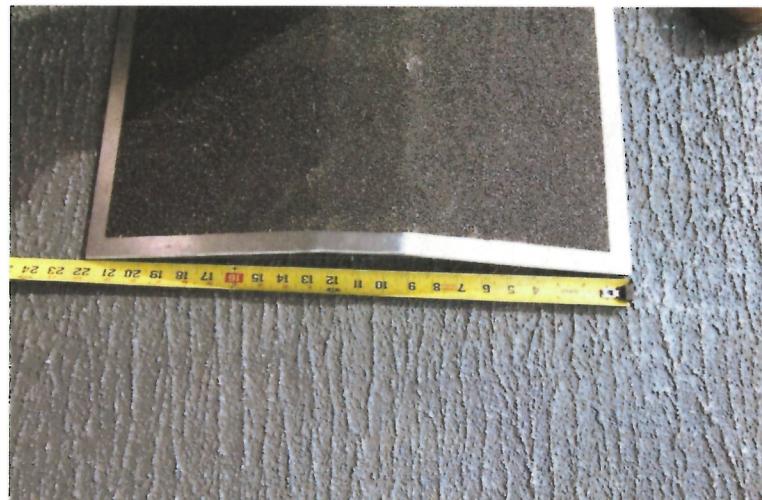
Figure 19: Wheelchair Ramp Length

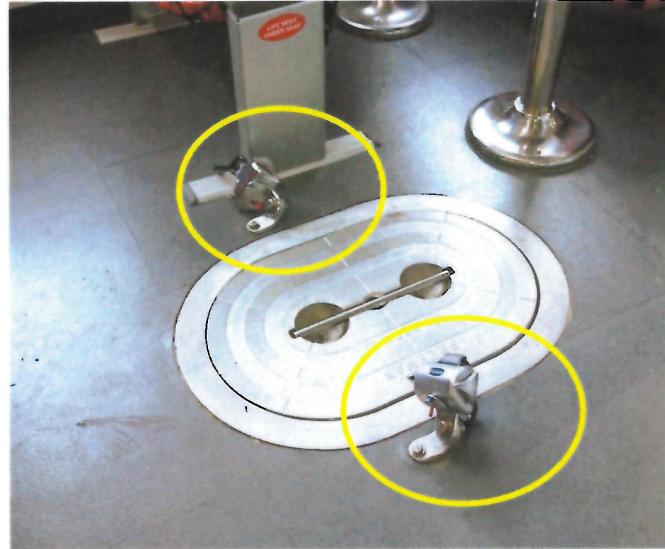
2. ADA wheelchair hold down presents tripping hazard as currently installed.

Figure 21: Wheelchair Hold Down

Recommended Resolution: Wheelchair hold-down slots to prevent tripping hazard of unmarked wheelchair hold-downs.

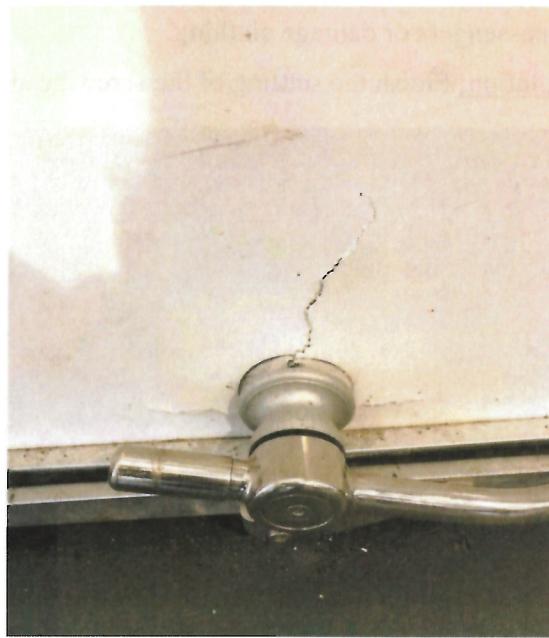
3. Weathertight door on port side of passenger compartment is damaged. Several dogs are non-functioning and have caused cracks to propagate.

Figure 23: Weathertight Door

Recommended Resolution: Replace door.

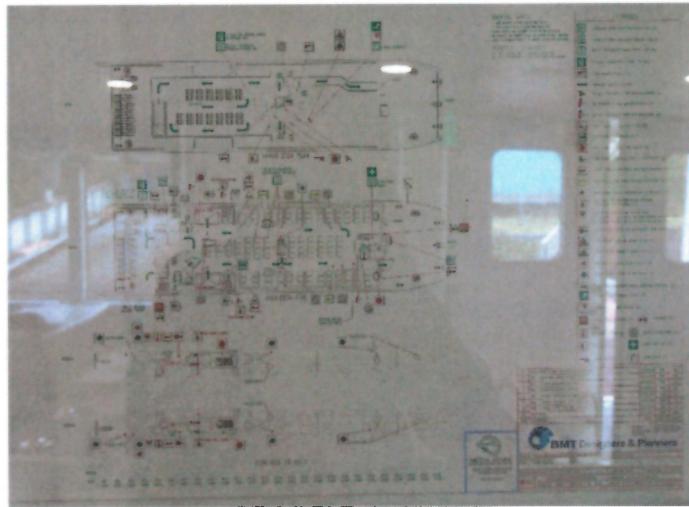
Fire and Safety Plan displayed onboard vessel does not match the existing equipment in its current status and will need to be updated before certification and before vessel can go into service.

Figure 24: Fire & Safety Plan

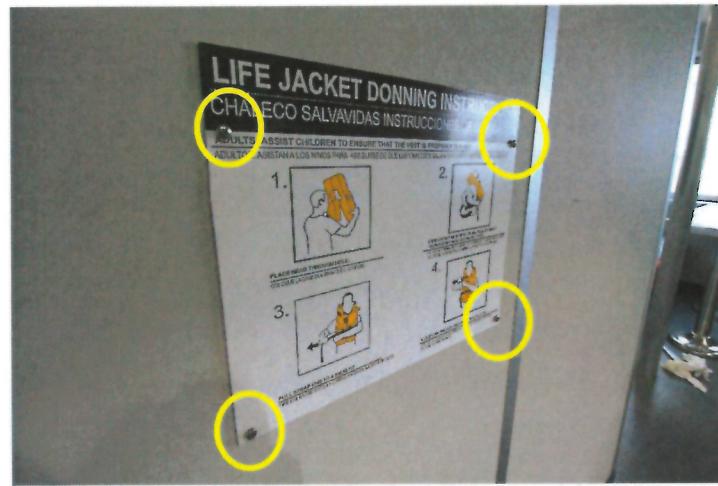
Some signage fastened with screws have screw heads protruding far enough from bulkheads to injure passengers or damage clothing.

Figure 25: Passenger Hazard, Main Cabin

Recommended Resolution: Finish the settling of the screw head to the bulkhead surface

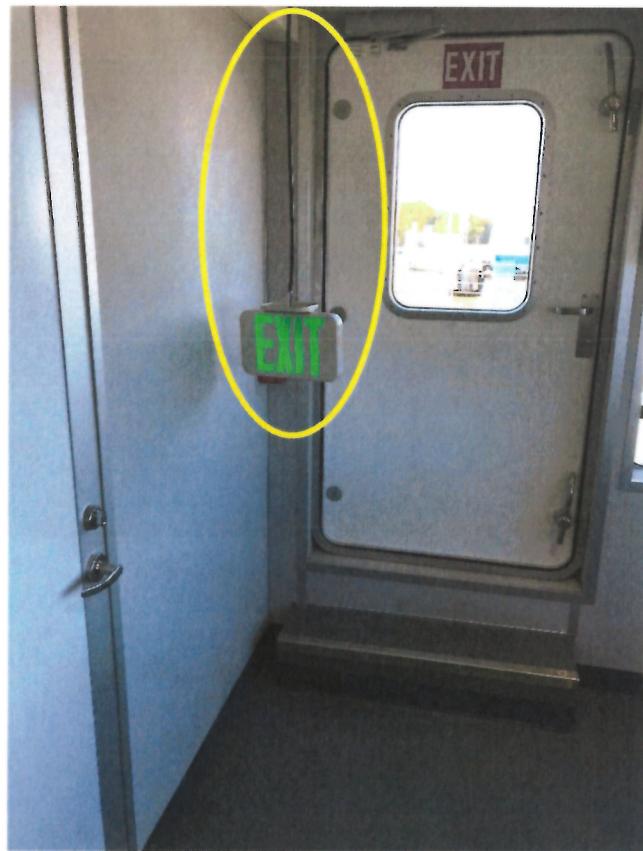
Exit sign mounted to overhead has broken and come loose. Adjacent to forward access door of main passenger compartment on Main Deck.

Figure 26: Damaged Exit Sign in Main Cabin

Recommended Resolution: Repair or replace all exit signs with a more durable fixture.

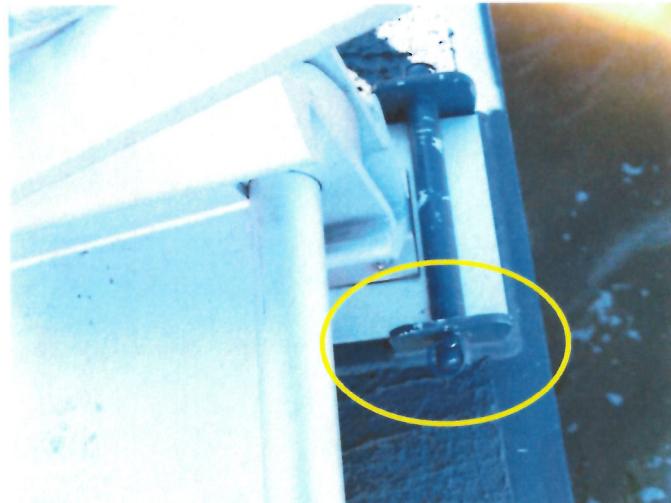
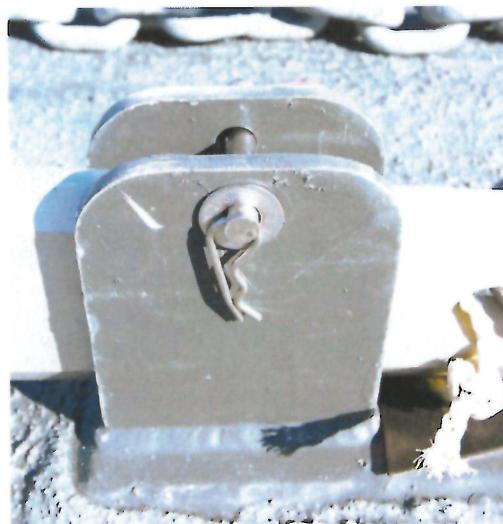
Anchor deployment will be difficult to deploy in an emergency. Pull pins shown in Figure 27 and Figure 28.

Figure 27: Anchor Locking Pin

Recommended Resolution: Redesign with different pull pins used for fast and safer operation.

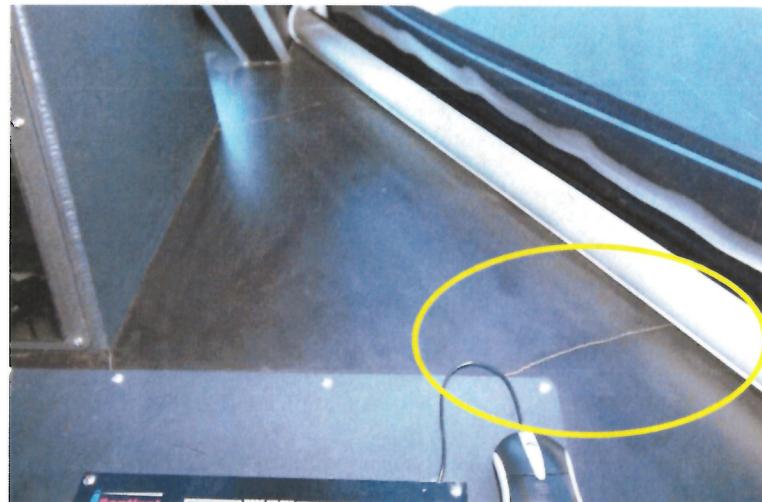
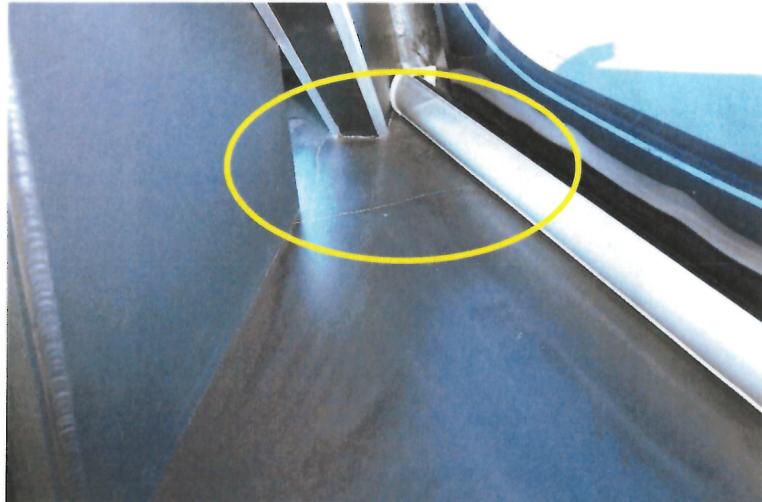
1. Cracks in the console and fitment issues with wall trim in Figure 29 and Figure 30.

Figure 29: Console Crack

Recommended Resolution: Replace console top before vessel begins service.

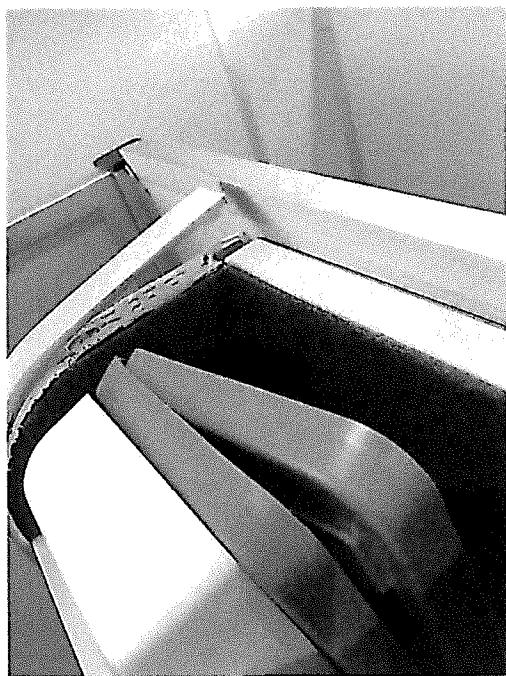
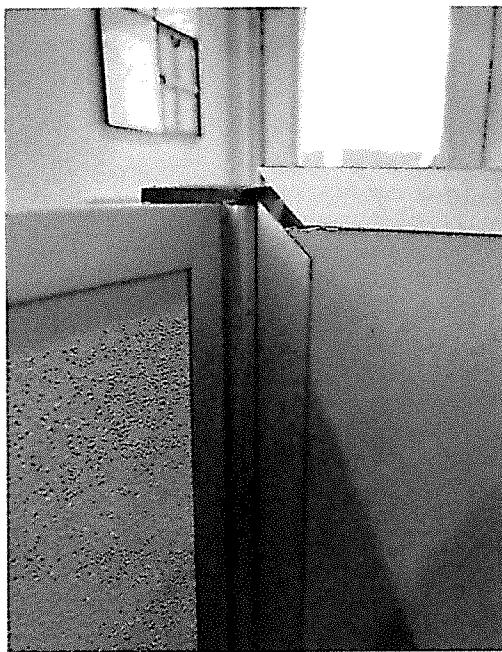
2. Joiner damage and trim fitment issues shown in Figure 31 and Figure 32.

Figure 31: Damaged Outfitting

Recommended Resolution: Replace and repair before vessel begins service.

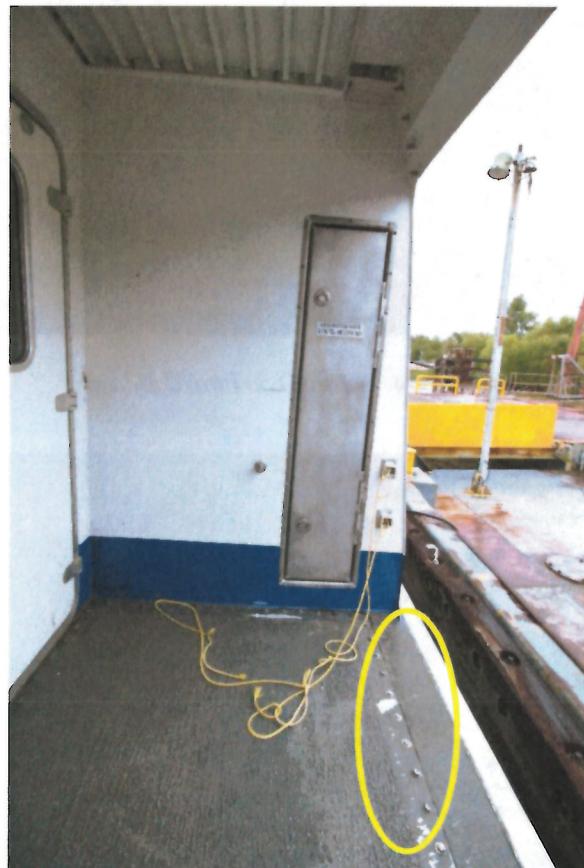
Bolted Equipment Removal Panel (BERP) is bolted in; port side is leaking; bolts on BERP are not flush. This creates a passenger/personnel hazard.

Figure 33: Deck Bolting Head Clearance

Recommended Resolution: Modify bolting so that the bolt heads do not extend up beyond the level of the deck plate or BERP plate. Condition is noted on exterior of the Upper Deck in passenger area, also.

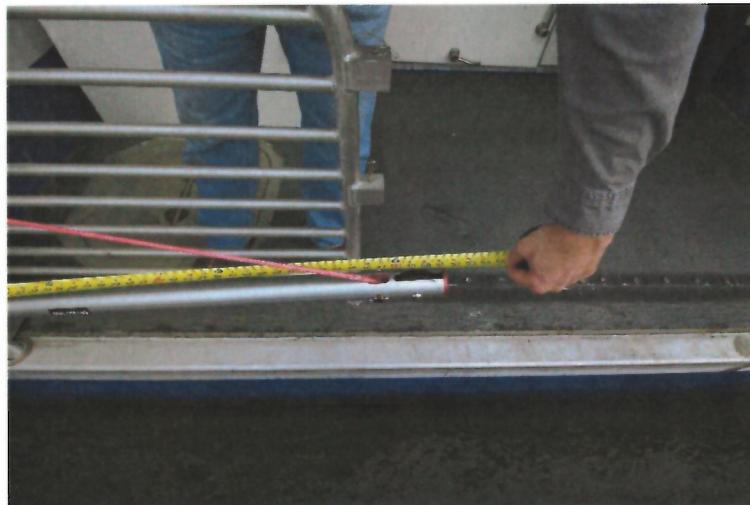
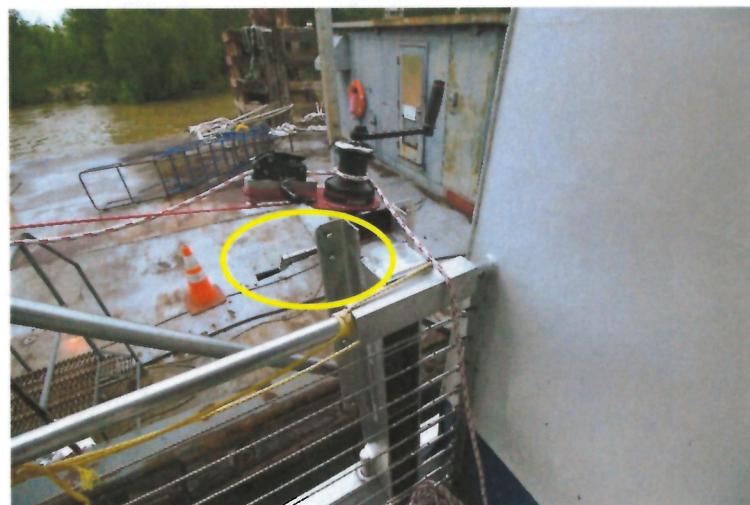
1. Man-overboard boom has not been updated to the 60" length as requested by RTA. The safe operation of the boom winching mechanism may be hindered on the starboard side due to the placement of the hand crank. Movement to the starboard side will prove cumbersome and impractical as currently designed.

Figure 34: Man-Overboard Boom

*Figure 35: Man-Overboard Boom Crank
as shown on Port Side*

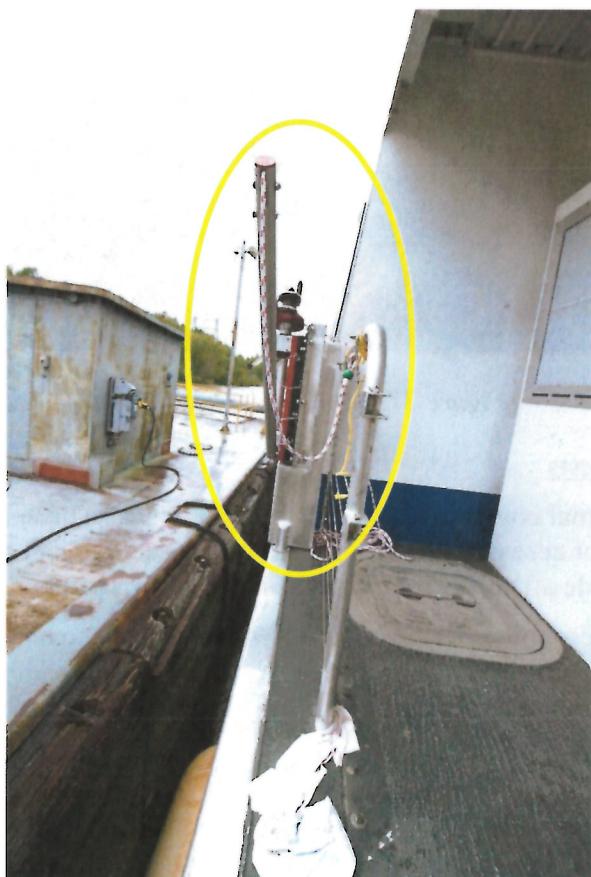
2. Recovery is not mounted high enough to bring rescued person onto deck.

Figure 36: Man-Over-Board Recovery System

Recommended Resolution: Re-configure MOB Recovery System so that an average adult can be lifted onto the deck to complete rescue operations. One possibility that has been investigated is replacing the current unit with a larger MOB recovery unit. Ensure unit is operable in port and starboard mounting locations. If customization is required for each location, installation of two units, one at each location (P & S), should be considered. Prior to reconfiguration the structure should be evaluated for the additional area stress issues.

Recommendation: Install additional lighting for rescue area for overboard visibility.

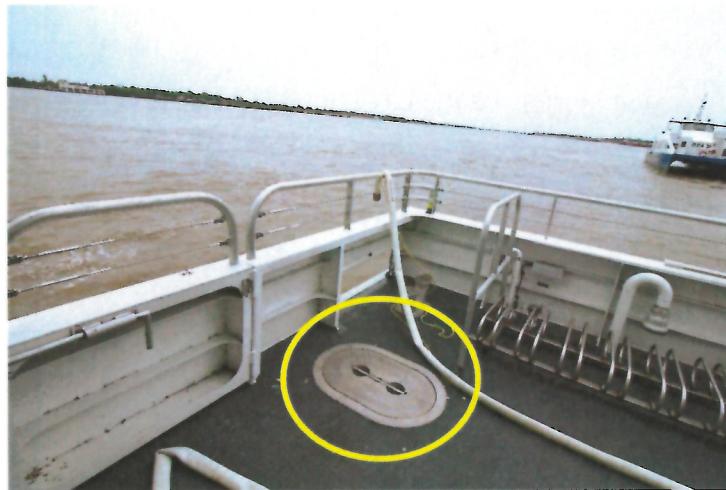
Hatches have athwartship orientation; should be forward-aft to match location of ladders for access to space.

Figure 37: Aft Hatch Orientation

Recommended Resolution: Arrangement between hatch and ladder should be resolved and physical change made.

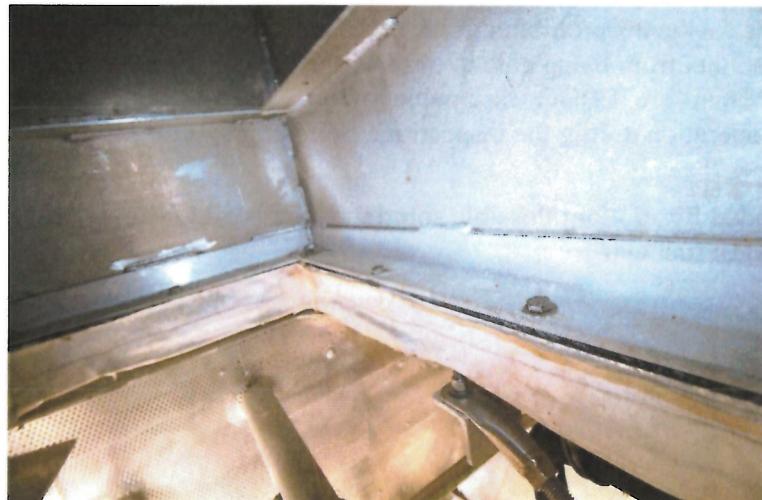
Located on gangway BERP at loading gangway. It is bolted on so that the bolts attaching the vent to the BERP are on the interior of the vent. This is very difficult to access.

Figure 38: Engine Room Ventilation Bolting

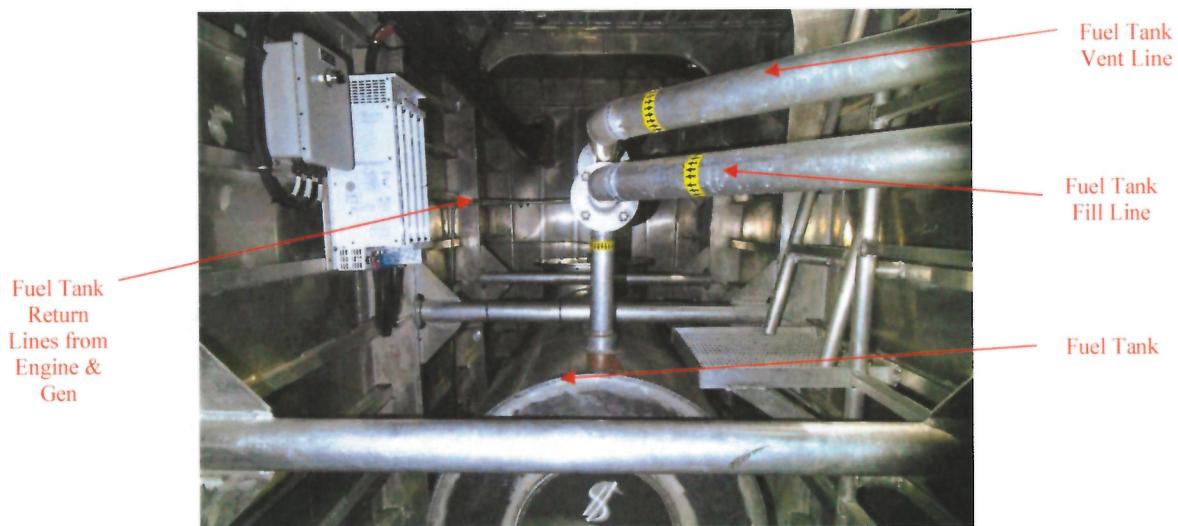
Within compartments R103 port and starboard, operating personnel cannot manually confirm how much fuel is on board in the fuel tanks. Tank levels cannot be manually determined with the present configuration of tank hardware. The inability to know much fuel is in the fuel tanks prohibited RTA personnel from running the diesel machinery and EBDG personnel from being able to observe the main engines and generators in operation. Therefore, EBDG was unable to verify the main engines and generator engines in operation during the inspection. Sounding system needs to be modified or repaired.

Figure 39: Fuel Tank Connections

Recommended Resolution: Possible solution is to install USCG approved sight glass on forward end of fuel tank.

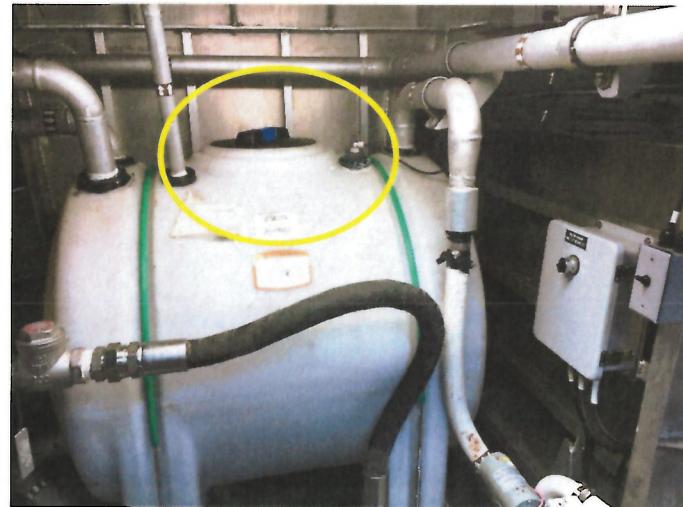
Tank is located in a below main deck compartment R101 starboard. It is unclear whether the cap is properly sealed to avoid venting into the space.

Figure 40: Black Water Tank Vent Location

Recommended Resolution: Verify tank cap is properly sealed and ensure proper venting outside the tank compartment.

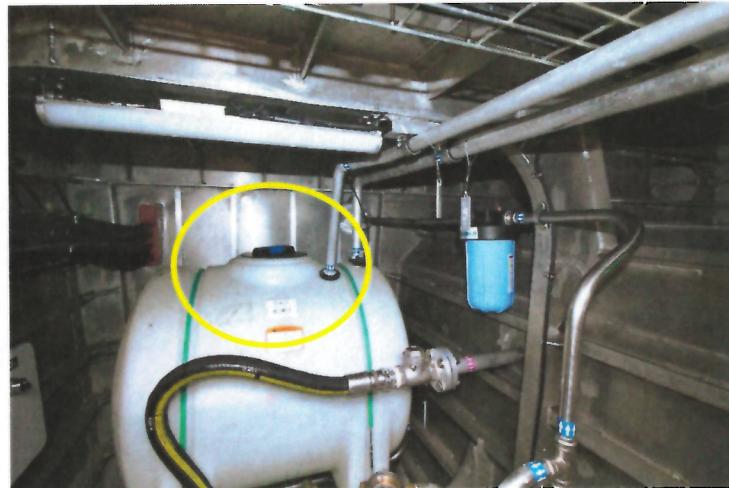
Tank is located in a below main deck compartment R101 port. It is unclear whether the cap is properly sealed to avoid venting and spillage into the space.

Figure 41: Potable Water Tank Vent Location

Recommended Resolution: Verify tank cap is properly sealed and ensure proper venting is installed for tank.

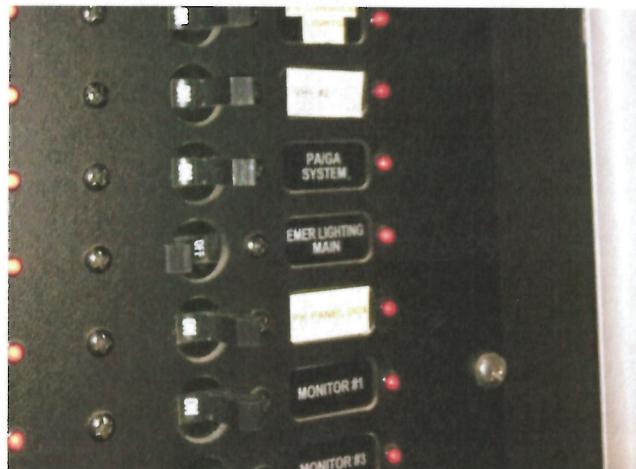
Emergency lighting in the main deck passenger area trips offline. When attempting to reset the DC supply in Panel DC#3, the panels ammeter actually drops from approximately 8 amps into the negative region, then the supply breaker trips after a few seconds. Once the breaker trips the indicator lamp remains lit, indicating the circuit is still energized. EBDG suspects the emergency lighting inverter is back feeding the circuit. Also, the emergency lighting drawing calls for a 25 amp breaker in Panel DC#3 to feed the emergency lighting. Breaker sizes are not identified in the Newmar panels, but an undersized or faulty breaker is suspected. Note this issue went away after the vessel was connected to shore power for several hours, indicating that a low battery charge was a factor.

Figure 42: 24VDC Emergency Lighting Circuit Still Energized after Trip

Recommended Resolution: Verify correct breaker is installed. Research back feed issue and correct as needed.

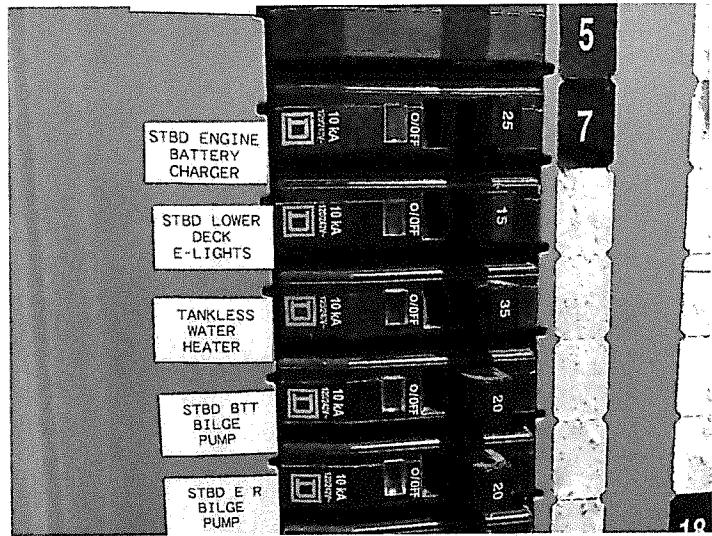
Panel P23 in the crew office has circuit number labels partially removed. The remaining panels, P21, P22, and P24 have no circuit number identifying labels.

Figure 43: Partially Removed Number Labels in Panel P23

Recommended Resolution: Rework panel circuit breaker labels so that each breaker has a unique circuit number.
