# County of Ventura

## Oak Dell Ballfield Inspection

October 6, 2023

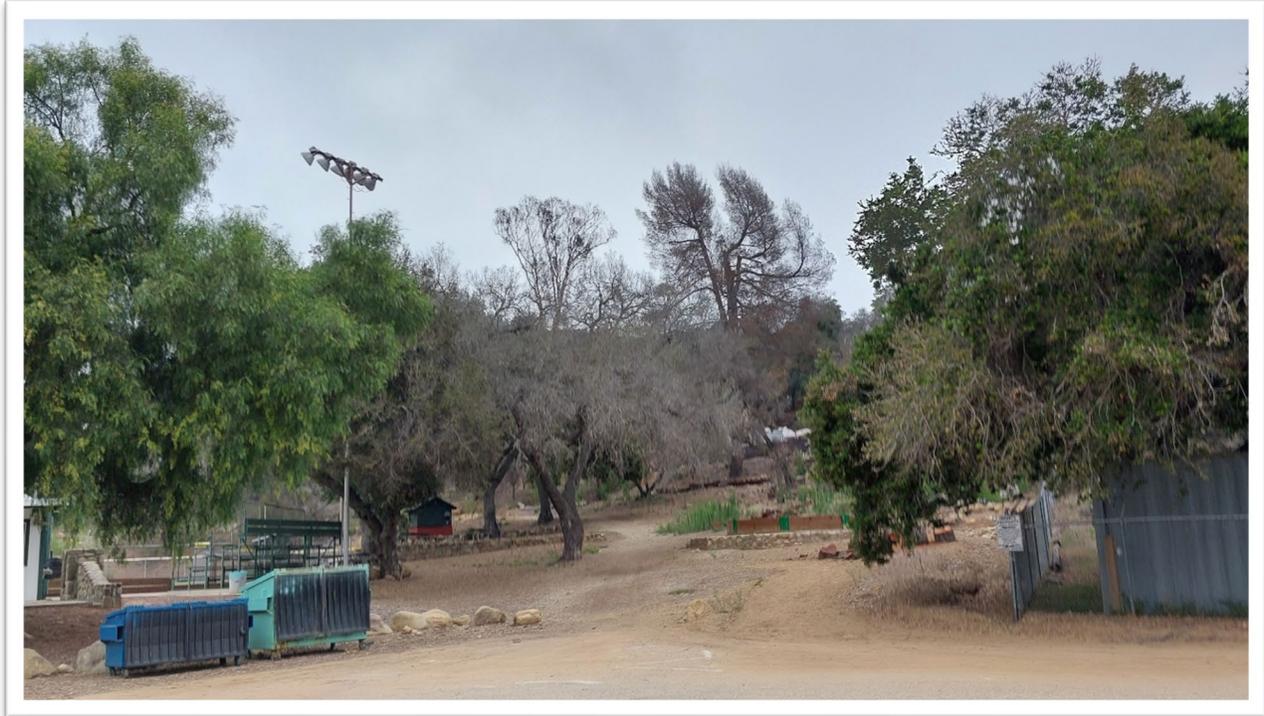
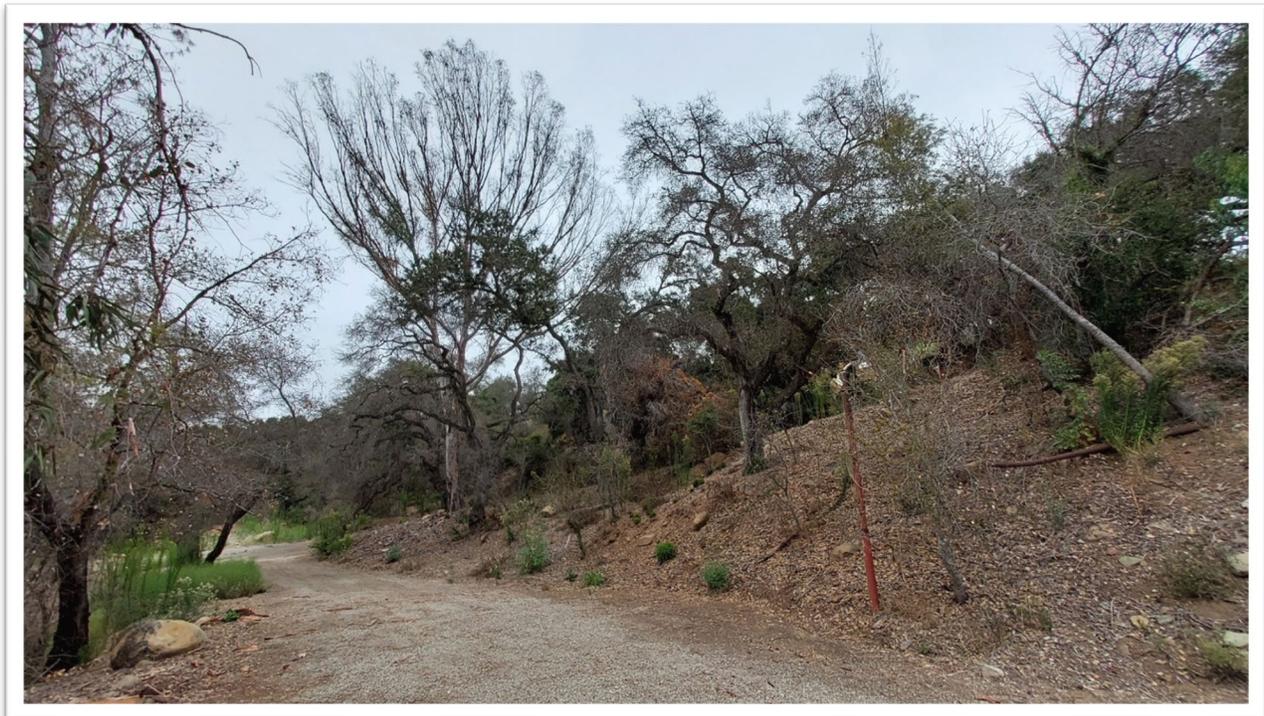
Imazapyr is a common herbicide found in commercial and retail products used to control weeds and is known to be highly damaging to trees. The application instructions, depending on the manufacturer, state not to use the product within the dripline of trees. Imazapyr has three very significant characteristics that make it deadly to trees. 1) It is a very broad-spectrum herbicide, meaning it is non-plant specific and can potentially kill any plant that comes in contact with it. 2) It is soluble in and transported by water (often via drift, leaching through the soil, or via lateral movement by precipitation or irrigation). 3) It does not bind to sediment, so leaching through the soil into groundwater is very likely.

*Image 1 (top). Shows the access road easterly up from the parking lot, with the ball fields on the left and a private property on the right. Note the dead oaks, a dead pine, and a dead eucalyptus in the background. Image 2 (below) was taken walking up the access road to the east of the ball fields. Note the large degree of plant mortality of oaks, eucalyptus, pines, shrubs, and ground cover. There was hardly any plant not impacted.*

Removal is the recommended treatment for trees that show a full or high degree of canopy death, especially for those near the ball fields, walkways, parking lots, or other areas where people may congregate.

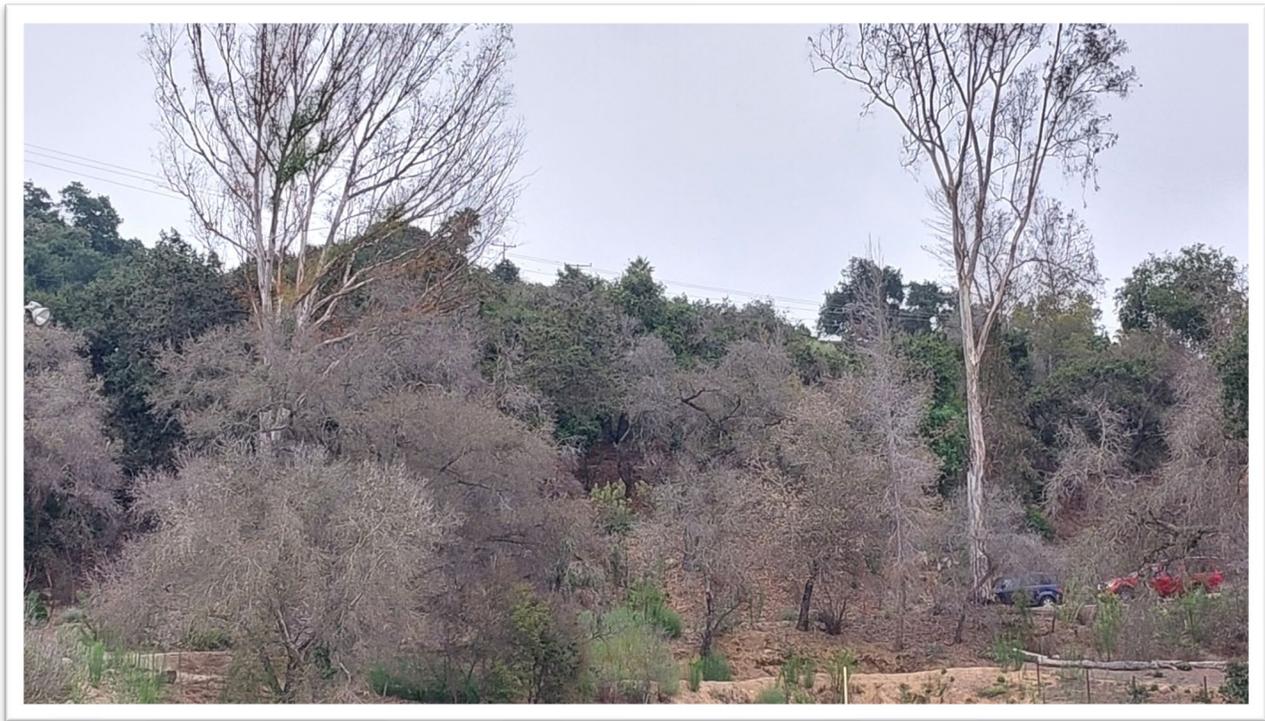
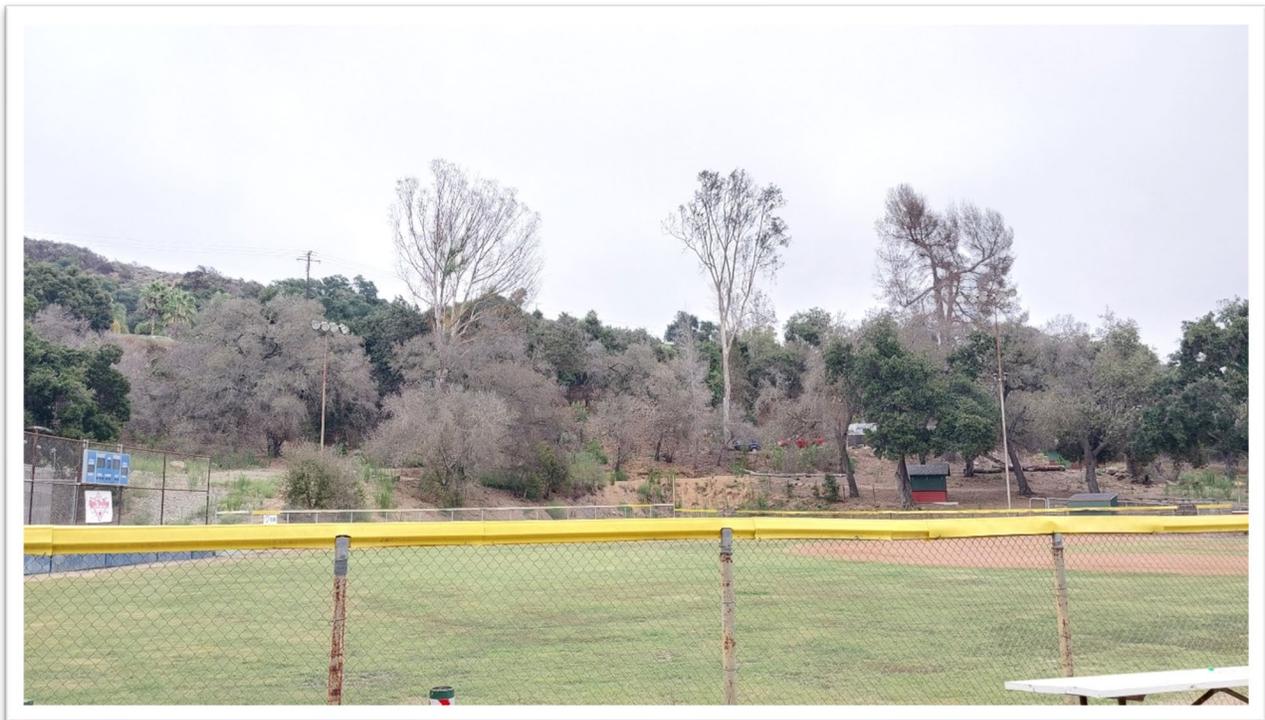
*Images 3 & 4 show the sloped area along the east side of the property as seen from the opposite side of the ball fields. Note the vast level of plant death, including mature oaks, eucalyptus, pines, and almost all shrubs and ground covers.*

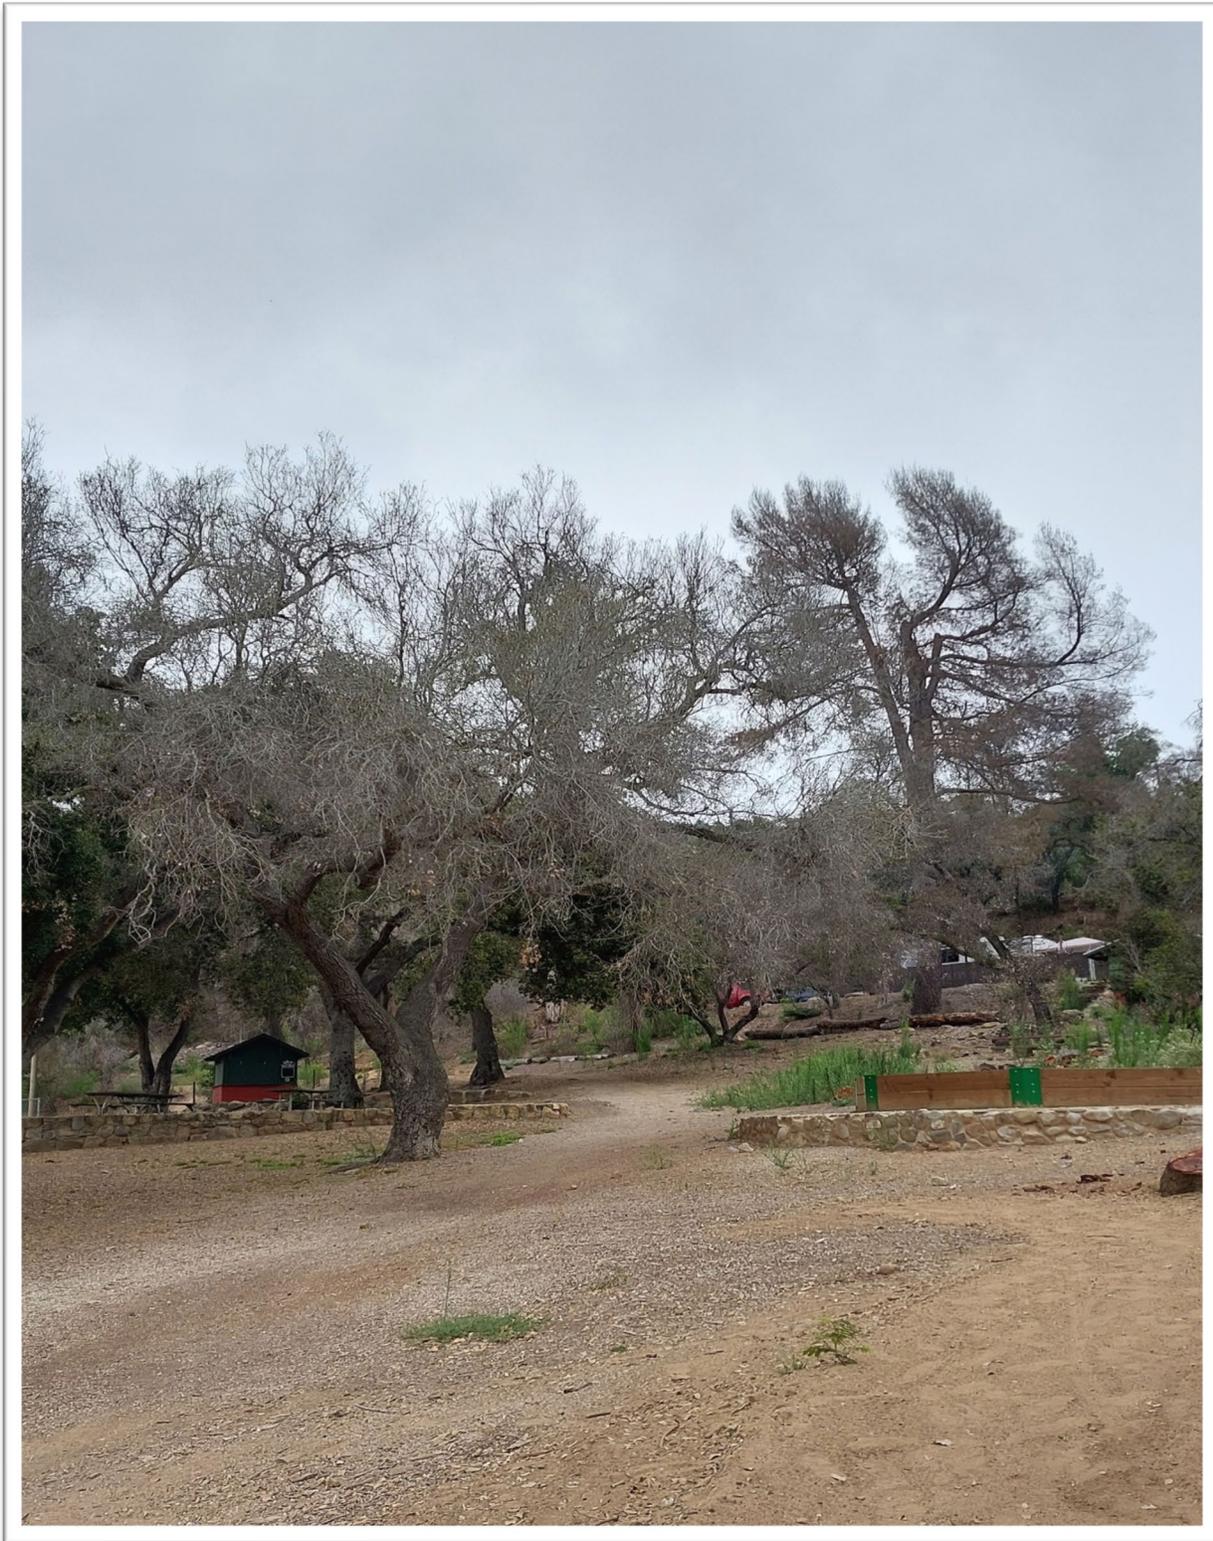
*Image 5. Showing more of the dead and impacted trees along the sought side of the ball fields. Trees displaying full canopy death are not expected to recover and should be removed from the site if located where falling trees or their parts could damage people or property.*

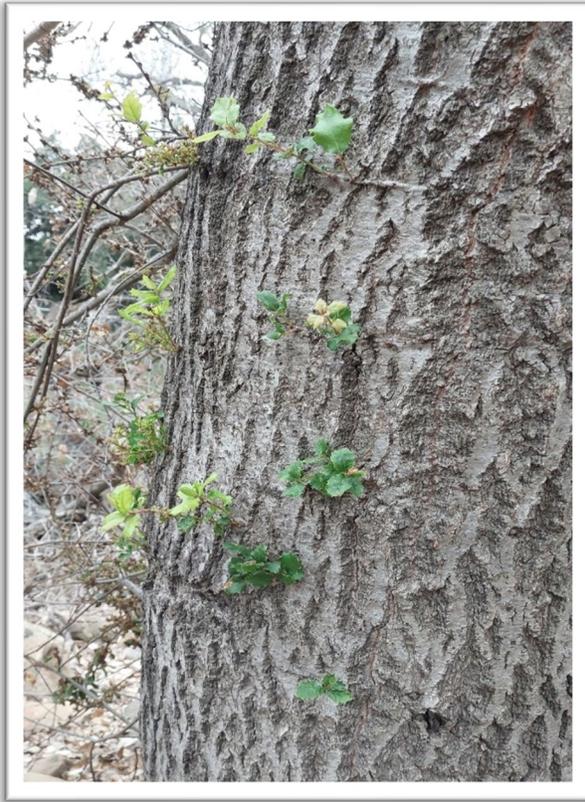
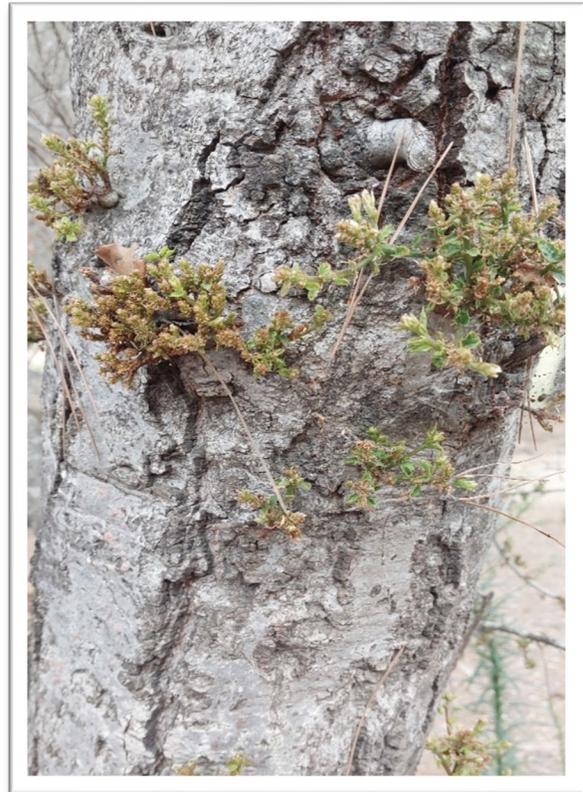
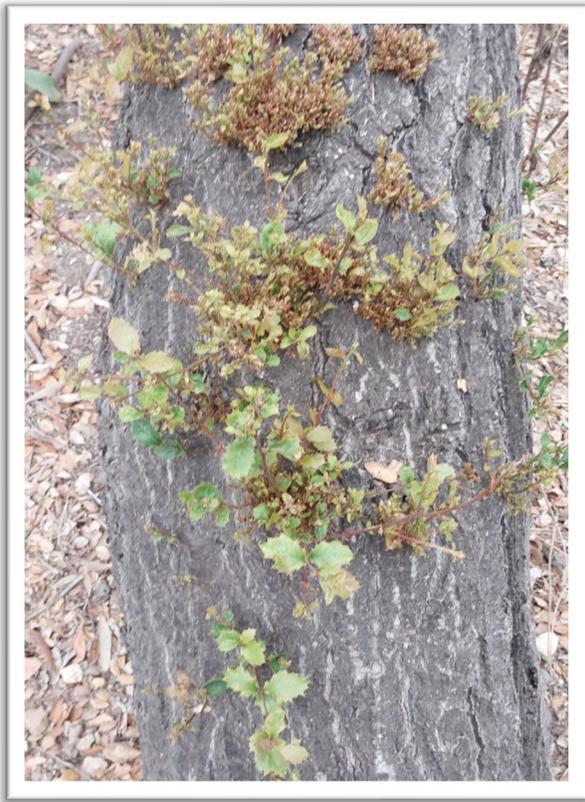
Many mature Coast Live Oaks have been significantly impacted and display full canopy death. A few of the oaks have epicormic growth on their trunks; this is generally considered a stress response and not a sign of recovery. Some of the oaks near the parking lot have not declined to the point where death is likely. However, they do display distorted terminal growth, often called “witches’ broom,” knobbing, or tufting. This type of growth is a classic response to chemical

*Images 6-8 show examples of the epicormic growth seen on the trunks of a handful of the oaks. This is a stress response and does not indicate that the tree has enough energy reserves to recover. Overall, vigor is very poor, and vascular damage is considered too great.*

Based on the level of dieback present on so many of the trees, the damage is believed to be too great to expect recovery for the majority of the trees affected. There are a few trees that have been damaged but appear to be stable, and these should be retained and monitored, pruning as needed to remove any dead material that could break out and possibly cause physical injury to site visitors. Ensure that affected trees are receiving adequate irrigation.

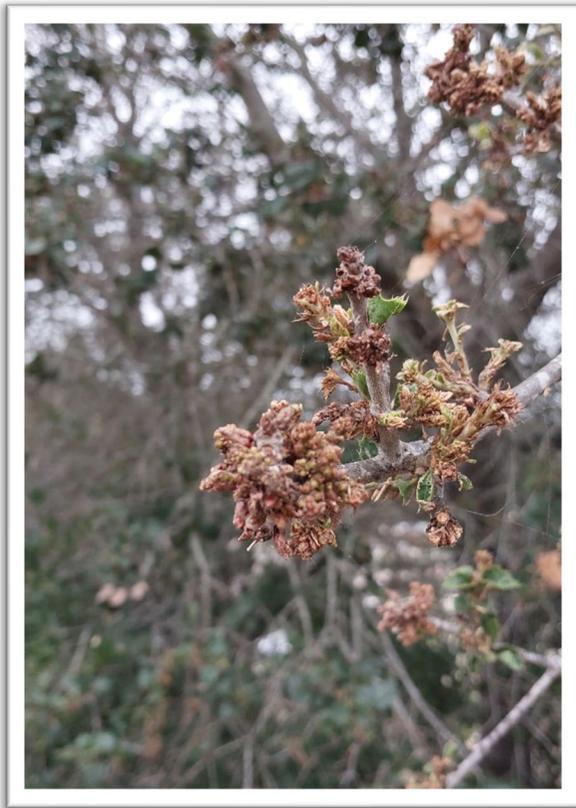
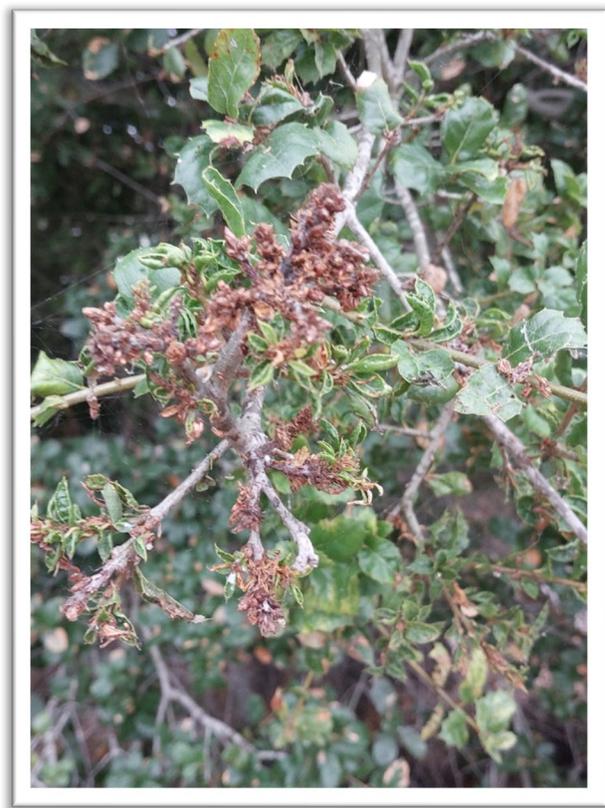
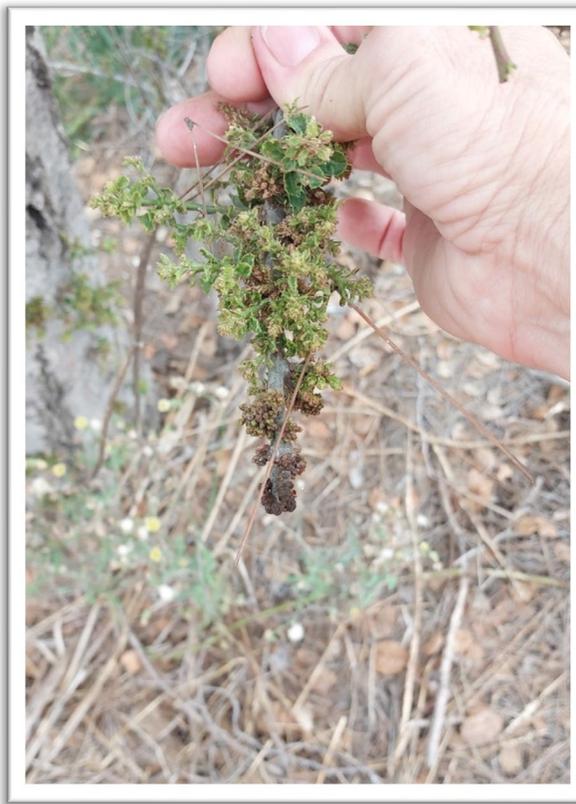
exposure via herbicide injury. Several pines in this same area display flagging (localized areas of dead branches) and were also most likely impacted by the same chemical exposure.

Multi-residue screening results obtained from Farm Growers Labs indicate that nutrient content is not a limiting factor in plant growth at the site. No root pathogens were isolated and are therefore ruled out as a causal agent. The herbicide Imazapyr was confirmed to be present in one of the samples provided to me by Count of Ventura staff. Another chemical, 0-Phenylphenol, was detected in the same sample and at a higher amount than the Imazapyr. This is a chemical I was not familiar with, but it appears to be present in pesticides (specifically fungicides) to control fungal and bacterial growth. It is also used as a disinfectant fungicide for industrial applications on ornamental plants and turf.

*Images 9-11 show examples of the abnormal, tufted, knobbed, “witches’ broom” growth seen on some of the oaks just along the south side of the upper ball field parking lot. This is a classic symptom of chemical exposure.*

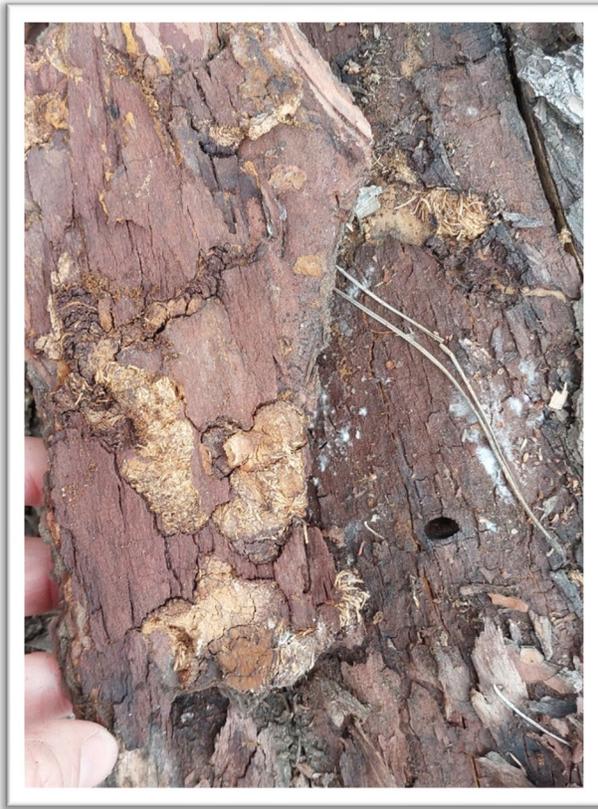
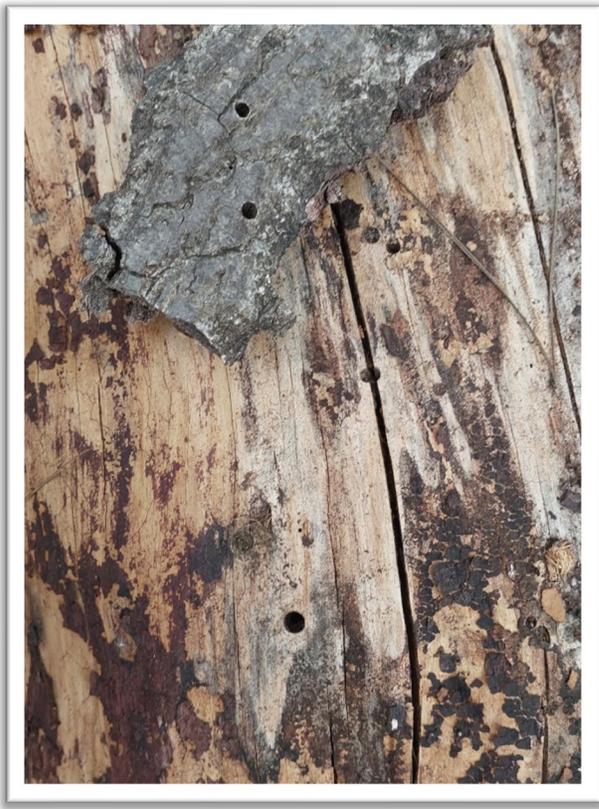
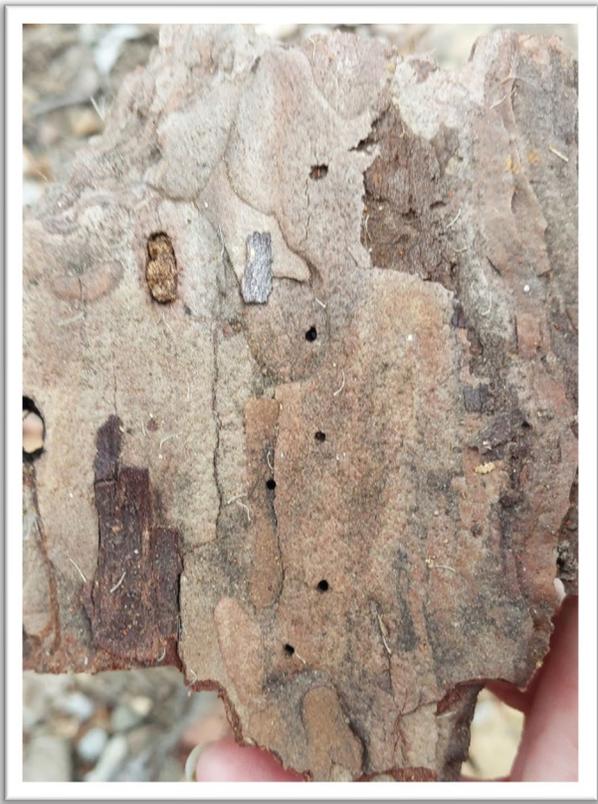
Inspection of the remnants of a fallen pine and the stump of a recently removed pine on the sloped area near the residential outbuilding showed evidence of bark beetle. However, no signs of insect presence were found on the symptomatic oaks or the dead eucalyptus.

*Images 12-14 show parts of the pine tree that have evidence of borer activity. Two different sized holes are present.*
