Spencer Dam Failure Investigation Report

In the early morning hours of March 14, 2019, Spencer Dam on the Niobrara River in northern Nebraska failed during a major flood and ice run on the river. An independent investigative panel was formed to examine the failure.

April 2020

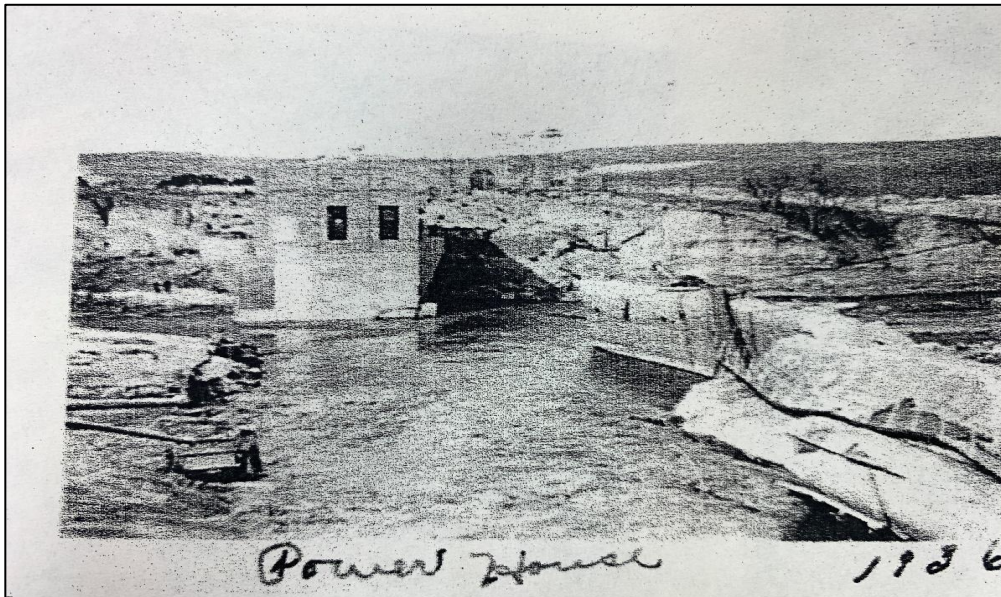
As the result of a high pool elevation, high water pressures developed within the foundation, and the entire spillway structure detached from its shale foundation and slid 30 to 50 feet downstream (Figure 2.8). The spillway was reconstructed in 1940 with foundation keys and anchors to prevent sliding.

Figure 2.10 - 1936 Spencer Dam failure due to the concrete spillway sliding 50 feet downstream – NPPD photo.

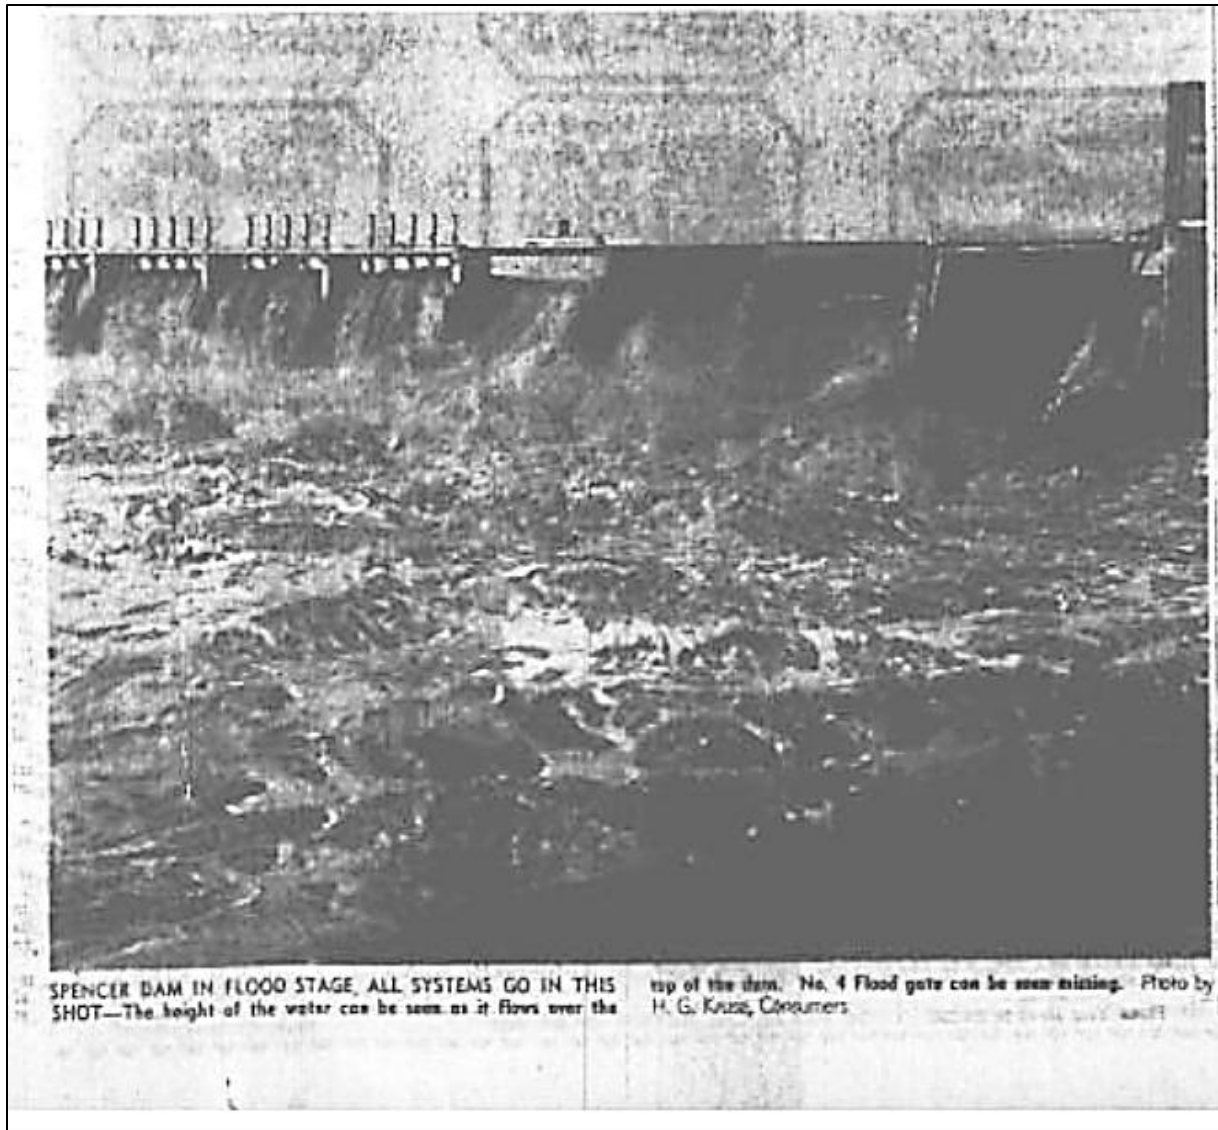
Figure 2.11 - Caption: "SPENCER DAM IN FLOOD STAGE, ALL SYSTEMS GO IN THIS SHOT" - The height of the water can be seen as it flows over the top of the dam. No. 4 flood gate can be seen missing. Photo credit Holt County Independent March 17, 1966, page 4. Research source: History Nebraska.

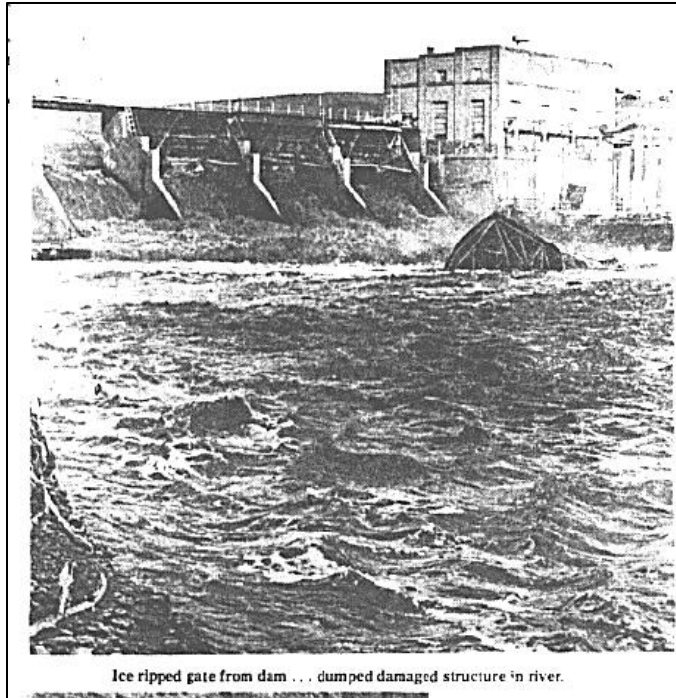
Figure 2.12 - Caption: "Ice ripped gate from dam. Dumped damaged structure in river."
[Photo: Omaha World Herald March 15, 1966, page 11]. Research source: History Nebraska.

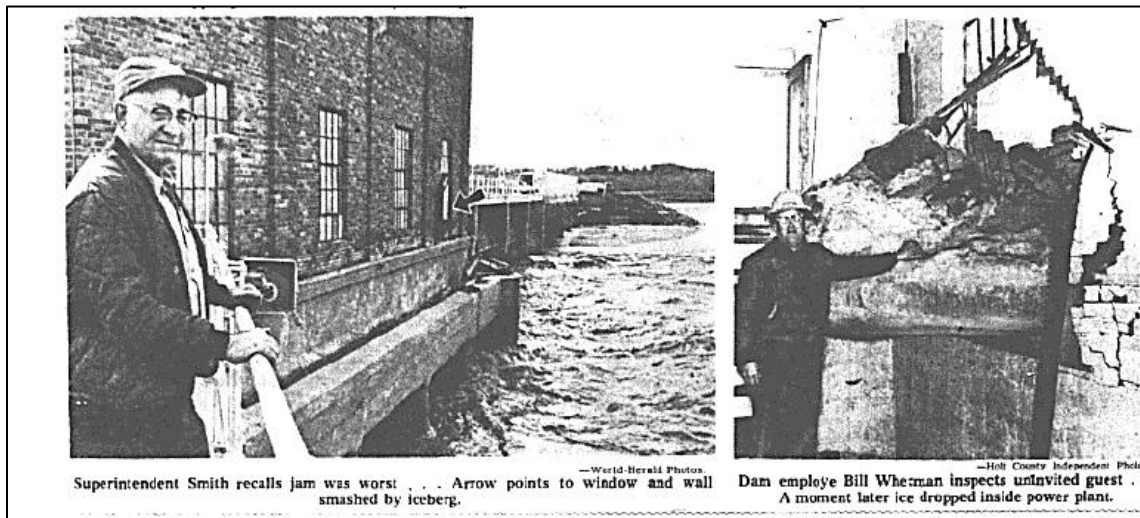
Figure 2.13 - Damaged window and ice – Photo: Omaha World Herald March 15, 1966, page 10. Research source: History Nebraska.

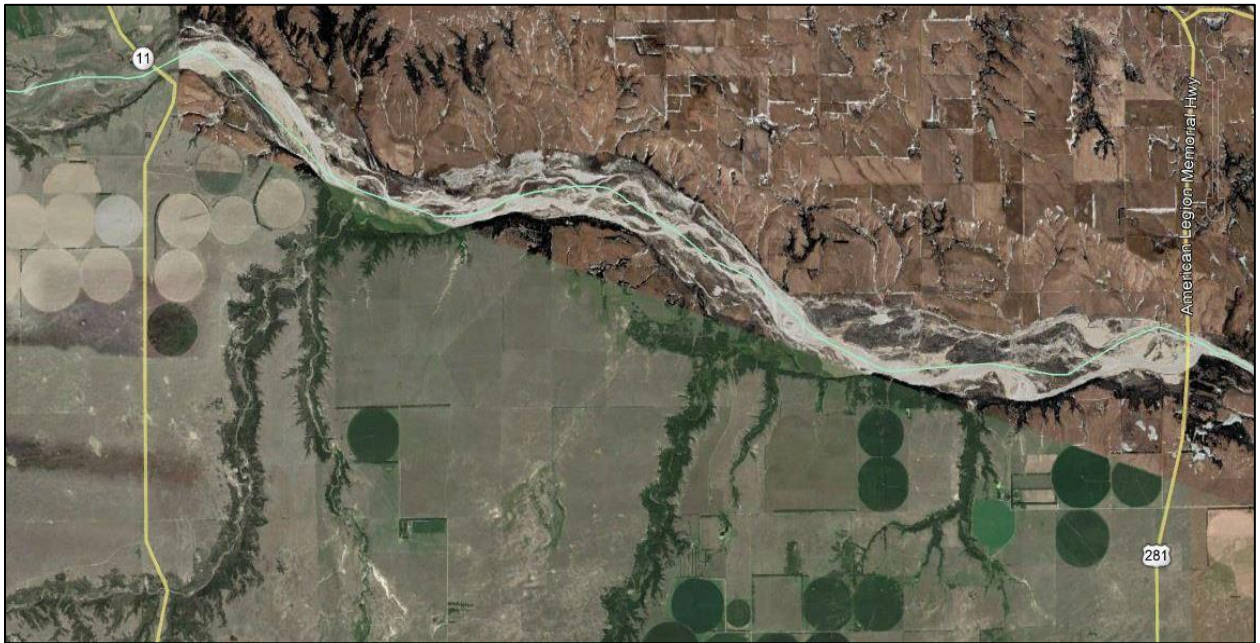
Figure 4.2 - Niobrara River between the Highway 11 Bridge (upstream) and the Highway 281 Bridge (downstream from the dam) after failure. From Google Earth (3/2019).

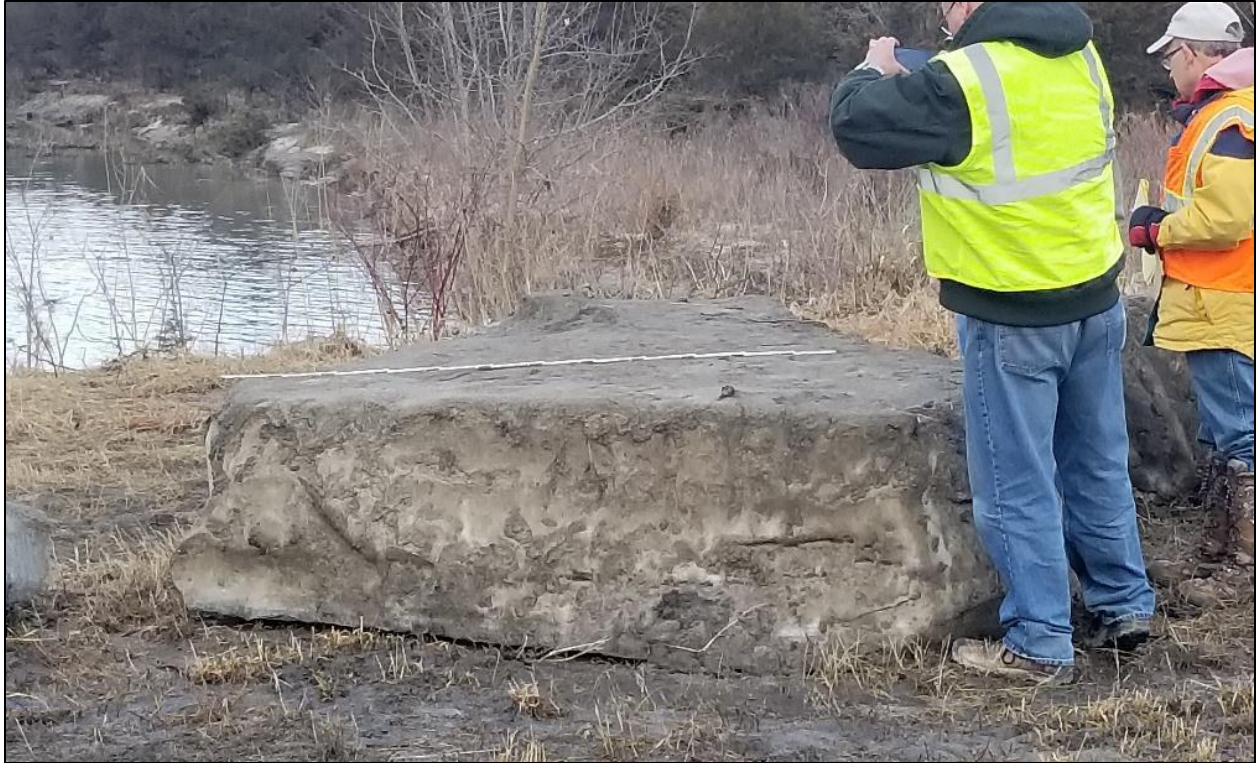
Figure 4.3 - 2-foot thick ice block (NPPD photo, March 2019).

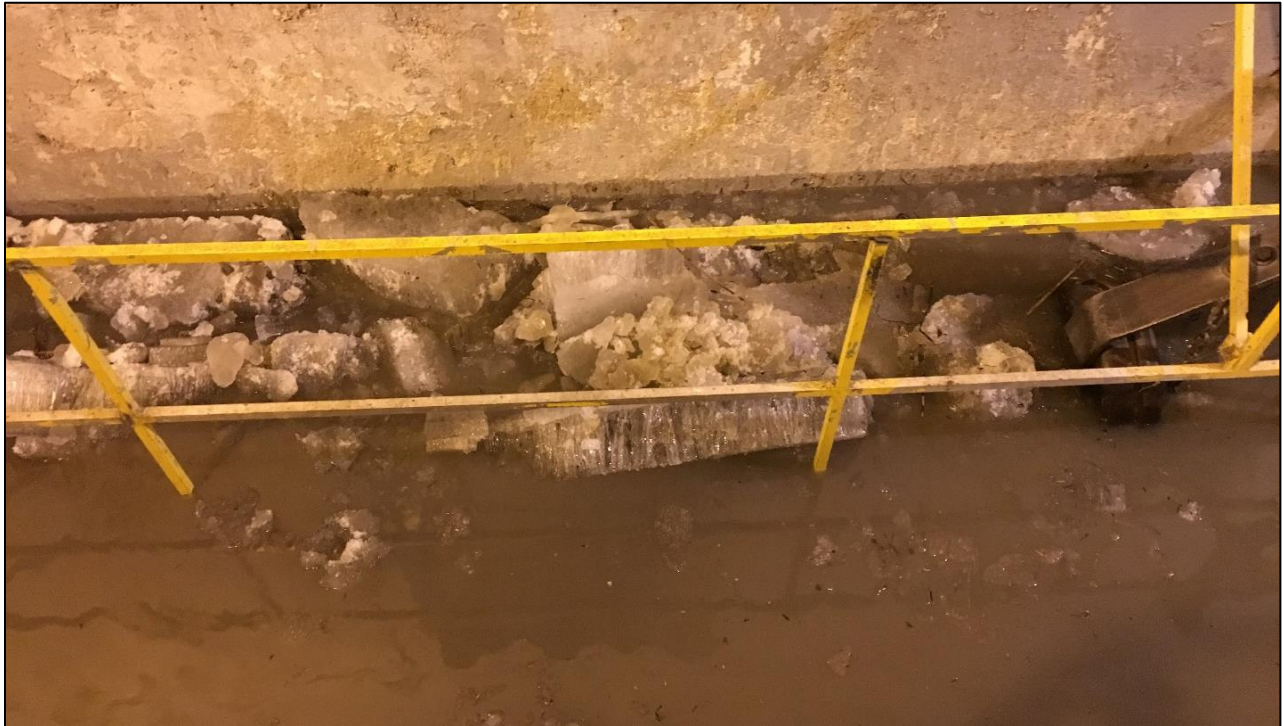
Figure 4.4 – Water and ice entering the trash-rake room at 4:38 AM on March 14. The trashrack slots are behind (upstream from) the railing (NPPD photo).

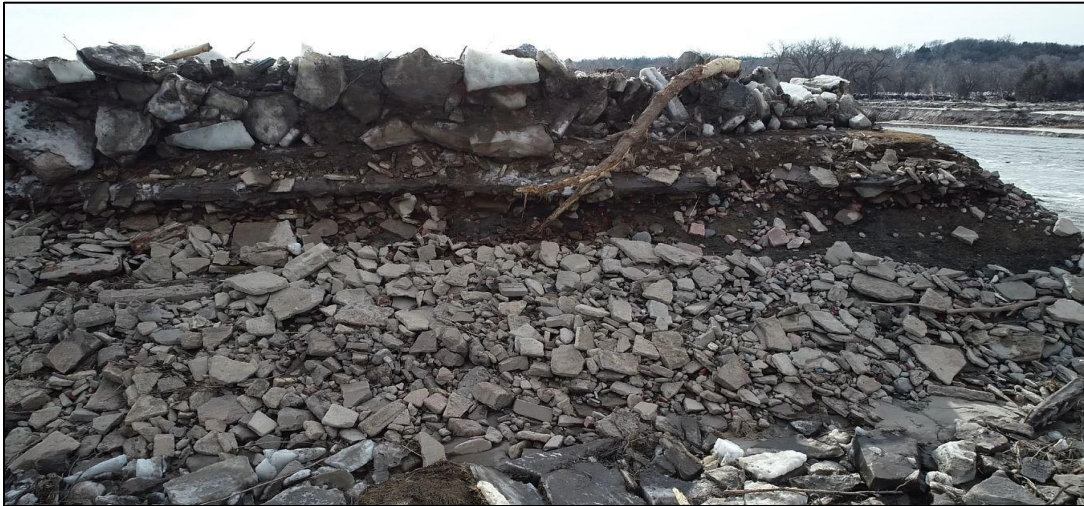
Since the physical evidence indicates that ice rubble, and not necessarily water was approximately 4.5 feet above the dike's crest (Figure 4.7), the water level itself may not have been this high. The high-water mark measured in the downstream generator room of the powerhouse was 7-feet 7.5-inches above the floor at elevation 1505.36 (Figure 4.5). This observation puts the water level at elevation 1513.0 (about two feet above the dike). The discrepancy between water level and ice level could be explained if the surge pushed, rather than floated the ice over the dike. Floating ice would only be several inches above the water surface. As the ice was being forced over the dike and through the powerhouse wall to a height of 4.5 feet above the dam, the reservoir water surface may have only risen to a height of two feet above the dam.

Figure 4.7 – Ice stacked on the north end of the south breach. The elevation of ice measured in the reservoir rim upstream from the powerhouse was about 4.5 feet above the design top of dam elevation (from NPPD video).

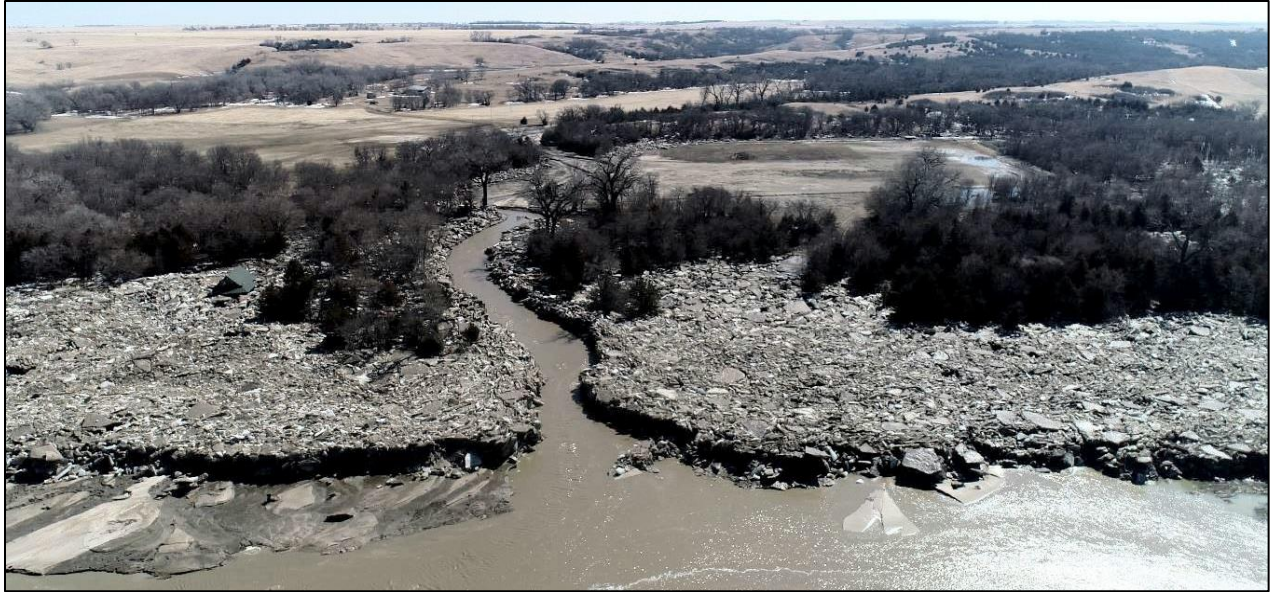
Figure 4.8 – Ice deposits upstream from the Stuart-Naper Bridge. For scale, note the roof sticking out of the ice on the left side of the photo (from NPPD video).

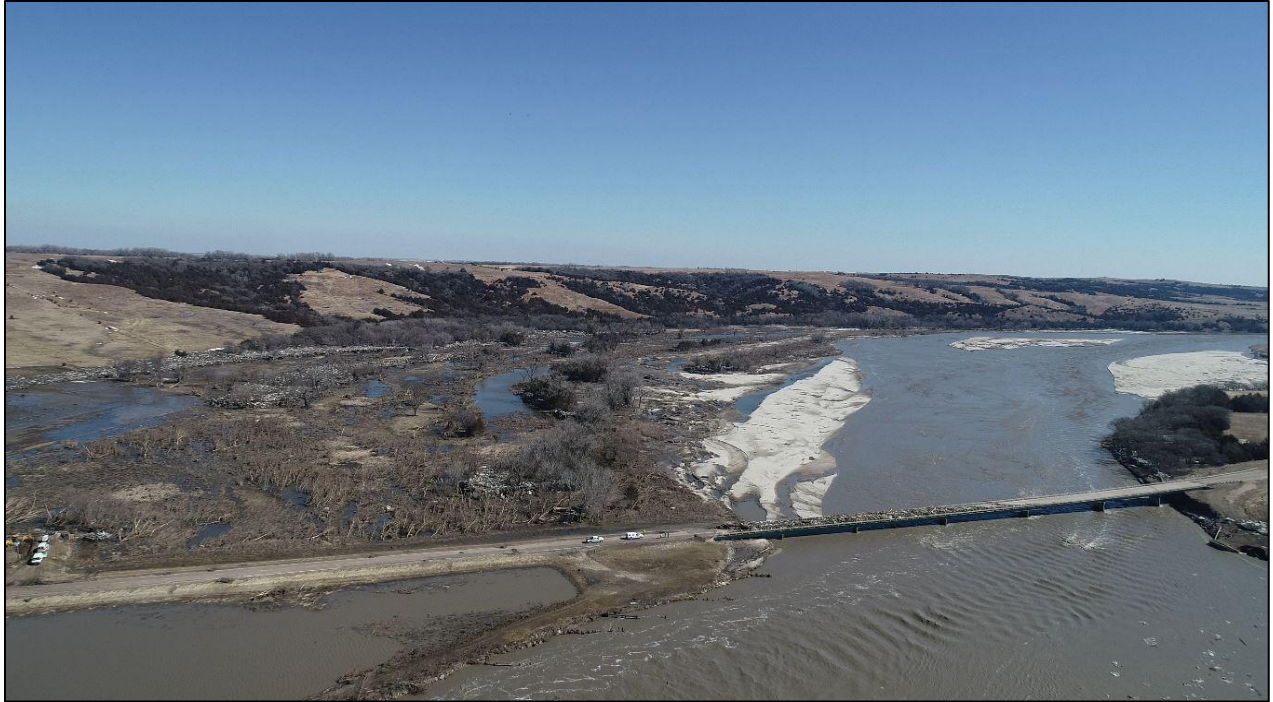
Figure 4.9 – Highway 11 Bridge and north approach looking downstream. Note the ice trapped between guardrails on the bridge and along the far-left bank (from NPPD video).

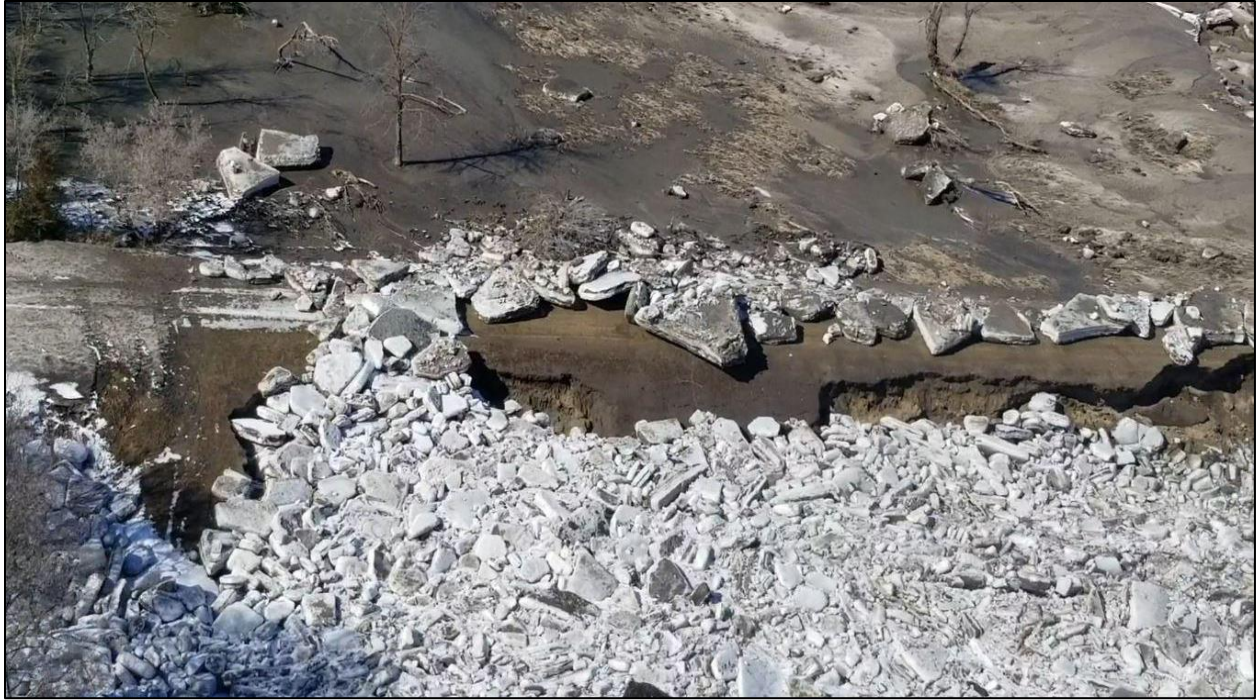
Figure 4.11 – South end of south dike looking upstream showing the headcut erosion on the downstream slope of the dike (NPPD video).

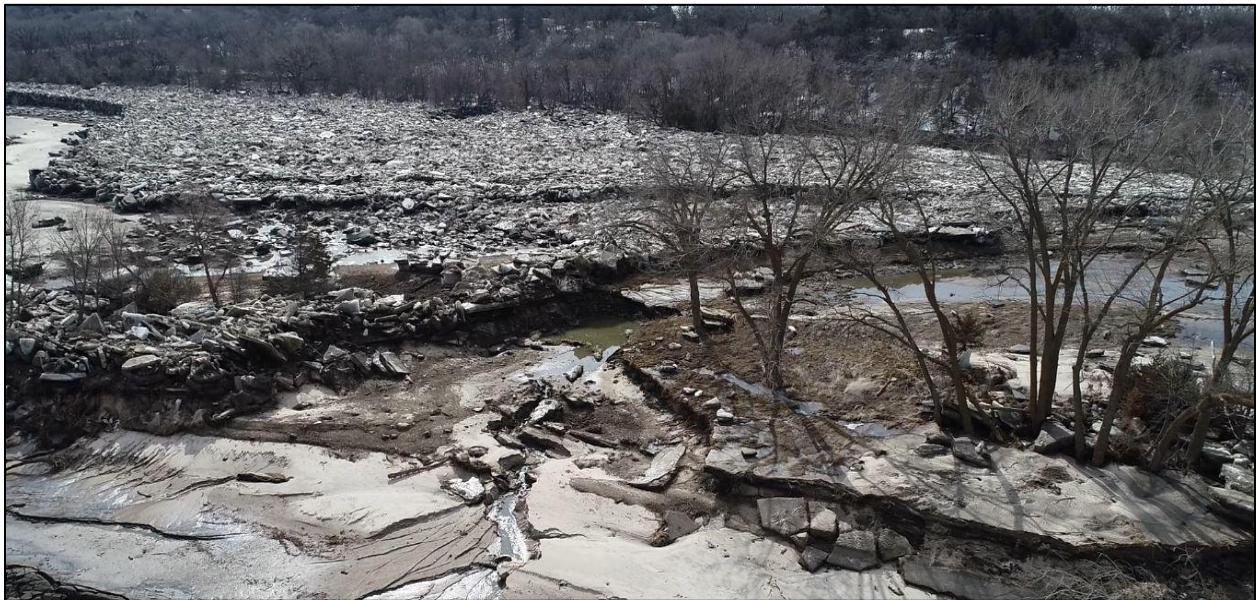
Figure 4.12 – South end of the dike looking downstream. The dike is at roughly mid-height in the figure. Thick ice fields can be seen downstream (MPPD video).

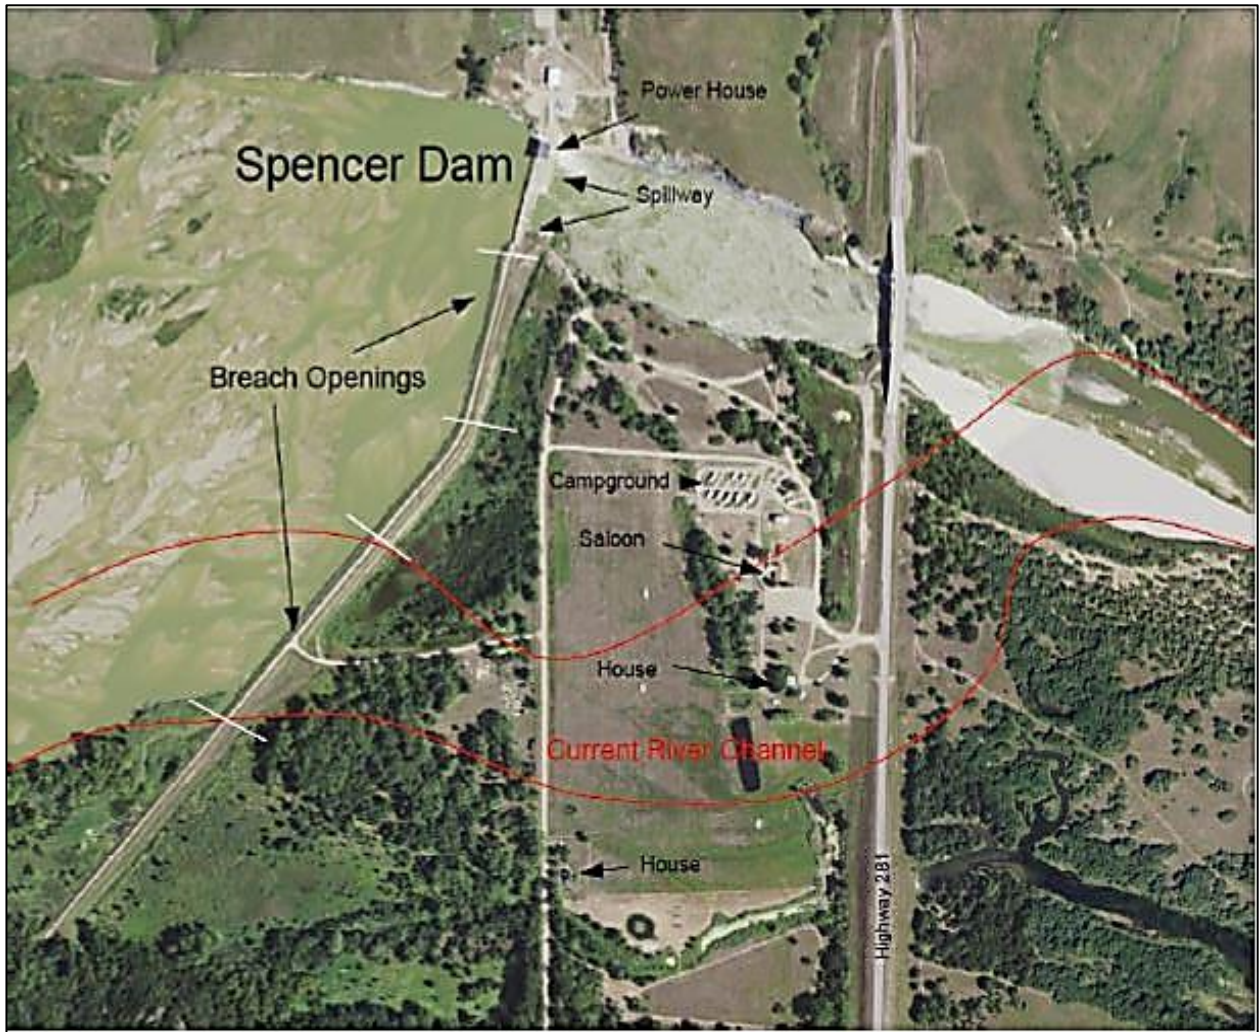
Figure 4.13 – Details of dam and area downstream showing dike breach locations and location of the river channel following the event (NPPD figure).

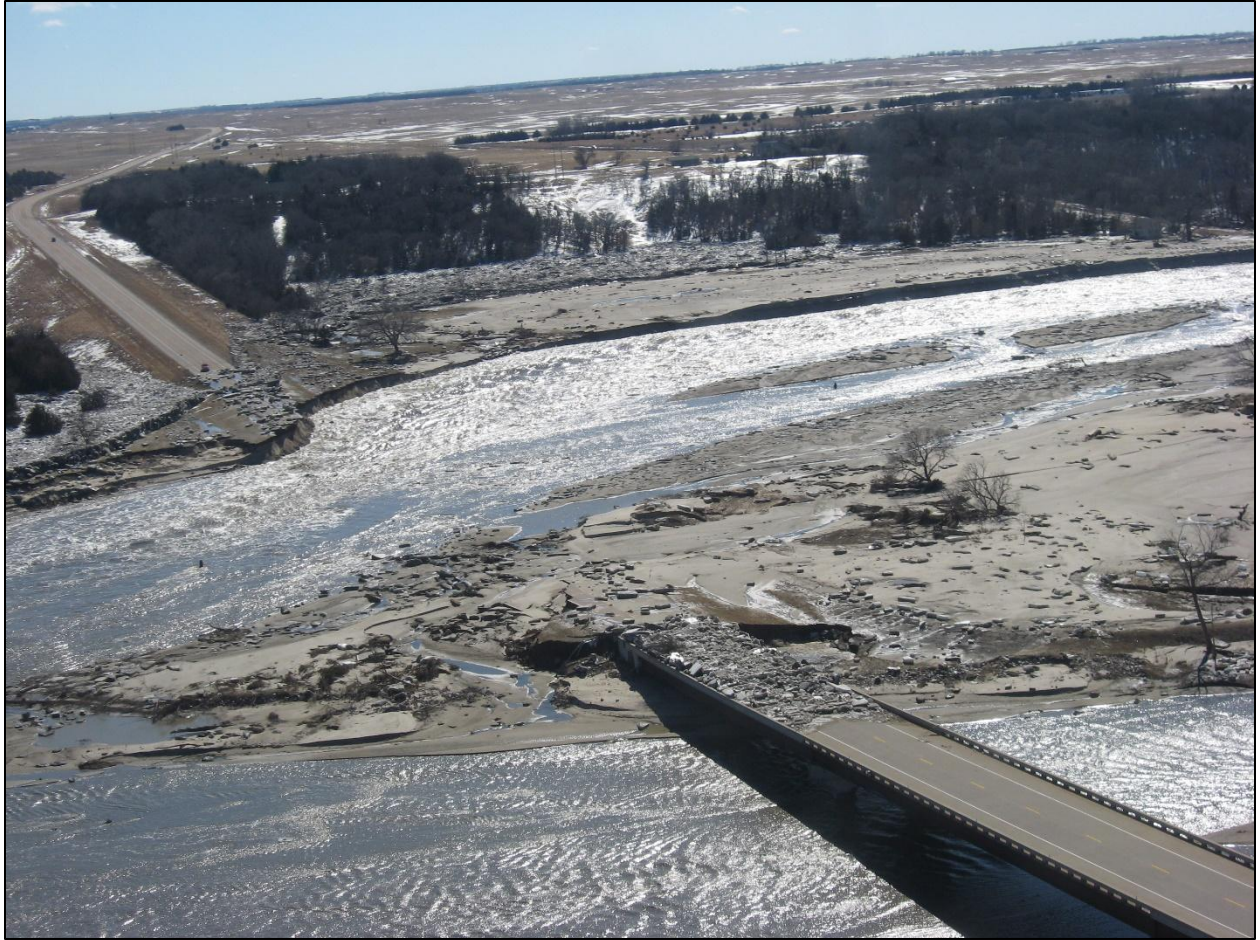
Figure 4.14 – View of washed-out Highway 281 approach ramp (looking south). Note the ice fields upstream and downstream from the road on the south bank (NPPD photo).

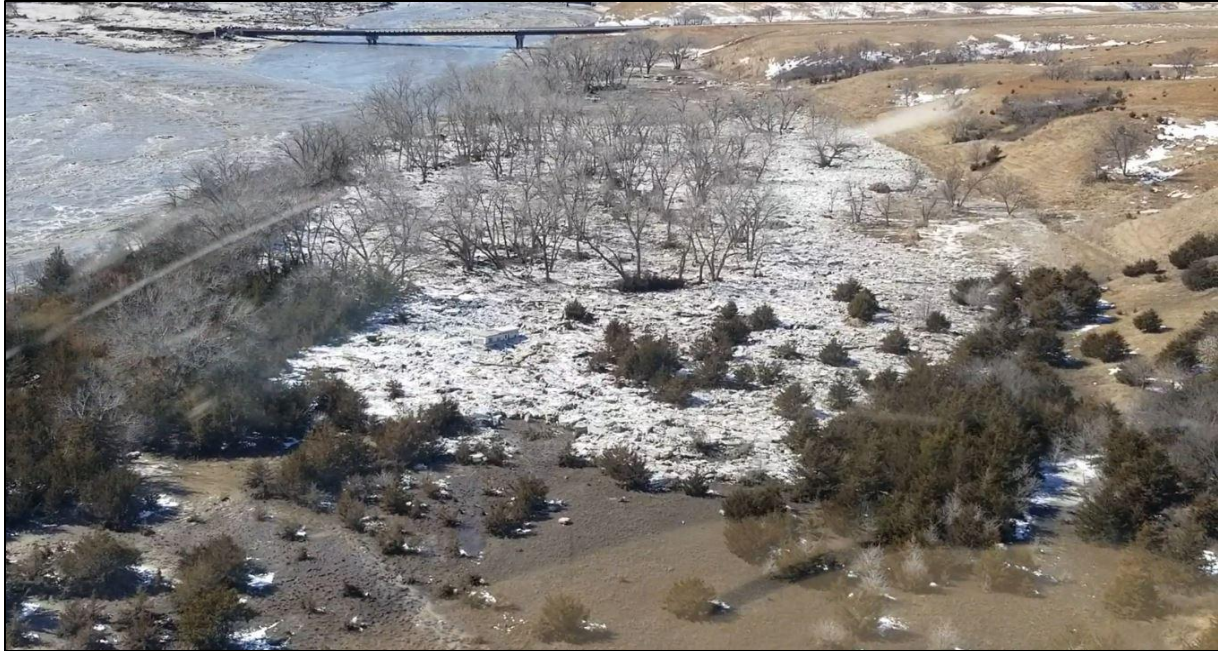
Figure 4.15 – Ice deposit on north side of river downstream from the highway (NPPD photo).

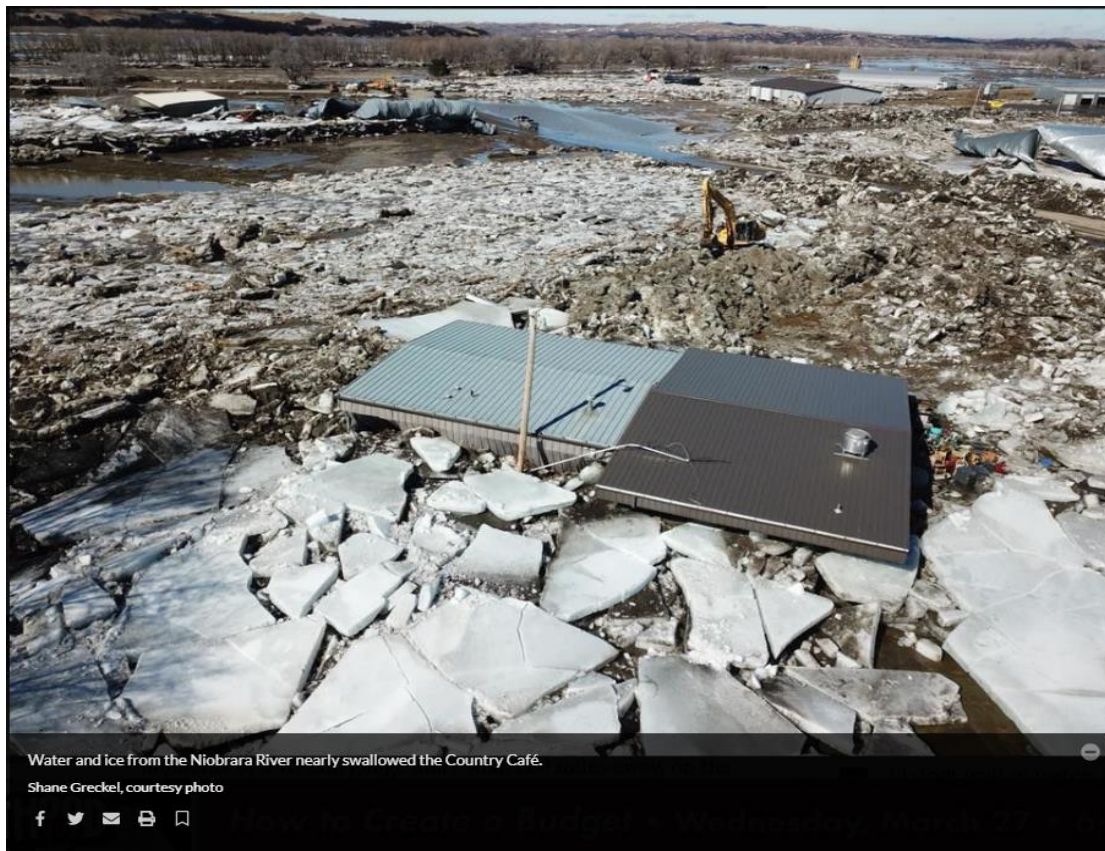
Figure 5.2. Ice and Flood Damage in Niobrara (Credit: Shane Greckel, used with permission)
