UNITED STATES AIR FORCE
AIRCRAFT ACCIDENT INVESTIGATION
BOARD REPORT

RC-135V, T/N 64-14848

OFFUTT AIR FORCE BASE, NEBRASKA

DATE OF ACCIDENT: 30 APRIL 2015

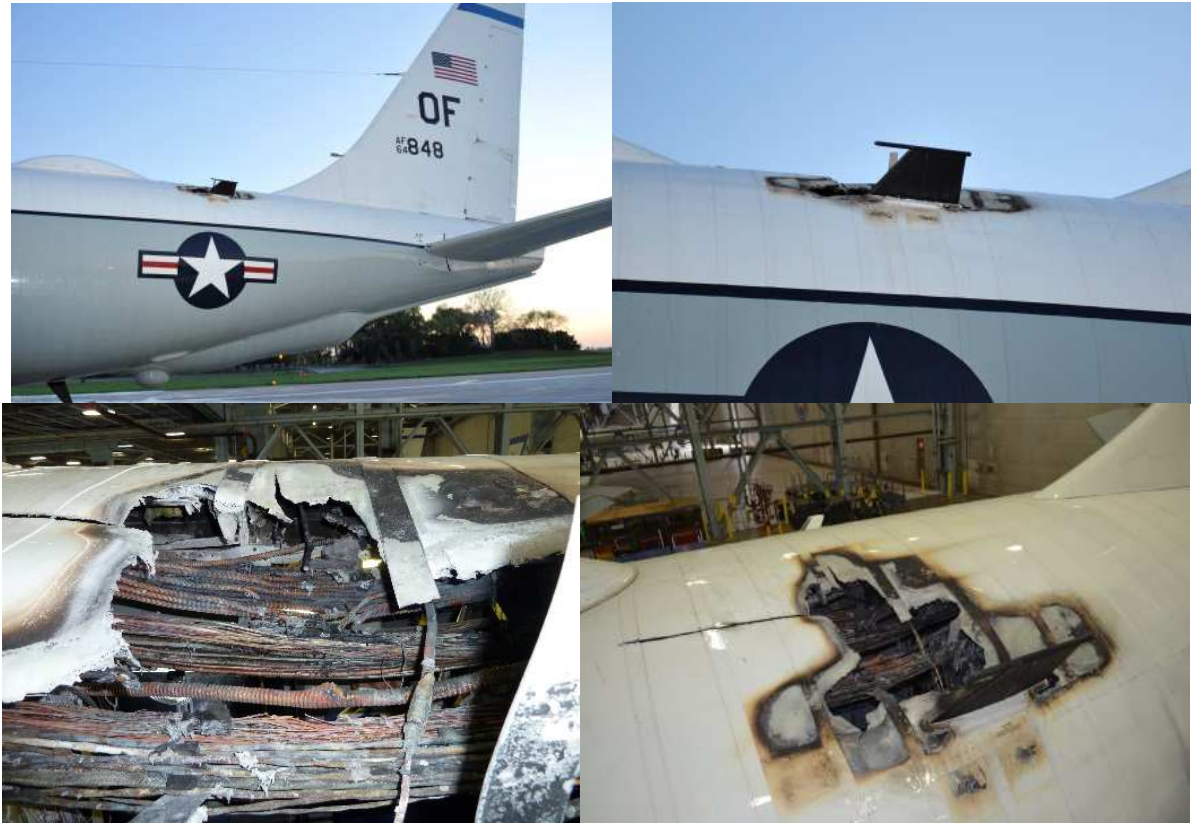
Damage to the MA was photographed immediately following the mishap (Tabs S-1.1 through S-1.5). The aircraft sustained substantial structural damage, including fire damage to several vertical and lengthwise structural components to the fuselage known as frames and stringers.

The fire also burned a sizable hole through the aircraft skin (Tabs S-1.11, Z-1.4, Z-1.5, Z-1.7).

Figure 1. Damage to Fuselage (Tabs S-1.11, Z-1.4, Z-1.5, Z-1.7)

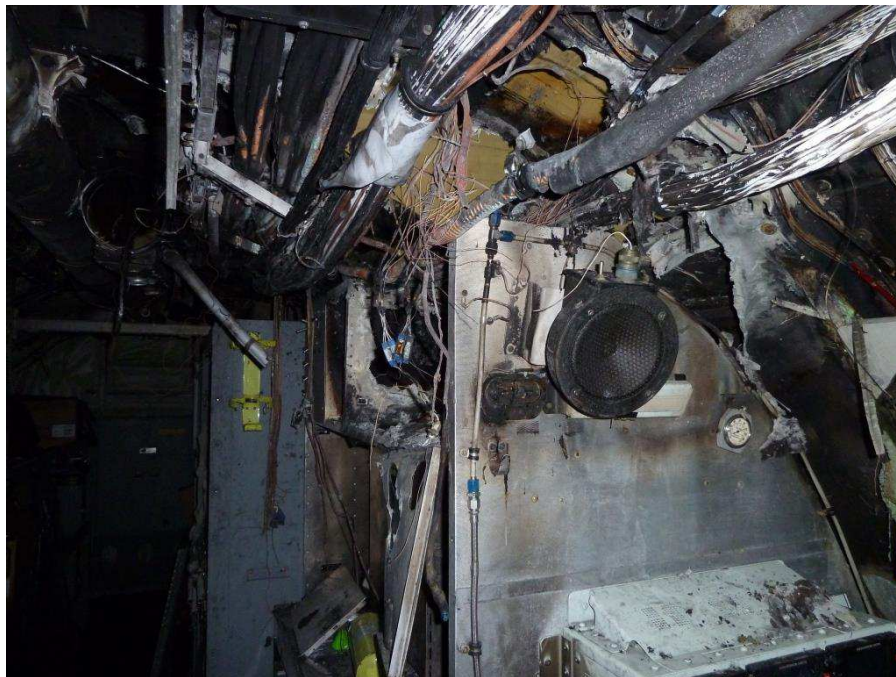
The mishap rendered a number of aircraft systems inoperable (Tab S-1.9). The MA sustained substantial damage to the oxygen system and electrical input to the rudder power control unit. An antenna located at the site of the hole in the fuselage was also damaged (Tabs S-1.2, S-1.9 through S-1.11). Portions of the crew rest area in the rear compartment and the entire aircraft galley were severely damaged (Tab S-1.3). See Figures 2 and 3. Additionally, the fire caused substantial damage to a number of aircraft mission systems (Tabs S-1.3, S-1.11).

Figure 3. Galley Area of T/N 64-14848 (Tab S-1.9)

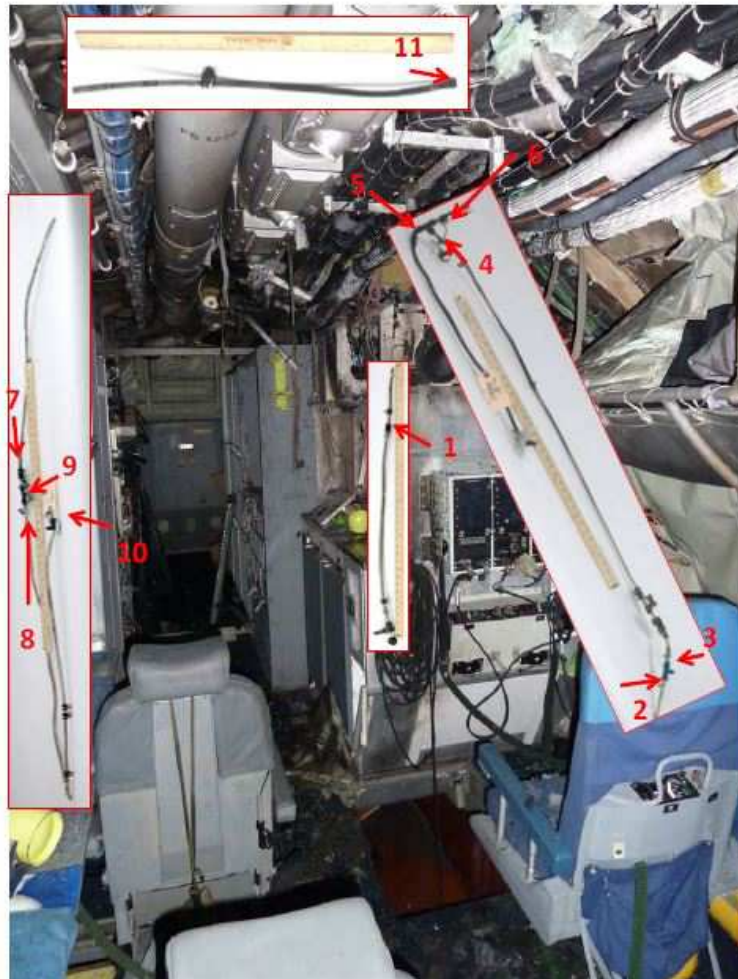
Figure 4 shows components of the oxygen system superimposed on an image of the MA. Figure 4 also has a numbering system for the junctions (also called joints or fittings) that will be used for reference in this report (Tab J-26). Prior to the mishap, Junction #5 was connected to Junction #11 via flex hose (Tab J-31).

Figure 4. Oxygen System Tubing (Tab J-26).

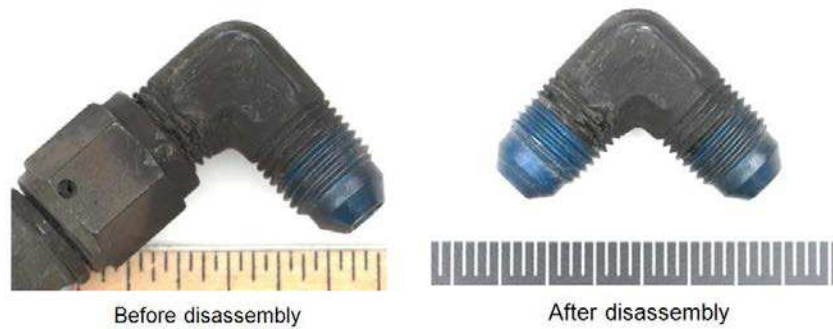
revealed there was no B-nut on the other side of Junction #11 (Tab J-8). A fragment of the missing B-nut was discovered in the debris (Tab J-8). Analysis of the fragment indicated that the B-nut had melted (Tabs J-8, J-29). There was no evidence that the B-nut had forcibly passed over either the sleeve or the flared end of the corresponding tube (Tab J-8).

Figure 6 shows the male threaded end of the elbow fitting where the B-nut at Junction #11 should have been located (on the right side of the elbow) (Tab J-29). Upon disassembly of the fitting, difference in colors of the threads between the protected side (left) of the elbow fitting and the missing B-nut side (right) indicate that the left side was exposed to some combustion products (such as soot), but not as much as the missing B-nut side (Tab J-29).

Figure 6. Elbow Fitting (Tab J-29).

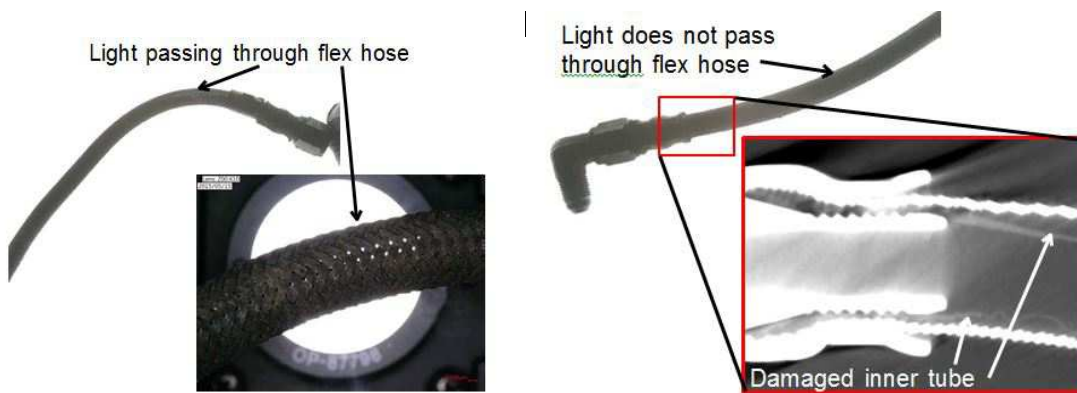
Further examination of the tubing system showed the inner liner of the flex hose between Junction #11 and Junction #5 was destroyed (Tab J-8). See Figure 7. Light passing through the flex hose indicates the inner tubing is completely destroyed near Junction #5 (Tab J-31). Images of the flex hose near Junction #11 shows rumpling deformation on the inner tube, indicating exposure to heat (Tab J-31).

Figure 7. Flex Hose Between Junction #5 (Left) and Junction #11 (Right) (Tab J-31).

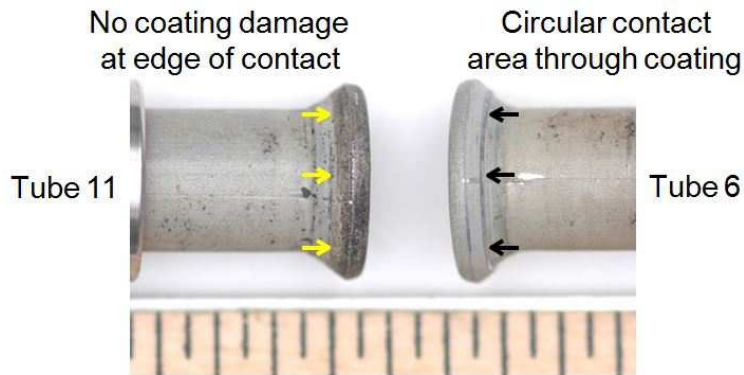
Examination of the flared ends of the tubes for each fitting indicated they all had a circular contact impression from the sleeve, through the tube coating to the base metal, except the flare at Junction #11 (also referred to as Tube #11) (Tabs J-10, J-35). See Figure 8. While the torque value at Junction #11 could not be measured due to the melted B-nut, the lack of a contact scar on Tube #11 indicates it had the lowest torque value of all the fittings examined (Tabs J-10, J-12, J-

Figure 8. Flared Tube Ends (Tab J-35).

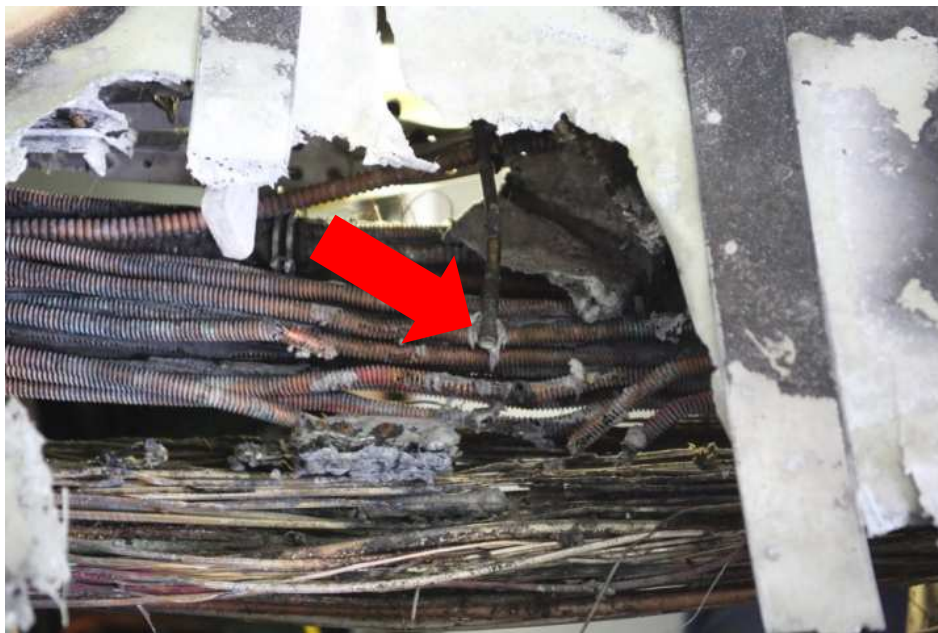
Additionally, the sleeve located at Junction #11 had significant pitting (i.e, tiny holes or “pits”) on one side (Tab J-10). The pitting on this sleeve indicates the damage was directional, since it was present on one side and not the other (Tab J-10). Pitting was also found more frequently on one side of the corresponding Tube #11, just past the area the sleeve covered (Tabs J-10, J-38). No pitting damage was found beneath the sleeve (Tab J-10). The damaged B-nut fragment also had localized melting, which is consistent with damage on one side of the tube, starting at the shoulder of the B-nut (Tab J-11). Physical evidence indicates the area of high heat was localized, causing damage predominantly to one side of the sleeve and Tube #11 (Tabs J-11, J-35). The location of Tube #11 prior to removal from the MA is shown in Figure 9 (Tabs J-26, S-1.9, Z-1.1 through 1.3).

Figure 11. Location of Tube #11 Prior to Removal (Tabs J-26, S-1.9, Z-1.1 through 1.3).

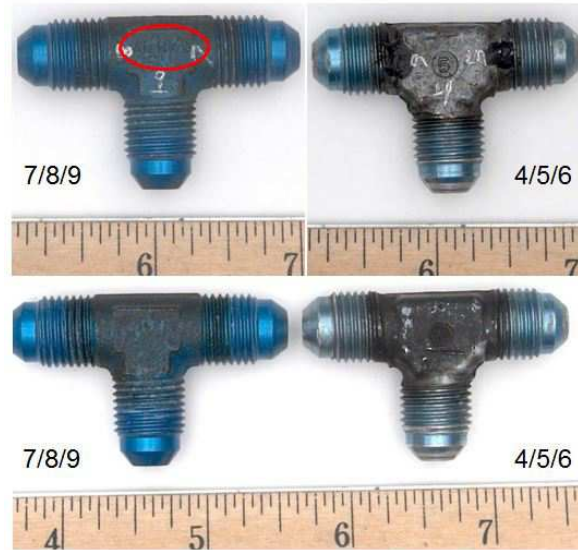
AFRL/RXSA also determined that the T-shaped fitting connecting Junctions #4, #5 and #6 (4/5/6 fitting) lacked required letter markings and appeared to have a parting line and a rough surface (Tab J-10). See Figure 10. Parting lines and rough surfaces are both typical of a casting, whereas a machined or forged part is required by the specifications (Tab J-10). The 4/5/6 fitting also showed uneven wear patterns, nicks, gouges, and large areas of exposed metal which would also be cause for rejection of the fitting (Tab J-10). AFRL/RXSA determined that fittings similar to the 4/5/6 fitting were last manufactured in 2003 (Tabs J-10, J-34).

Figure 10. T-Shaped Fittings. Red circle indicates a correct marking (Tab J-34).
