RE: Hotel Aiken Site Visit and Report

Hotel Aiken - Structural Assessment Summary

Hotel Aiken - Structural Assessment

235 Richland Ave. W, Aiken, SC

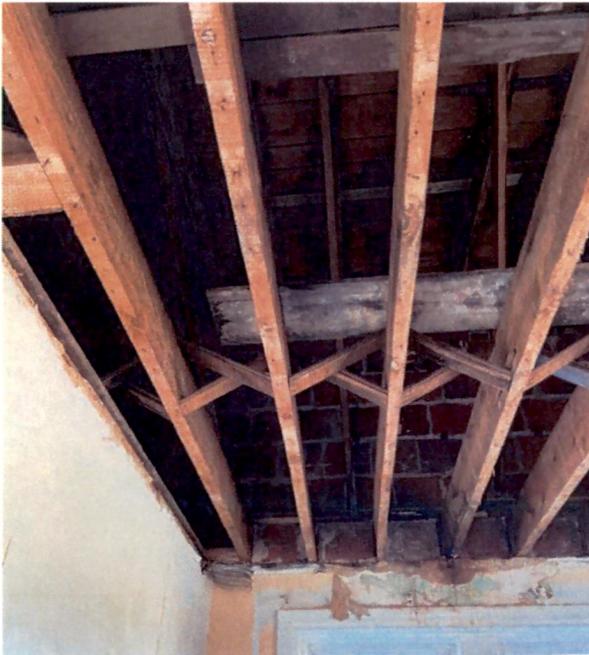
Figure 1: Roof Framing at North Wall – Generally Fair Condition

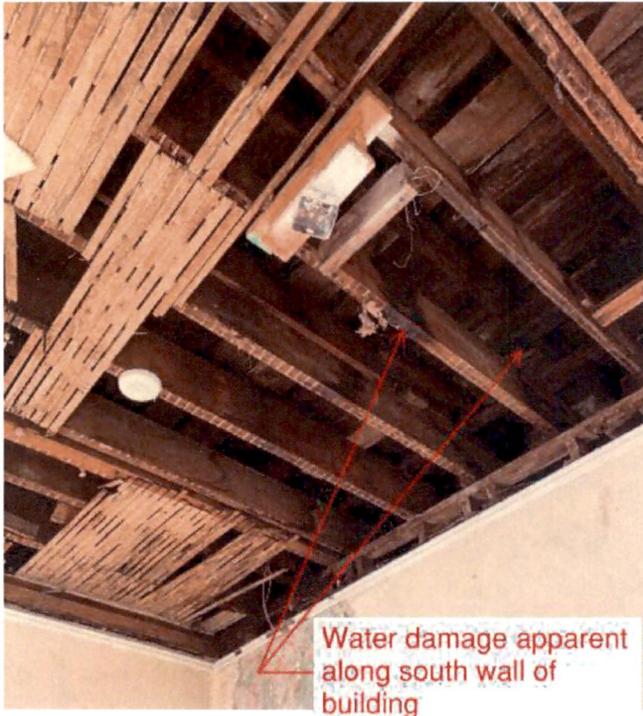
Figure 2: Roof Decking at South Wall – Generally Poor Condition

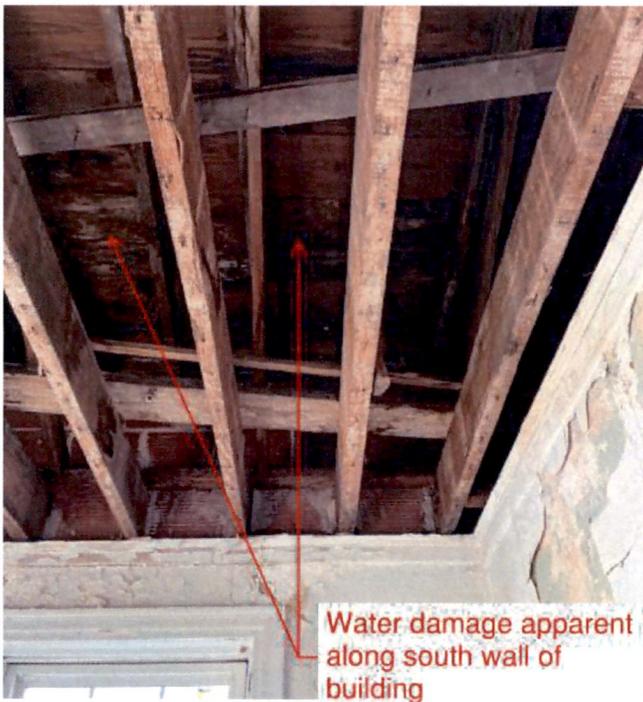
Figure 3: Roof Decking at South Wall – Generally Poor Condition

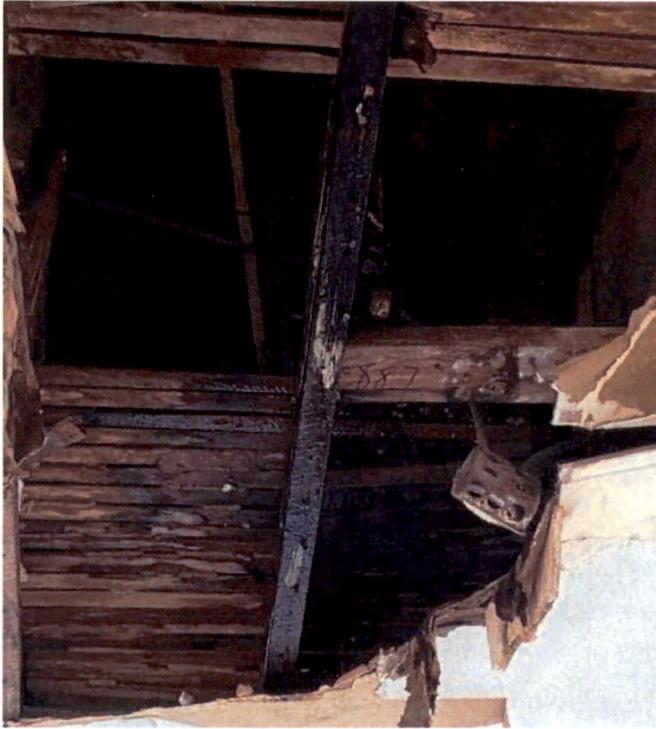
Roof framing spans perpendicular to the longitudinal walls of the building and consists of built-up trusses with 2x top and bottom chords and 1x web members. The roof diaphragm consists of 1x decking laid perpendicular to trusses. Generally, roof framing appeared to be in fair condition with the exception of framing along the south wall of the building and other isolated areas which indicated considerable water damage. Actual dimensions of roof framing were unable to be determined during the visit, but trusses are generally deeper at the North side of the building (Fig.1) and taper down towards the South to provide positive drainage to scuppers located on the South side of the building (Figs. 2-3). Evidence of water intrusion was noted along the south wall of the building (Figs. 2-3) suggesting ponding of rainwater along this wall. Significant water damage was also noted in isolated locations (Fig. 4).

Figure 4: Roof Framing – Localized Substantial Water Damage

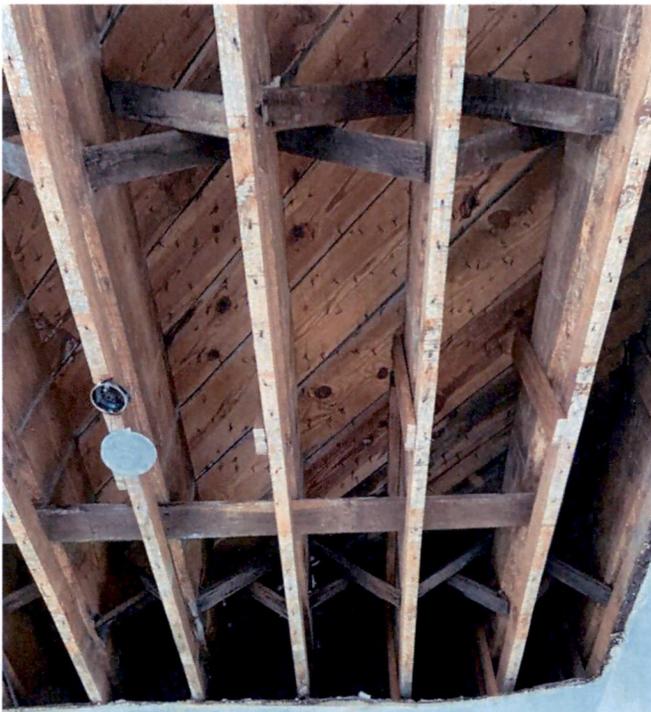
Figure 5: Floor Framing – Generally Fair Condition

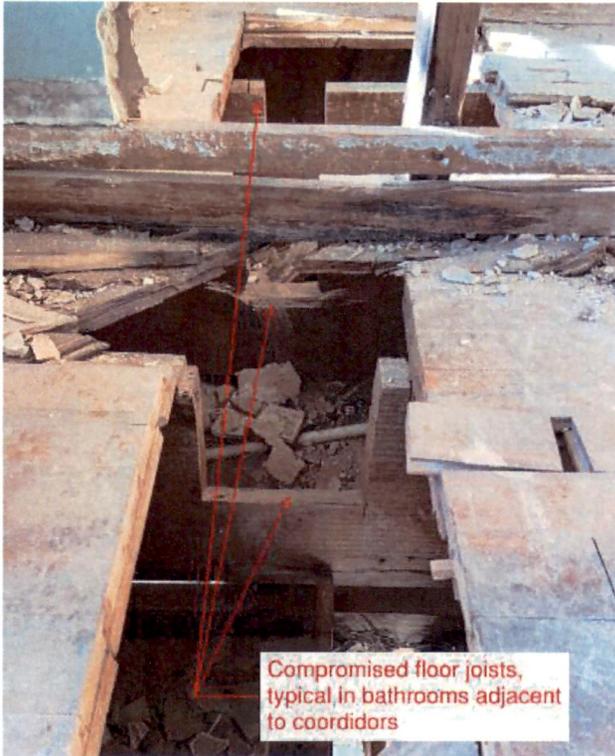
Figure 6: Floor Framing – Severely Compromised Adjacent to Corridors

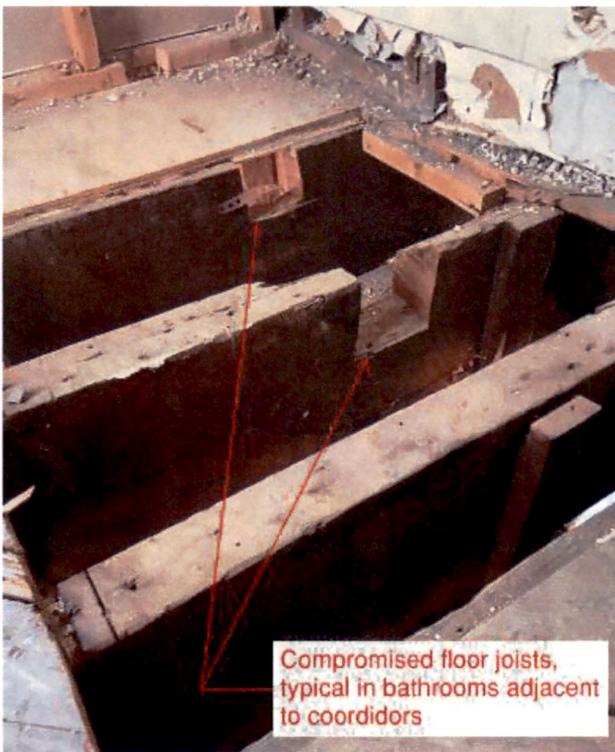
Figure 7: Floor Framing –Compromised Adjacent to Corridors

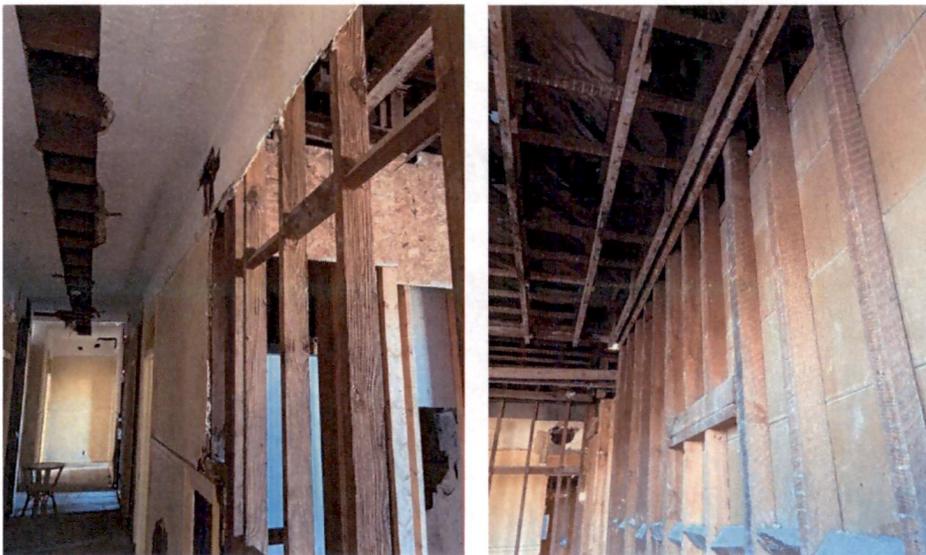
Figure 8: Interior Stud Wall Framing – Generally Fair Condition

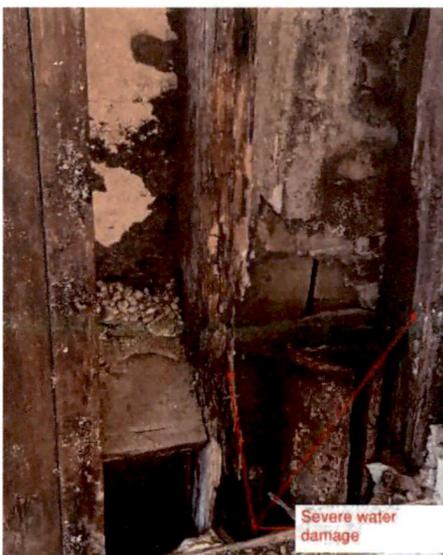
Figure 9: Severe Water Damage

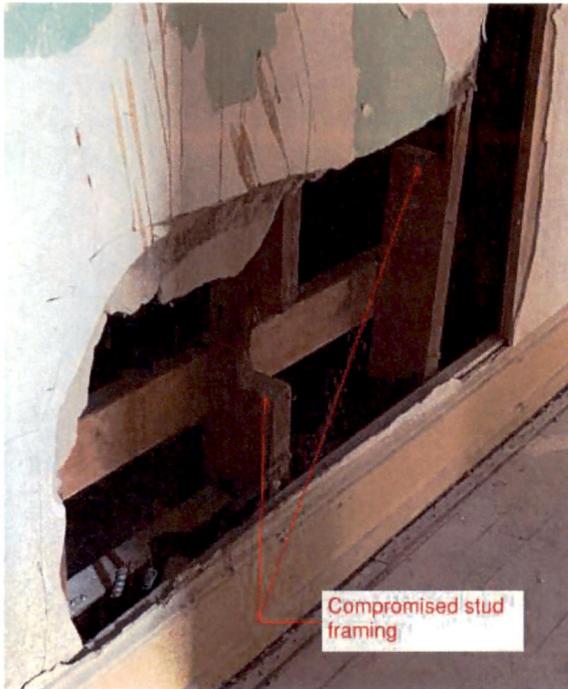
Stud wall framing was found to be rough cut 2x4s at 16" oc typical at all demising and corridor walls full height. Exposed studs at the time of visit were found to be generally in fair condition (Fig. 8) with localized areas that have been severely compromised (Figs. 9-11). Considering stud size and floor-to-floor heights, existing walls were determined to be inadequate to meet current design standards (see Structural Evaluation section). Localized areas of exposed studs were noted where substantial water damage (Fig. 9) and excessive modifications (Fig. 10-11) have severely compromised stud wall framing.

Figure 10: Compromised Stud Walls – Excessive Modifications

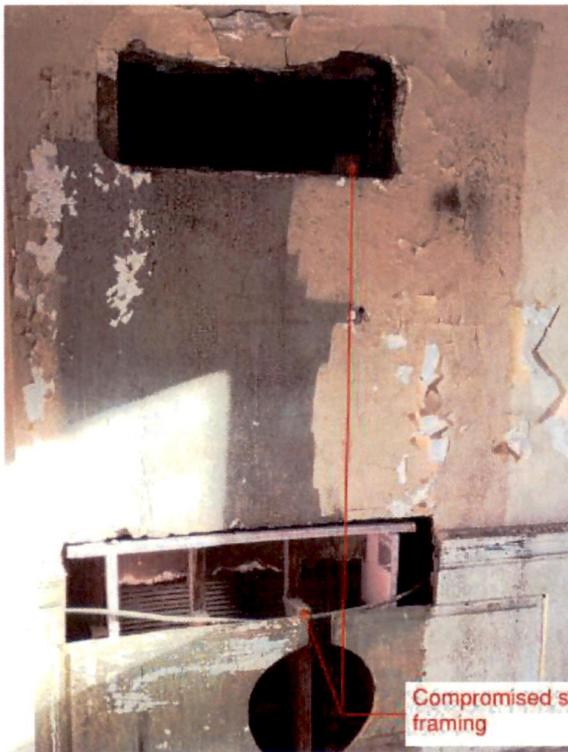
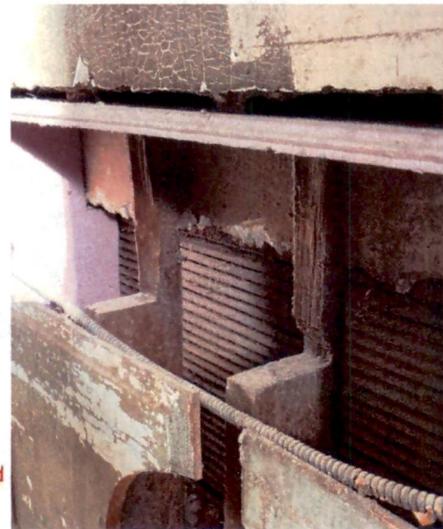
Figure 11: Compromised Stud Walls – Excessive Modifications

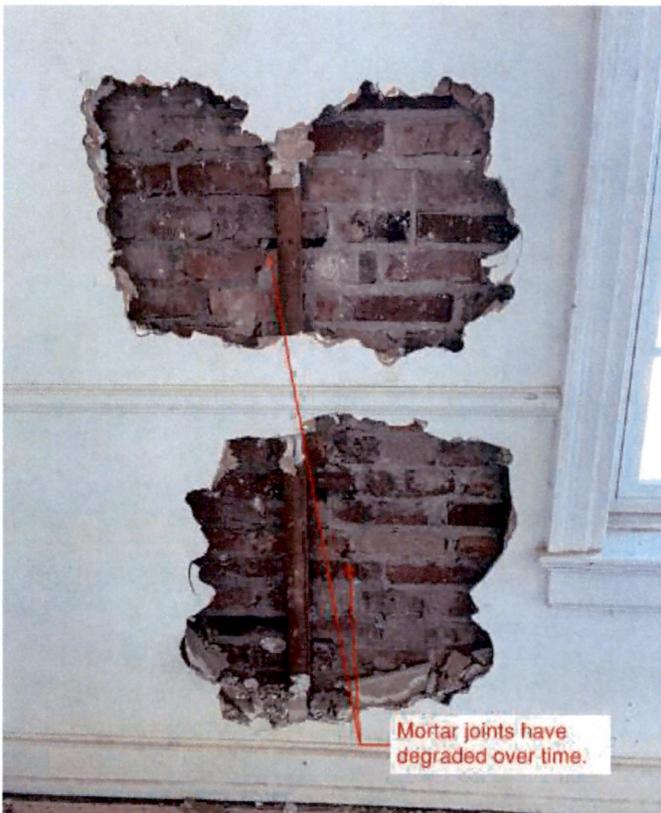
Figure 12: General Exterior Wall Conditions – Fair-to-Poor Condition

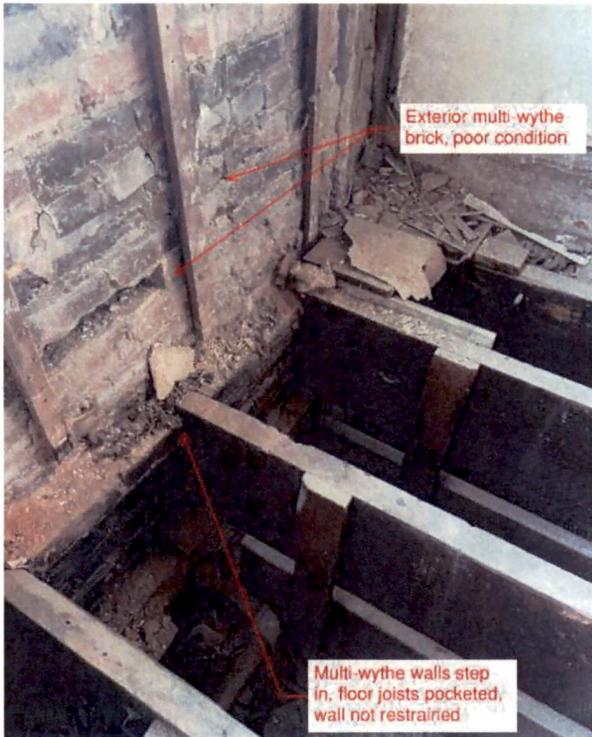
Figure 13: General Exterior Load Bearing Multi-Wythe Brick Wall

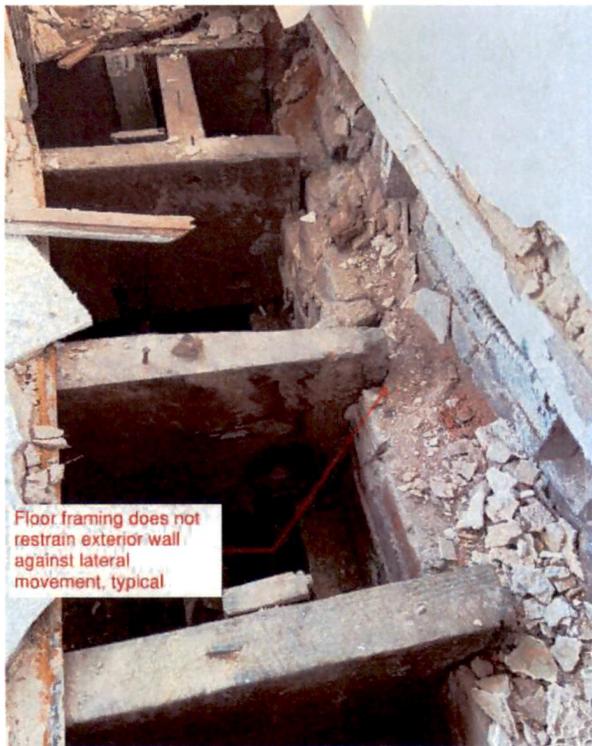
Figure 14: General Exterior Load Bearing Multi-Wythe Brick Wall

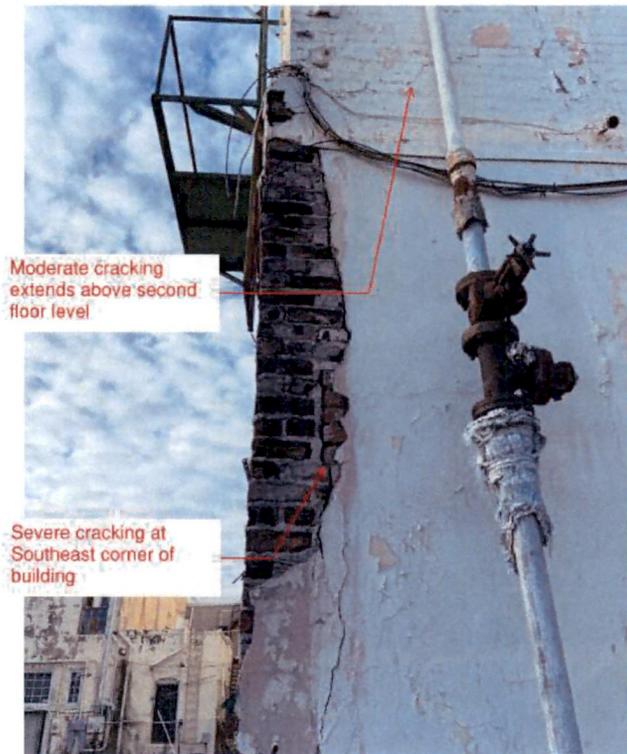
Exterior walls are multi-wythe brick unreinforced masonry (URM), and are load bearing along the longitudinal sides of the building. It was noted that exterior walls are thicker at the base and step in at upper levels of the building. Exterior walls were found to be in generally fair-to-poor condition (Fig. 12). Over time, mortar joints have degraded and the building has settled which has caused widespread cracking. This building would fall into Seismic Design Category C, and current codes require masonry walls to be tied into and braced against lateral environmental forces by building diaphragms. Such bracing was not found to be present (Figs. 13-14), which was expected considering the building's age; nevertheless, exterior walls should be mechanically fastened and braced at each floor level to restrain lateral forces should it be desired to occupy the building in the future. Outside the the building, cracking present at numerous wall openings (Figs. 17-18) and severe cracking was noted in the Southeast corner of the building due presumably to excessive settlement (Figs 15-16).

Figure 15: Southeast Building Corner – Severe Cracking

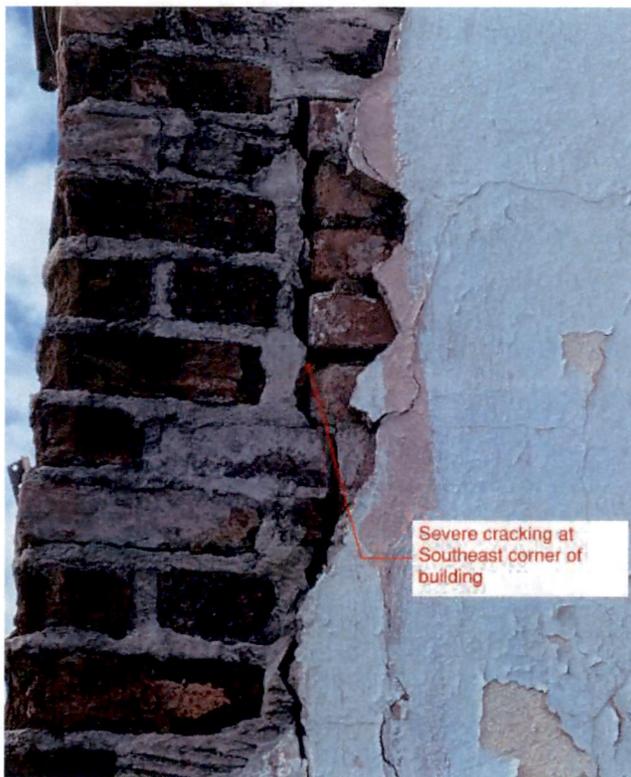
Figure 16: Southeast Building Corner – Severe Cracking

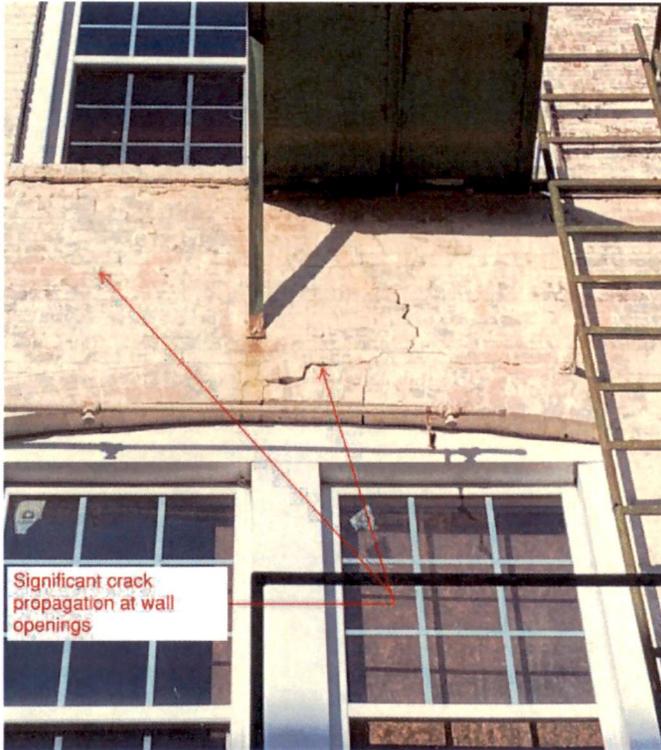
Figure 17: Crack Propagation at Window Openings

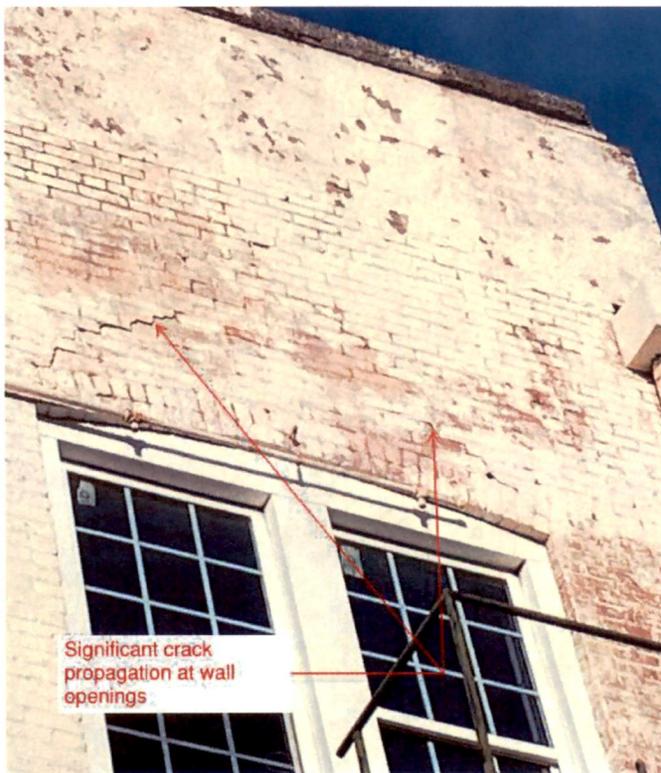
Figure 18: Crack Propagation at Window Openings

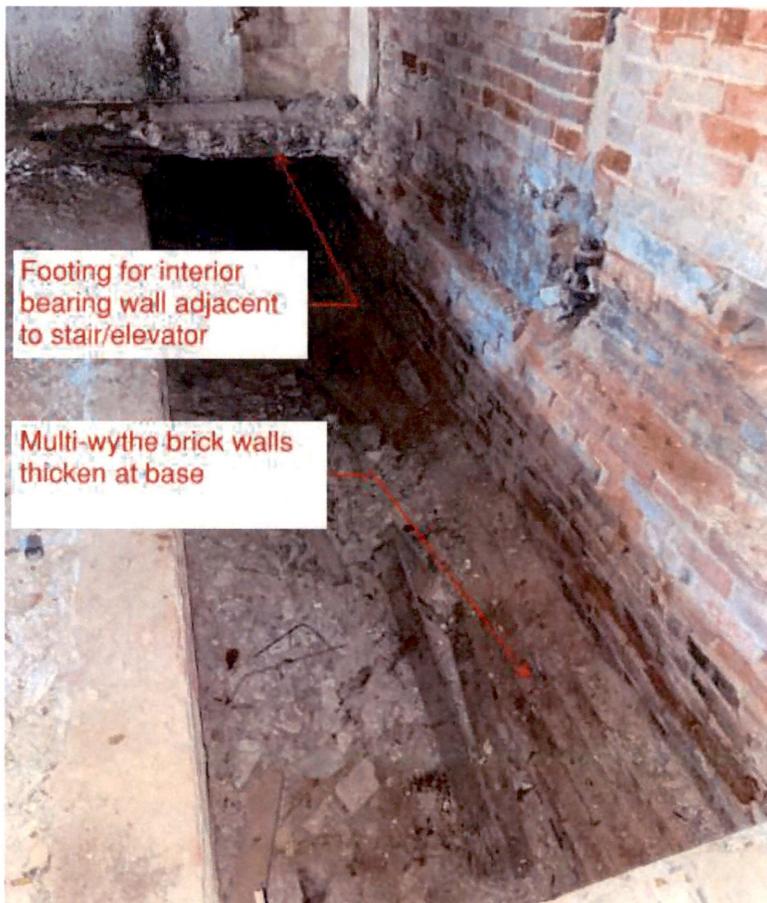
Figure 19: Base of Multi-Wythe Exterior Walls

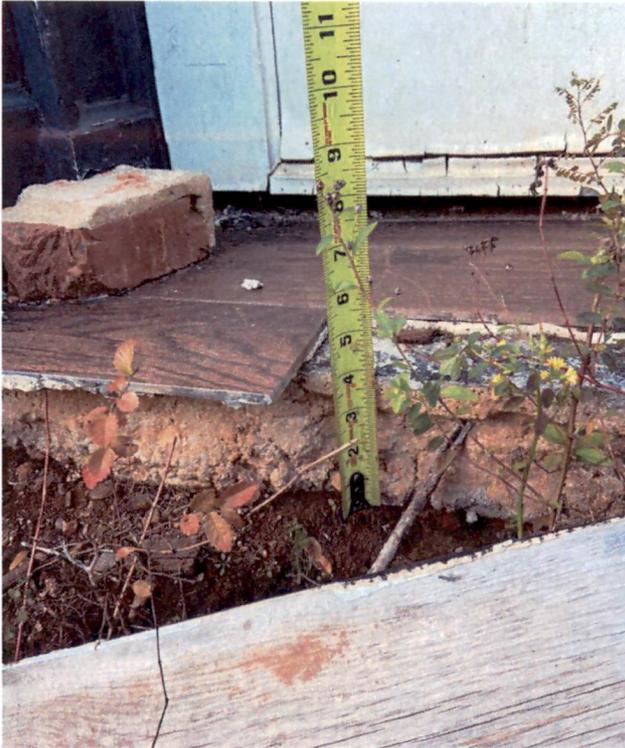
Figure 20: Mudsill Along South Wall Adjacent to Excessive Wall Settlement

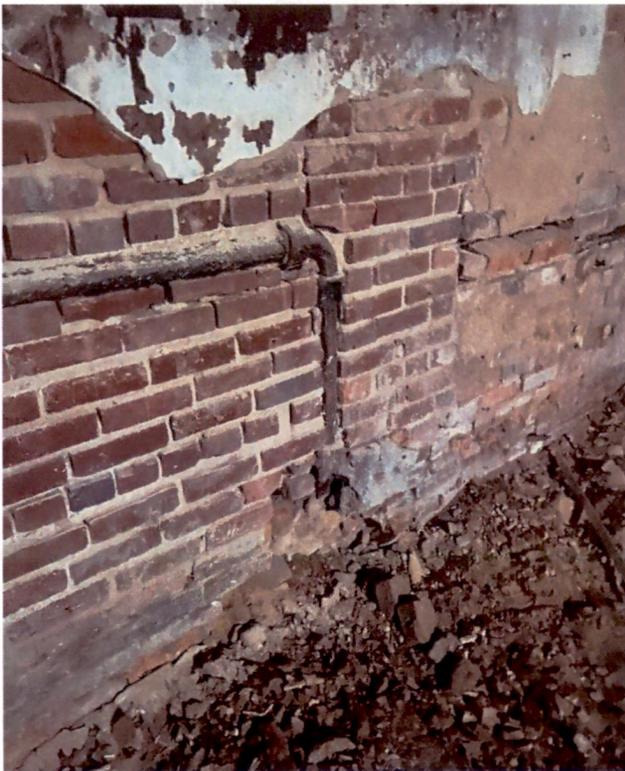
Existing footings (if present) were not exposed in most locations. Evidence suggests, however, that the multi-wythe brick walls thicken at the base of the wall to form a wider soil bearing area (Fig.19). This would be consistent with our experience with buildings of similar age and construction. There were also locations that indicate a mudsill was poured under masonry walls (Fig.20). Where observed, mudsills were 4-6 inches thick and appeared to be unreinforced (Figs 19-20). These bearing conditions, brick bearing directly on soil, or unreinforced mudsills are highly susceptible to differential settlement. As previously discussed, differential settlement is apparent in the Southeast corner of the building (Figs. 15-16) where significant cracking has occurred. It is likewise also probable that differential settlement due to inadequate foundations is responsible for generally poor wall condition along the longitudinal bearing sides of the building (Fig 21).

Figure 21: Inadequate Bearing Conditions

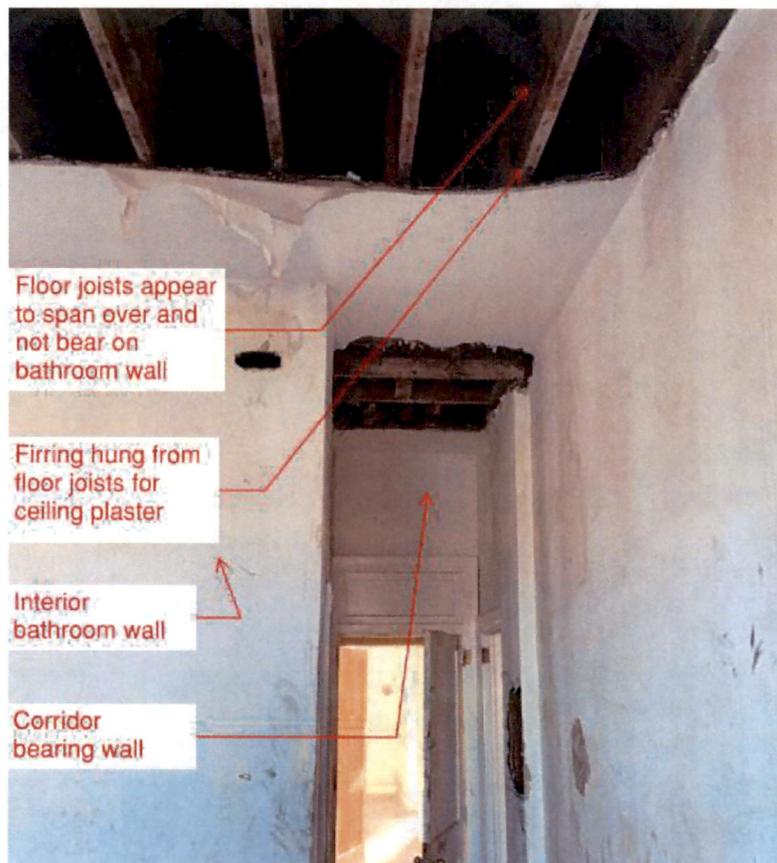
Two framing conditions in particular raised concerns during our visit. One was the relatively long spans for floor joists, and another was the presence of 2x4 full height bearing walls. A subsequent analysis revealed that these elements are inadequate, regardless of condition, for the current configuration and intended use. Analysis results for these elements are presented below. Also, an abbreviated section for lateral resistance is provided for reference.

Figure 22: Floor Framing Appears to Fully Span from Exterior Walls to Corridor Walls
