## Incident Report

**TO: Guam Environmental Protection Agency**

**FROM: Brown and Caldwell Constructors (on behalf of the Receiver GBB)**

Paul Bourke, Ordot Dump Post-Closure Facility Project Manager,  
Hagatna, Guam

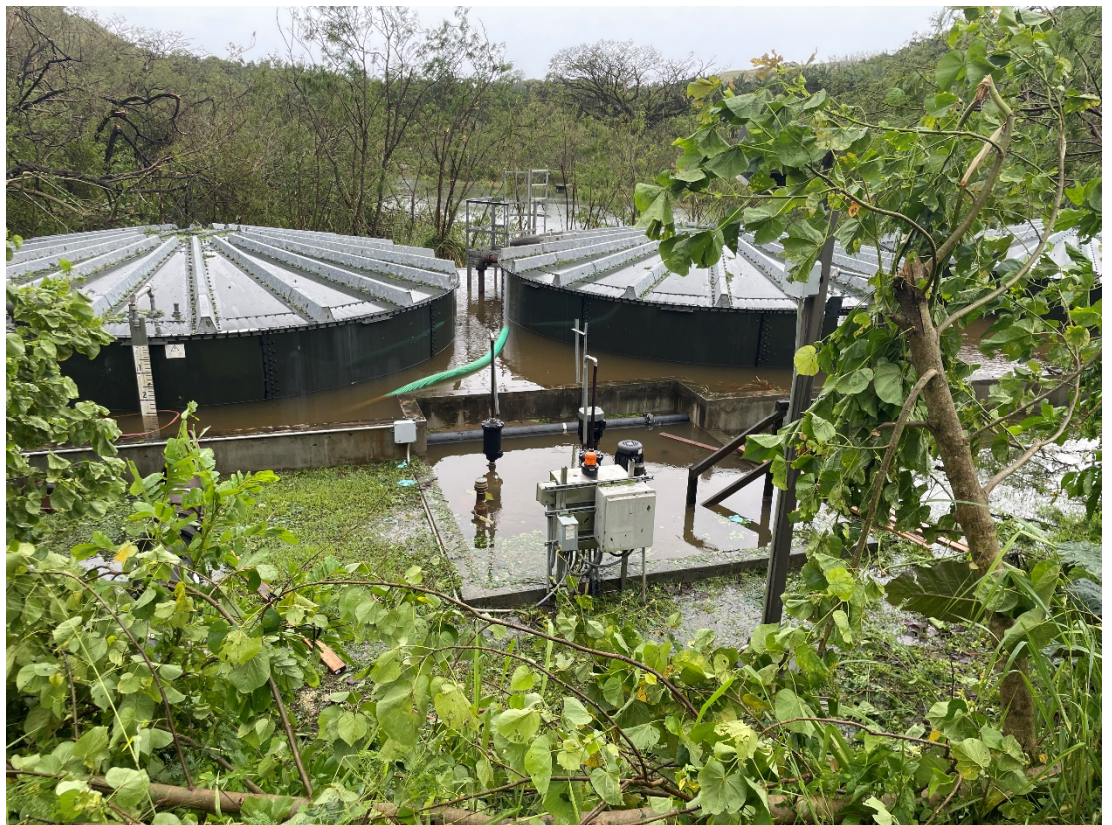
After clearing fallen vegetation on the tank road which took approximately 10 minutes, staff were able to access the leachate storage tanks and pump station in the southern portion of the Facility. The secondary containment surrounding the tanks was found to be overflowing and pumps were not operating. The pumps were immediately switched to manual control and pump operation was restored. Operation of the pumps stopped the overflow within a few minutes and resulted in the drawdown of water in the secondary containment and the leachate storage tanks. Pump operation allowed the use of a portable pump to transfer water from the secondary containment into the tanks for discharge to the sewer.

**Figure 1. Condition of Leachate tanks and pump station when staff made it back to the site after the storm on the 25<sup>th</sup> of May.**

Pump operation was immediately restored when Facility staff arrived at the leachate storage tanks and pump station. At that time, a portable pump was used to transfer water in the secondary containment into the storage tanks for discharge to the sewer.

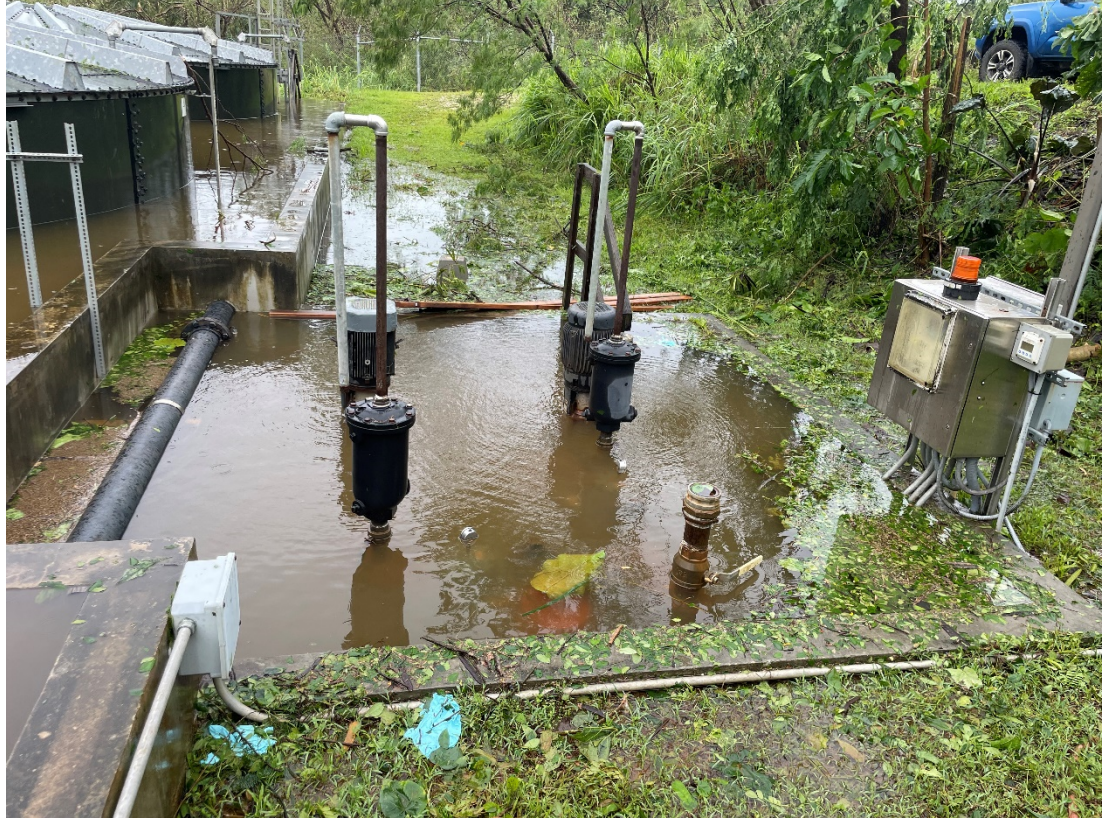
The pumps were being powered by the Facility's emergency generator and for an unknown reason stopped operating even though the generator was still running. It is estimated the pumps may have ceased operating sometime between 17:00 and 21:00 on 05/24/2023 (approximately 9 to 13 hours after a pre-storm assessment at 07:44 on 05/24/2023). Pump operations were restored at 13:00 on 05/25/2023. (At the date of this report, we are awaiting an evaluation by a pump system contractor to ascertain, if possible, the cause of the pump stoppage. We will file a subsequent report on this matter with Guam EPA).

**Figure 2. Condition of the Leachate pump station when staff made it back to the site after the storm on the 25<sup>th</sup> of May.**

A reason for the non-operational period of the pumps has not yet been ascertained. Since pumping resumed when the manual operation began, an electrical/control problem is suspected. The Facility's staff is working to secure the Facility's electrical/controls contractor to investigate and assess the situation, implement repairs, and recommend further corrective steps, if any. We will provide a subsequent report on corrective action.

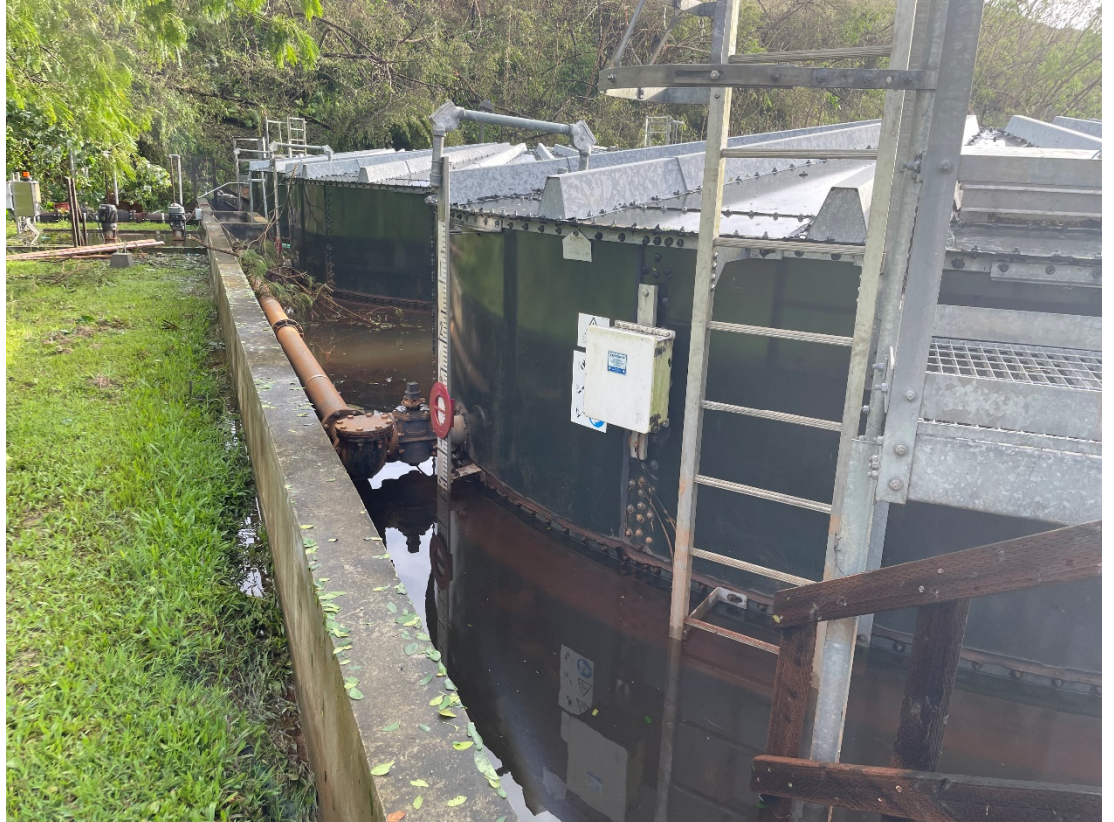
**Figure 3. Level of drawdown in the secondary containment due to the use of the portable pump to return the liquid into tank 2 by the morning of the 26<sup>th</sup> of May.**

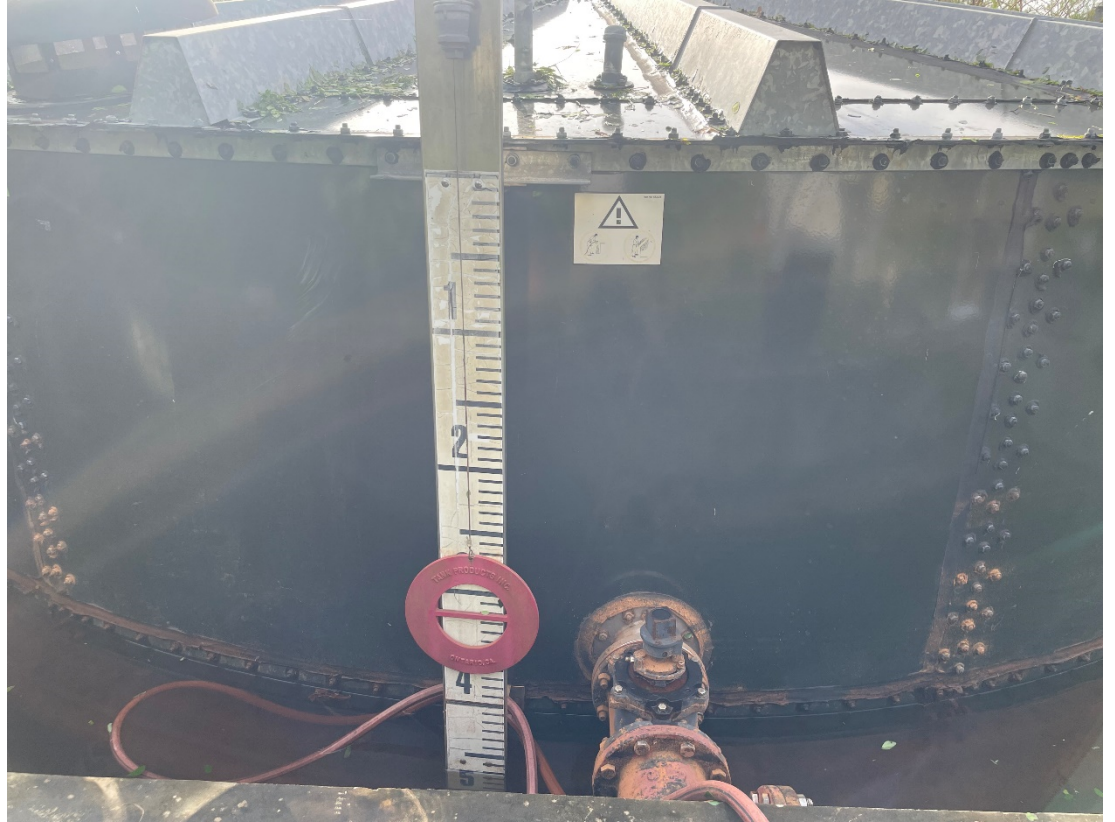
**Figure 4. Level of drawdown in the leachate tanks by the morning of the 26<sup>th</sup> of May.**

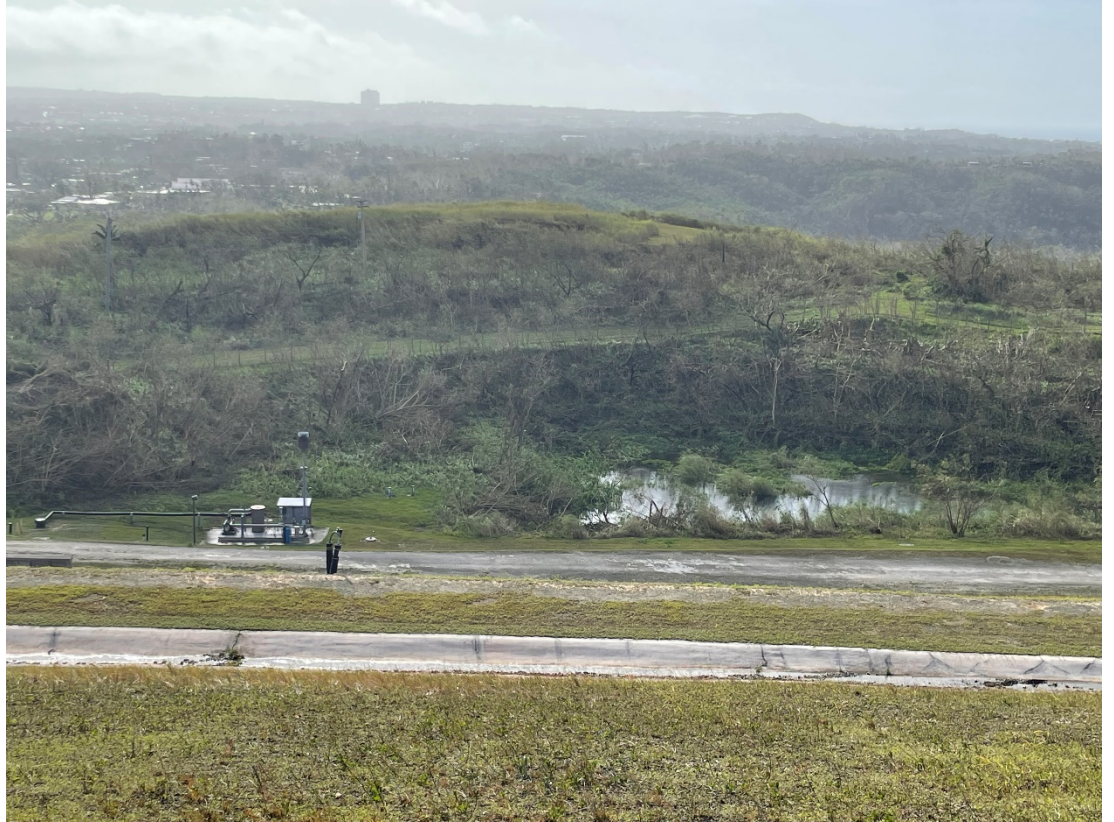
**Figure 5. Photo of the Landfill Gas Flare and Pond 4 taken from the cap when staff made it back to the site after the storm on the 25<sup>th</sup> of May.**

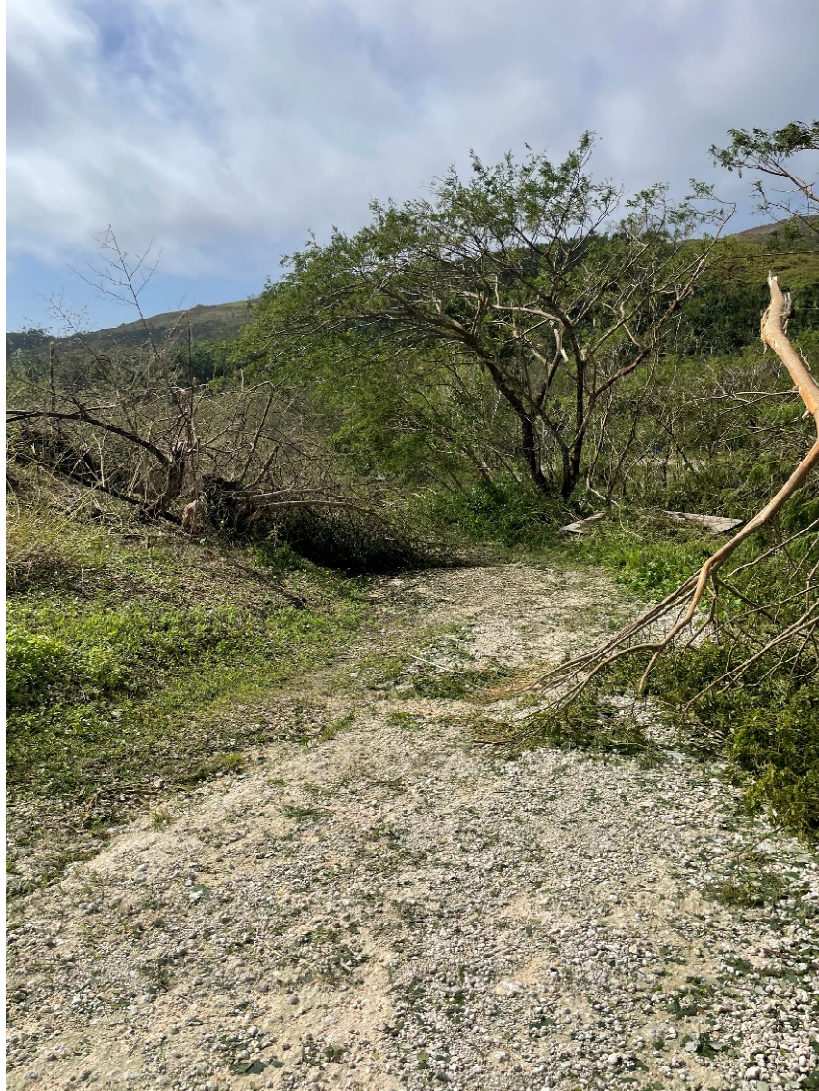
**Figure 6. Trees across the tank access road when staff made it back to the site after the storm on the 25<sup>th</sup> of May.**

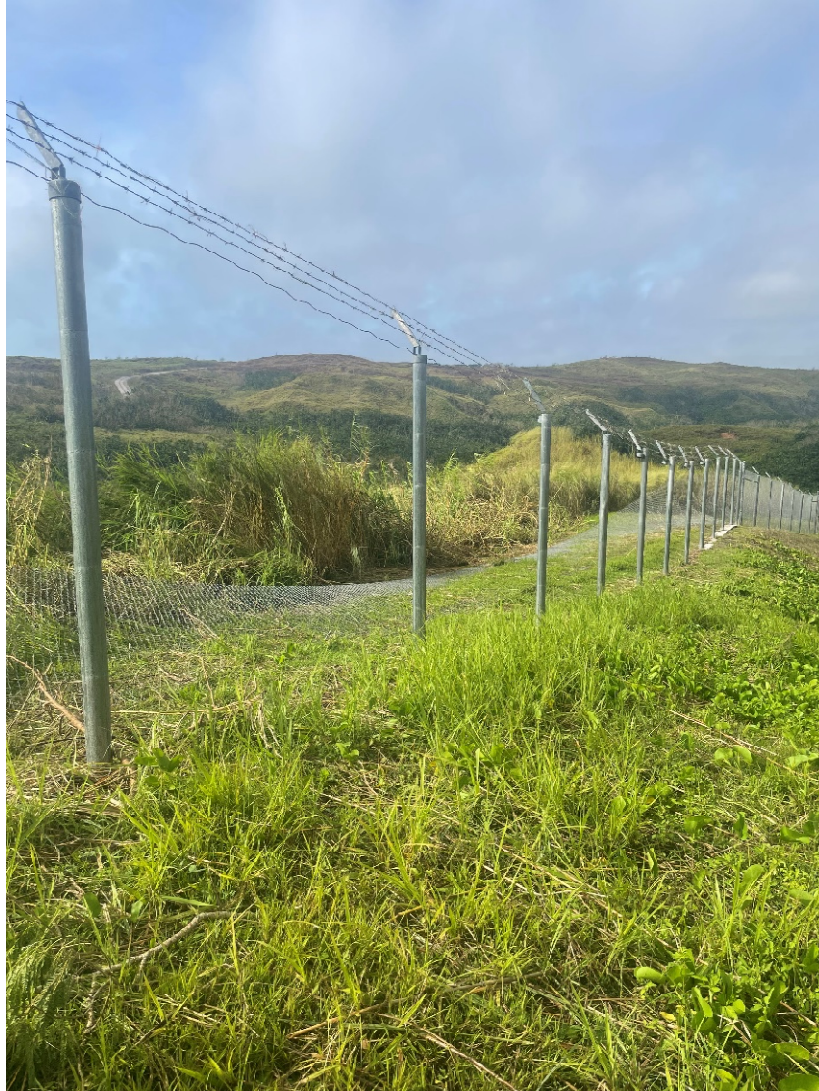
**Figure 7. Part of the perimeter fence on the eastern side of the site—damaged during the storm.**
