SUBJECT: Site Inspections at Samsung Mangilao Solar Project Site, July 23 and 18, 2021

ADDENDUM (July 28, 2021)

Site Inspection at Samsung Mangilao Solar Project Site, July 23 & 28, 2021
Page 5 of 24

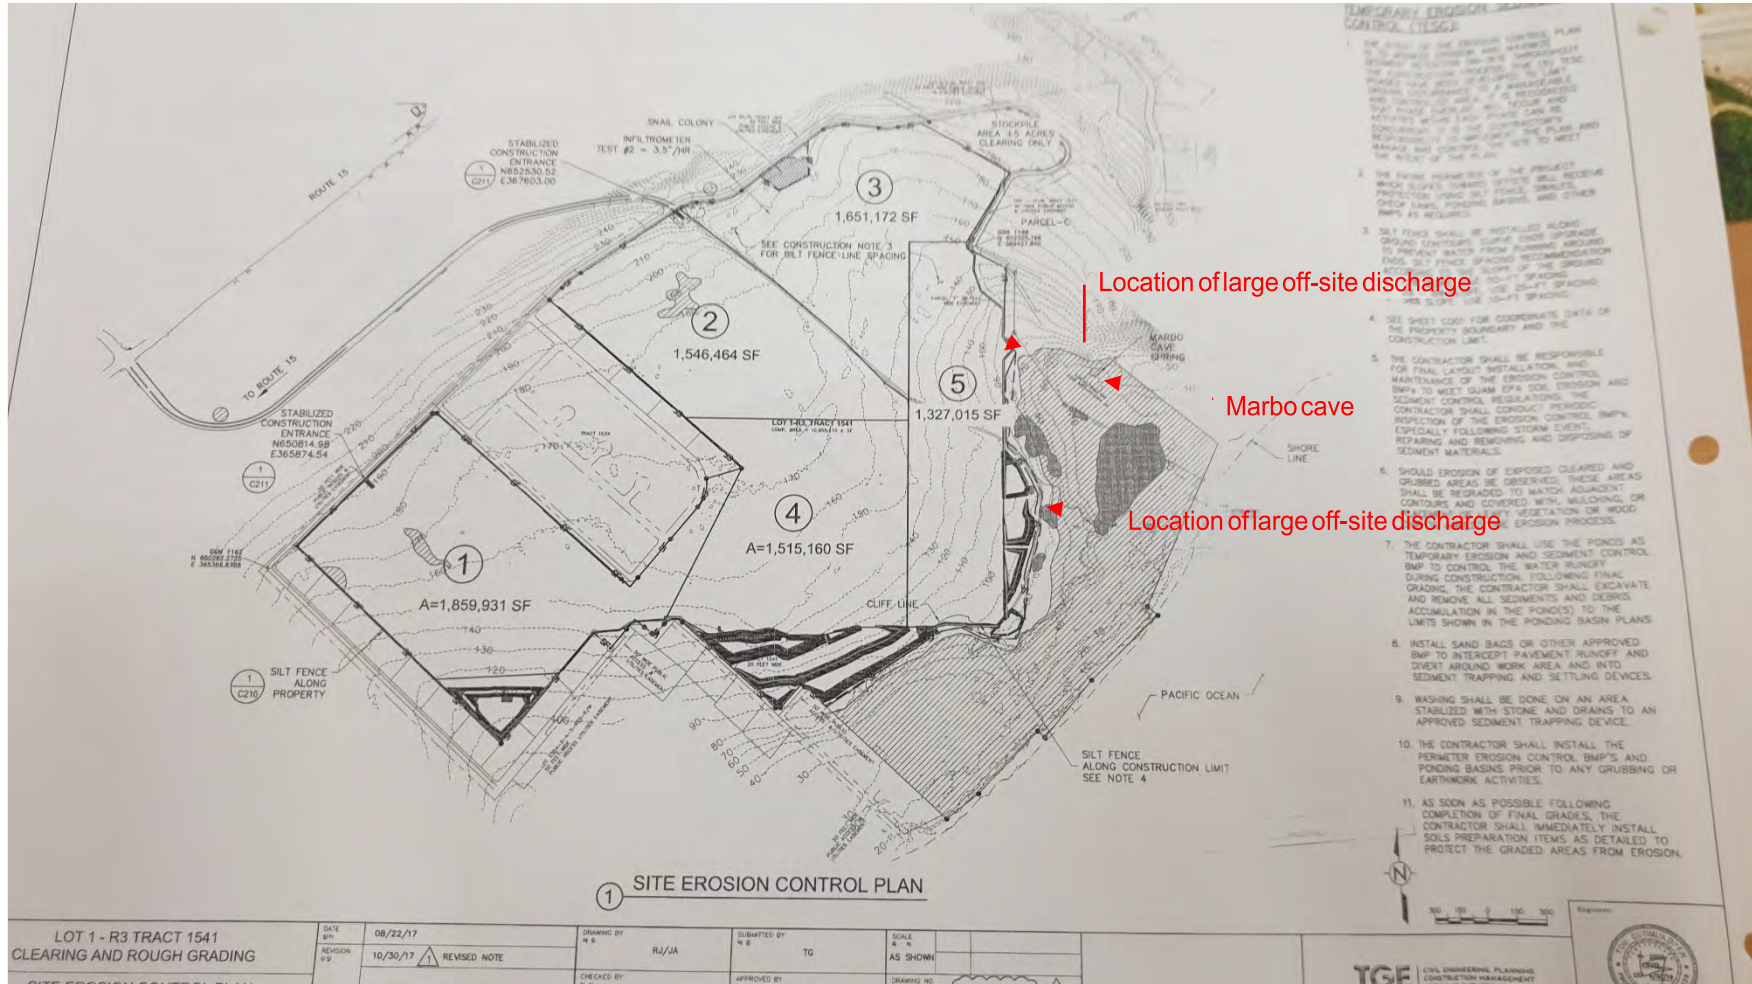
Overall site plan, but note that the designs of Pond 3 (center bottom) and Pond 4 (right bottom) were changed, and a Pond 5 was added (upper annotated discharge location) w/ GEPA approval (see additional photos)

Annotations in red added to highlight location of discharges toward Marbo Cave (upper) and from Pond 4 area (lower), which was the subject of the complaint.

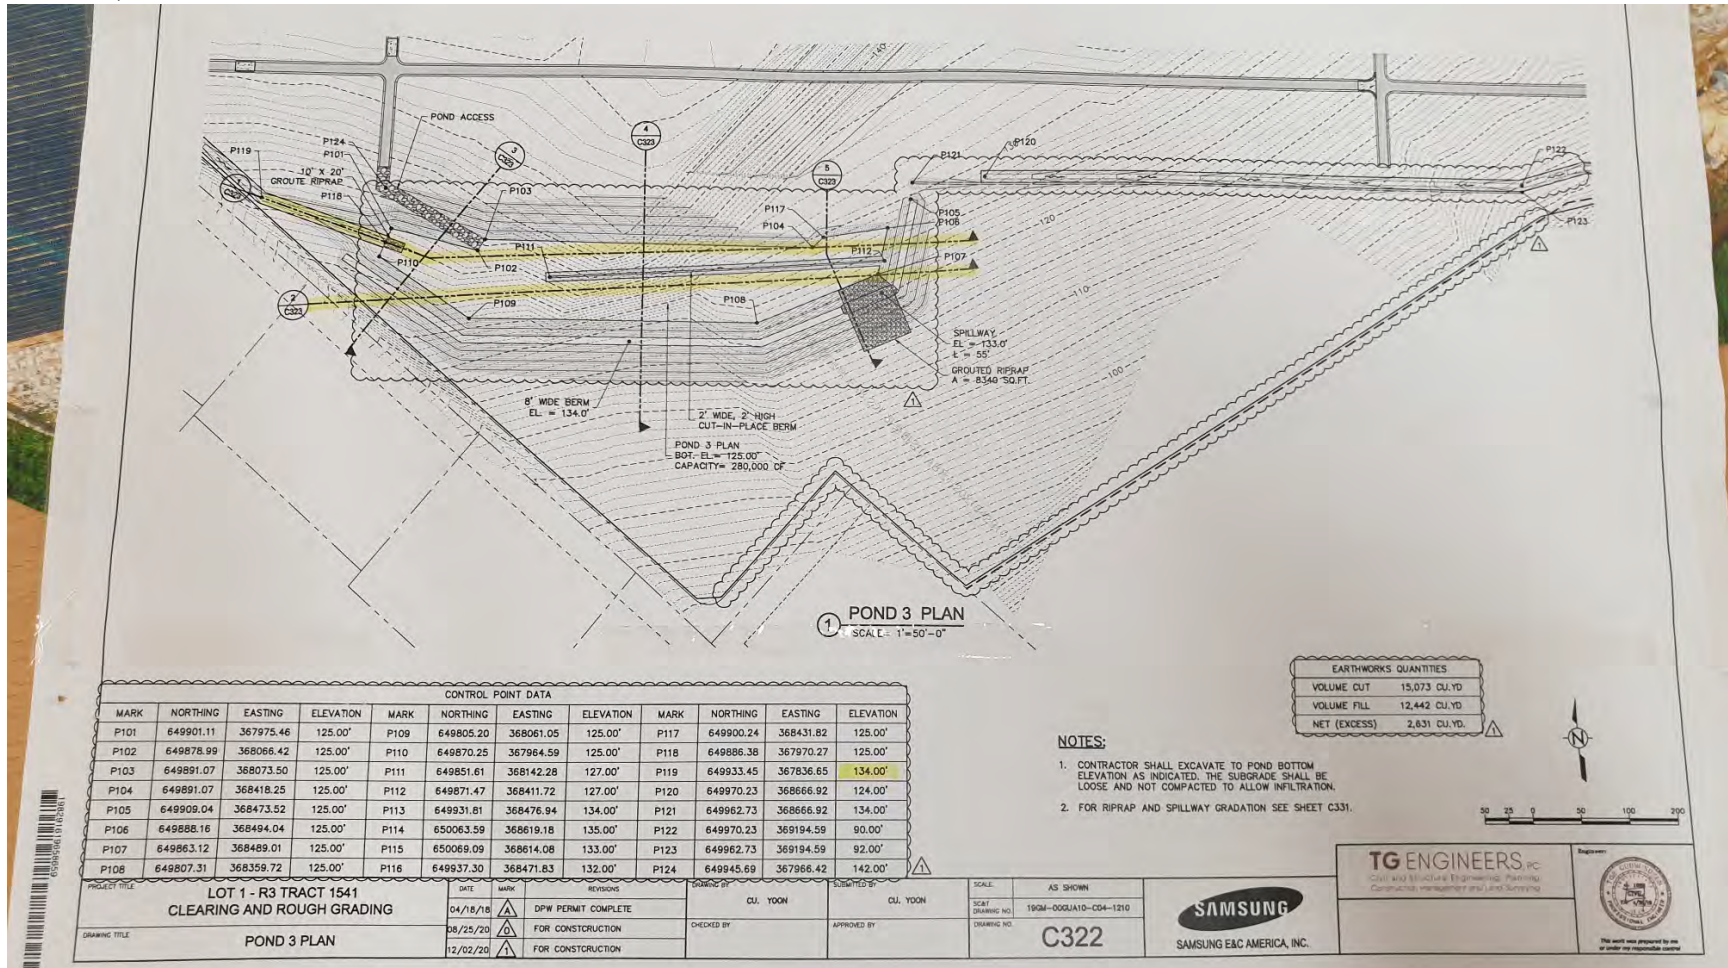
Revised Pond 3 plan, as approved by GEPA July 2020. Note stone riprap at overflow. Per Samsung, this had not yet been installed. (July 23, 2021)

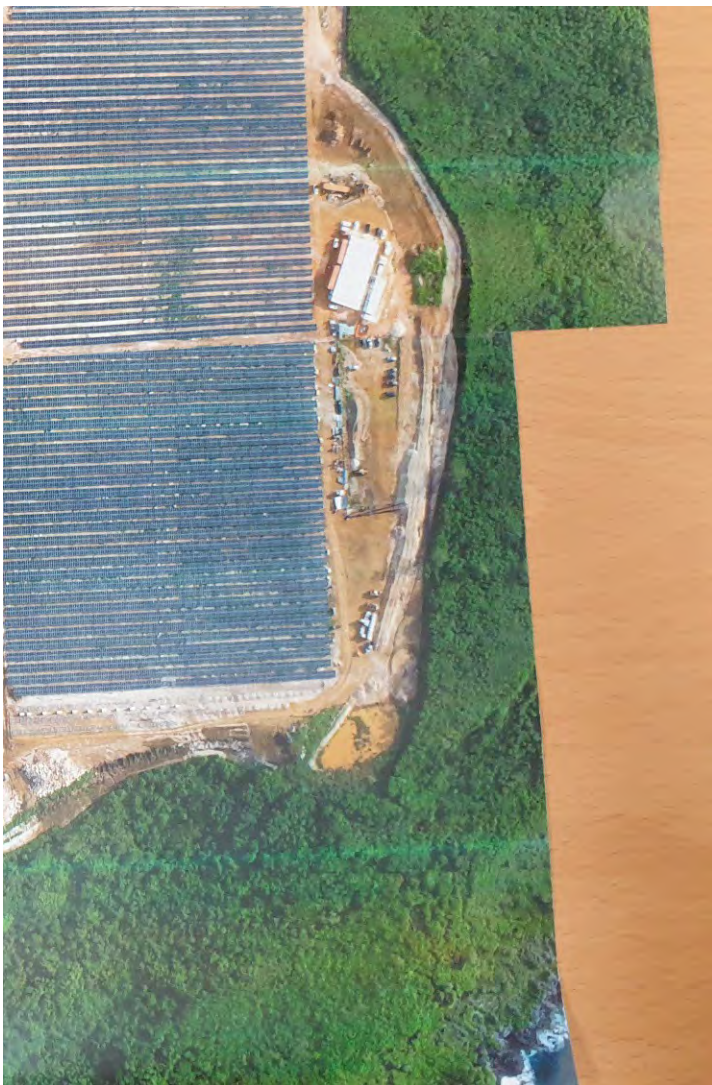
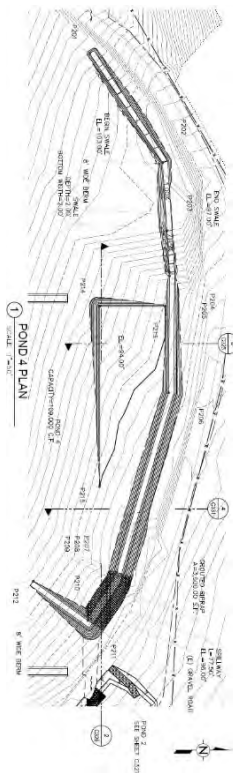
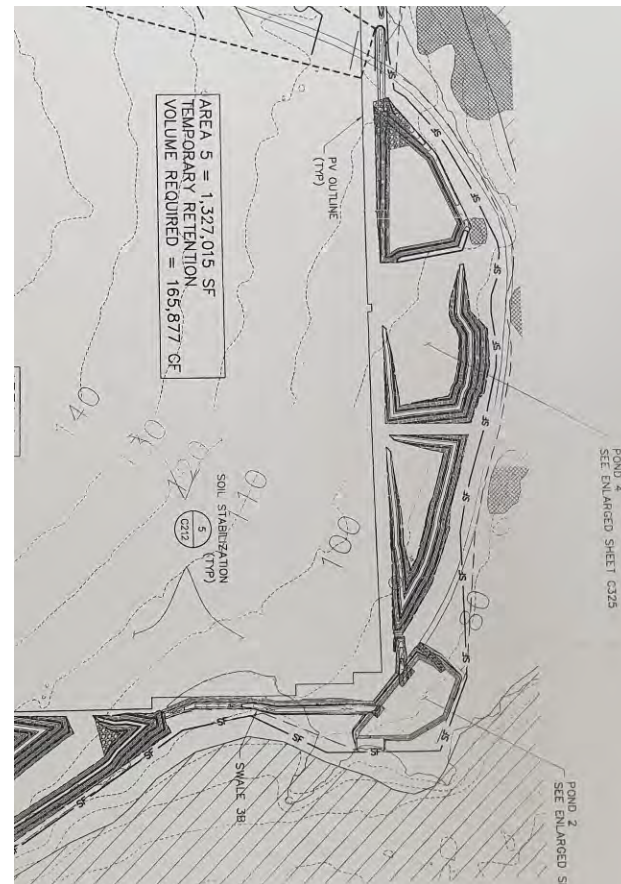
From the aerial images I noted that the location of Pond 4 appeared to coincide with the location of the project offices. Mr. Kim and staff confirmed that Pond 4 had not been constructed yet, and that the project offices were indeed located in the same spot. I also noted that construction of Ponds 1 and 3 appeared to still be underway. This was also confirmed by Mr. Kim and others that were present.

Site aerial image taken July 22, compared to approved E&SC plans (revised plan approved July 2020 in center), showing location of office at Pond 4 site (July 23, 2021)

- I strongly recommended that Samsung begin construction of Pond 4, at the very least the lower sections of the pond where the office is not located, to prevent further discharge.

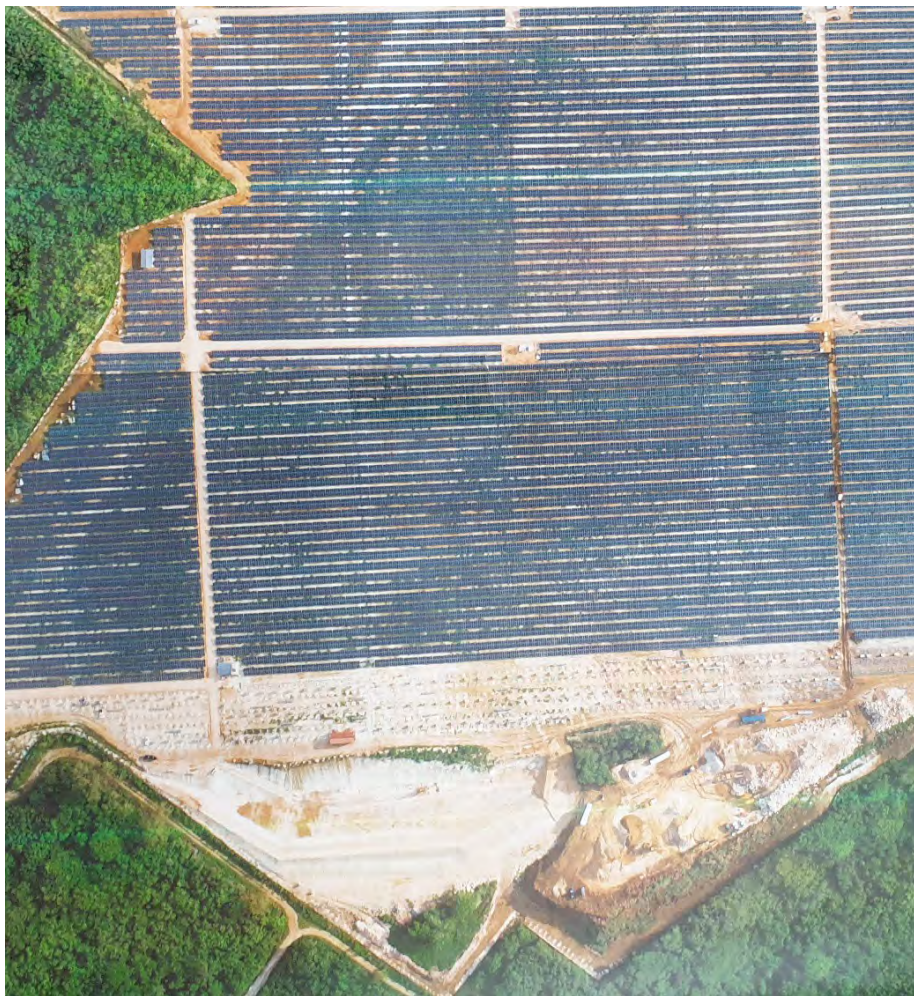
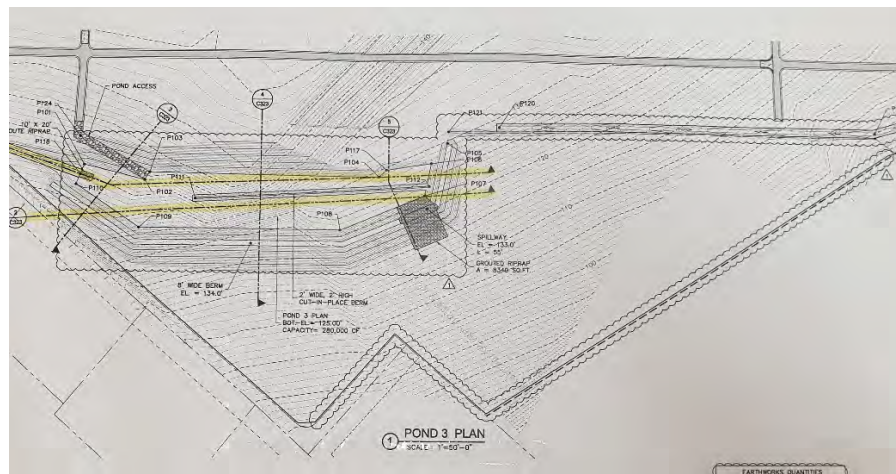
Aerial photo dated July 22, 2021 at location of Pond compared to approved E&SC plan (July 23, 2021)

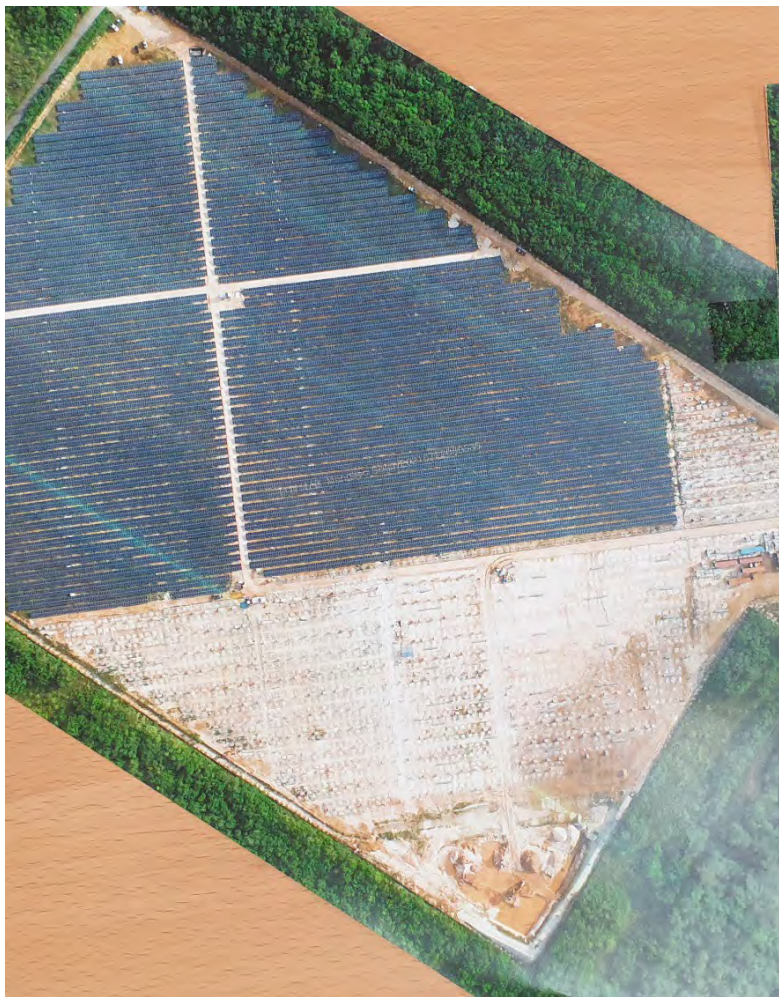
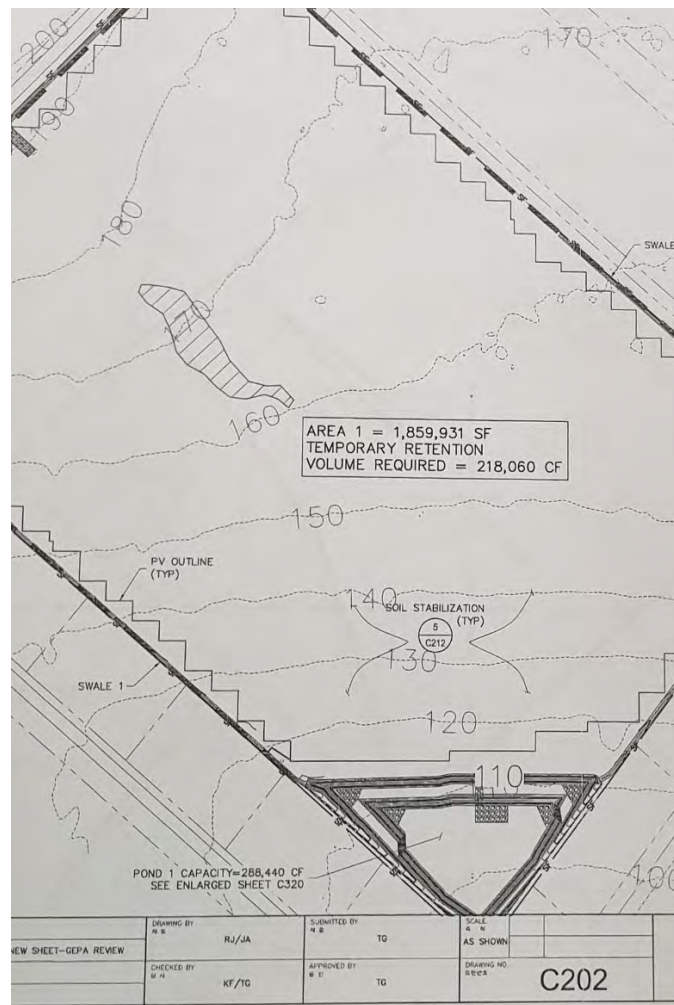
Site aerial image of Pond 1 area, taken July 22, 2021, compared to approved E&SC plan: (July 23, 2021)

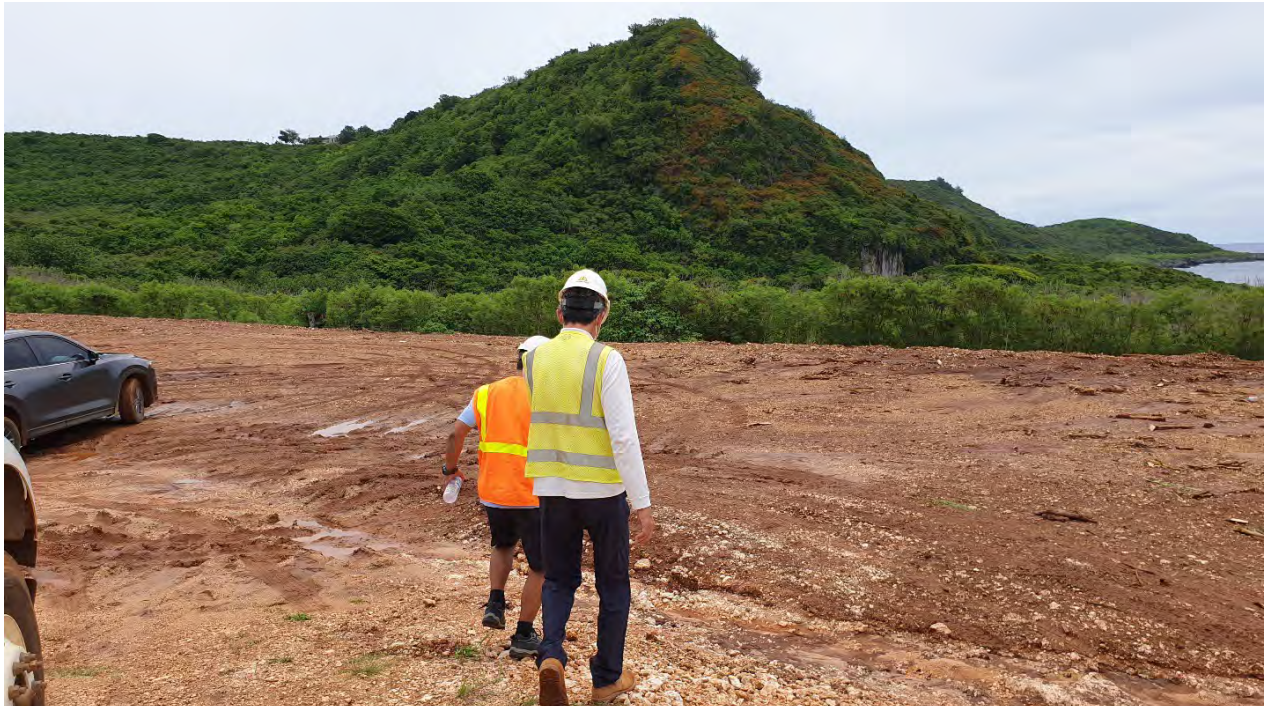
View looking from site office to area where start of Pond 4 berm and swale should be located.
(July 23, 2021)

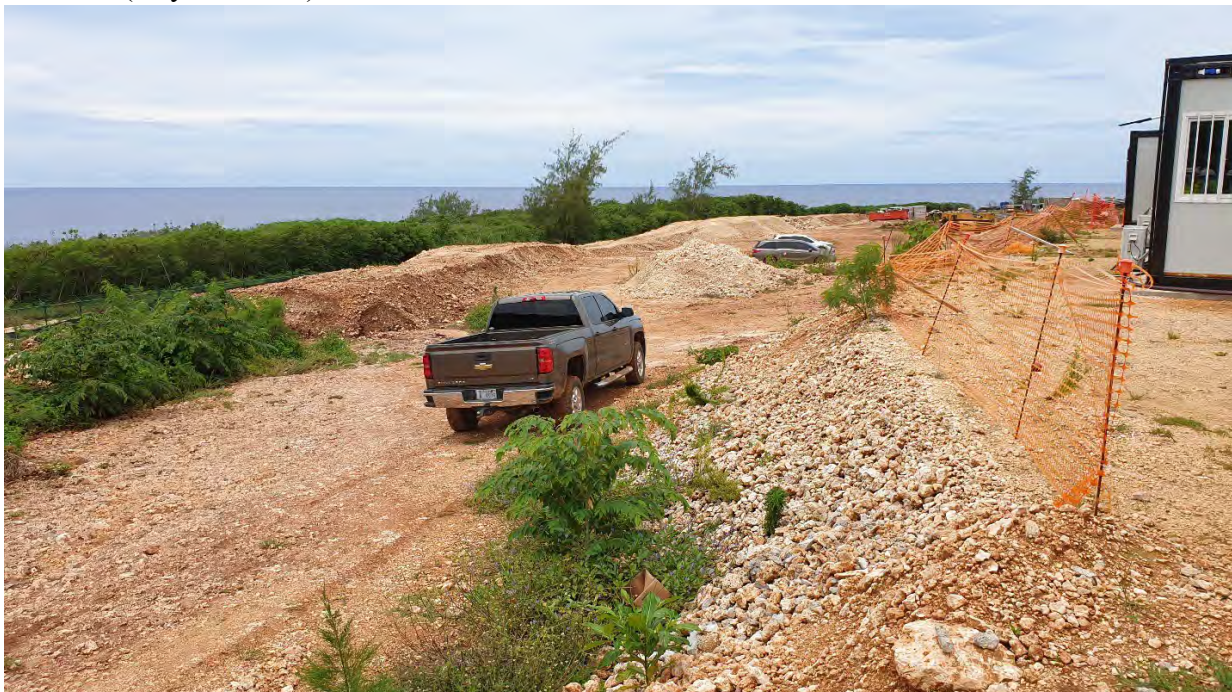
View looking downslope where Pond 4 berm construction has begun, and toward Pond 2 in distance. (July 23, 2021)

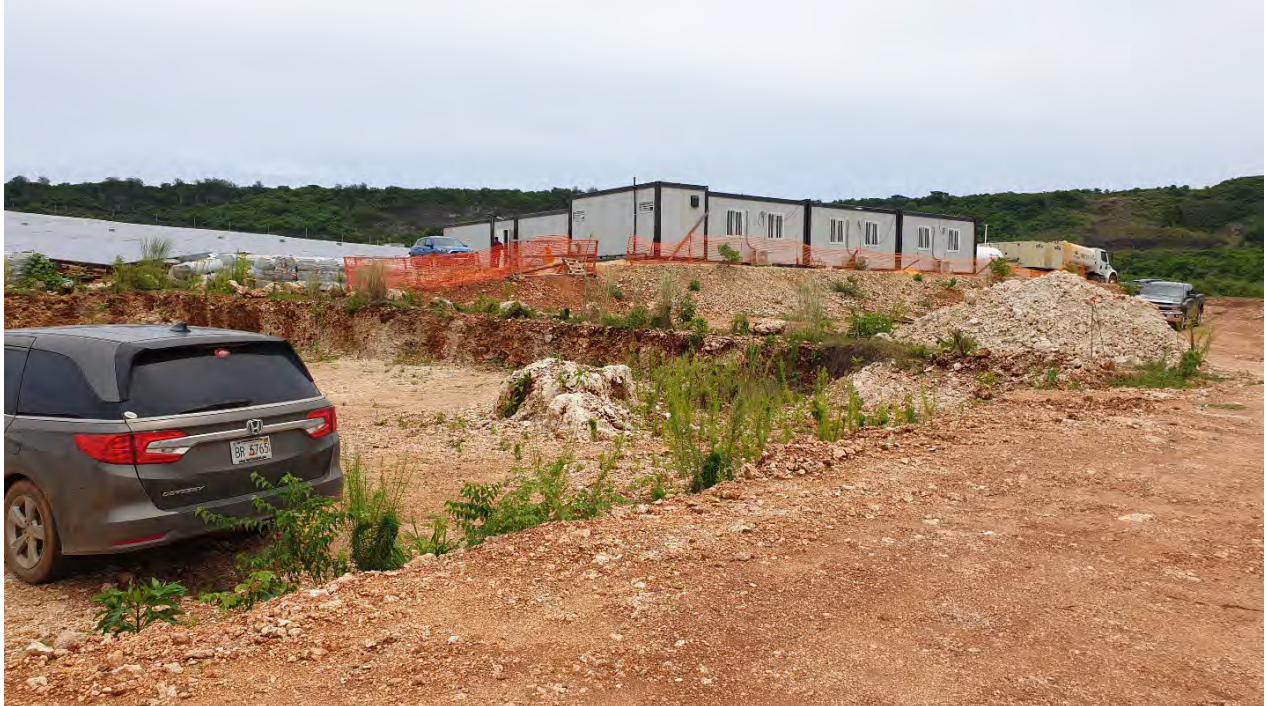
Looking back upslope toward Project Site Office, showing start of (revised) Pond 4 excavation (July 23, 2021)

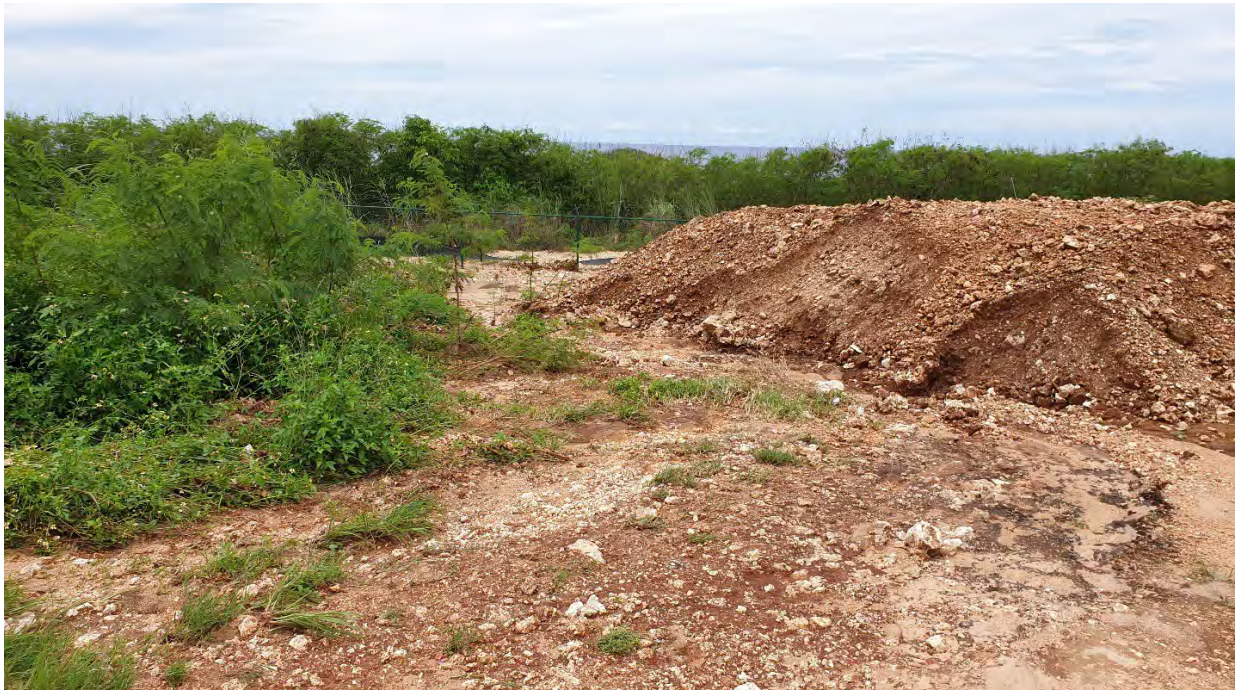
Location of discharge from Pond 4 area to off-site. This is reportedly the location of the complaint. See next page for close up. (July 23, 2021)

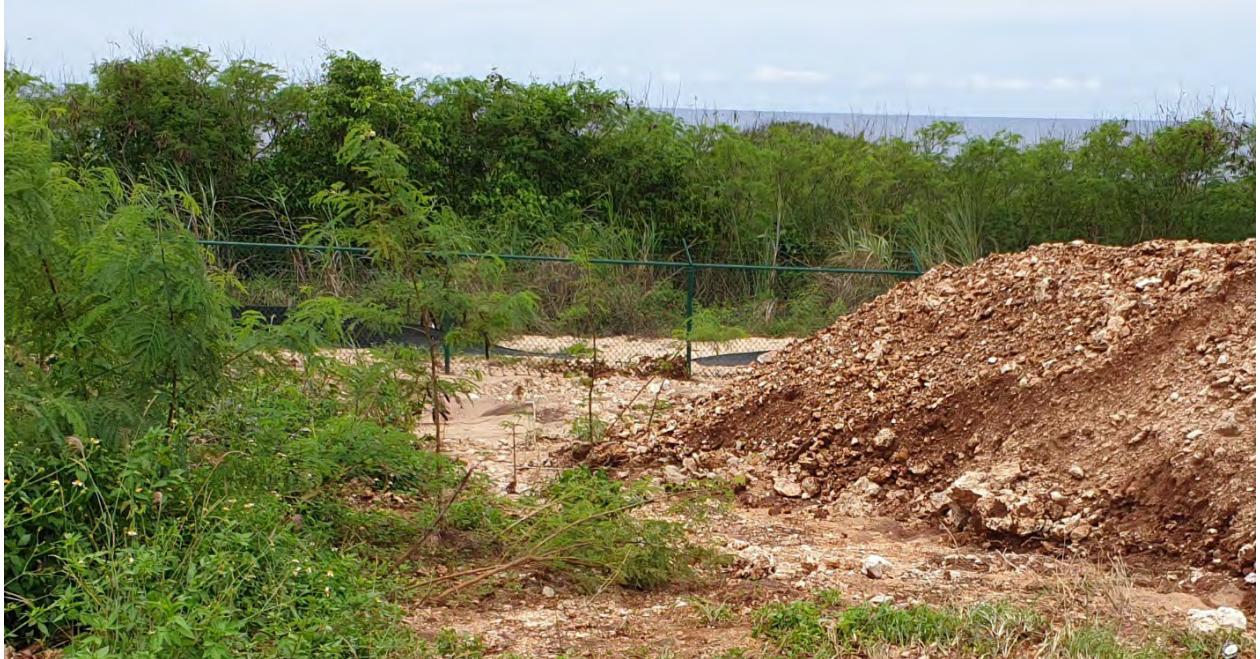
Close up of Pond 4 discharge location. Note accumulated sediment in delta-pattern, and overwhelmed silt fence. (July 23, 2021)

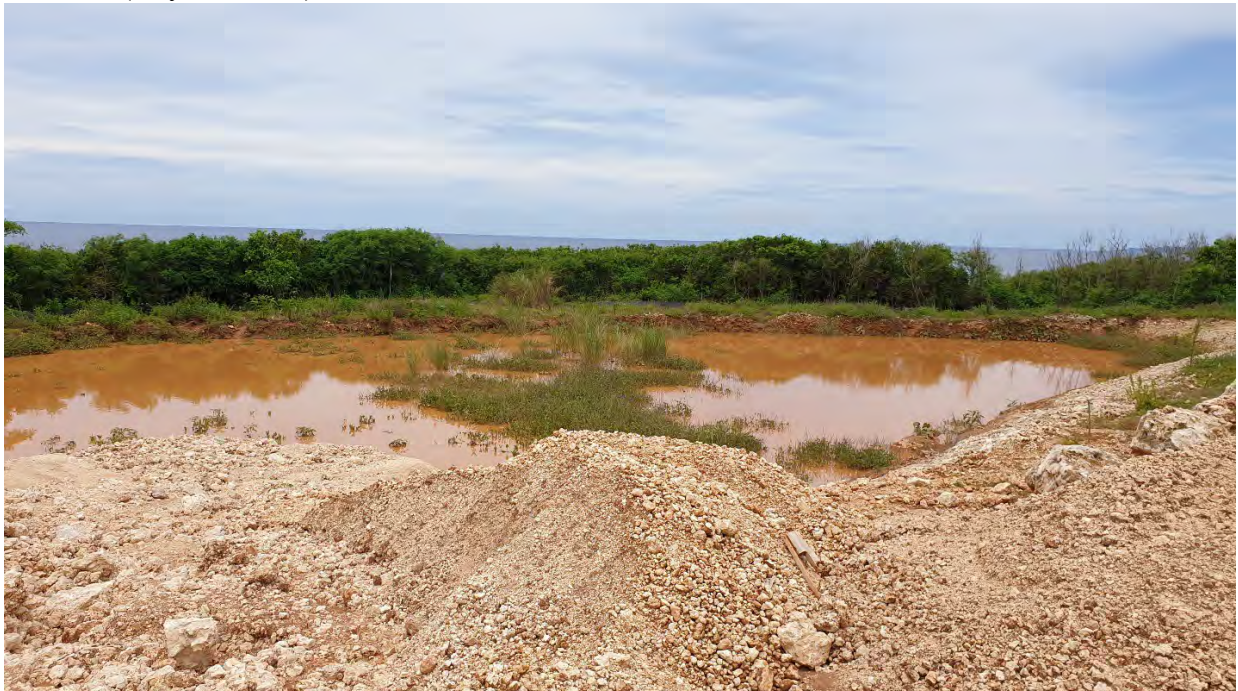
Pond 2, with accumulated runoff and sediment from storm. This pond does not appear to be finished. (July 23, 2021)

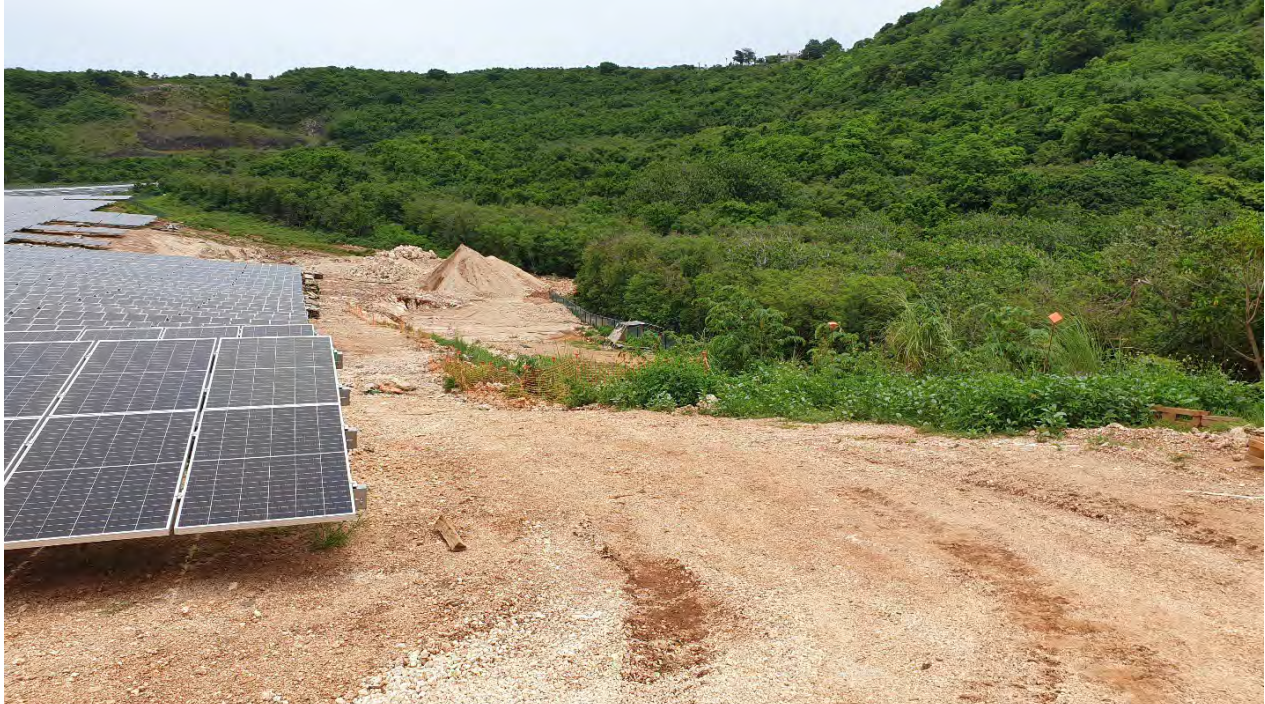
Location of apparent discharge toward Marbo Cave. See next photo for close-up. (July 23, 2021)

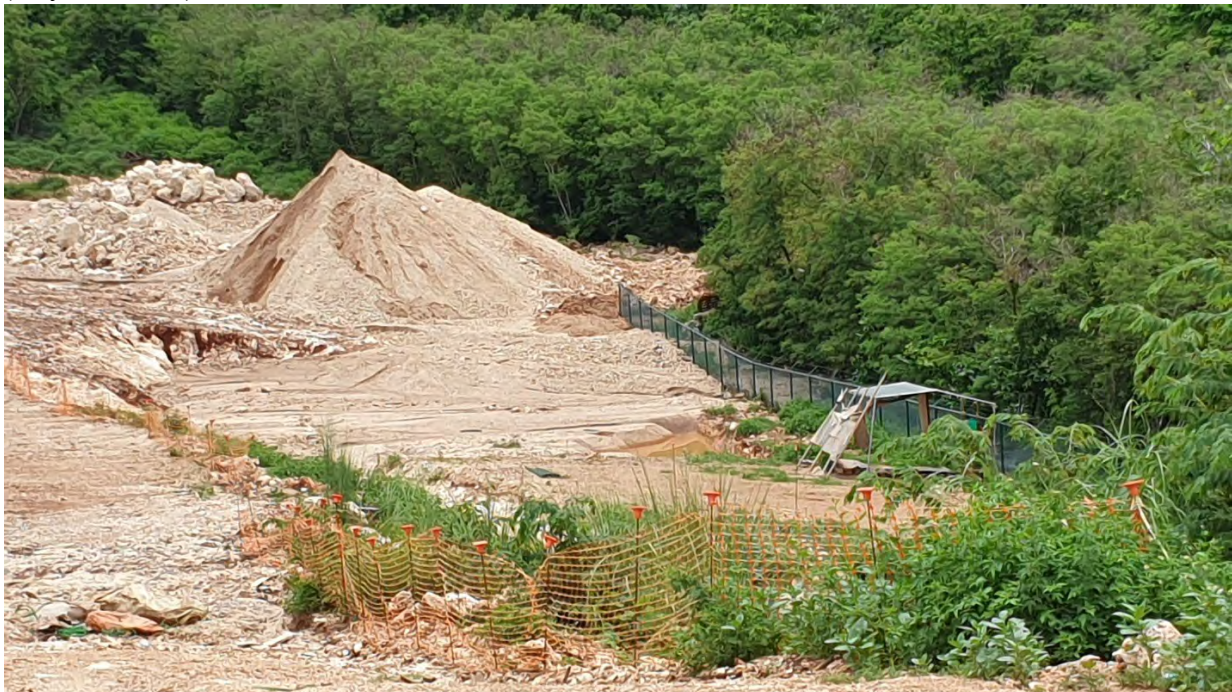
We then drove through the project site to visit Ponds 1 and 3. On the way I stopped and took pictures of an area where evidence of a large discharge of runoff was present. This area does not appear to be served by a sedimentation basin (pond) in the approved E&SC plans, and is directly upstream of Marbo Cave according to the site plans. On the way between Ponds 3 and 1, I observed that the perimeter swale had a large number of ironwood saplings growing in it, as well as a lot of sediment that was obstructing the cross section of the swale. (See addendum below – Pond 5 was added to the site E&SC plans and approved by GEPA on January 4, 2021. I inspected with Johnny Abedania on July 28, 2021 to further investigate).

Close-up of area that appears to be a large, unprotected off-site discharge toward Marbo Cave area. Note large delta-type formation of sediments, indicating long-term history of discharge. (July 23, 2021)

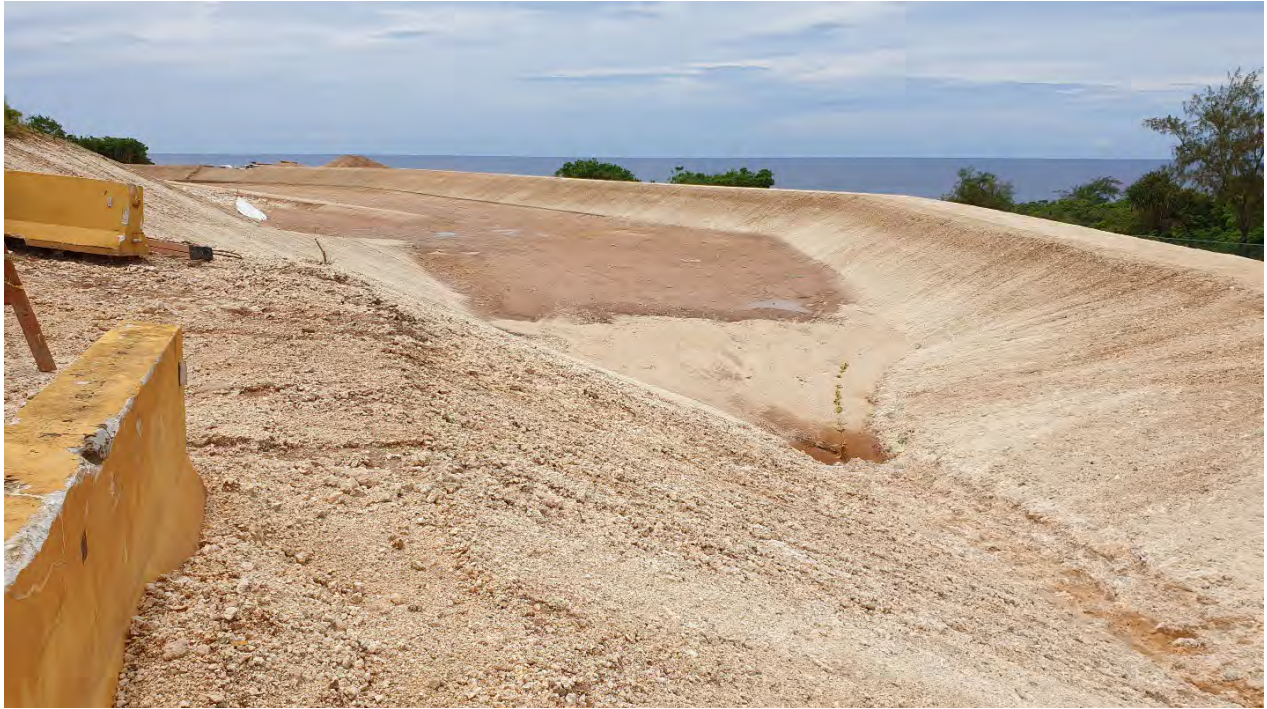
Pond 3 was mostly in place but according to Mr. Kim it was not yet finished; the stone overflow structure still needed to be built. We observed that runoff had only filled Pond 3 about a foot or two. Pond 1 was complete, according to Mr. Kim. We observed that runoff had filled Pond 3 almost to the point of overflowing, by evidence of a clearly visible high water mark. However Mr. Kim stated that it had not overflowed. We observed that there were several stockpiles of material in Pond 1 that served to reduce its capacity to hold runoff. We also observed that a large amount of sediment had accumulated in Pond 3, and discussed the need for maintenance to remove it periodically, and completely once the site was stabilized with vegetation, to ensure that the pond worked as an infiltration basin post-construction.

Pond 3. Overflow weir in distance is not yet finished – still requires stone riprap. (July 23, 2021)

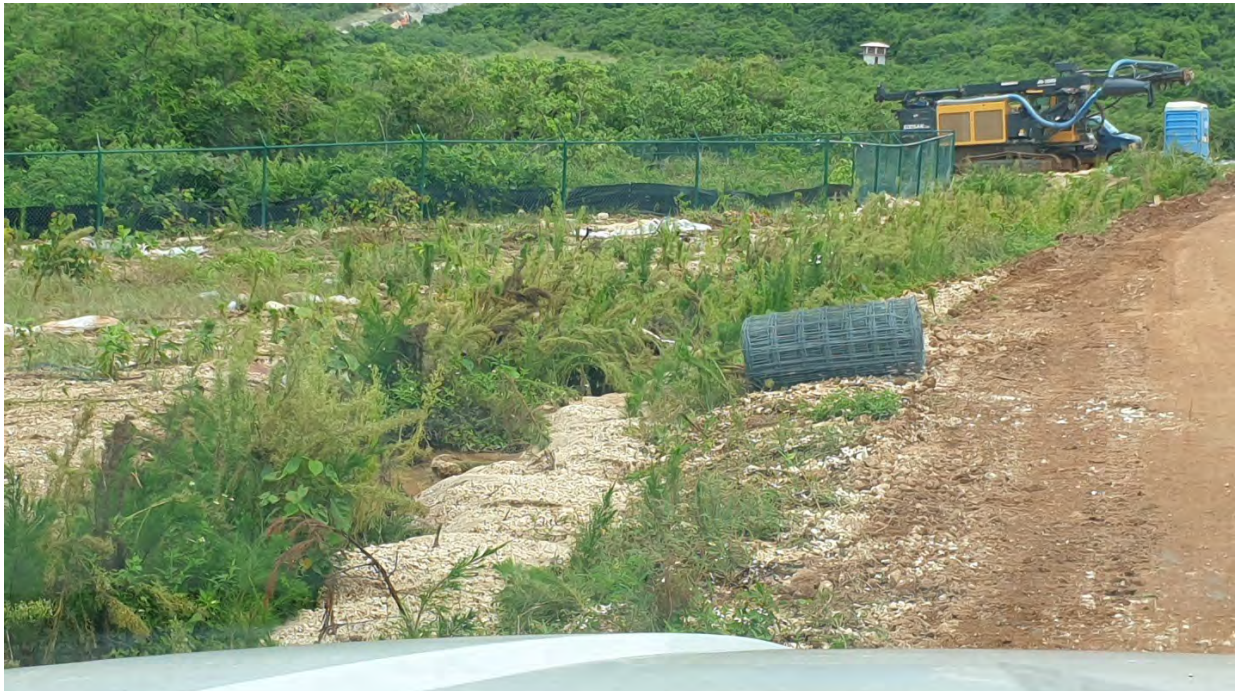
Perimeter berm which conveys runoff to Pond 3. Ironwood saplings and a large amount of accumulated sediment obstruct the flow. (July 23, 2021)

- I recommended that the ironwood saplings seen growing in the perimeter swales be removed as soon as possible, otherwise they would block the flow of water and potentially cause discharge of runoff off-site, instead of to the approved ponds.

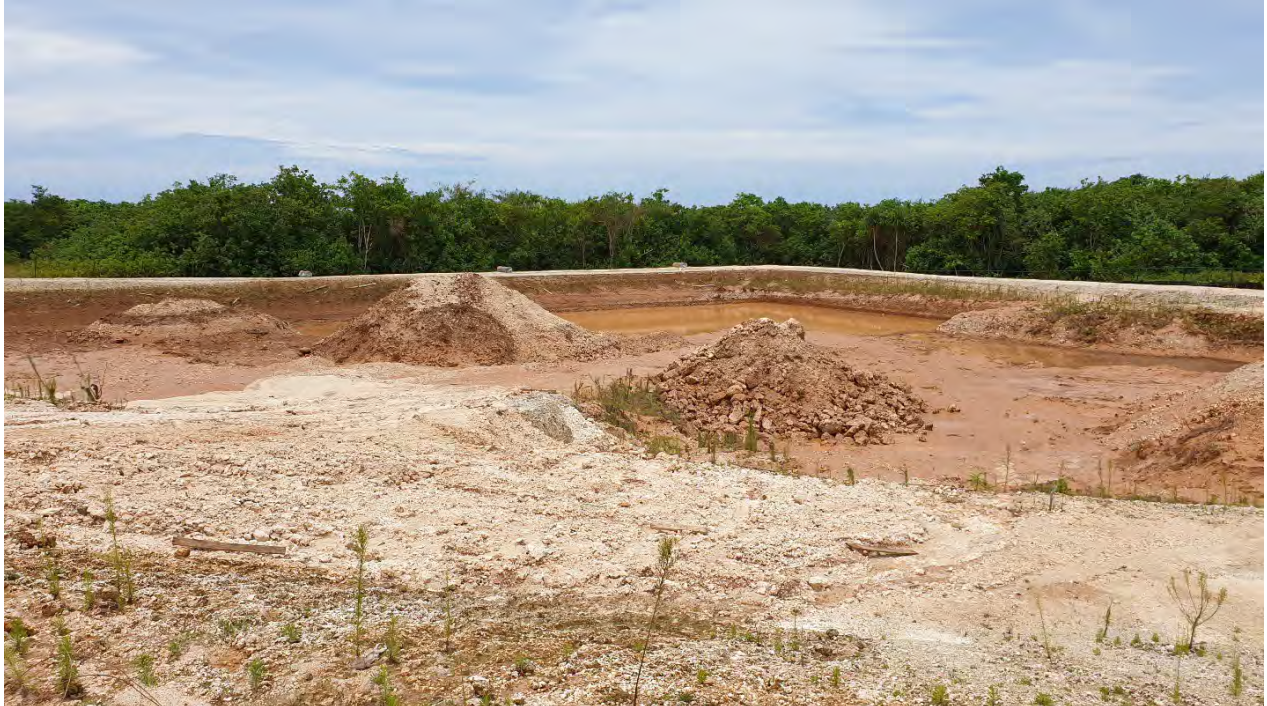
Pond 1. Note stockpiles of earth material, which reduce pond capacity. Also note high water mark from the previous storms. (July 23, 2021)

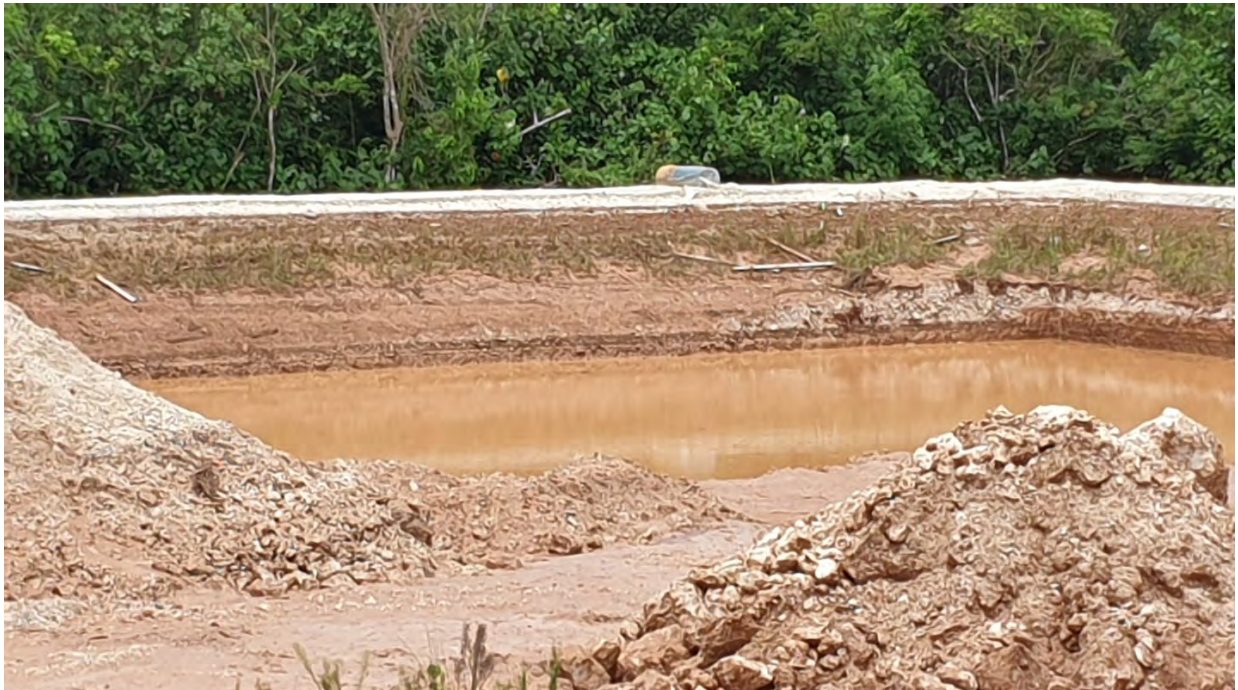
Close up of Pond 1 rim, showing high water mark indicating near-overtopping from prior storm. (July 23, 2021)

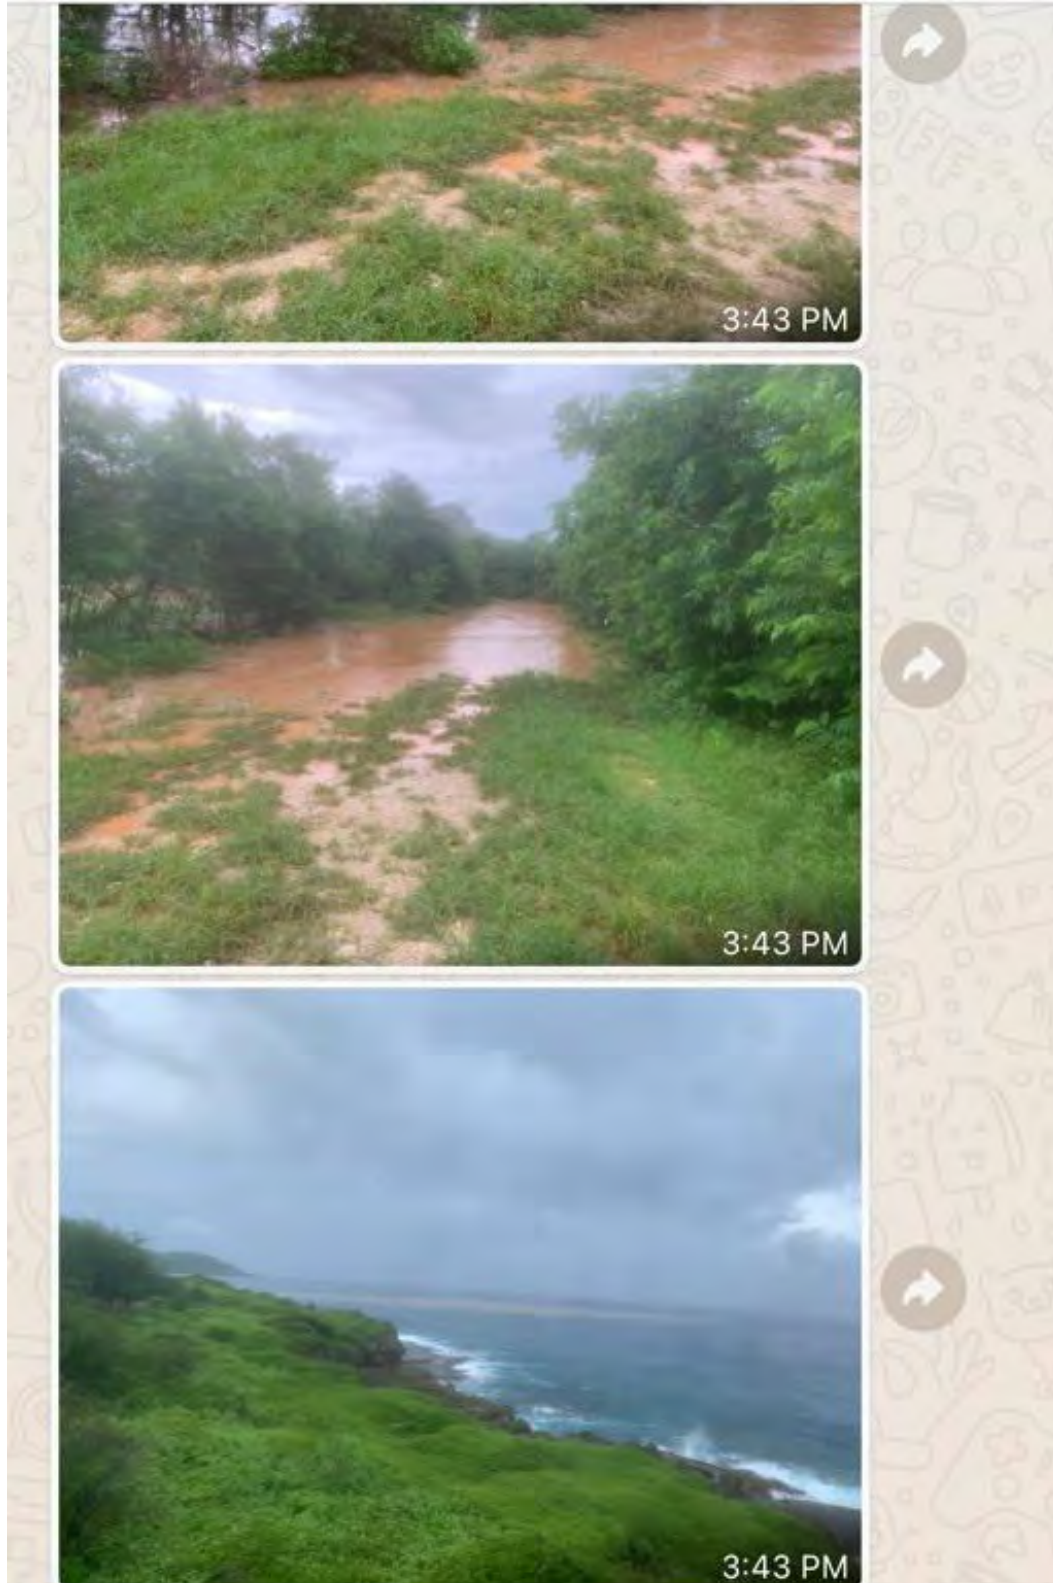
- There was evidence of discharge of runoff off-site, and also evidence submitted to us electronically that sediment-laden runoff had discharged to the ocean.

Images received over social media with original complaint. Bottom image purports to show sediment plume in ocean, originating from Samsung Mangilao Solar Project. (July 23, 2021)

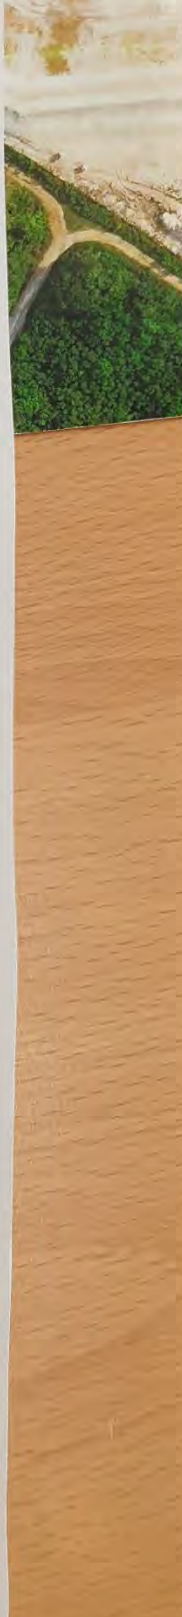
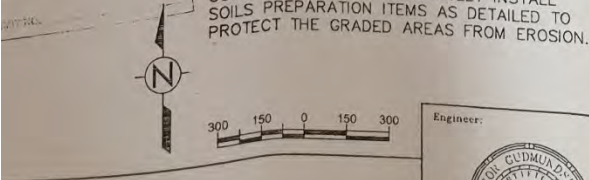
Note concerning required sequence of construction

- Sedimentation basins (ponds) had not been constructed prior to the start of clearing and construction operations, and that this sequence of operations was required by Guam's regulations and was also spelled out in the approved plans that we reviewed at the office. I noted that Samsung is a very large company and should have known the proper sequence of installing E&SC measures.

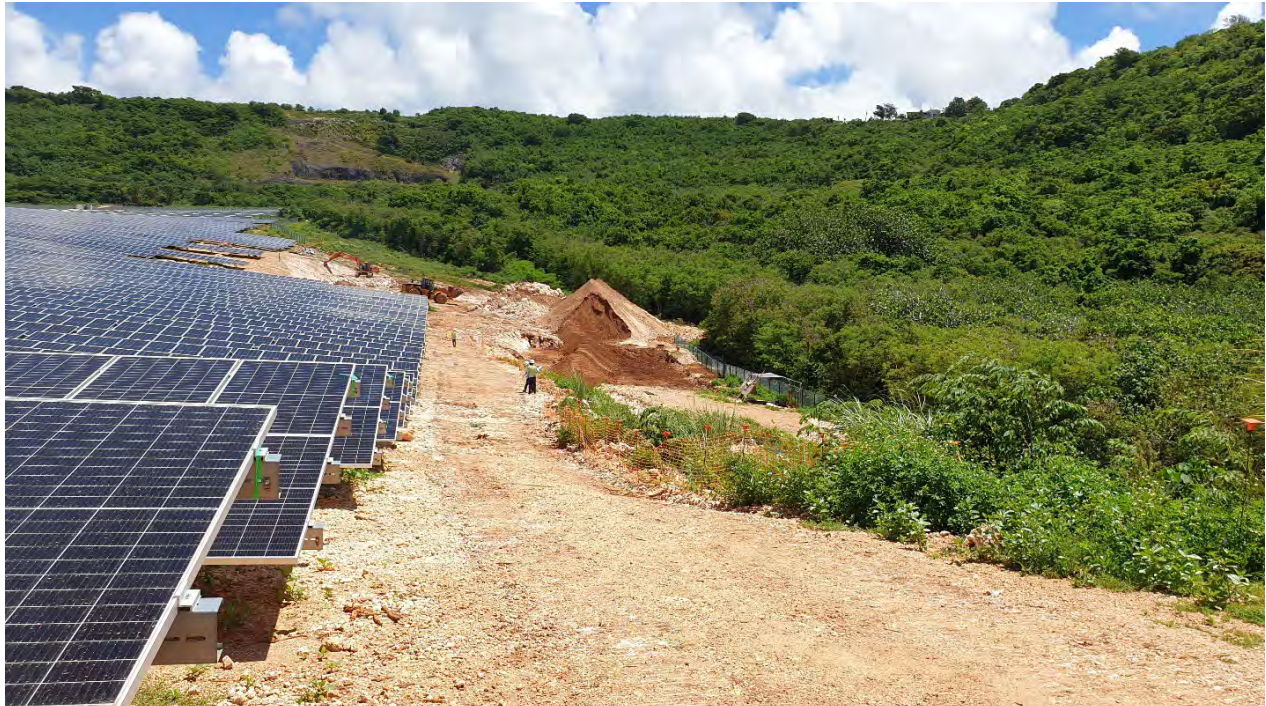
The location of the Marbo Cave discharge and Pond 5, showing activity underway to install E&SC measures on July 28, 2021:
