SUBJECT: Site Inspections at Samsung Mangilao Solar Project Site, July 23 and 18, 2021

ADDENDUM (July 28, 2021)

Site Inspection at Samsung Mangilao Solar Project Site, July 23 & 28, 2021
Page 5 of 24

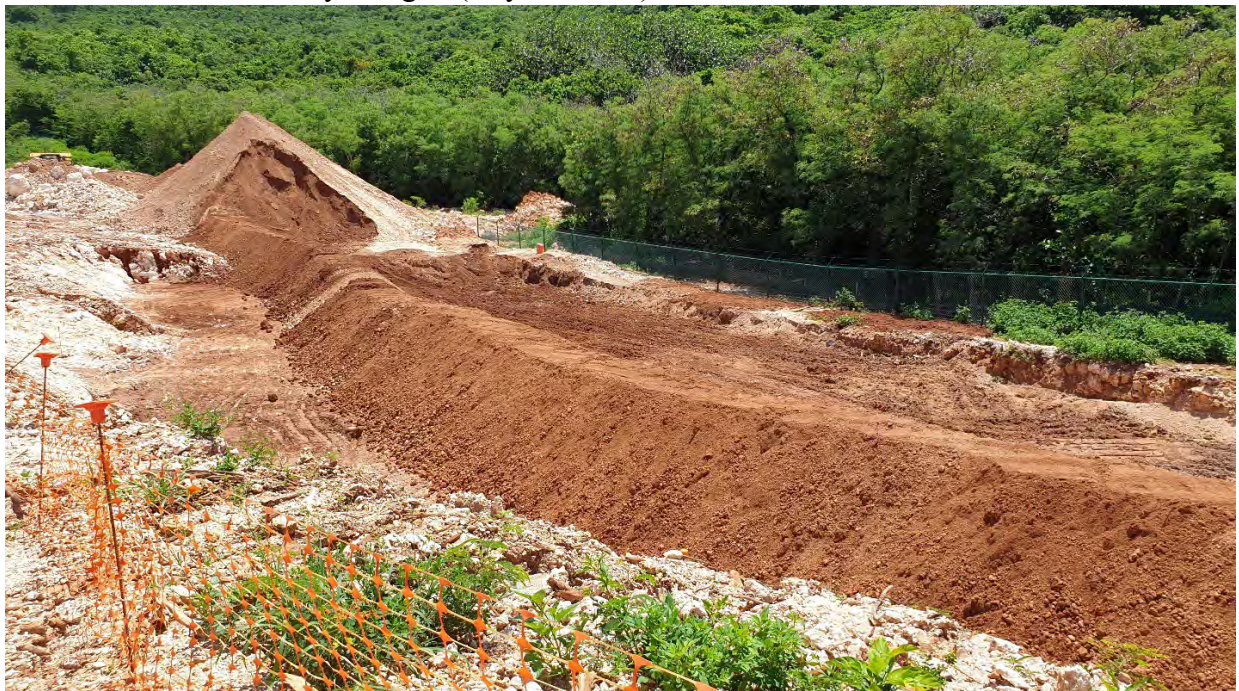
Pond 5B installation had only just begun, following our July 23 inspection. Mr. Kim explained that a temporary pond had been created using the available earth fill material, as shown in the photos. The permanent pond will be formed by the embankment downhill from the temporary embankment, but placement and compaction of fill for the permanent embankment had not yet begun. I expressed my concern to Mr. Kim that the temporary pond berm might be easily washed out by another large storm event because it appeared to have not been compacted in lifts, and was constructed of a topsoil-like material that did not appear to meet the typical requirements for embankment fill.

The beginning of construction work for Pond 5B. The soil embankment is to delineate a temporary storage pond, while the permanent embankment is installed just beyond (to the right). Base preparation for the permanent embankment has begun, but emplacement and compaction of embankment fill had not yet begun (July 28, 2021):

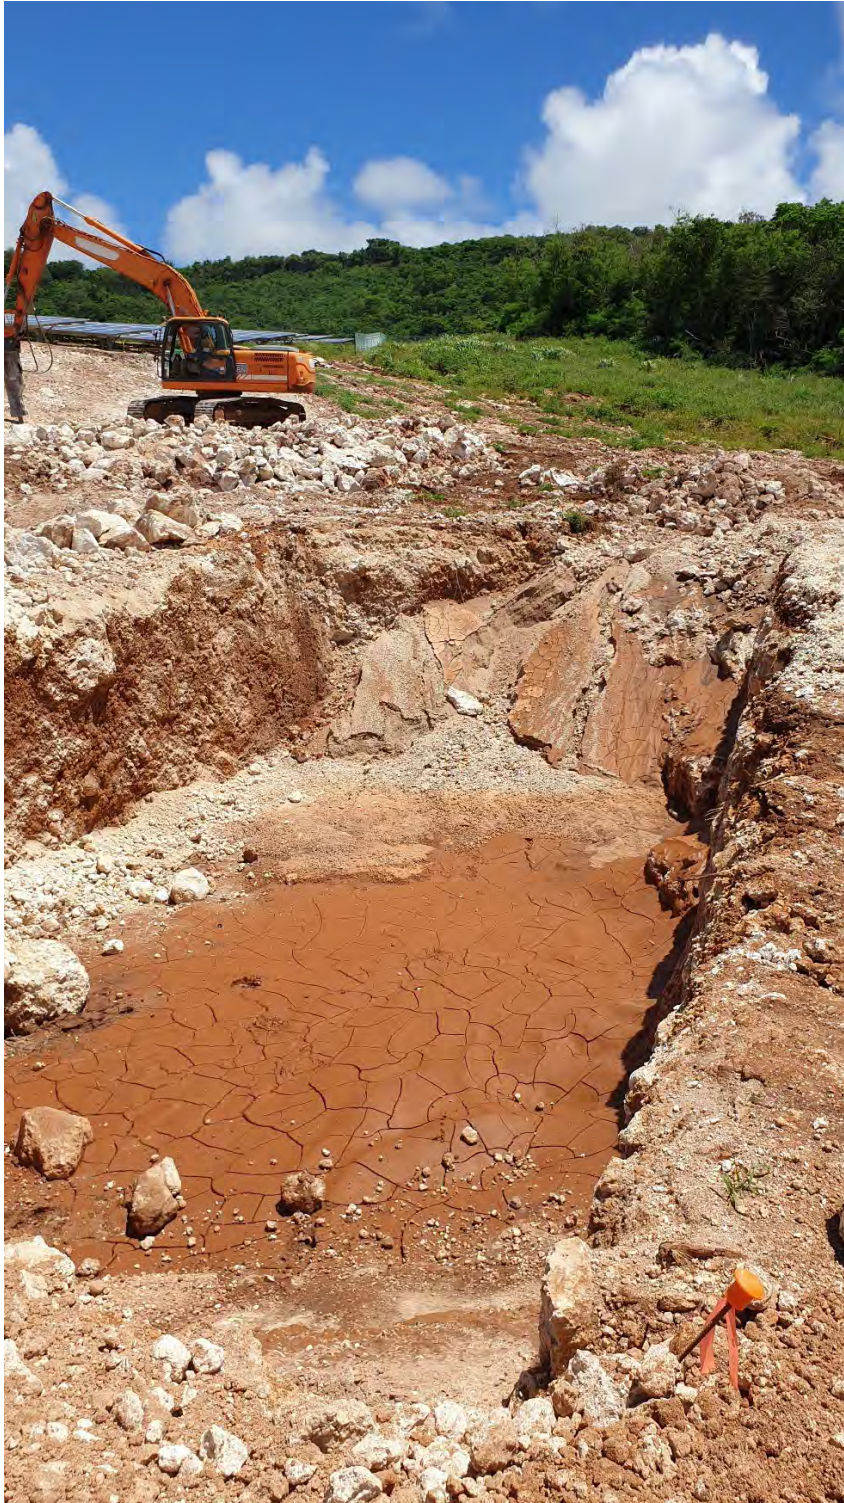
Pond 5A excavation, which according to Samsung site personnel was begun in June. However the excavation is not yet connected to the site swale, so mass runoff is unable to enter the basin. Sedimentation pictured is from incidental runoff that the excavation collected due to its location (July 28, 2021):

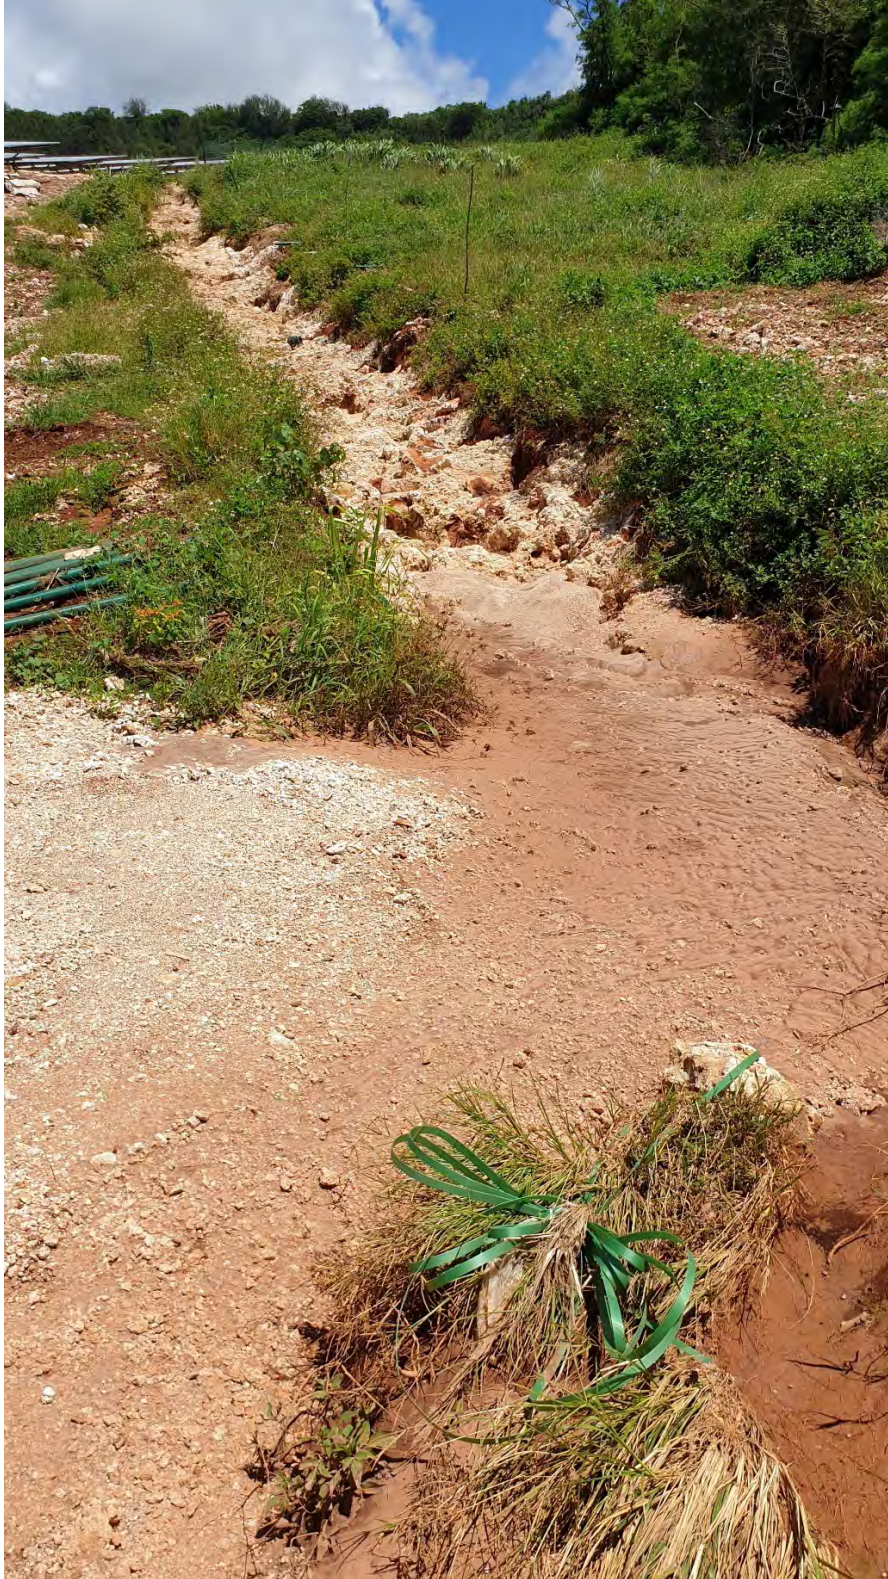
I conducted the inspection with Helen Gumataotao, Environmental Inspector I, between approximately 11:00 a.m. and 11:30 a.m. on July 28, 2021. We were met at the front gate by Mr. Kim and other representatives of Samsung. I explained that we were there to inspect the location of Pond 5, which we had missed during the previous inspection on July 23. We were led into the site and to the location of Pond 5. We saw that active construction was underway, and Mr. Kim confirmed that Pond 5 had not been fully installed yet. We saw that the excavation for Pond 5A had been partially completed, which we were told happened in June, but we also observed and confirmed that the perimeter swale was not connected to the Pond 5A excavation.

The perimeter swale which would discharge to Pond 5, but at the time of inspection it was not connected and sedimentation patterns showed that runoff discharged off-site (July 28, 2021)

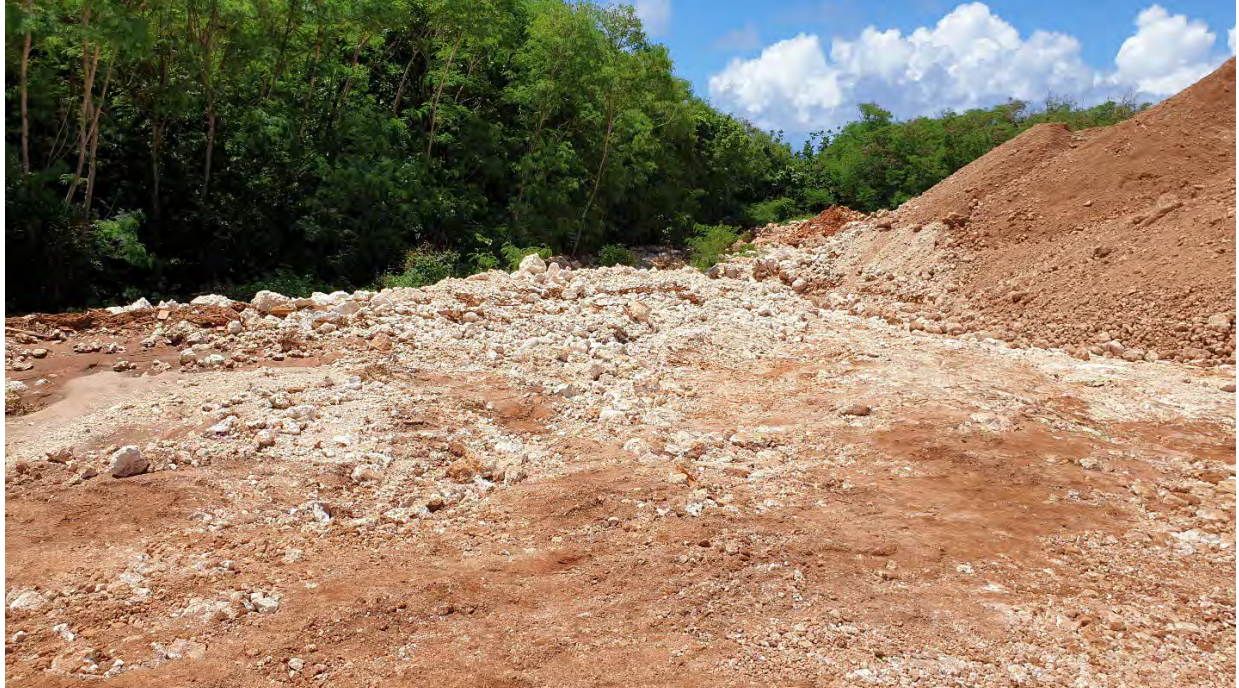
We observed that the perimeter swale had discharged to the open ground near the fence, and along with the surface runoff from the surround project area, had left a very large alluvial/delta formation of sediments, up to and including rocks around 1 to 2 feet in diameter. The deposited sediments could be seen extending into the forest far past the site boundaries, toward the Marbo Cave area.

This is the area where the perimeter swale currently discharges. A large delta-type (alluvial) formation of sediment is evident, showing that a large volume of runoff discharged off-site during the recent rainfall events (July 28, 2021).

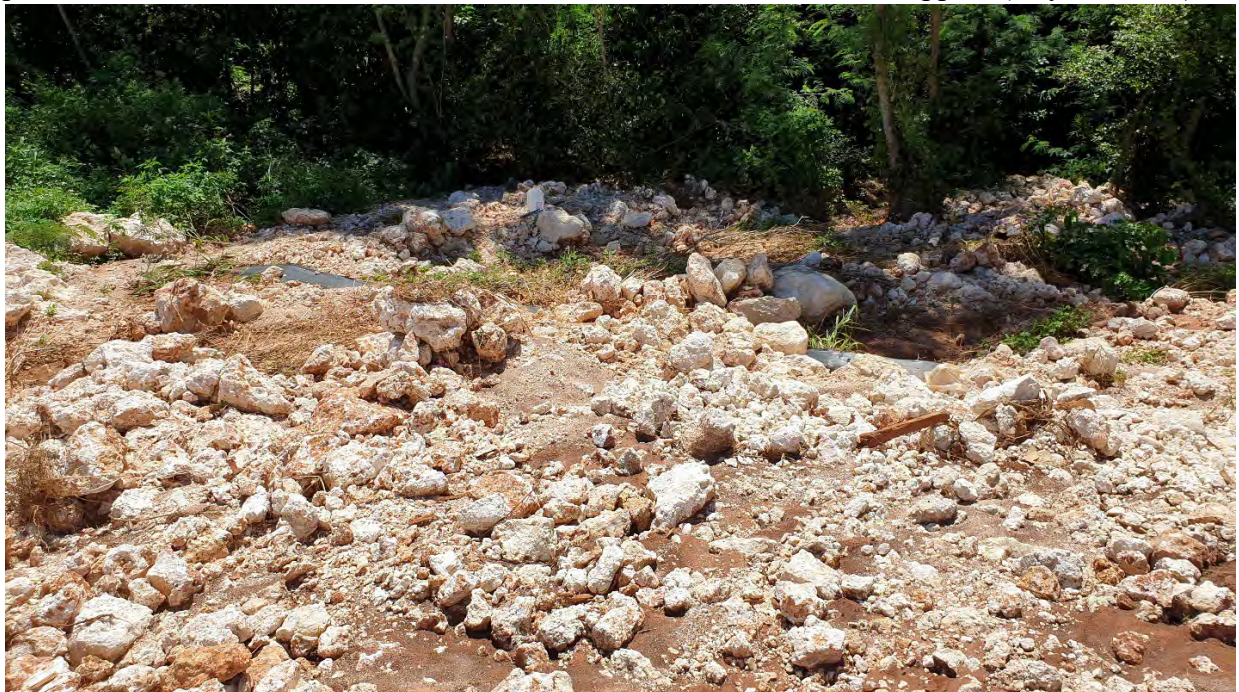
A view of the sediment discharged off-site during the recent rainfall events. The size of the deposited rocks demonstrates that flow volumes and velocities were very high. The top of the perimeter silt fence can be seen, where it was knocked down and overtopped. (July 28, 2021)

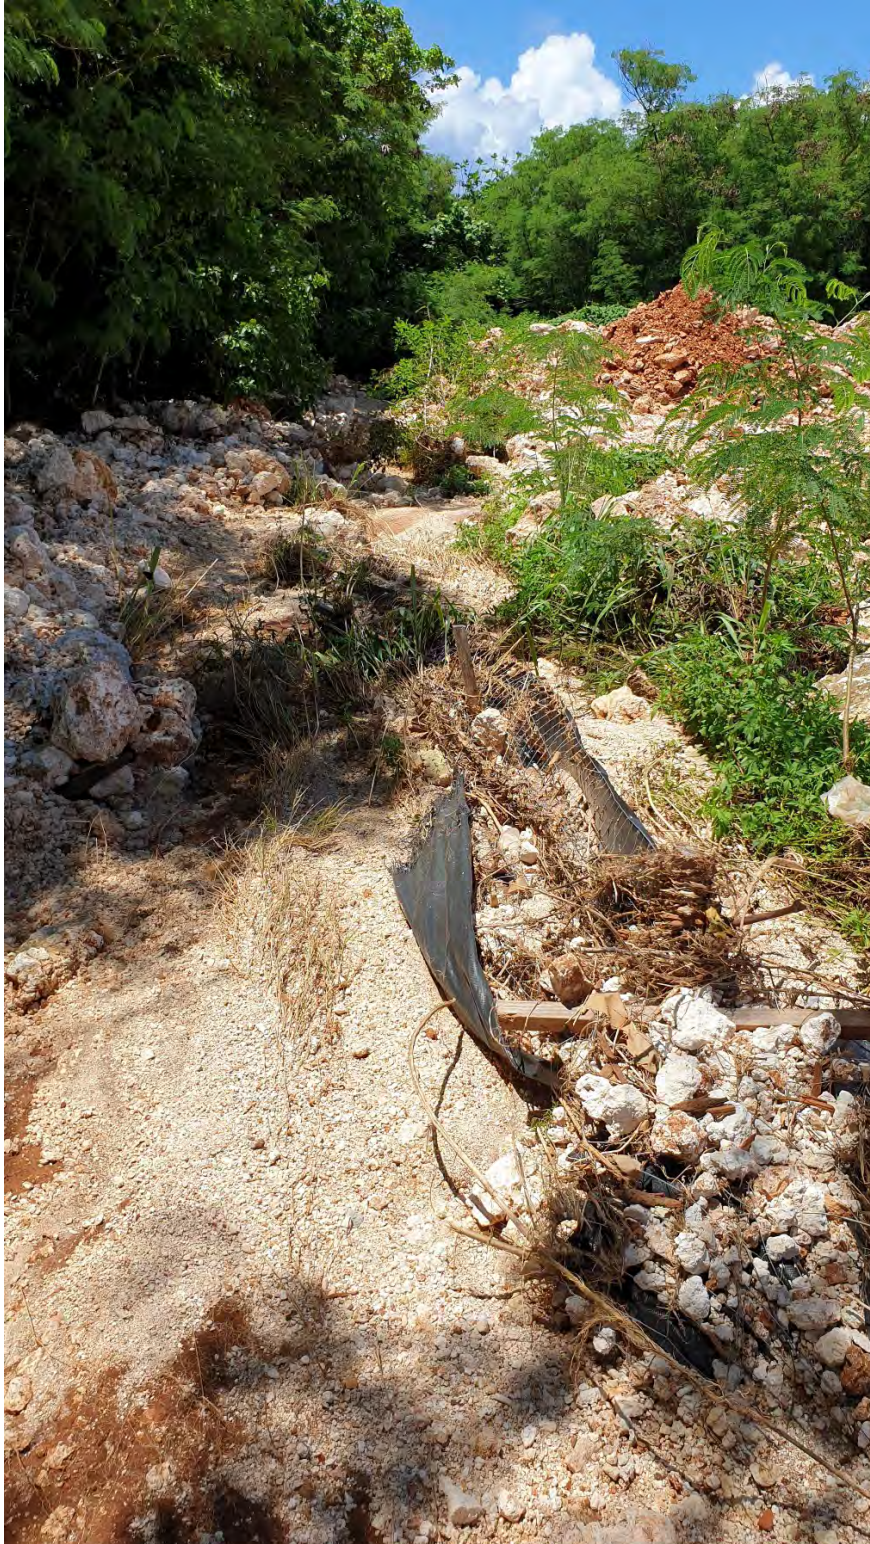
Another view of the sediment plume/delta formation resulting from the off-site discharge during the rain events the week of July 19. This photo is looking toward the off-site properties, headed downhill roughly in the direction of Marbo Cave. (July 28, 2021)

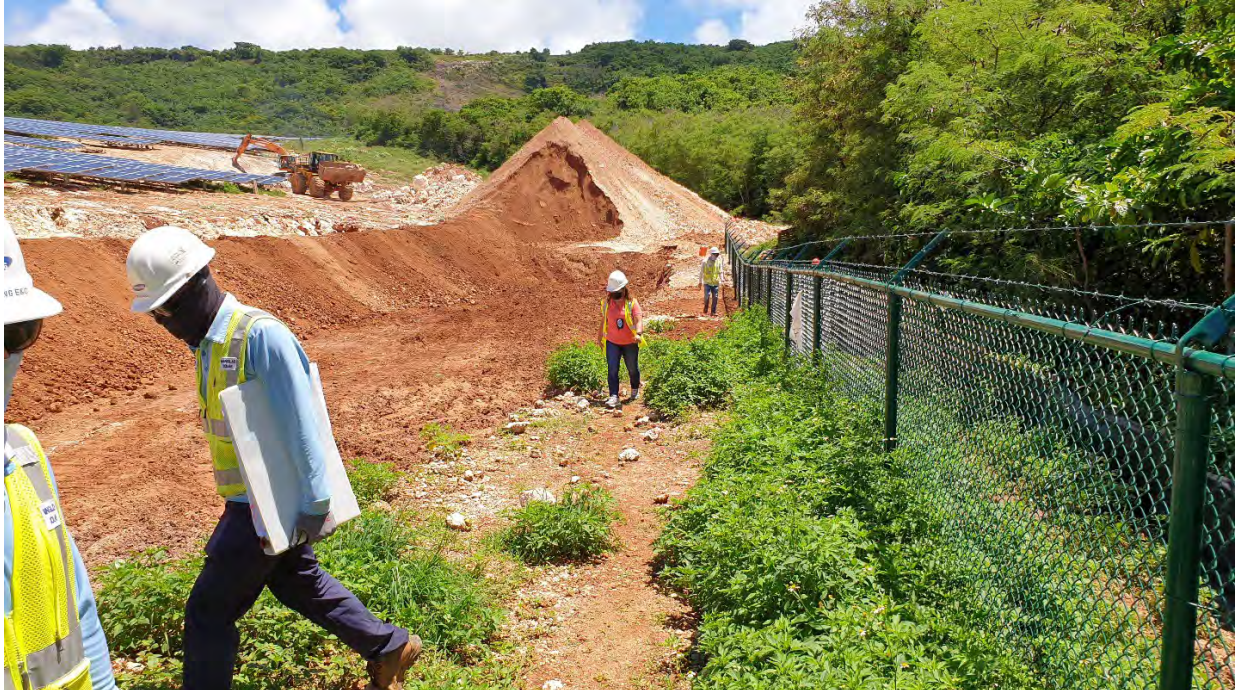
View toward Pond 5B location. The graded area to the right of the earthen embankment is the base of the permanent pond embankment, which Samsung had not yet begun to install. (July 28, 2021)

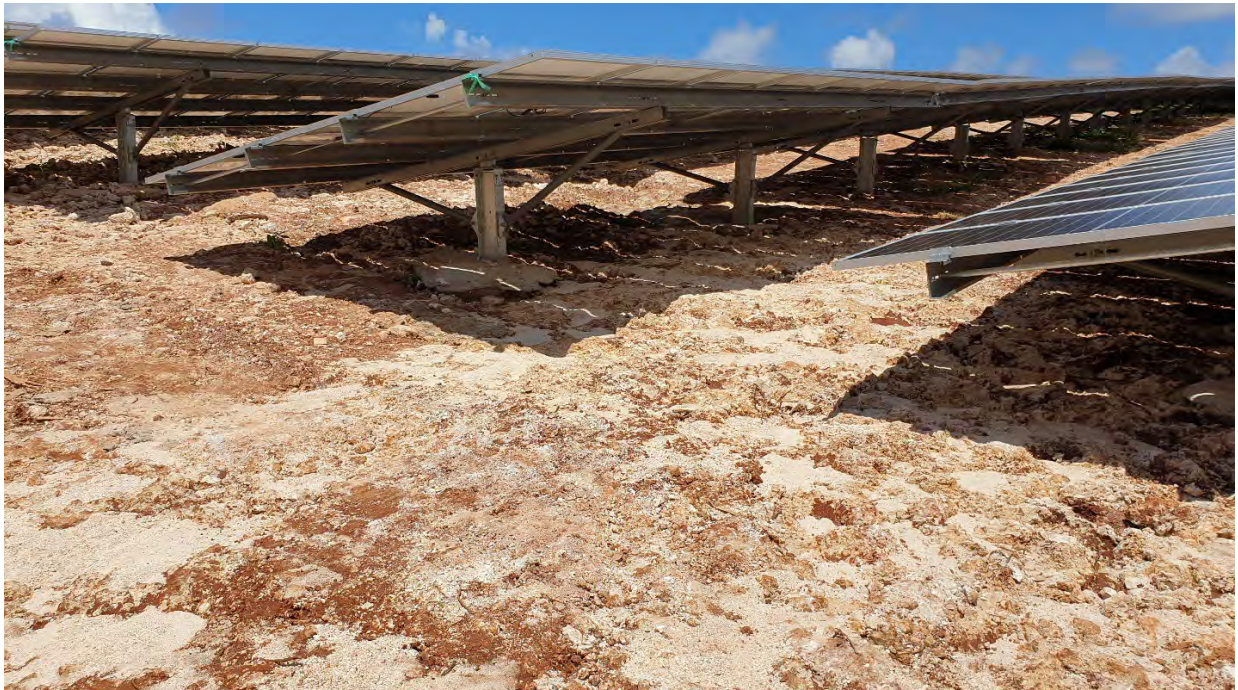
We observed extensive scouring and erosion of almost the entire upland project area above the Pond 5 area, with the ground surface beneath the solar panels visibly scoured down to bare limestone, with only thin deposits of sand and other sediments showing the direction that runoff had taken during the heavy rains the week before.

A partial view of the uphill project area which contributed to the discharge of runoff the week of July 19. Soil and fill material has been scoured from an area several hundred feet wide, leaving bare limestone bedrock in much of the area covered by the solar panels. (July 28, 2019)

- I recommended that Samsung take active steps to begin re-vegetating the site to stabilize the soils, which will reduce both runoff volume and the quantity of sediment that accumulates in the ponds.
