# School Consolidation Study

PREPARED FOR:  
WEST RIVER EDUCATION DISTRICT

STEVENS & ASSOCIATES, P.C.  
SMART DESIGN FOR LIVABLE COMMUNITIES

## FACILITY CONDITION ASSESSMENT

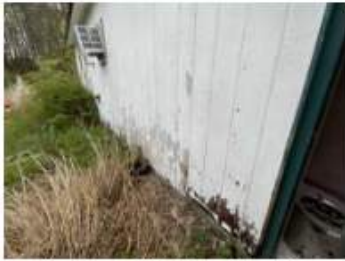
### Exterior Walls in Poor condition.

Wood Siding  
JAMAICA VILLAGE SCHOOL - Main Building Exterior

Exterior, T1- 11 siding is deteriorating and needs replacement - A:

Uniformat Code: B2010  
Recommendation: **Replace in 2023**  
Priority Score: **89.9**  
Plan Type: Performance/Integrity  
Cost Estimate: \$30,000  
\$\$\$\$

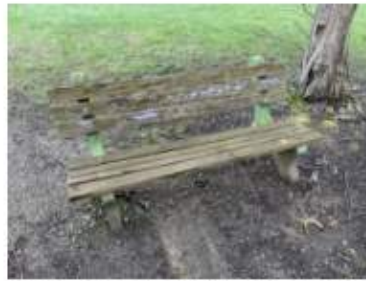
### Park Bench in Poor condition.

Precast Concrete  
JAMAICA VILLAGE SCHOOL - Main Building

Bench is broken and past useful life - Asset

Uniformat Code: G2060  
Recommendation: **Replace in 2023**  
Priority Score: **81.9**  
Plan Type: Performance/Integrity  
Cost Estimate: \$2,000  
\$\$\$\$

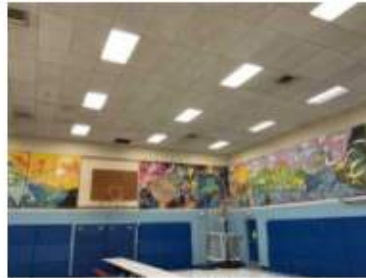
### Suspended Ceilings in Poor condition.

Acoustical Tile Fiberglass  
JAMAICA VILLAGE SCHOOL - Main Building Gymnasium

Ceiling tiles look stained and worn. - AssetCALC ID: 6087904

Uniformat Code: C1070  
Recommendation: **Replace in 2023**  
Priority Score: **81.9**  
Plan Type: Performance/Integrity  
Cost Estimate: \$15,400  
\$\$\$\$

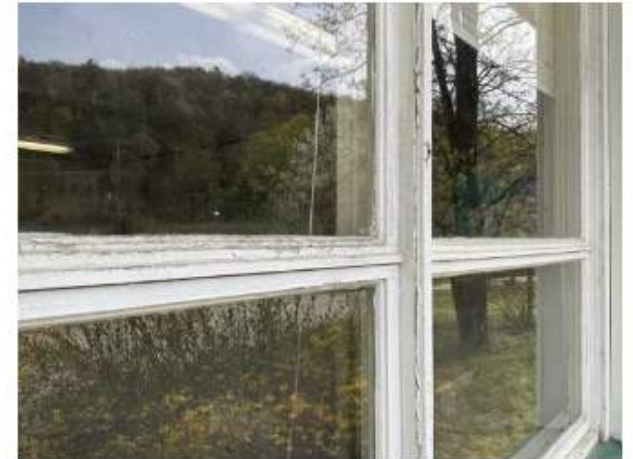
10 - WOOD WINDOWS (DETEAIL)

Single pane windows experiencing wood rot - AssetCALC ID: 6126624

Uniformat Code: B2020  
Recommendation: **Replace in 2024**  
Priority Score: **87.8**  
Plan Type: Performance/Integrity  
Cost Estimate: \$38,400  
\$\$\$\$

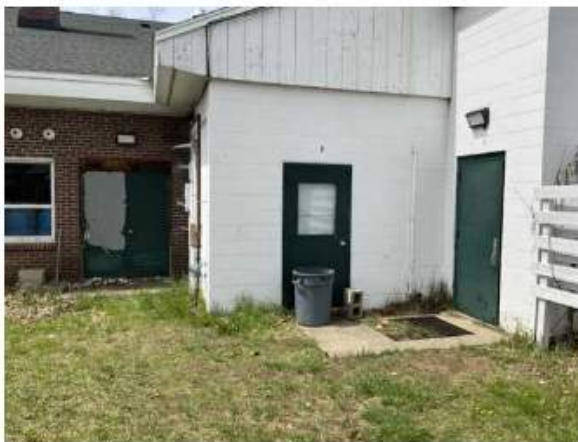
5 - EXTERIOR STEEL DOORS

Deteriorating due to rusting, physical damage to door and finish, lack of weather stripping. - AssetCALC ID: 6135748

Uniformat Code: B2050  
Recommendation: **Refinish in 2023**  
Priority Score: **81.9**  
Plan Type: Performance/Integrity  
Cost Estimate: \$1,000  
\$\$\$\$
