| <b>Report Title:</b> | Safe Drinking Water Act Compliance Inspection Report | | |
| <b>Inspection Date(s):</b> | Tuesday, July 26, 2022 – Thursday, July 28, 2022 | | |
| <b>System Name:</b> | City of Richmond | | |

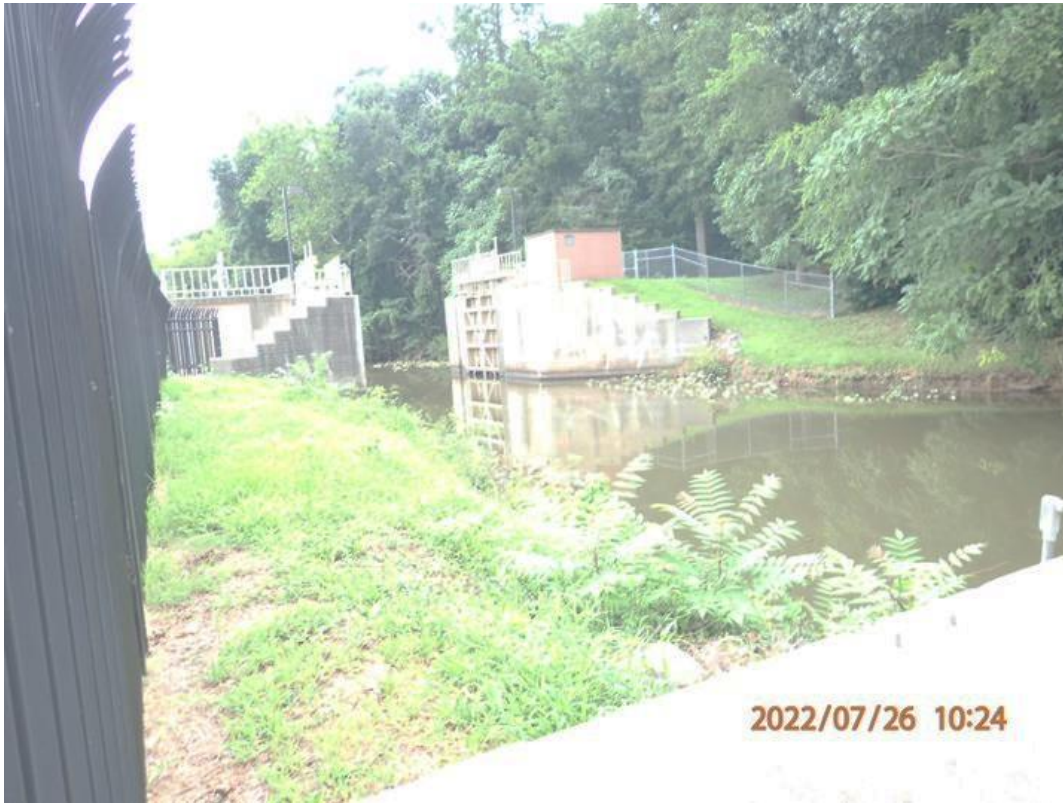
**Photograph 7.** Kanawha Canal near plant intakes.

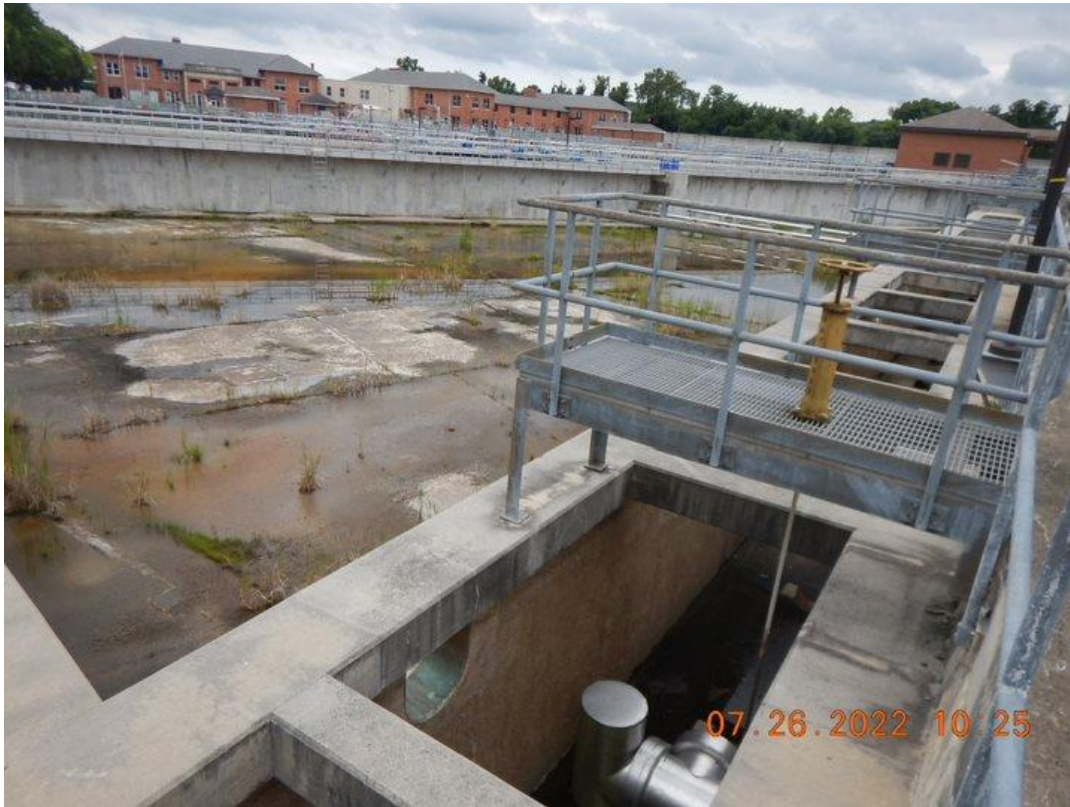
- EPA observed an inactive basin adjacent to and south of the raw water basin. The Superintendent explained that the sedimentation basins in Plant 1 had to be reduced in size to match the sedimentation basins in Plant 2 during the plate settler upgrade installation (*Photo 9*).

**Photograph 9.** Inactive basin, former sedimentation basin area.

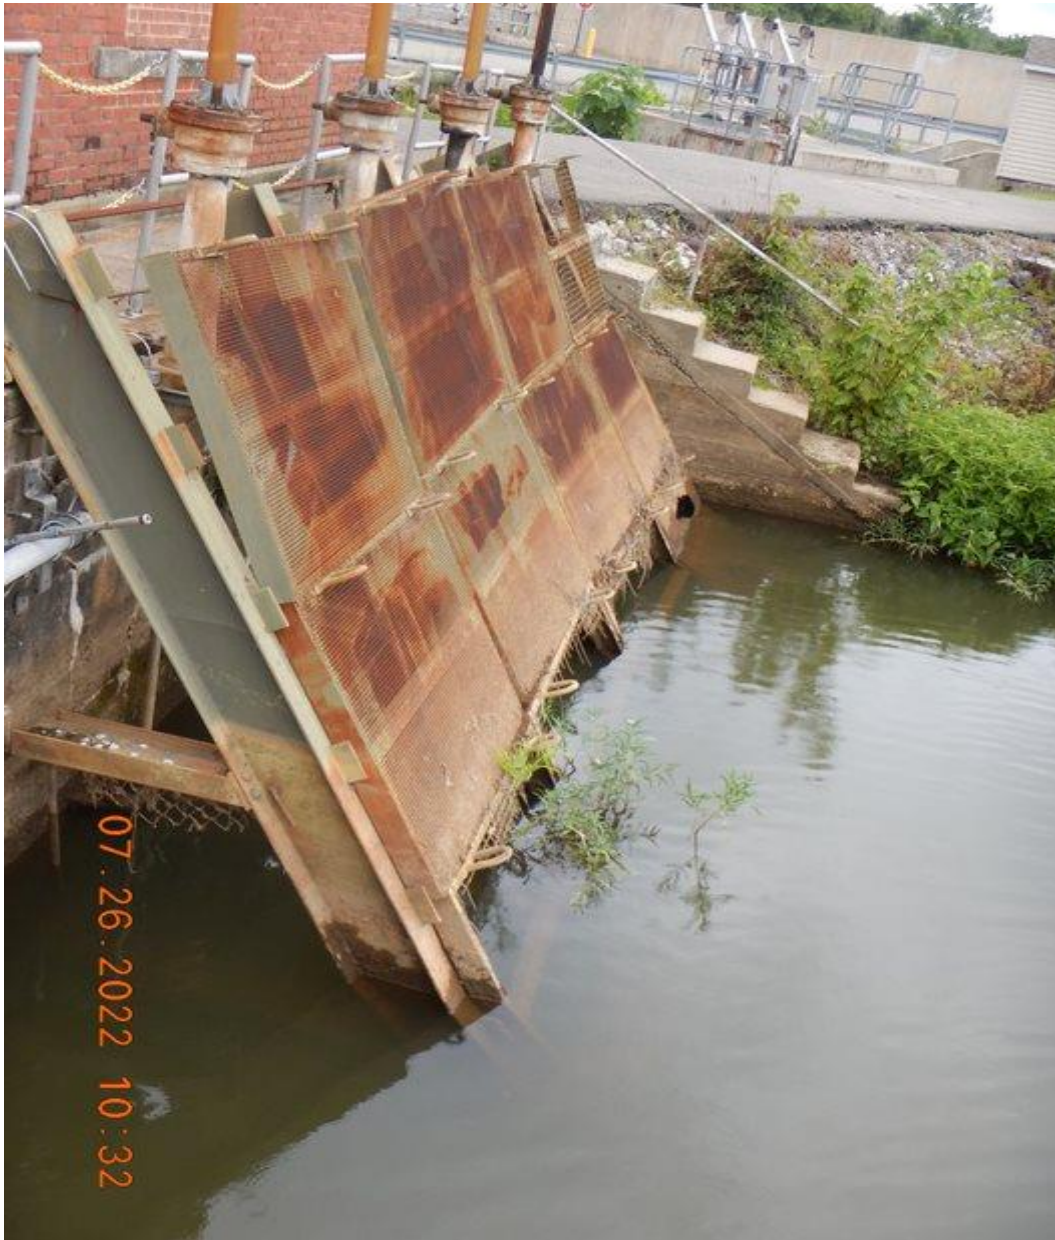
3. Treatment Plant intake area, Raw Water Coagulation Channel
- EPA observed raw water screens at the treatment plant intake that were in poor condition with corrosion and holes; one of the screens was not attached and had fallen to the bottom of the raw water basin (*Photos 10-11*). These screens were permanently out of service per comments by System Representatives.

**Photograph 11.** Out of service screens at raw water intake area.

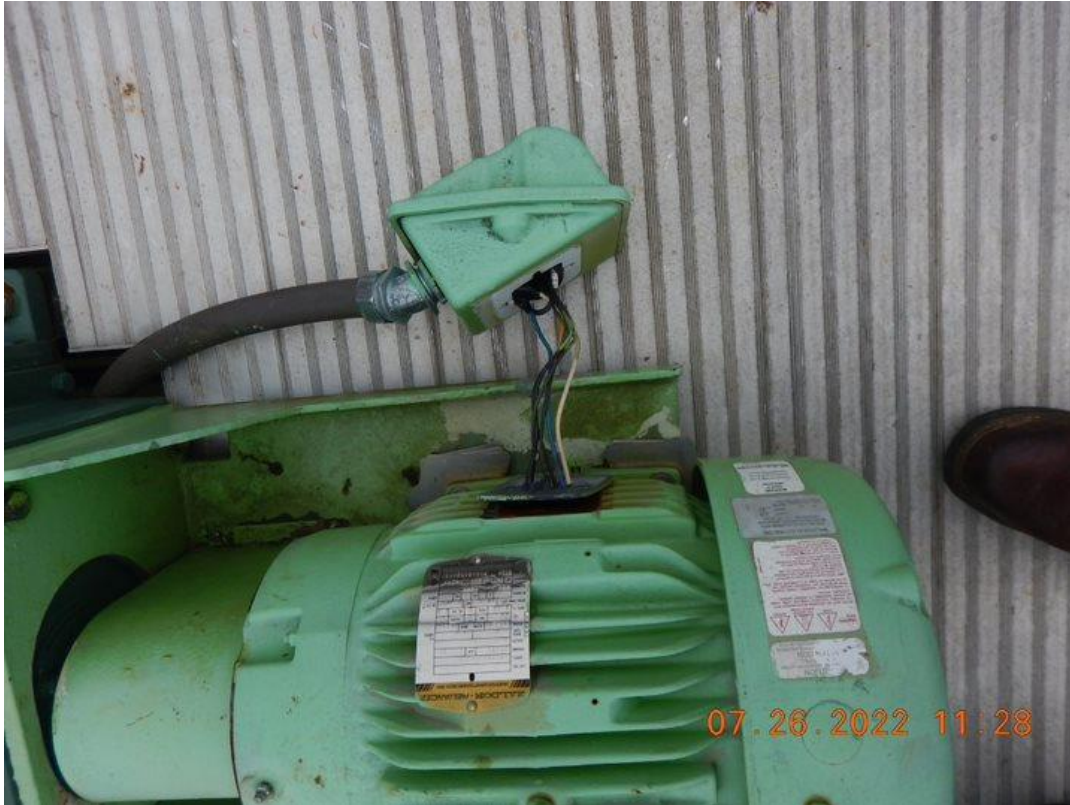
**Photograph 24.** Exposed wiring at flocculator 4-2A.

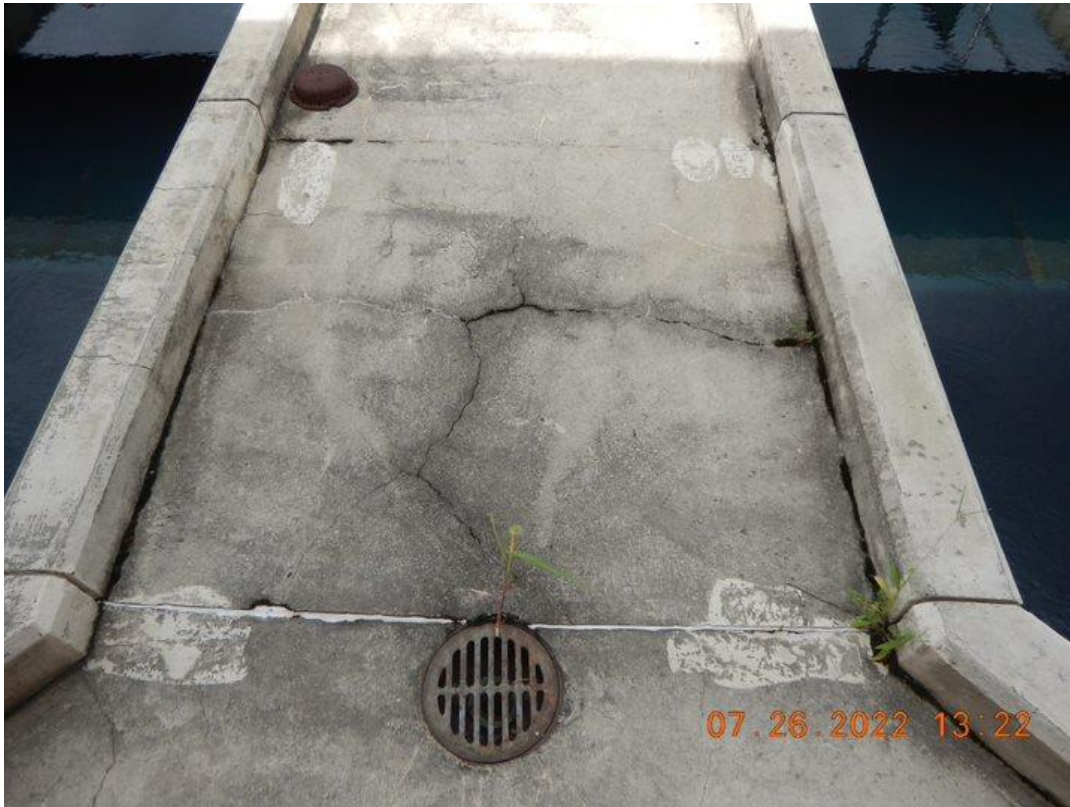
- EPA observed cracking in the concrete, some more than 12" in length and 1/8" in width, in the concrete structure above the filters of Plant 2. EPA also observed vegetation growing out of several of the cracks in the concrete above the filters (*Photos 26-28*).

**Photograph 26.** Cracks in concrete above Plant 2 filter beds.

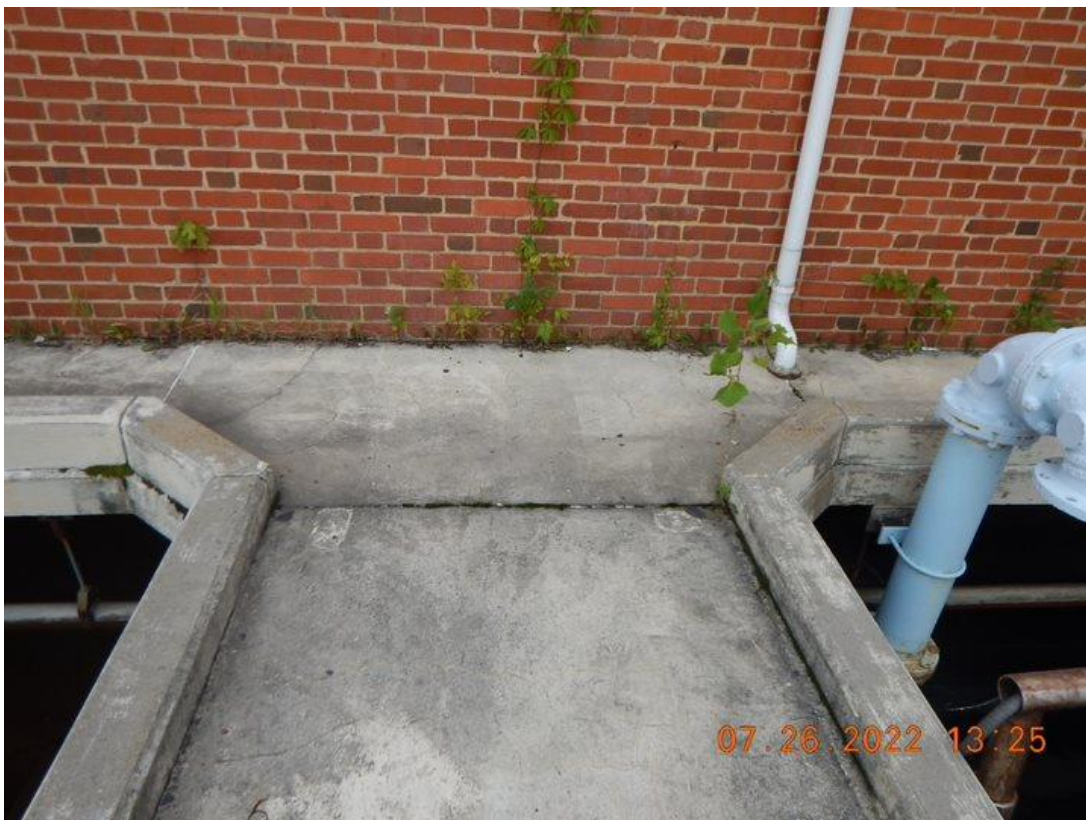
**Photograph 27.** Cracks in concrete above and vegetation growing around Plant 2 filters.

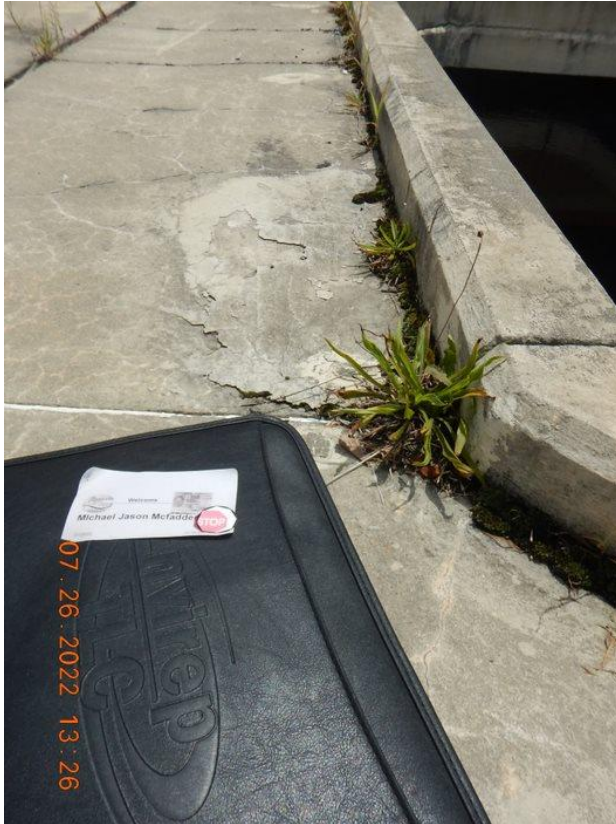
**Photograph 28.** Vegetation growing around concrete structures above Plant 2 filters.

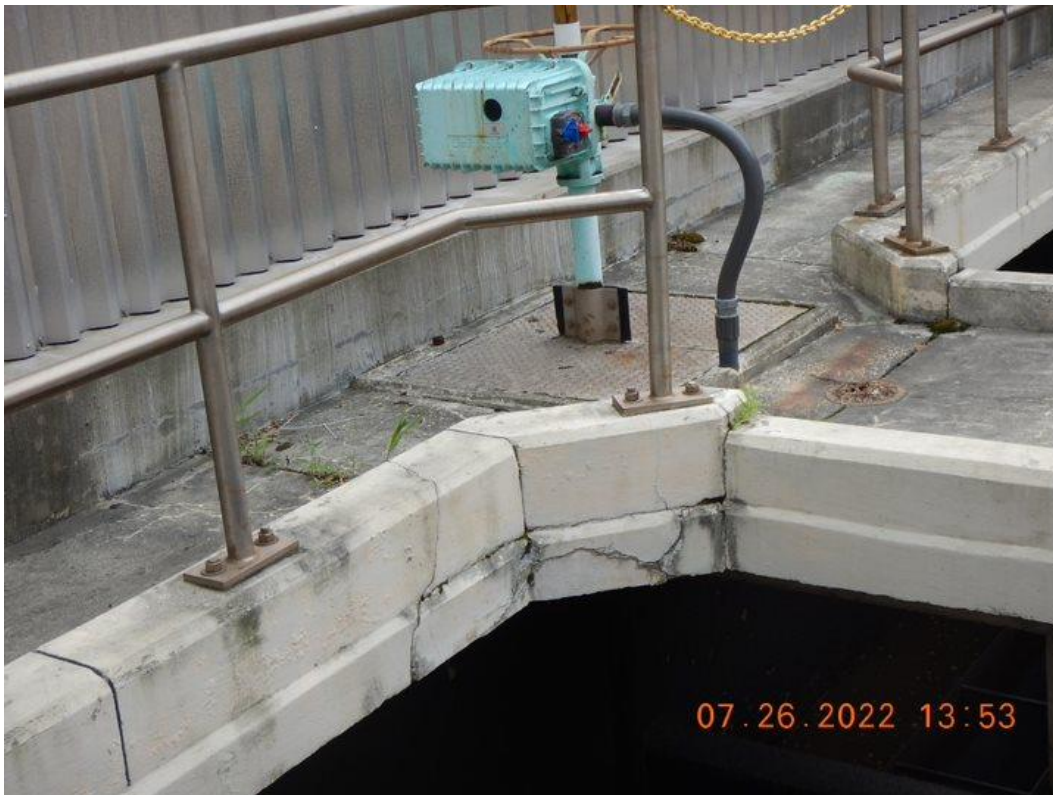
- EPA observed significant cracking around the concrete at Filter 16, especially above the influent valve area on the southern wall (*Photo 29*).
  - EPA observed a piece of debris along the wall between the filter troughs and the influent/effluent channel, approximately 18” long and 2-4” wide; the debris was located near the influent valve on the southern side of the filter (*Photos 30-31*). The debris remained in place throughout the backwash cycle but was at risk of falling into the filter media.

**Photograph 29.** Cracking above influent valve of Filter 16.

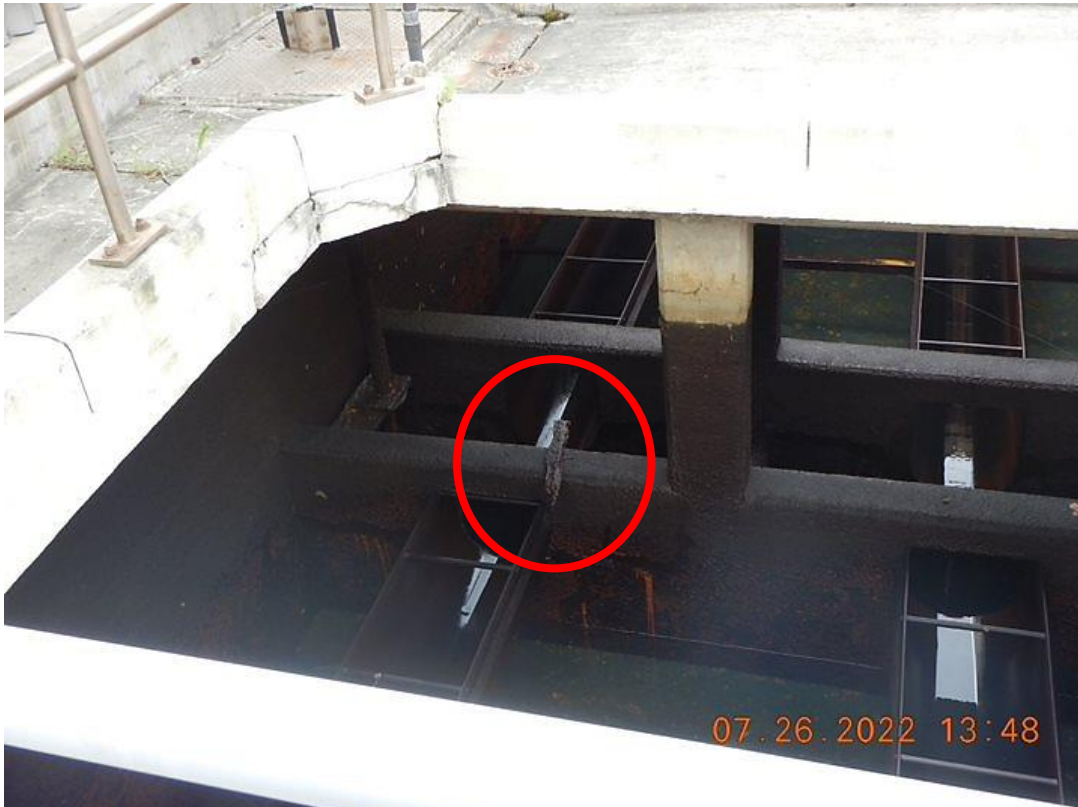
**Photograph 30.** Debris near influent/effluent channel of Filter 16.

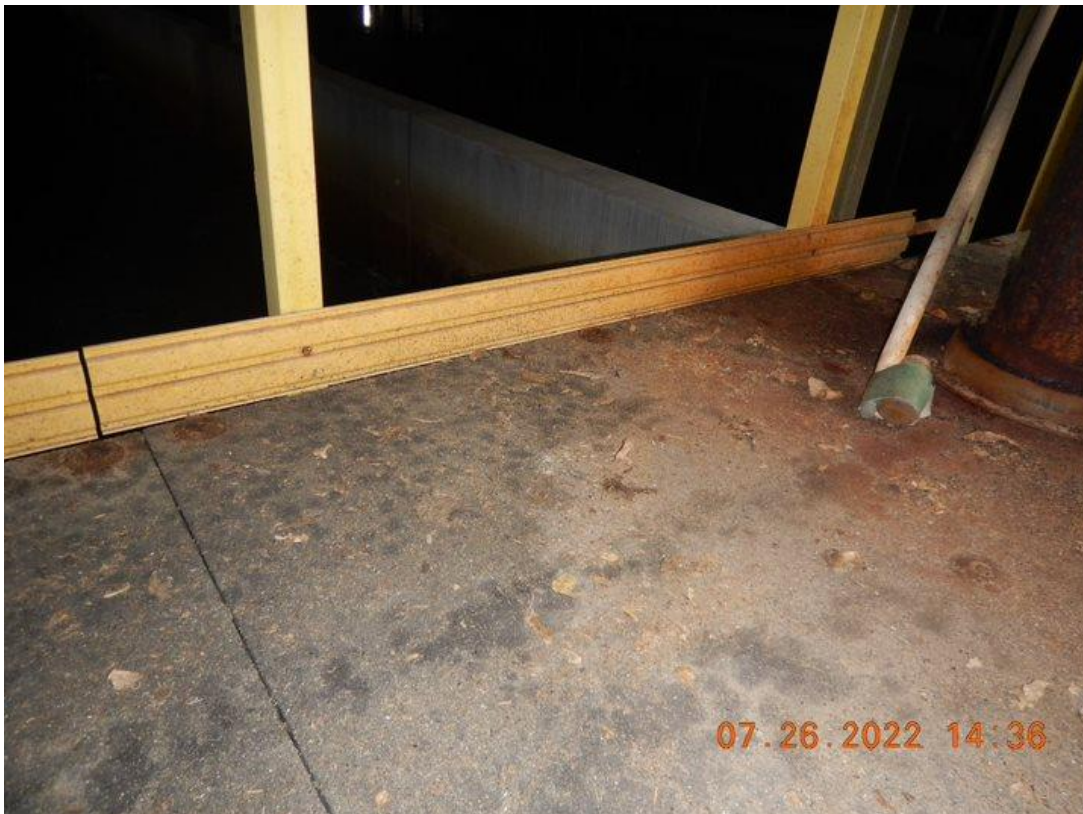
7. Plant 2 Finished Water Basin
- EPA observed leaf litter and other debris collected at the entryway of the finished water basin of Plant 2. EPA also observed dirt and other debris on the landing area and entry of the finished water basin. The landing area, directly above a portion of the finished water basin, did not have walls or structures at its base to prevent dirt and debris from falling directly into the finished water basin (*Photos 32-33*).

**Photograph 33.** Dirt and debris on landing area above Plant 2 finished water basin.

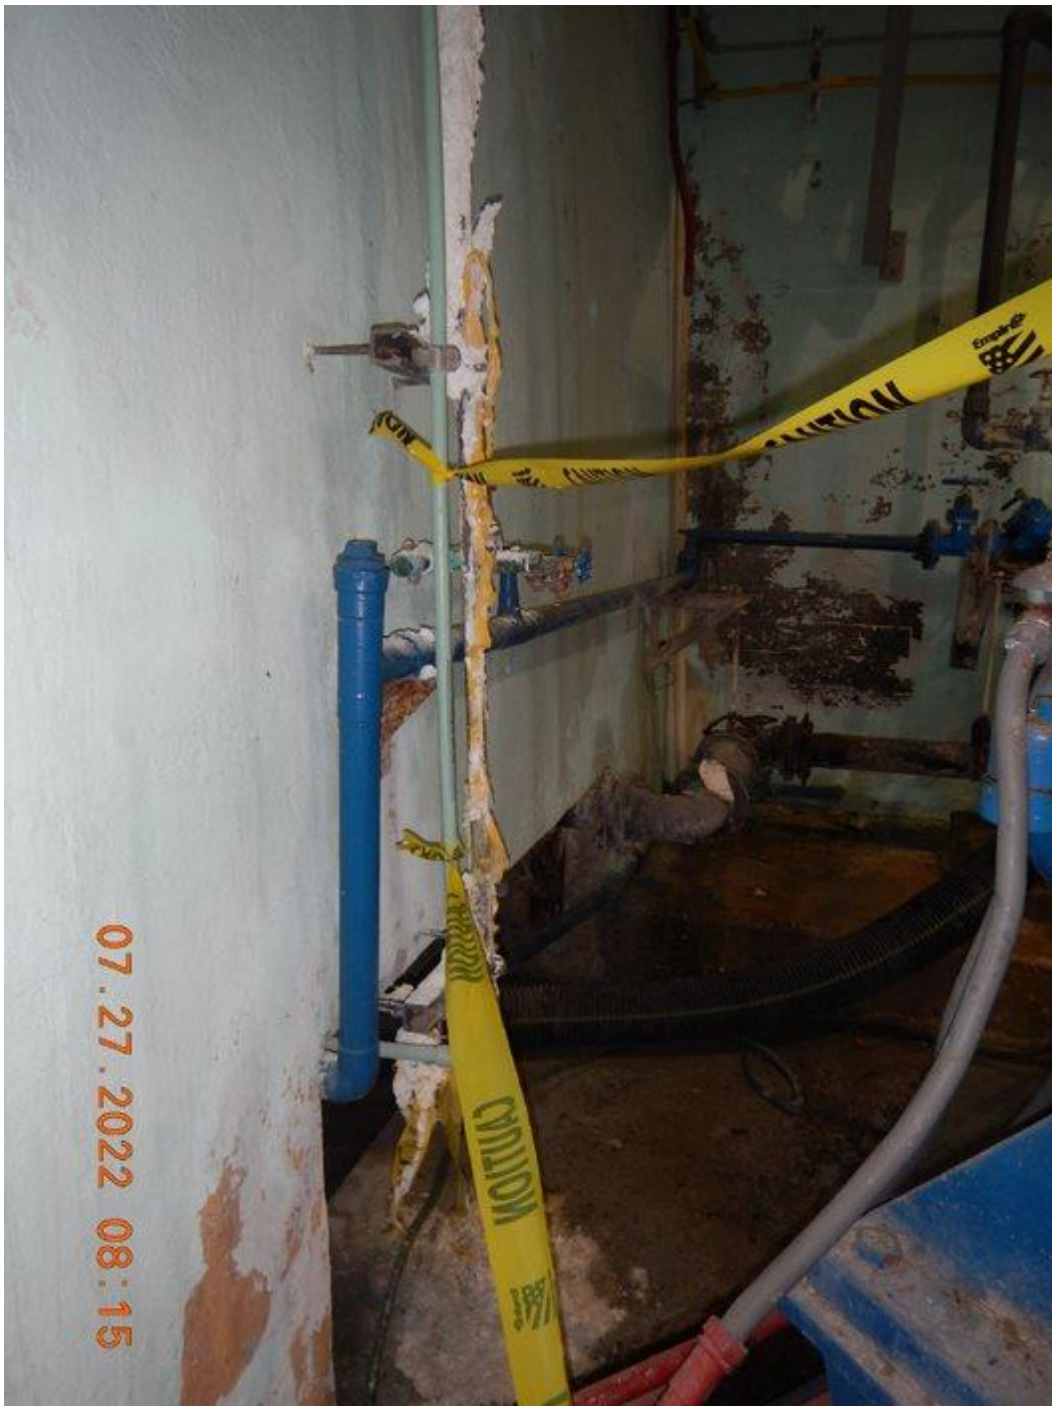
- System Representatives explained that Korah 1 pumps to the Byrd Park Reservoir.
- EPA observed a caustic soda line with chemical on the exterior of the pipe. There was caution tape around the pipe and the immediate area (*Photos 34-35*).
- EPA observed pH meters reading 8.16 and 7.62; System Representatives explained they are used to control caustic soda dosing (*Photo 36*). EPA observed dust and dirt built up on the analyzers and the screen.
- The caustic soda is stored in a separate area adjacent to the pump station in two tanks, one is 9,000 gallons and the other is 8,000 gallons (*Photo 37*). There are four pumps, two were in operation at the time of the inspection (pumps 2 & 3). There was secondary containment at each of the pumps. The caustic soda is injected at the end of the finished water basin.
- EPA observed exposed wiring at the K1-2 pump (*Photo 38*).

**Photograph 34.** Caustic soda line leak and caution tape in Korah 1 Pump Station.

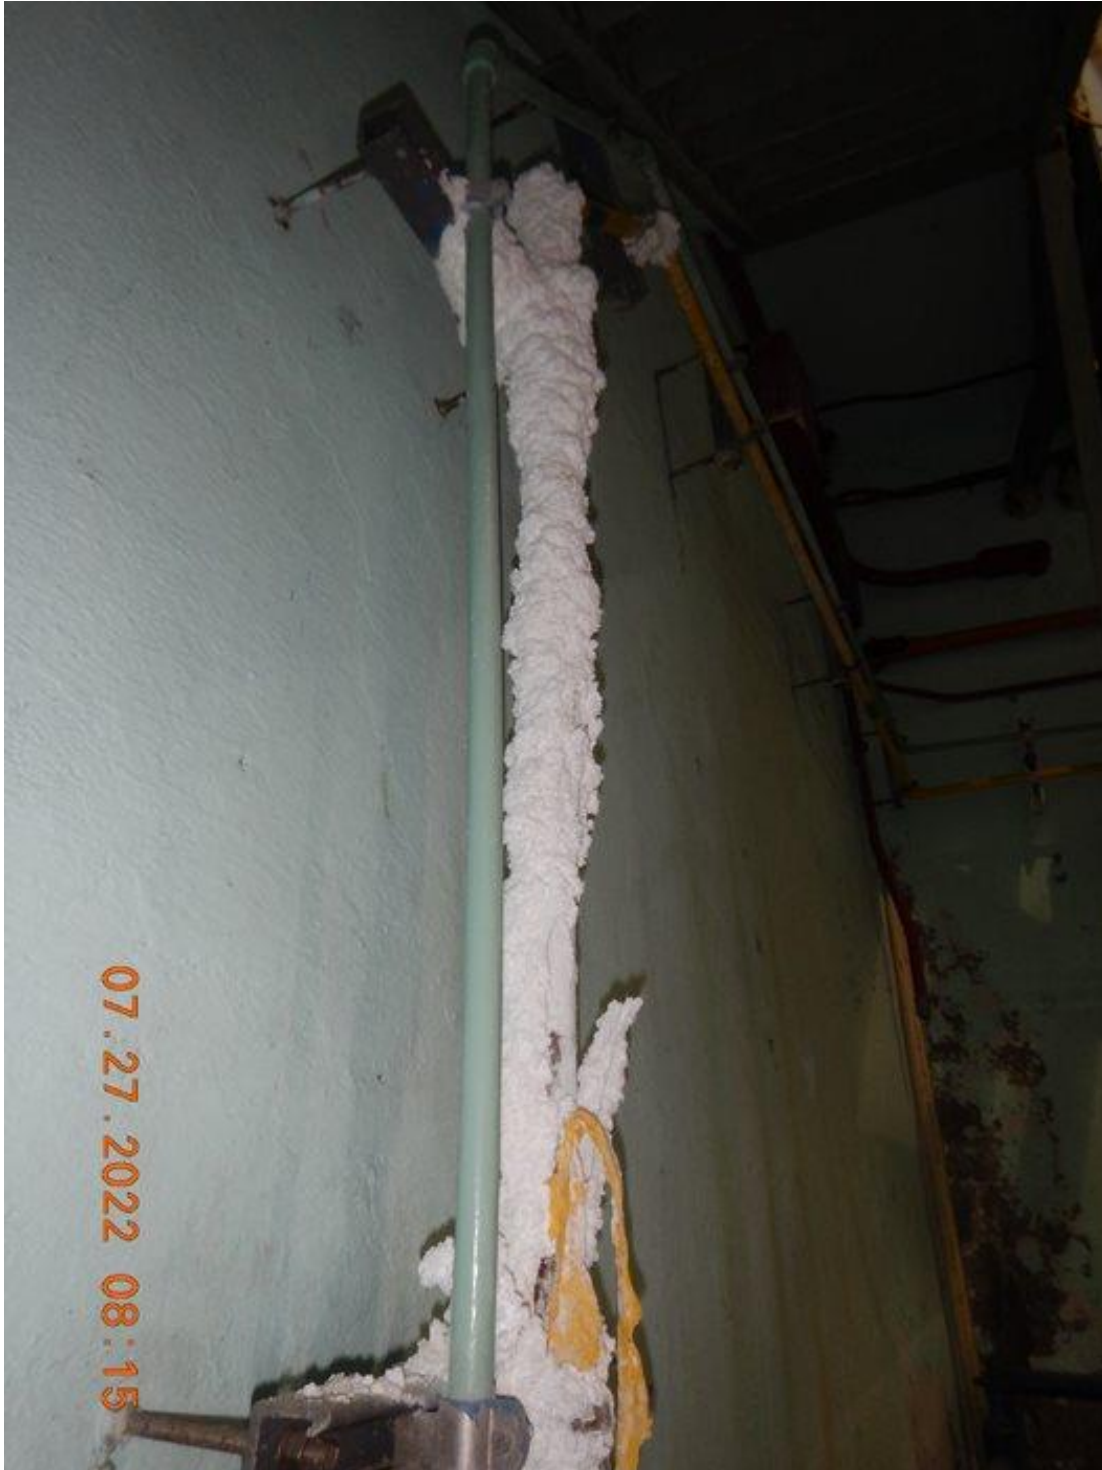
**Photograph 35.** Caustic soda line leak in Korah 1 Pump Station.

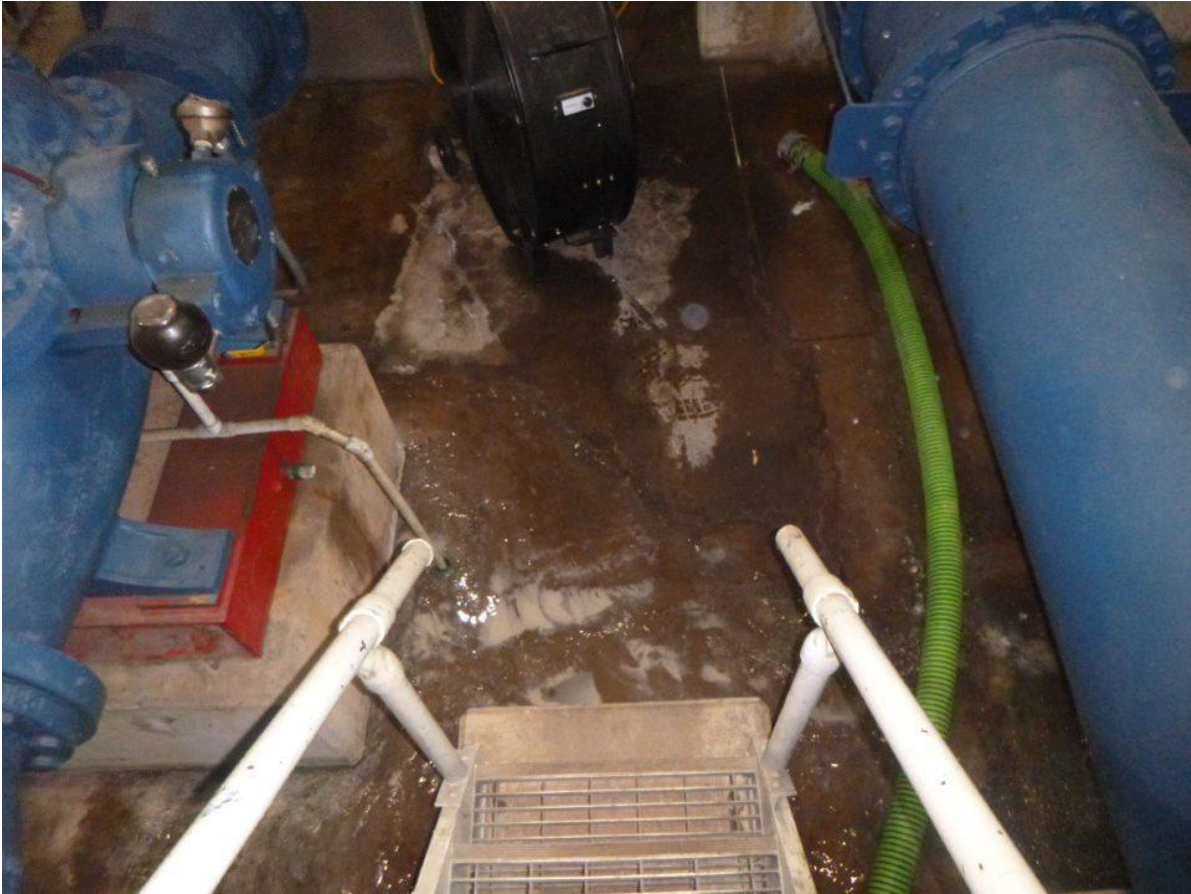
- On the lower level of the pump station, EPA observed a white PVC pipe discharging process water from 3-4' above ground level near pump K3-2. Water was not being captured and was left to drain across the entire lower-level floor toward the floor drain. (Photos 43-45).

**Photograph 45.** Water and algal growth on floor of Korah 2 and 3 Pump Station.

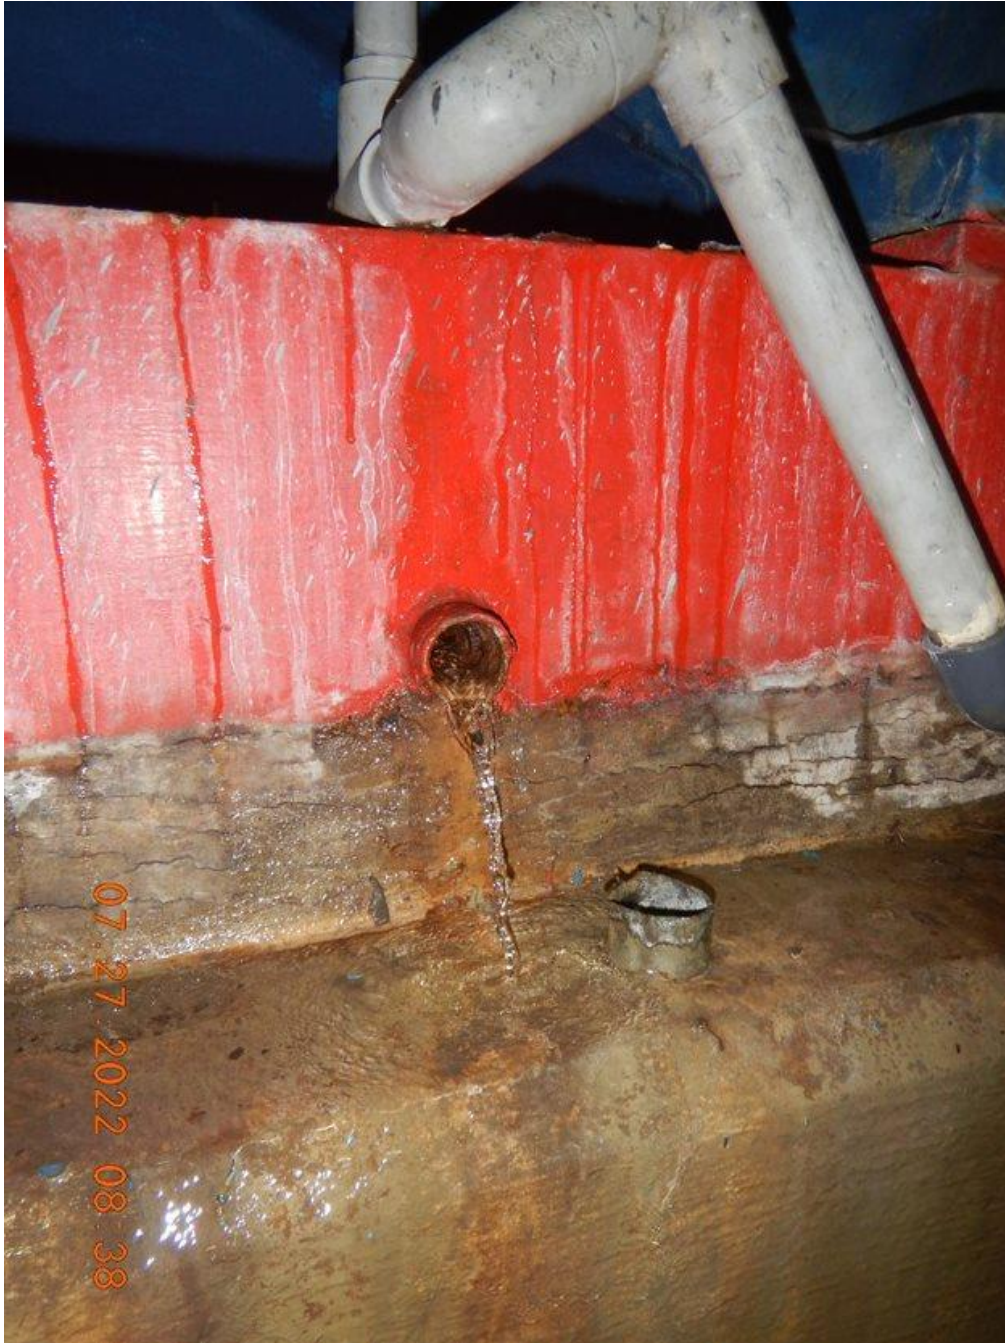
- EPA also observed the water line on the K2-2 pump motor was discharging about 2" from the drain and none of the water was being captured. Water was leaking on the equipment and draining across the floor (Photos 46-47).

**Photograph 46.** K2-2 pump motor discharging water onto Korah 2 and 3 Pump Station floor.

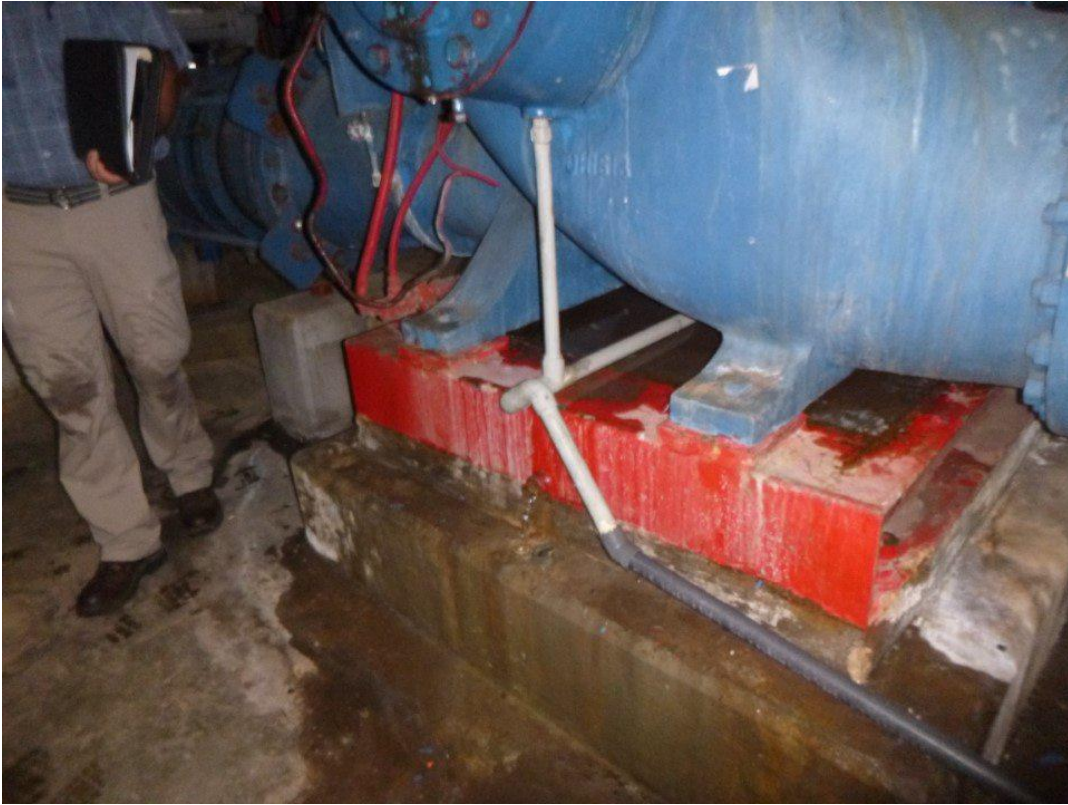
**Photograph 47.** K2-2 pump motor discharging water onto Korah 2 and 3 Pump Station floor.

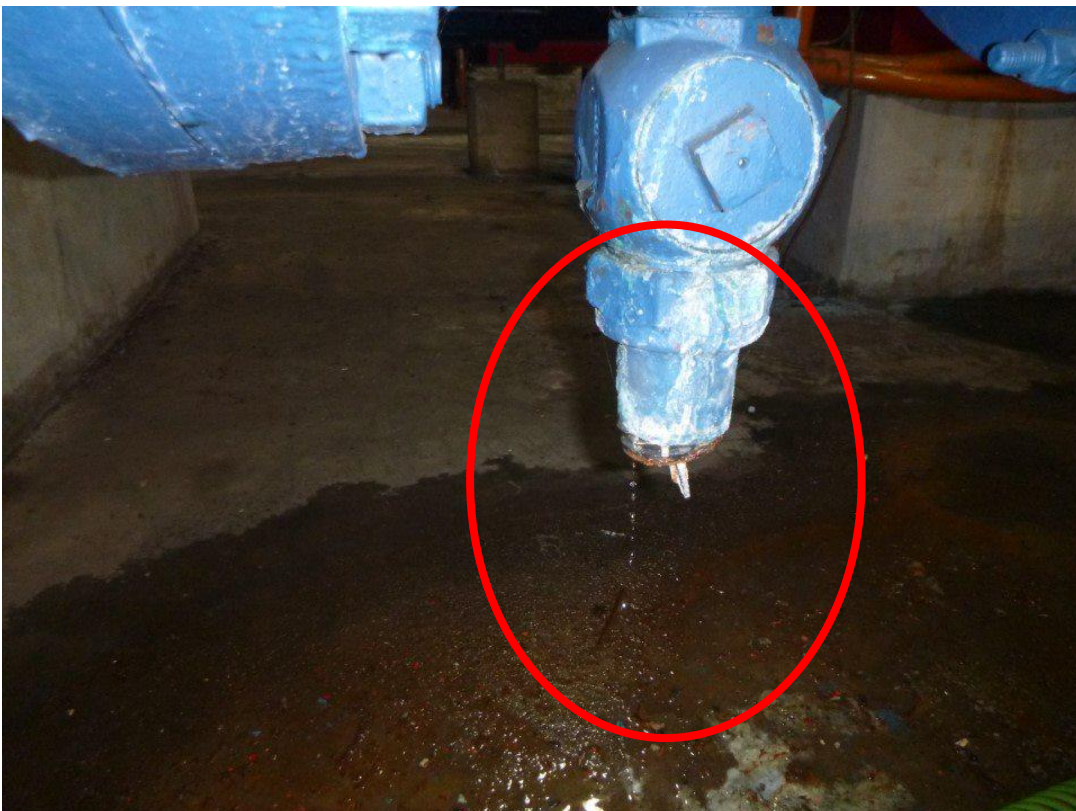
- EPA observed a corroded fitting leaking from a pipe with water accumulating on the ground below it (Photos 48-49).
3. Trafford Pump Station (full team)

**Photograph 48.** Leaking fitting from corroded pipe in Korah 2 and 3 Pump Station.

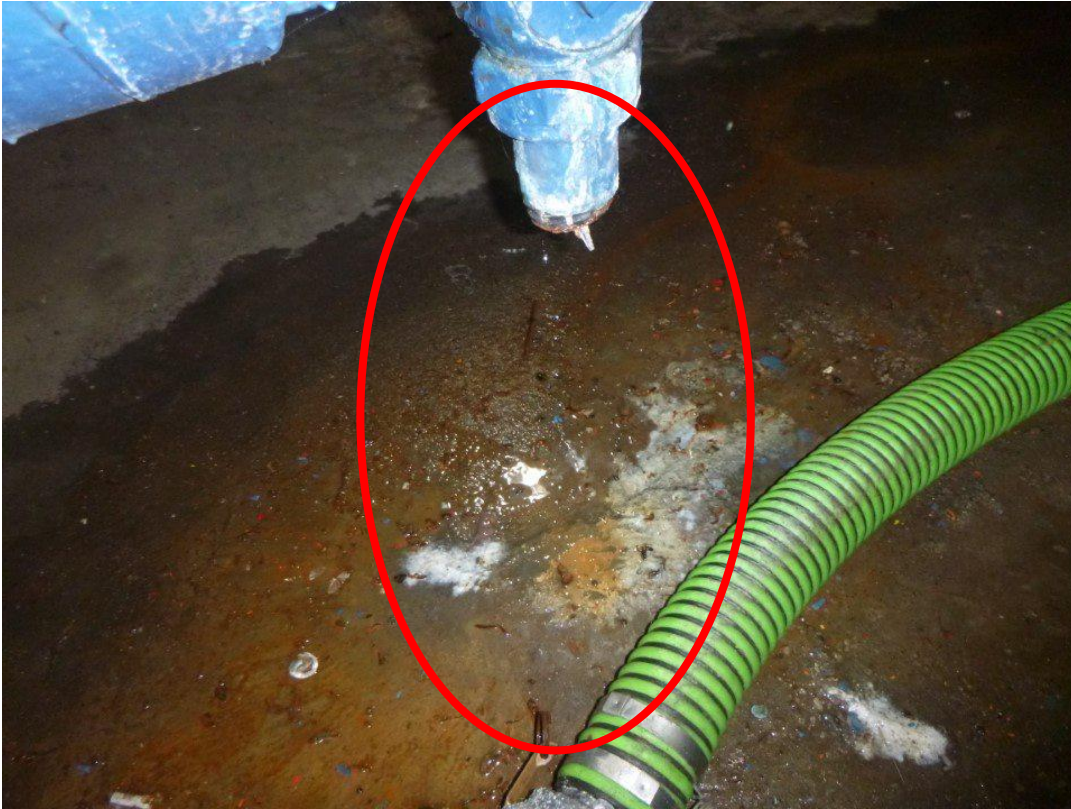
**Photograph 49.** Fitting leaking from corroded pipe onto floor in Korah 2 and 3 Pump Station.

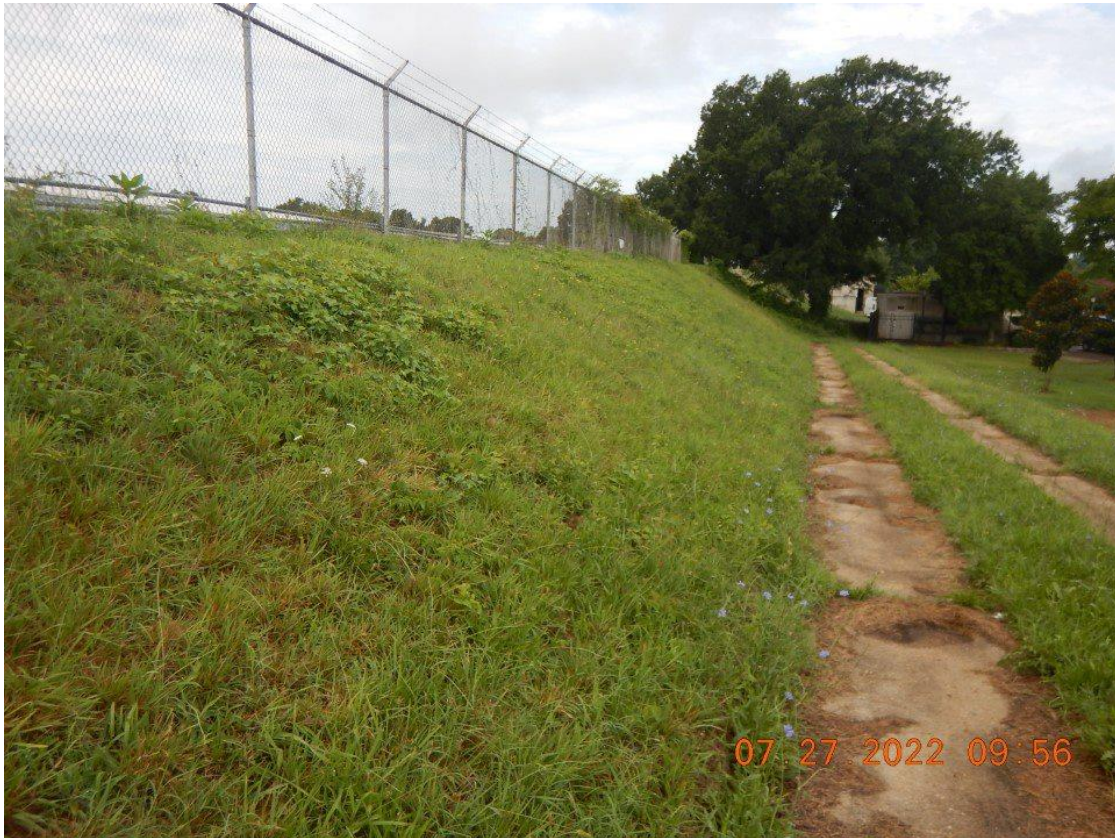
- EPA observed security fencing with barbed wire around the perimeter of the reservoir. EPA observed significant vegetation in some areas of the fencing (Photos 51-52).

**Photograph 51.** Fencing and vegetation growth at the Byrd Park Reservoir.

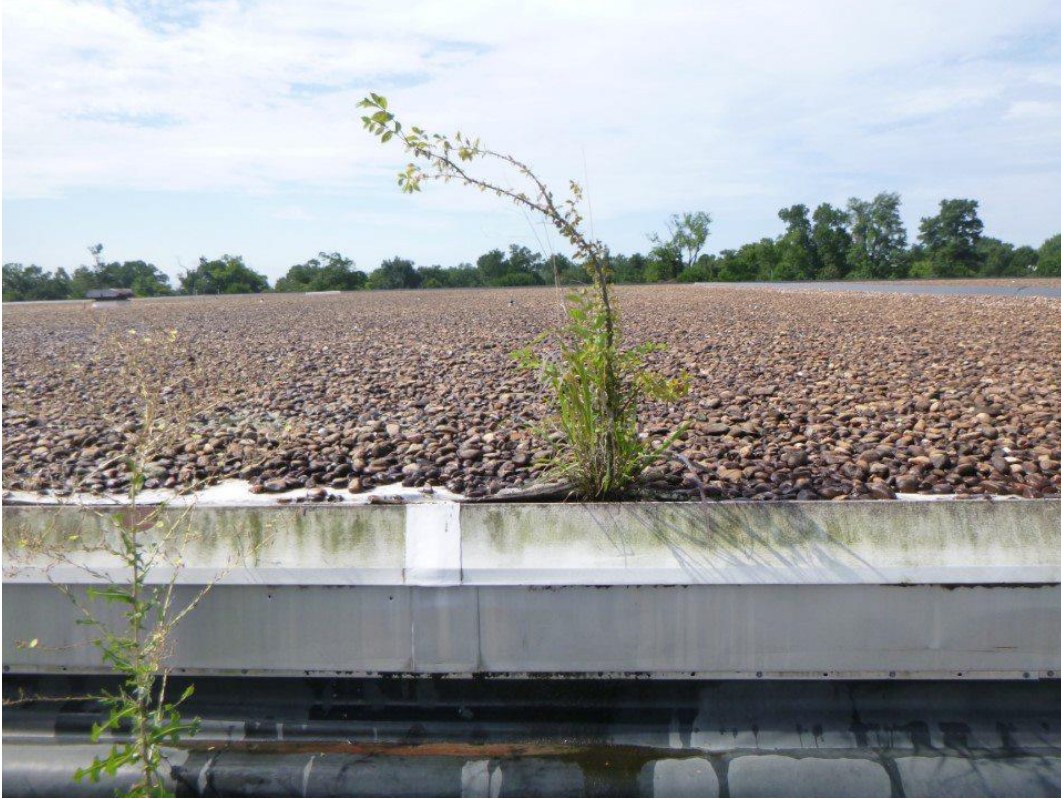
- The reservoir is a clay foundation with a concrete liner, and the roof covers 8 acres (*Photos 53-54*). Several areas of the roof had vegetation growing in between the stones (*Photos 55-56*).

**Photograph 55.** Vegetation growth on the roof of Byrd Park Reservoir.

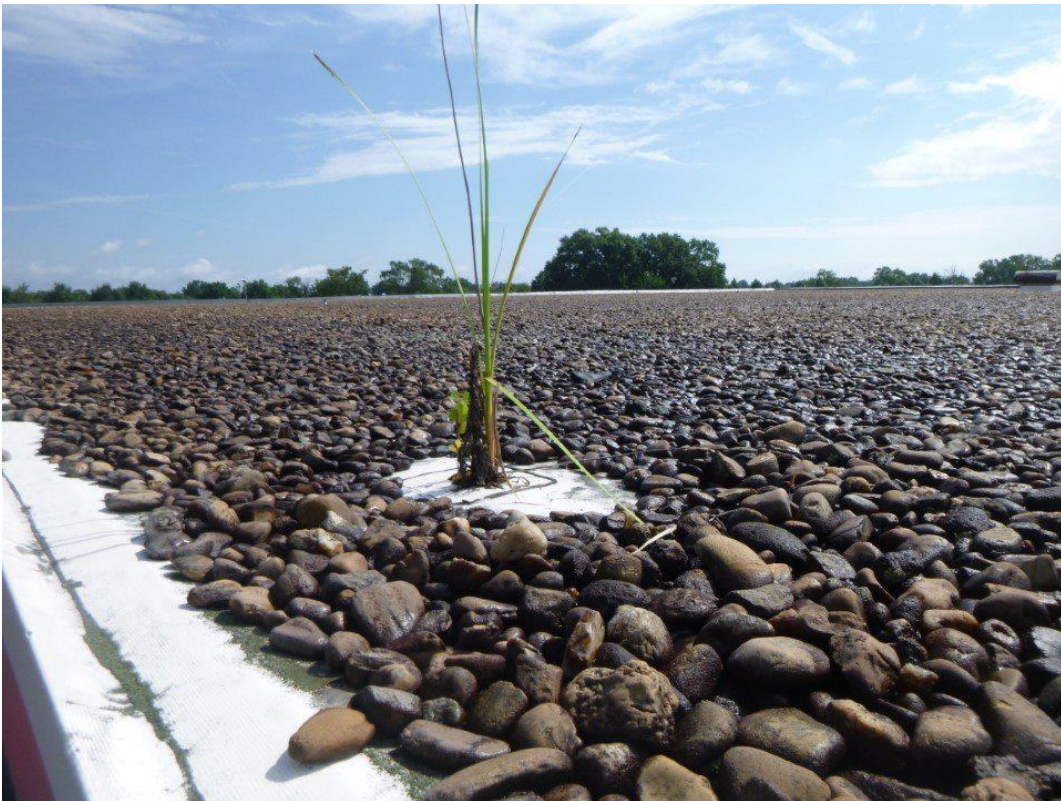
**Photograph 56.** Vegetation growth on the roof of Byrd Park Reservoir.

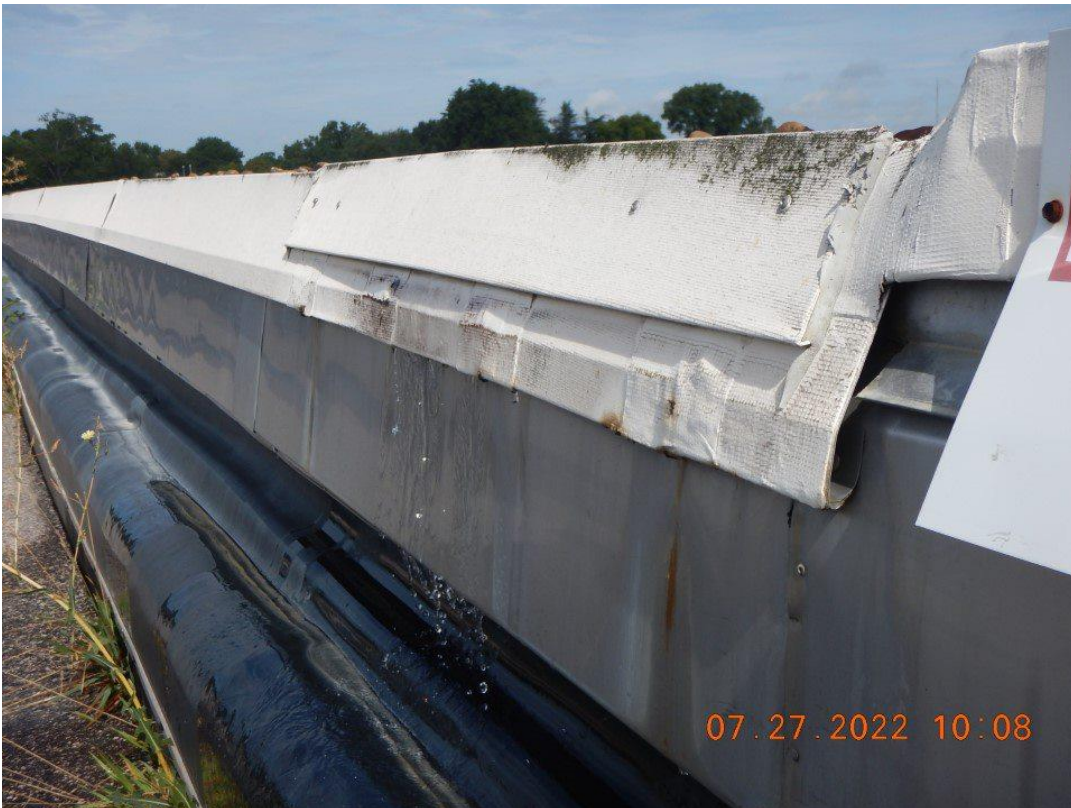
- EPA observed pooled water on top of the reservoir roof that was seeping out of the aluminum siding in several areas of the roof (*Photos 58-60*).
  - EPA observed significant plant growth at the base of the reservoir roof and sidewalk (*Photos 61-63*).

**Photograph 58.** Water leaking from siding on Byrd Park Reservoir roof.

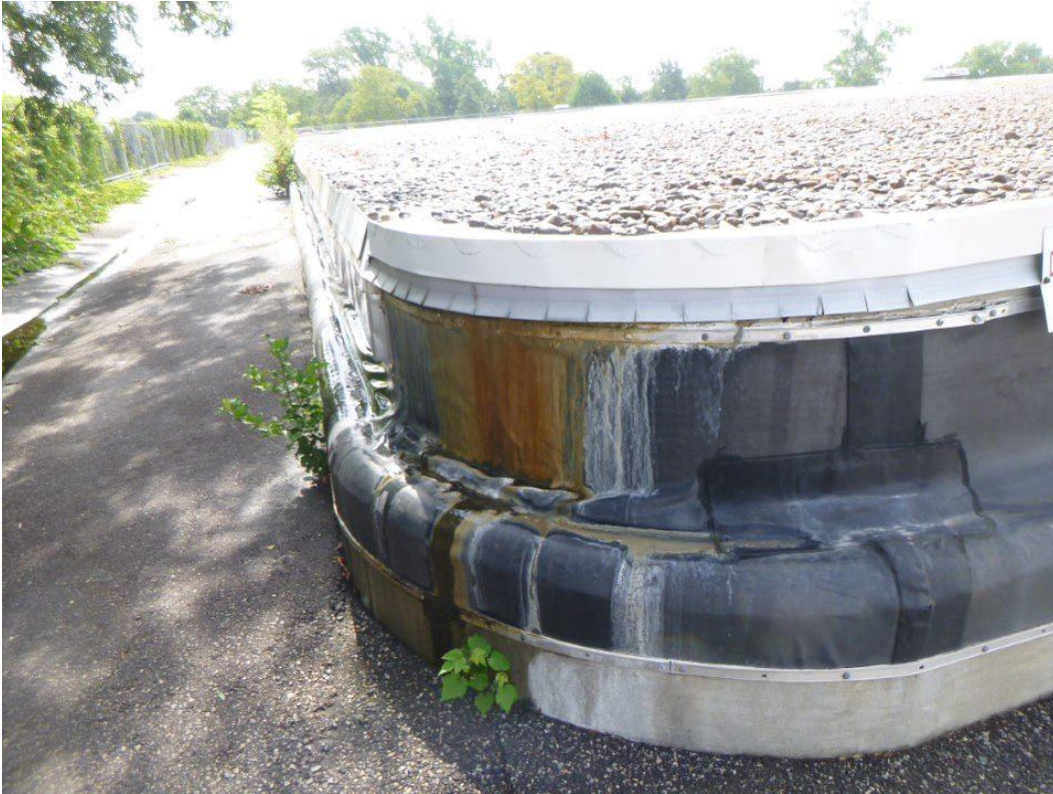
**Photograph 59.** Water leaking from siding on Byrd Park Reservoir roof.
