| <b>Report Title:</b> | Safe Drinking Water Act Compliance Inspection Report | | |
| <b>Inspection Date(s):</b> | Tuesday, July 26, 2022 – Thursday, July 28, 2022 | | |
| <b>System Name:</b> | City of Richmond | | |

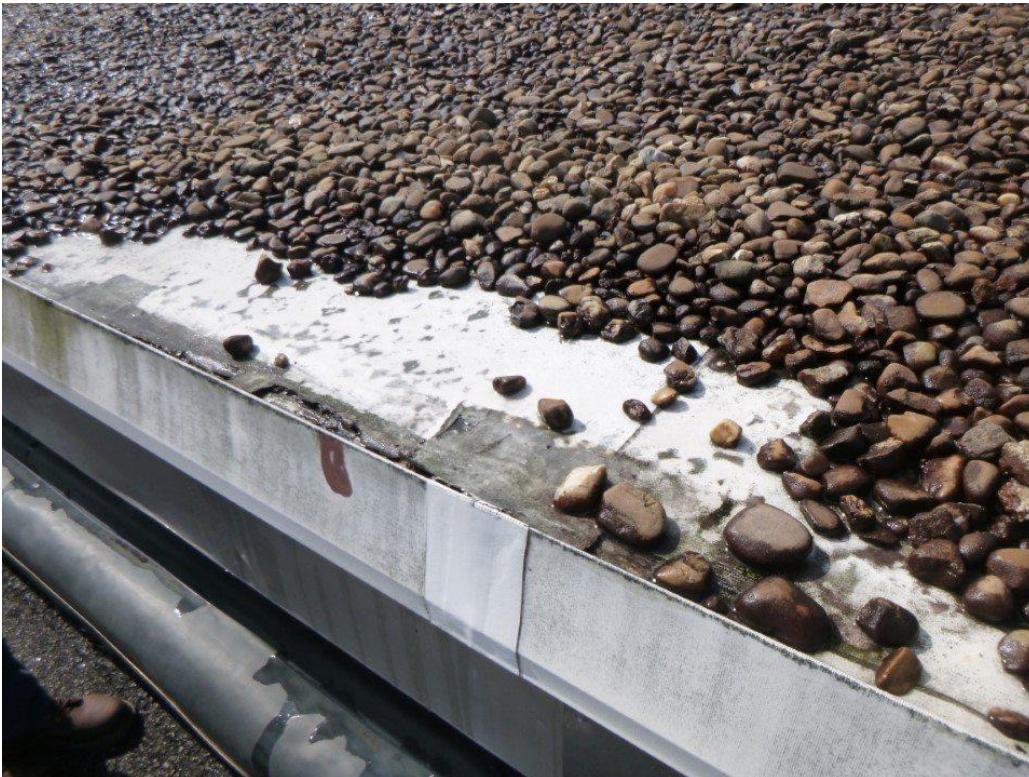
- EPA observed pooled water on top of the reservoir roof that was seeping out of the aluminum siding in several areas of the roof (*Photos 58-60*).
  - EPA observed significant plant growth at the base of the reservoir roof and sidewalk (*Photos 61-63*).

**Photograph 60.** Damage and water leaking from roof and siding on Byrd Park Reservoir.

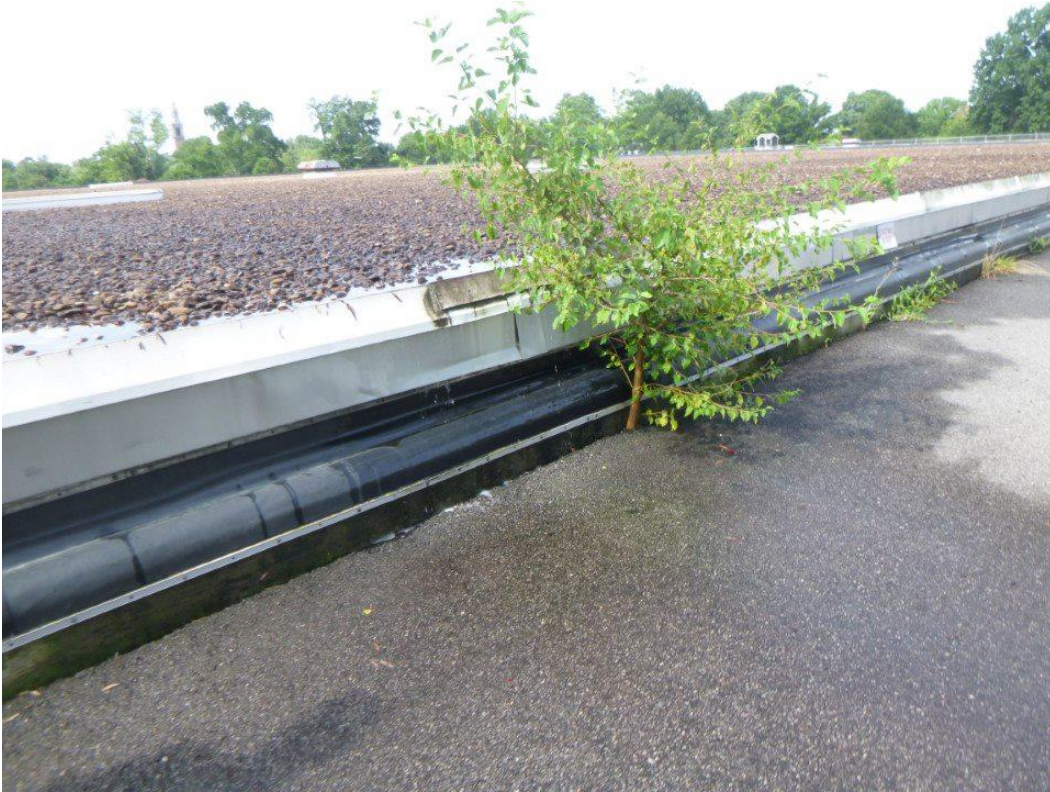
**Photograph 61.** Plant growth at base of Byrd Park Reservoir.

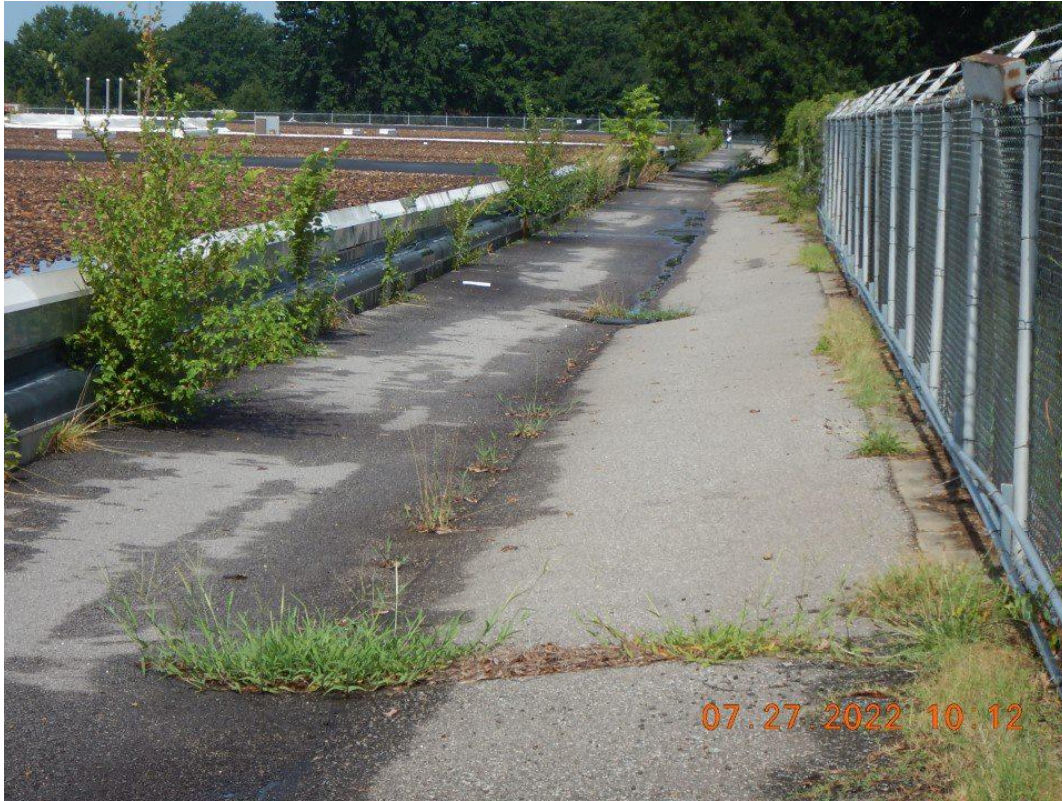
**Photograph 63.** Plant growth at base of Byrd Park Reservoir.

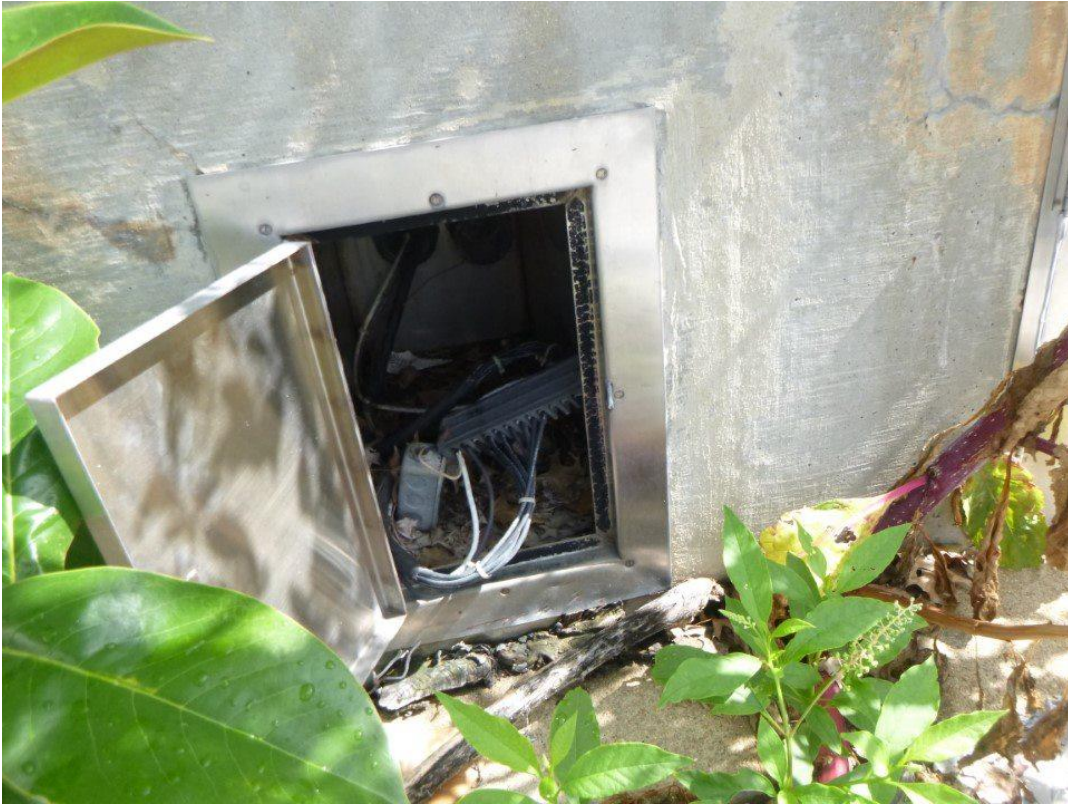
- EPA observed another walkway on the southern side of the reservoir, slightly shorter in length than the access walkway on the northern side. It is unclear if the southern walkway portion also serves as access, but it was arranged similarly with vents on the eastern and western walls and metal plates on the ground. EPA observed leaf litter and debris on top of the metal plates, as well as more mature vegetation growing around the base of the structures. EPA observed an access panel with electrical wiring open with leaves and other debris inside (*Photos 68-69*).

**Photograph 69.** Opened electric box at end of southern access walkway at Byrd Park Reservoir.

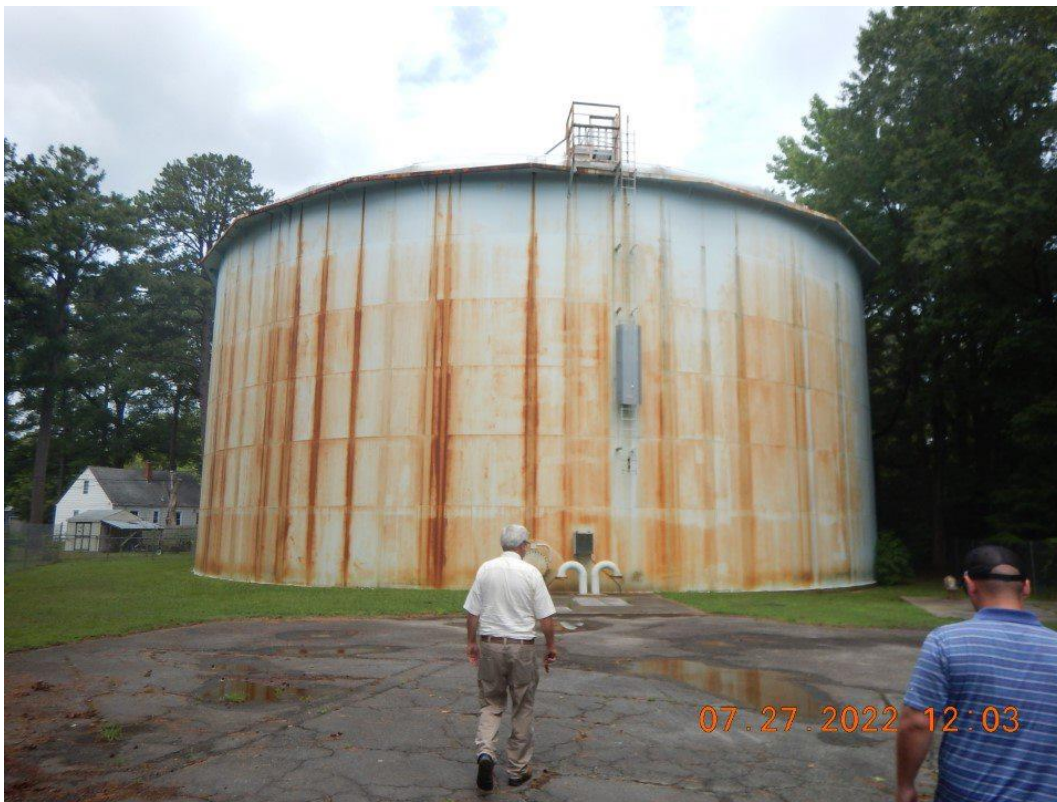
- EPA observed a significant amount of rust on the outside of the tank (*Photo 76-77*). System Representatives explained that the rust appears to be where the aluminum roof meets the side of the steel tank. There was not as much visible rust in the rear of the tank where the trees overhang the roof and cover the steel gutter.

**Photograph 76.** Rust on exterior of Jahnke Road Tank.

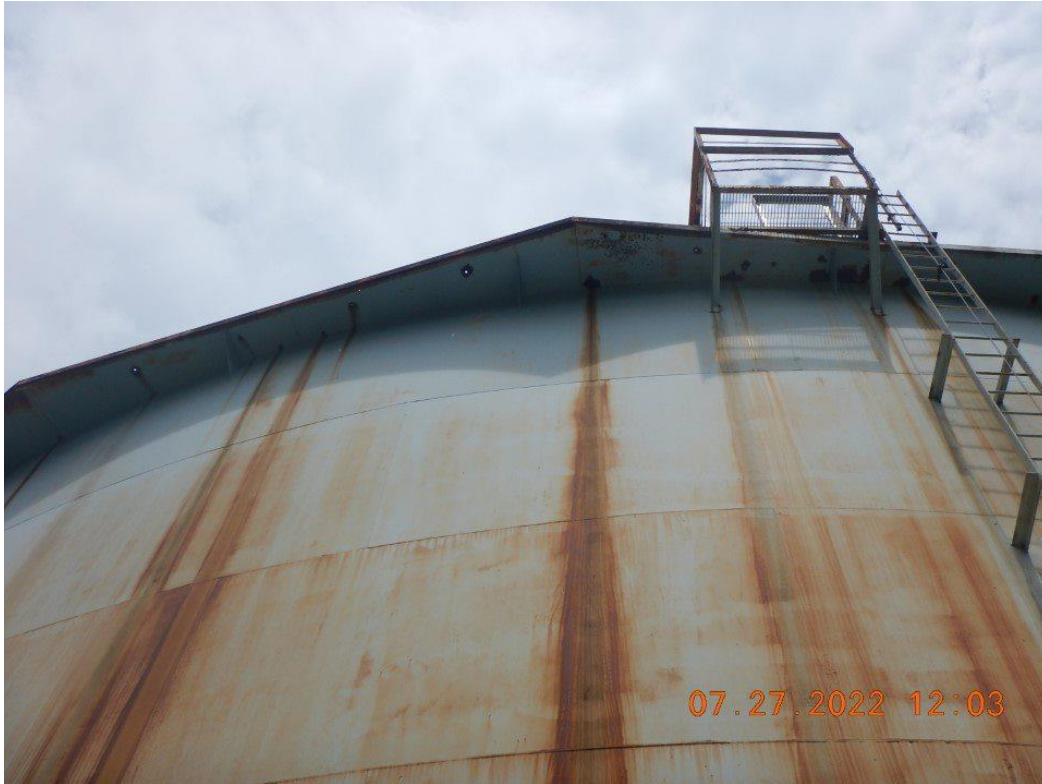
**Photograph 77.** Rust on exterior of Jahnke Road Tank.

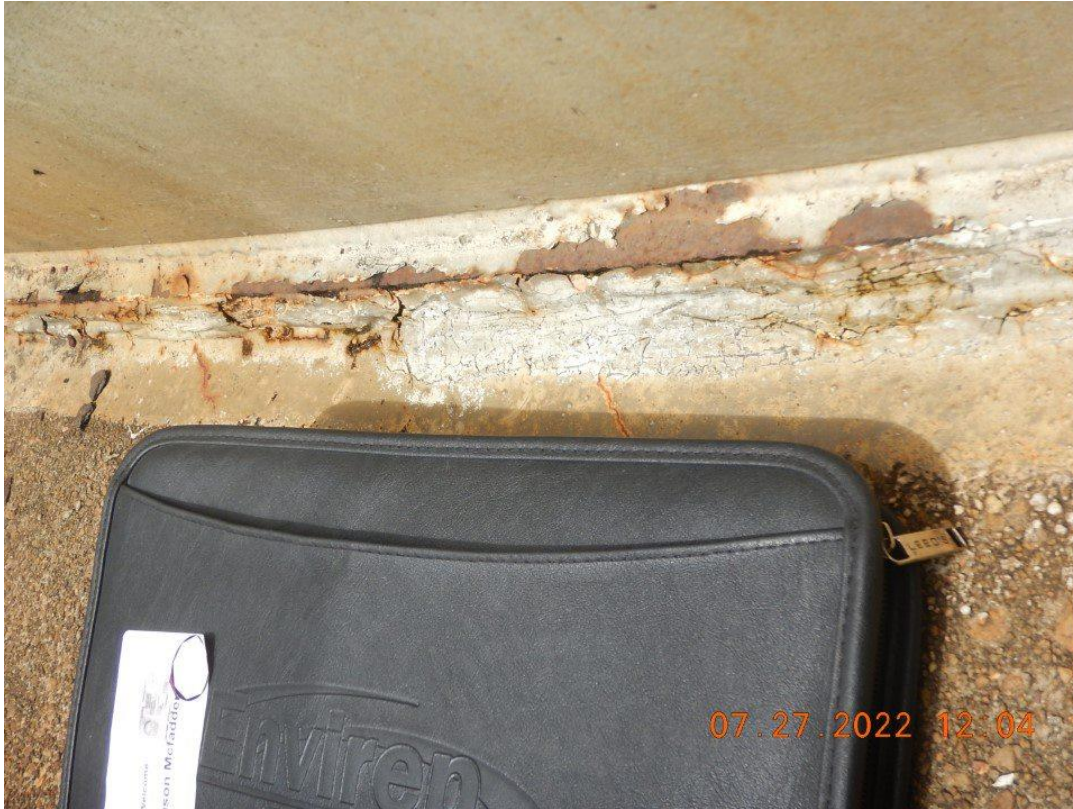
**Photograph 79.** Corrosion and degraded seal at base of Jahnke Road Tank.

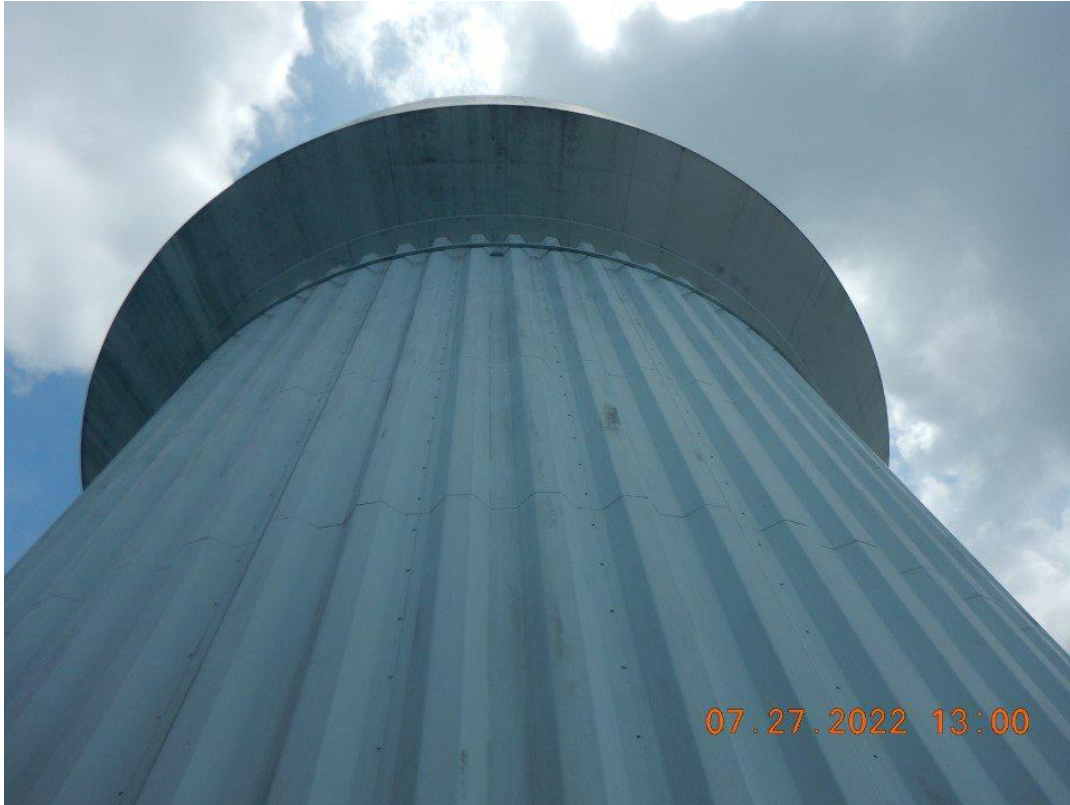
**Photograph 81.** Base of Warwick Road Tank with algal growth on bottom.

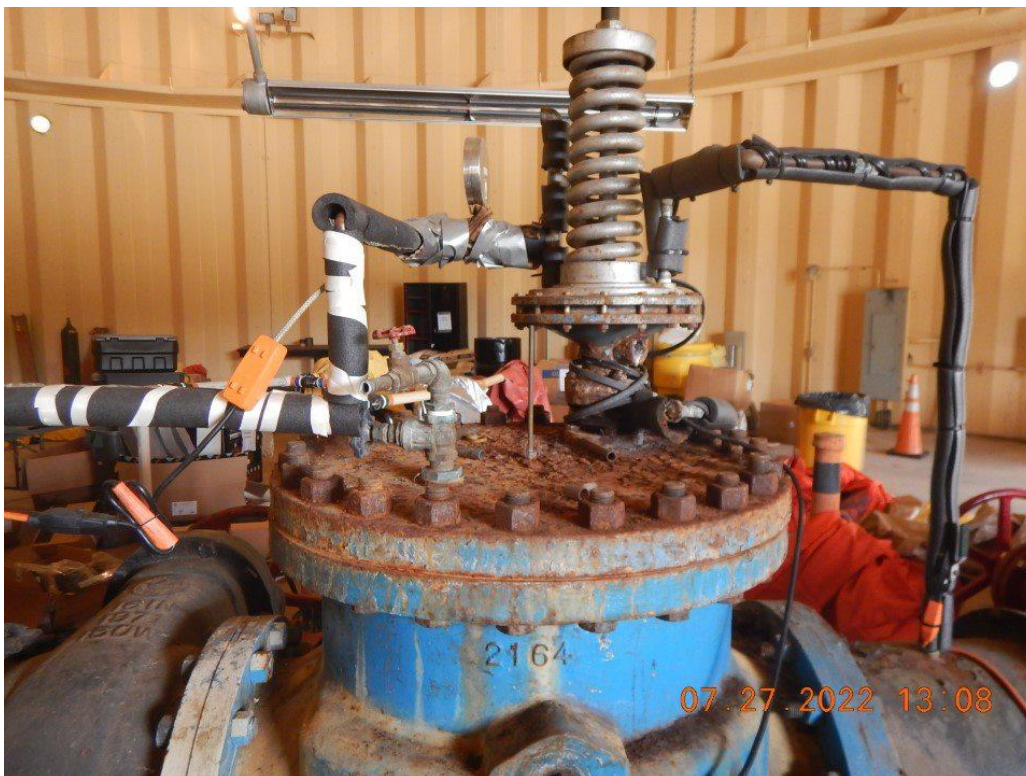
**Photograph 84.** Corrosion on the control valve on the transmission pipe of the Warwick Road Tank.

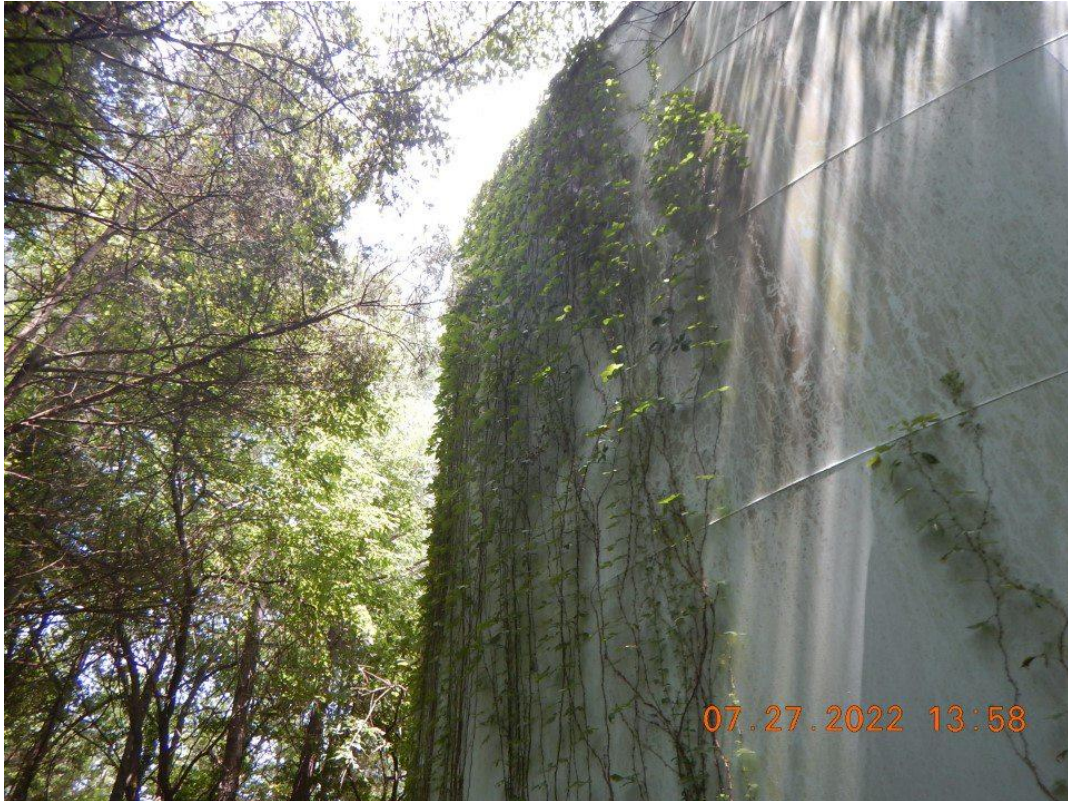
**Photograph 87.** Vegetation growing up and overhanging the Huguenot Road Tank.

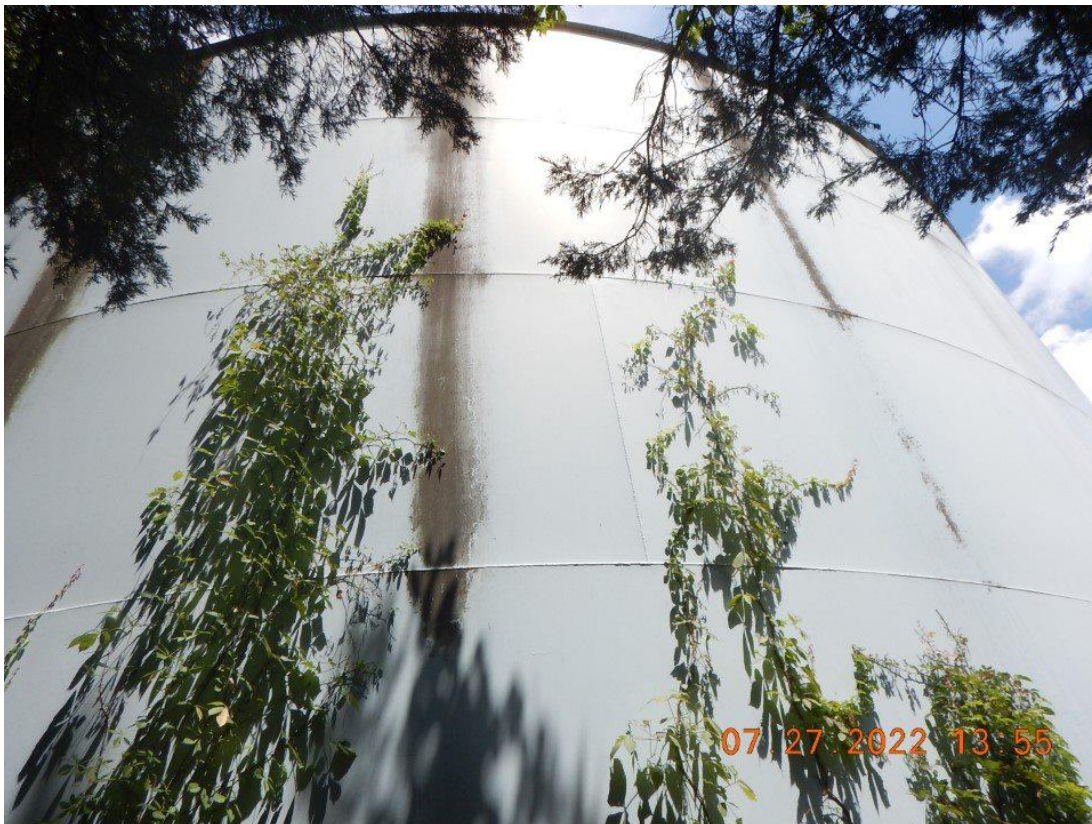
**Photograph 88.** Vegetation growing up and overhanging the Huguenot Road Tank.

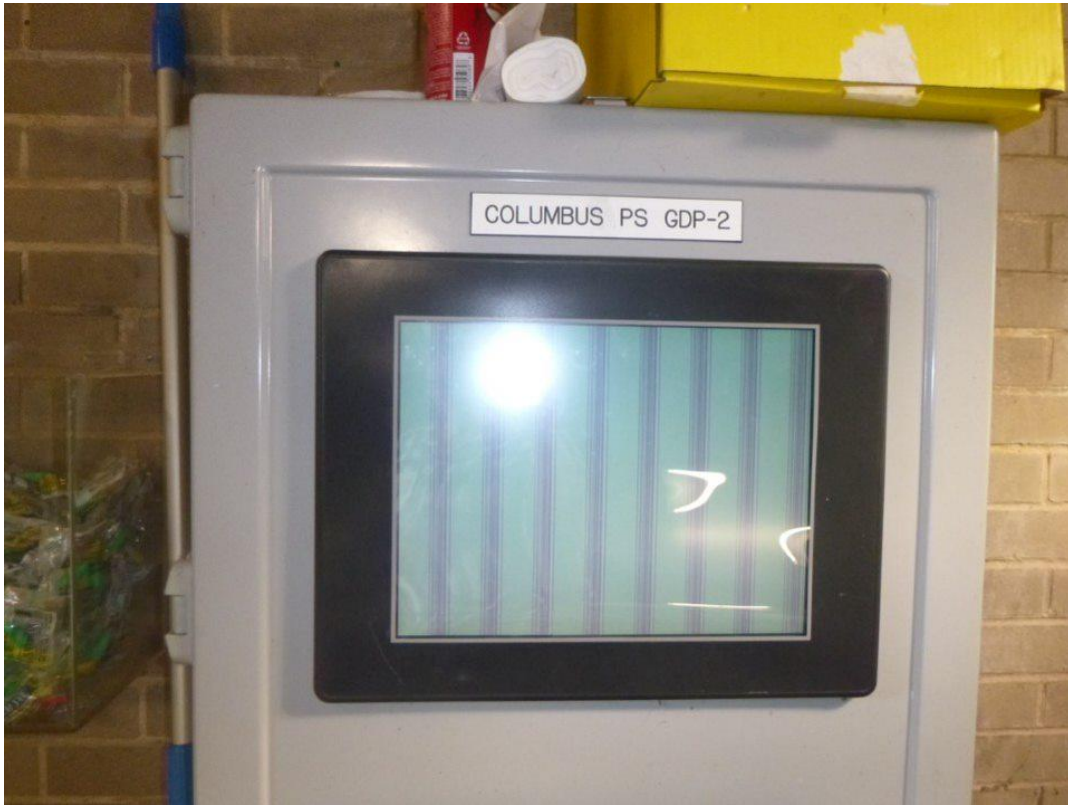
**Photograph 91.** Programmable logic controller (PLC) out of service at the Columbus Pump Station main building.

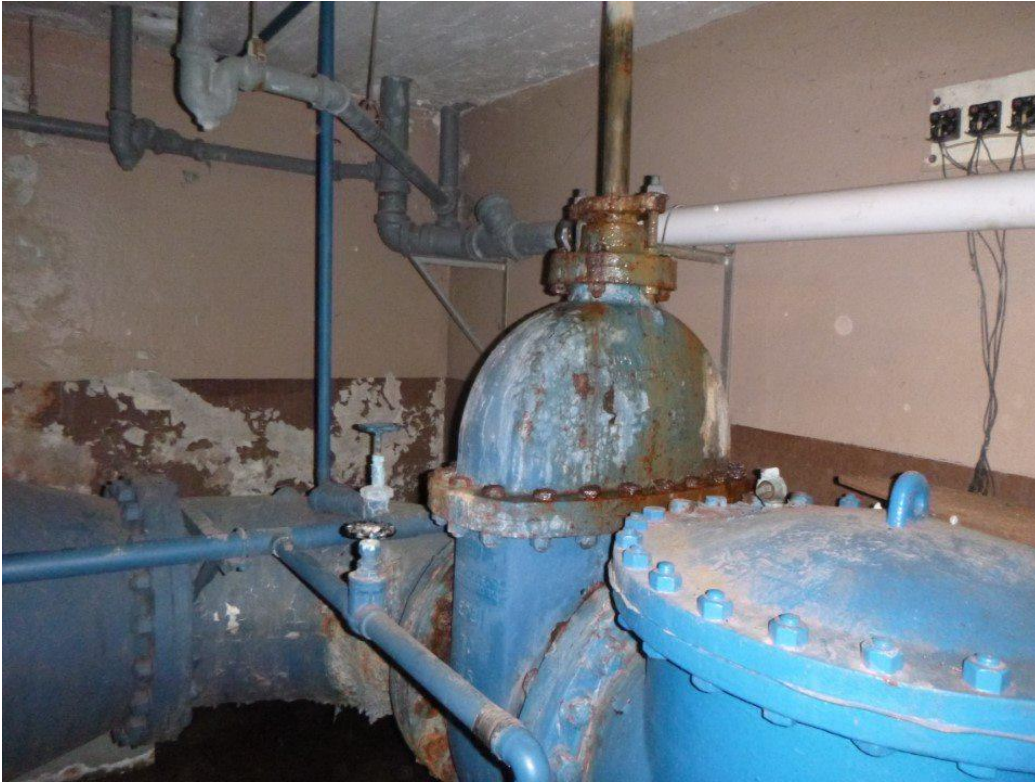
**Photograph 99.** Leaking seals on gate valves at Byrd Park Main Pump Station.

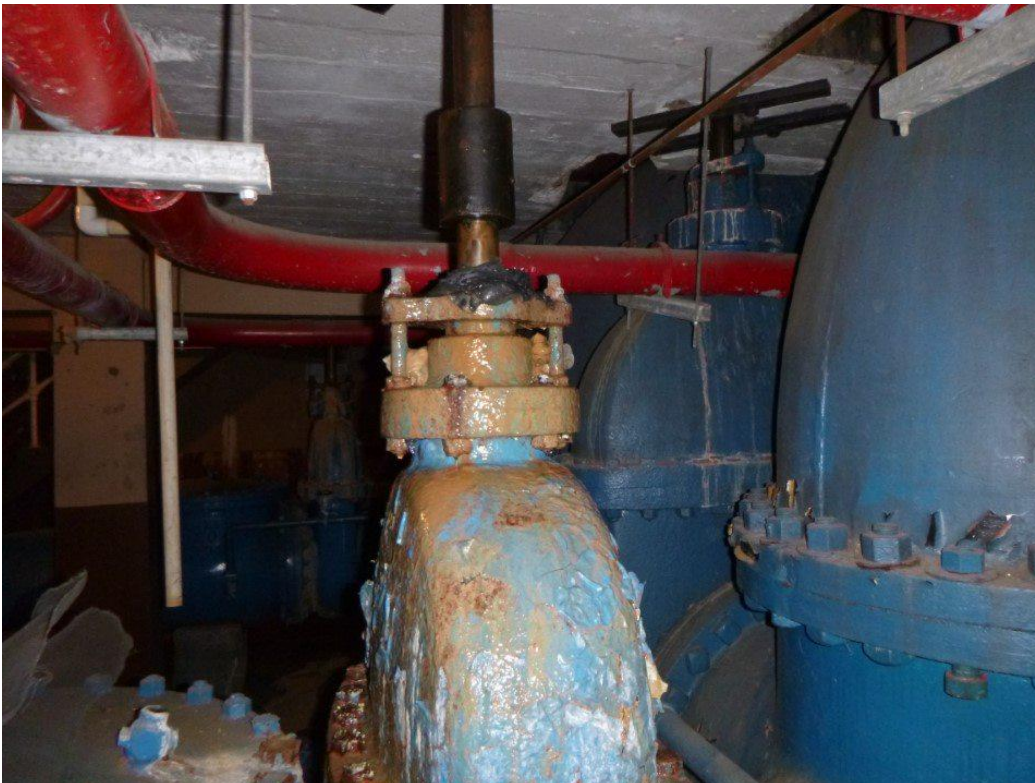
**Photograph 100.** Leaking seals on gate valves at Byrd Park Main Pump Station.

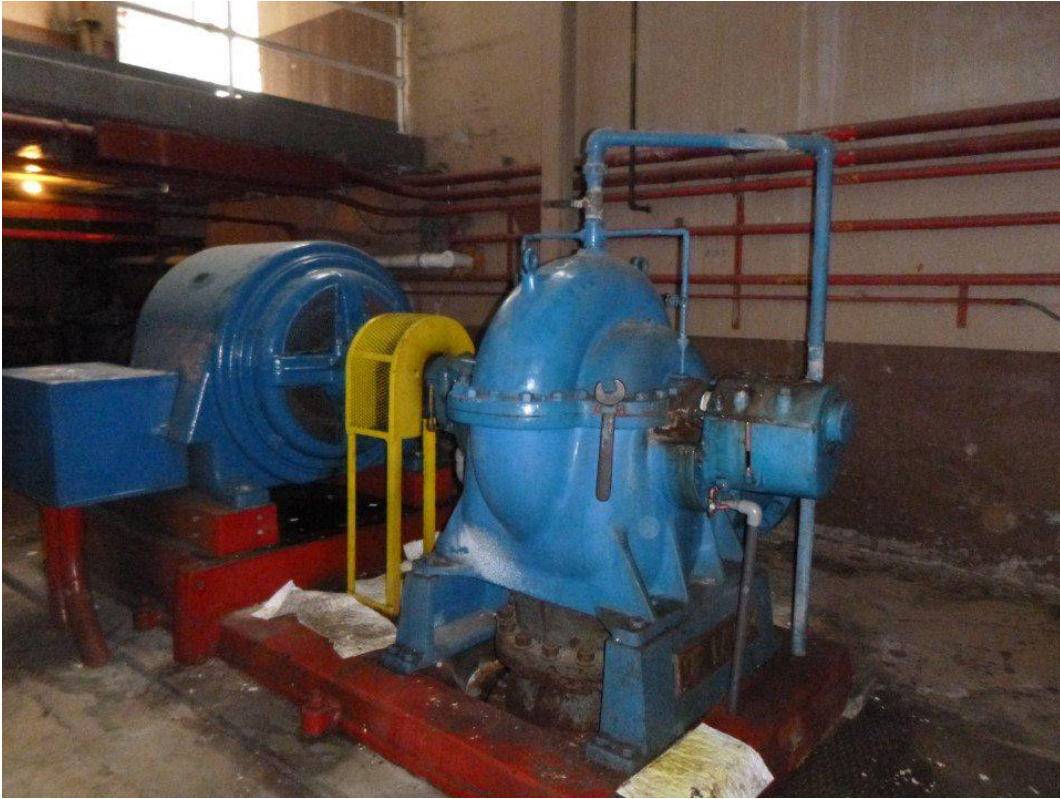
**Photograph 101.** Leaking lubrication at pump at Byrd Park Main Pump Station.

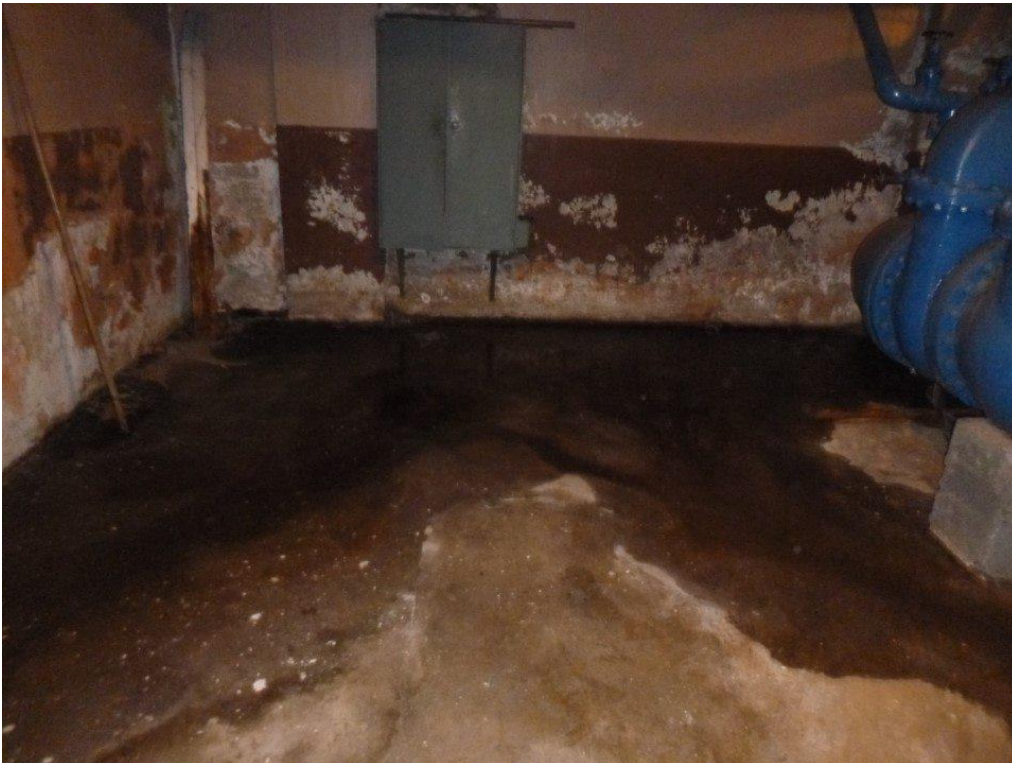
**Photograph 102.** Standing water on floor at Byrd Park Main Pump Station.

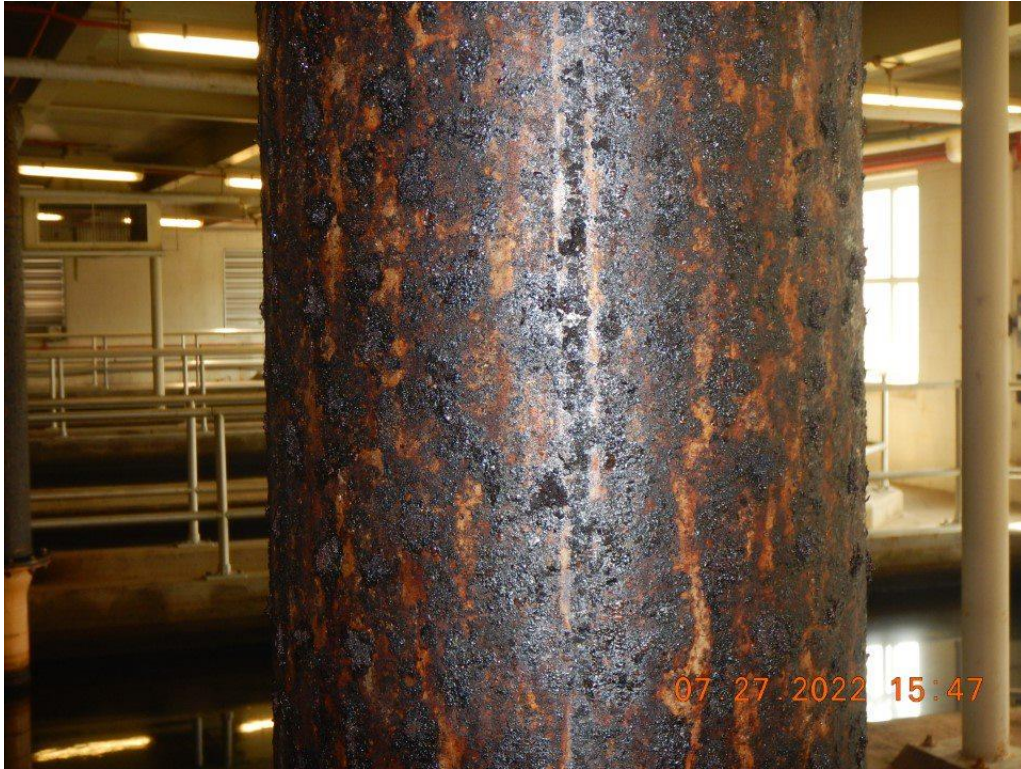
**Photograph 113.** Corrosion on air scour pipes located inside the enclosed Plant 1 filter room.

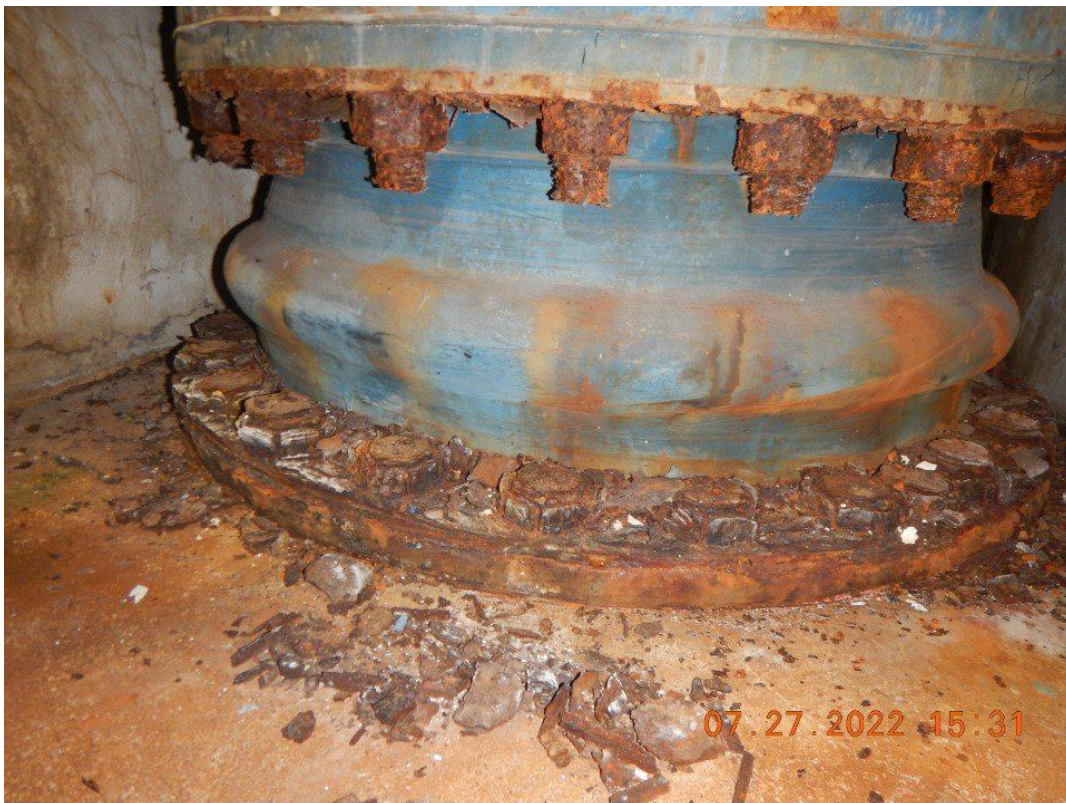
**Photograph 114.** Corrosion on pump 1 that takes water from the Plant 1 clearwell to the finished water basin.

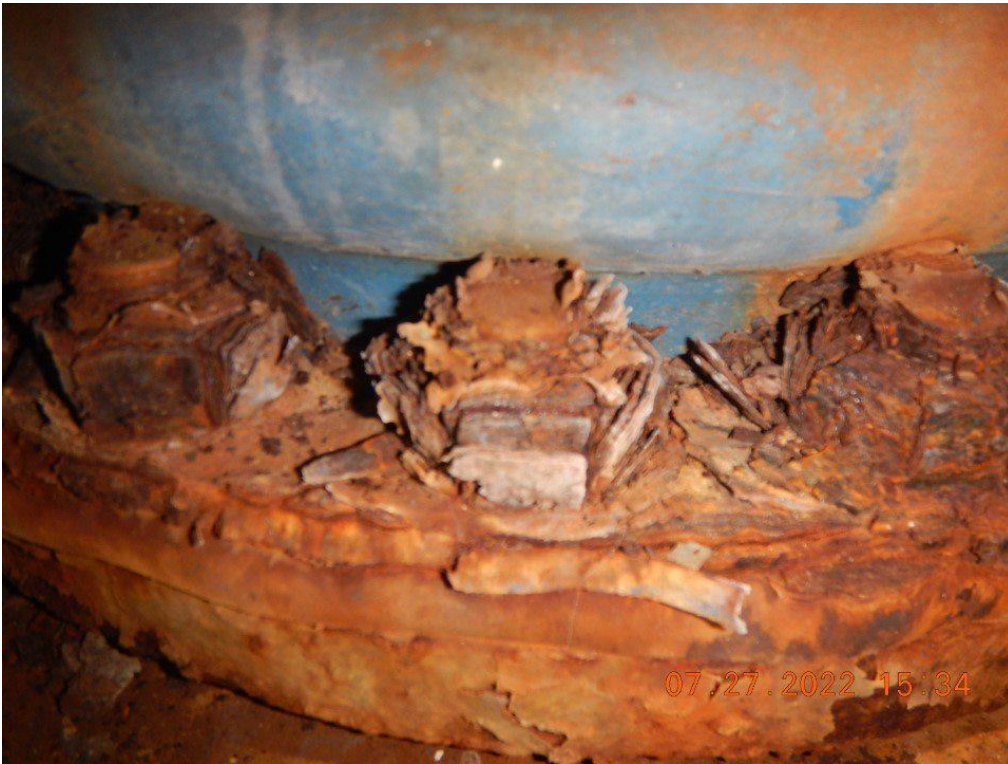
**Photograph 115.** Corrosion on pump 2 that takes water from the Plant 1 clearwell to the finished water basin.

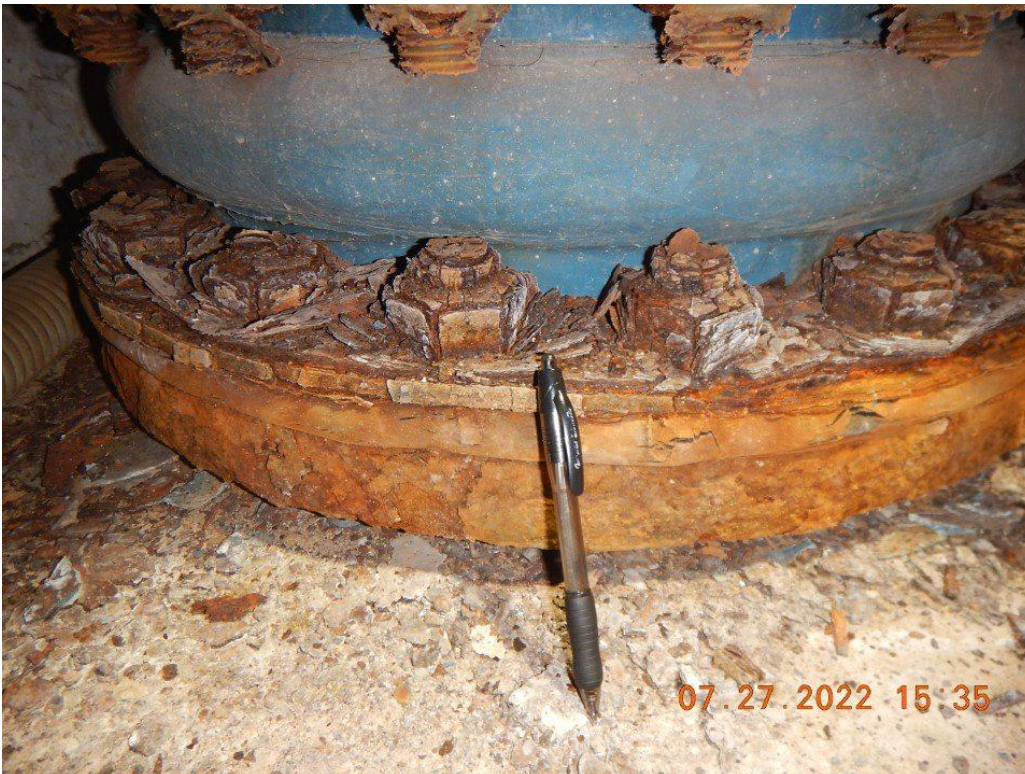
**Photograph 116.** Corrosion on pump 3 that takes water from the clearwell to the finished water basin in Plant 1 pipe gallery.

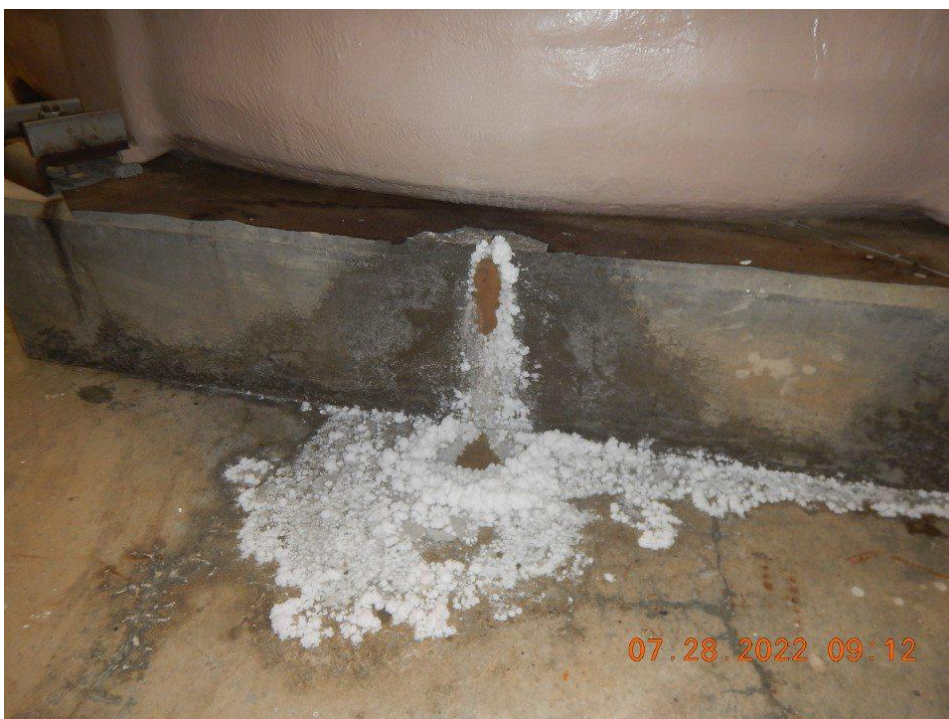
**Photograph 118.** Floor below active sodium hypochlorite leak at Tank T-SH-1-3 at the West Chemical Building.

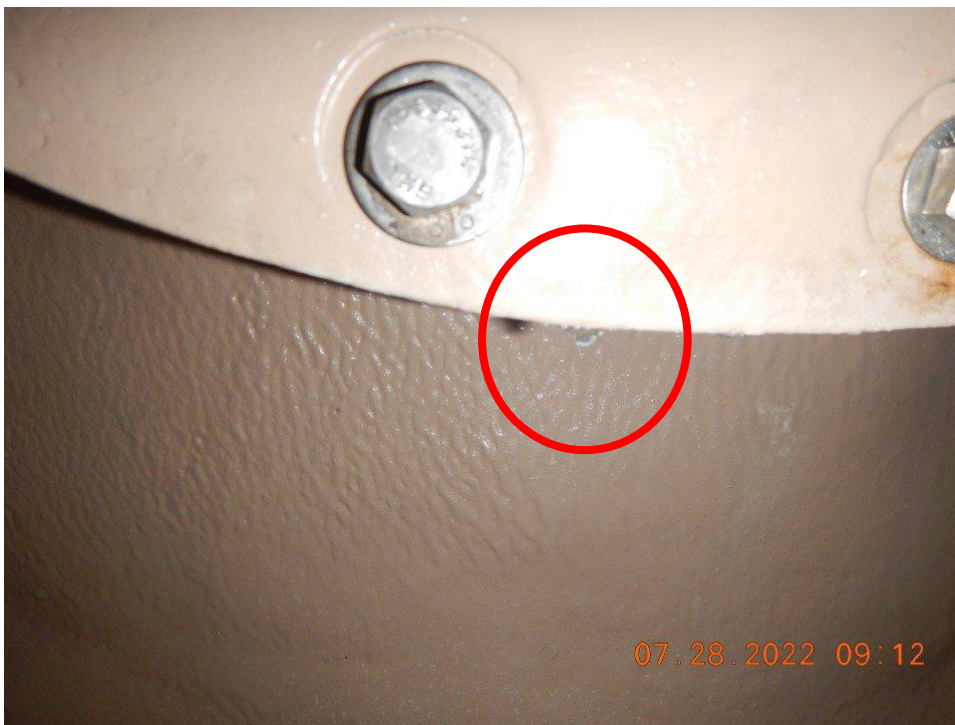
**Photograph 119.** Leak around gasket of sodium hypochlorite tank T-SH-1-3 at the West Chemical Building.

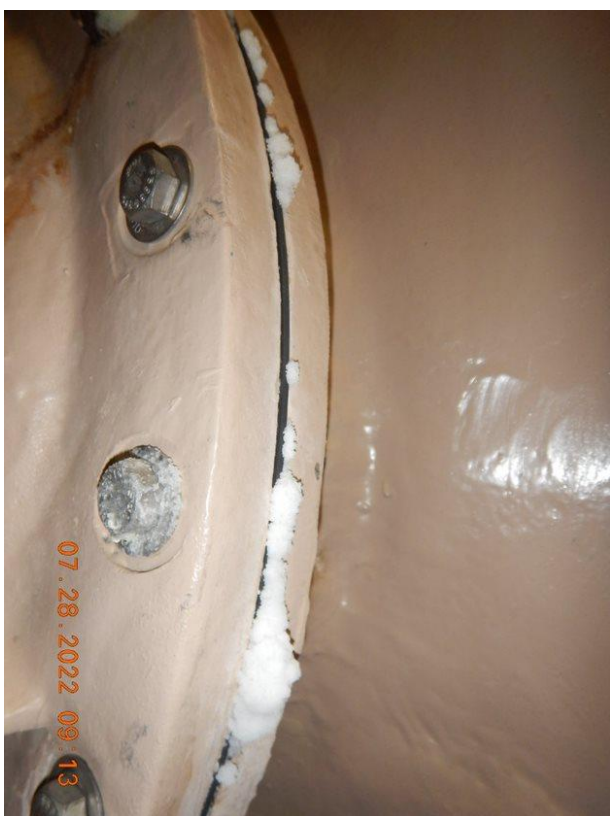
**Photograph 120.** Crystallized sodium hypochlorite around gasket at tank T-SH-1-3 at the West Chemical Building.

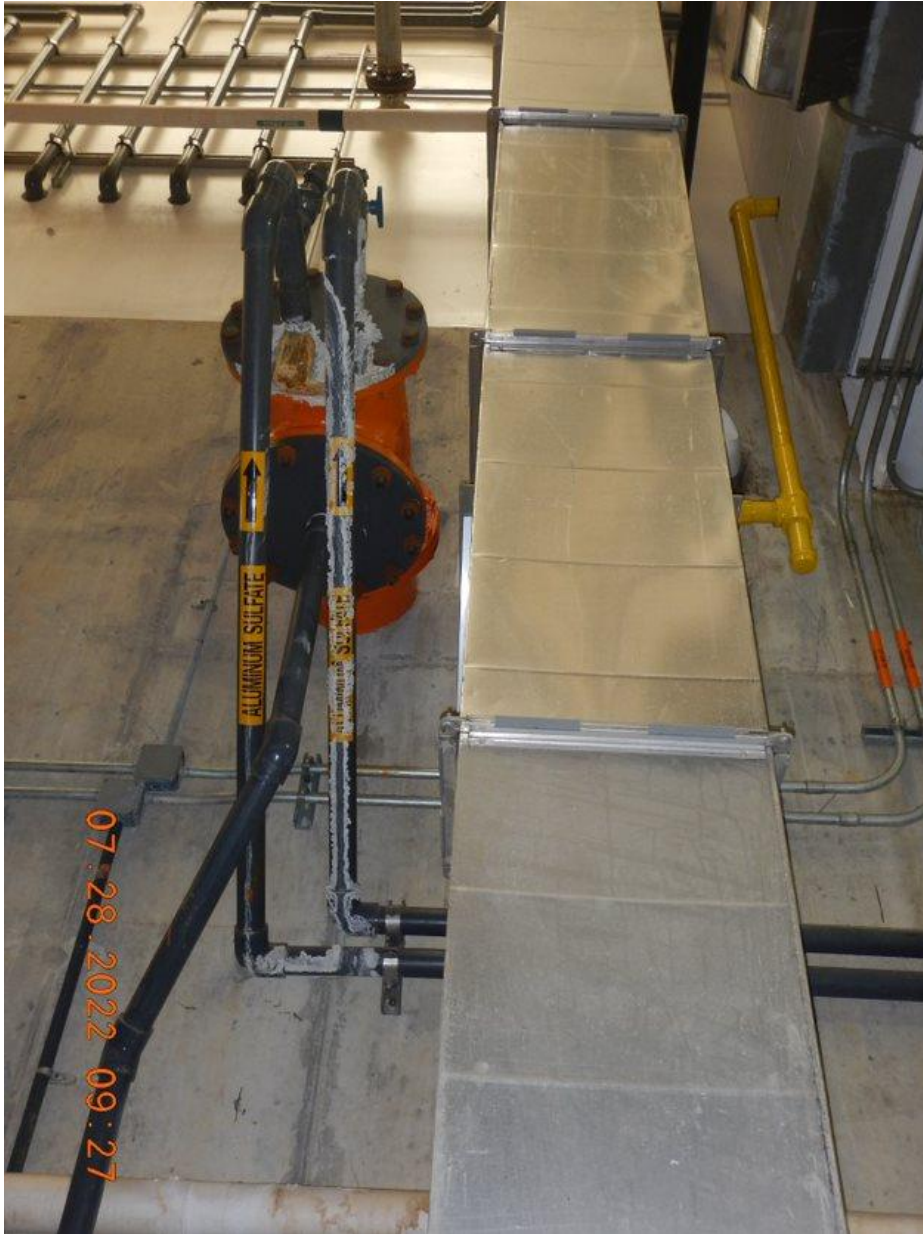
**Photograph 123.** Crystalized aluminum sulfate on the day tank supply line.

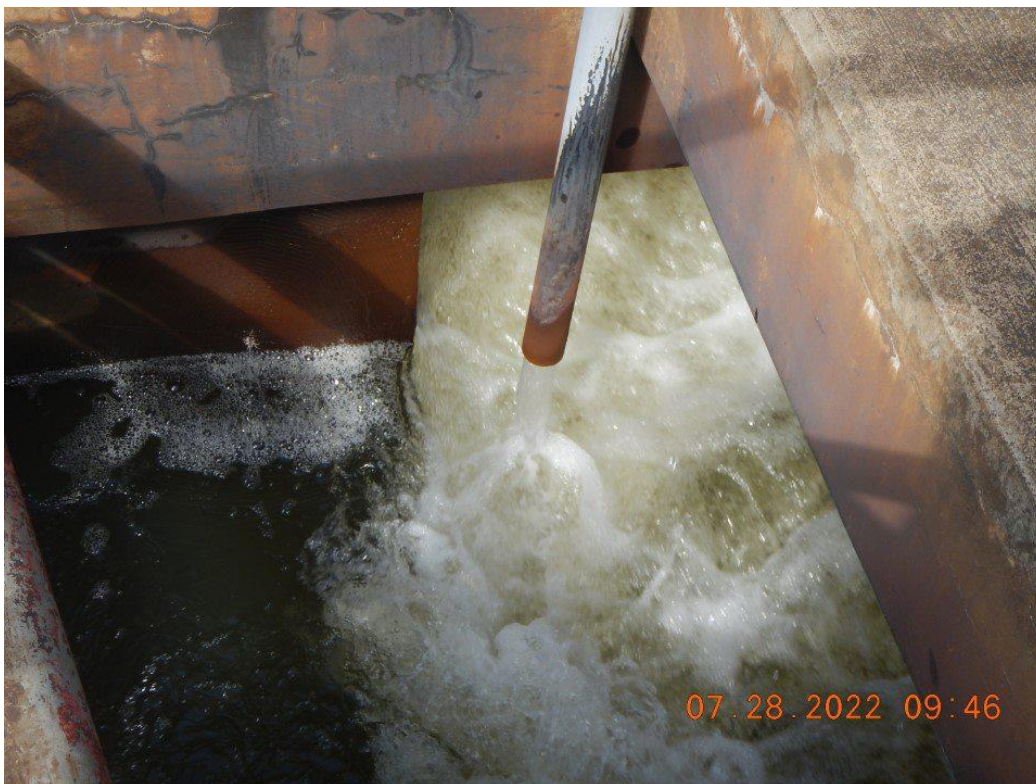
- EPA observed vegetation growth near the entry of the concrete raw water coagulation channel at the water line (*Photo 13*).
  - EPA observed that the potassium permanganate chemical application was not in operation at the time of the inspection, as the water discharging from the chemical pipe was clear rather than purple. The Superintendent acknowledged that the chemical application would be purple if the chemical application was dosing properly. The Superintendent confirmed that the chemical system was in operation, but that the chemical feed had failed (*Photo 14*). The Superintendent said that he notified operators to address the issue.

**Photograph 125.** Potassium permanganate in raw water coagulation channel during Day 2 of inspection out of service with clear water at chemical application point.
