FIRE INVESTIGATION REPORT

FIRE INVESTIGATION
201 E. Franklin St.
Richmond VA 23219

Incident # C202204301

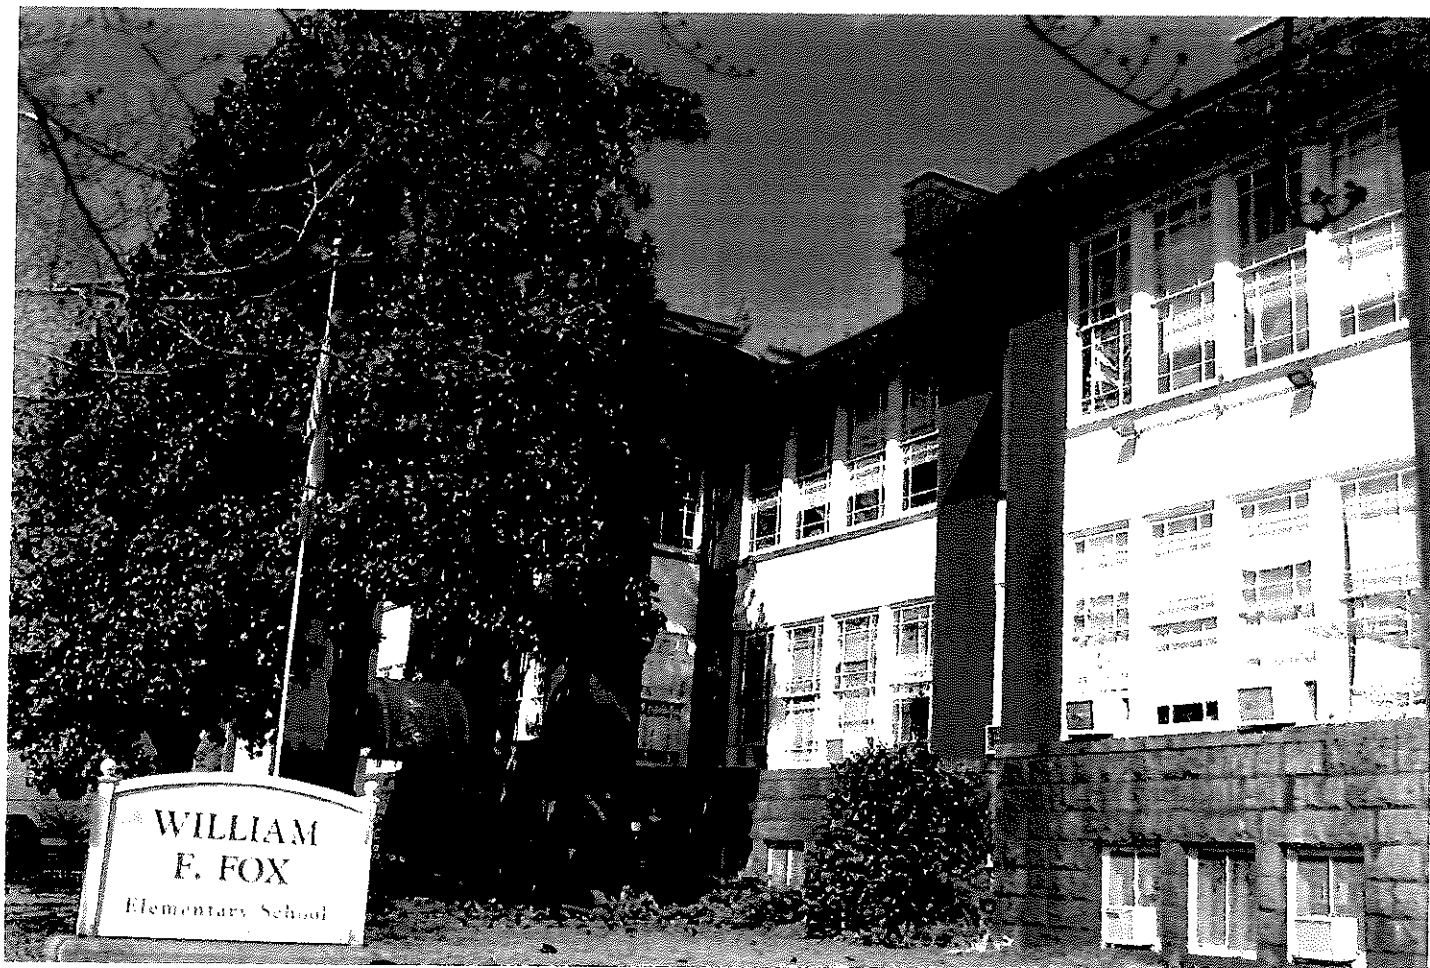
Structure Exterior Areas

Examination of the structure's exterior roof areas revealed it had been constructed using composition type (asphalt shingles). Examination of the roof areas revealed fire and heat-related damage. These damages were the result of heat impingement from the interior areas.

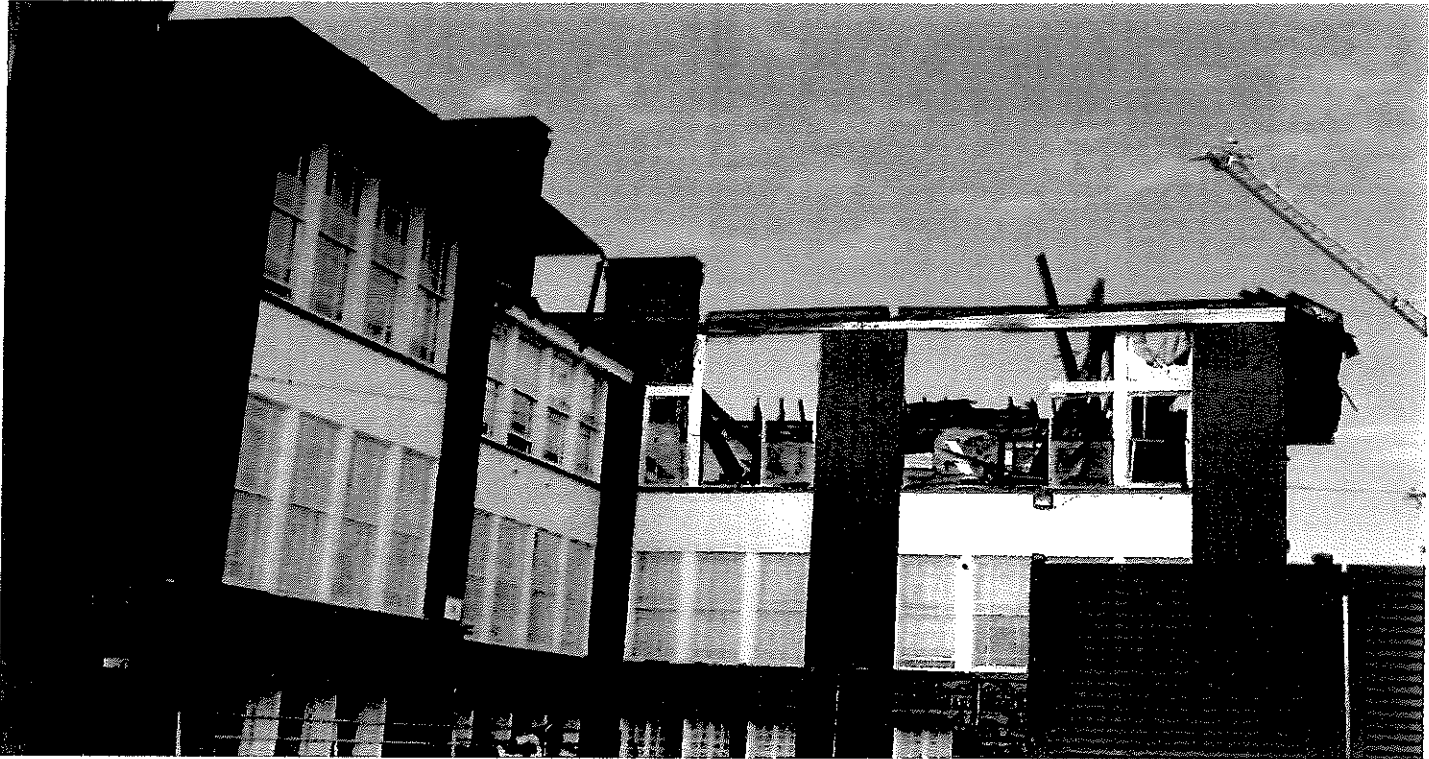
Interior (Non-Areas of Origin)

There was an absence of a fire suppression system, which would not have been required during the original construction of this building. The lack of an internal suppression system during the incipient stage of the fire caused or contributed to the propagation of the fire. In addition, this absence possibly contributed to the consumption of and degradation of the combustible materials within the structure.

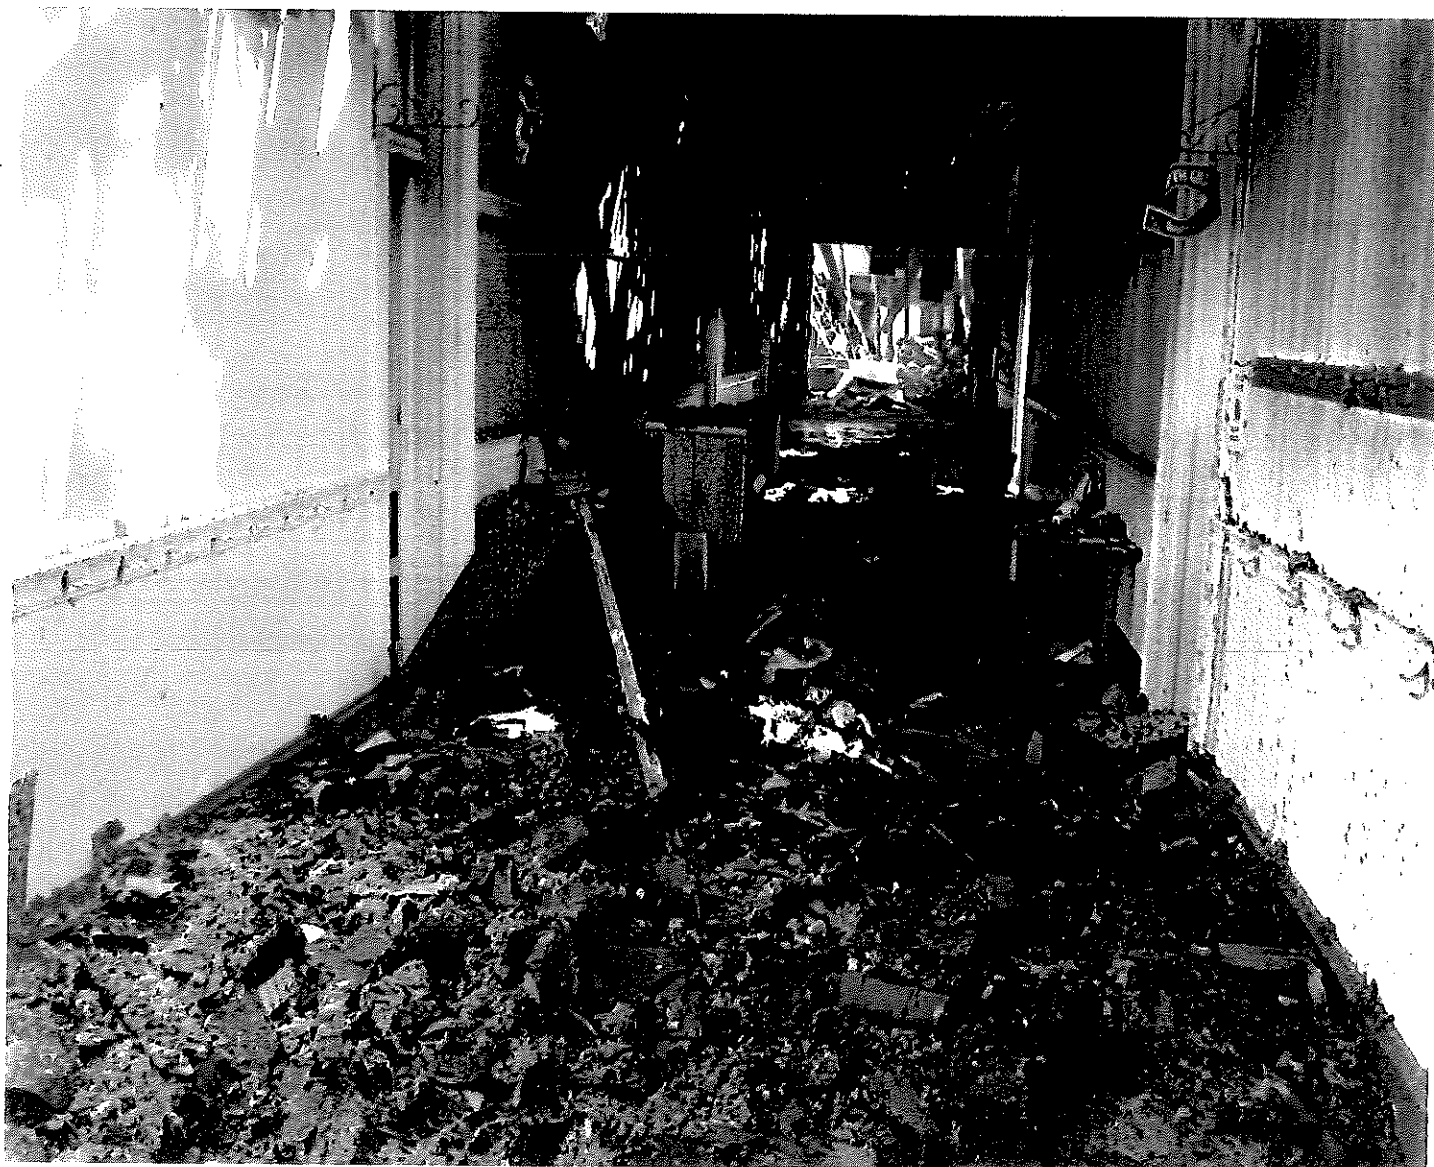
The examination then continued to the second floor of the structure starting on the "B" side of the building. While starting in this area of the structure I noticed the roof had been burned away on this side of the structure. The roof trusses were also burned, but the burn patterns indicated the fire was on the top side of the trusses. This was documented by photographs. There were large amounts of fire debris on the floor in the hallway and visible signs of smoke stains on the walls. The roof in this area of the structure had been burned completely away. There was a large pile of burnt debris located on the floor including shingles, insulation, and smaller pieces of wood that had fallen from the ceiling further ahead down the hallway. The roof trusses were still present but did present with signs of top-down burning on the majority of them. Each classroom presented with the same type of burn patterns on their respective ceiling trusses.

[REDACTED] The fire damage observed on the second floor was deemed to be more significant than what was observed on the first floor. I continued documenting this area while moving towards the end of the hallway located at the opposite end of the building where the attic area was located which contained the classroom and auditorium that Mrs. Jacobs informed investigators of during the documented interview. Once I made it to this area of the second floor I noticed the fire damage appeared to be the most significant compared to the other areas of the structure. The charring on the remaining wood was heavier, and there were signs of incomplete combustion located in the classroom located next to this area. The roof in this area of the structure had collapsed onto the floor. This area could not be accessed due to safety concerns for the investigators.
