Reference: 3 Year AHERA Asbestos Survey  
Elizabeth D. Redd Elementary School  
5601 Jahnke Road  
Richmond, Virginia

**ASBESTOS HAZARD EMERGENCY RESPONSE ACT  
(AHERA)  
THREE (3)-YEAR REINSPECTION REPORT**

Three-Year AHERA Re-Inspection Report

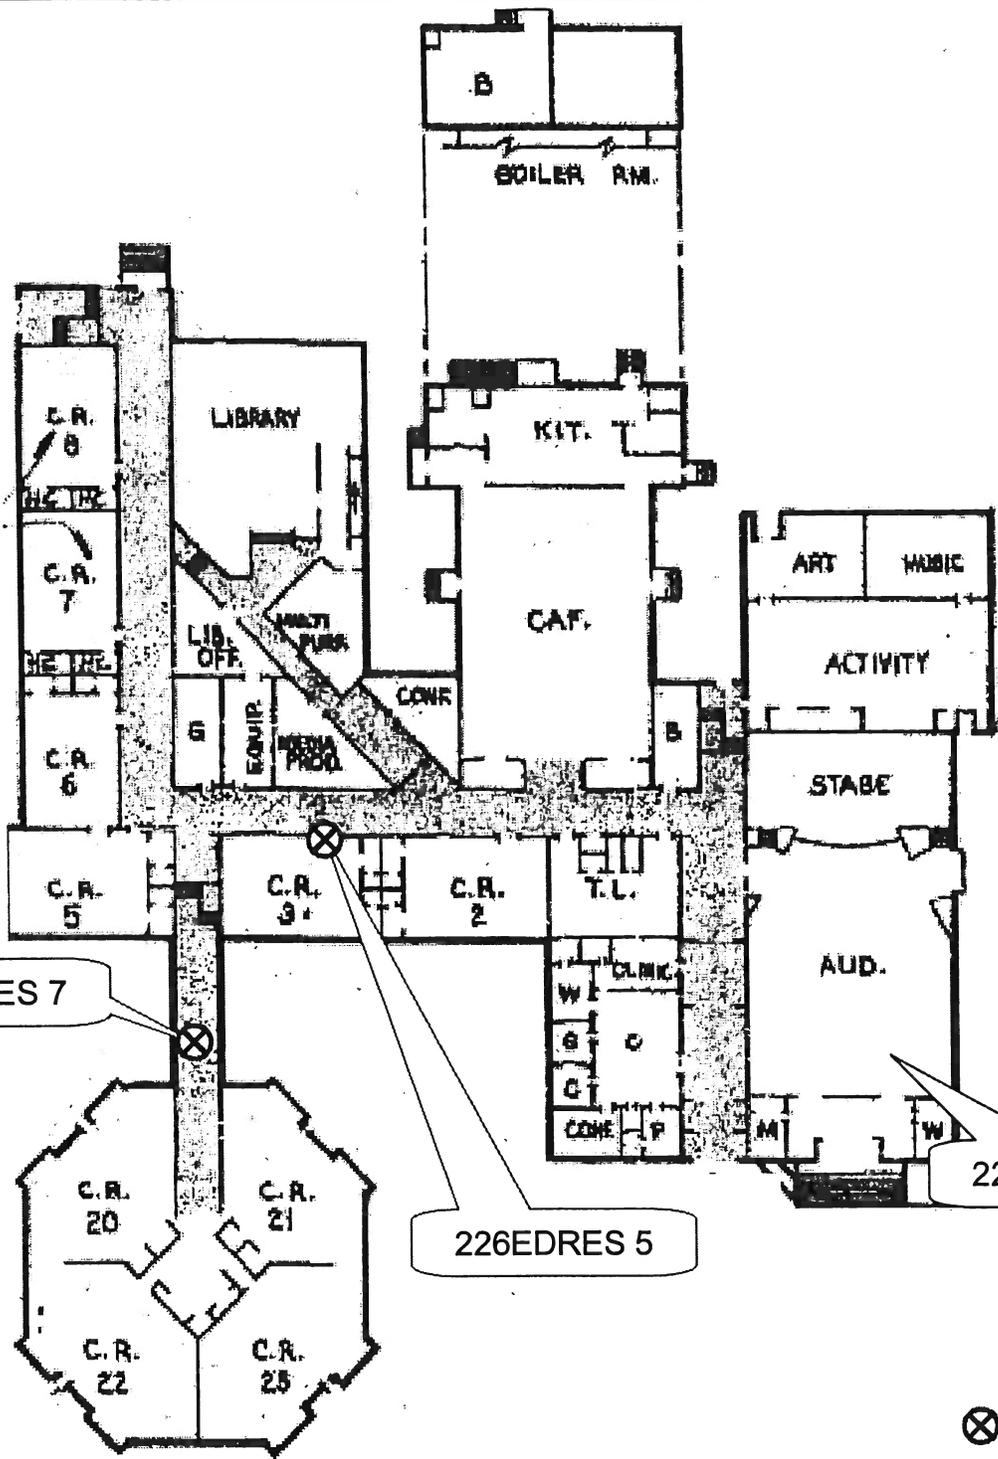
The analytical testing of samples collected indicated that the black floor tile mastic associated with the 9" x 9" floor tile was detected to contain asbestos in concentrations greater than 1%. By definition, these materials contain asbestos and should be included in the periodic surveillance surveys.
