# **DRAFT North Guadalupe Street Post Reconstruction Multimodal Operations and Safety Analysis**

**August 2026**

**Prepared for: Santa Fe  
Metropolitan Planning  
Organization**

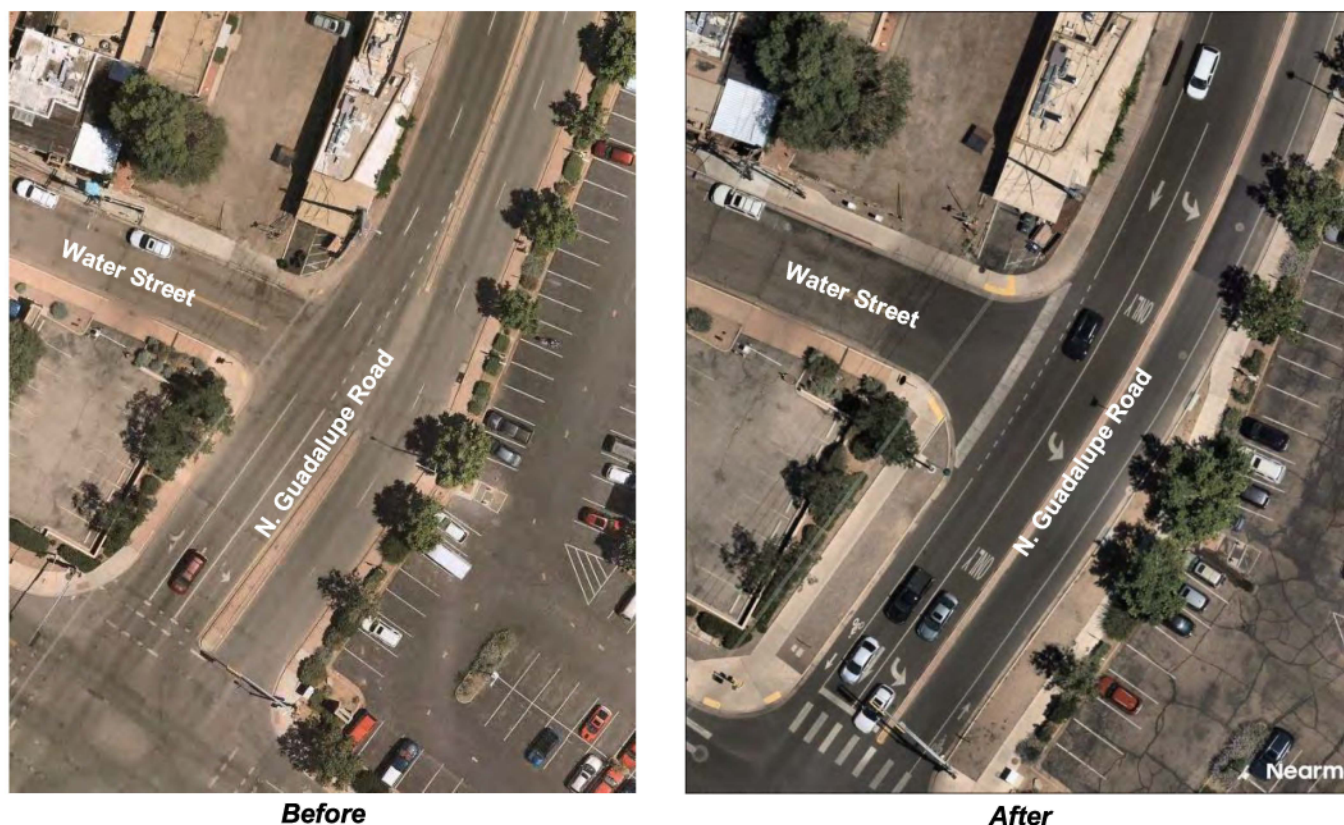
**Figure 1. Water Street and N Guadalupe Road**

At Water Street, the recommended access management improvements were generally implemented. The median full-access point was closed, the intersection was converted to right-in/right-

out only, and the southbound left-turn storage at Alameda was extended. These improvements addressed the previously identified conflict point, low volume eastbound left turning movement from Water Street, and operational limitation issues. However, post-construction observations also identified a new concern that southbound U-turns have very little space to complete the movement. **Figure 1** provides aerial imagery for the intersection of Water Street and N Guadalupe Road in 2023 (before) and in 2026 (after).

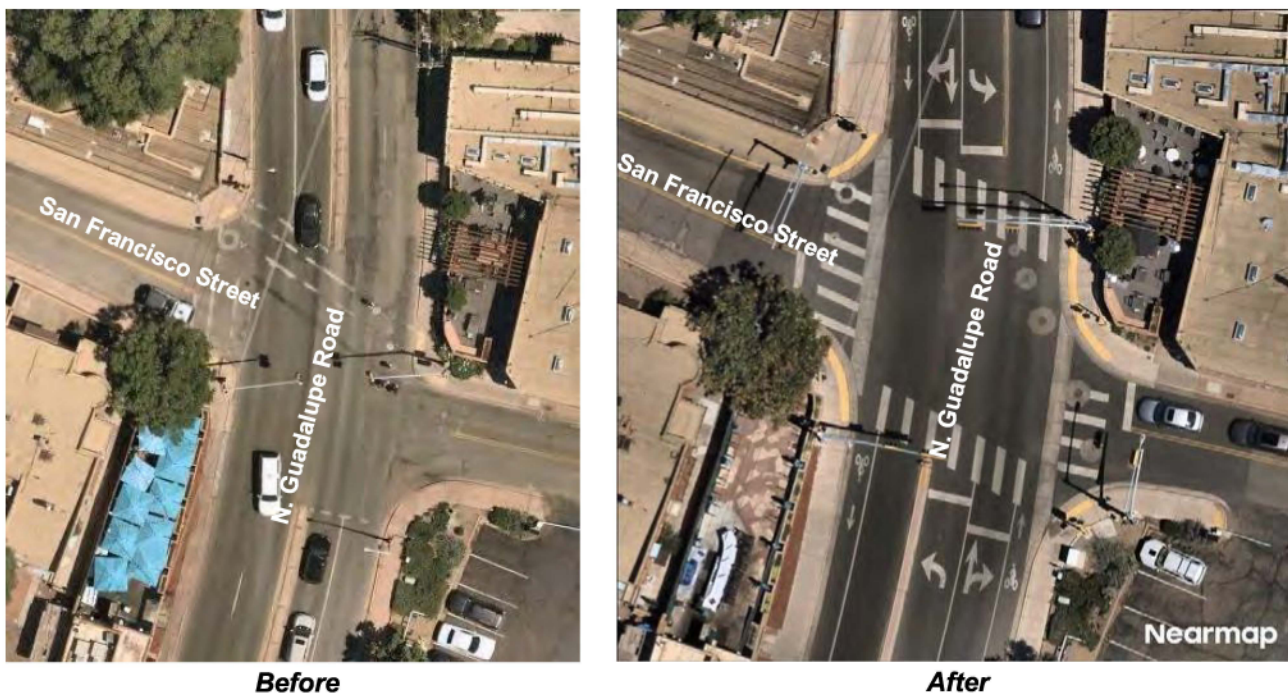
**Figure 2. San Francisco Street and N. Guadalupe Road**

At San Francisco Street, curb radii were improved on all corners, traffic signal hardware was upgraded, pedestrian signal equipment was improved, and northbound/southbound left-turn offsets were improved. Despite the geometric and operational improvements, post-construction observations demonstrated persistent challenges and opportunities for improvement. For example, curb ramp designed would facilitate a pedestrian scramble movement that has not been implemented. If implemented, a pedestrian exclusive phase could dramatically reduce conflicts between pedestrians and turning vehicles. Even if the exclusive phase is not implemented, the City should explore additional opportunities to reduce right turning conflicts, particularly at the northeast and southwest corners given the large turning radii that facilitate higher speed right turns. **Figure 2** provides aerial imagery for the intersection of San Francisco Street and N Guadalupe Road in 2023 (before) and in 2026 (after).

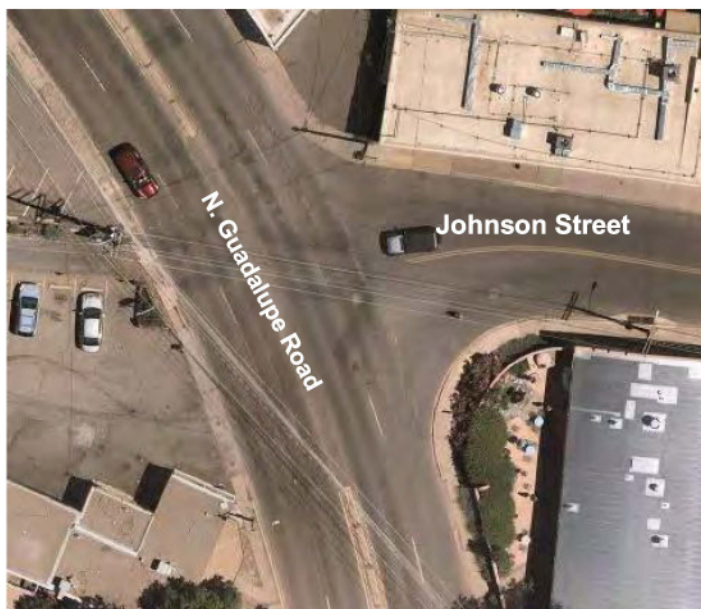
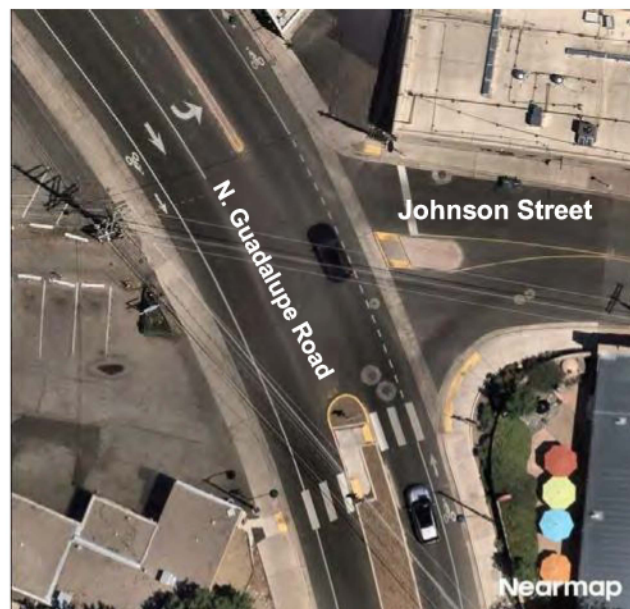
*After***Figure 3. Johnson Street and N. Guadalupe Road****Jefferson Street / McKenzie Street**

- The pedestrian refuge island located at the Johnson Street intersection has been a vehicle hazard. There is a small curb on the west side of the refuge island that is repeatedly struck by vehicles. One business owner indicated that they have assisted in unloading vehicles stuck on the curb.

At Johnson Street, the proposed pedestrian crossing and refuge improvements were largely implemented. Improvements included a new pedestrian crossing, a pedestrian refuge island, widened sidewalks on both sides, pedestrian crossing improvements, and a southbound left-turn lane. These improvements generally addressed the high pedestrian crossing demand, wide crossing distance, insufficient pedestrian accommodations, and community requests for safer crossings. Additional review is warranted for several follow-up items, including ADA features, refuge island design, and crosswalk marking conditions. Post-construction observations also identified a new issue involving diverted U-turns and turns to Johnson Street, including vehicles driving over the pedestrian refuge. **Figure 3** provides aerial imagery for the intersection of Johnson Street and N Guadalupe Road in 2023 (before) and in 2026 (after).

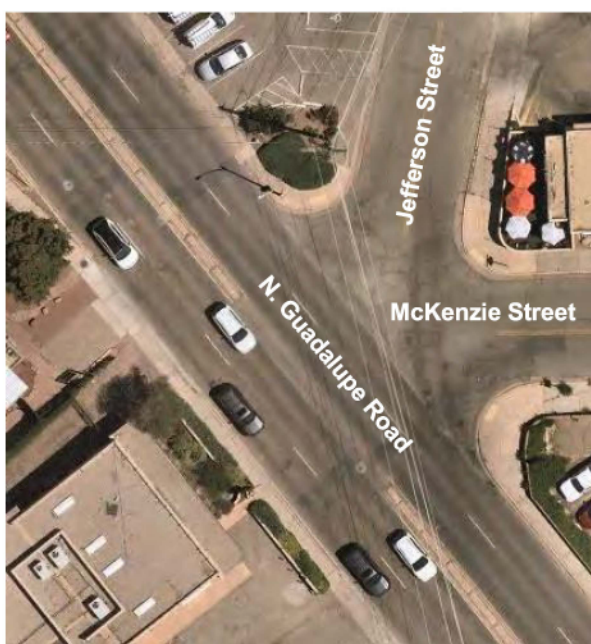
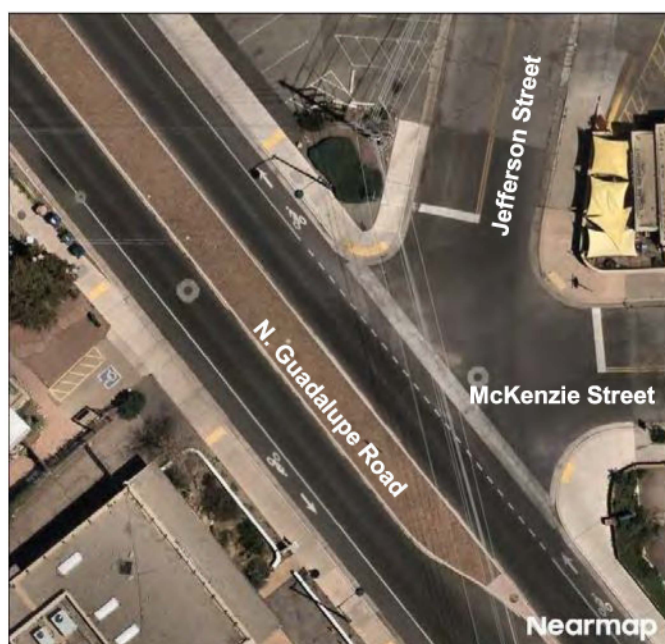
*After***Figure 4. Jefferson Street / McKenzie Street and N. Guadalupe Road**

At Jefferson/McKenzie, some geometric and access management recommendations were implemented while others were not fully addressed. The intersection opening was narrowed through sidewalk improvements and curb extensions, and the crossing distance was shortened by approximately eight feet. A median was constructed to address southbound left-turn conflicts. However, the recommended mid-block crossing and associated median refuge island north of Jefferson was not implemented. **Figure 4** provides aerial imagery for the intersection of Jefferson Street / McKenzie Street and N Guadalupe Road in 2023 (before) and in 2026 (after).

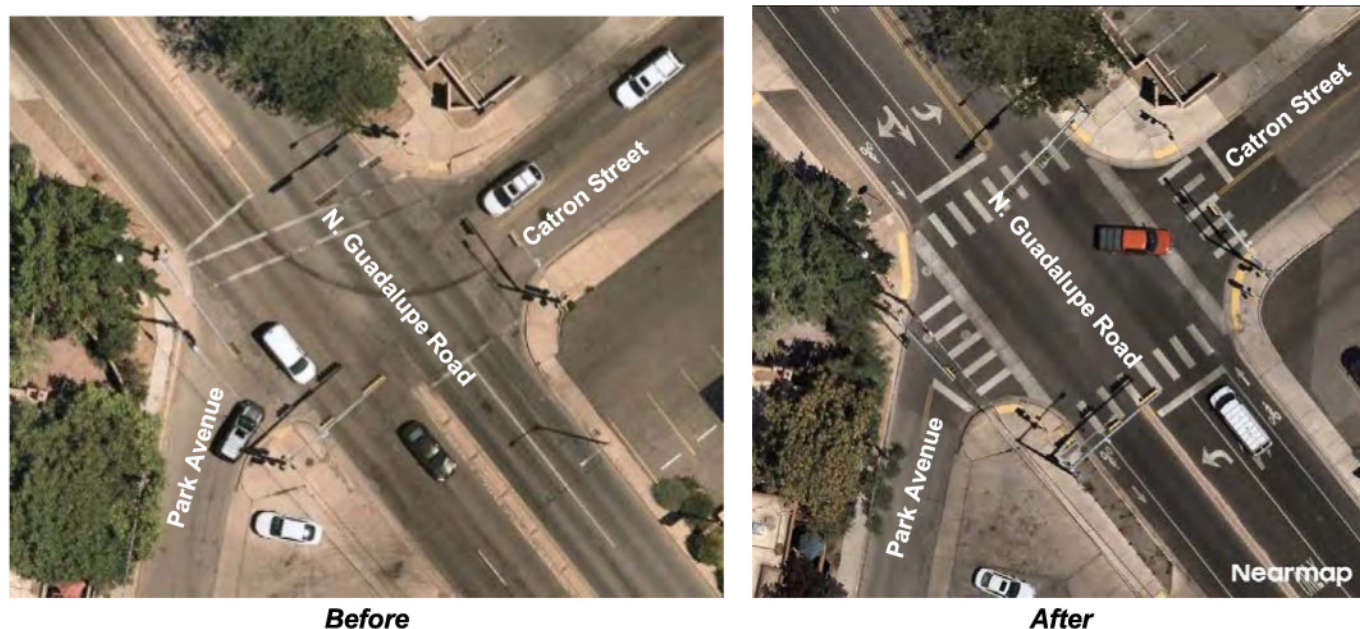
**Figure 5. Catron Street/ Park Avenue and N. Guadalupe Road**

At Catron / Park, observed improvements included intersection geometry improvements, directional pedestrian ramps, improved turn radii, a neutral left-turn offset, and exclusive north/south left-turn lanes. These improvements addressed the highest crash rate concerns at this intersection and tight west leg corner geometry issues. The left-turn operations and striping improvements appear to have partially addressed the original operational concern, while school-zone pedestrian activity conditions may require additional review and recommendations. **Figure 5** provides recent aerial imagery for the intersection of Catron Street / Park Avenue and N Guadalupe Road in 2023 (before) and in 2026 (after).

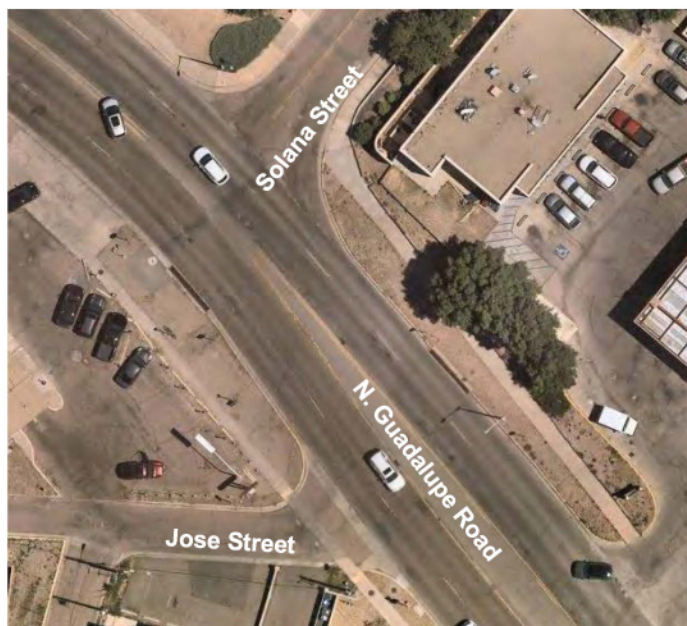
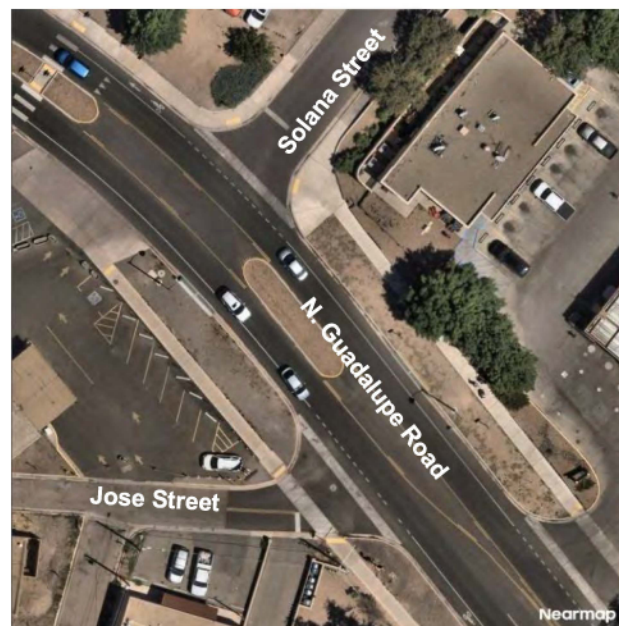
*After***Figure 6. Jose Street / Solana Street and N. Guadalupe Road**

At Jose Street, all proposed recommendations appear to have been implemented. Observed improvements included removal of obstructions on the west side, reconstruction of the parking lot, widened sidewalk, widened buffer, reconstructed sidewalks, and added curb ramps. These improvements addressed pedestrian encroachment, ADA accessibility deficiencies, sidewalk obstructions, and parking conflicts. At Solana Street, improved curb radii on the east side and a pedestrian mid-block crossing were observed, addressing the geometric deficiency and traffic calming opportunity identified for that location. Further observations noted the northbound bike lane ending at the mid-block crossing. Signage to denote bike lane ending in the northbound direction may be appropriate at the mid-block crossing, north of Solana Street. **Figure 6** provides aerial imagery for the intersection of Jose Street / Solana Street and N Guadalupe Road in 2023 (before) and in 2026 (after).

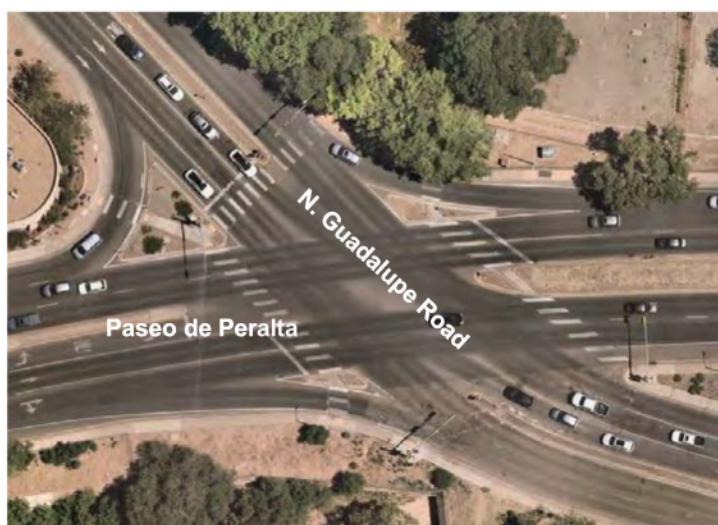
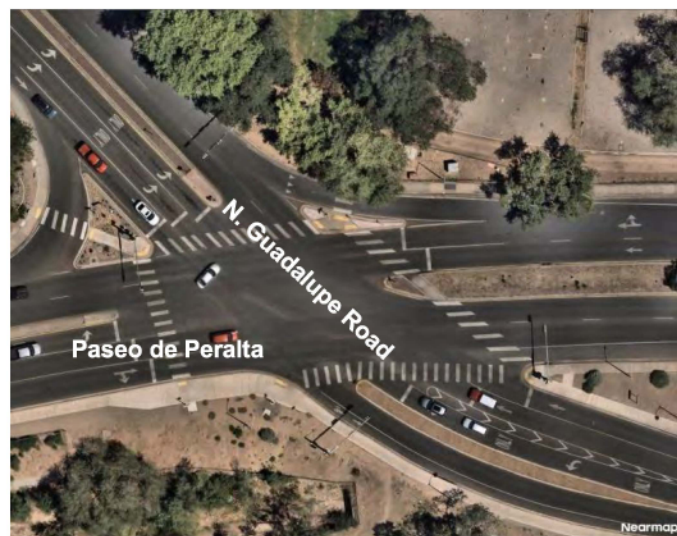
*After***Figure 7. Paseo de Peralta and N. Guadalupe Road**

At Paseo de Peralta, several improvements were implemented, including intersection modifications, extended medians, increased northbound left-turn storage, crosswalk reconfiguration, and signal upgrades specific to pedestrian equipment. These improvements addressed several crash, operational, crossing configuration, and signal infrastructure issues. However, multiple recommendations at this location were not implemented or require field verification, including Guadalupe median refuge islands, removal of a low-volume eastbound-to-northbound left-turn lane, bicycle accommodations, pedestrian signal visibility, and signal head placement. **Figure 7** provides aerial imagery for the intersection of Paseo de Peralta and N Guadalupe Rd in 2023 (before) and in 2026 (after).

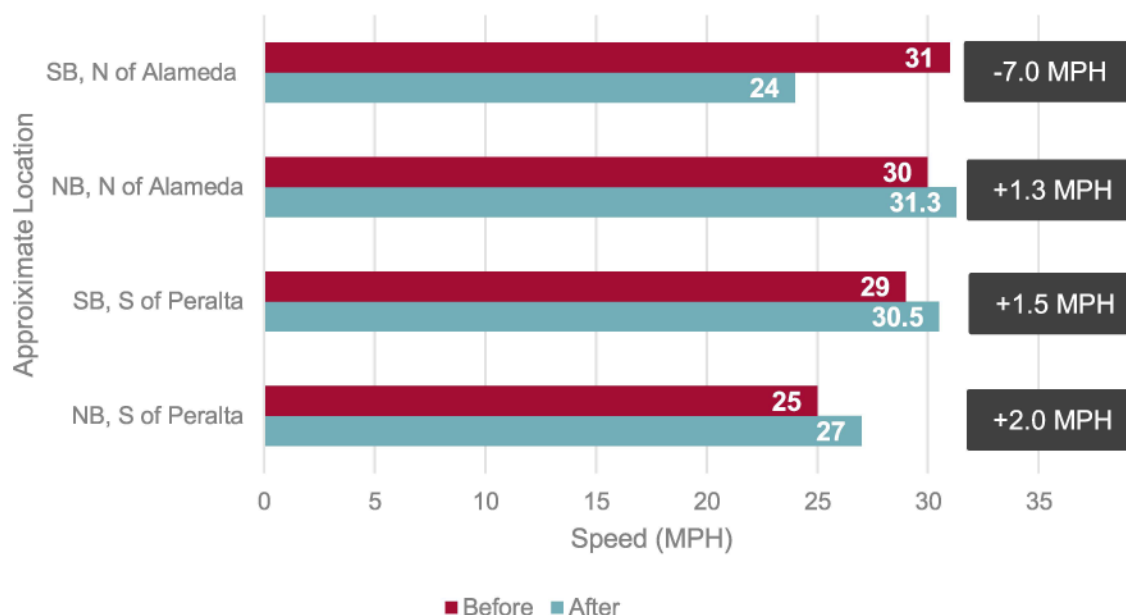
**Figure 21. Before and After Comparison of 85th Percentile Speeds**

**Figure 21** provides a before-and-after comparison of 85th percentile speeds for the data previously summarized in **Table 1** and **Table 4**. Overall, post-reconstruction vehicle speeds are generally consistent with, and in some locations marginally higher than the speeds documented in the 2014 RSA. The most notable decrease was observed north of Alameda Street in the southbound direction, where the 85th percentile speed decreased by approximately 7 mph and vehicles generally traveled below the posted 25 mph speed limit.

While the corridor generally operates as a lower-speed downtown street, most observed 85th percentile speeds remain slightly above the posted speed limit. These findings do not suggest a need for major reconstruction changes. However, they support targeted speed management treatments to further encourage speed compliance at specific locations.

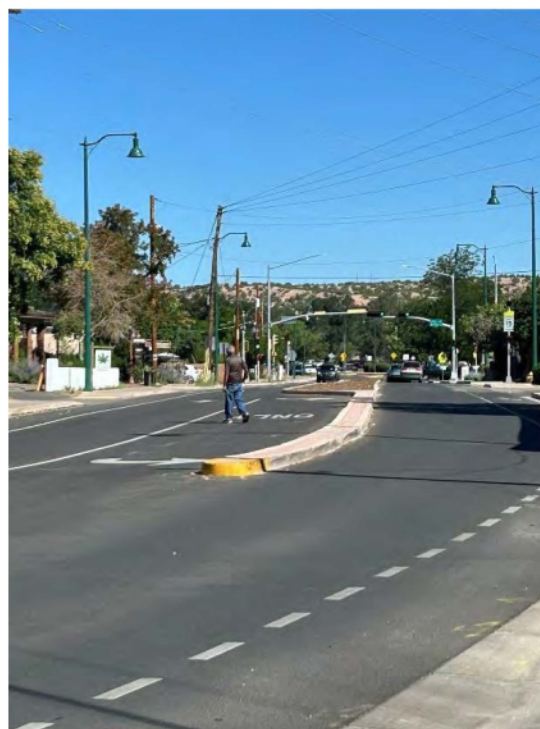
**Figure 23. Jaywalking Observed near Catron Street**
