Aviation Investigation Preliminary Report

Location:	Statesville, NC	Accident Number:	WPR26MA063
Date & Time:	December 18, 2025, 10:22 Local	Registration:	N257BW
Aircraft:	Cessna 550	Injuries:	7 Fatal
Flight Conducted Under:		Part 91: General aviation - Personal

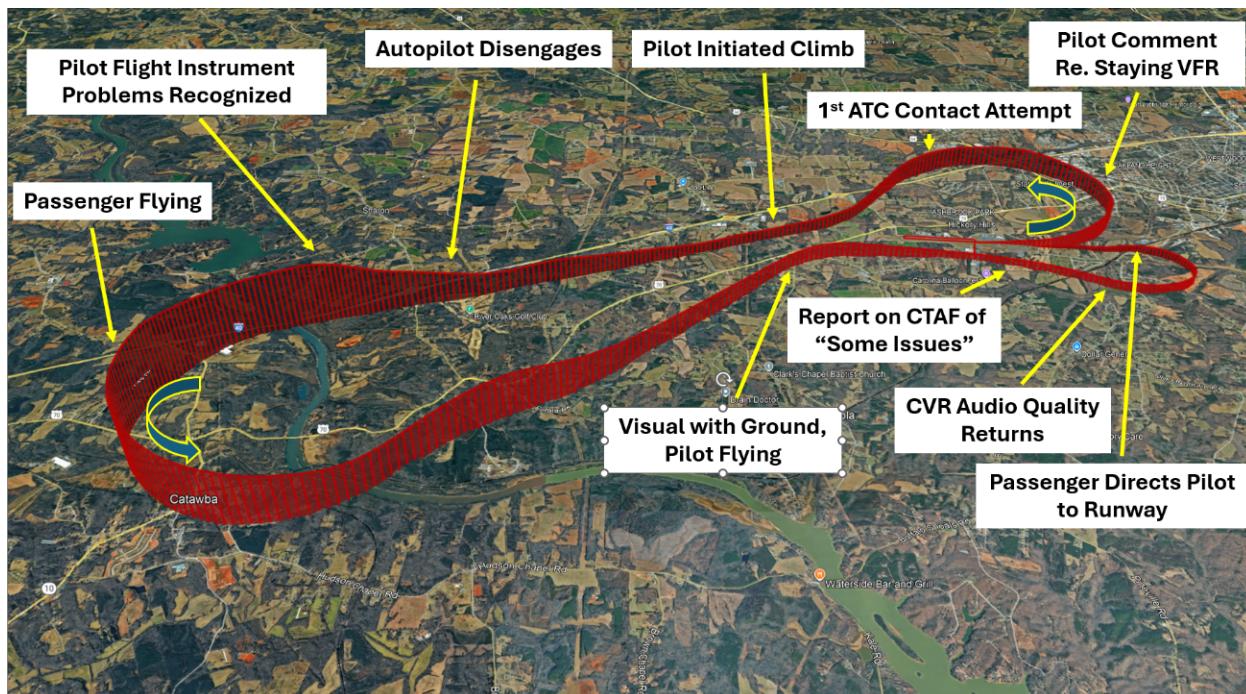
The airplane started a left turn (consistent with the base leg) towards runway 28 about 1014:10, at an altitude of about 1,325 ft and 142 kts groundspeed. The Garmin GTN-750 recordings of airspeed data returned at 1014:12. The GPS data showed the airplane rolled out of the turn onto runway heading about 1014:50, at an altitude of about 1,240 ft msl and 114 kts IAS. Recorded CVR audio indicated the right seat passenger visually acquired the runway and provided directions to the pilot as to where the runway was. About 1015:00, the pilot made comments which indicated he had acquired the runway visually.

Recorded data from the GTN-750 showed that the airplane's airspeed and altitude continued to decrease from the time the airplane was aligned on final approach to the runway until 1015:18, when the airplane was at 984 ft msl and 99 kts IAS. The airplane continued to descend to 942 ft msl until the CVR audio and GPS data ended at 1015:23. The IAS increased to 107 kts and then decreased to about 93 kts during the final five seconds of data. (See figure 1.)

Figure 1: Flight Path Overview with Sequence of Events

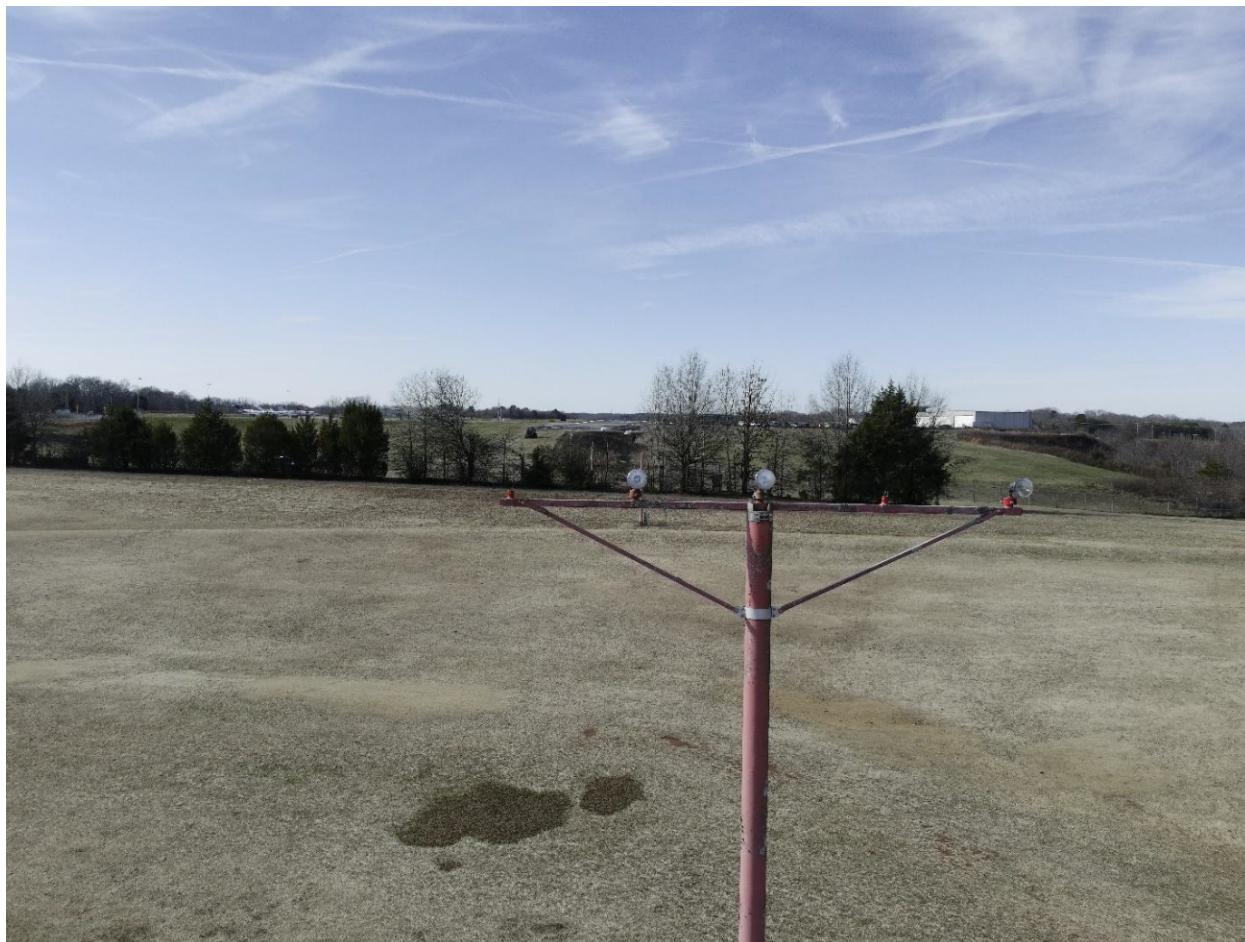
Examination of the accident site revealed that the first identified point of impact (FIPI) was the first (easternmost) light station of the runway 28 Medium Intensity Approach Light System with Runway Alignment Indicator Lights (MALSR), located about 1,380 ft from the runway threshold. Two lightbulbs, the left and fourth from the left position (when viewed looking towards the runway), approximately 6 ft apart, were separated from the otherwise intact 29 ft tall light station (figure 2) and located on the ground near the station. The upper portion of the second MALSR light station located about 180 ft from the FIPI was separated, of which about 15 ft of the frangible pole was still standing. A group of damaged trees located about 235 ft from the FIPI, were sheared about 12 ft above ground level (agl). The first indication of fire was blackened branches and grass near the west side of the trees.

A ground impression was observed about 350 ft from the FIPI, near the airport perimeter fence, and extended through the MALSR decision light station. The debris path continued along a westerly heading through the runway overrun to where the main wreckage came to rest on the runway blast area about 400 ft short of the runway 28 threshold, oriented on an easterly heading. Heavy charring of the ground began near the decision light station and continued along the remaining length of the debris field to the wreckage.

Figure 2: First Identified Point of Impact

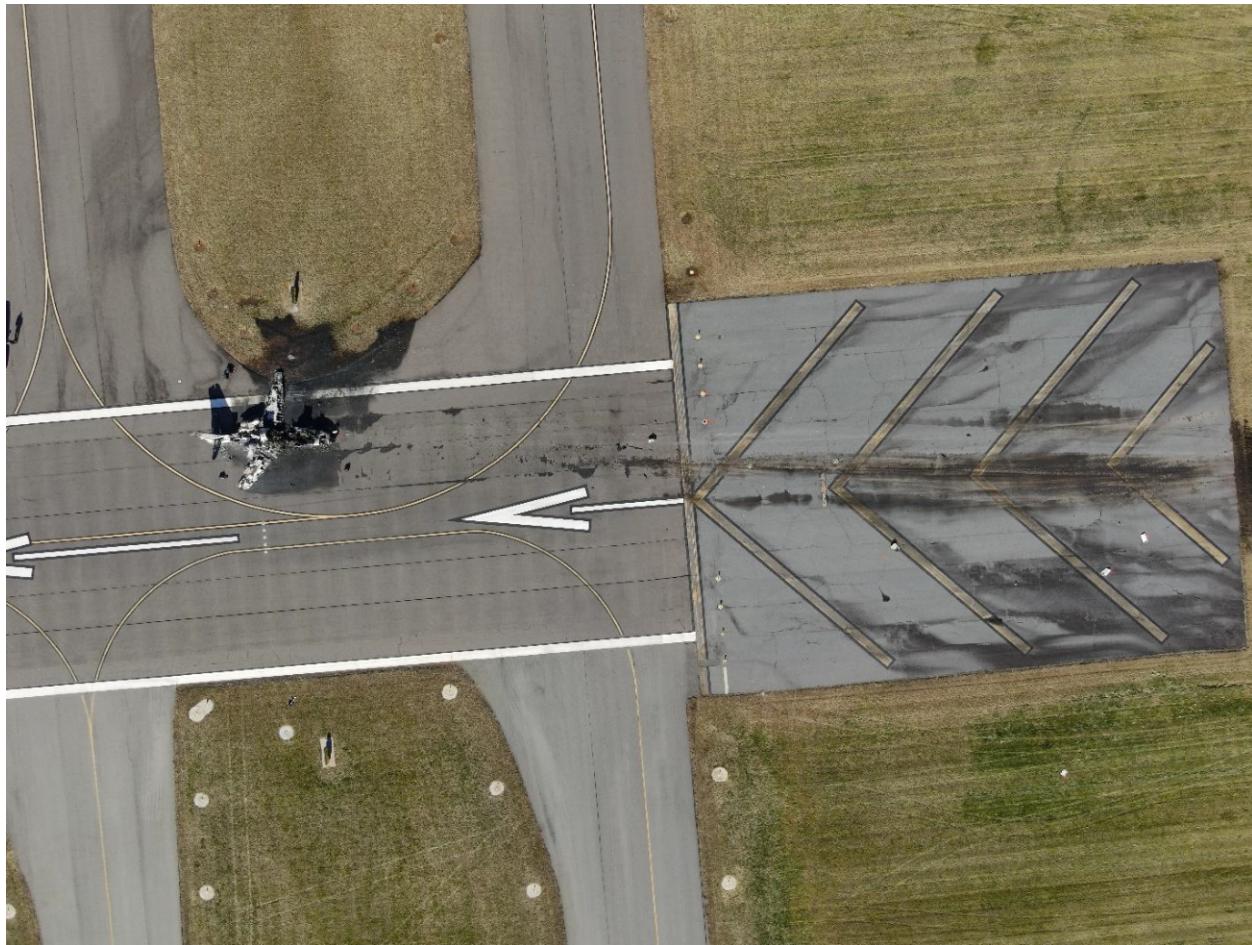
A post impact fire consumed a majority of the fuselage and heat damaged both wings, empennage, and both engines (figure 3). All flight control surfaces were identified in the debris path and main wreckage. No evidence of pre-impact separation of any airplane component or structure was observed.

Figure 3: Aerial view of the accident site.
