Field Investigation of Sinkhole Occurrences at the West Fork Tailings Dam, Impoundment ID No. 23-00409-04 Doe Run Company, West Fork Unit-Fletcher Mine, Mine I.D. No. 23-00409, Reynolds County, Missouri

REPORT NO. MW14-095

INVESTIGATION OF SINKHOLE OCCURRENCES  
DOE RUN COMPANY  
WEST FORK TAILINGS DAM  
IMPOUNDMENT I.D. NO. 23-00409-04  
FLETCHER MINE  
MINE I.D. NO. 23-00409  
REYNOLDS COUNTY, MISSOURI

SEPTEMBER 29, 2014

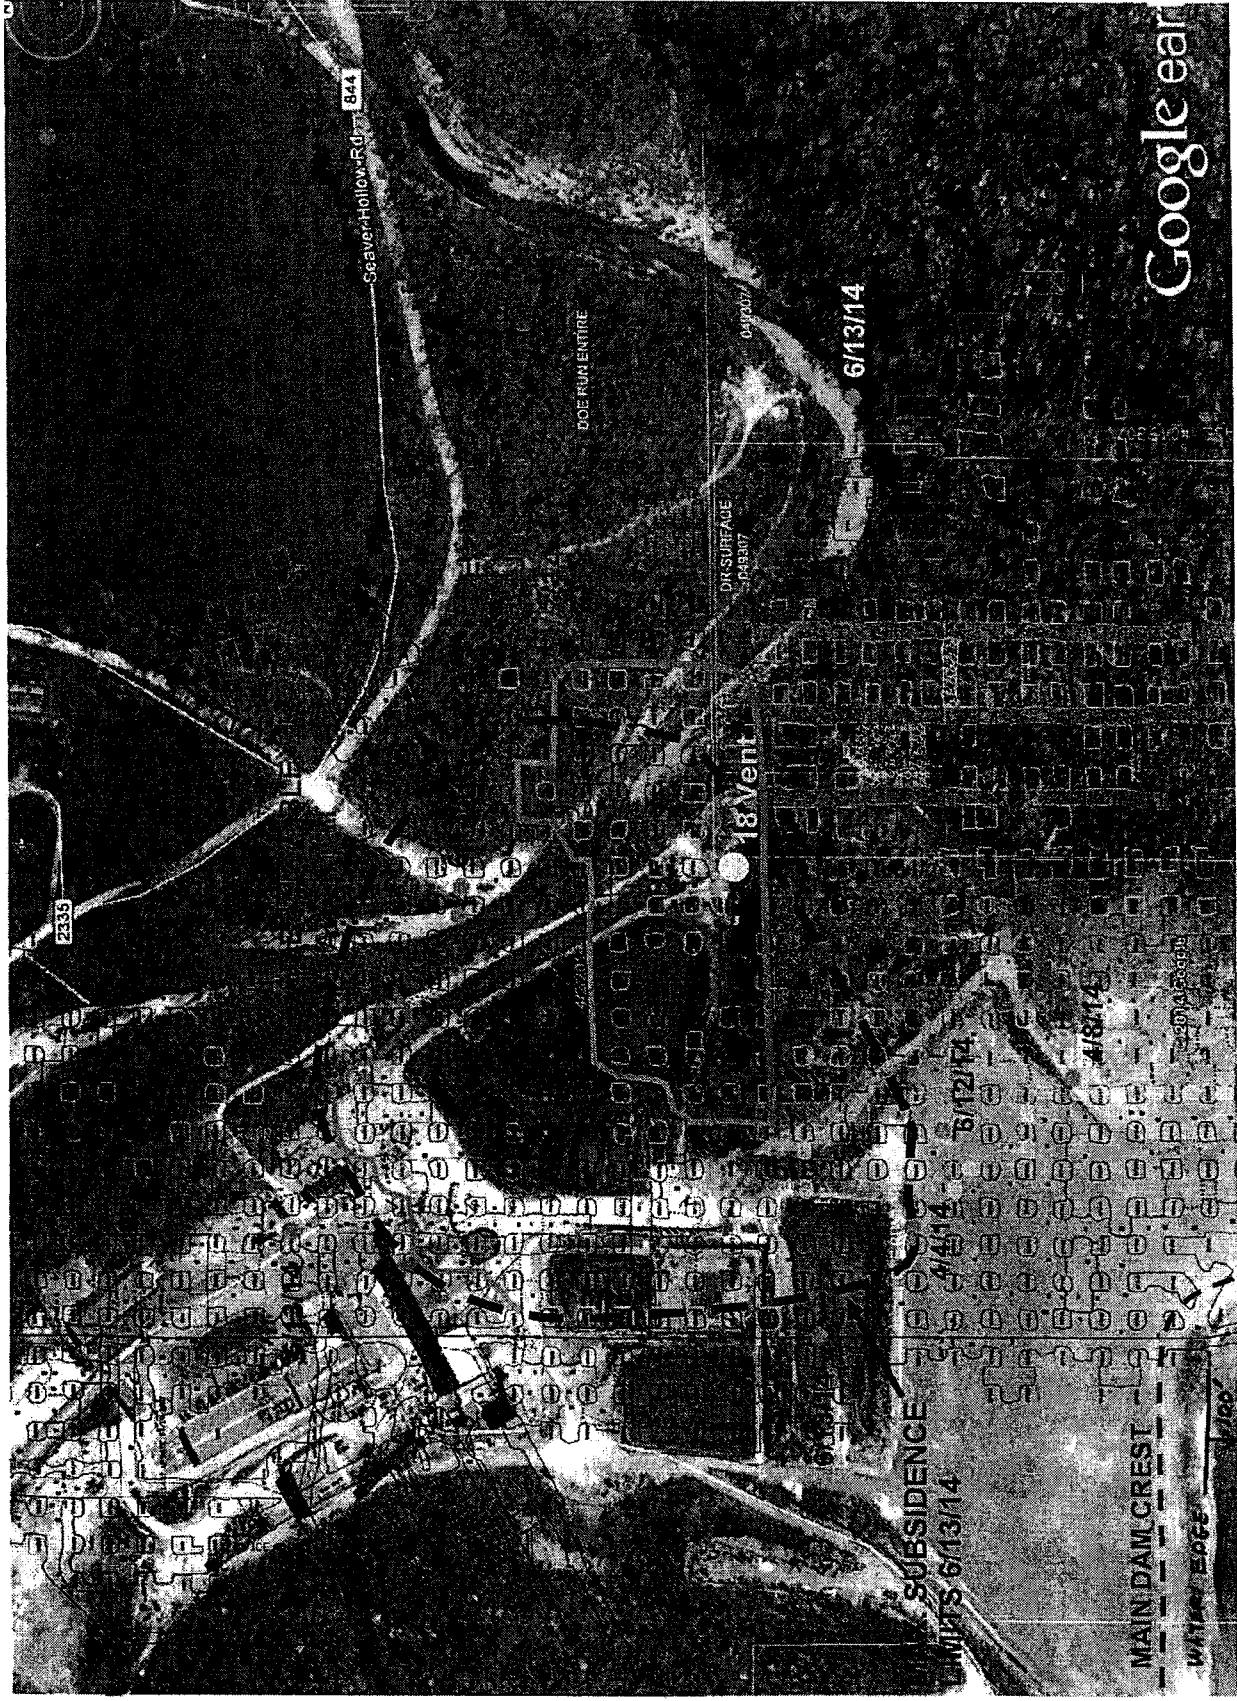
Figure 1 - Mine map overlay over aerial view of site, furnished by Doe Run. Red dots are sinkhole locations with latest date of appearance indicated.

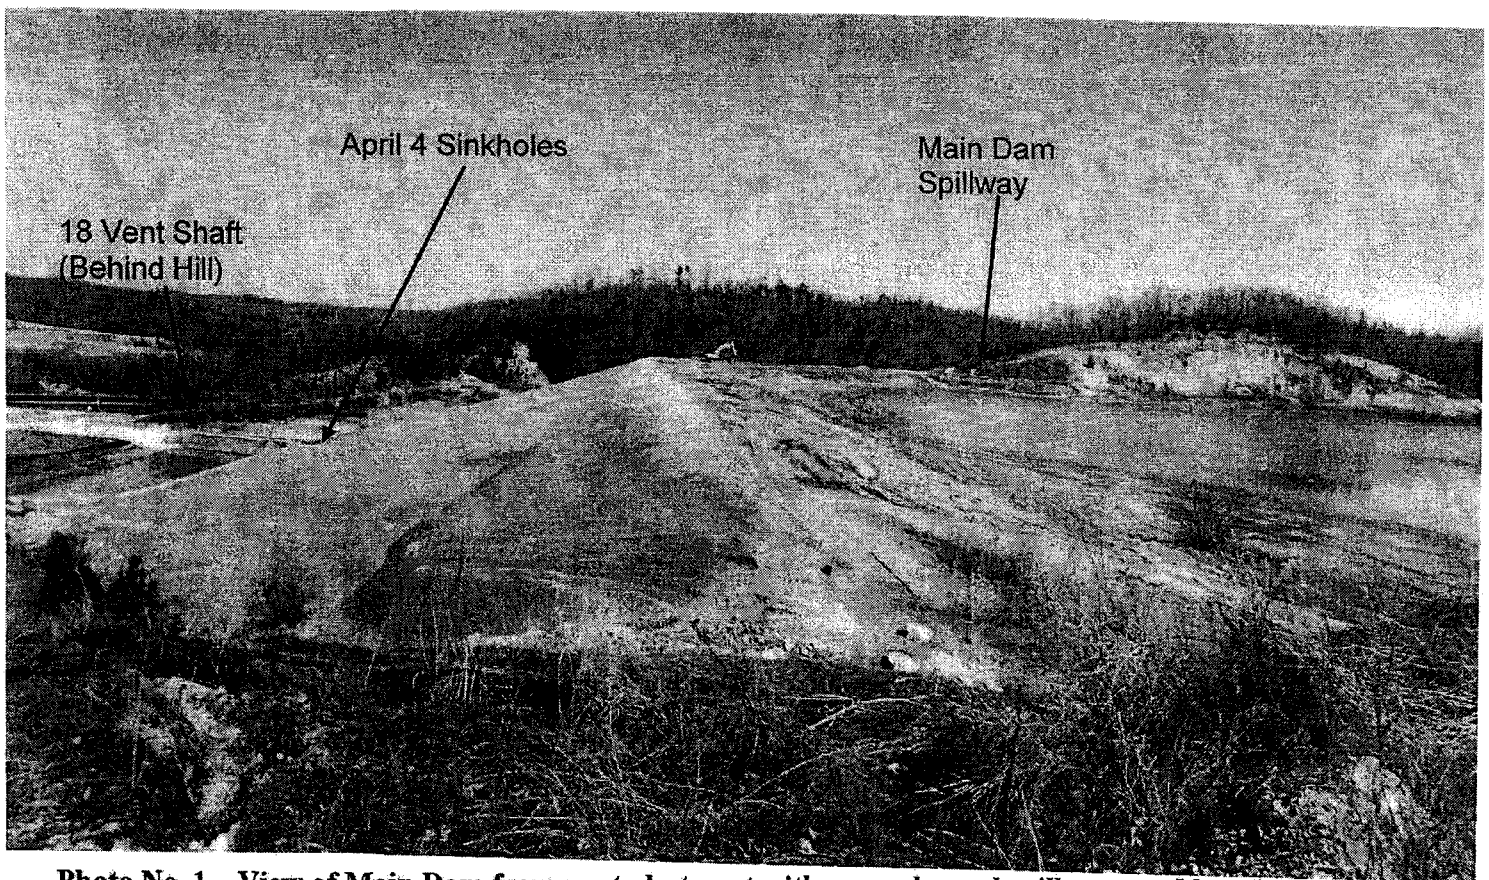
Following the sinkhole observations, a reconnaissance was made of the Main Tailings Dam, the Southeast Dam and the spillways. Photo No. 1 provides a view of the Main Tailings Dam from the left (west) abutment which is the opposite side end of the dam where the sinkhole activity was occurring. The dam is constructed from cycloned tailings consisting of fine to medium sized sand and some silt. Downstream slopes were a uniform 3H:1V (horizontal:vertical), except for a zone of about 2.75H:1V where the dam axis curves southward to join the topographic spur that

**Photo No. 1 – View of Main Dam from west abutment with open-channel spillways and location of sinkholes shown.**

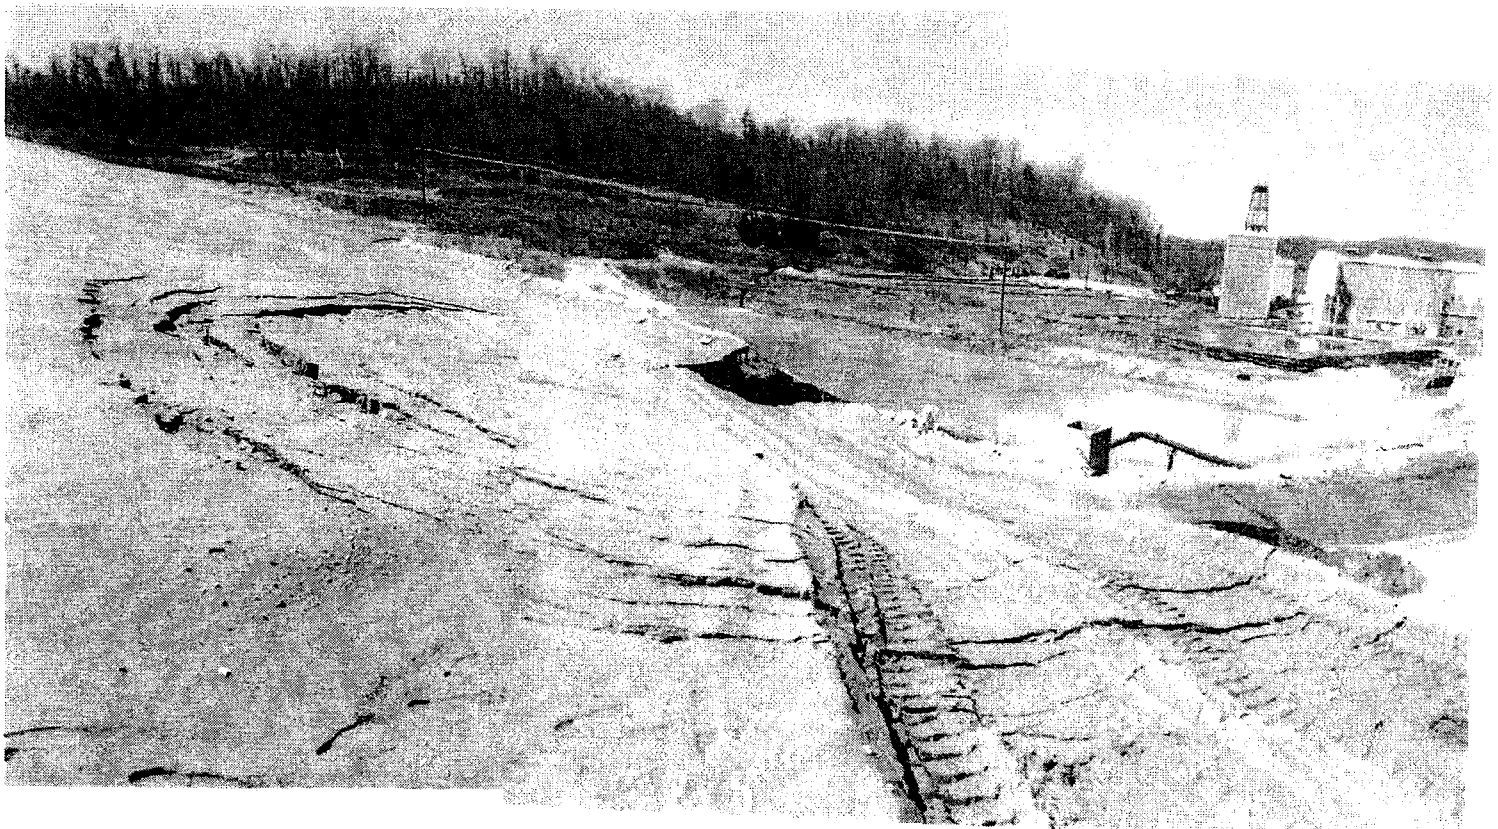
The sinkholes and an associated circular conical subsidence depression are shown on Photos Nos. 2 through 4. The sinkholes were both about 30 feet by 50 to 60 feet in least and greatest dimension respectively and about 18 feet deep. The holes were located on the northwest and northeast periphery of the circular depressed area which is bounded by surface cracks and small scarps about 150 feet in diameter. The materials exposed on the sinkholes were tailings in the upper parts of the hole and reddish-brown silty gravelly clay in the lower part. There was no evidence of water seepage or wet materials in the sinkholes.

**Photo No. 2 – Photo of sinkholes and depression that formed on April 4, 2014, taken on April 5, looking northwest. Note the muddy mine water discharge into pond with similar color as residual soil exposed on hill in background.**

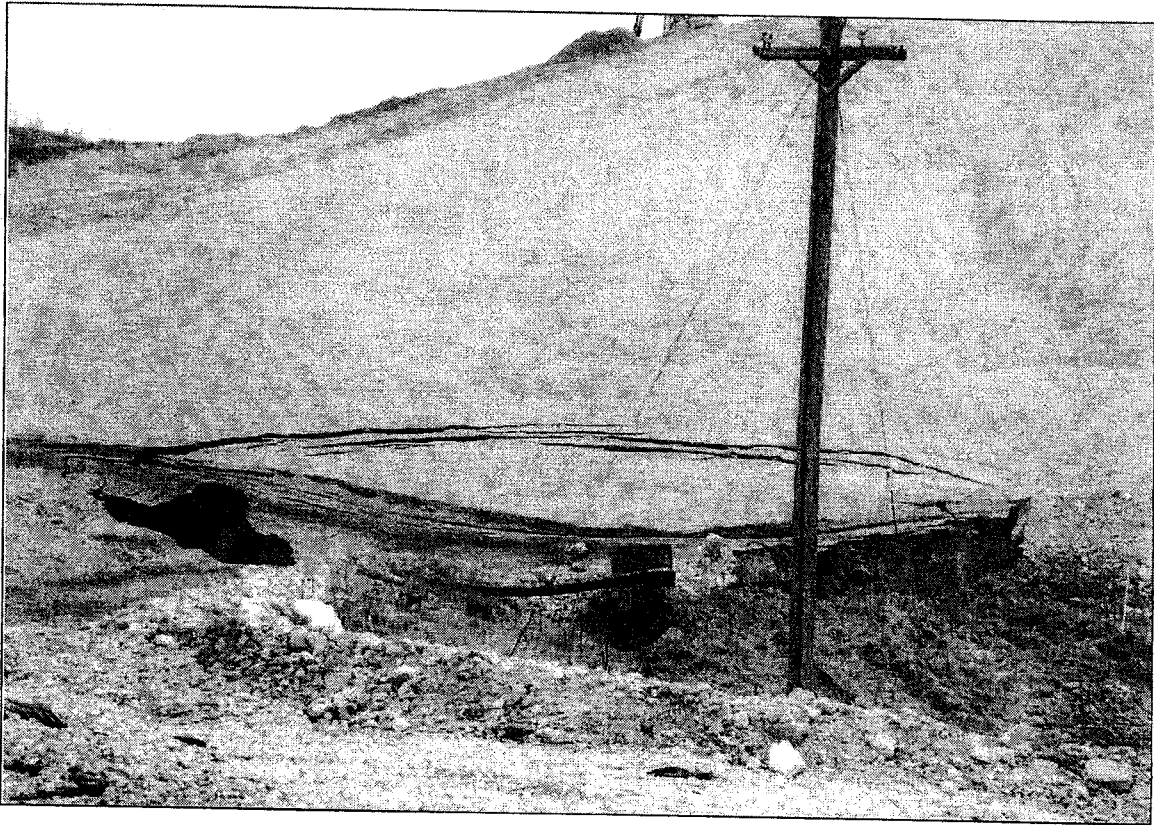
The sinkholes had changed very little from the previous day except for some collapses around the edges. The broad surface depression had deepened slightly and the cracks around the circumference of the depression had enlarged, as shown in Photo Nos. 3 and 4.

**Photo No. 3 – April 4 sinkholes and depression, looking south, photo taken on April 6.**

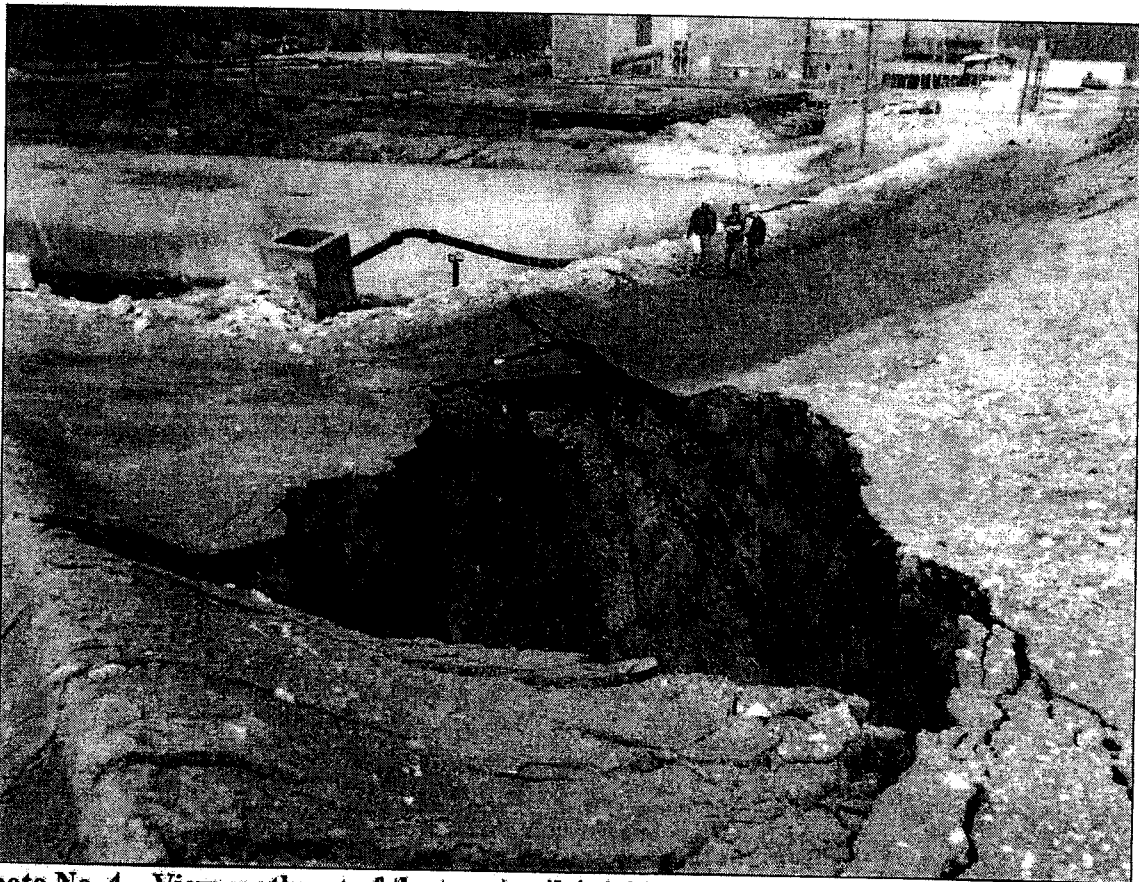
**Photo No. 4 – View southeast of the two April 4 sinkholes, photo taken late April 6.**

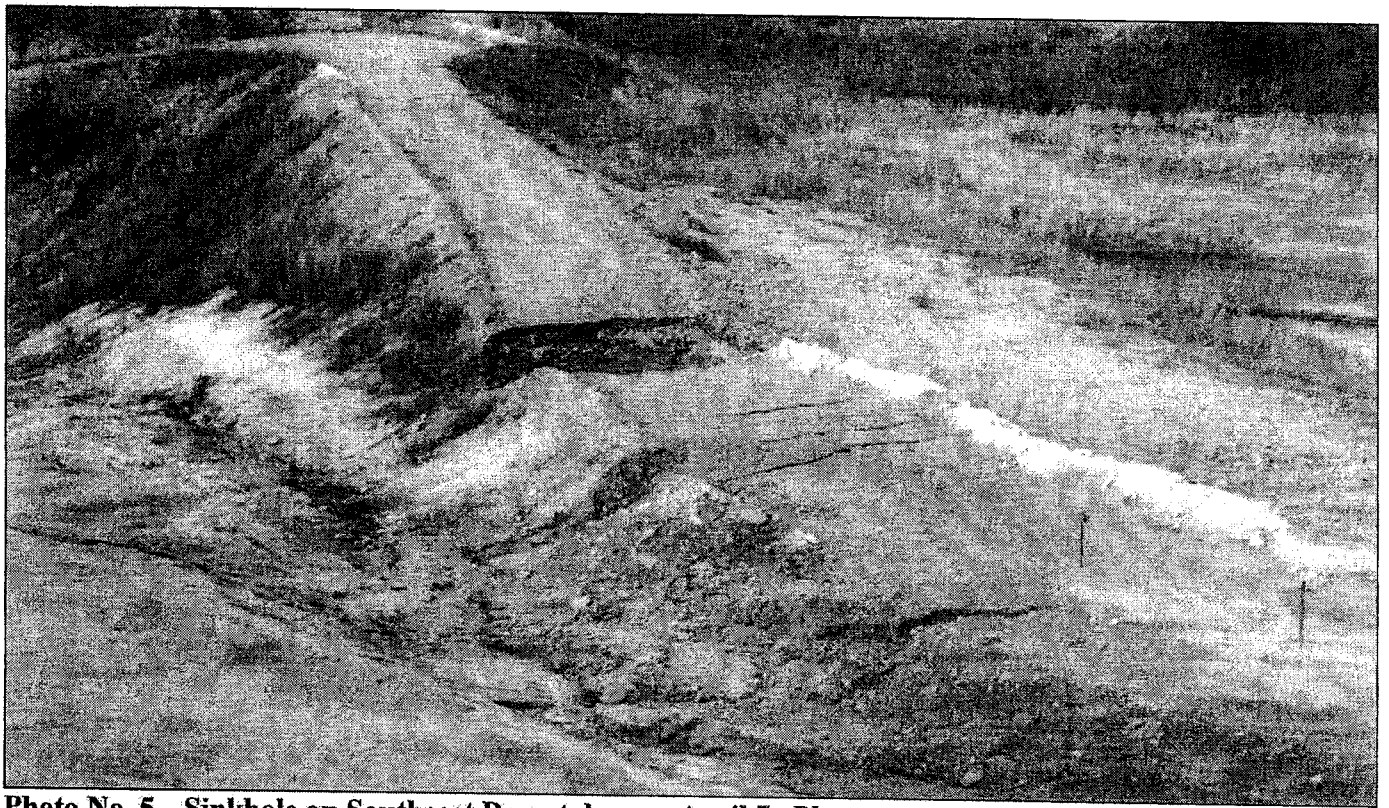
Following observations of ground cracking late on April 7, a sinkhole developed on the crest of the Southeast Dam crest overnight or on the morning of April 8. This sinkhole is shown in Photo No. 5. The sinkhole was 15 to 18 feet wide, up to 30 feet deep, and centered in a subsided area with tension cracks is visible in the photo.

**Photo No. 5 – Sinkhole on Southeast Dam, taken on April 7. Photo courtesy of J. Knudsen, Tierra Group**

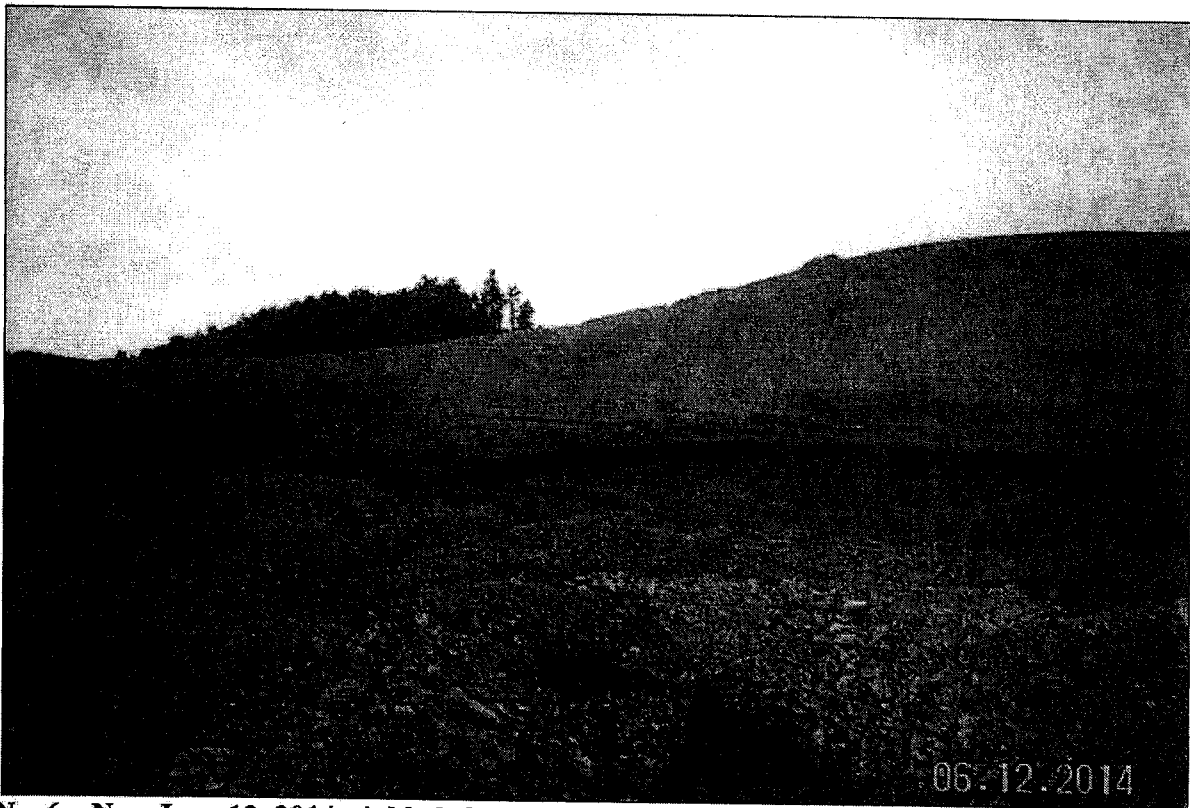
On June 12, Keith Markeson, Inspector, Rolla, Missouri, Field Office, reported a large new sinkhole near the previous April 4 sinkholes at the toe of the Main Dam. More significantly, a large area of surface subsidence had rapidly developed over a large area of the West Fork site. The subsidence area was bounded by tension cracking in the ground enclosing approximately 20 acres, as shown on Figure 1, although vegetation and ground relief made the northeastward extent of the subsidence uncertain. The subsidence was reported by Doe Run to be up to 6 feet in the vicinity of the finishing pond located between the mill building and the South Fork River, which ponded in the subsided area to form a slack pool against the toe of the east pond dike. Some foundation settlement and wall cracking was visible in the mill building. Mr. Markeson expanded the area under the 103(k) order to once again include the entire West Fork facility. With this subsidence, Doe Run reported that inflows into the mine increased by a significant amount with 12,000 gpm being pumped from the mine and water levels still rising in the now-large pool within the mine. The (b) (7) reported 8,000 gpm loss of stream flow from the South Fork from one side of the subsided area to the other.

**Photo No. 6 – New June 12, 2014, sinkhole located to southeast of filled April 4 sinkholes, note the linear tension cracks possibly associated with large area of subsidence formed on this date. Photo courtesy of Keith Markeson, MSHA.**

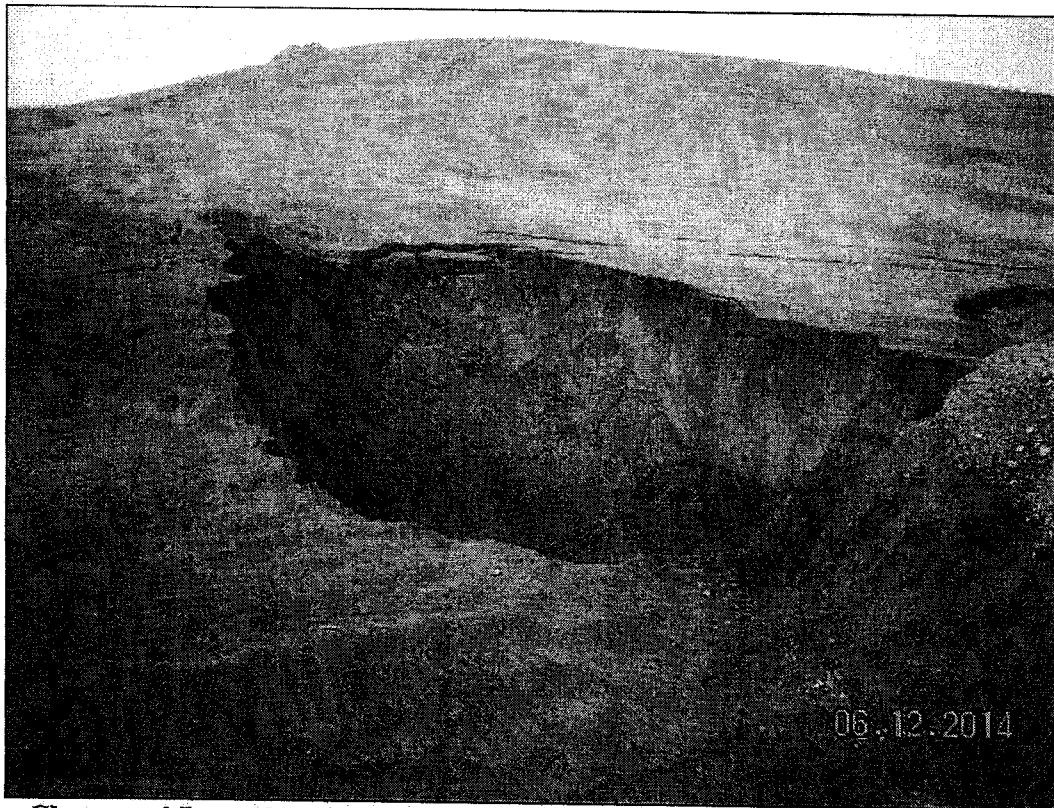
**Photo No. 7 – Closeup of June 12 sinkhole (left side of Photo No. 6). Photo courtesy of Keith Markeson.**

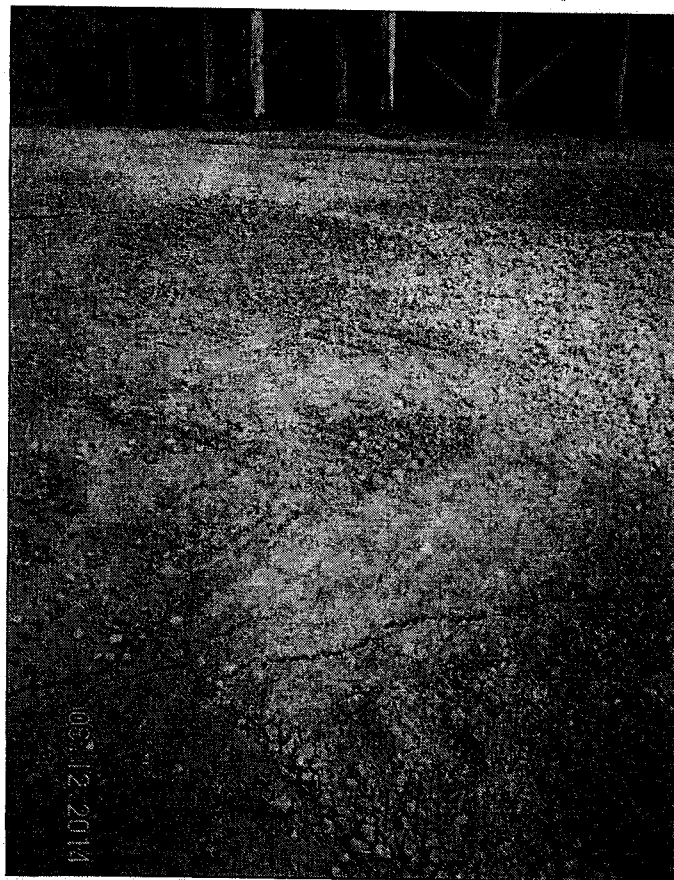
**Photo No. 8 – Ground cracking in periphery of subsided area adjacent to Mill Building, taken June 12, 2014. Photo courtesy of Keith Markeson.**
