**MISSOURI STATE HIGHWAY PATROL  
MISSOURI UNIFORM CRASH REPORT  
TECHNICAL SUPPLEMENT**

CRASH DATE 08/10/2018	SUPP RPT DATE 10/10/2018	TRP / DIST / PCT C	COUNTY St. Louis (095)	REPORT / CASE / INCIDENT NUMBER 180491040
SUPPLEMENT REPORTING OFFICER Sgt. Paul J. Kempke		DSN / BADGE 982	SUPPLEMENT REVIEWING OFFICER Sgt. J. A. Mulkey	
			DSN / BADGE 1186

**Synopsis:**

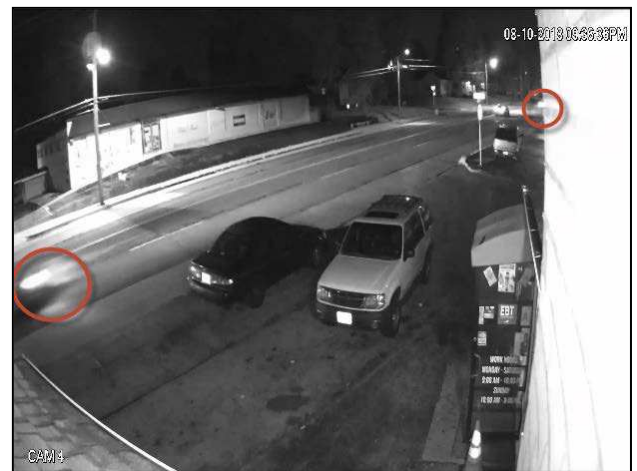
The earliest view of the St. Louis County Police Vehicle and the Hyundai was from Jenny Market, 929 Airport Road. The Hyundai enters into view of the camera at 09:36:33.33. The police car comes into view at 09:36:36.33. At one point, both vehicles are on the screen. The gap between the vehicles was approximately 3 seconds.

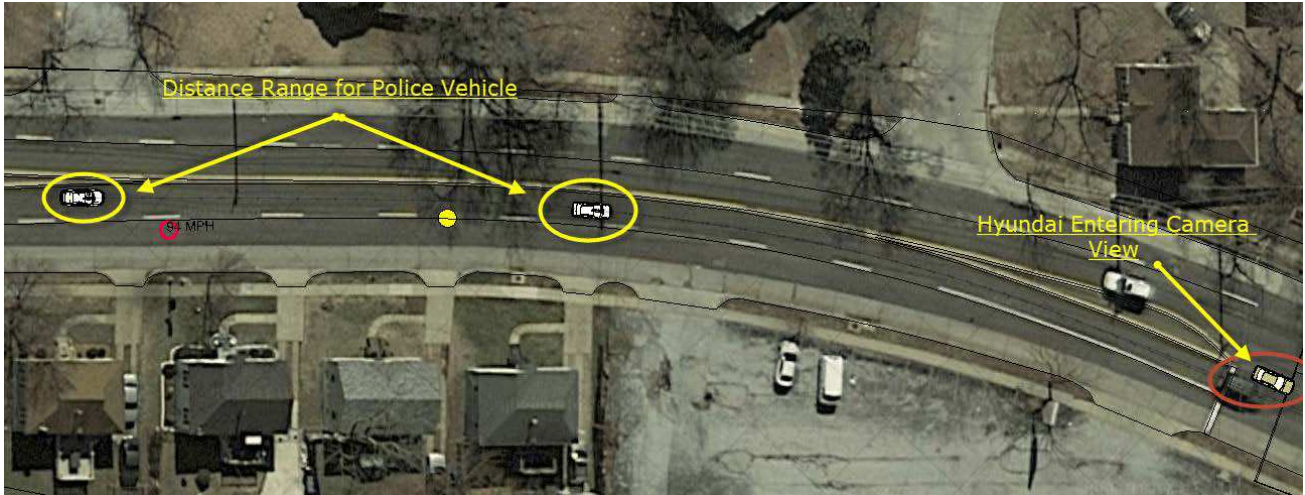
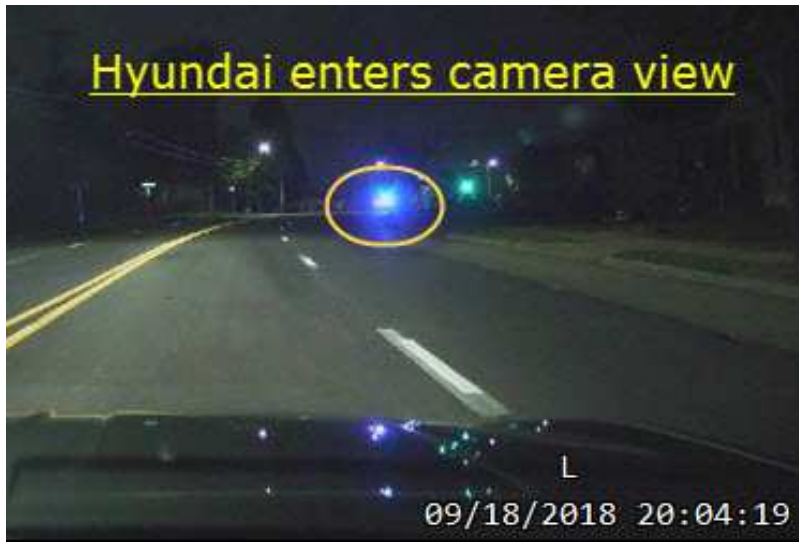
The first snapshots depict the location and view from a vehicle when another vehicle is entering into the view of the Airport Elementary School camera.

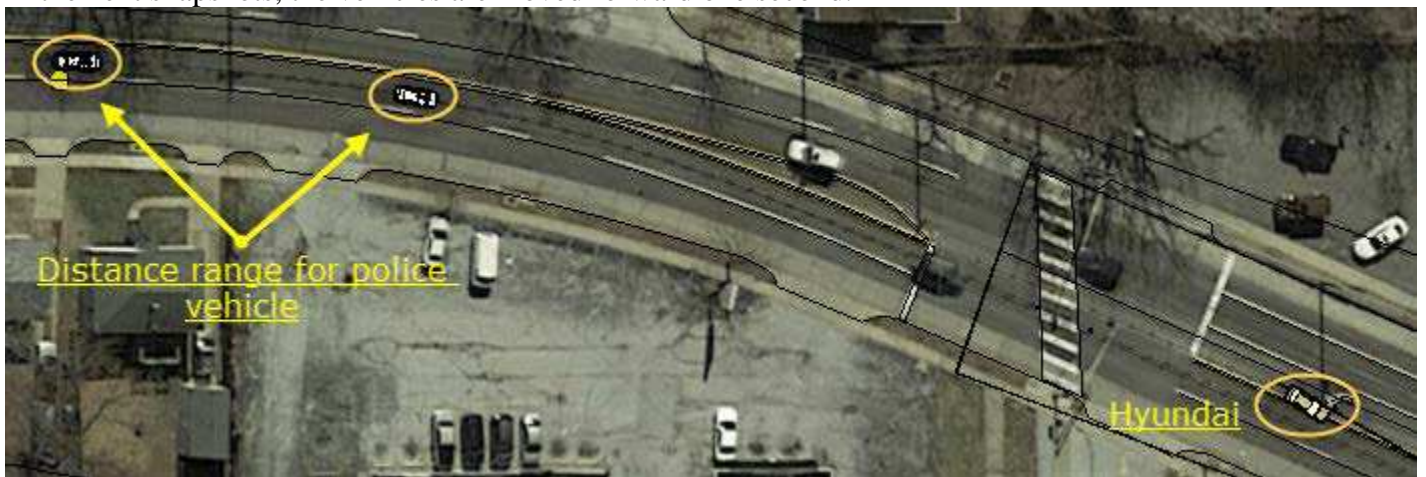
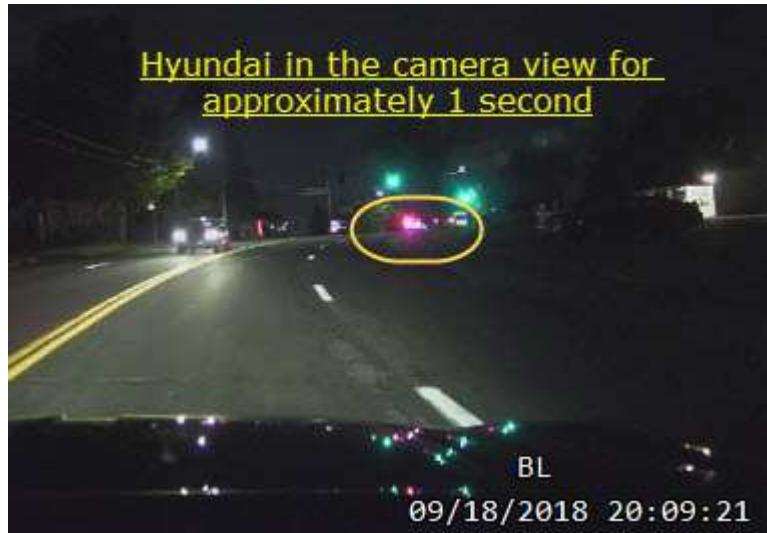
In the next snapshots, the vehicles are moved forward one second.

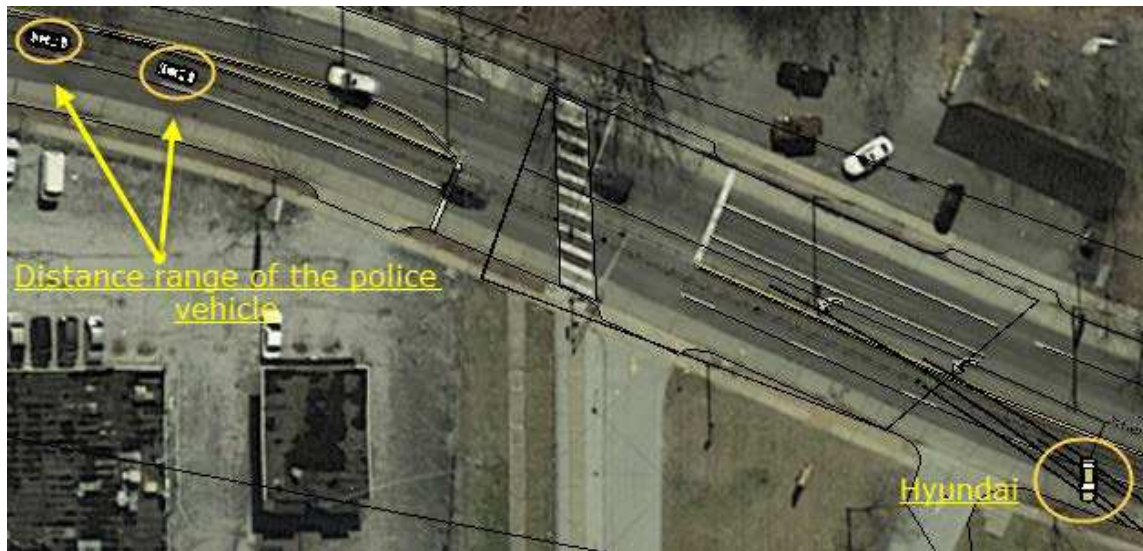
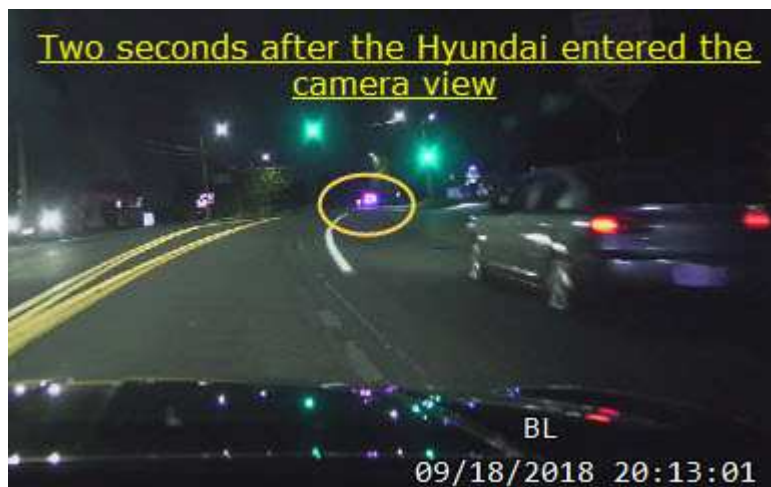
In the next snapshots, the vehicles are moved forward another second.

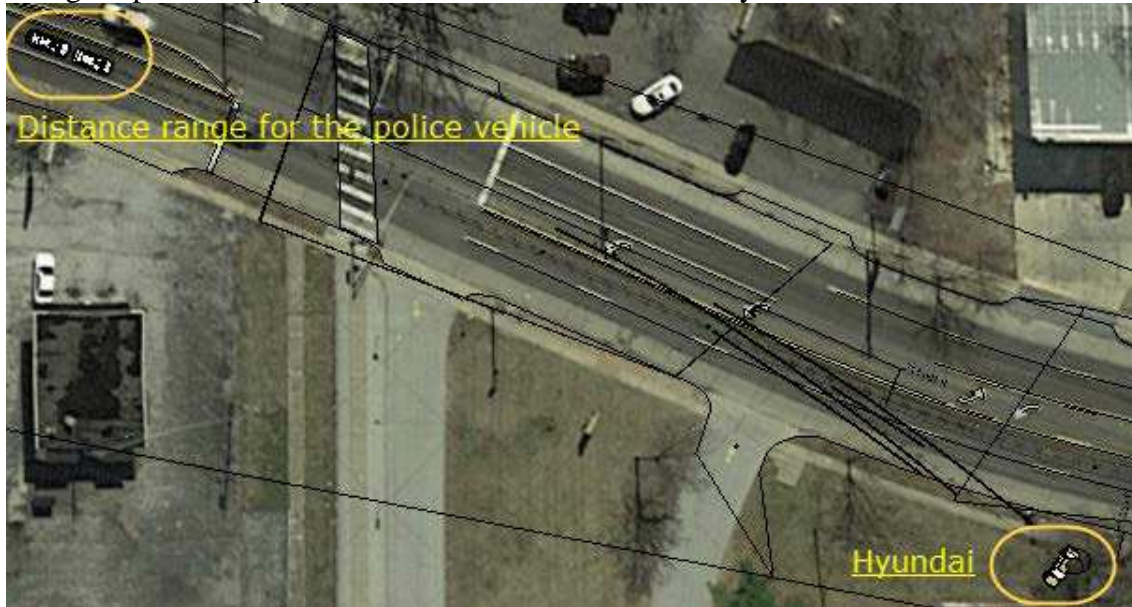
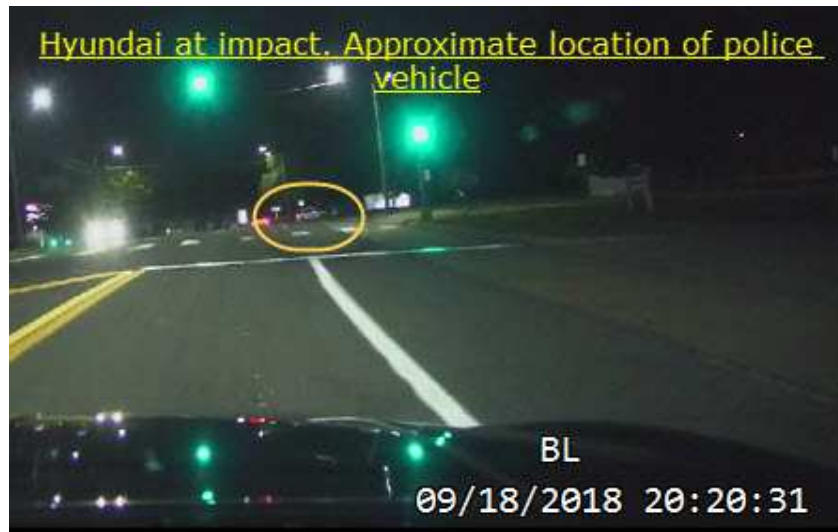
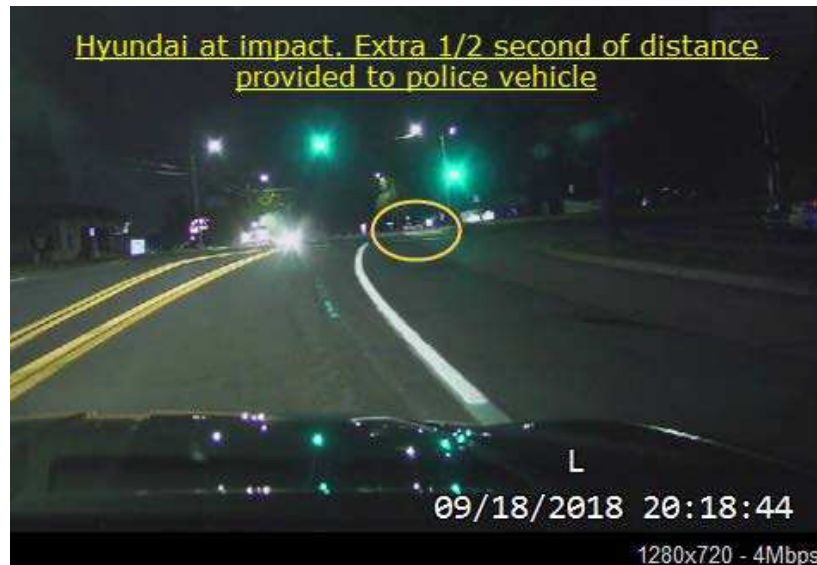
The following snapshots depict the vehicles locations when the Hyundai strikes the tree.

Prior to striking the tree, the Hyundai entered into a critical speed yaw. A critical speed yaw is a maximum performance maneuver. The only way a vehicle enters into a critical speed yaw is through the application of an inappropriate steering input (Fundamentals of Traffic Crash Reconstruction, Daily, Shigemura, Daily). There was evidence the driver may have been braking and steering into the skid. While this may affect the critical speed, my calculated speed is within two miles per hour of the speed calculated from the video. There are a couple of possible reasons why the Driver of the Hyundai steered inappropriately. The mapped tire marks indicated the Hyundai was over the centerlines, on the wrong side of the road, when it was yawing. It also appears the Hyundai was rapidly closing in on a vehicle prior to the driver losing control. There was no evidence indicating the Hyundai was "pitted" or otherwise made contact with the St. Louis County Police vehicle prior to entering into the yaw.
