# Inspection Report

## General/Annual Inspection Inspection Result

| Address | Suite | City | State | Zip |
|---|---|---|---|---|
| 3111 S 31ST ST | Temple Mall<br>Master | TEMPLE | TX | 76502 |
| 3111 S 31ST ST TEMPLE MALL<br>MASTER, TEMPLE, TX, 76502 | | Temple Mall | This inspection report is provided to help clean-up previous inspection reports without losing historical data. Violations are listed in order of acuity - Low, Moderate, High. | |

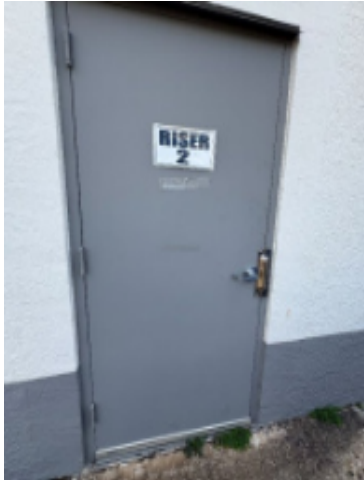
8/24/2026- Knox box needed for each riser room.

Riser 2 Knox Box Needed

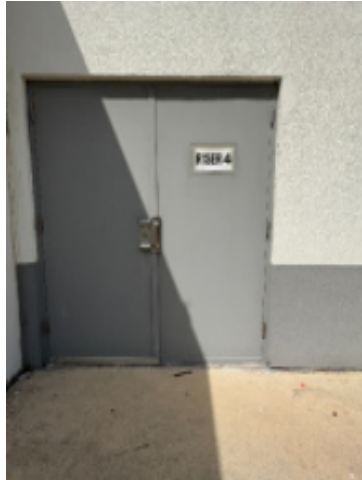
Riser 4 Knox Box Needed

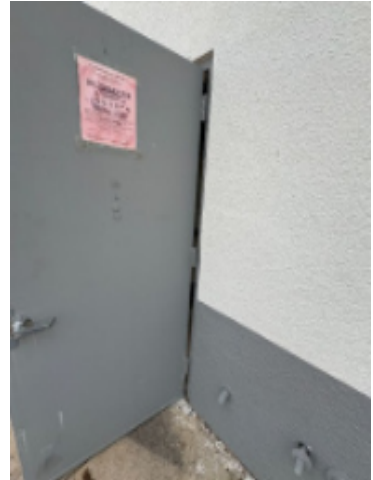
Riser 3 Knox Box Needed

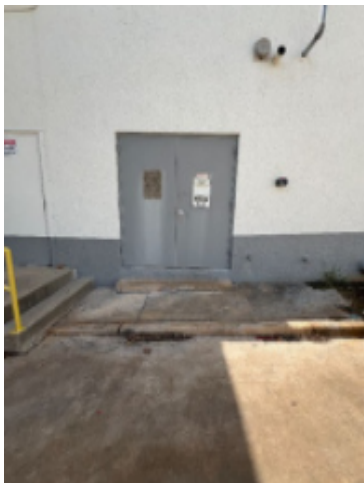
Pump Room Knox Box Needed.

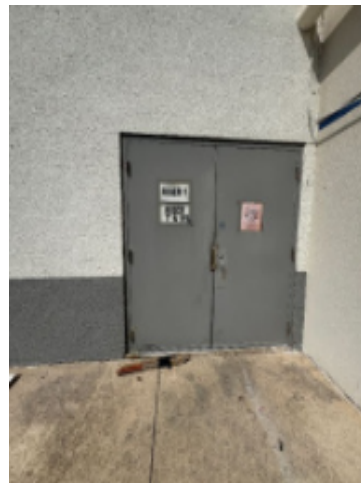
Riser 1 Knox Box Needed

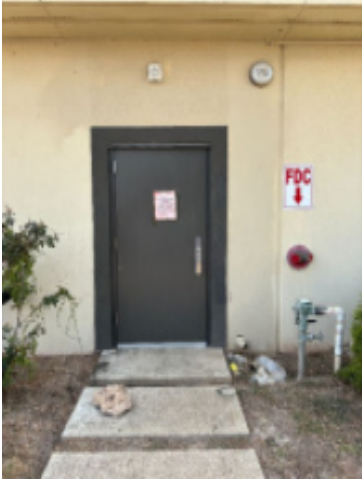
Vacant JC Penney's Riser Knox Box Needed

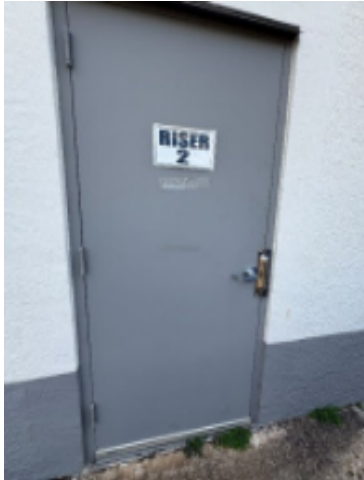
8/24/2026- Riser 1, 2, 3, 4, 5, 6 and Fire Pump Room needs identification signage. Permanent metal signs are required to meet compliance as the code states, "shall be constructed of durable materials, permanently installed and readily visible."

Riser 2 Signage Needed

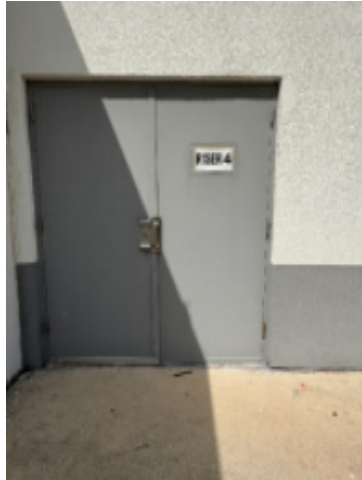
Riser 4 Signage Needed

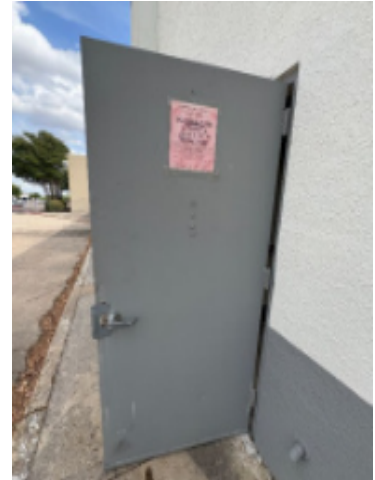
Riser 3 Signage Needed

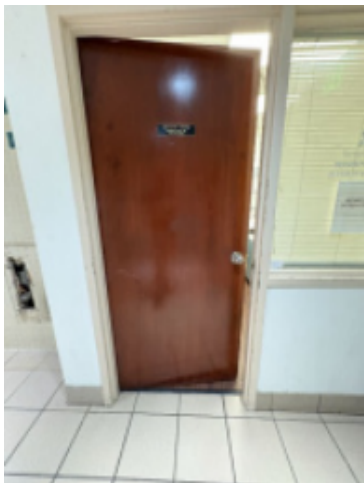
-Office that houses FACP needs signage placed on doorway.

FACP signage on office door

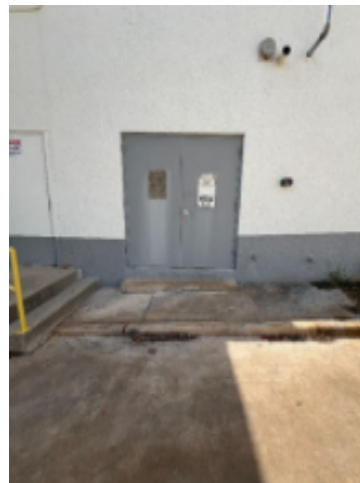
Pump Room Signage Needed

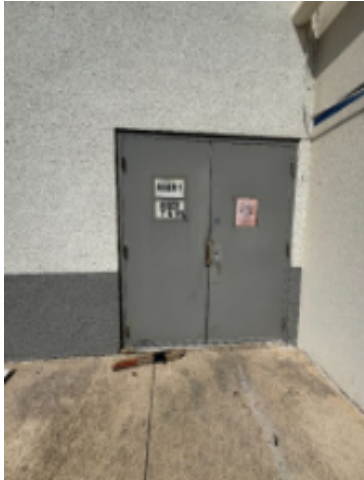
Riser 1 Signage Needed

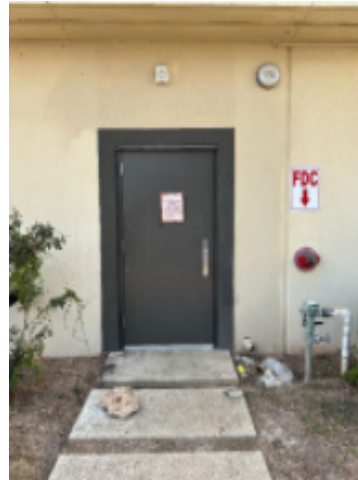
Vacant JC Penney's Riser Signage Needed

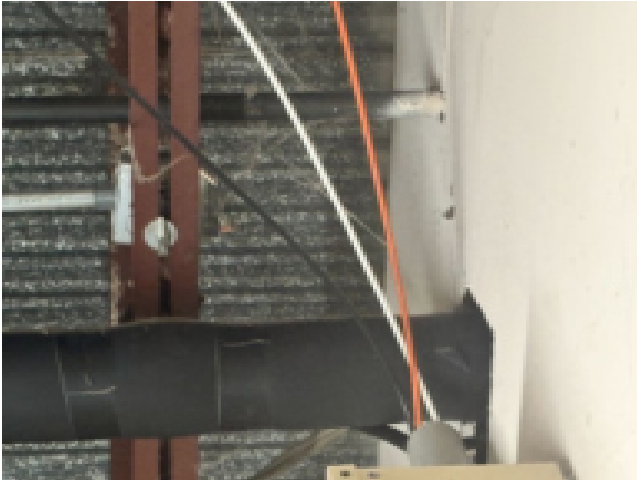
Extension cord in use as permanent wiring.

Extension cord in service hallway

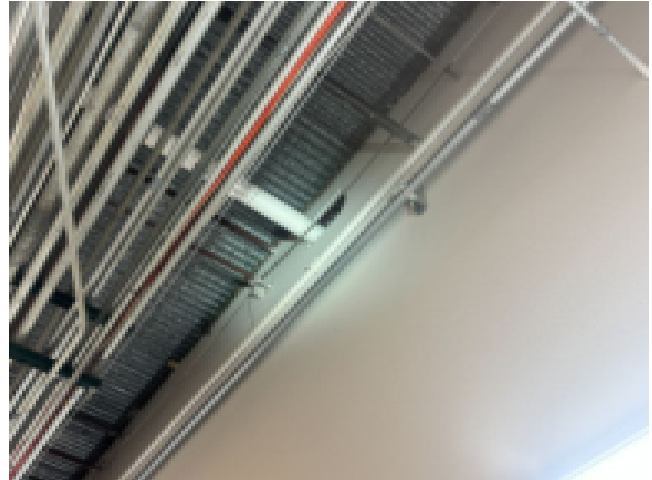
Extension cord in service hallway

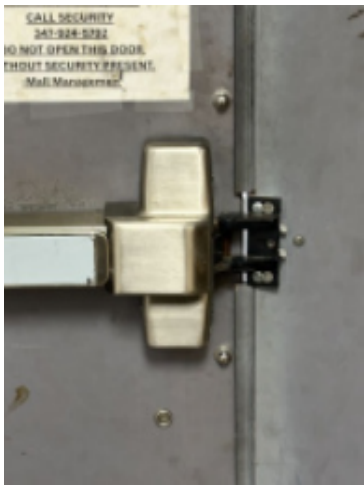
Exit door not operable near Riser 1

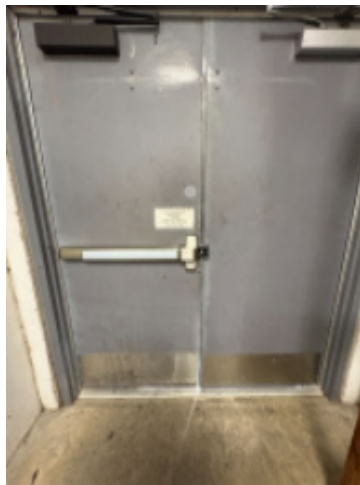
Exit door not operable near Riser 1

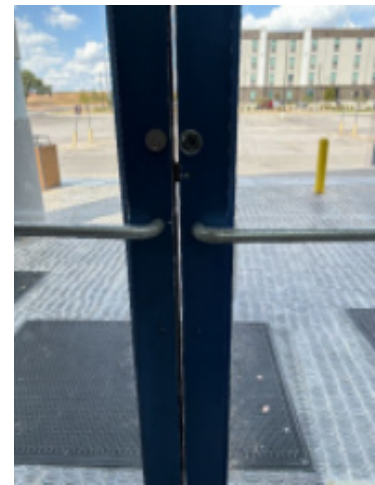
Exit door at North Entrance not operable.

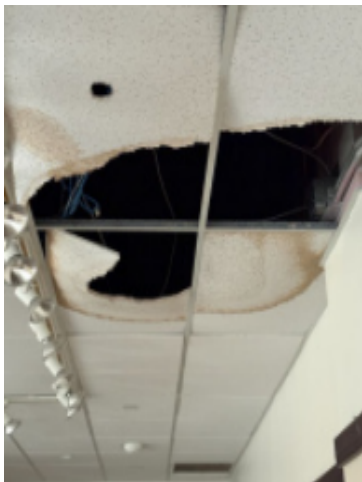
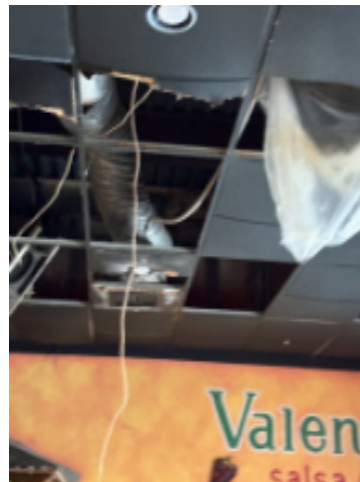
9/18/2026---Missing ceiling tiles and sheetrock throughout building.

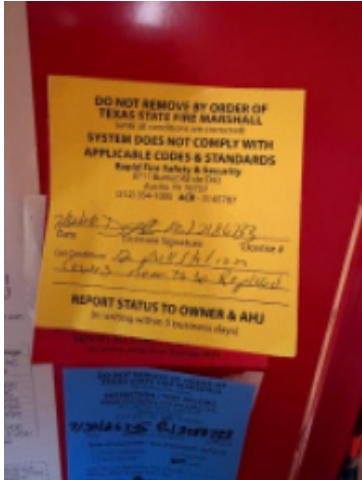
Cinema FACP is yellow tagged

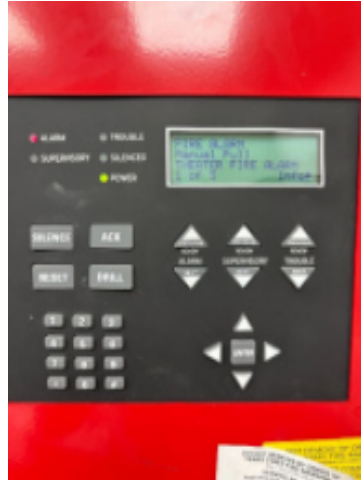
FACP has active alarms

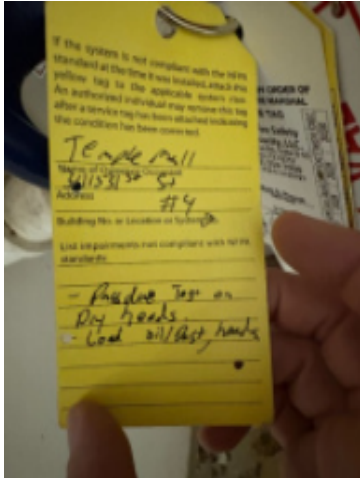
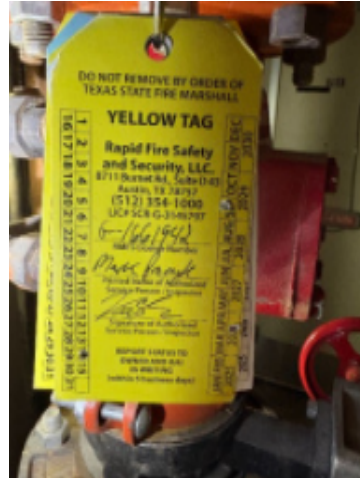
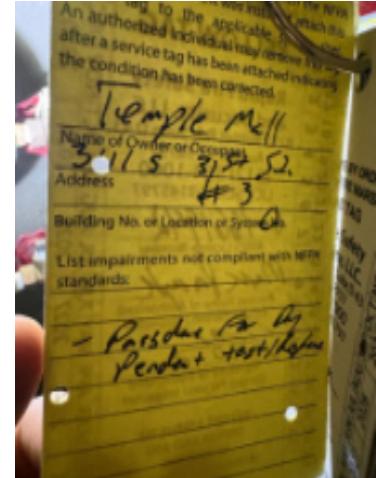
Riser 3 Yellow Tagged

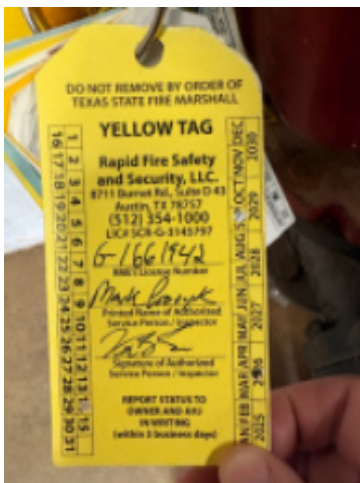
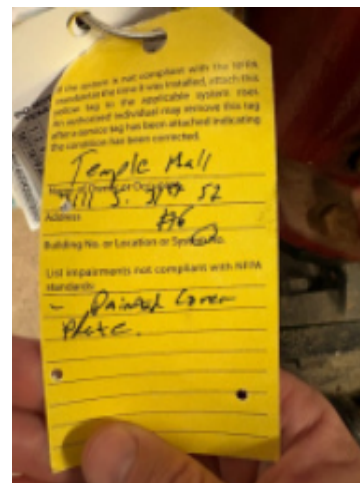
Riser 6 Yellow Tagged

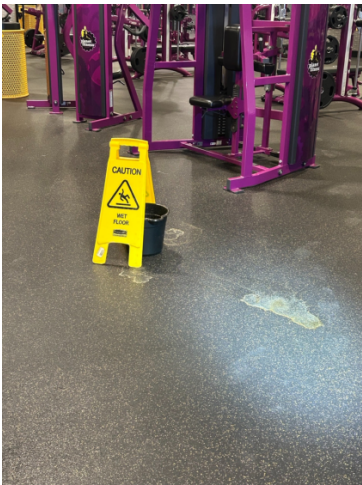
During the inspection, staff observed multiple roof leaks in Planet Fitness, the main mall area, Casa Ola, and numerous other tenant units across the mall. The observations indicate that water intrusion remains an ongoing issue in several areas of the property.

Photo 1 - Planet Fitness: bucket and wet-floor warning near exercise equipment.

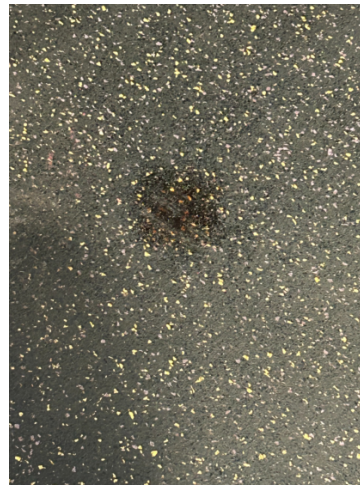
Photo 2 - Darkened area on flooring.

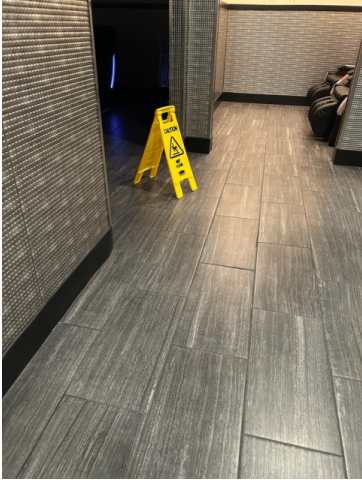
Photo 3 - Wet-floor warning in an interior circulation area.

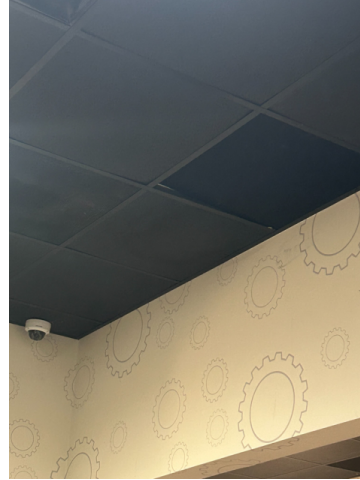
Photo 4 - Interior ceiling with an open ceiling panel area.

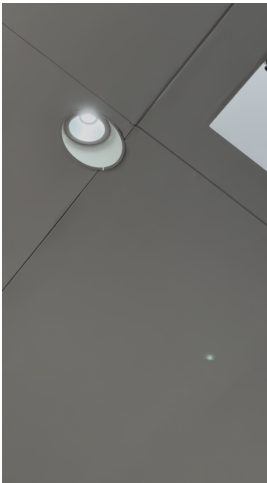
Photo 5 - Interior ceiling and recessed light.

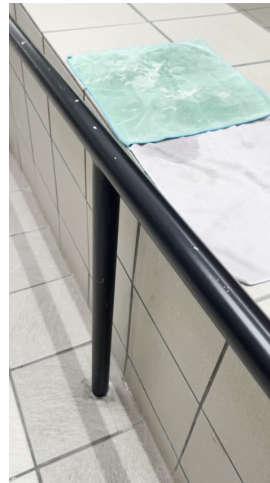
Photo 6 - Still from IMG\_0426.mov showing towels on an interior surface.

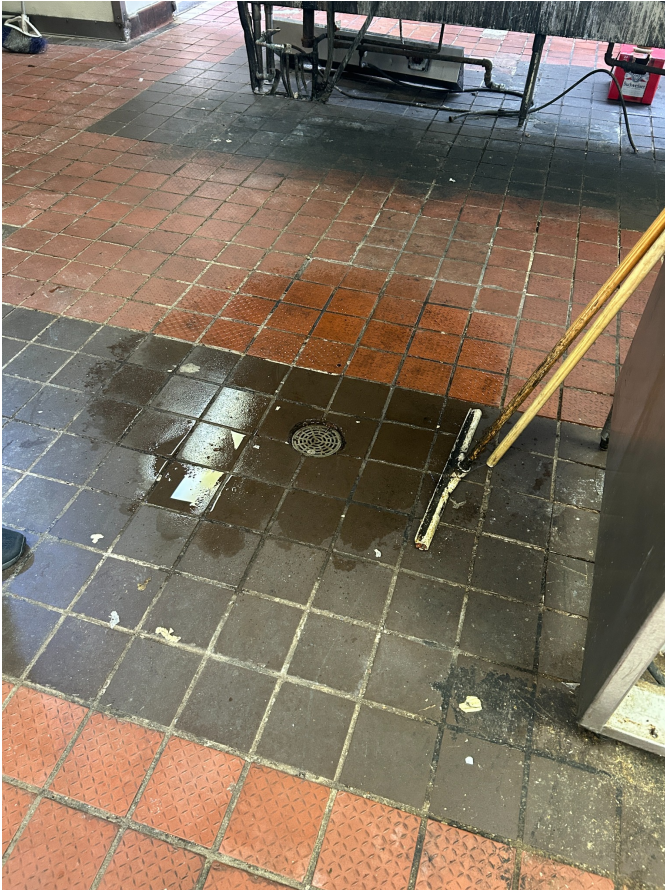
Photo 7 - Water on the tiled floor around a floor drain.  
Source: IMG\_2639.JPEG.

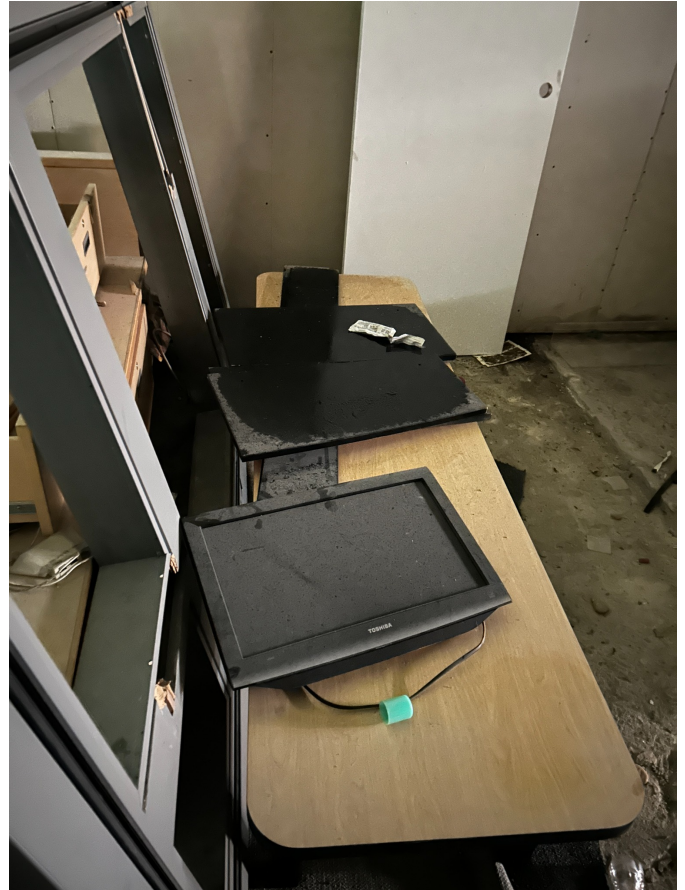
Photo 8 - Moisture visible on equipment and surfaces in an interior storage area. Source: IMG\_2643.JPEG.

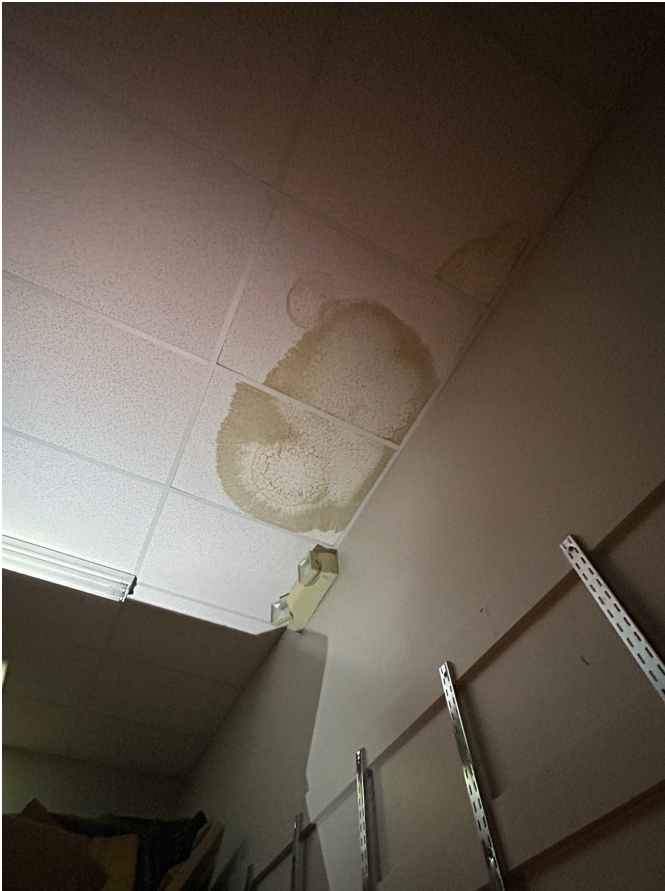
Photo 9 - Staining across ceiling tiles near lighting and an emergency light. Source: IMG\_2648.JPEG.

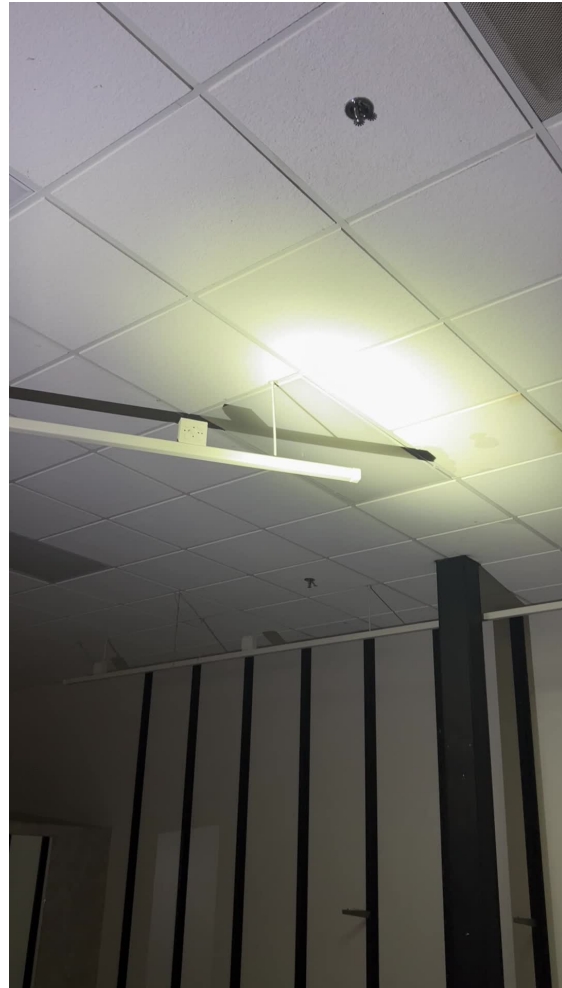
Photo 10 - Video still showing ceiling tiles and light fixtures. Source: IMG\_2644.MOV.

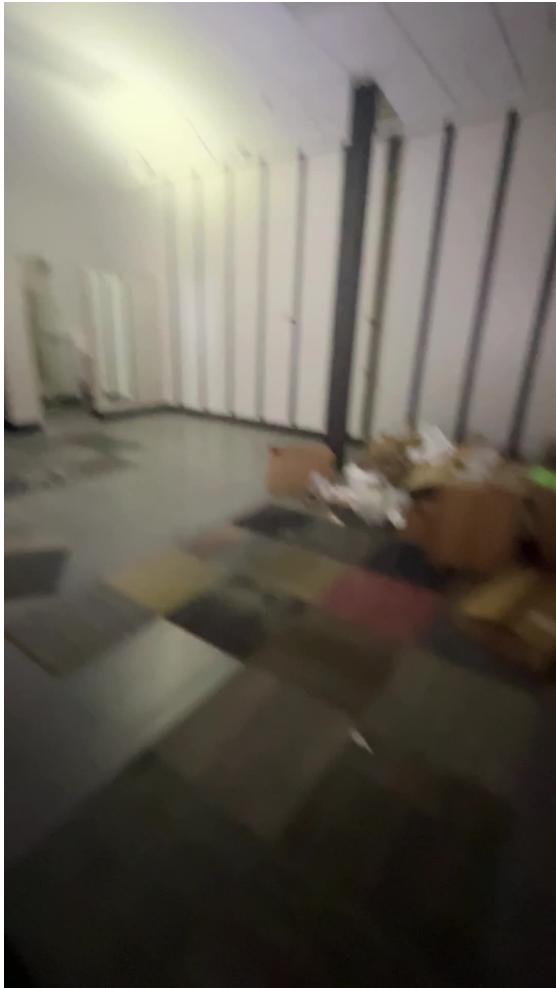
Photo 11 - Video still showing water on an interior floor.  
Source: IMG\_2645.MOV.

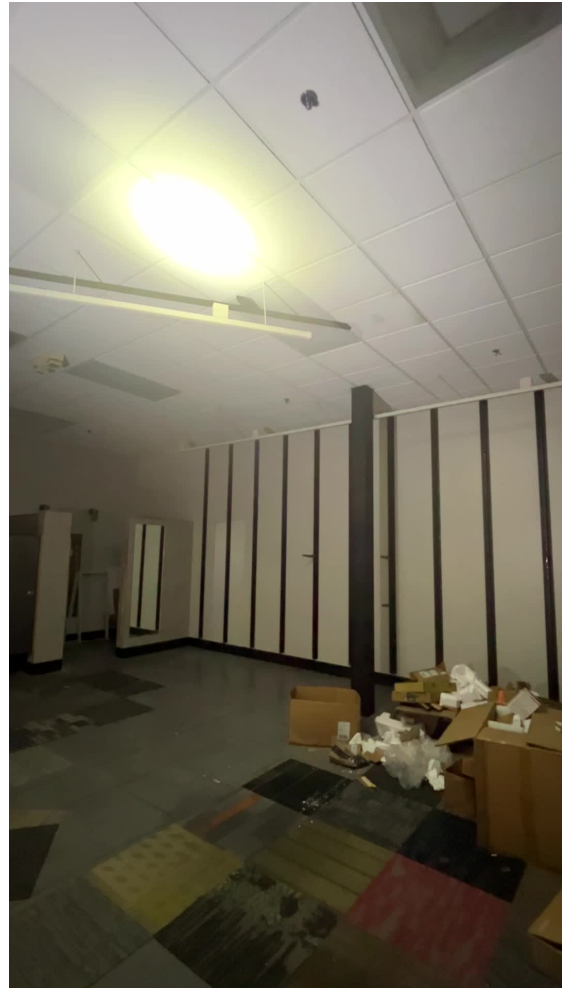
Photo 12 - Video still showing interior ceiling, flooring and stored materials. Source: IMG\_2646.MOV.
