INTRO

IOWA FALLS HS AUDITORIUM LIGHTING ANALYSIS

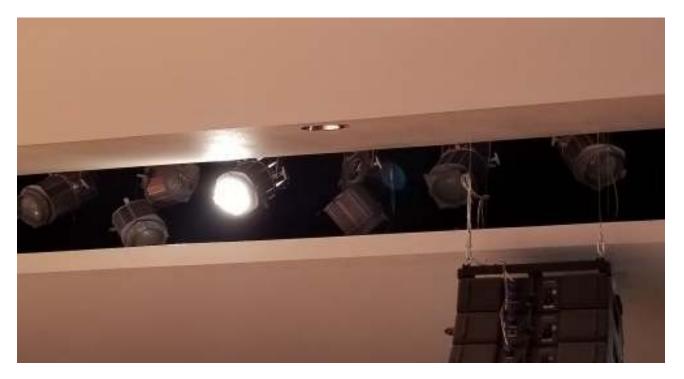
- Several fixtures "out of commission" due to missing pieces
- Fixtures still using asbestos insulated cords
- Focus (beam spread) is too narrow for the location of the fixtures

1. Several Fixtures unusable

2. Asbestos

3. Mounting condition

Image shows front light mounting location and only \underline{one} of every \underline{six} fixtures working.

| 1. Replace most of the existing theatrical lighting fixture inventory with LED. At minimum, the dozen |

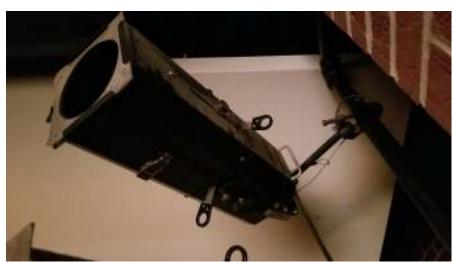
- Fixtures haven't been maintained.
- Lamps have been replaced but not put into correct focal point locations for the brightest results/ focus of the instrument

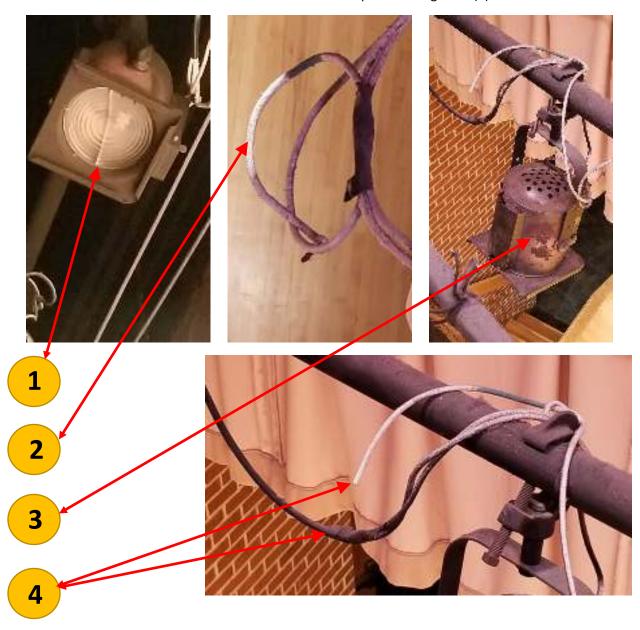
- Multiple fixtures observed with broken glass lenses (1)
- Fixtures use asbestos insulated cords (2)
- Many housings showing significant corrosion (3)
- Ground wires have been cut and taped back together (4)

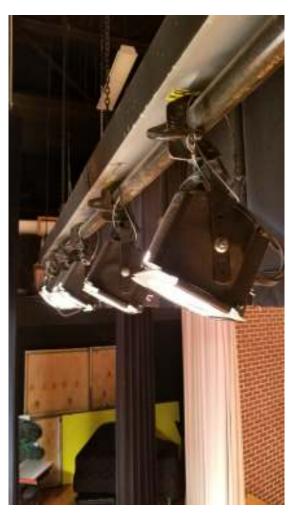
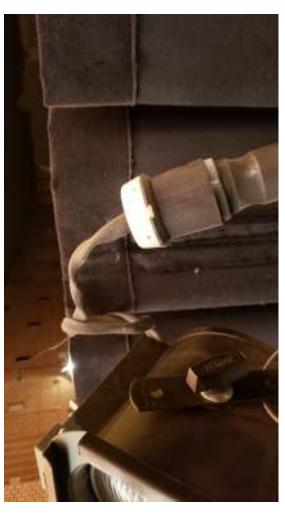
- None. Still in decent condition.
- Fixtures have rubberized insulation and tight connectors.

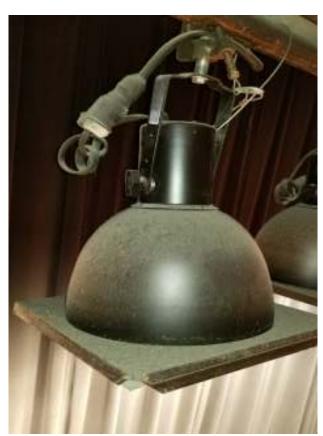
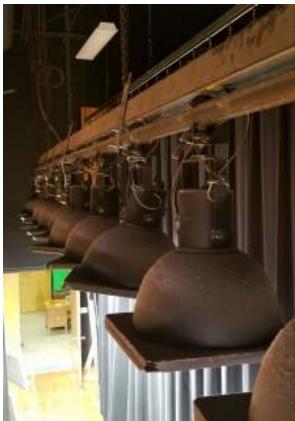
- Fixture condition is ok.
- Not a useful fixture.
- 1000w lamps create a lot of heat and waste energy

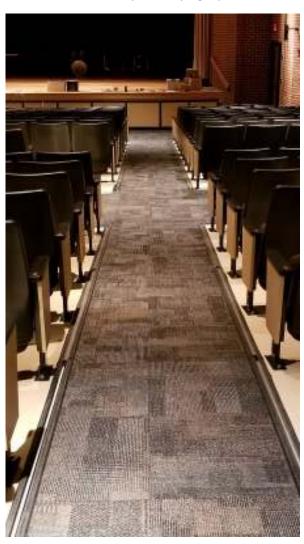
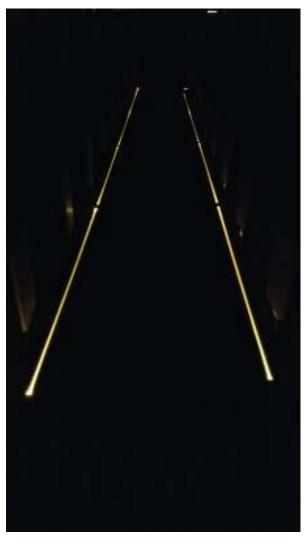
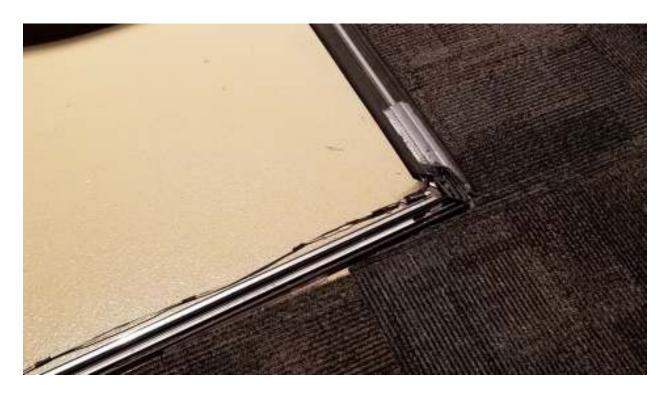
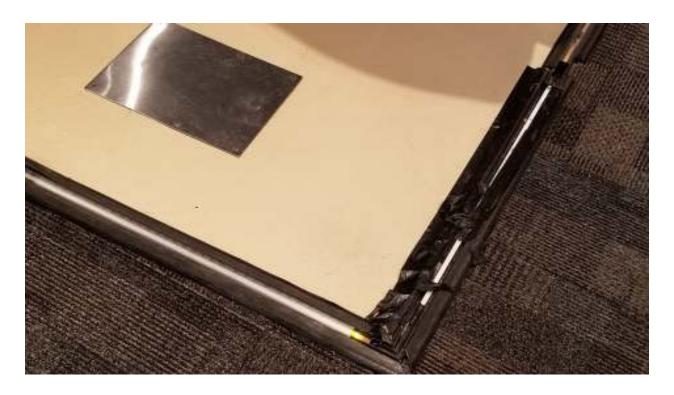
Aisle lighting has been in dis-repair for some time. The existing lighting is a low-voltage fiberoptic type system w/ a single amber colored LED at the end of each section. Low-voltage transformers are shown to be located under the stage and in a back-storage room according to drawings created when the product was installed in 2005.

- 1. Fixtures all have to be replaced. Re-wiring may be difficult.
- 2. "Runway" lighting systems do not meet current code. NFPA 101 Section 7.8.1.3(3) states that "In assembly occupancies, the illumination of the walking surfaces of exit access shall be at least 0.2 foot-candles during periods of performances or projections involving directed light." The "runway" type lighting systems do not provide ANY useable light on the floor surface only identifying a path.

| disposed of based on current regulations. | |
|--|---|
| 4. Replace floor lighting system with one of two options: | |

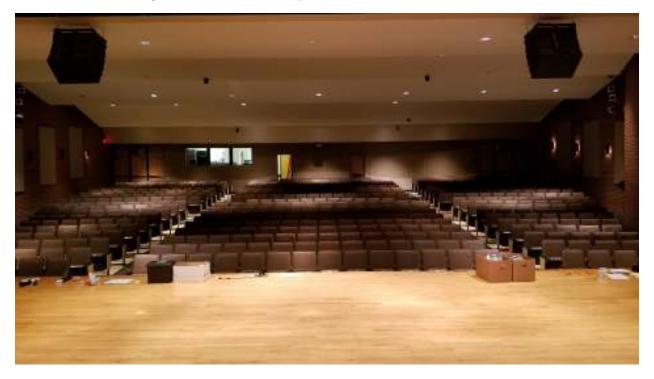
House lighting, in general, appears to be in good condition. Ignoring the fact that multiple fixtures were burned out at the time of MODUS' visit, all of the fixtures that were on responded to the dimming system and were observed dimming up and down with the use of the slider station in the control room.

Future maintenance on the fixtures needs to include verification that the correct lamps are being used. Clear shielded lamps appear to have been used in several locations resulting in "hot spots" directly below the fixtures. All of these lights should use a frosted outer envelope to smooth out the light so that the auditorium in general is more uniformly lit.

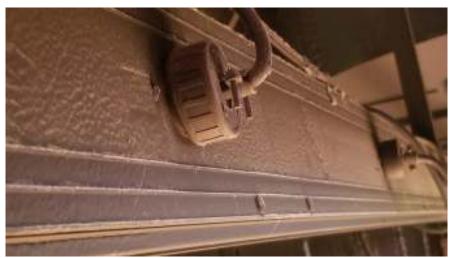
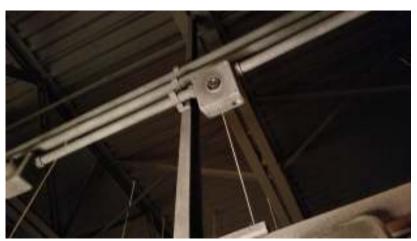
The distribution (plugs and outlets) currently in use appear to be mostly original components dating from the 1950s. Although, most appear to be in working order, MODUS recommends that a trained electrician open several receptacles and review the condition of the wiring inside of the raceways back to the dimming panel. The connectors are all LM-20 twist-lock style plugs and receptacles that are not widely used any more in theatrical systems.

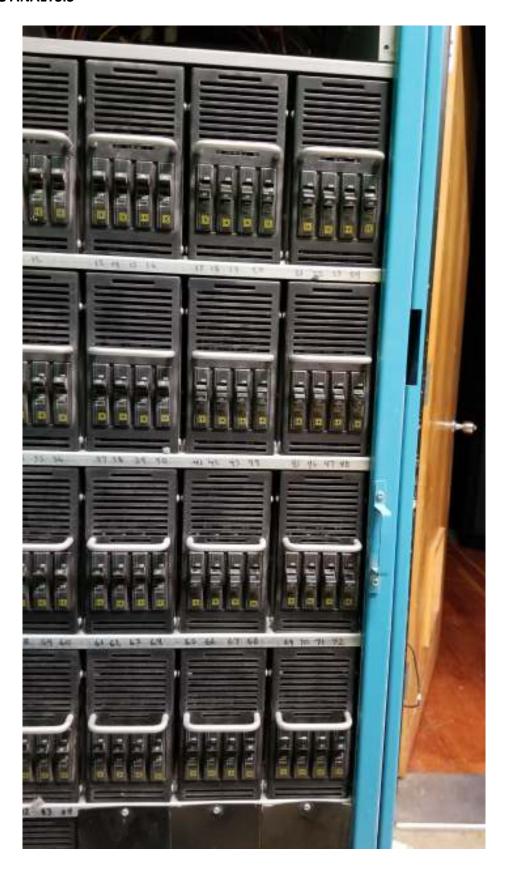
Although the dimmers are mostly still operating, they are an antiquated style and may not be capable of operating new LED fixtures should the existing fixture inventory be replaced in the future.

| disposed of based on current regulations. | |
|--|---|
| 5. Update dimmer rack with new panel capable of controlling new LED light fixtures. | |

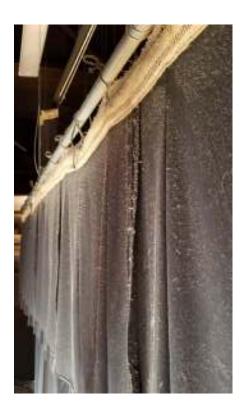
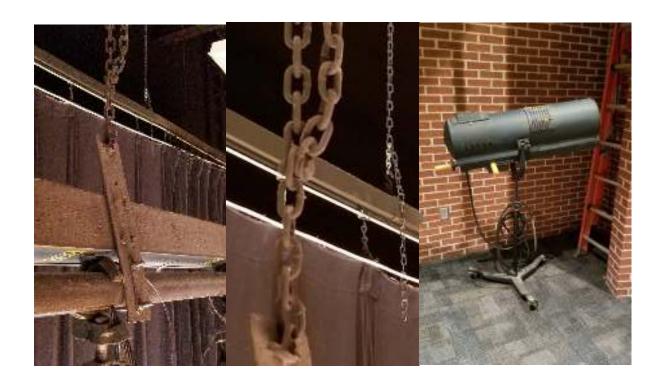
- 1) CURTAINS Most of the curtains were covered in dust and appeared to have not been replaced in sometime. Original fireproofing applied to these fabrics will have worn offcreating a fire hazard on the stage. Webbing is frayed and tie lines are disintegrating as the ropes dry out. Curtains should get new fireproofing applied by a licensed professional or replaced completely.
- 2) STRUCTURAL/ RIGGING Many of the existing pipes, electrics and other stage mechanics are all supported by chain and clamps. Considerable drift, tilting and movement can be seen as referenced by the images below. A certified rigging inspector needs to be retained to inspect all of this to ensure a safe area over the stage.
- 3) **FOLLOW SPOTS** Follow spots should be replaced with a newer/ quieter version due to their location in the auditorium and proximity to the audience.

| disposed of based on current regulations. | |
|--|---|
| 7. Replace all curtains on the stage/ inspect rigging (by others) | |
