Re: Domtar Paper Company, LLC's Kingsport Mill ("Domtar") Response to Director's  
Order and Assessment Case No. WPC23-0153

# Preliminary Engineering Report and Corrective Action Plan

For Submittal to Tennessee Department of Environment and Conservation

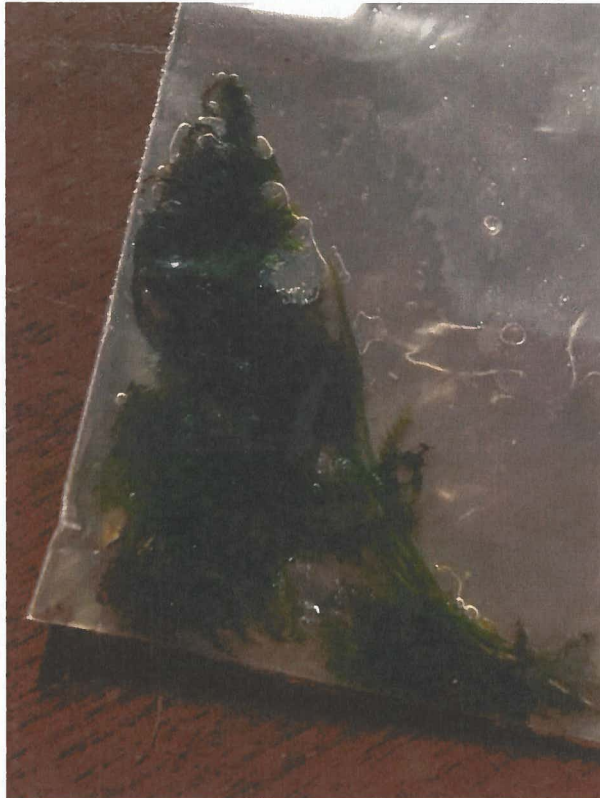
**Figure 1: Stream Sample Taken July 5, 2024**

Review of the conditions in the settling zone of the ASB shows a potential environment for growth of sheathed bacteria. This environment includes the presence of organic acids, low dissolved oxygen and low orthophosphate. A sample at the settling zone outlet had an organic acid concentration of 12 mg/l. Monthly samples analyzed for orthophosphate at the settling zone inlet (aeration zone outlet) showed soluble orthophosphate concentrations below the detection limit of 0.1 mg/l. Additionally, the oxygen present in the settling zone is less than 1.0 mg/L. The conditions in the ASB settling zone along with the presence of sheathed bacteria below Outfall 001 indicate that the effluent may be contributing to the growth of sheathed bacteria attaching to the diffuser and river substrates and algae downstream of the outfall.

observed in the past. Figure 1 shows a sample of the algae taken on July 5, 2024 and Figure 2 shows a sample of algae taken from the same location downstream of Outfall 001 on May 1, 2024. These figures show an improvement in the amount of sheathed bacteria since addition of calcium nitrate began on May 1, 2024.

In addition to adding calcium nitrate, it is recommended that a study be performed to identify alternative means to increase the oxidation potential in the settling zone without addition of calcium nitrate. After the study, a full-scale trial of the selected means to add oxygen to the settling zone should be conducted to determine if this can reduce or eliminate the white slime below the discharge.

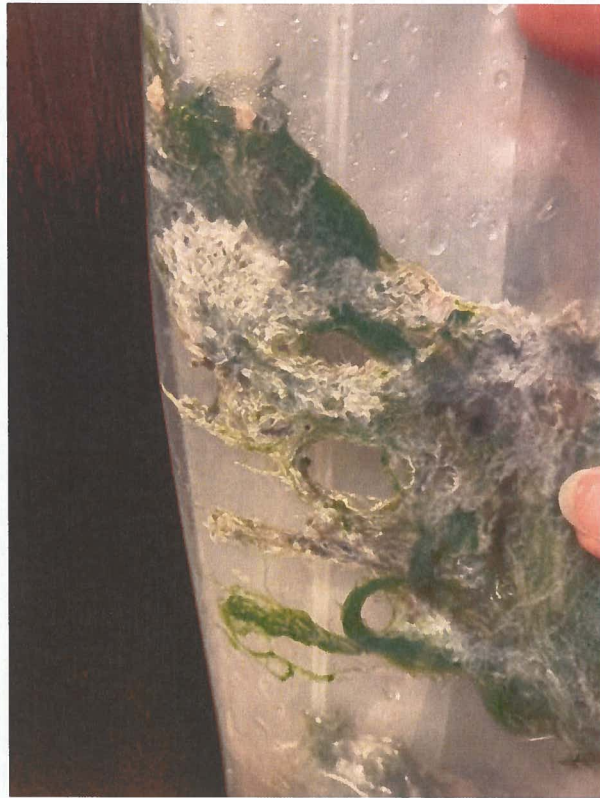
**Figure 2: Stream Sample taken on May 1, 2024**

Subsequent testing by EMSL Analytical, Inc. in May 2024 detected what was described as a heavy presence of sheathed bacteria downstream of the outfall with none detected upstream. This testing was performed by a single laboratory and is the basis for the conclusions about how to control formation of this substance. As part of Arcadis due diligence for the Engineering Report, another set laboratory analysis should be performed to determine whether the conditions have changed since start-up in 2023. This analysis should be made on both the Domtar discharge and the water in the river downstream of the discharge.
