Aviation Investigation Final Report

Location:	Litchfield, Maine	Accident Number:	ERA23FA346
Date & Time:	August 22, 2023, 17:40 Local	Registration:	N55RP
Aircraft:	Beech C-99	Aircraft Damage:	Destroyed
Defining Event:	Sys/Comp malf/fail (non-power)	Injuries:	2 Fatal
Flight Conducted Under:	Part 91: General aviation - Instructional

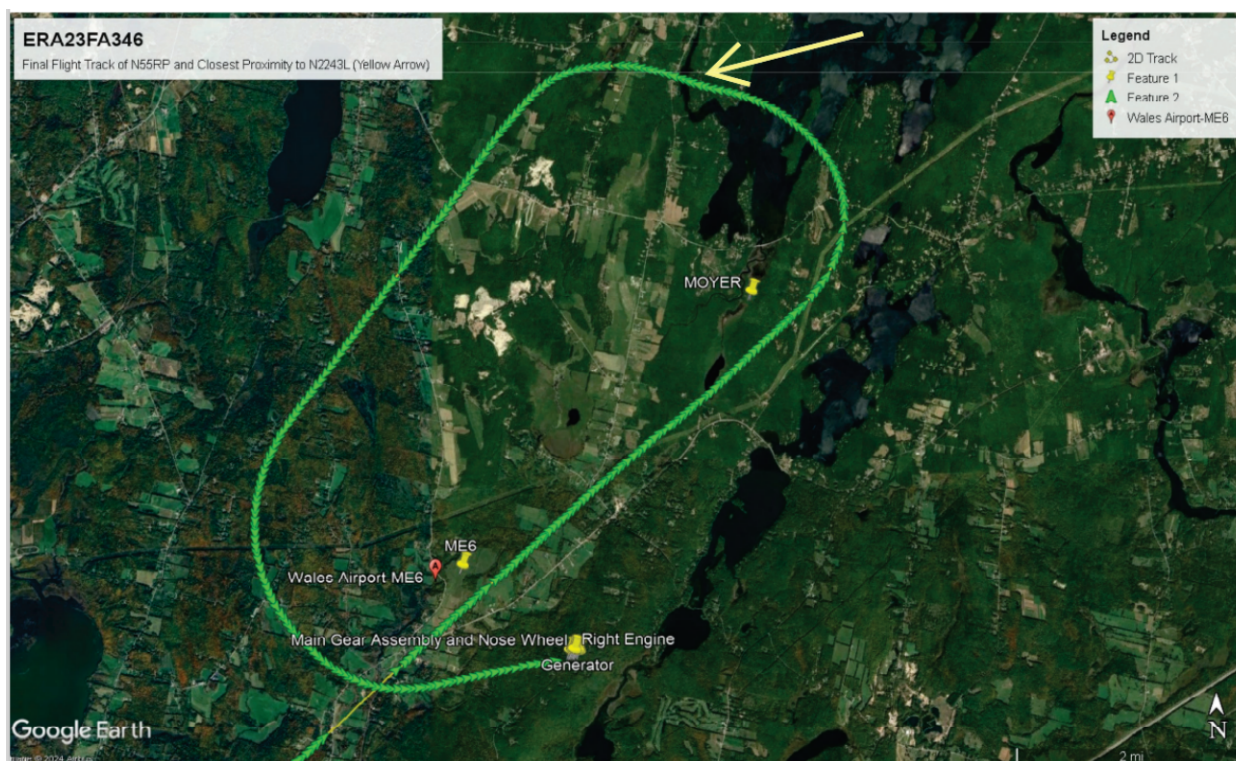
As the accident airplane was established in the holding pattern for the runway 4 approach, at about 3,000 feet msl, another airplane, a Beech C23, was airborne in the vicinity. A pilot receiving instruction and a flight instructor were practicing maneuvers at the time. As the C23 was turning east, both pilots observed another airplane flying in their direction at about the same altitude. They observed the other airplane make an abrupt turn to their right. They described the encounter as a “near miss.” They did not observe the airplane again and heard no distress calls. A review of ADS-B track data revealed that the C23 and accident airplane came within 0.38 nm laterally, with about 250 ft vertical separation. A further review of accident airplane’s flight track showed the airplane maintaining the holding pattern for another 8 miles after the event and before the descent and collision with terrain (see figure 1).

Figure 1 –Flight track of the accident airplane in the holding pattern. The yellow pin at the end of the track shows the accident site. The yellow arrow shows where the reported near-miss occurred.

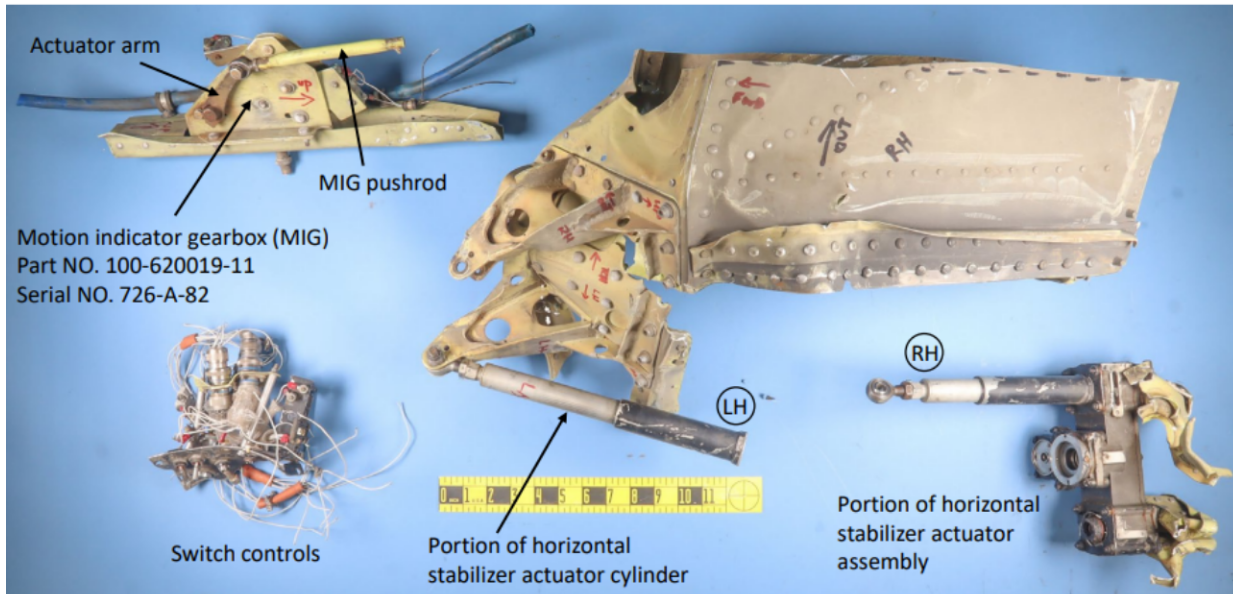
During the on-scene wreckage examination, the right-side horizontal stabilizer actuator cylinder rod end was found disconnected from the right-side clevis fitting. The fitting was spread open, and the attaching nut, bolt, and washers were missing. The left-side actuator cylinder fractured from the motor housing and the rod end remained connected to the left-side clevis fitting on the stabilizer.

The control rod to the MIG was also found disconnected. The MIG control rod uses the same hardware that is used to secure the right actuator cylinder rod to the horizontal stabilizer. During normal operation, the MIG provides aural and visual cockpit indications to the flight crew for takeoff trim position and trim movement. The MIG is an indicating system only; it does not control operation of the horizontal stabilizer actuator.

An examination of the recovered components of the horizontal stabilizer system revealed witness marks and scrapes consistent with the attaching hardware for the right actuator and MIG control rod being missing at some point during the accident flight. Figure 2 shows the recovered components of the horizontal stabilizer trim system.

Figure 2 – Recovered components of the horizontal stabilizer trim system

The extension of the right-side horizontal stabilizer actuator cylinder was measured at 4.25 inches, which equated to a horizontal stabilizer position of 3.5° leading edge up (nose down). The nose-down travel limit for the stabilizer was 4.25°. The nose up travel limit was 4°.

A review of engineering data provided by the airframe manufacturer revealed that, with only the left actuator cylinder rod connected to the horizontal stabilizer, the arm would be operating in the “limited emergency operation” mode. The limited operation period is not known and unspecified by the manufacturer. The consequences of operating in this mode for an extended time are also unknown.
