HIR-25-06

Cargo Tank Combination Vehicle Roadway Departure, Rollover, and Release of Anhydrous Ammonia

Teutopolis, Illinois
September 29, 2023

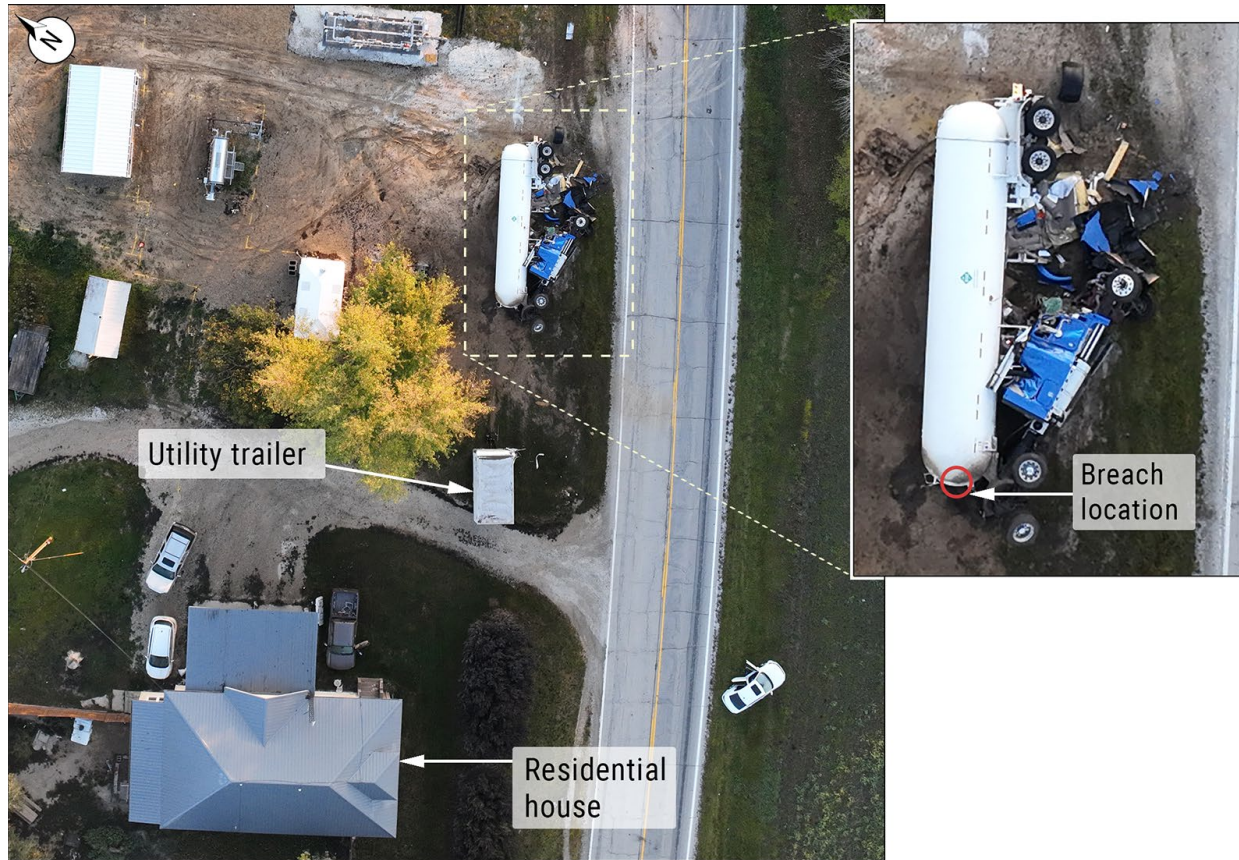
Figure 1. Aerial view of the crash location with an inset showing the combination vehicle's final rest position.

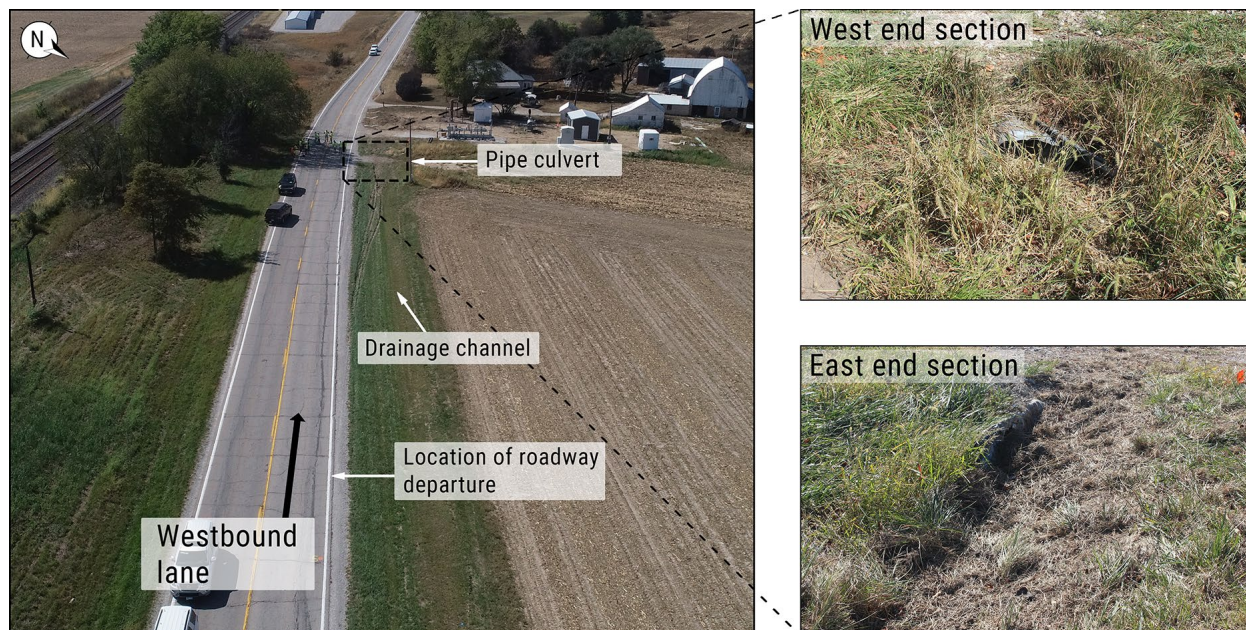
A driveway off the right side of the westbound lane provided access to a field to the north. Beneath the driveway, a 12-inch-diameter corrugated metal pipe culvert connected the east and west sides of the drainage channel (see figure 3). A residential house was located about 200 feet west of this driveway. A 2021 Sure-Tac utility trailer was parked near the house, positioned about 27 feet north of the westbound lane shoulder and 105 feet west of the west end of the culvert.

Figure 3. Aerial view of the crash location, with insets showing the east end (the one struck by the combination vehicle) and the west end of the pipe culvert.

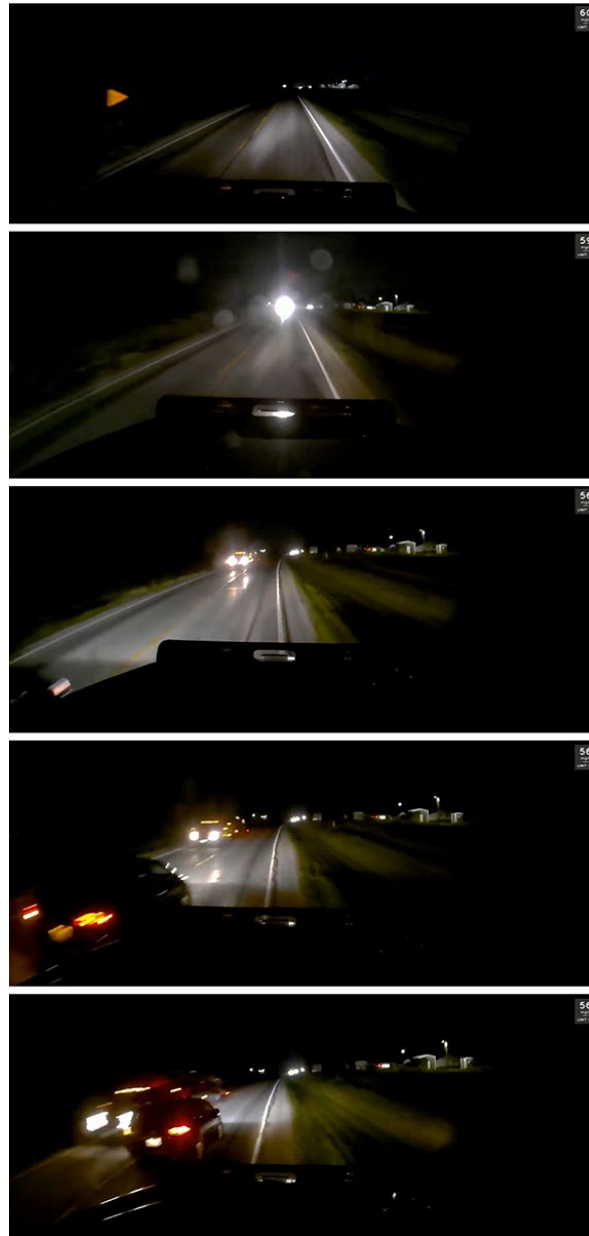
Forty seconds into the video (see figure 4), the footage showed a no passing zone sign located on the left shoulder (indicating the beginning of the no passing zone for the westbound traffic). At that time, the headlights of an oncoming vehicle were clearly visible and approaching.

Figure 4. Screenshots of video footage from the combination vehicle's forward-facing camera showing: (1) the vehicle entering the no passing zone; (2) beginning of rightward steering 5.6 seconds later; (3) minivan front end visible in the oncoming lane 1.9 seconds later; (4) minivan emerging in front of the combination vehicle 0.3 seconds later; and (5) minivan reentering westbound lane 0.3 seconds later. (Source: Samsara, the fleet management system provider; screenshots resized by NTSB)

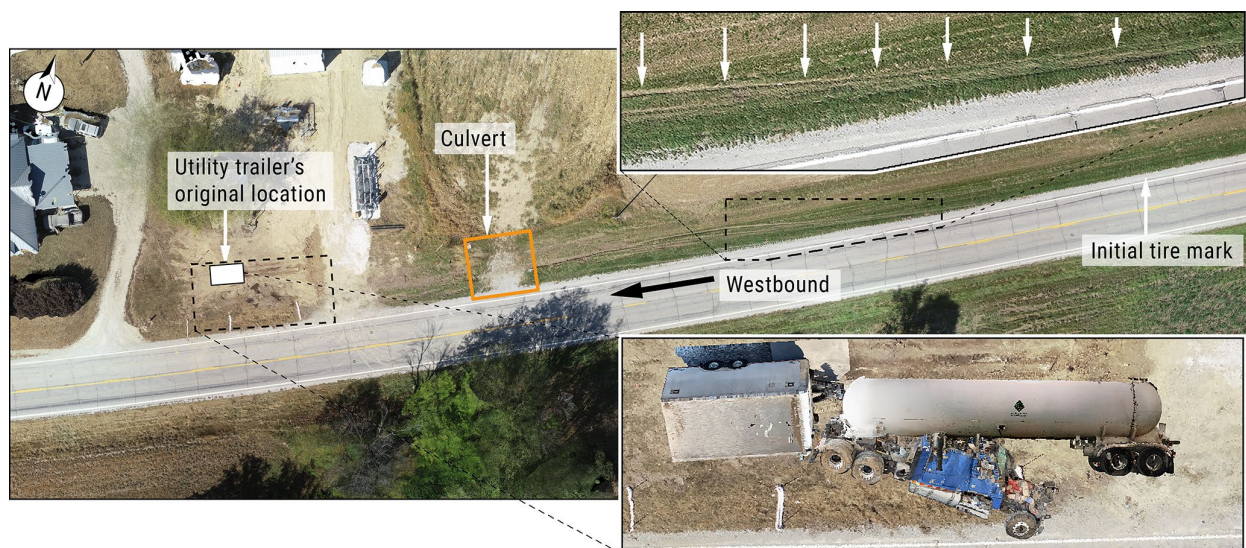
Figure 5. Orthomosaic overhead image of the crash area showing roadway evidence of roadway departure (detailed in upper inset) and the reconstructed orientation of the utility trailer and the combination vehicle at impact (lower inset). (Source: Illinois State Police; impact reconstruction and annotations by NTSB)

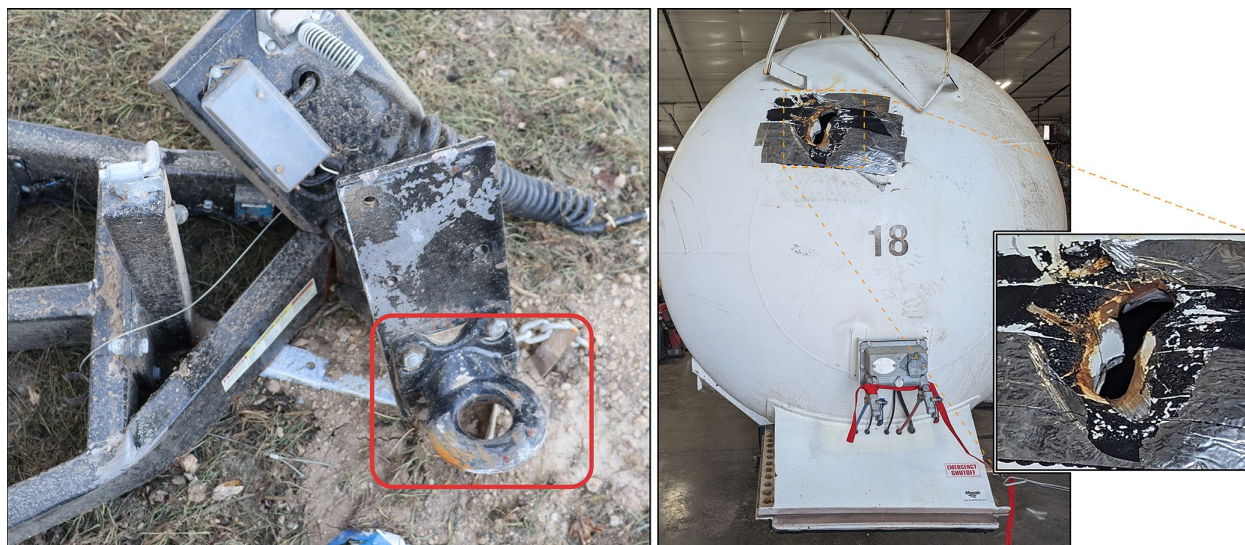
Figure 6. Images of the tongue and lunette ring (left, highlighted in red) and the punctured cargo tank head (right).

The investigation determined that the mechanical condition of the truck-tractor and the construction of the cargo tank were not factors in this crash. The circumstances leading to the breach—a small object made of hardened steel impacting the cargo tank at a weld seam—are extremely unusual. A cargo tank with a capacity to withstand such impact forces would require a substantial increase in material thickness. The only other packaging containers with such extreme design characteristics are intended for the transportation of radioactive materials.³⁷

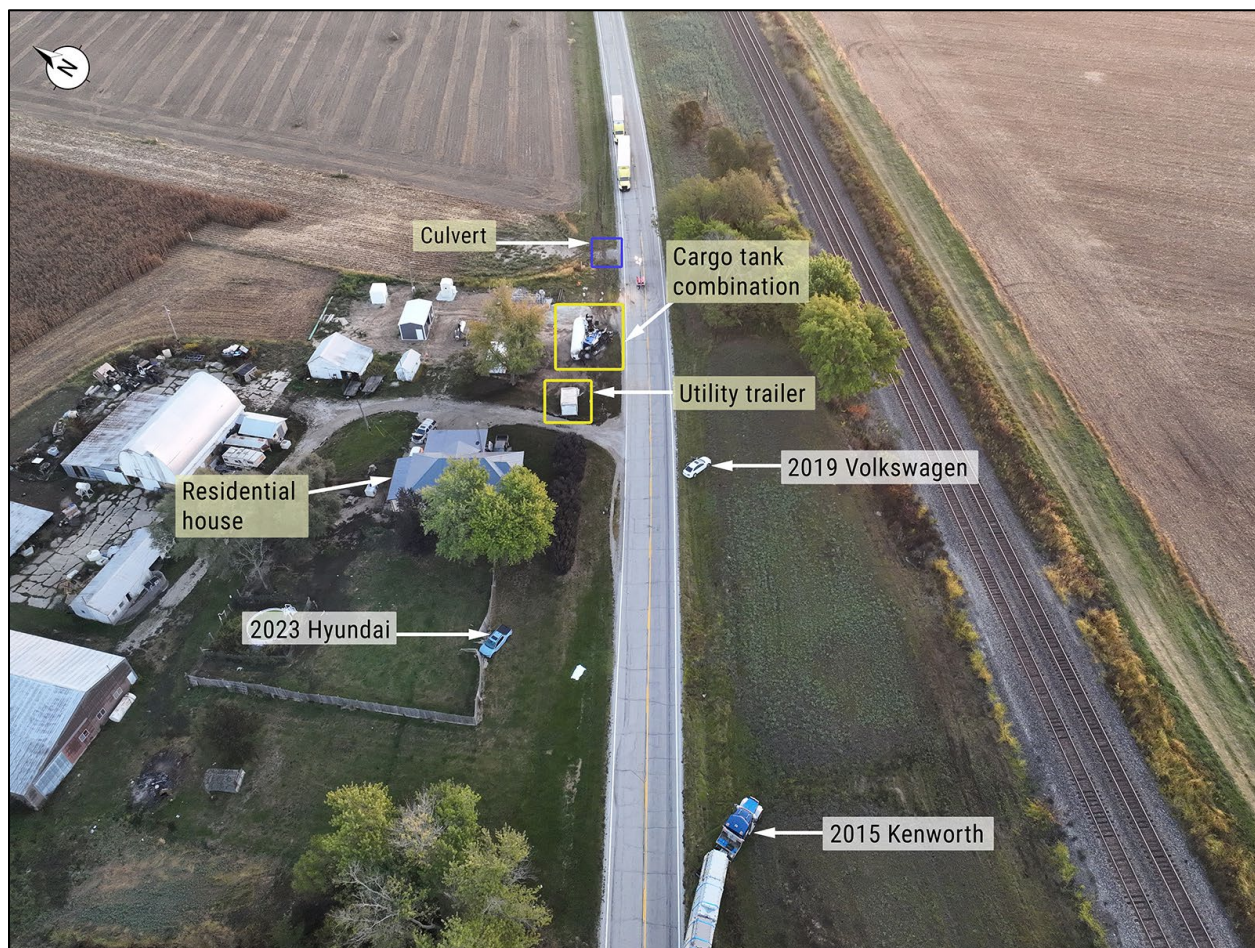
Nearly all fatalities and injuries were due to anhydrous ammonia exposure. Figure 7 shows the area where most affected vehicle occupants and home residents were located. The five fatally injured people all sustained chemical burns to their skin, eyes, and mouth and hemorrhaging in the respiratory system as a result of exposure to anhydrous ammonia.

Figure 7. Aerial view of the crash area, showing the final resting positions of the combination vehicle and utility trailer, and several vehicles whose occupants suffered fatal and serious injuries.

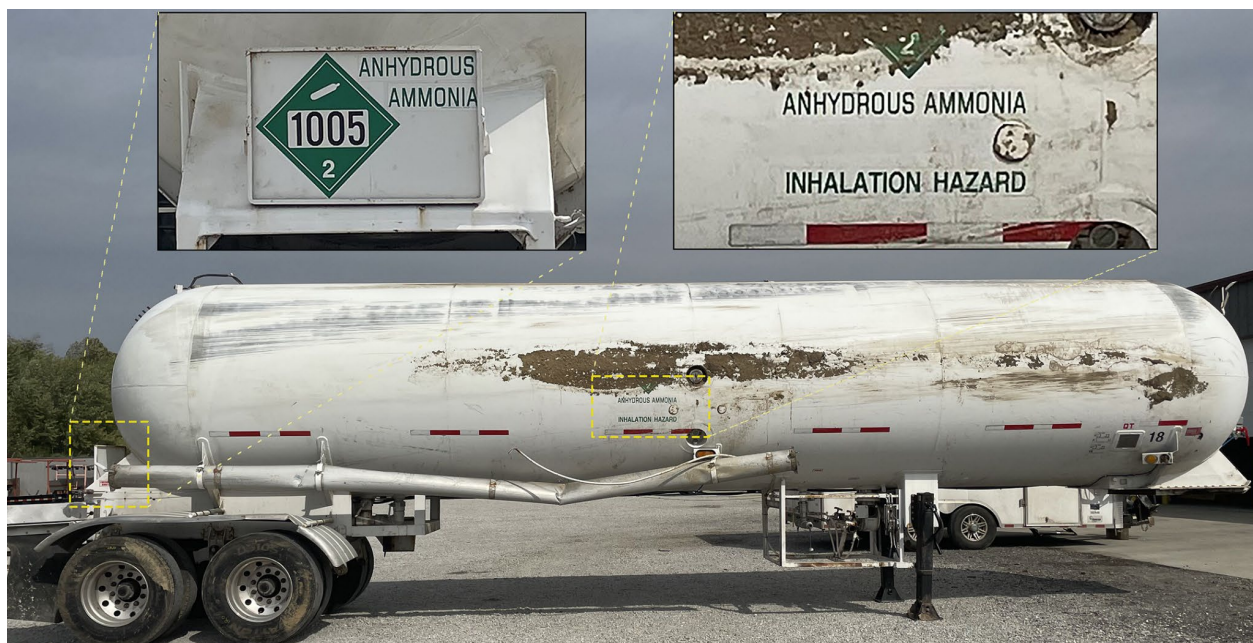
Figure 8. Marking and placarding on the cargo tank. The left side of the cargo tank does not have soil deposits and the marking and placarding is clearly visible.

The postcrash inspection of the truck-tractor and cargo tank semitrailer revealed no preexisting deficiencies that would have caused or contributed to the crash. The postcrash examination of the cargo tank showed that it was properly placarded and marked. It further showed that it met the manufacturing standards that existed at the time of manufacture and would also meet current manufacturing standards.¹⁹
