March 10, 2019

Re; Preliminary Summary
Louisville Zoo Ground Subsidence
Louisville, Kentucky
Vector Project Number 19-3623

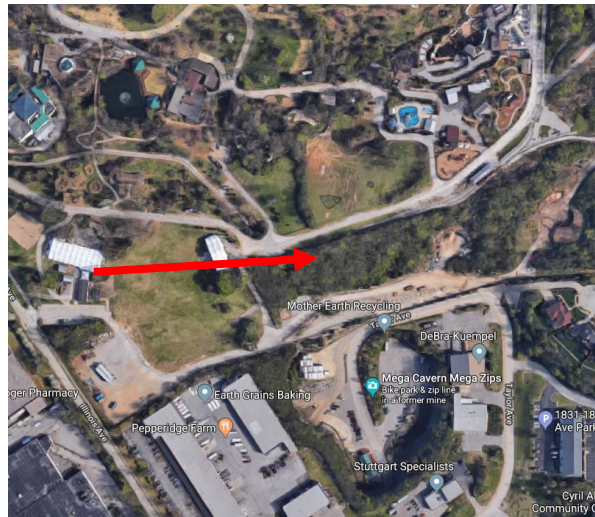
Figure 1: General area of subsidence indicated by the red arrow.

The area of subsidence is located in an unmanaged area of heavy tree growth and underbrush. A large drainage area converges on the area where the subsidence occurred. A drainage swale was observed beyond where the subsidence occurred generally traversing the center of the subsidence area. Visually, there is a substantial drainage area that converges on the area that subsided.

To reduce the risk of future subsidence, the surface drainage should be directed away from the area. The Louisville Zoo expediently installed a temporary berm and 24-inch pipe to direct water away from the subsidence area. This assisted greatly in preventing a large rain event on Saturday, March 9, 2019 from impacting the already subsided area. We recommend that the entire drainage area for this area be evaluated for future permanent improvements to reduce the amount of water over this portion of the mine. We believe additional smaller sections of the area may subside due to the location of observed joints and the saturated overburden. The subsidence may enlarge as perimeter sections of the already subsided areas reach a natural breaking point.

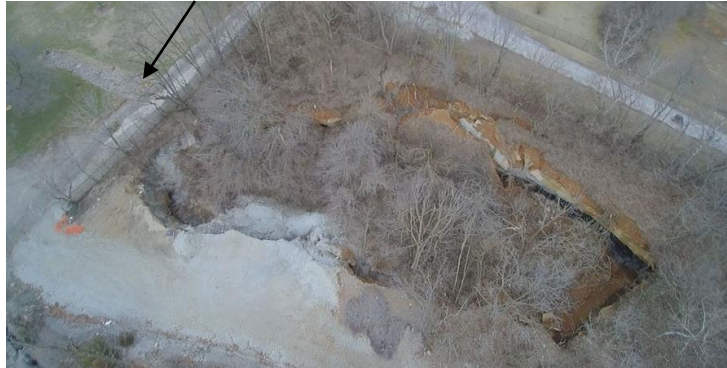
excessive surface water flow over the area. Based on our observations during our site visit, a large drainage area upgradient from the subsided area directs water to a 24-inch diameter concrete pipe that focused the water flow to a shallow ditch at the west end of the subsided area and traversed eastward over the area where it continued west of the subsided area (Figure 2).

Figure 2: Location of the 24-inch pipe indicated by the black arrow (Photograph from WAVE News).

The ground subsidence event is most likely due to oversaturation of the overburden soils and from saturation of the pre-existing vertical joints within limestone unit over many years. This saturation of the joint(s) resulting in loss of strength between either side of the joint resulting in the subsided Louisville Limestone upper strata dropping into the undeveloped and unoccupied section of the cavern. As one section of the strata sheared, other sections may have been “pulled” causing a larger subsidence area. This is evident by the near vertical, clean face of the exposed bedrock (Figure 3). The subsidence was not what would be referred to as a sinkhole. A sinkhole is typically due to soil raveling into a void or conduit within a limestone or dolomite bedrock over a period of time. Bedrock collapse sinkholes are rare in Kentucky.

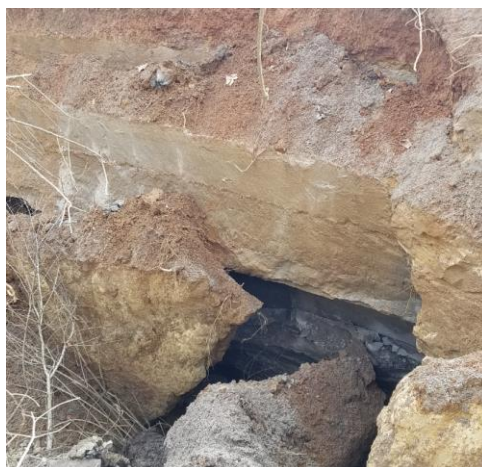
Figure 2: View of Shear Face standing on subsided material looking back to the south toward the access road.
