# **CHAMBERS DEVELOPMENT**

PARCEL NOS. 222007000125  
222007000100  
222007120050

## **CHELAN COUNTY, WASHINGTON**

### **GEOLOGICALLY HAZARDOUS AREA EVALUATION**

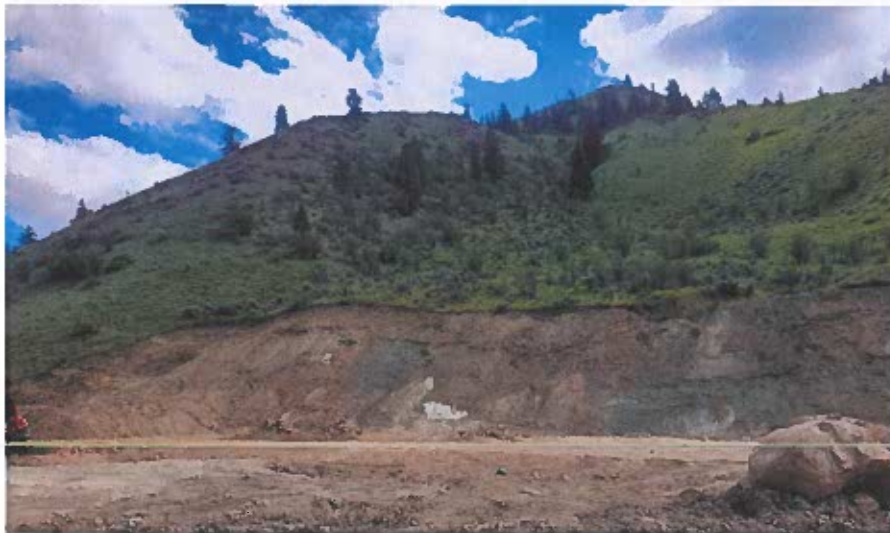
**Figure 1.1 Hillside south of proposed building location**

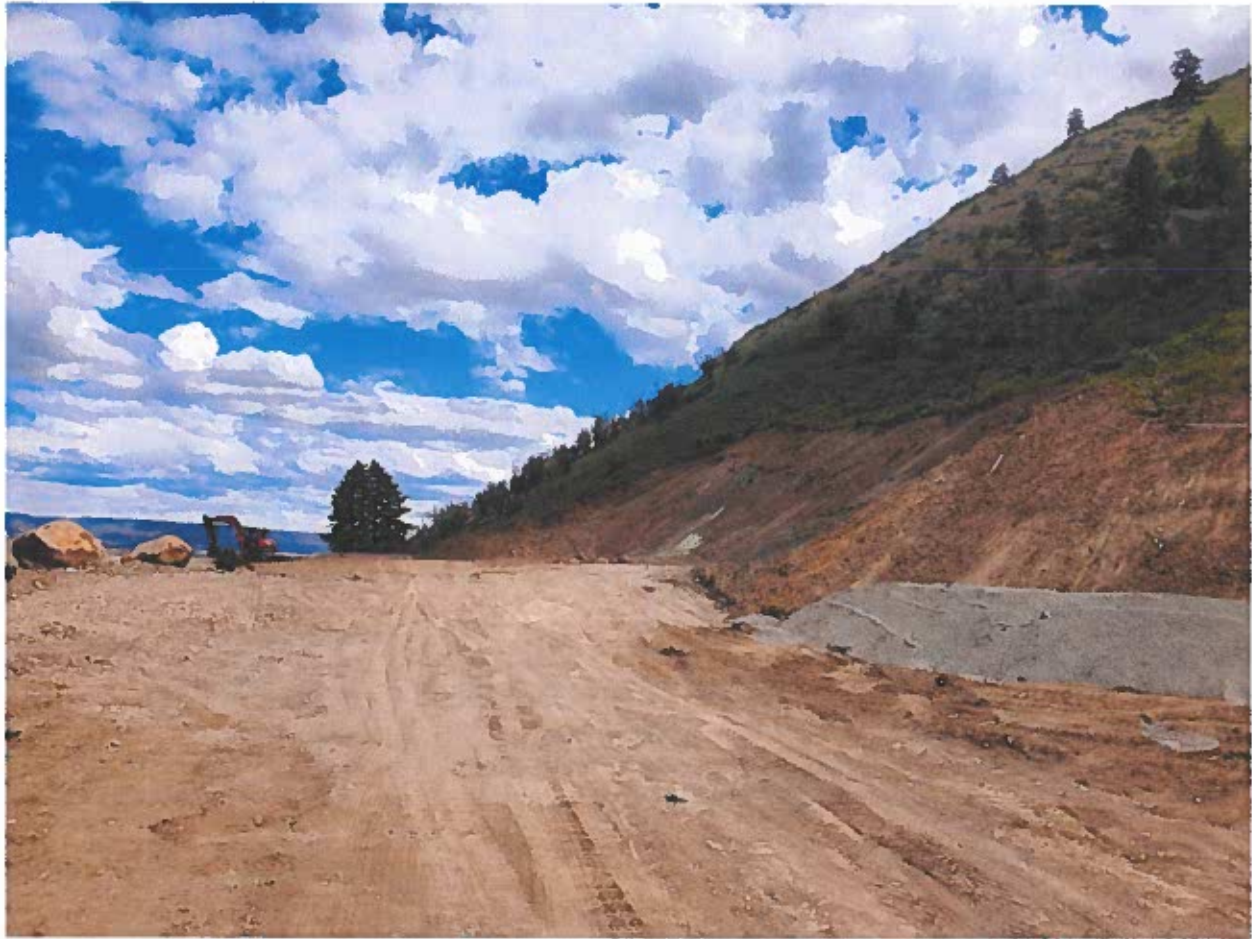
**Figure 1.2 Slope east of proposed building area**

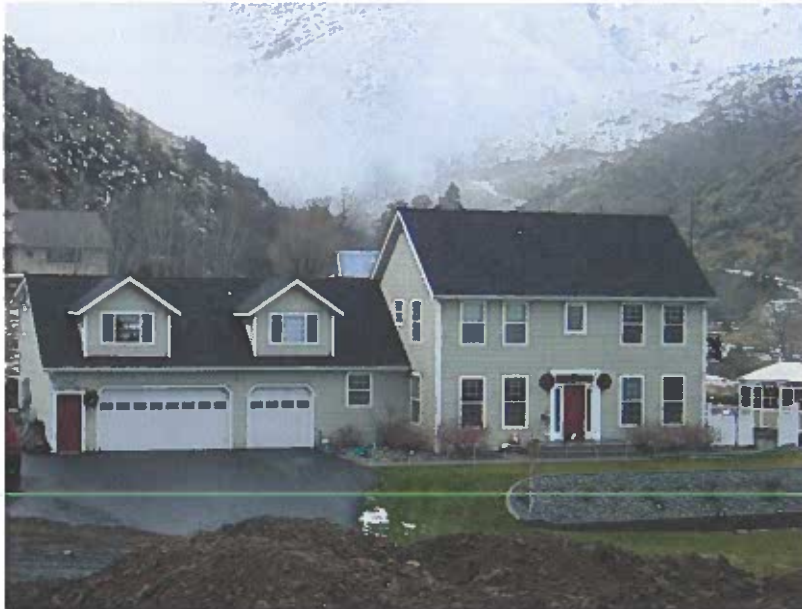
**Figure 1.3** Single-family home on adjacent property to the north

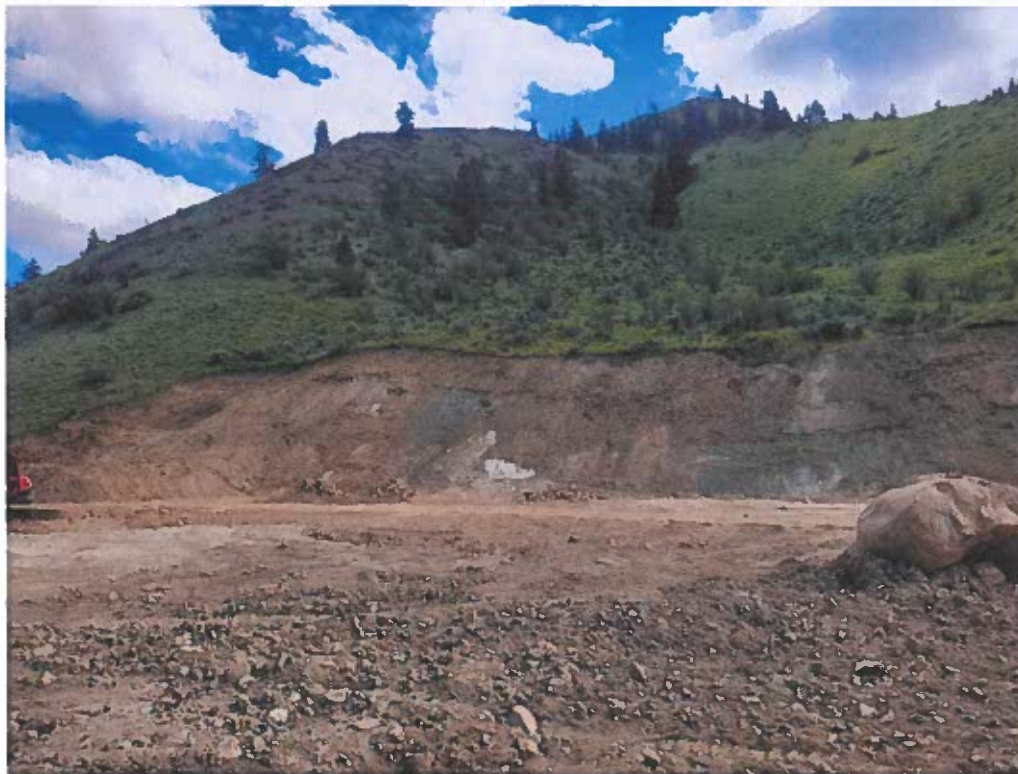
In the current condition, the property shows no signs of erosion. The areas that have been cleared or are naturally bare of vegetation show no signs of erosive activity. There are no signs of erosion in the area observed near the building sites (Figures 1.4 and 1.5 below).

**Figure 1.4    Cut slope south of proposed building location**

There are no signs of erosive soil or topographical variations that show signs of erosion, however, the steep slopes found onsite will allow runoff to reach erosive velocities. Any areas disturbed during construction should be stabilized with vegetation or other standard erosion control methods as soon as possible. Silt fencing should be placed along the downstream perimeter of all disturbed areas and maintained as necessary.

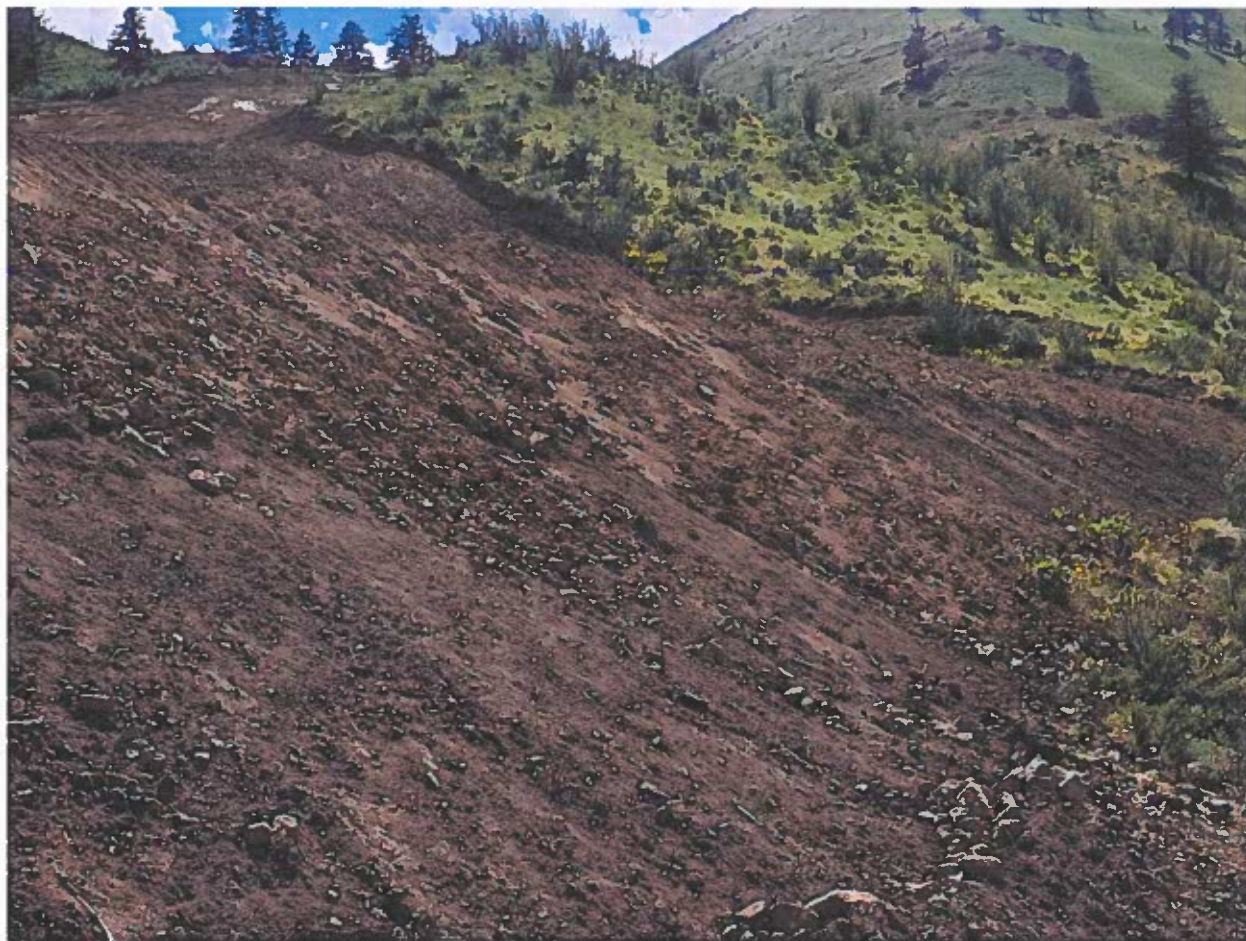
**Figure 1.5 Fill slope north of proposed building location**

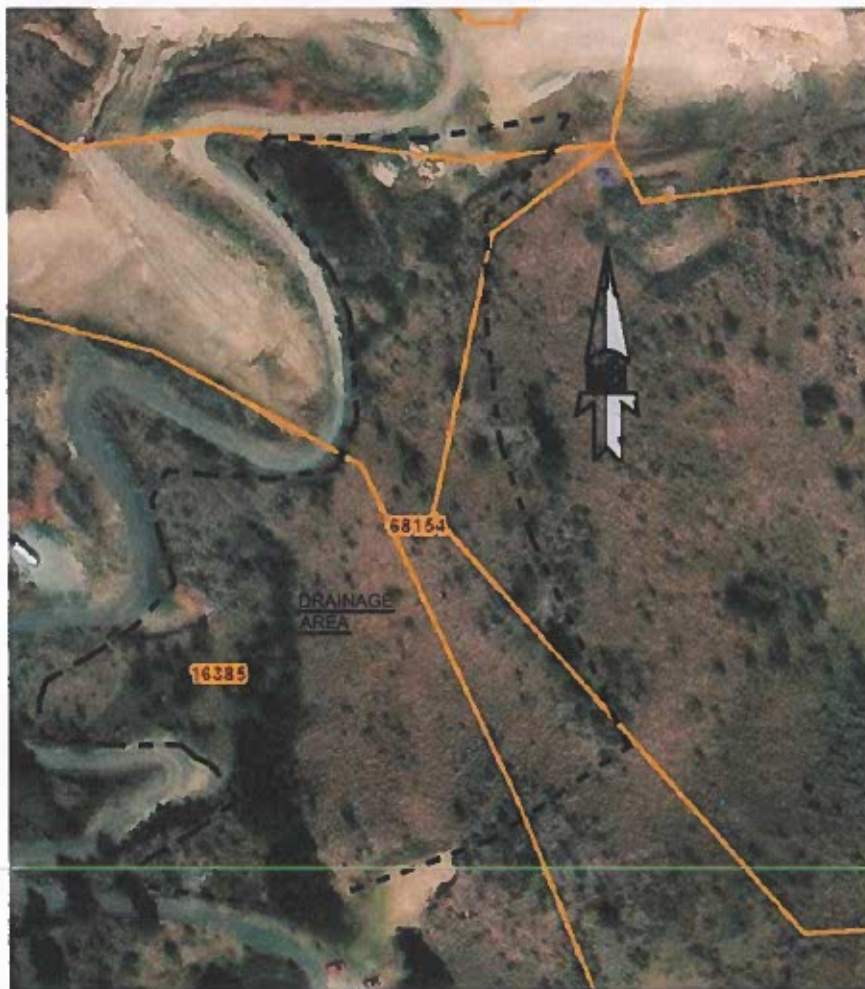
The site has natural drainage patterns that shed runoff to the north. The site has multiple natural drainage channels that are tributary to the flows within the stream south of Number 1 Canyon Road. Runoff may concentrate before leaving the site. The three observed drainage channels onsite are on parcels 222007000100, 222007000125, and 222007120050. The drainage channel on 222007000125 is intercepted by an existing driveway and developments on the parcel directly north of the subject property. The grading that has occurred on the subject property has very little impact on any contribution to the stream. Future stormwater mitigation efforts should consider the drainage area between the existing development on the neighboring parcel and the subject property (approximately 5 acres of undeveloped hillside). An aerial image of the drainage area is shown below as Figure 1. The second and third drainage channels observed to be within parcel 222007120050 and 222007000100 are at the easterly end of the site. No grading has occurred in this area. Any future developments that may impact the drainage channels on these parcels will need to be mitigated at the time of development and considered in future stormwater mitigation plans.

**Figure 1      Drainage area between existing developments and onsite grading**

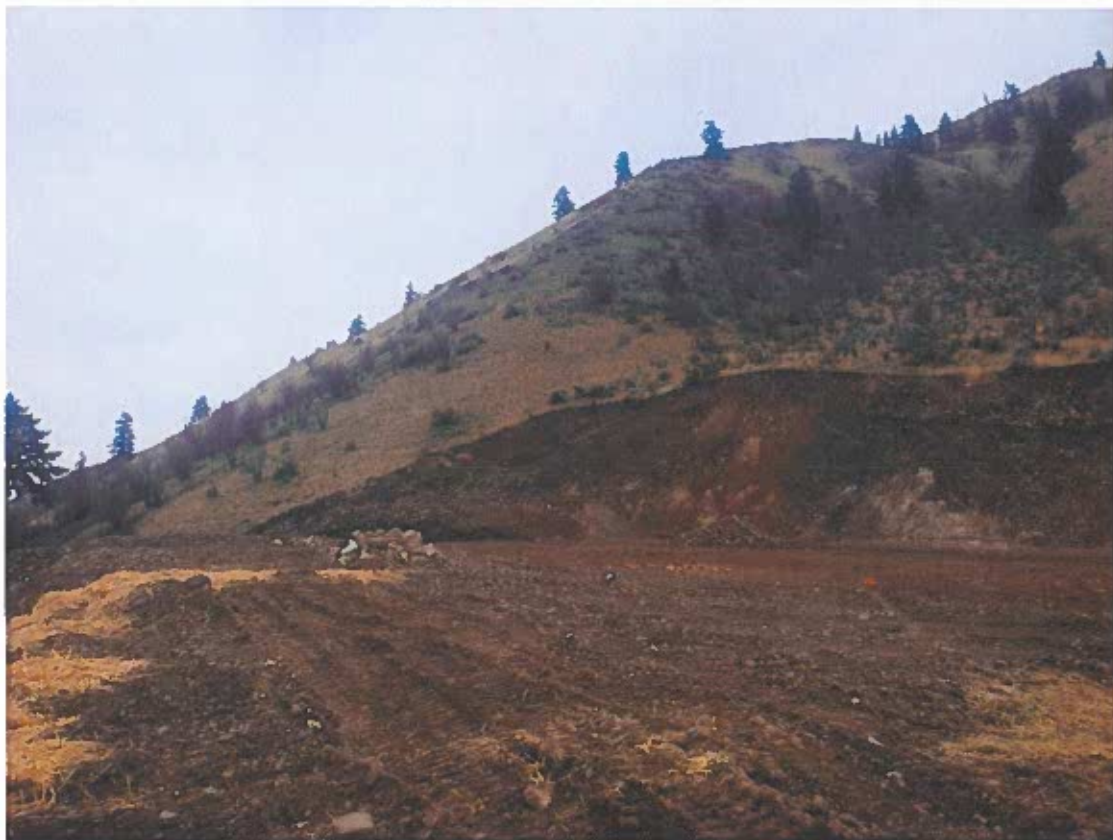
The natural slopes onsite and the cut slopes at all three disturbed areas appear to be stable and without any substantial erosion. Photographs of the cut slopes at all three disturbed areas are shown below as Figures 2,3, & 4. Some erosion was observed along the northerly face of the fill slope of the building pad on parcels 222007120050 and 222007000100. The areas that have shown signs of erosion have been partially stabilized by the use of straw ground cover (Figures 5 and 6 below). The ground cover that has been employed will reduce the effect of rain droplet impact on the surface and slow runoff that migrates to the slope from upstream sources.

**Figure 2 — Cut slope south of building pad on Parcel 222007120050**

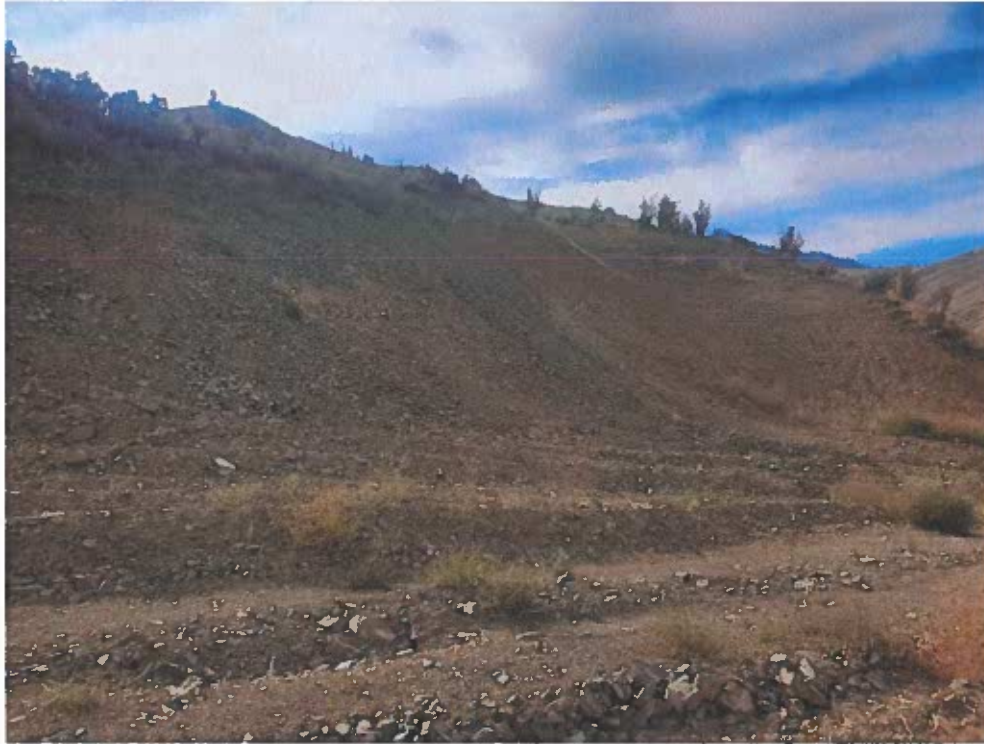
**Figure 3** Cut slope southwest of building pad on Parcel 222007000125

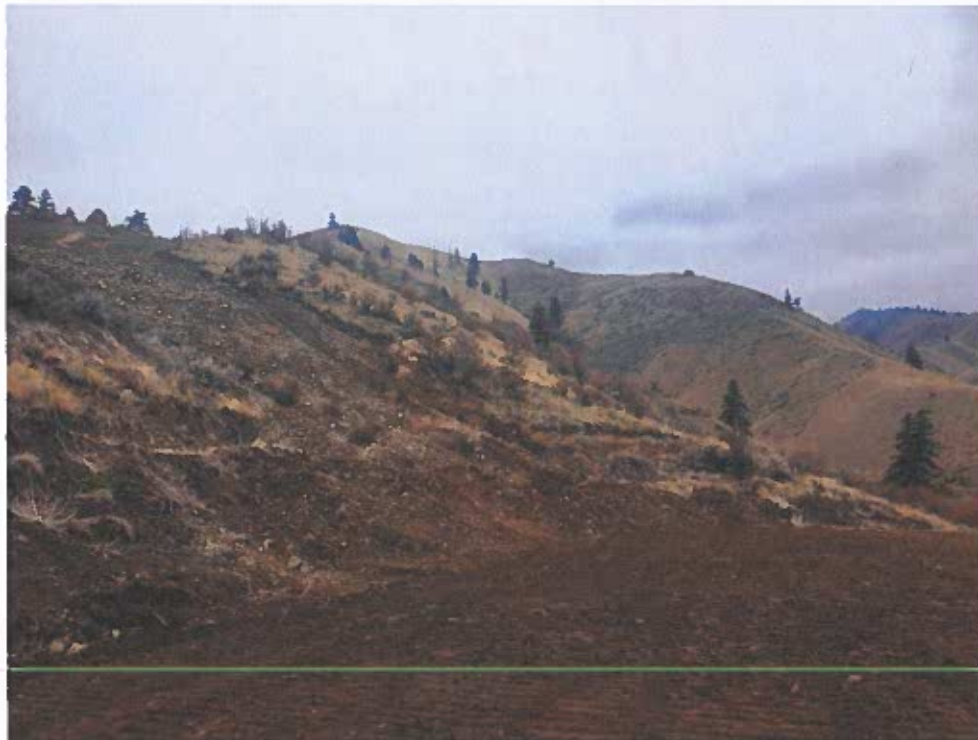
**Figure 4** Cut slope south of building pad on Parcel 222007000100

It is recommended that this building pad be graded in a way that prevents runoff generated upstream of the slope to migrate down the face of the slope. Concentrated runoff that flows across the building pad and down the slope is the cause for the rills and deep incisions that have occurred. Rills that propagated at the ridge line allow for further concentration of runoff. It is also recommended that straw wattles be placed along the northerly fill slope if further deterioration of the slope is observed during the course of the project. Silt fence should also be securely installed at the base of the hillside and maintained throughout the course of the project to prevent sediment from leaving the site. Any other slopes that are demonstrating signs of erosive behavior should be stabilized by the use of straw ground cover or wattles. It is also recommended that silt fence be securely installed along the ridge of the northerly fill slope until the site is properly graded to reduce runoff velocity and prevent upstream

sedimentation from flowing down the slope on potentially offsite. Silt fence should be securely installed downstream of any current or future disturbed areas.

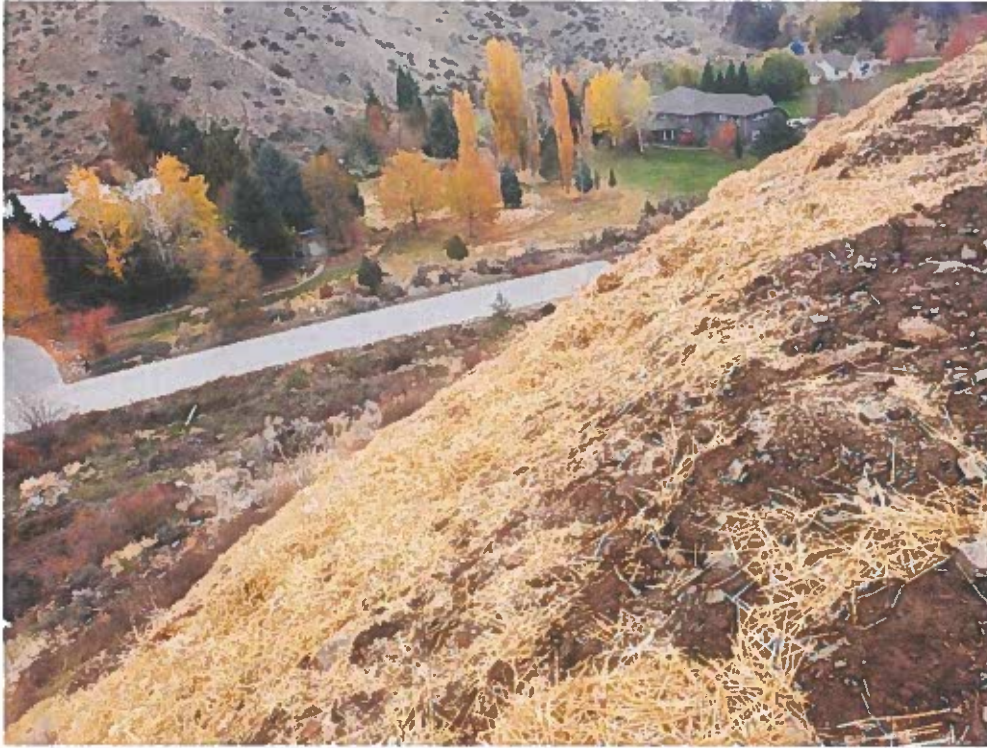
**Figure 5      Straw ground cover on southerly fill slope**

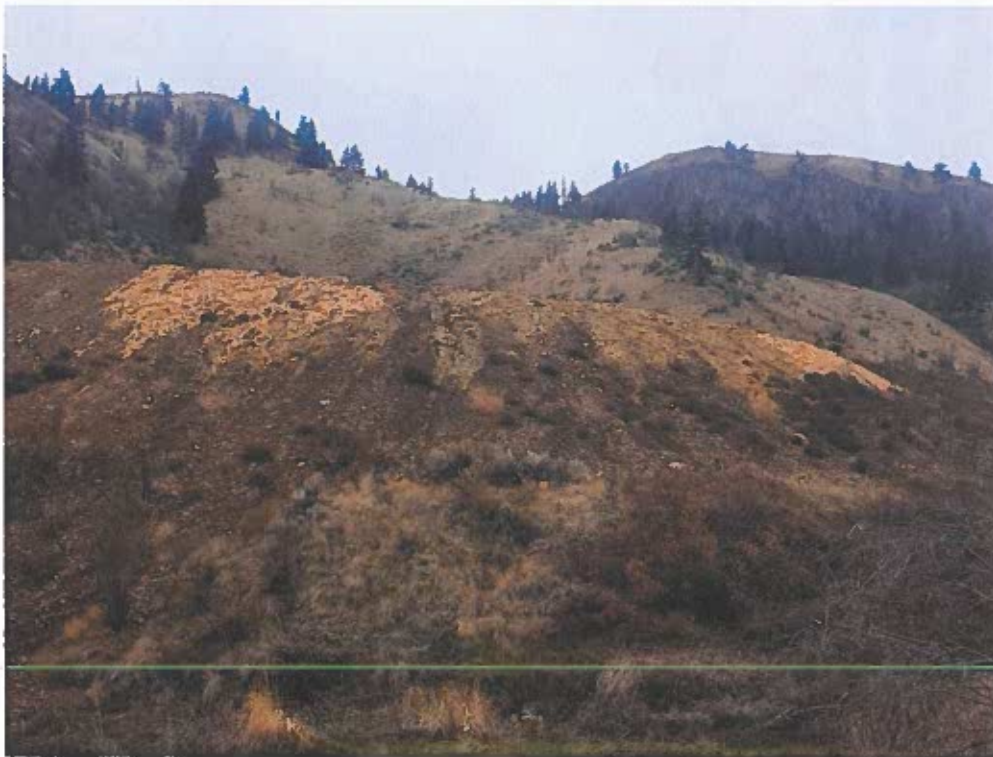
**Figure 6      Straw ground cover on southerly fill slope**

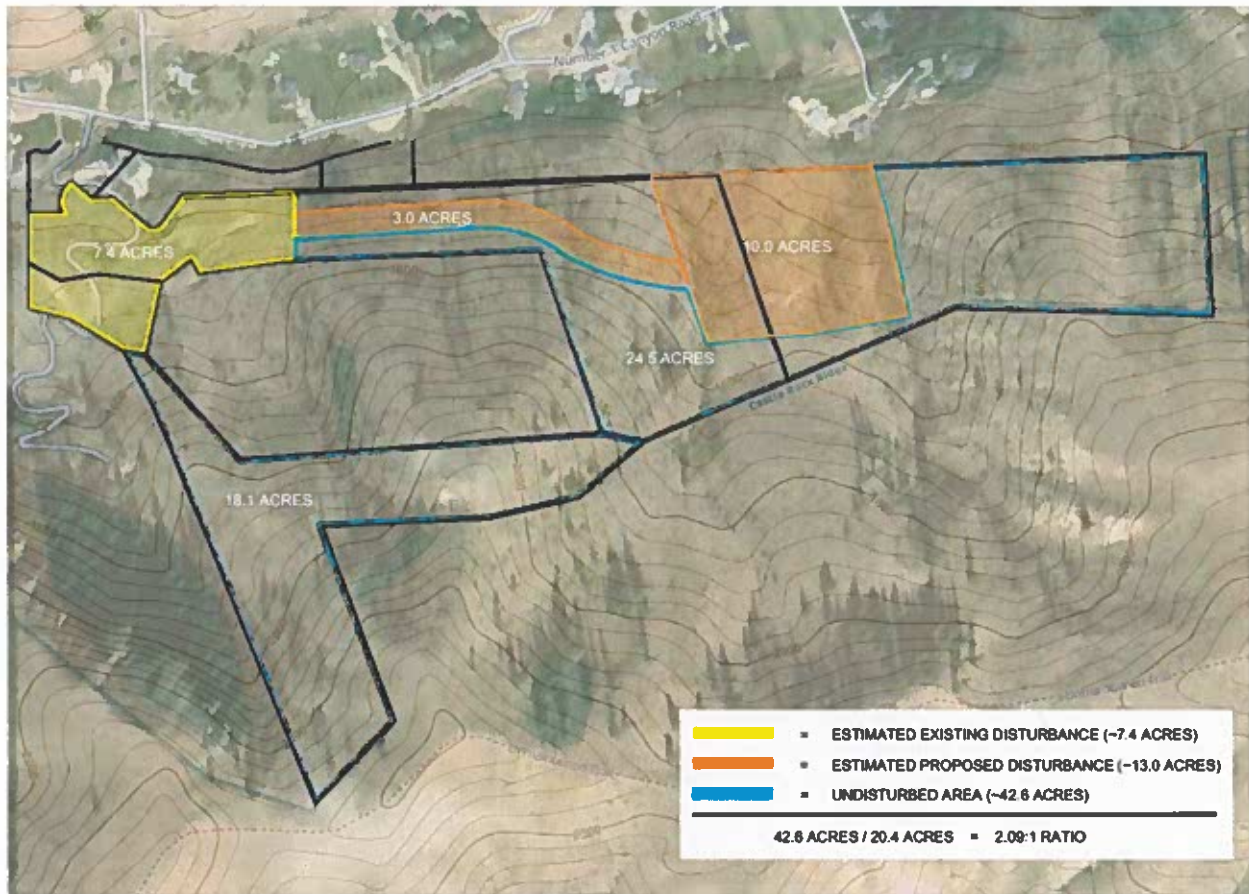
**Figure 7 Existing and proposed land disturbance areas**

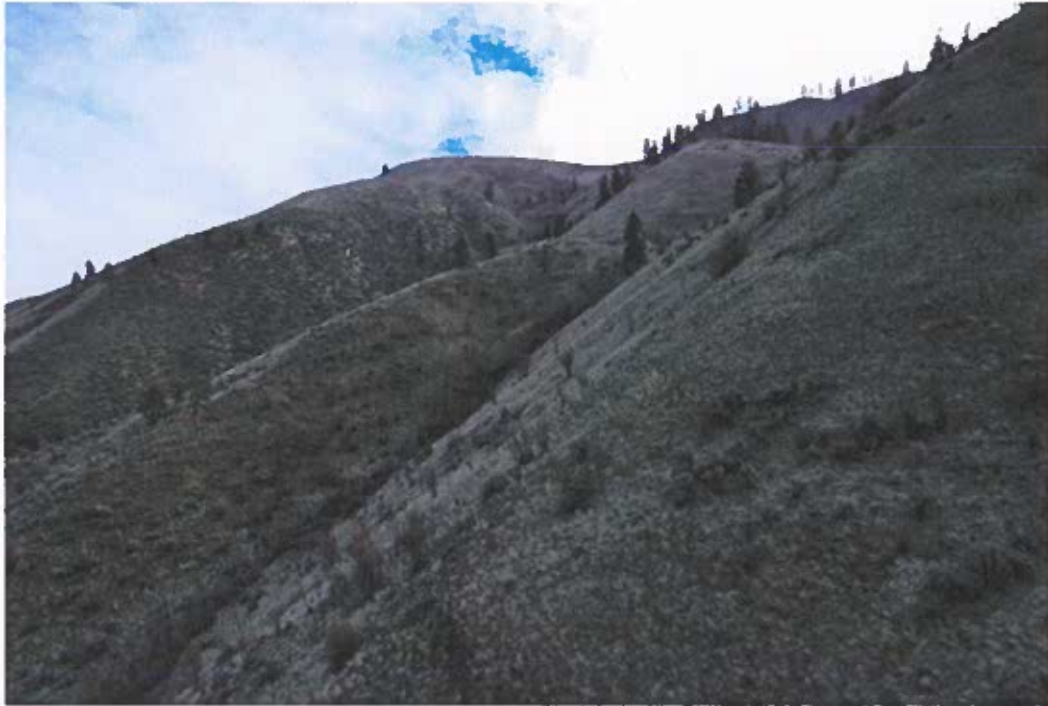
The proposed disturbed areas encompassed within the westerly end of parcel 222007000100 and a portion of 222007120050 were observed on February 23<sup>rd</sup>, 2024. These areas are currently undisturbed and with moderate ground cover (shrubsteppe). The portions of the site that demonstrate steep slopes and/or are sparsely vegetated do not show any obvious signs of erosive activity. No rilling or soil mobilization from water

**Figure 8      Drainage channel and area to be disturbed**

It is recommended that future disturbances are conducted in a way that prevent runoff generated upstream of proposed cut/fill slopes to migrate or concentrate down the face of the slopes. Runoff concentration and flow down proposed slopes may cause erosive action to occur. Silt fence should also be securely installed at the downstream boundaries of future disturbed areas and maintained throughout the course of the project to prevent sediment from leaving the site. Erosion control measures should be employed and consistently maintained throughout the course of any future land disturbing activities.

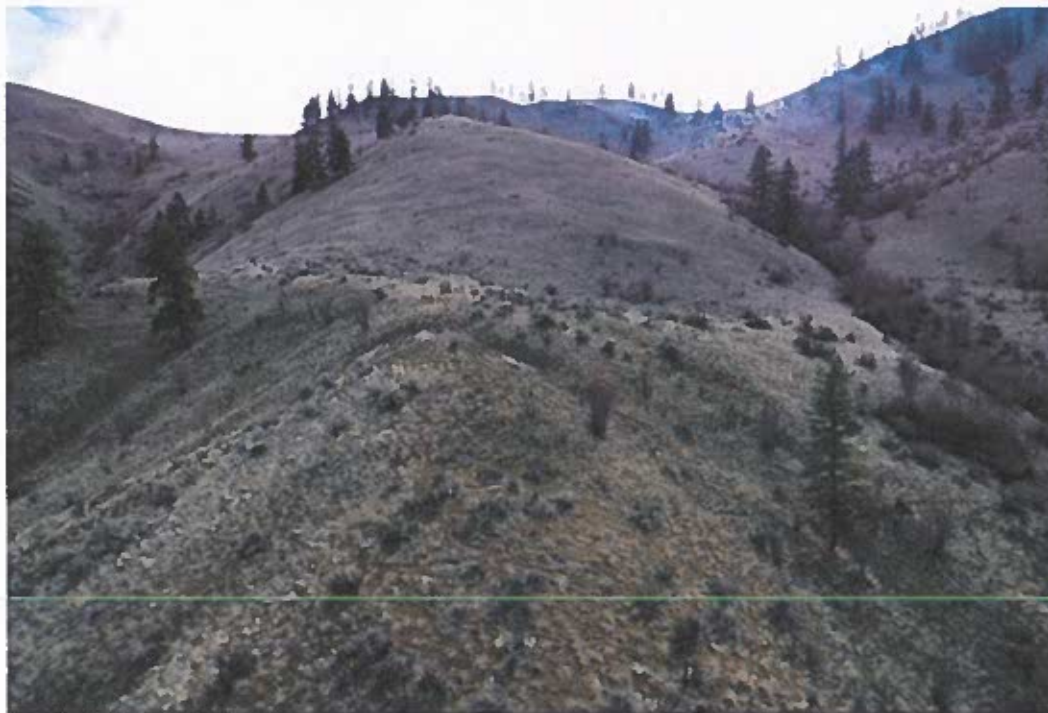
**Figure 9      Proposed disturbed area in vicinity of proposed home site**

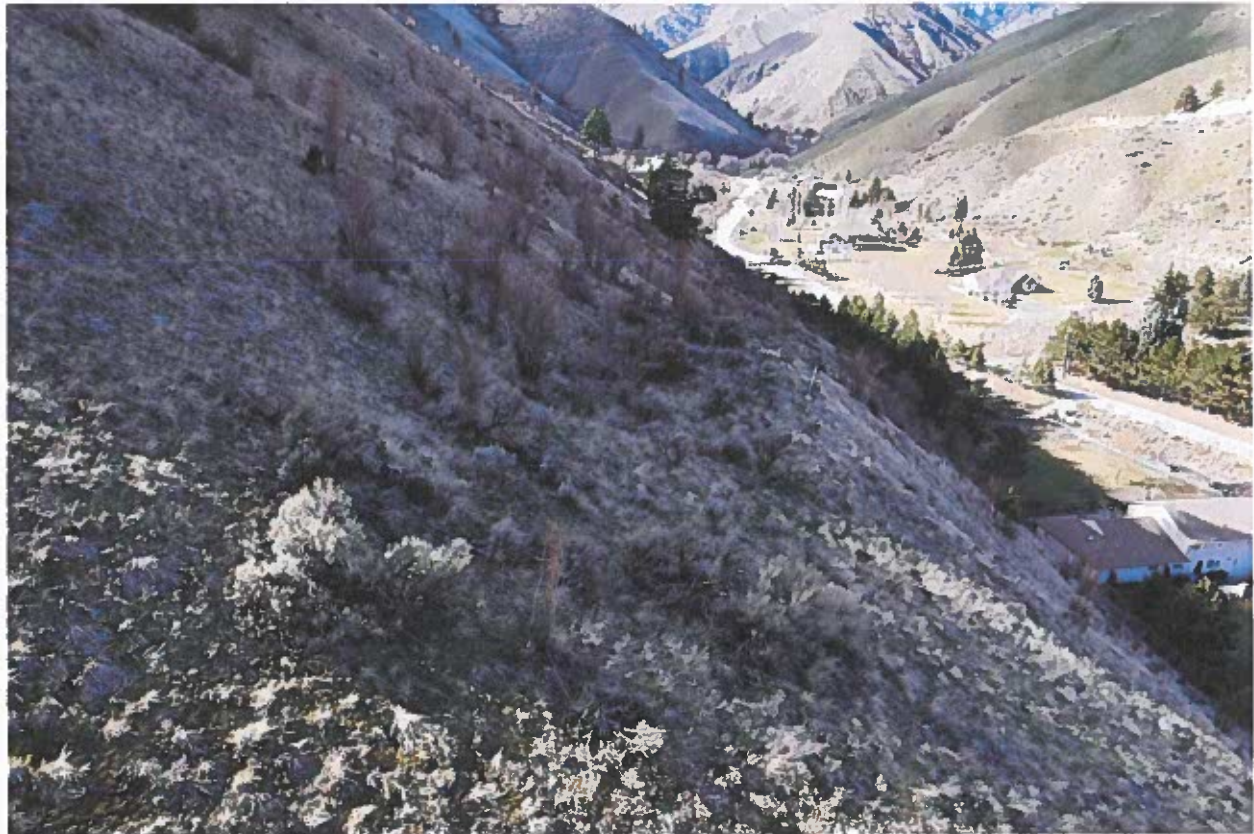
**Figure 1 Proposed disturbed area in vicinity of proposed driveway**

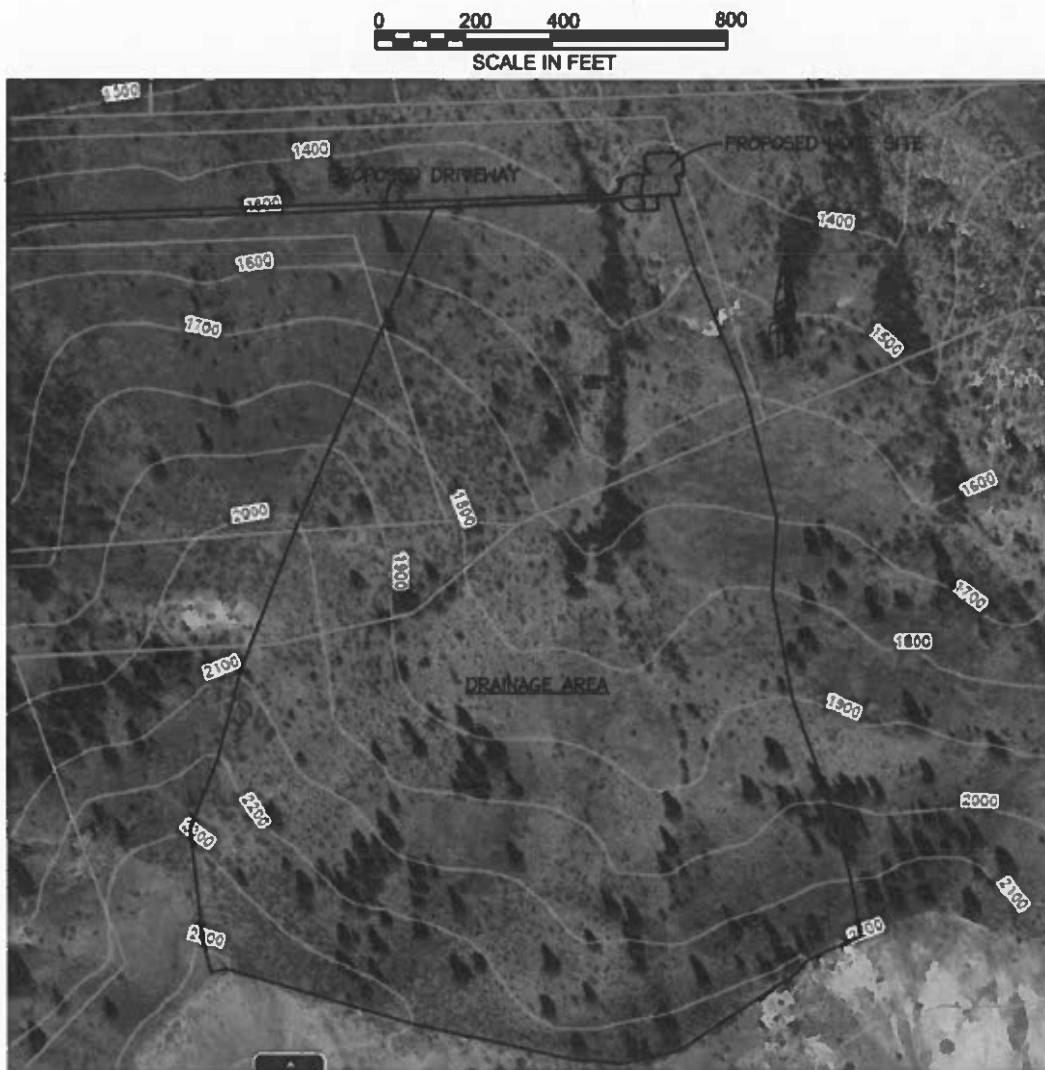
**Figure 10     Drainage area intercepted by proposed development**
