# Aviation Investigation Final Report

| <b>Location:</b> | Whitesville, Kentucky | <b>Accident Number:</b> | ERA23FA380 |
| <b>Date &amp; Time:</b> | September 27, 2023, 22:49 Local | <b>Registration:</b> | N3079M |
| <b>Aircraft:</b> | Piper PA28 | <b>Aircraft Damage:</b> | Destroyed |

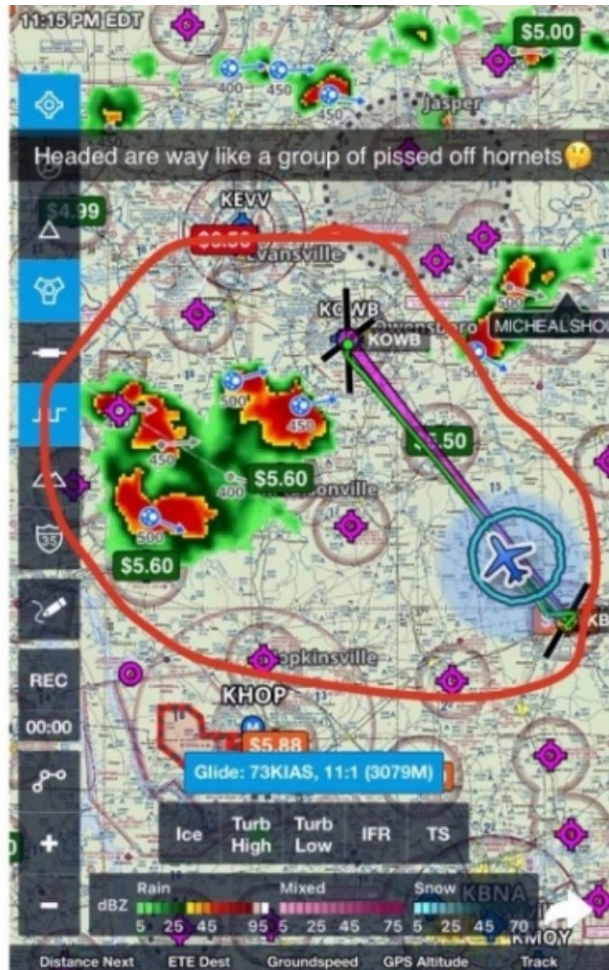
Figure 1 - Screen capture of a post to the flight instructor's social media account. Note the airplane's current position (blue airplane icon), the planned route of flight (magenta line), the depicted weather radar imagery, and entire area circled in red.

Additional information from ForeFlight was compared to the flight instructor’s screen capture (figure 1). The information revealed that the weather radar image was from internet sources and not Flight Information Services – Broadcast (as might be available to aircraft flying within ADS-B coverage and being equipped to receive such broadcasts). Based on the airplane’s position at the time of the screen capture, the weather radar information depicted was about 10 minutes old.

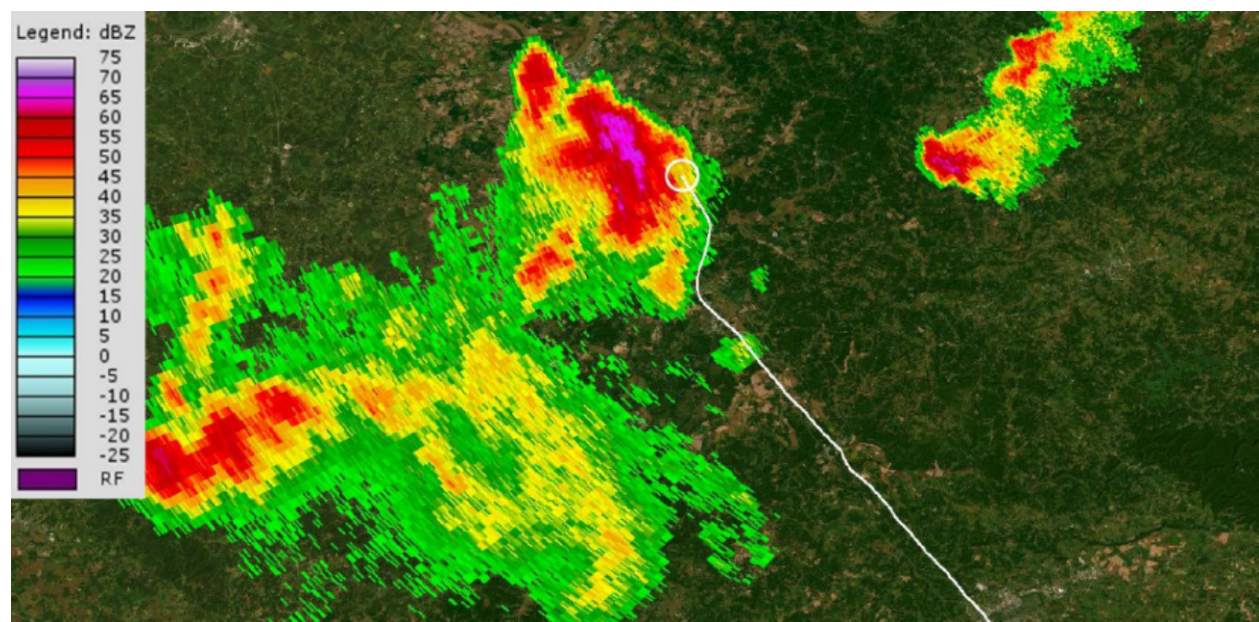
Figure 2 depicts the airplane’s ground track (white) and the Louisville, Kentucky WSR-88D weather radar base reflectivity product. The weather radar image represents a sweep that was initiated at 2245, while the circled portion of the airplane’s flight path represents its position at 2236.

Figure 2 - Aerial image with the airplane’s flight track (white) and weather radar reflectivity information overlaid.
