**131 WEST WILSON PARKING STRUCTURE
& PLAZA DECK**

STRUCTURAL CONDITION STUDY

August 17, 2016

GUNNAR MALM & ASSOC., INC

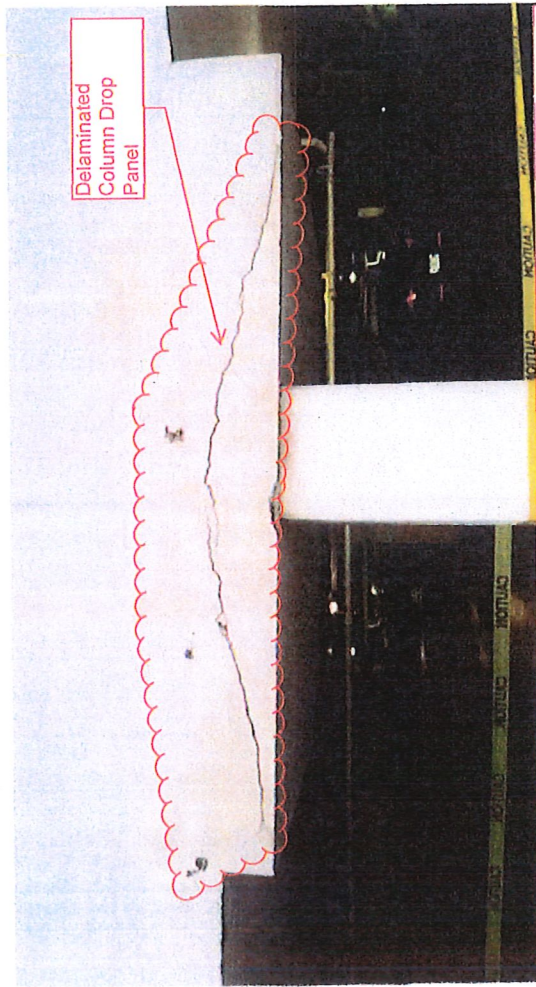
1.1 Column Drop Panel

Underside slab delaminations extended into some of the column drop panels. Unit costs for these repairs takes in account the increased 4" depth of slab & high concentration of reinforcing steel.

Delaminated
Column Drop
Panel

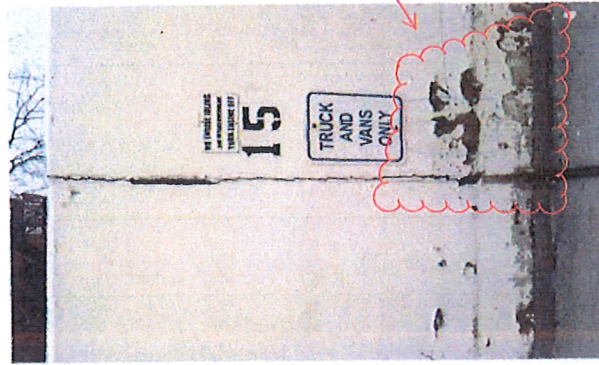
1.2 East Wall

Interior face of wall was sounded from top of slab up to 8 feet, areas of delamination were found adjacent to top of slab and adjacent to wall expansion joint.

Failed East Wall
Exp. Joint & Wall
Delaminations

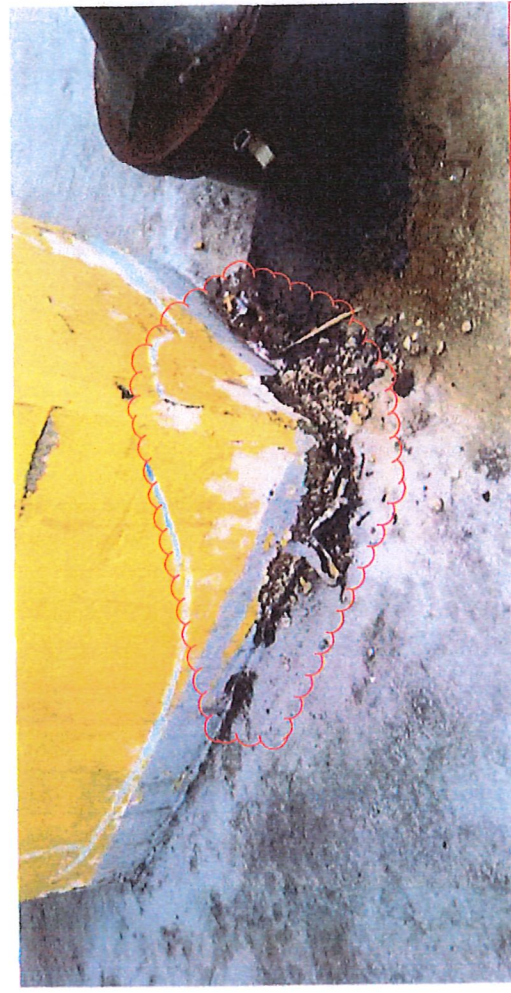
Concrete columns were sounded with delaminations found at column bases adjacent to top of slabs, as well as high on columns where delamination were caused by leaking water from above.

1.3 Deteriorated Column Base

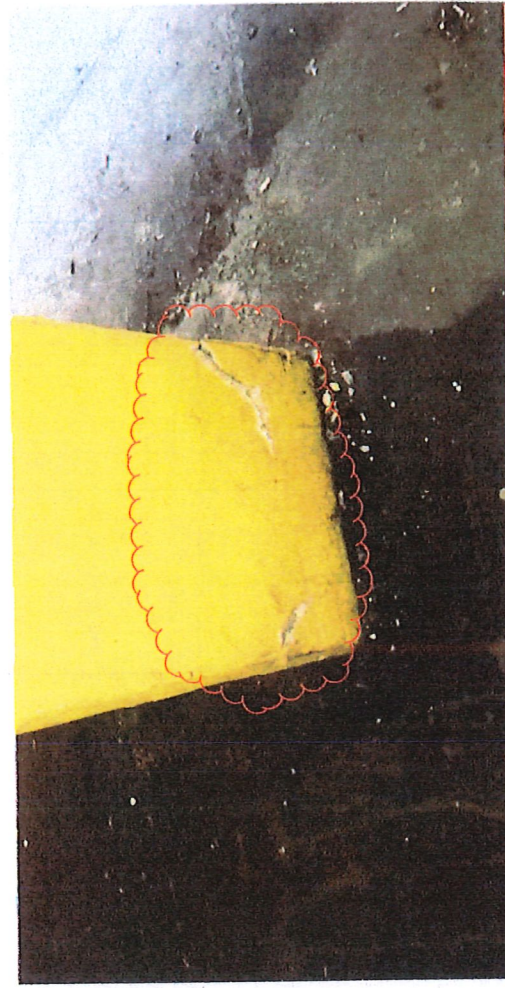
1.4 Column Base Delaminations

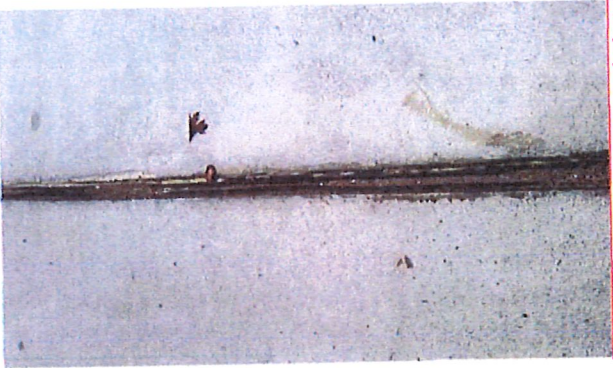
Although there were numerous observed areas of expansion joint failure, in our opinion the water outflow observed at the underside of expansion joints is attributed to water infiltrating the slab and traveling along the un-bonded interface between the structural & topping slabs.

2.1 Failed Slab Exp. Joint

Remove 7 replace 100% of expansion joints once topside delamination repairs are completed.

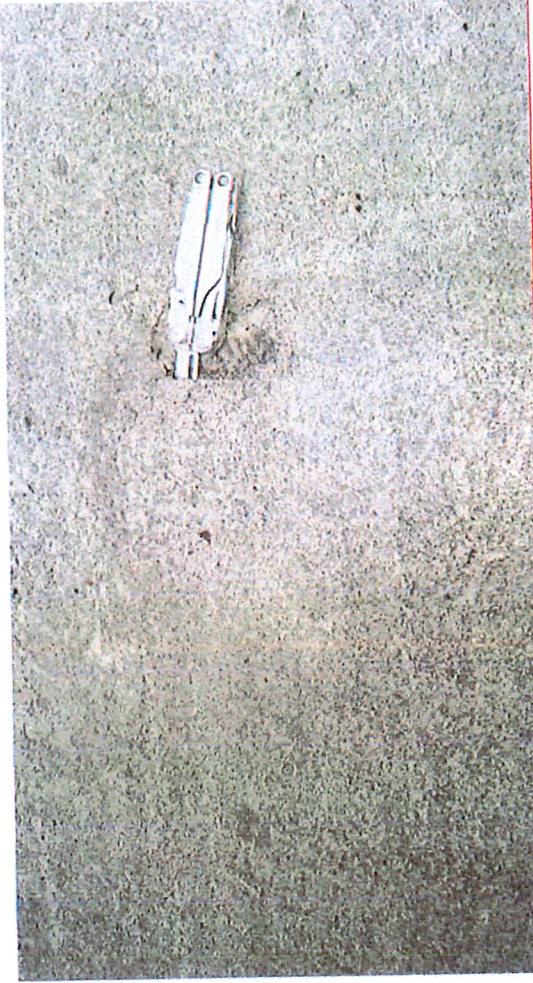
Kelmar vehicular membrane for the remainder of the ramp. Although this membrane uses a more abrasion resistant epoxy wear coat, failure of the drive lane membrane was present, with P1U drive lane failures in excess of 65%. Membrane wear and failures are reduced as you move down the ramp, in relationship to the reduced amount of overall traffic.

2.2 Failed & Worn Membrane

Recommendations include full removal of membrane in order to define topside slab delamination areas so debonded membrane can be excluded from concrete repair quantities. Additionally, with the extensive amount of topside delaminations to be repaired either by conventional hammering or epoxy injection, a new membrane system will provide long term protection in lieu repairing old membrane.

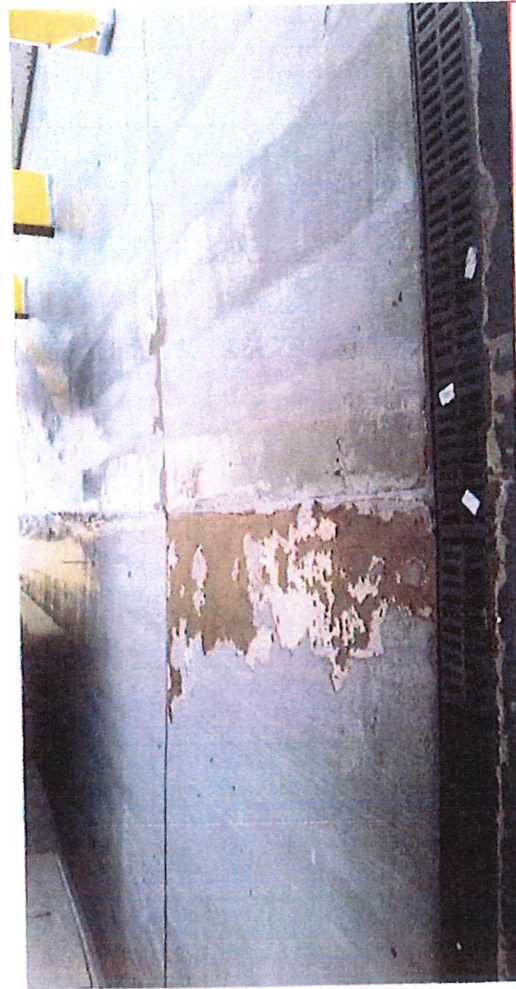
The entry ramp from W. Wilson Street (level P0) is a urethane based vehicular traffic membrane that is in poor condition. 75% of the overall membrane either shows significant wear, through both top wear courses, or a complete failure if the base coat is compromised.

2.3 Failed Membrane

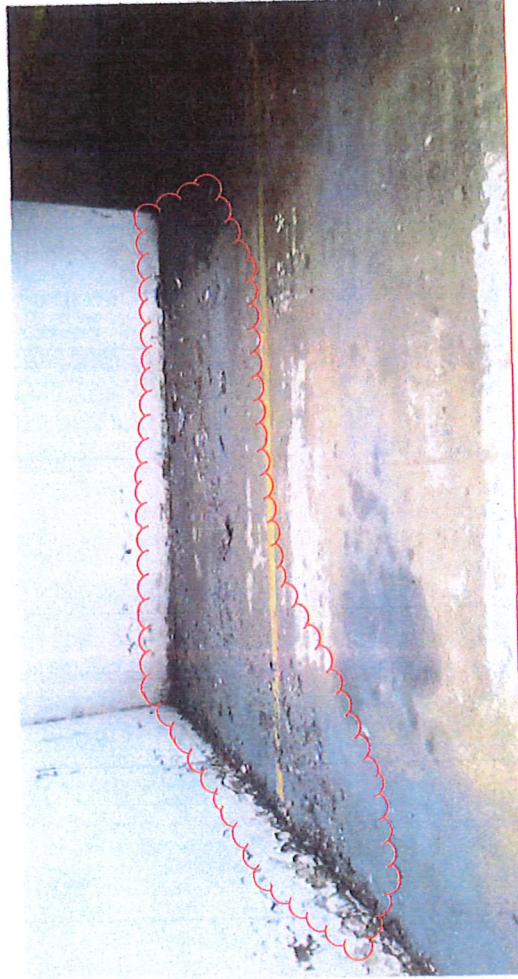
2.4 Debris on Slab

See Appendix A; Structural Preventative Maintenance, where cleaning and inspection of expansion joints are performed after typical annual spring wash downs of parking surfaces. Additional periodic housekeeping to vacuum accumulated debris from within joint at regular intervals will reduce the debris caused damage to the expansion joints.

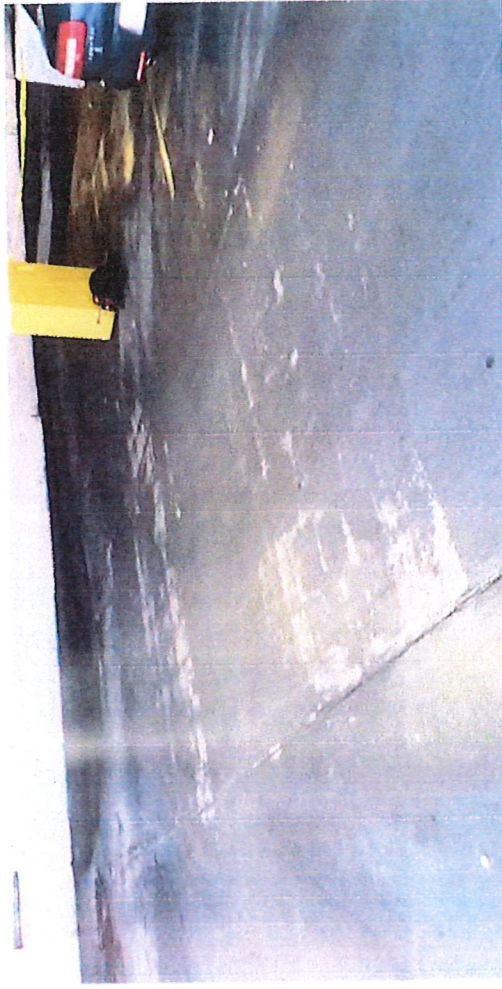
3.1 Worn Membrane

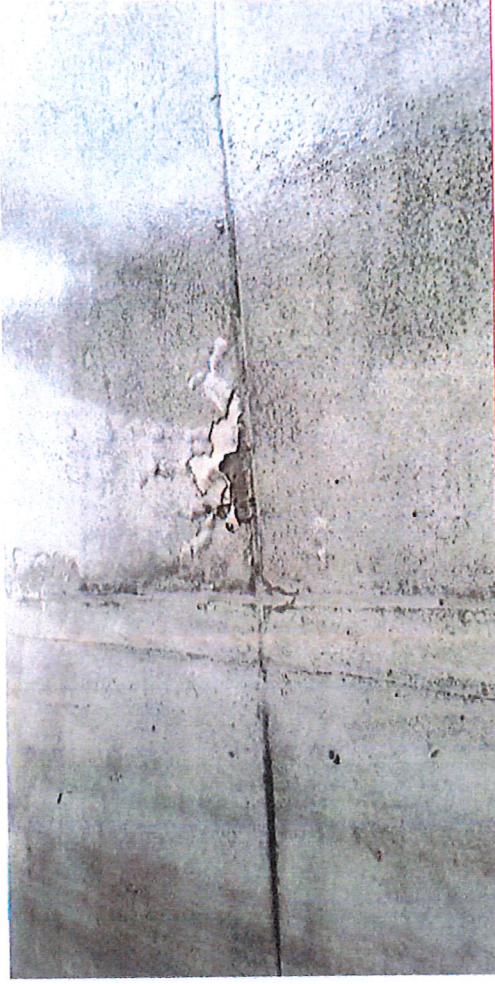
3.2 Failed Membrane

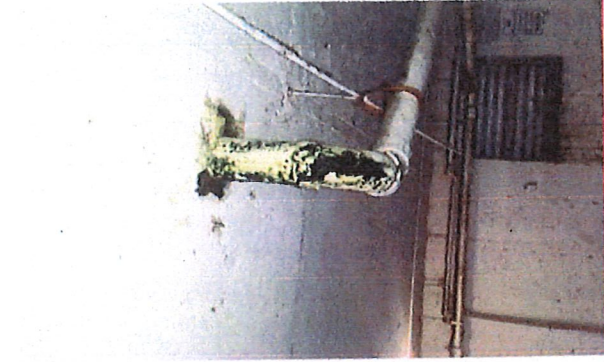
Underside of trench drains showed extensive signs of leaking and rust staining, these repairs within the estimate have a higher unit repair cost due to the increased amount of reinforcing steel. Coating of the interior of the trench drain with special epoxy coatings will prevent future water infiltration into the slab below.

3.3 Leaking Drain

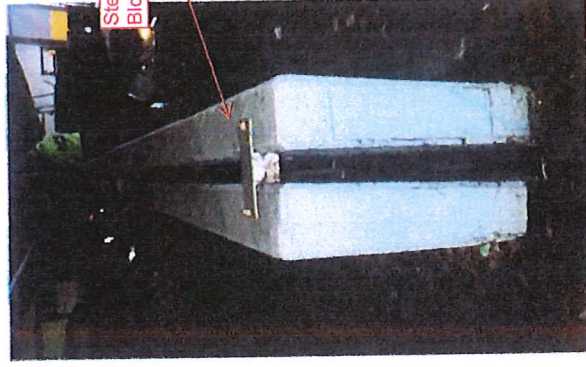
4.4 Interior Parapet Wall

Observations found delamination and rotation of walls out of vertical plane, but more importantly there have been modifications like steel spacer block between walls, and columns from slab to top of walls, need further investigation. Documentation of these modifications, should be found, along with destructive investigation should be performed. Repair of these items were not included within the estimate.

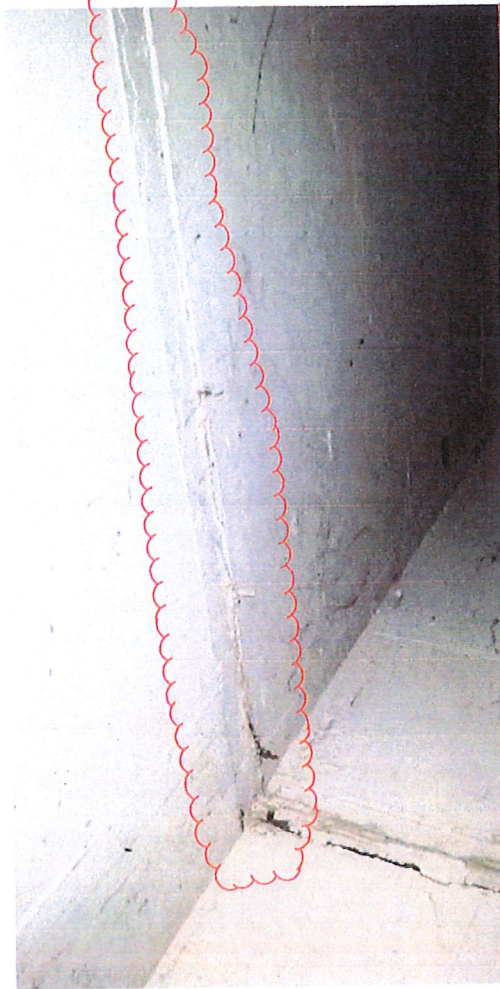
While performing field work we observed water leaking from underside of expansion joints for multiple days after a rain event. During these periods after rain events, there was no water on the surface of the slab above, and all joints leaked to some extent, including all the way down to the lowest joints in the ramp, P2U, north of grid C adjacent to Red's office & storage.

4.1 Leaking Slab Expansion Joint

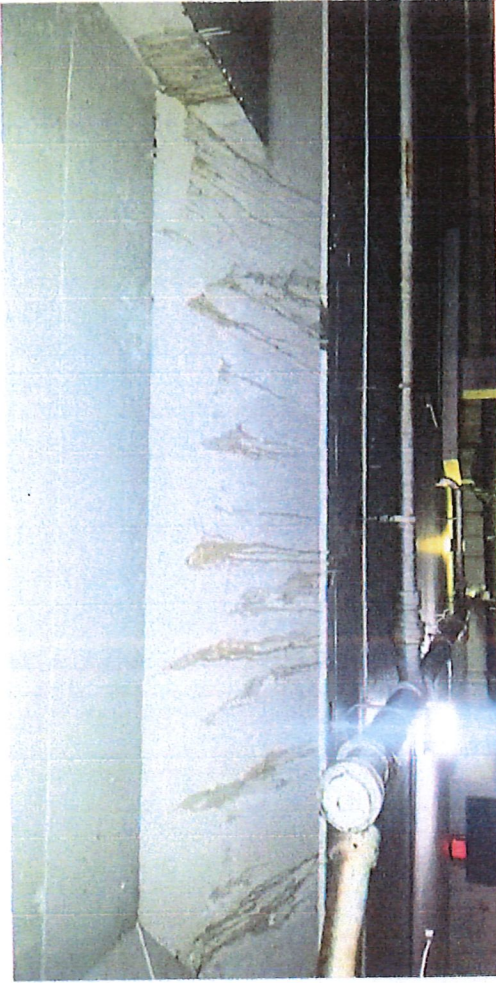
A waterproofing layer and concrete wear surface is indicated on the structural details but not identified. No internal drainage mat is called out or indicated on the drawings. No waterproofing specifications are available at this time. CMR performed repair on north stair, GMA was present during demo where a built up tar "roofing system" was identified. This built up system has failed due to it's age, noted by the system had swollen with moisture. When Paisan's restaurant was added, Miron Construction installed an unknown orange waterproofing membrane under the south plaza. Both of these membranes have failed as evidenced by the 1,084 lf of active leaking observed during a rain event.

4.2 Underside Plaza Leaking

- Removal of the entire existing 4" concrete wear surface.
- Remove the existing water proof membrane and install a new waterproof membrane. Included would be leak testing of the new waterproofing.

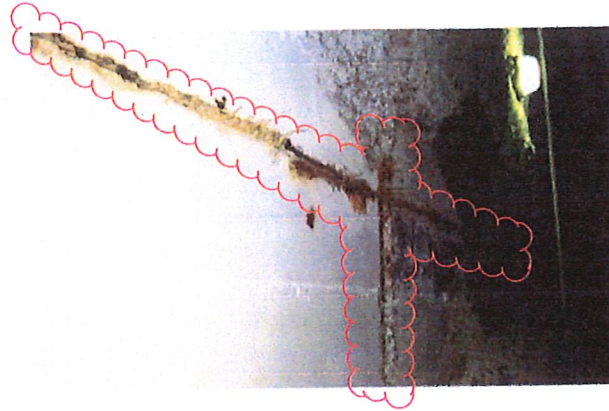
4.3 Failed Slab Exp. Joint

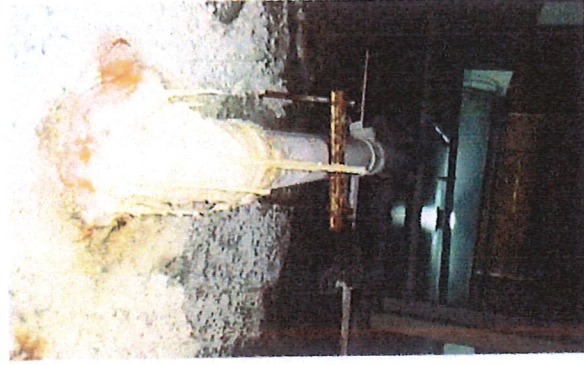
4.4 Leaking Drain

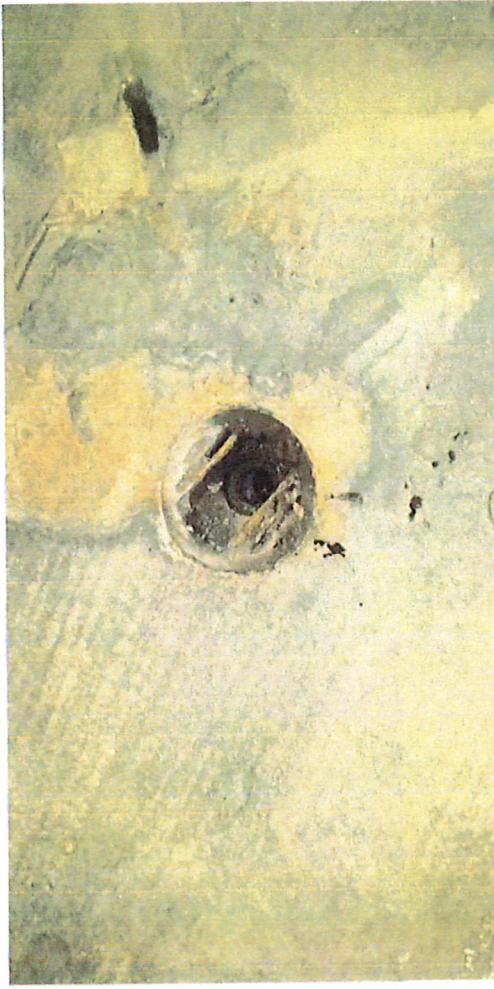
5.1 Broken Drain Grate

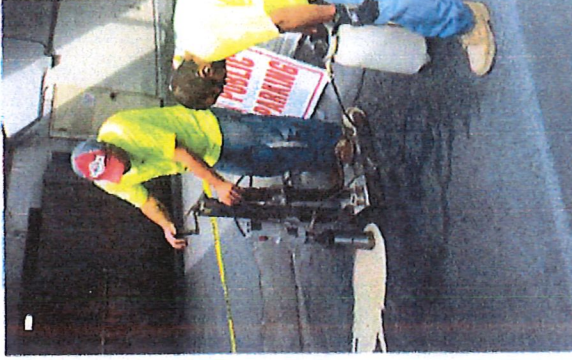
15 of the 16 cores extracted had the topping slab de-bond from the structural slab during coring operations. When the coring bit was extracted, the topping slab portion was loose

5.2 Coring Operations
