# Seismic Risk Assessment, Conceptual Seismic Retrofit, Budgetary Structural Construction Estimate and Additional Liquefaction Analysis Report

**CONNEL F. SMITH BUILDING/IL-7-4**  
1101 Ohio St.  
Cairo, Illinois

OCTOBER 19, 2022

# Seismic Risk Assessment and Conceptual Retrofit Report

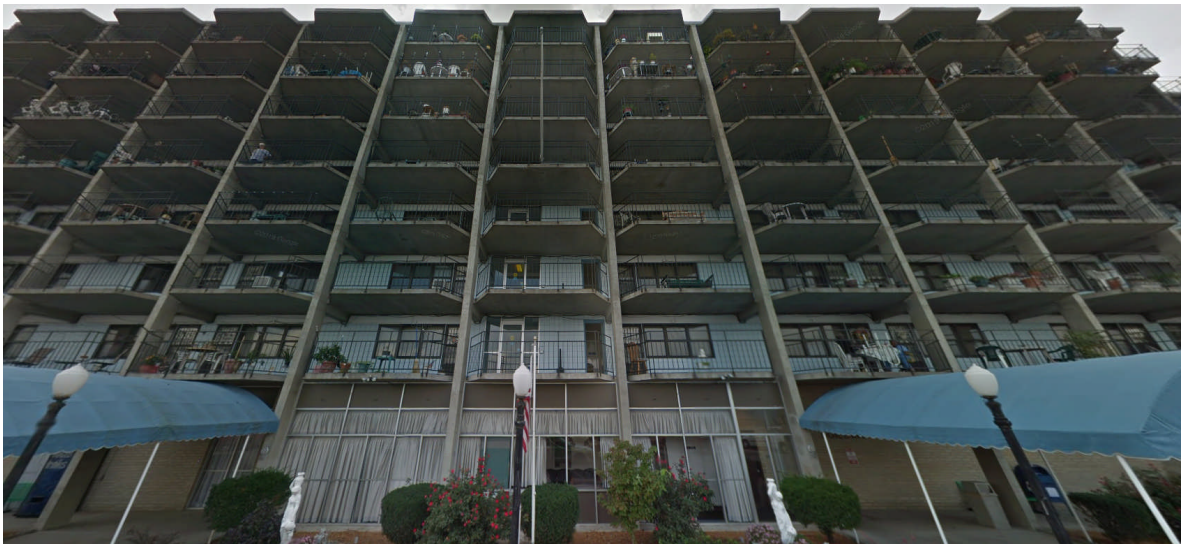
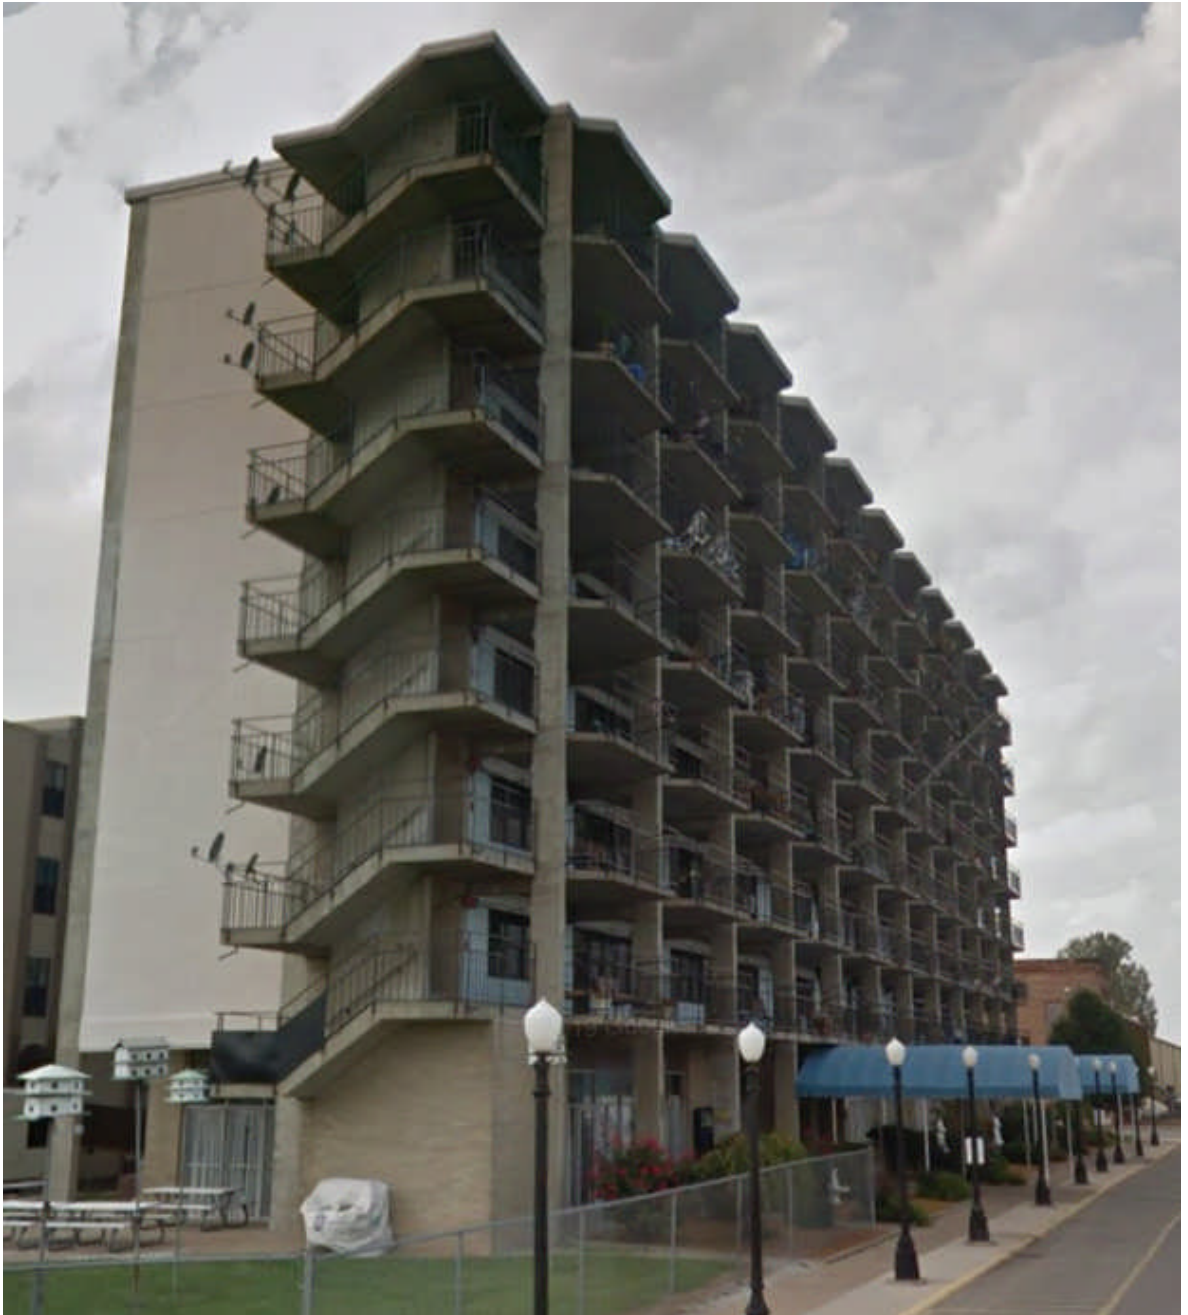
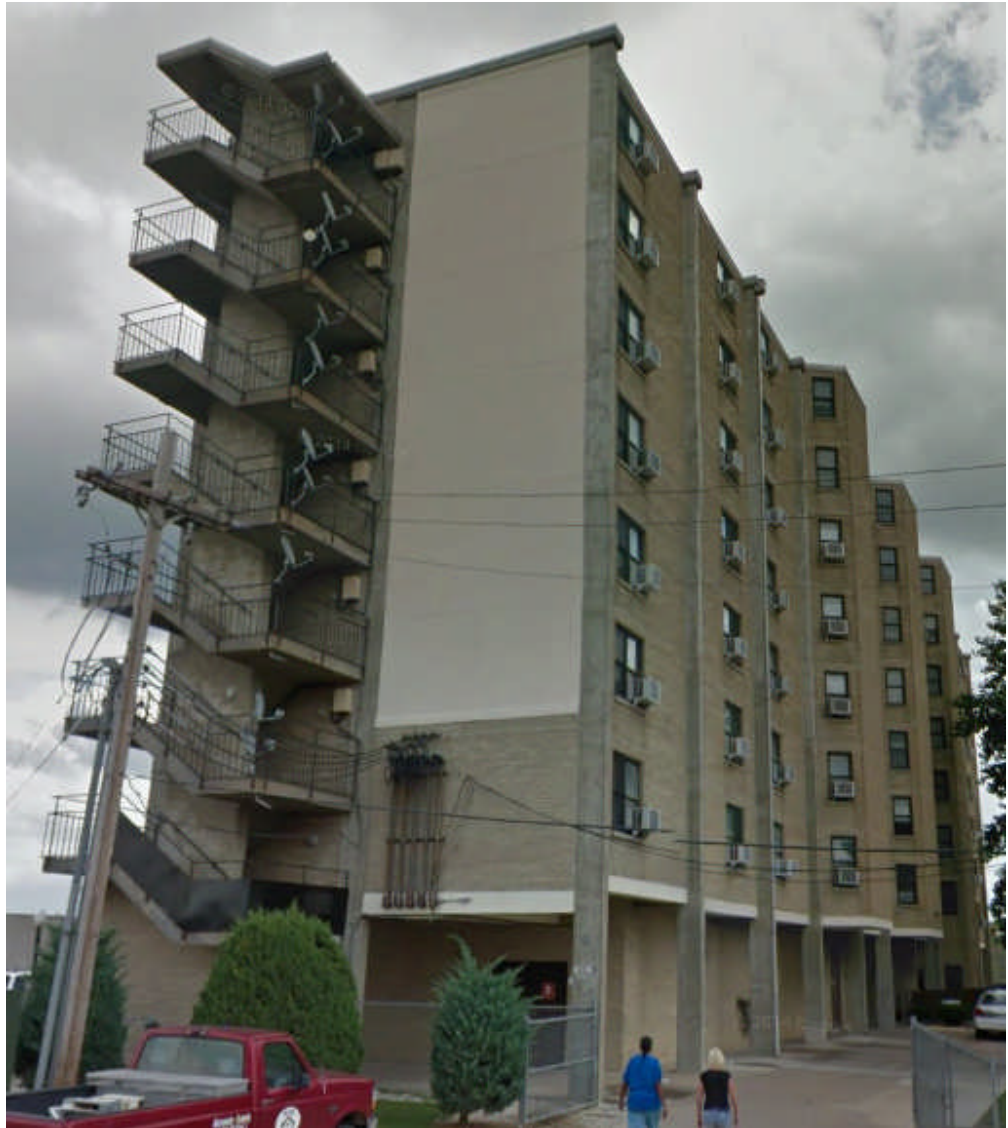
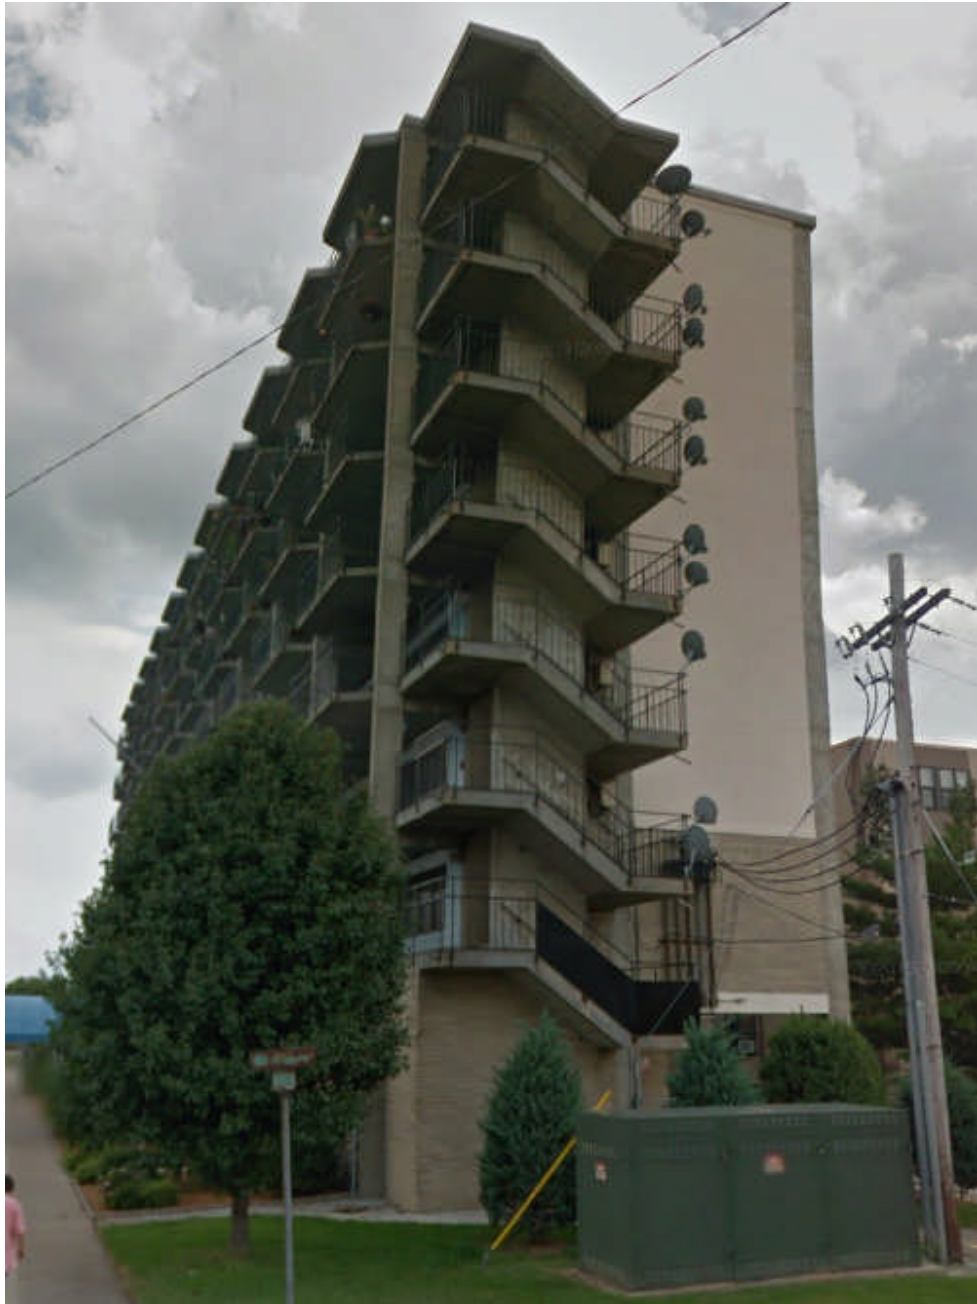
Figure 2 – 1: Smith Building North Elevation

Figure 2 – 2: Smith Building East Elevation

Figure 2 – 3: Smith Building South Elevation

Figure 2 – 4: Smith Building East Elevation

A site visit, including condition assessment and visual observation, has been performed by Fendrich Engineering, Inc. At the time of this site visit, the overall existing building condition was determined to be in fair to poor condition. Observed existing structural conditions contributing to the overall condition assessment include concrete cracking, spalling, and exposed reinforcement at several column, beam, and slab locations throughout the structure and are further described within the referenced Fendrich Engineering, Inc.'s report.

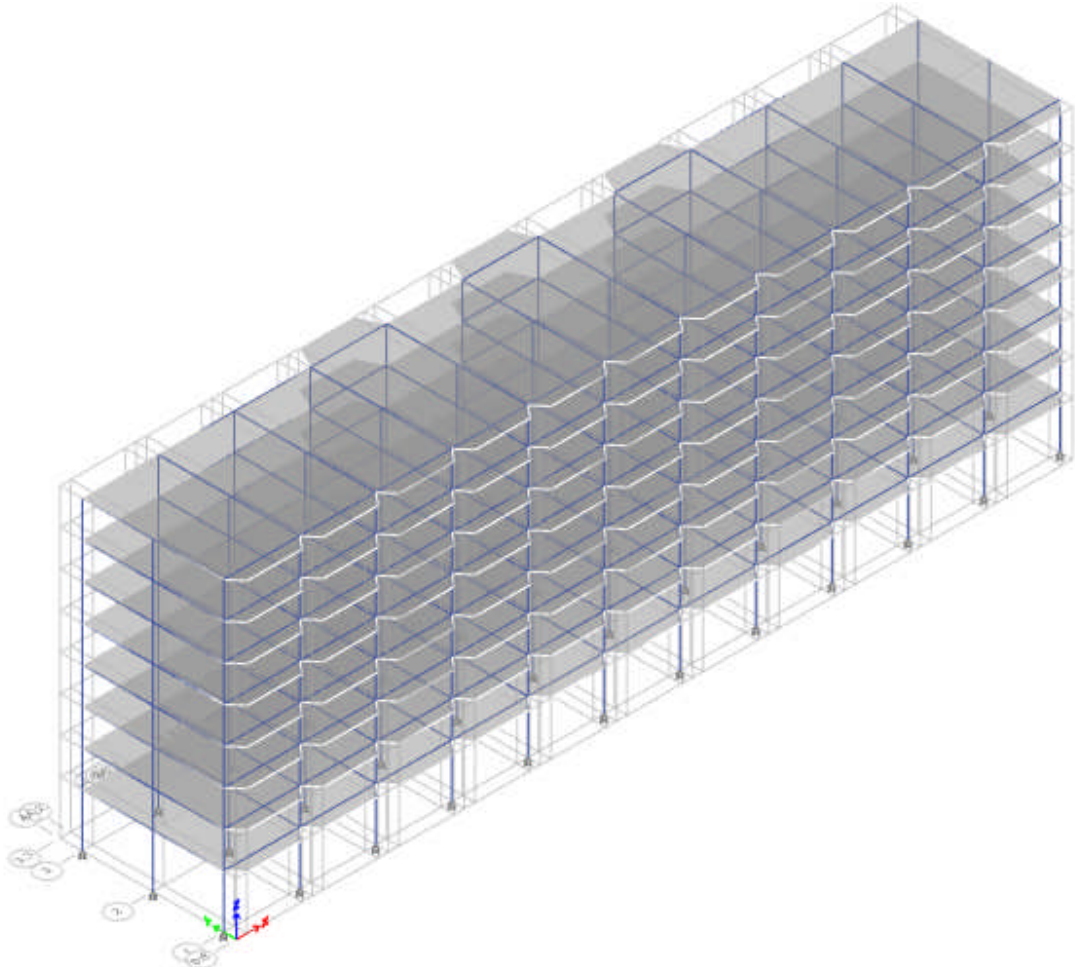
Figure 4 – 1: Three-Dimensional View of the ETABS Model of Existing Building

Foundation supports are modelled as pinned base, with anticipated liquefaction-induced differential settlements, per the geotechnical report, ranging linearly from 1 inch at the southwest corner of the building to 20 inches at the northeast corner of the building with a maximum of 25 inches at the northeastern corner column location.

The linear dynamic analysis corroborated the deficiencies that were identified in Section 4.1 and substantiated the concern that the existing building could collapse in the scenario seismic event. The most prominent finding of this analysis is that both the existing building fundamental period and drift in the long direction are excessively large, with the latter being considerably exacerbated by anticipated liquefaction settlement. The corroborated description of existing building seismic deficiencies derived from our structural analysis model are detailed in Table 4 – 2 below.

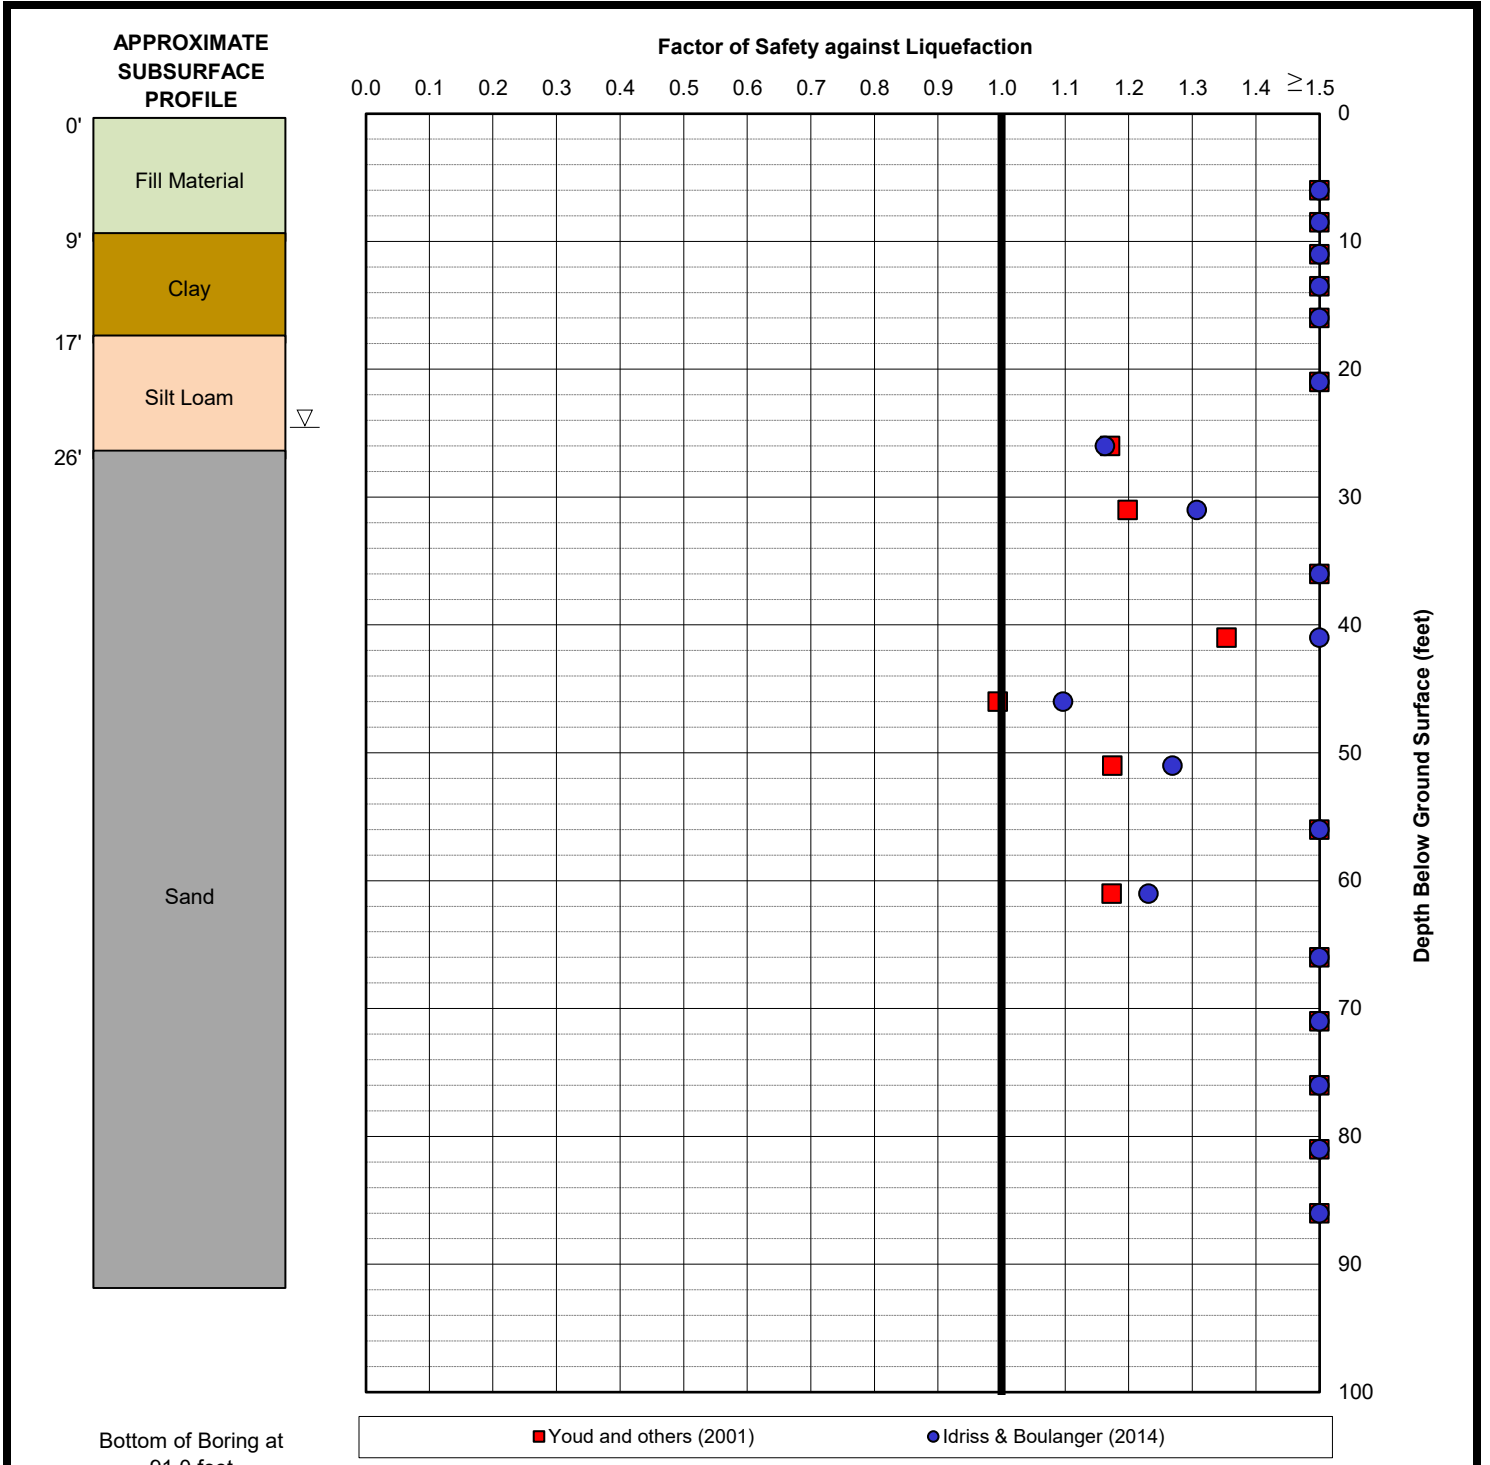
Liquefaction Analysis Alexander County Housing Authority Building Cairo, Illinois	
<b>RESULTS OF LIQUEFACTION ANALYSES</b> <b>BORING B-1 (1965)</b> <b>M = 7.5, PGA = 0.18g</b>	
September 2022	110072-001
<b>SHANNON &amp; WILSON, INC.</b> Geotechnical and Environmental Consultants	<b>FIG. 1</b>

1. See main text for references.
2. The liquefaction resistance of a soil is based on its density and fines content. We used the results of the standard penetration testing to estimate the density, and the results of selected laboratory tests to estimate the fines content.
