# Aviation Investigation Final Report

| <b>Location:</b> | Cuba, Kentucky | <b>Accident Number:</b> | ERA24FA304 |
| <b>Date &amp; Time:</b> | July 13, 2024, 15:27 Local | <b>Registration:</b> | N2003Y |
| <b>Aircraft:</b> | Air Tractor AT802 | <b>Aircraft Damage:</b> | Substantial |

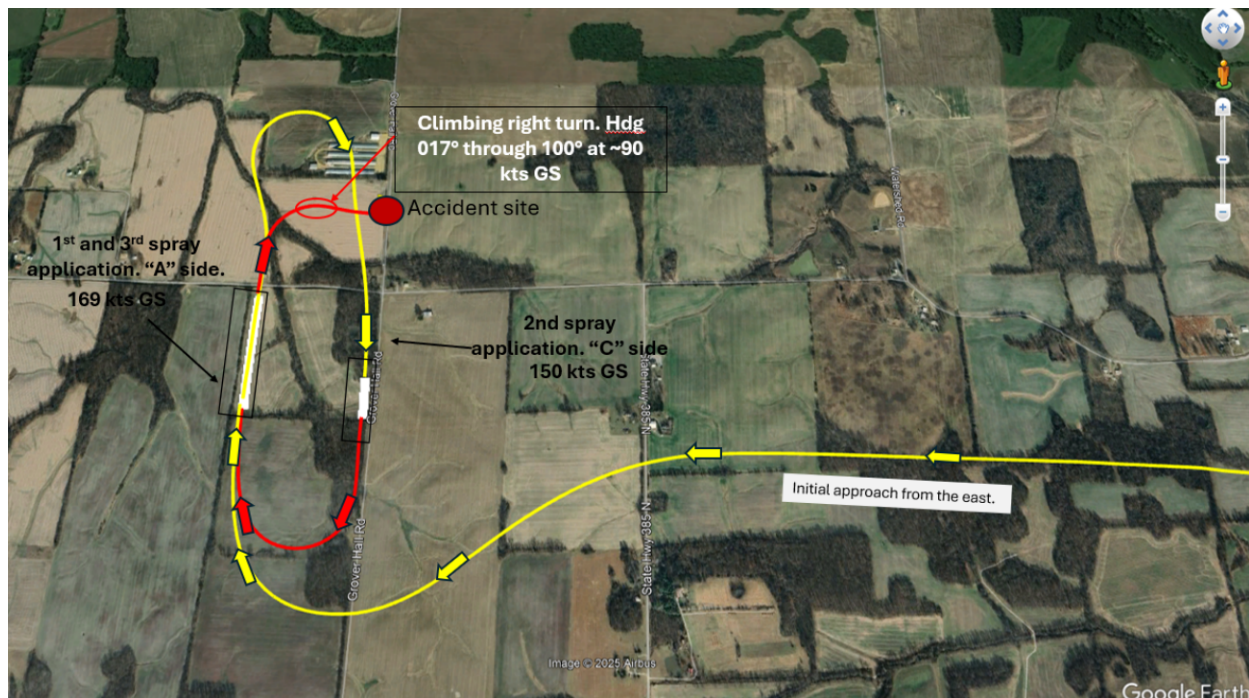
The flight track data showed that the pilot approached the property from the southeast and began spraying the western section of the field (A side). The data did not include an altitude parameter; however, the subsequent increases and decreases in ground speed data implied a climb or a descent without absolute altitudes. The pilot’s first and brief application pass on the field was conducted at 169 kts (all speeds reference the airplane’s ground speed) on a heading of 360°. After that pass, he made a climbing right turn followed by an approach to the eastern side of the field (C side), which he overflew at 150 kts on a heading of about 180°.

After the second application, the pilot made a climbing right turn at 104 kts and then established an approach for another application on the A side of the field, on a heading of 360° and 146 kts. According to the operator, the first spray must have been a partial spray based on the second pass in the same location to re-apply product. The owner stated that the next pass was likely going to be the center of the property (for the “B” pass).

After the second A-side application, the pilot made a right turn through about a 100° heading and 86 kts then leveled out; the airplane remained on an easterly heading at a stable 90 kts where it flew into the mature corn, then impacted terrain in a flat, right-wing-low attitude and continued its forward trajectory along the ground, where it traveled over an embankment

Figure 1. Flight track overview showing spray applications and accident location.
