## Aviation Investigation Preliminary Report

| <b>Location:</b> | Canton, MS | <b>Accident Number:</b> | CEN25MA115 |
| <b>Date &amp; Time:</b> | March 10, 2025, 12:37 Local | <b>Registration:</b> | N835CS |
| <b>Aircraft:</b> | EUROCOPTER DEUTSCHLAND<br>GMBH EC 135 P2+ | <b>Injuries:</b> | 3 Fatal |

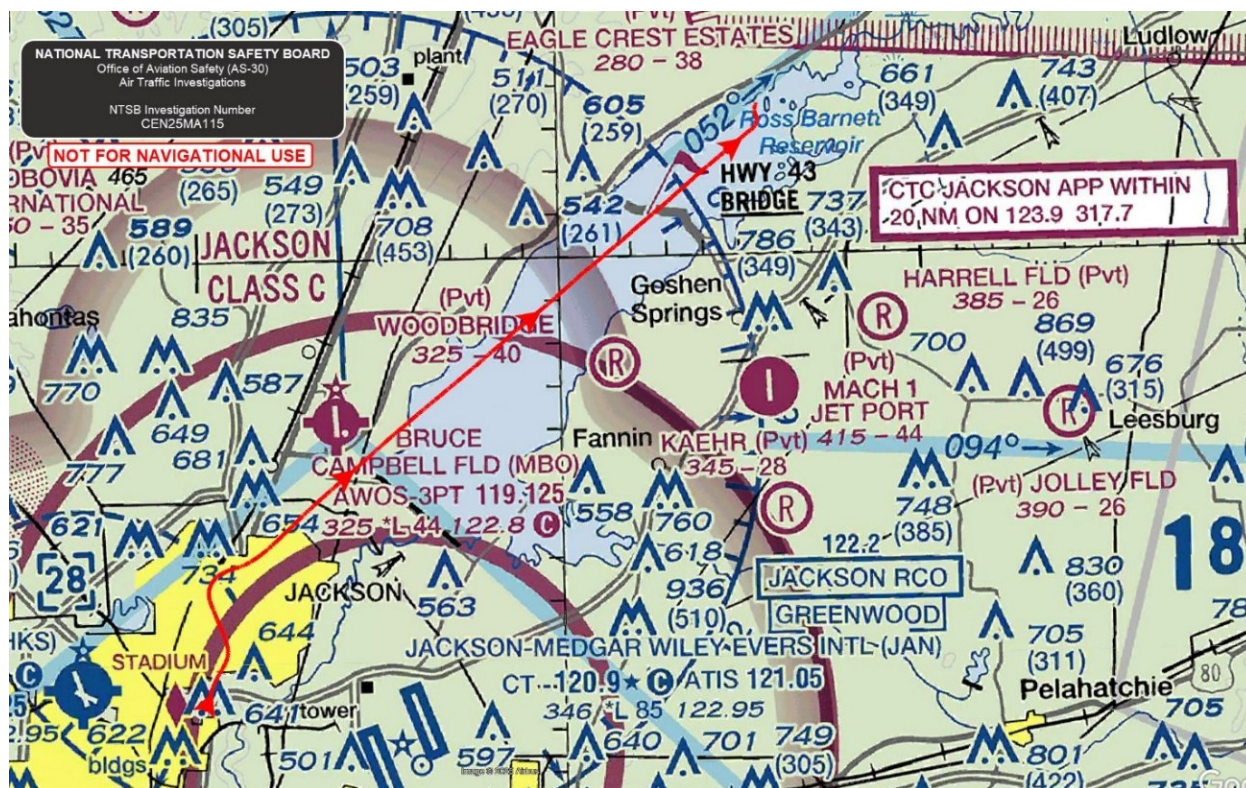
**Figure 1.** The accident flightpath, shown in red, overlaid on a visual flight rules sectional chart.

A preliminary review of automatic dependent surveillance-broadcast (ADS-B) data showed the helicopter departed from MS46 and began to climb to the northeast. The helicopter flew over the Ross R. Barnett Reservoir, and the flightpath remained south of the Natchez Trace Parkway, as shown in figure 1. The helicopter eventually reached an altitude of about 2,500 ft above mean sea level (msl).

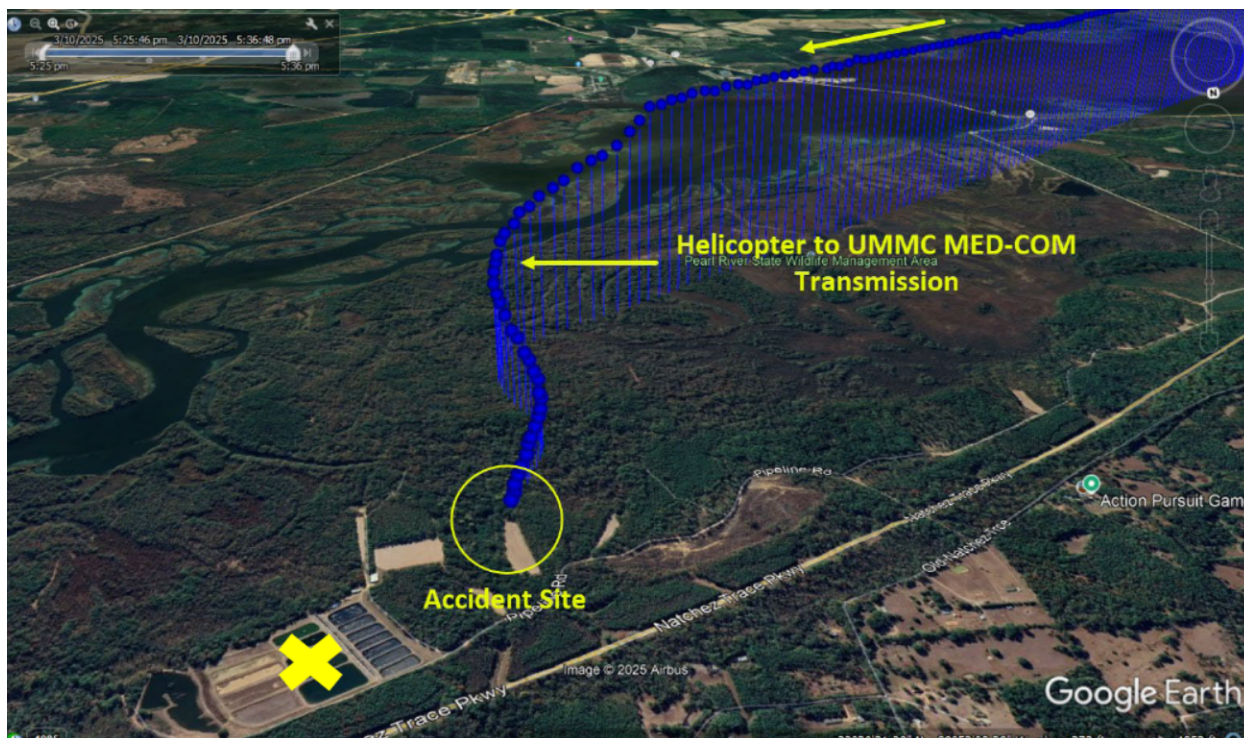
**Figure 2.** Accident flightpath, shown in blue, terminating at the Pearl River State Wildlife Management Area, according to ADS-B data (Sources: FAA and Google Earth). The Turcotte Fish Hatchery is shown by the yellow X.

ADS-B data indicate that, during the descent, the helicopter turned to the north. It impacted multiple trees just to the south of a flat grass field on the Pearl River State Wildlife Management Area, as shown in figure 2. The helicopter came to rest on the southern end of the grass field, at the tree line, at an elevation of about 320 ft msl. The accident site was located about 1/4 mile southwest of the Turcotte Fish Hatchery. The wreckage was destroyed by a postimpact fire that burned for about 3 hours. Due to the remote location of the accident site, fire department units had to deploy 1,300 ft of hose after the initial fire suppression, which was carried out using tank water. Water was then shuttled for the remainder of the firefighting operation.

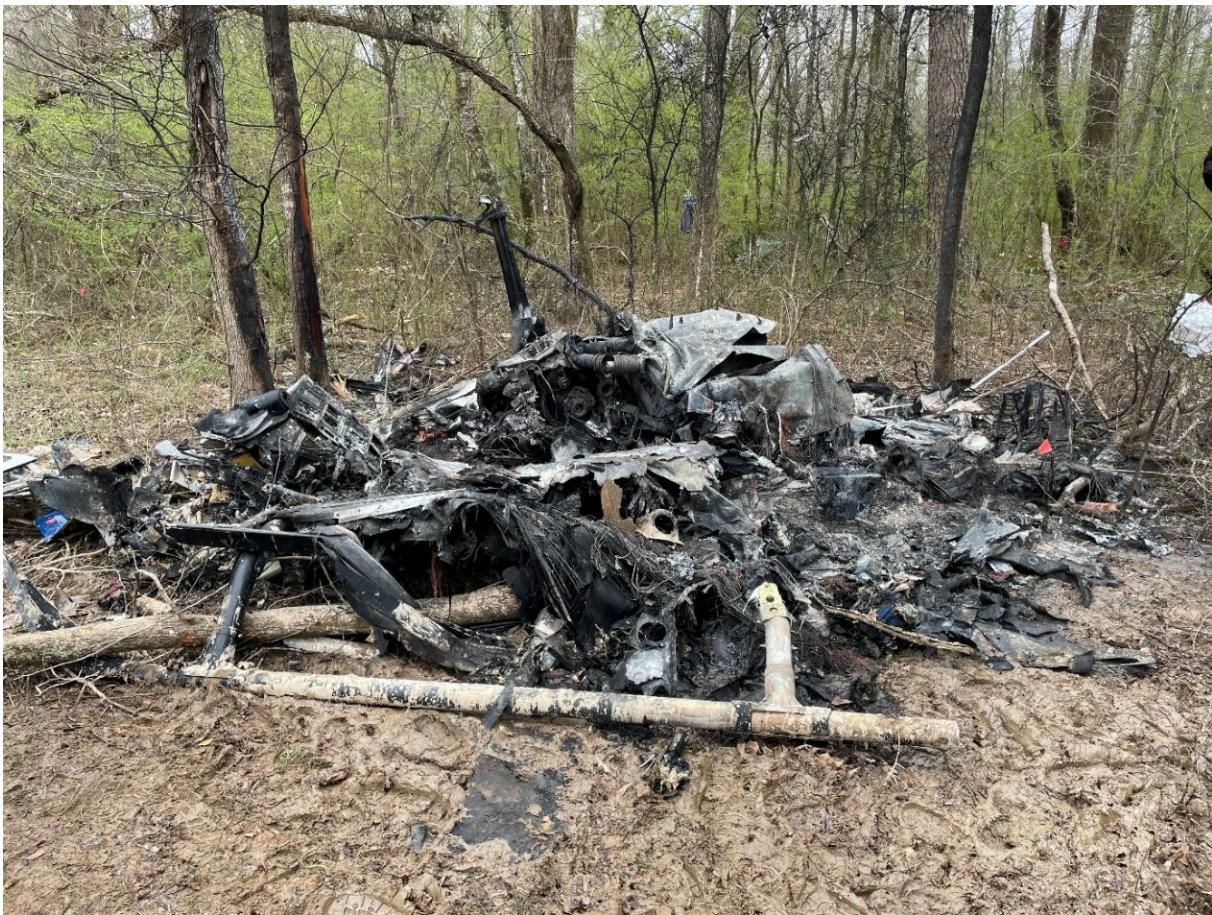
**Figure 3.** The destroyed helicopter at the accident site.

The National Transportation Safety Board, the FAA, Airbus Helicopters, Med-Trans Corporation, and Global Medical Response traveled to the accident site. Due to postcrash fire damage as shown in figure 3, none of the helicopter systems could be functionally tested.
