MEMORANDUM

**RE:** Investigation of June 13, 2018 Incident at Rock Island Dam, Gate No. 17

EXECUTIVE SUMMARY

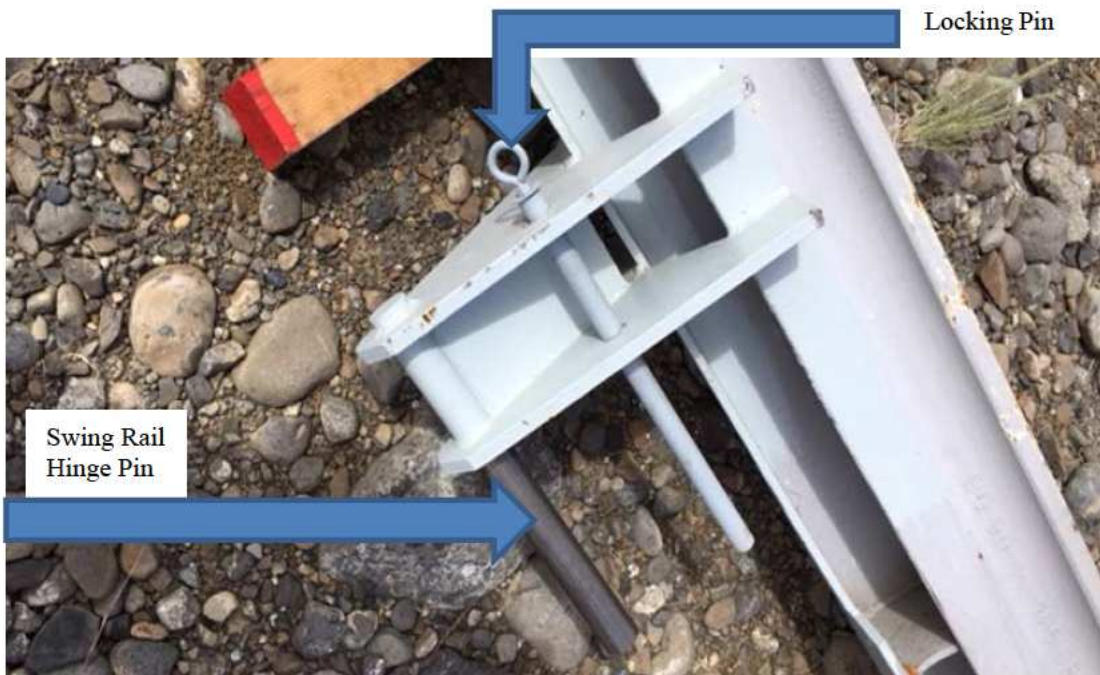
Photo No. 4 - Gate 17's north swing rail lower hinge assembly with hinge pin (left) and locking pin (right). The swing rail was removed from the spillway after the incident and relocated to a maintenance yard adjacent to the Dam.

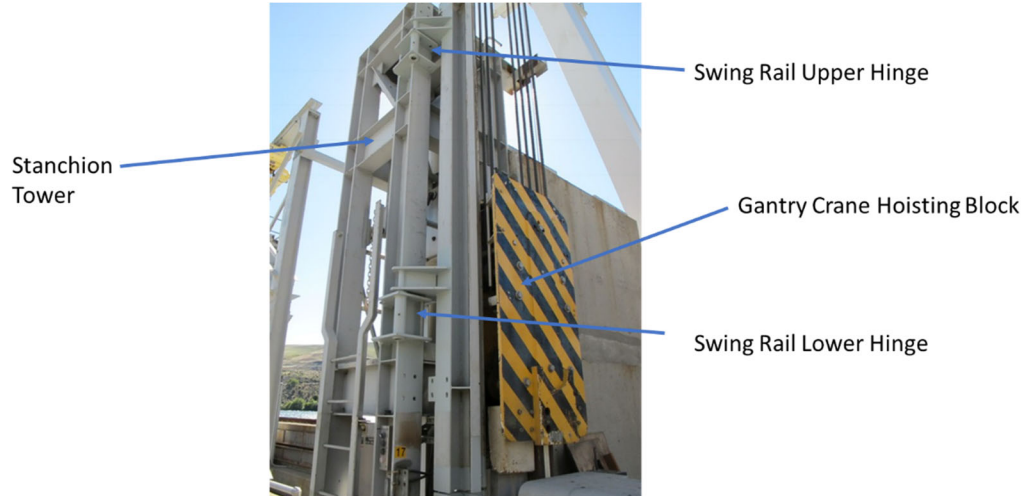
Photo 2: Gate Bay 17 South Stanchion with Swing Rail Assembly

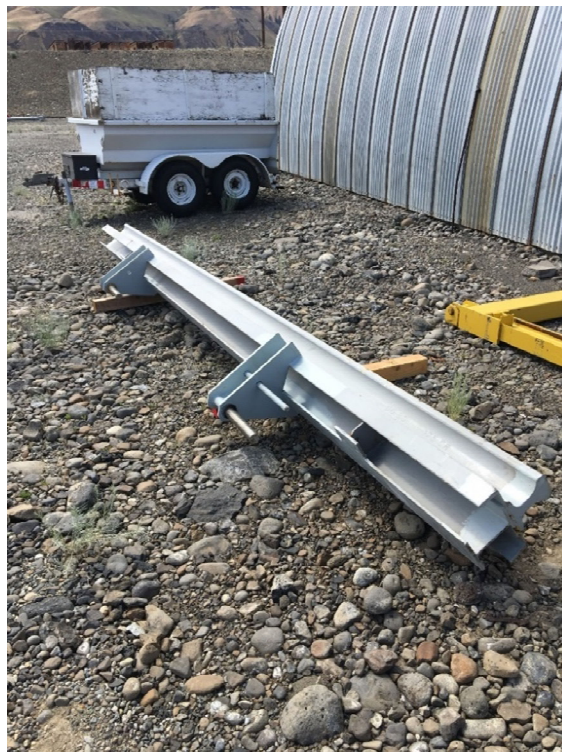
Photo 3: Bay 17 North Swing Rail – Relocated to Storage Yard after Incident

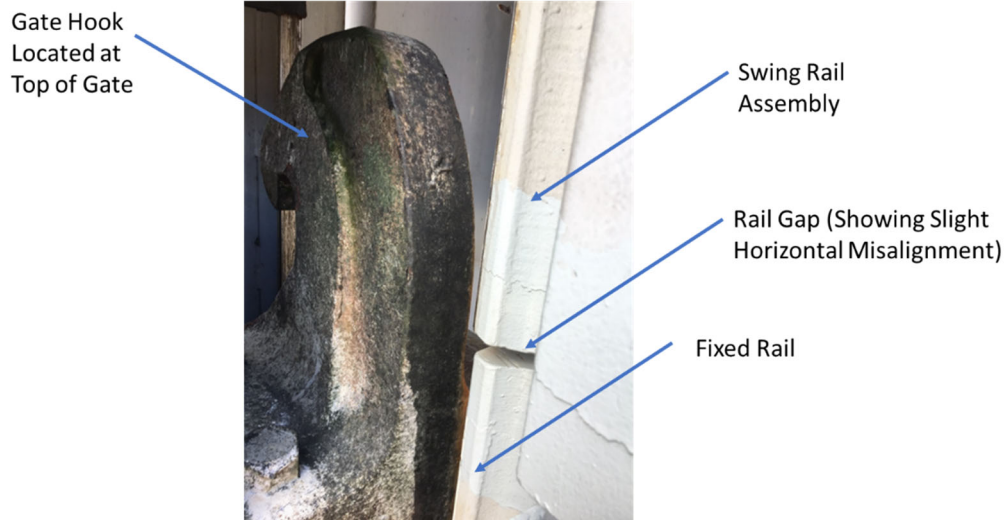
Swing rail modifications have evolved over the years to accommodate the variety of in the field conditions of the rails. Currently, the swings rail assembly is modified on site to fit the dimensions of the as-built stanchion (DWG 4030-18ME-0001). The as-built alignment of the swing rail assembly with the fixed rail it replaced varies across the dam. There are variances in the vertical distance between the fixed rail and the swing rail of  $1/2''$  to  $3/4''$  and in the horizontal offset of the rails at the rail gap from  $1/16$  inch to  $3/16$  inch. For example, the gap at Gate 19 is illustrated in Photo 5 where the fixed rail and the swing rail are shown. It is evident from the photo, that there is a slight horizontal misalignment between the fixed and swing rails.

Photo 5; Rail Gap at North Stanchion of Gate Bay 19

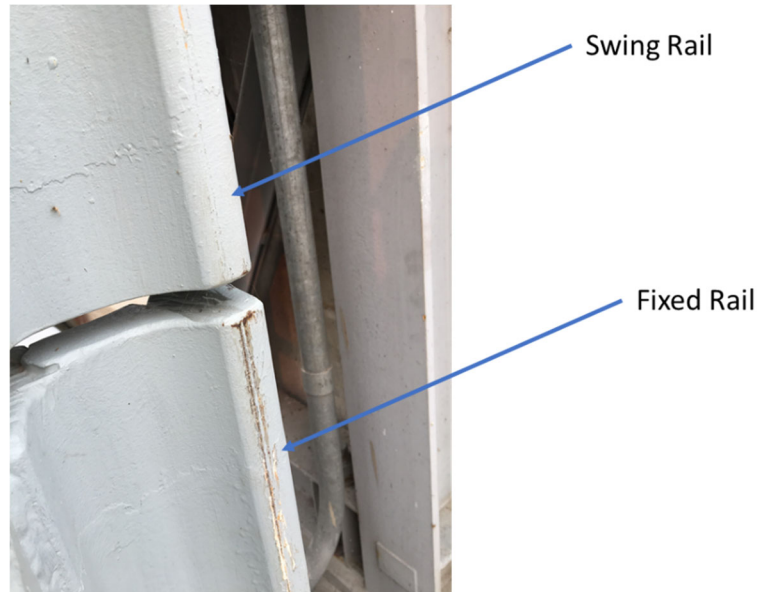
Crane 3's hoist block mechanism includes a tapered guide to allow the hoist blocks to engage a rail from above. The taper, which is composed of a front leader and a rear leader, align the hoist block to engage the rail centerline. Such a design is typical of hoist blocks on overhead cranes. The tolerances at Gate Bay 17 for the north stanchion are not known as the assembly has not been reinstalled after the incident. The south stanchion however may be representative of the precision of the installation. Photo 6 shows the south stanchion at the rail gap between the fixed rail and the swing rail. At this location the gap is relatively small, and the rail horizontal misalignment appears minimal. There is however some horizontal offset as evidenced by the abrupt change in wear along the rail flange above and below the gap. The relative horizontal offset is approximately 1/16 inch.

Photo 6; Gate 17 South Stanchion –Gap and Slight Misalignment Between Fixed Rail and Swing Rail

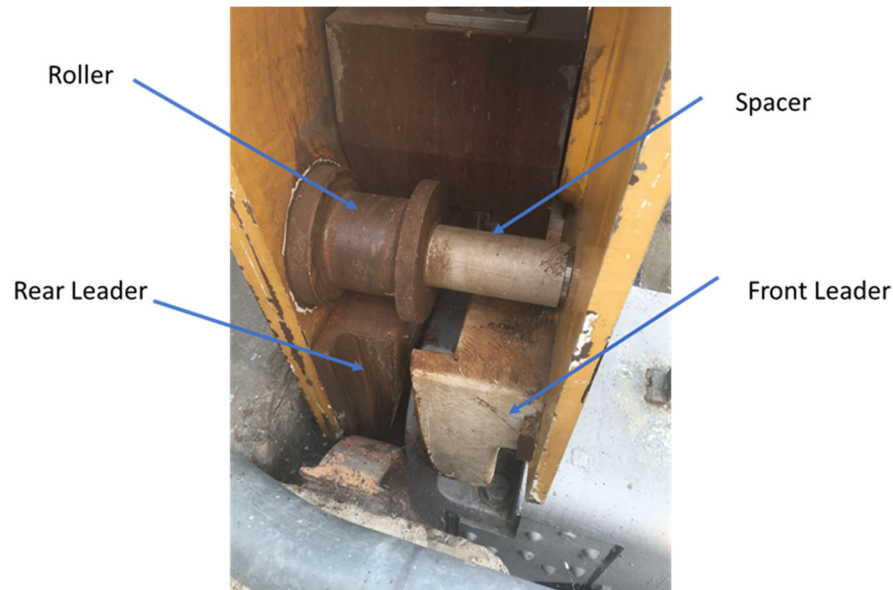
While Crane 3's hoist block rollers have capability to follow slight degrees of rail misalignment, the rollers' ability to track rails is limited by spacers (as shown in Photo 7). There is a range of horizontal misalignment between the swing rails and the fixed rails at the site as discussed previously. Misalignment at the rail gap between the fixed rail and swing rail is due to the precision of the swing rail modification when the hinge pivots are welded to the stanchions. The design does not include capacity for rail adjustment after the field welds are made. Further, the degree of allowable misalignment is not included in the swing rail modification drawing we were furnished by the District (DWG 4030-18ME-0001).

Photo 7; Hoist Block Detail of Aligning Features

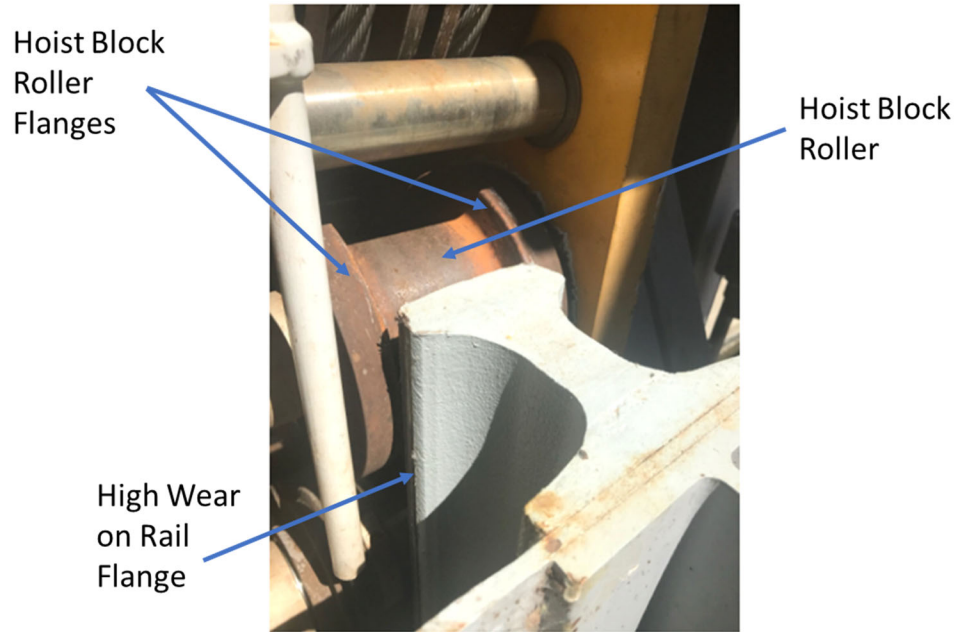
Photo 8: Gate Bay 17 North Stanchion After Incident (Gantry Crane 3 Hoist block Is Not Engaging the Downstream Fixed Rail)

It appears that during the lift, the north hoist block could not follow the north downstream rails over the gap at the junction of the swing rail with the fixed rail. Photo 8 shows the north hoist block upper roller has lost contact with the fixed rail. The hoist block's guide roller flange is riding on the rail flange bearing surface. This might be due to imprecision in the set-up of the crane over the gate, as frequently occurs in such operations, or misalignment of the North and South downstream rails.

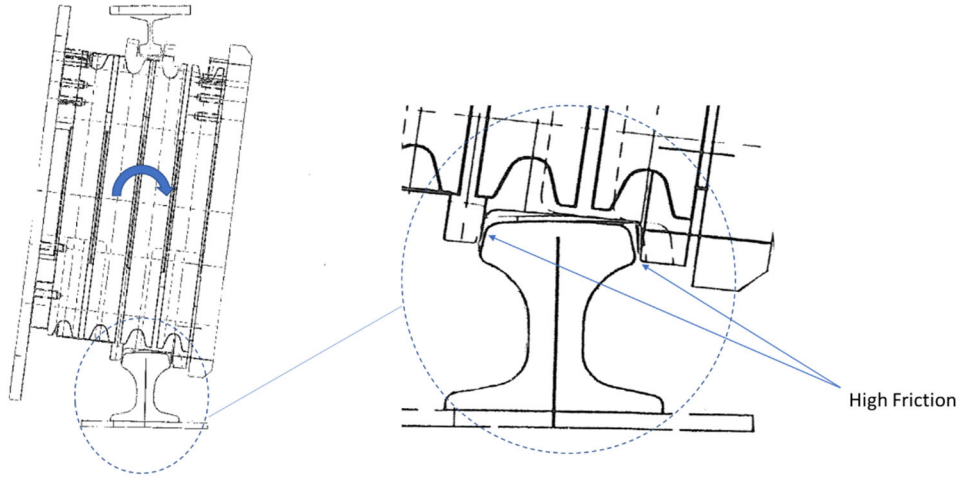
The cause of failure is shown in Figure 1. As the hoist block cleared the top of the dam deck during the lift, and it came free of the upstream rail, the block twisted slightly rotating around the downstream rail. As the hoist block rotated, the top edge of the leaders pressed into the rail flanges and were able to catch the bottom edge of the swing rail assembly.

Figure 1: Pivoting Crane Block Increases Friction on Downstream Rail

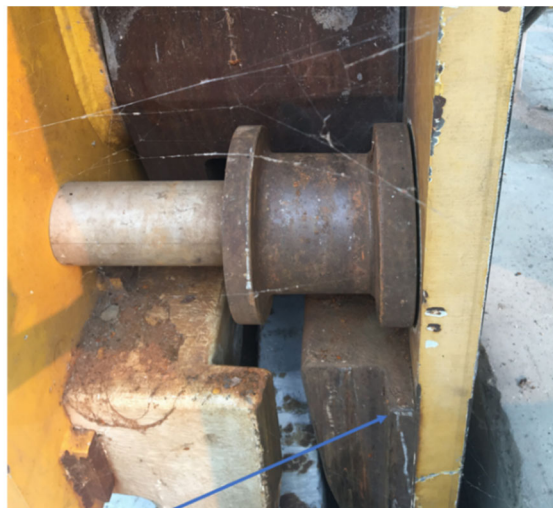
The leaders at the top of the hoist block are potential catch points, as shown in Photo 9. The leaders likely lifted the bottom edge of the swing rail assembly. The potential for this scenario is increased if the crane is not aligned with sufficient precision over the lifting hook centerline and the resulting block rotation, under the high lifting load, can cause significant friction of the leaders along the rail flanges. This friction can allow the leaders to catch on and lift the exposed bottom edge of a swing rail assembly.

Photo 9: Crane 3 North Block Potential Catch Point on the Hoist Block Leader

<p><b>Recommendations for District Consideration</b></p>	
<p><b>TTRC1</b></p>	<p>The PUD should consider modifying Crane 3 block leaders to allow them to travel across rail gaps with slight misalignment. By grinding a larger radius into the top of the leader blocks, the ability of the hoist to travel across rail gaps with misaligned rails will be increased. This recommendation may be applicable to Crane 2 if it has similar geometry.</p>
<p><b>TTRC2</b></p>	<p>The PUD should also consider eliminating the need for a swing rails along the spillway altogether, as this may, in the long run, prove to be the safest and most economical solution. The swing rail can be eliminated with any of the following alternatives:</p> <ul style="list-style-type: none"> <li>Lift the entire segmented gate out of the slot above the dam deck (roadway), from the top of the gate. This would eliminate the need for guide rails. This will require new permanent hoists and towers.</li> <li>Install an emergency spillway. This would eliminate the need to fully remove the gates.</li> <li>Extend the stanchions and rail guides so the gates can be fully removed from the slots and possibly remain on top of the dam.</li> </ul>

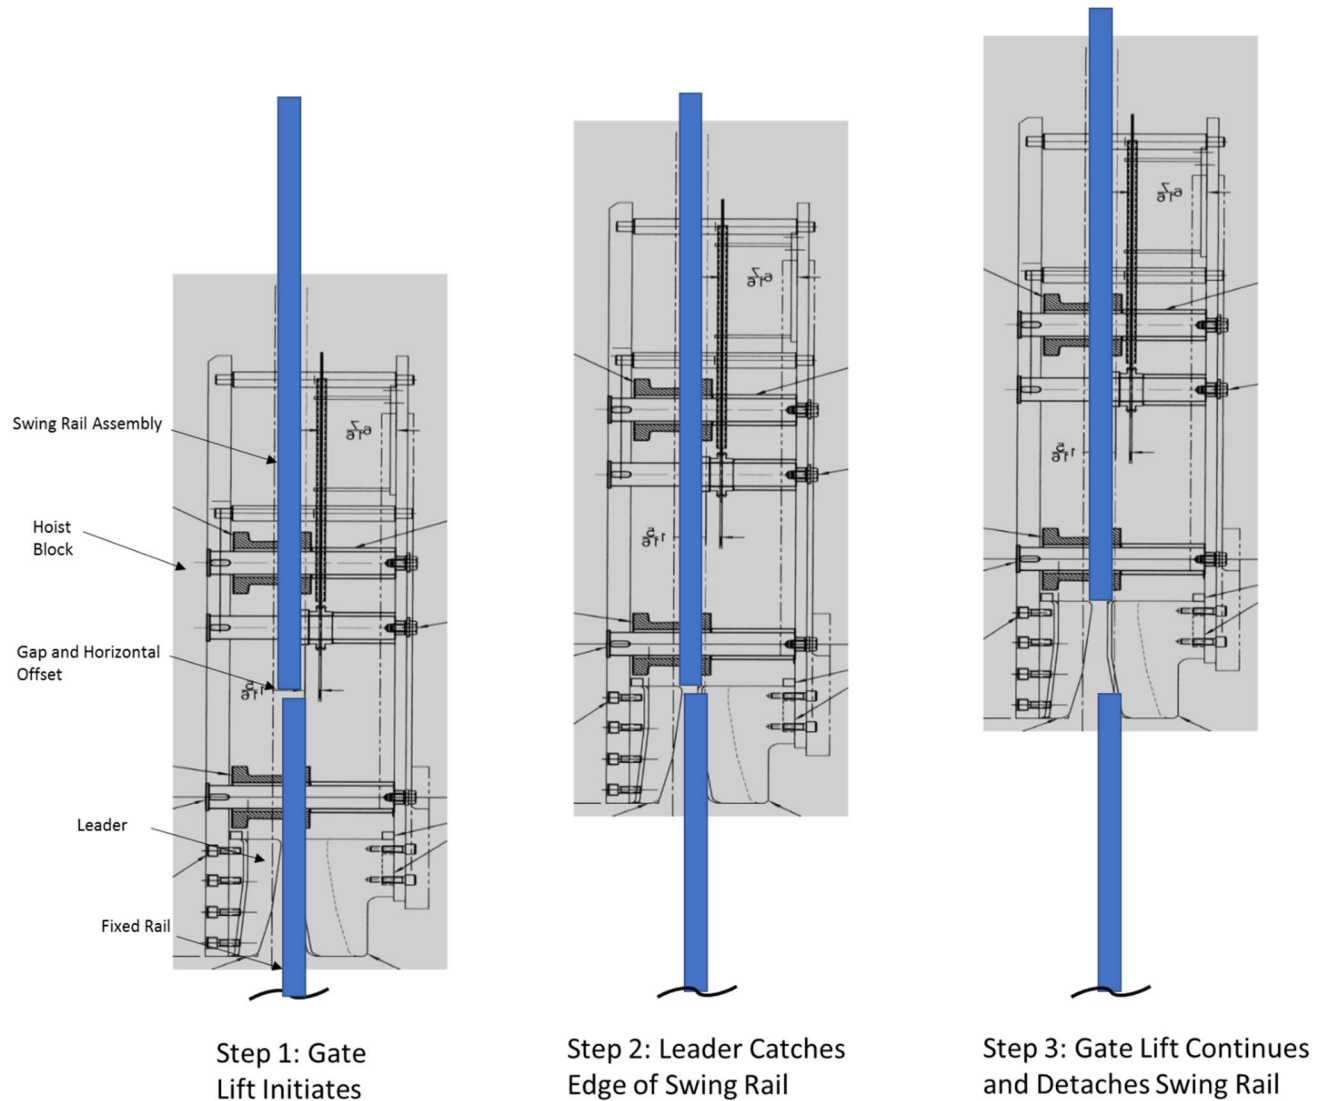
The failure sequence is depicted below in Figure 2. There is a slight horizontal misalignment at the rail gap between the swing rail assembly and the fixed rail at the North stanchion of gate bay 17. Although the hoist block successfully passed the gap on its way down the rail, when the lift operation starts as shown in Step 1, the leaders are pushed to one side due to the set-up of the crane above the gate. This slight offset causes the top on one of the leaders to catch the bottom edge of the swing rail assembly as the leaders, while lifting, pass over the rail gap as shown in Step 2. As the lift continues, the leader starts lifting the swing rail assembly as shown in Step 3.

Figure 2: Root Cause Failure Sequence
