Aviation Investigation Preliminary Report

Location:	Venice, FL	Accident Number:	ERA23FA079
Date & Time:	December 3, 2022, 19:38 Local	Registration:	N4676F
Aircraft:	Piper PA28	Injuries:	3 Fatal
Flight Conducted Under:	Part 91: General aviation - Personal

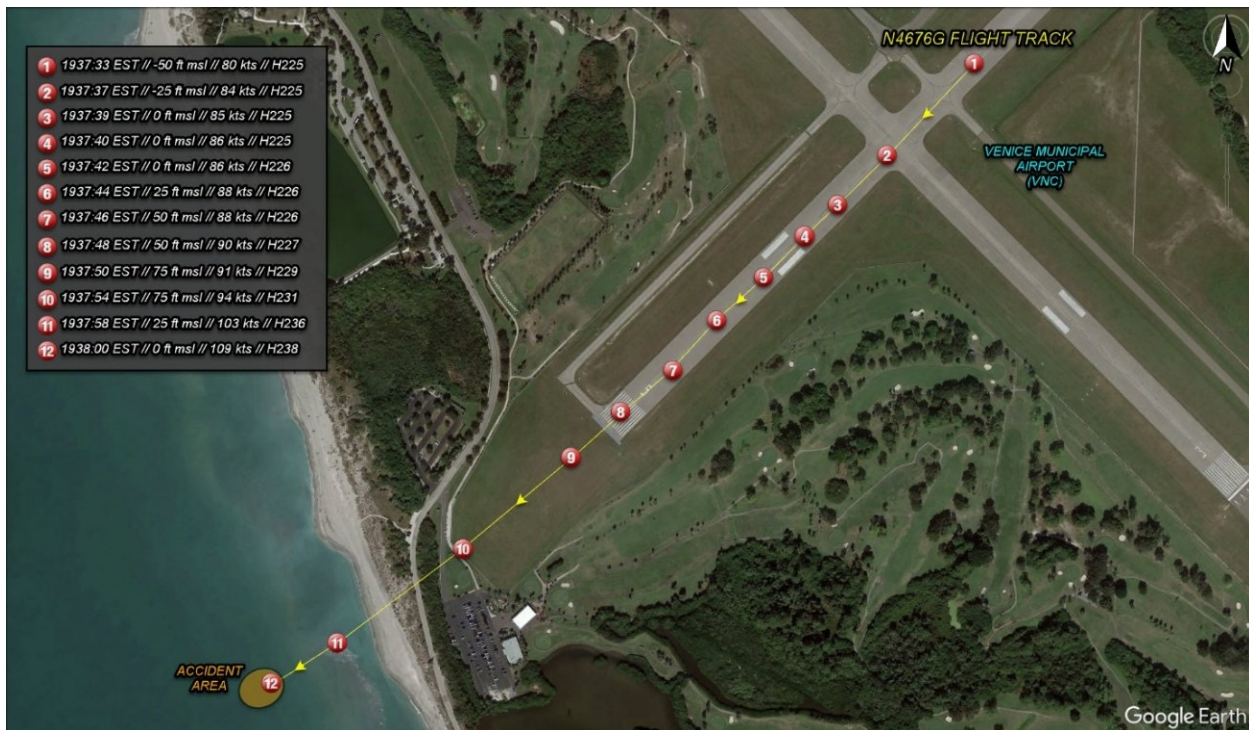
The airplane departed runway 23, which was 5,000 ft long. The track data suggested that the airplane lifted from the runway at 1937:44, about 4,100 ft beyond the approach end of the runway at 88 knots (kts) groundspeed. Over the remaining 900 ft of runway, the airplane accelerated to 90 kts groundspeed and climbed to about 50 ft. Over the next four seconds, the track data showed two plots, both at an altitude of 75 ft and groundspeeds of 91 kts and 94 kts, respectively, before the airplane descended. At 1938:00, the final plot depicted the airplane at 0 ft and 109 kts groundspeed about 1,800 ft beyond the departure end of runway 23.

Figure 1 shows preliminary flight track information in relation to the runway 23, with estimated altitudes and groundspeeds.

Figure 1. Preliminary ADS-B flight track information
