# Slum & Blight Report

Town of Adams

2026

The purpose of this study is to assess and document the parcel and public infrastructure conditions in the northern and southern gateways to downtown and the adjacent Summer Street area to determine whether the area is eligible for designation as a slum and blighted area, as defined by the Massachusetts Executive Office of Housing and Livable Communities ("EOLHC").

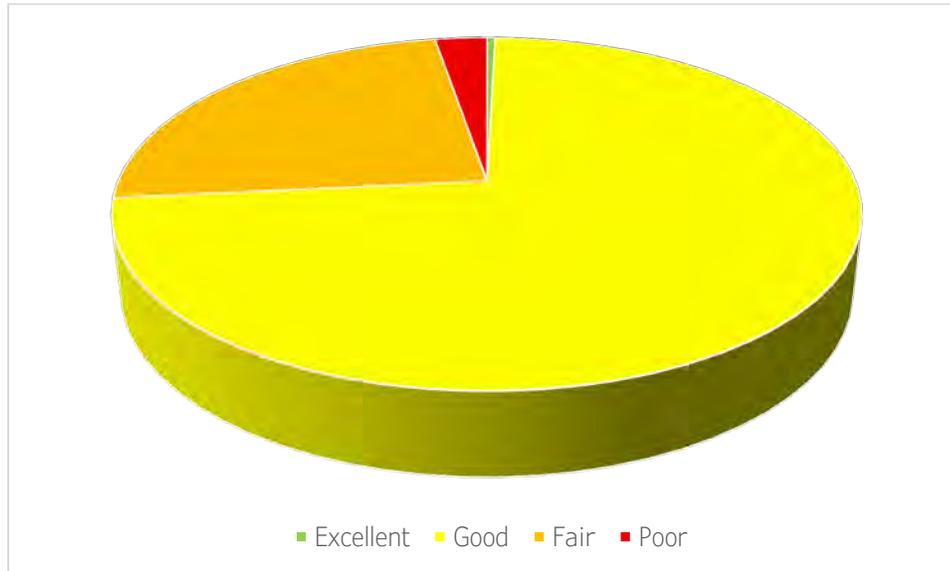
Figure 6 Building Condition

Of the 486 parcels scored, 45 of those parcels are undeveloped or town parks that contain no buildings. Therefore, the total number of primary buildings rated in the Target Area is 486. One important finding of this study is that 129 out of 486 or 26.5% of the primary buildings within the Target Area are in either fair or poor condition. The Target Area contains over the threshold of 25% of parcels experiencing deterioration or disinvestment.

<u>Condition</u>	<u># of Buildings</u>	<u>Percentage</u>
Excellent	2	0.4%
Good	355	73.0%
Fair	115	23.7%
Poor	14	2.9%
<b>Total</b>	<b>486</b>	<b>100%</b>

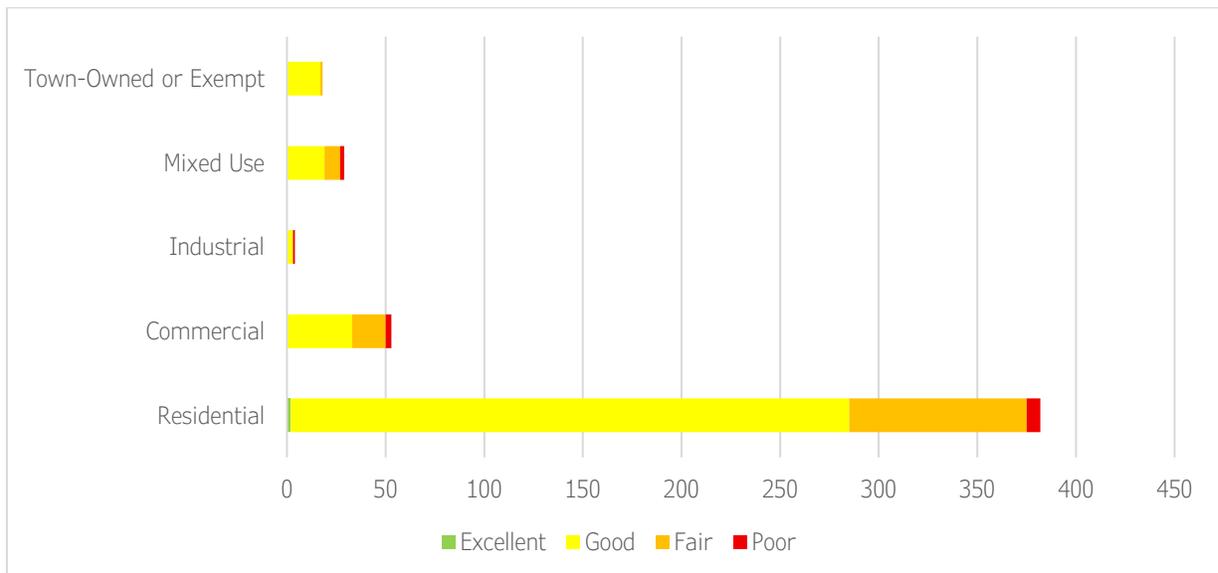
Figure 8 Condition by Building Use

The land use classification with the highest percentage of buildings rated as fair or poor is commercial (37.7%). This is followed by mixed use (34.5%), residential (25.4%), industrial (25.0%), and town-owned or exempt (5.9%). Residential buildings, however, have the largest numeric share of buildings in fair or poor condition (97).

Excellent	% of	Good	% of	Fair	% of	Poor	% of
Residential	2	0.5%	284	74.2%	90	23.6%	7	1.8%
Commercial	0	0%	33	62.3%	16	30.2%	4	7.5%
Industrial	0	0%	3	75.0%	0	0%	1	25.00
Mixed Use	0	0%	19	65.5%	8	27.6%	2	6.9%
Town-Owned or Exempt	0	0%	16	94.1%	1	5.9%	0	0%

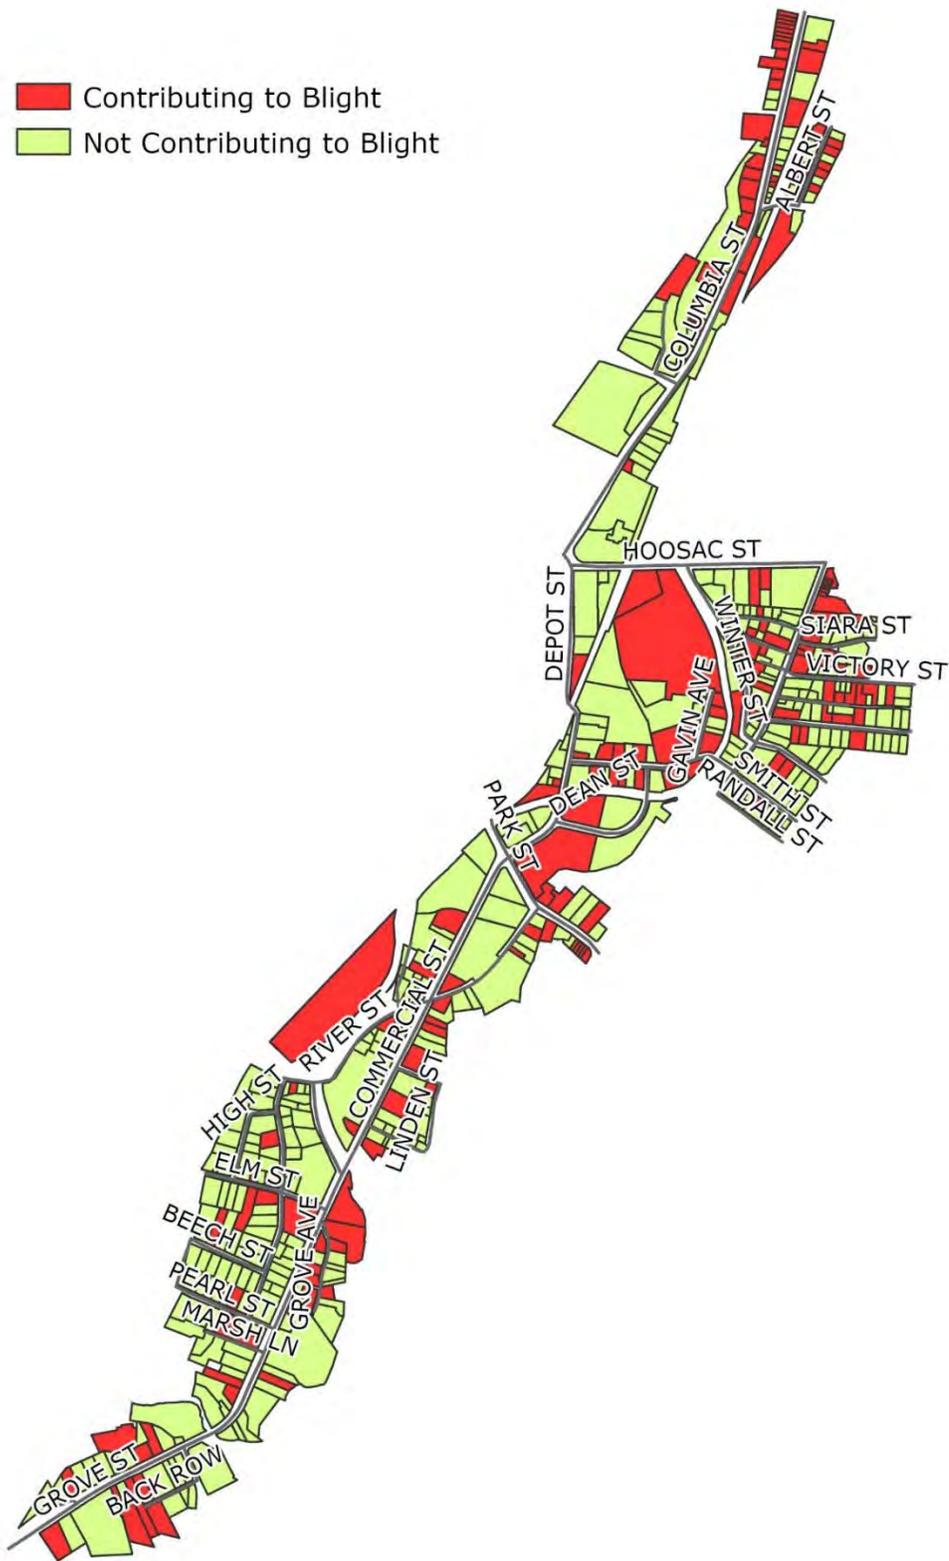
Figure 11 Contribution to Blight Map

When all of the above factors are summarized, a total of 173 parcels meet one of the criteria for contributing to slum and blight. This amounts to 32.1% of the parcels.

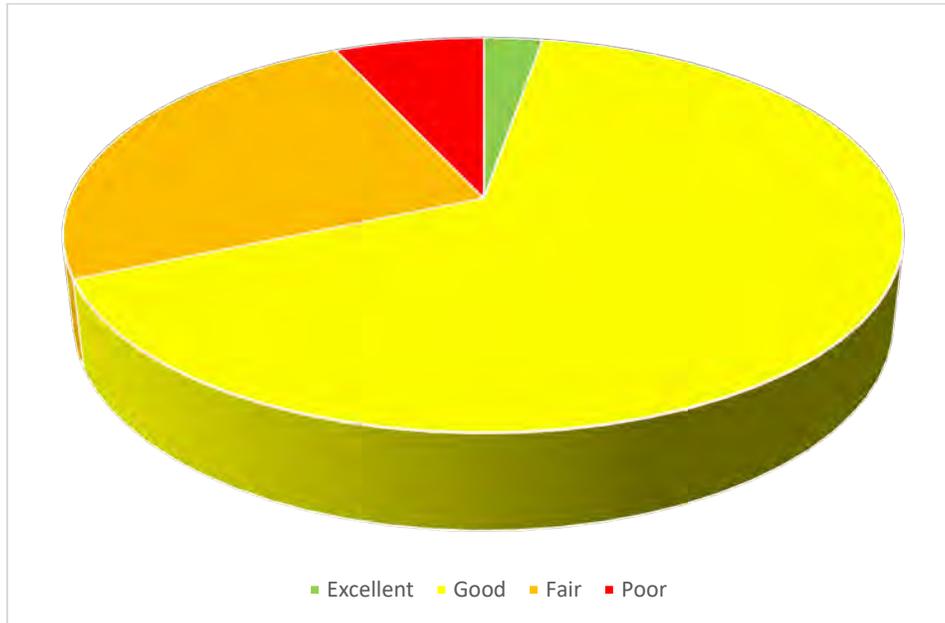
Figure 12 Road Condition

The Target Area contains a total of 35,285 linear feet of roadway. Of that amount 11,103 linear feet or 31.5% of the roadways are physically deteriorated (poor or fair condition).

Condition	Length (ft)	%
Excellent	947	2.7%
Good	23,235	65.8%
Fair	8,680	24.6%
Poor	2,423	7.0%
<b>Total</b>	<b>35,285</b>

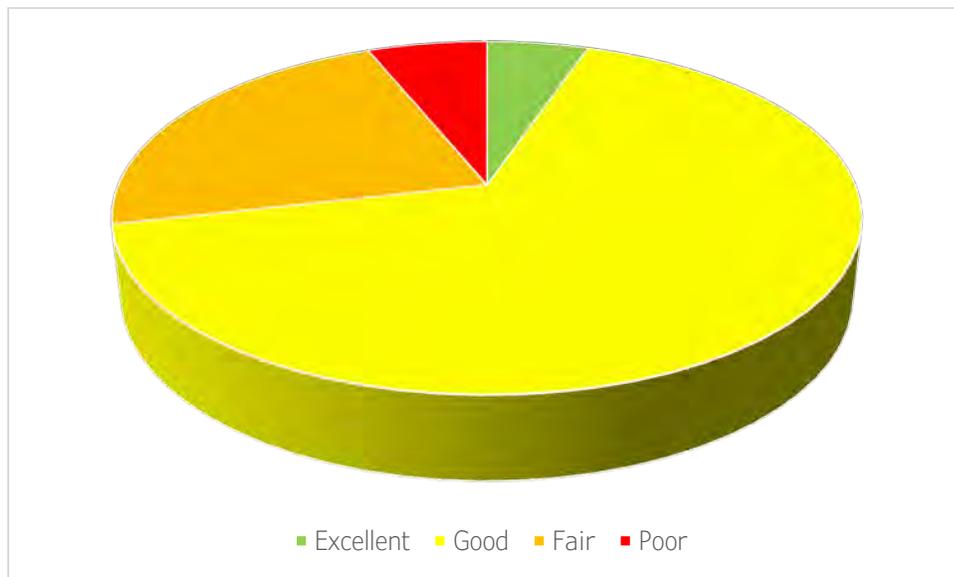
Figure 14 Sidewalk Condition

Condition	Length (ft)	%
Excellent	1516	5.2%
Good	19250	66.2%
Fair	6515	22.4%
Poor	1790	6.2%
<b>Total</b>	<b>29071</b>

The Target Area contains 29,071 linear feet of sidewalks. Of that amount, 8,304 linear feet or 28.6% of the existing sidewalks are physically deteriorated (poor or fair condition).

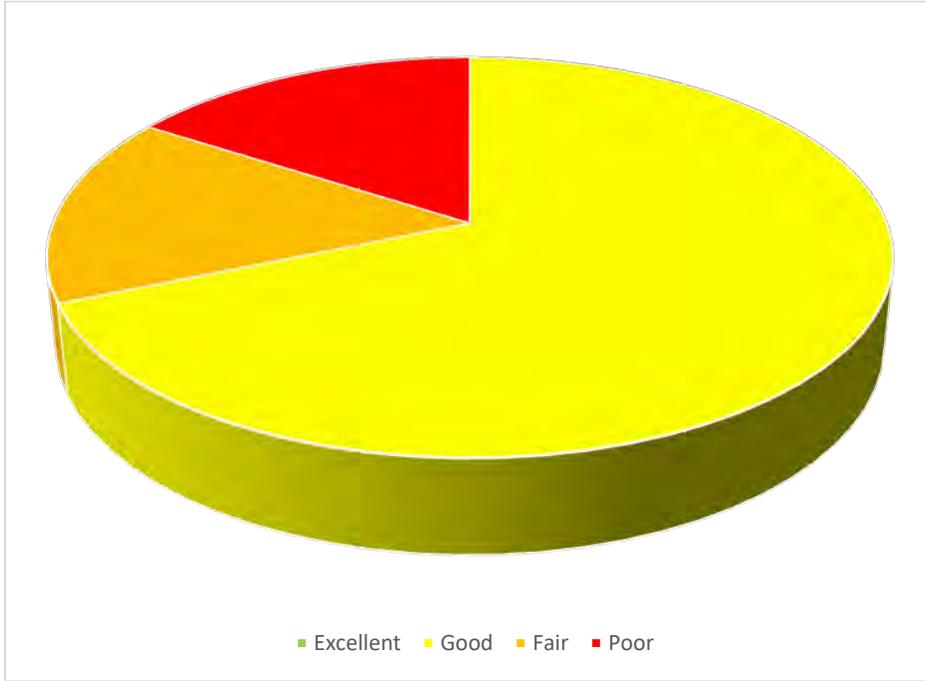
Figure 16 Parking Condition

The Target Area contains an estimated 1,548 parking spaces within parking lots. An exact number of parking spaces could not be determined due to the large number of undefined parking spaces and gravel parking lots. Any business that has a parking lot that could support more than five cars is included in this list. In addition to this, another five hundred (500) on-street parking spots are available. Overall, parking lots in the target area are considered Good (68.7% Excellent or Good).

<u>Location</u>	<u># of spaces</u>	<u>Ownership</u>	<u>Condition</u>
Adams Visitors Center	130	Public	Good
Adams Memorial School	39	Private	Fair
Rite Aid/Berkshire Mill	188	Private	Good
Angelina's	20	Private	Fair
5-7 Hoosac Street	200+	Private	Poor
127 Columbia Street	15	Private	Good
PNA	25	Private	Fair
82 Summer Street	10	Public	Good
The Grille	13	Private	Fair
78 Summer Street	15	Private	Good
54 Summer Street	8	Private	Good
Kearns Lane	14	Public	Good
44 Spring Street	25	Private	Good
2 Gavin Ave	8	Private	Good
17 Depot Street	18	Private	Good
19 Depot Street	11	Private	Good
37 Pleasant Street	12	Private	Fair
CJ's	13	Private	Good
35 Spring Street	15	Private	Good
Dean Street Housing	63	Residential	Good
Barrett House	20	Residential	Good
1 Pleasant Street	46	Private	Poor
Big Y	147	Private	Good
South Adams Savings	24	Private	Good
Elks	12	Private	Good
McDonalds	53	Private	Good
8 Liberty Street	16	Private	Good
Liberty Street Park	49	Public	Good

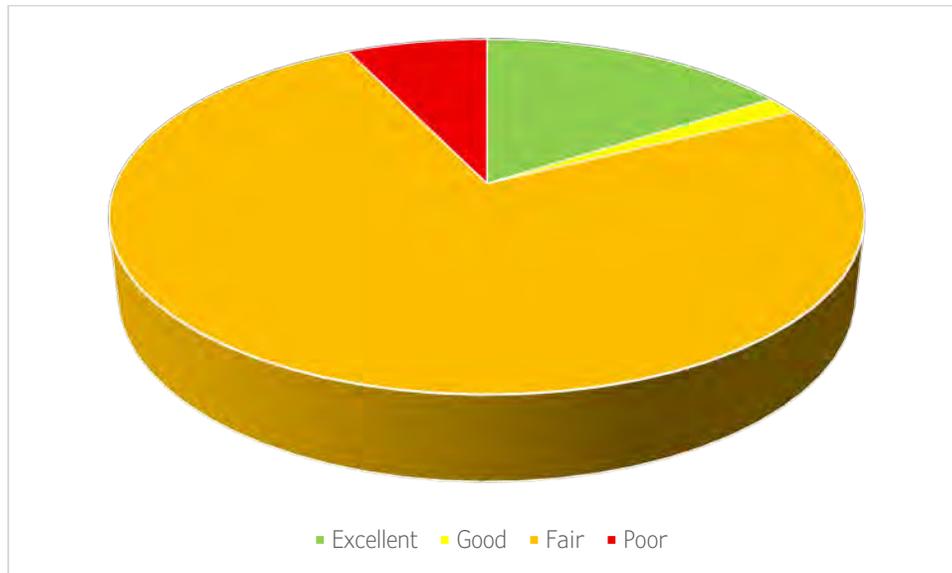
Figure 19 Water Line Condition

The Adams Fire and Water District reviewed the water system in the area for the last report and found 82.4% of the water lines were in Fair or Poor condition. Most of Grove Street and Commercial Street has gotten new water service along with a few smaller side streets. The rest of the target area is covered by an antiquated system.
