Preliminary Engineering Report for  
**WASTEWATER TREATMENT  
PLANT EVALUATION**

DANVILLE, VT

June 5, 2024

**60% DRAFT**

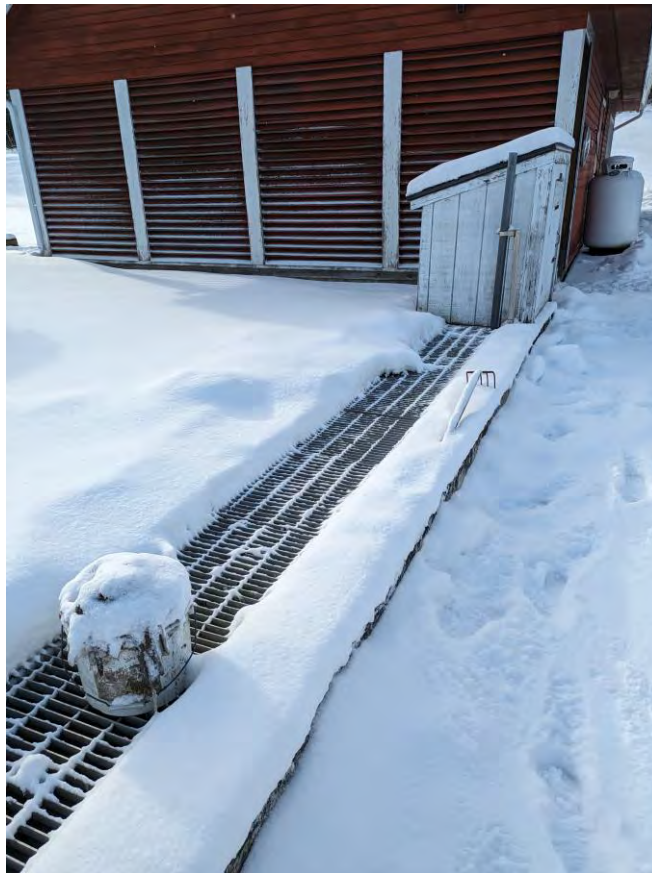
**Figure 2-7: Headworks Channel & Influent Sampler**

Operators report that the screen is cleaned daily, and the stone trap as required. There are no operational complaints or significant conditional issues with the headworks channel at the Danville facility. A summary of the design criteria, existing equipment and any deficiencies is included in Table 2-7 below.

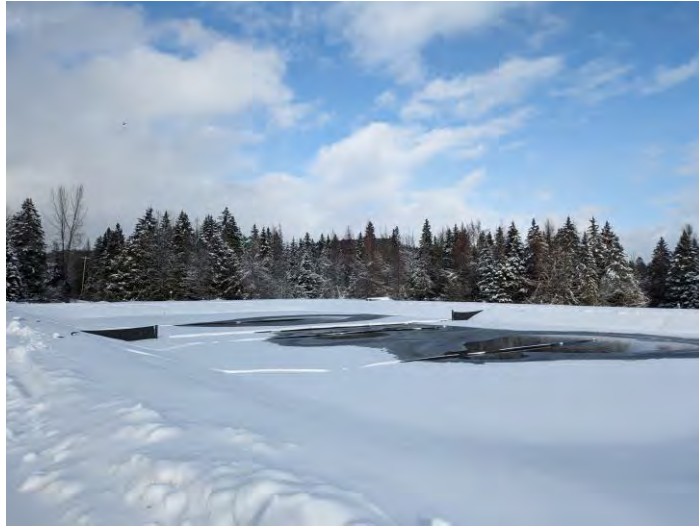
**Figure 2-8: Lagoon #2**

In 2021 excessive weed growth was observed in lagoon #2 causing frequent cleaning of the lagoon's telescoping effluent valve and the UV system. The operator was unable to determine the cause at that time, but this issue has not occurred since.

The existing lagoon structure appears to be in good condition with no reported concerns associated with the aeration diffusers, piping, or lagoon liners. The blower systems function properly and appear in fair condition. The telescoping valves to control the lagoon levels are reported as operable and in good condition. At design average day flow and a 10-foot operating depth the lagoons have a hydraulic residence time (HRT) of 27 days and accommodate an additional 21 days of storage for dry weather flow periods. Under current average day flow conditions, the HRT is approximately 44 days. The additional storage is necessary to meet the NDPEs permit ultimate oxygen demand (UOD) limitations based on the baseline stream flow of the Water Andric during the summer months (June 1<sup>st</sup> through September 30<sup>th</sup>). To meet this requirement, the UOD of the wastewater is calculated based on the most recent BOD<sub>5</sub> and TKN measurements. The wastewater UOD is then compared to the daily streamflow and if necessary, the facility effluent discharge is limited using the PVC ball valves in the disinfection vault to maintain stream health.

Sludge depths have been monitored and recent measurements indicate approximately 155,000 gallons of sludge is present in lagoon #1, with an additional 95,000 gallons in lagoon #2. Sludge depths and volumes indicate that the Town should be planning for a significant sludge removal evolution in the next year or two. A summary of the design criteria, existing equipment and any deficiencies is included in Table 2-8 below.

Any project recommending a process change to address TAN removal should also incorporate sludge removal from both lagoons. Although the sludge levels do not appear to be impacting the facility performance, they are considered high and should be lowered in the short term. Allowing the sludge blanket to continue to grow will lower the effective treatment volume in each lagoon, could short circuit the lagoons, and impact the facility's ability effectively treat for BOD and TSS.

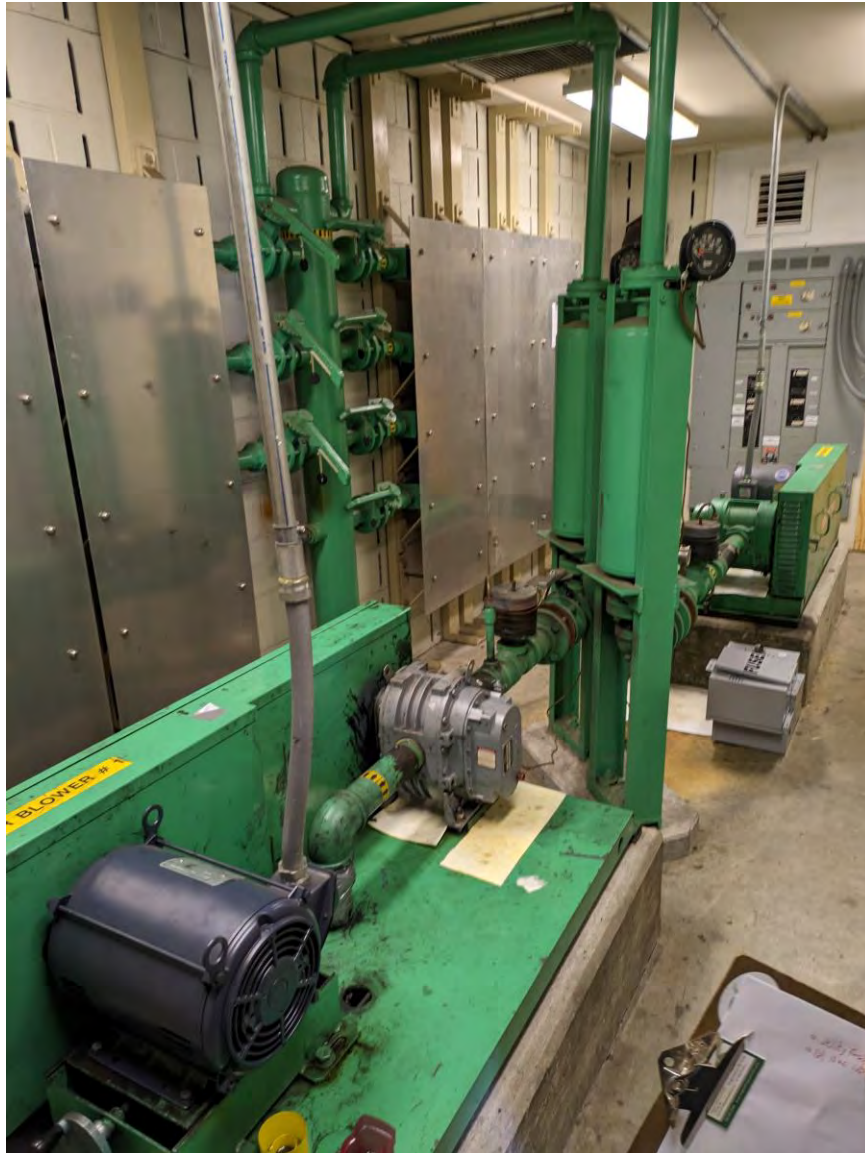
**Figure 2-9: Aeration Blowers & Discharge Manifold**

Aeration is provided by two Gardner Denver positive displacement 10 hp blowers in the main control building. One of the blowers is original to the facility and has been rebuilt, and the second blower was replaced in 2016. One blower is utilized at a time and the blowers are alternated to balance wear. A VFD has been installed on the lead blower allowing for a speed reduction to optimize performance and provide a power usage cost savings.

At the wastewater treatment facility there are systems that have reached the end of their useful life that should be considered for replacement. The UV disinfection systems are in need of replacement and can no longer be reliably serviced. The blowers are original to the facility, and although one has been rebuilt and retrofitted with a VFD, consideration of a blower upgrade based on age should be made. Although the aeration diffusers were upgraded in 2006, significant improvements to aeration have been made over the past 20-years and replacement of the diffuser membranes should be considered. There are no known

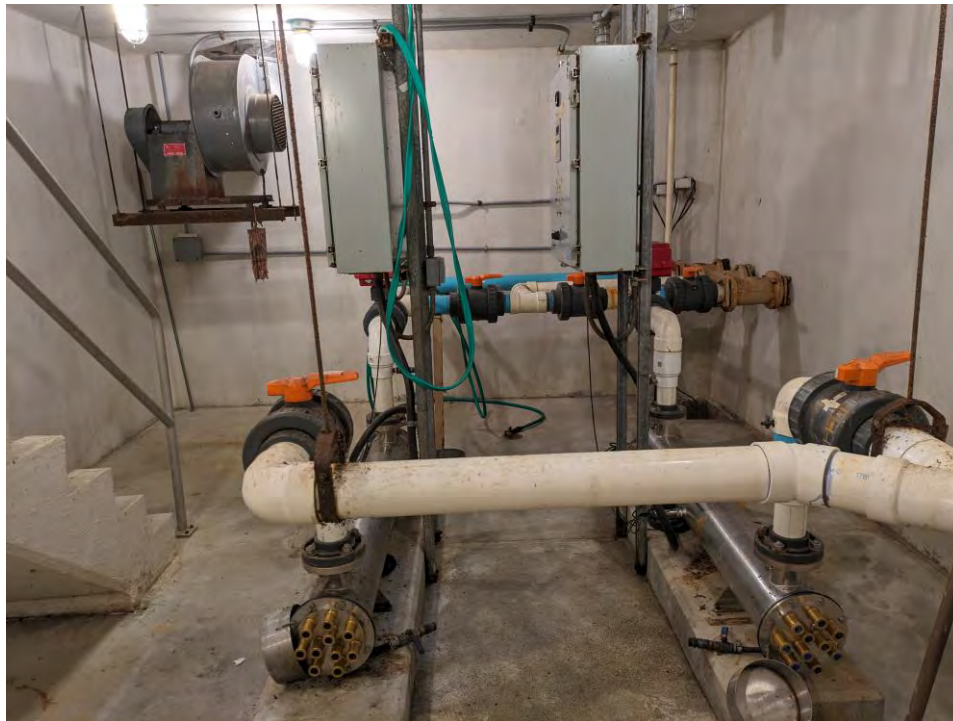
**Figure 2-10: UV Disinfection Systems & Control Panels**

On the lower level of the disinfection building are housed two UV systems in parallel. The systems are Aquafine Corporation RBE-8 with individual control panels. The UV systems were upgraded in 2004, but the existing units and panels are showing signs of wear. Wastewater flows through one of the two UV units where disinfection of the effluent takes place before the flow moves into an open effluent trough with v-notch weir. Located above the weir is a level transducer to monitor and record effluent flow.

The existing UV disinfection systems have reached the end of their expected useful lifespan and are in need of replacement. Although they have maintained adequate performance as demonstrated by the e-coli sampling results of the facility, spare parts are difficult to find, and the control panels are showing significant signs of age.

Although the UV disinfection building is in fair condition, and access is reasonable with the use of stairwells and railings, the UV control panels are located on the lowest level and evidence of significant condensation causing corrosion is apparent. It is believed that the open effluent channel allows condensation to build up within the structure leading to corrosion of steel components including electrical conduit, fixtures, and handrails. A

The control building is in fair condition, but much of the HVAC and electrical systems are original and should be modernized. An electrical and ventilation upgrade should also be considered in the disinfection building where corrosion of electrical conduit and panels is visibly noted.

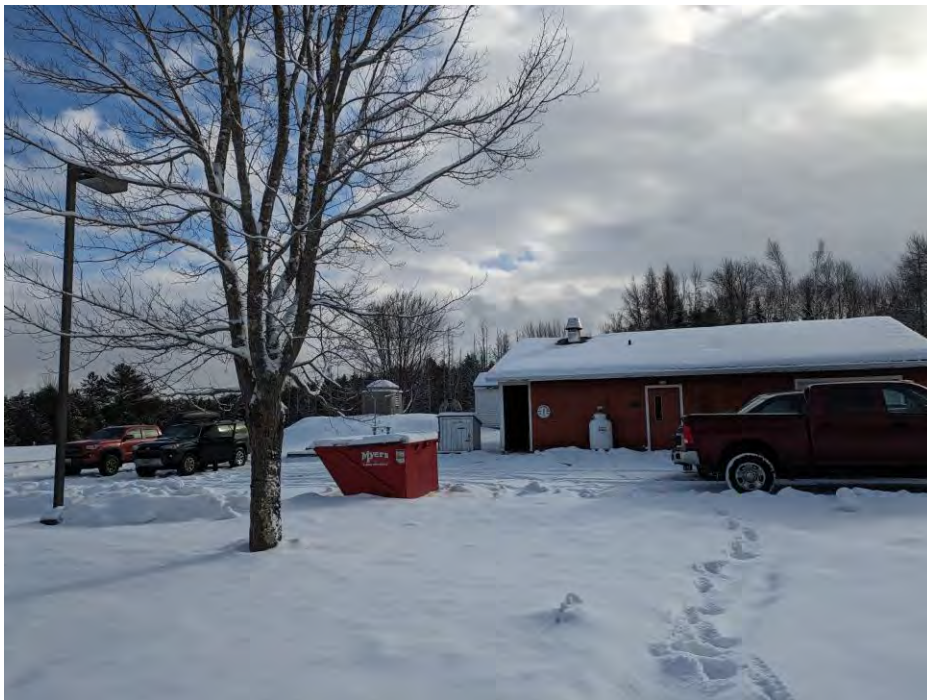
**Figure 2-11: Control Building**

The control building contains the maintenance and storage garage, office, laboratory, blower room and mechanical equipment. The control building is a small structure that does not have full-time use. The building overall has been well maintained however, much of the electrical and HVAC equipment in the building is original and is recommended for replacement in the review completed by Engineering Services of Vermont, LLC.

Heating, ventilation, electrical and air condition systems were reviewed by Engineering Services of Vermont (ESV), a summary report is included as Appendix C of this PER. In summary, the electrical heating systems should be replaced, along with much of the ventilation system infrastructure. Significant electrical improvements should also be considered. ESV recommends replacement of both of the facility circuit panels, raceway replacement, lighting upgrades, the installation of a standby generator, installation of GFCI outlets, and the installation of emergency lighting in the blower room. It is also recommended that the autodialer alarm system be replaced and modernized to include more information as part of an alarm callout than just one general alarm signal.

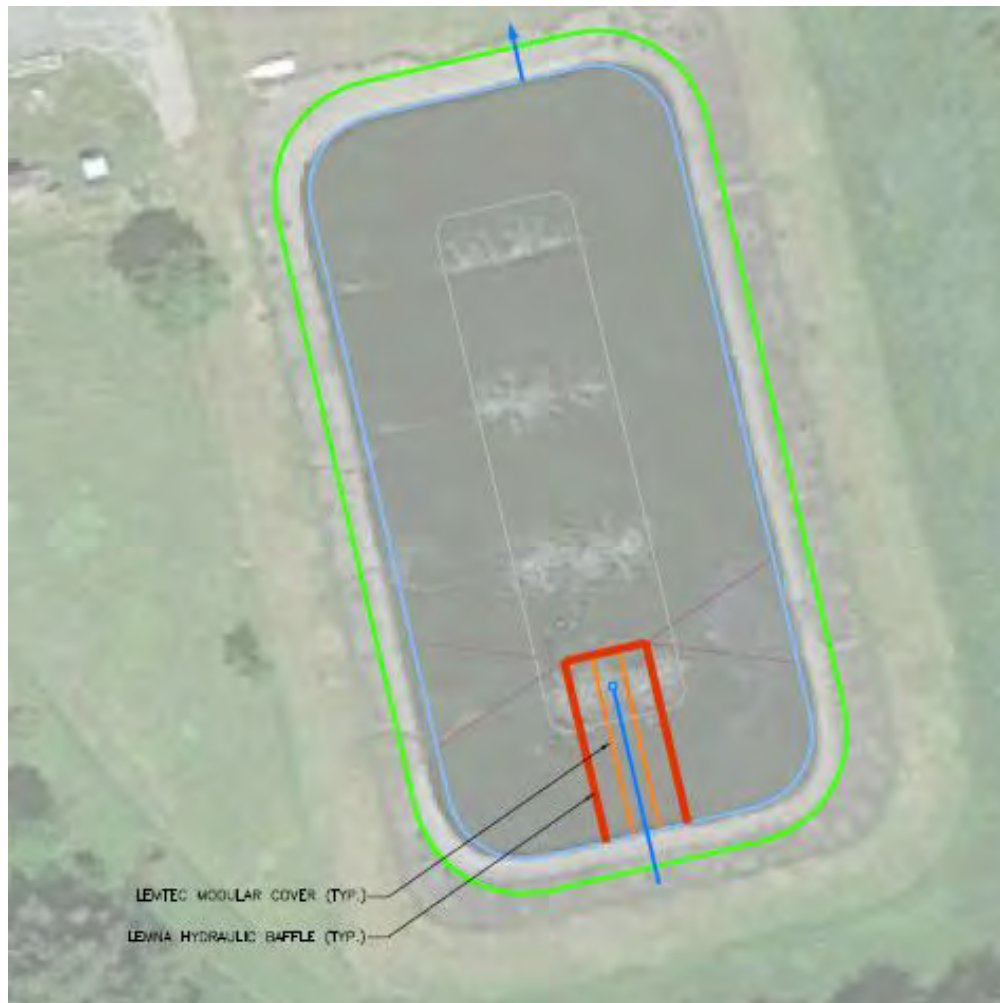
**Figure 4-1: Alternative 2 – ARC Layout**

Figure 4-1 below illustrates the baffle and cover layout as developed and proposed by LET in 2021 for the Danville wastewater treatment facility operator.

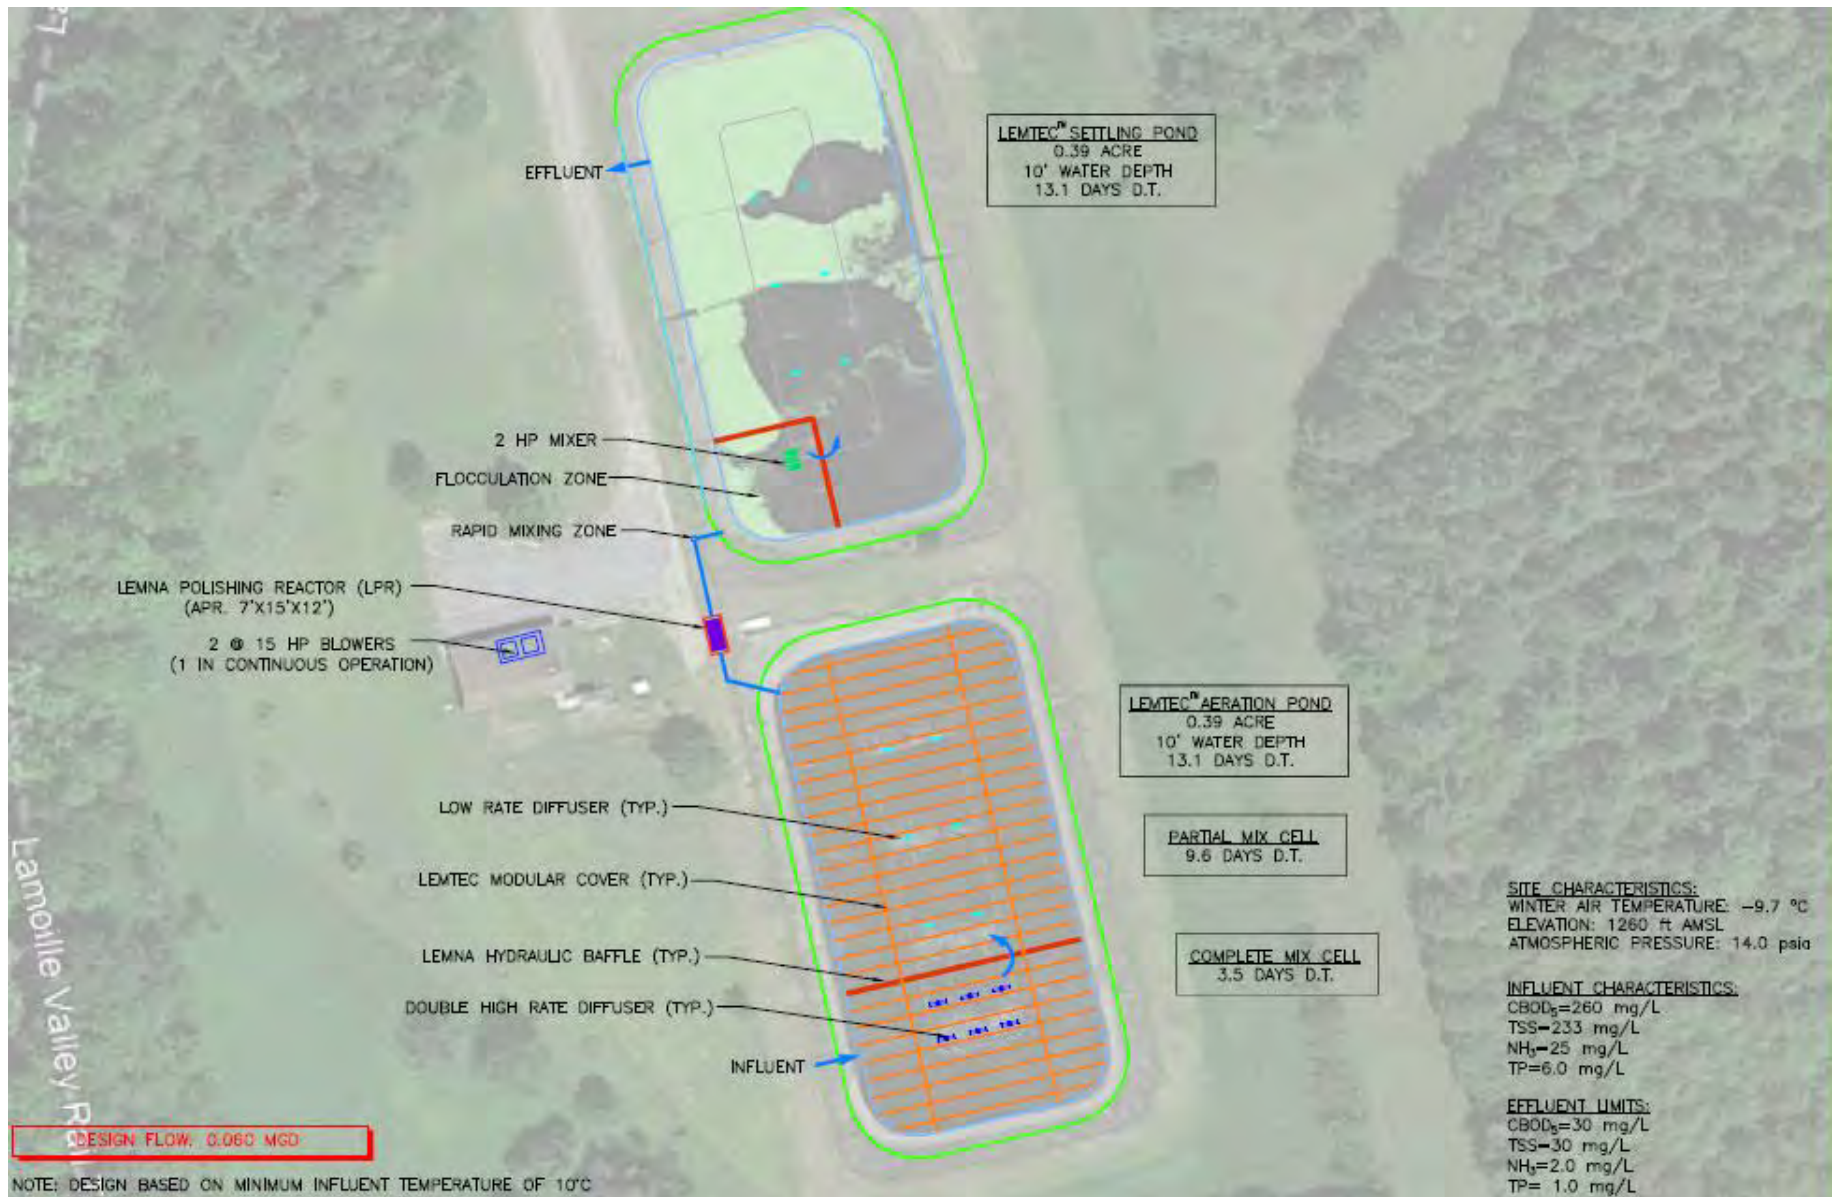
Figure 4-2: Alternative 4 – Covered Lagoon Layout

During design, piping would need to be incorporated to allow for flow to continue to be received during periods of cleaning and maintenance of Lagoon #1 so that flows could be directed to Lagoon #2 temporarily then pumped back to the head of the system after maintenance is complete.

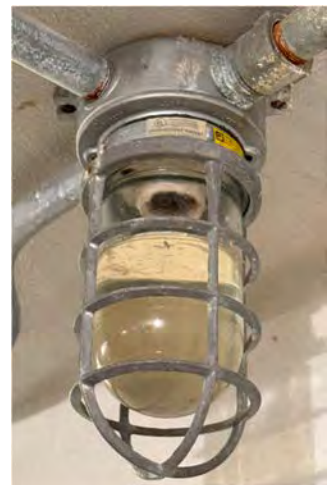
- e. Exterior building mount luminaires are HID wall packs controlled via switch inside the building.

- f. The Operators had relayed that it would be helpful to have motion sensor lights on the exterior of the building to illuminate the front of the building when they arrive after dark.
