Overview: Danville Capital Project

Danville Schools
April 5, 2022

REVIEW - WHAT HAVE WE DONE?

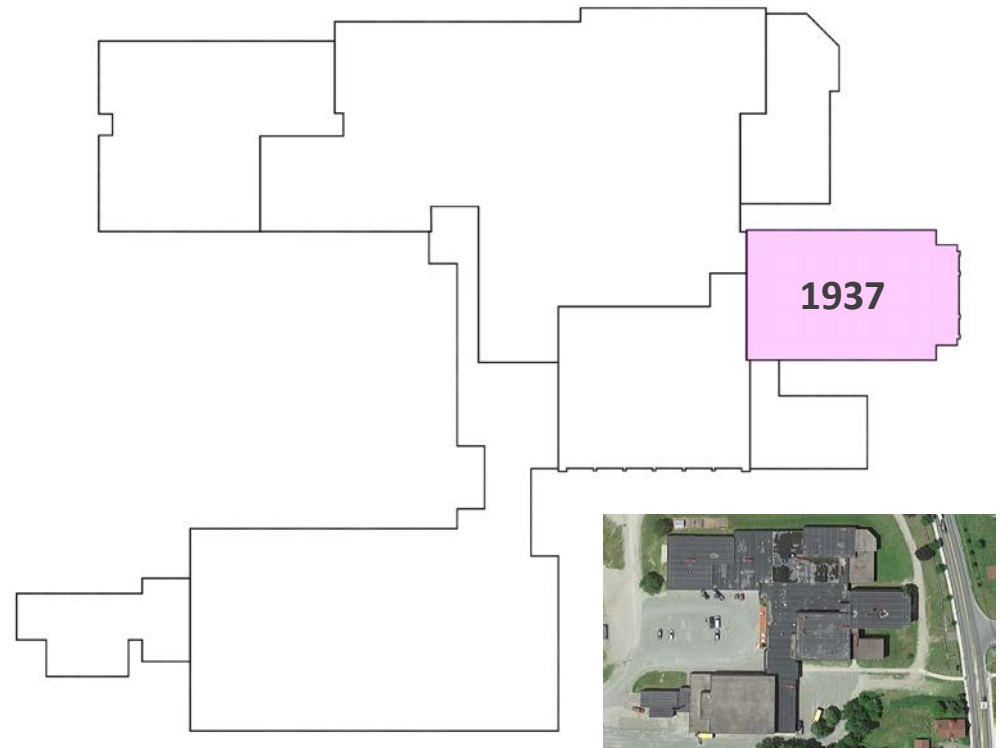
PLAN DIAGRAM

- *5,170 SF/Floor x 2 Stories*
- *1,585 SF Basement*
- *Masonry bearing walls – exterior & interior*
- *Exterior: Brick & clay tile (uninsulated)*
- *Concrete floor structure*
- *Wood rafter and deck roof (combustible)*
- *8-in Cellulose insulation at attic space*

Area Total: 11,295

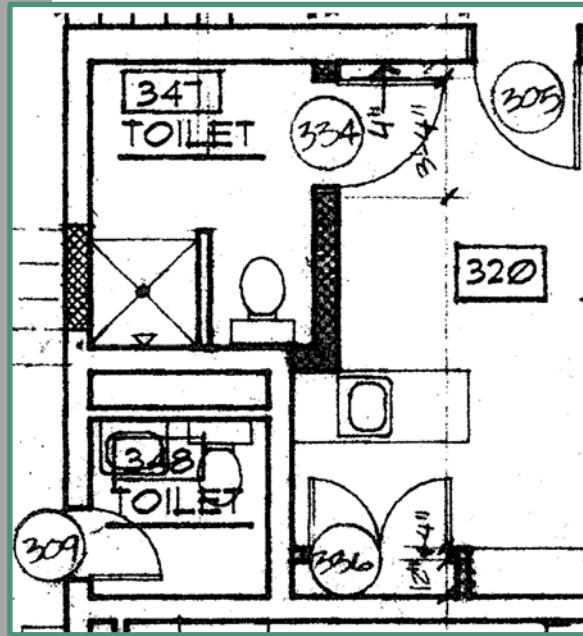
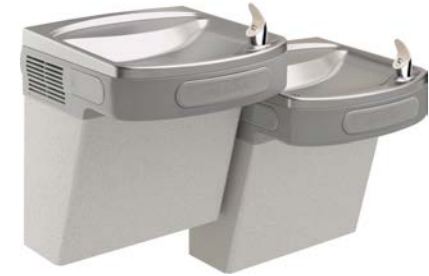
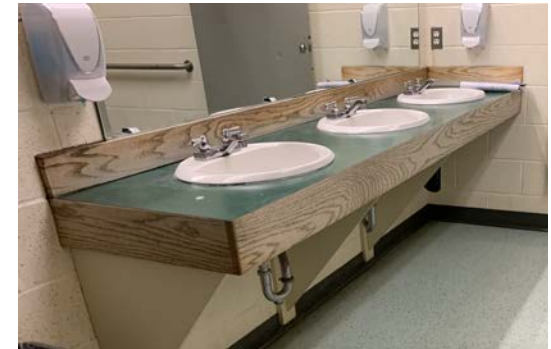
ACCESSIBILITY CONCERNS

- Existing Multi-Fixture Bathrooms not fully compliant
- Single-hole bathrooms non-compliant
- Auditorium Seating
- Counter Heights
- Drinking Fountains

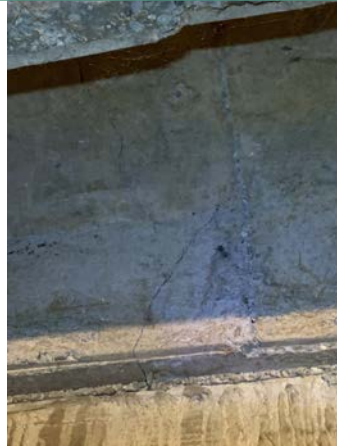
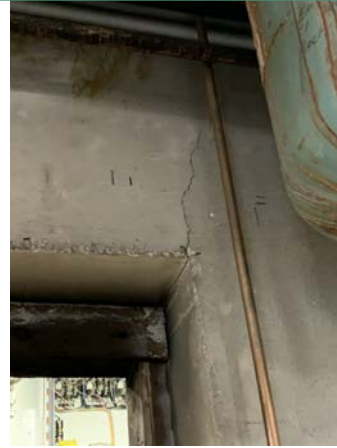
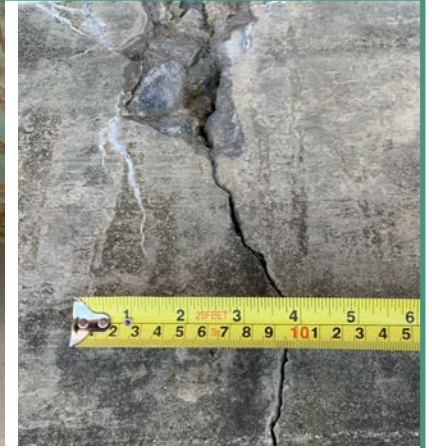
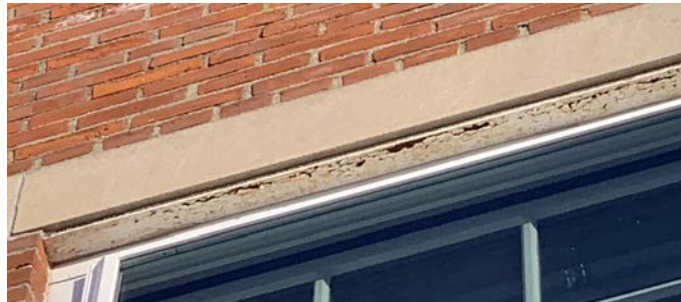
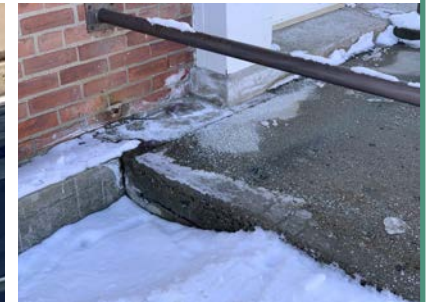
BUILDING STRUCTURE

- *Monitor Floor Slab Crack*
- *Stabilize Wall Crack at Basement Concrete Wall*
- *Repair Rusting Steel Lintel*
- *Repair Cracked/Spalling Concrete Foundations*
- *Repair North Entry Ramp*

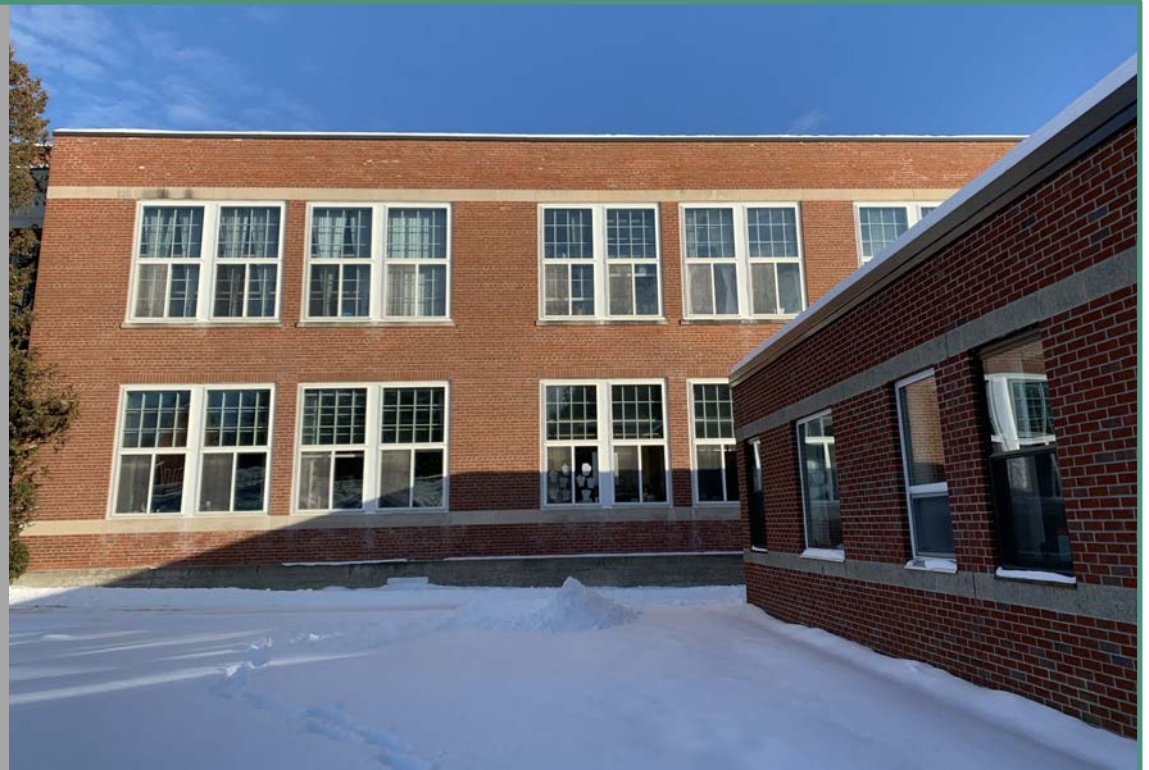
BUILDING ENVELOPE

- *1937: Exterior storms over single-pane wood windows*
- *1957: No original 1957 windows remain*
- *1969: A few 1969 era windows remain ...now 50 years old and failing*
- *1989: Original windows were of relatively poor quality, now at the end of useful life ...30 years old*

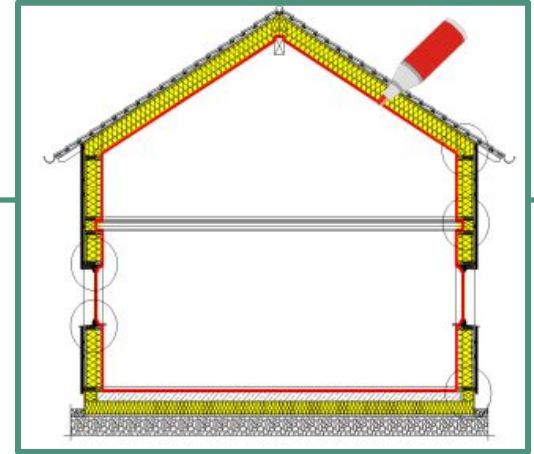
BUILDING ENVELOPE

- *Primarily constructed prior to the understanding of the Air Barrier Concept (except 2007 Addition)*
- *Multiple defects, holes and unsealed joints in the envelope*
- *Air moves freely between exterior and interior making it difficult to control the indoor environment*

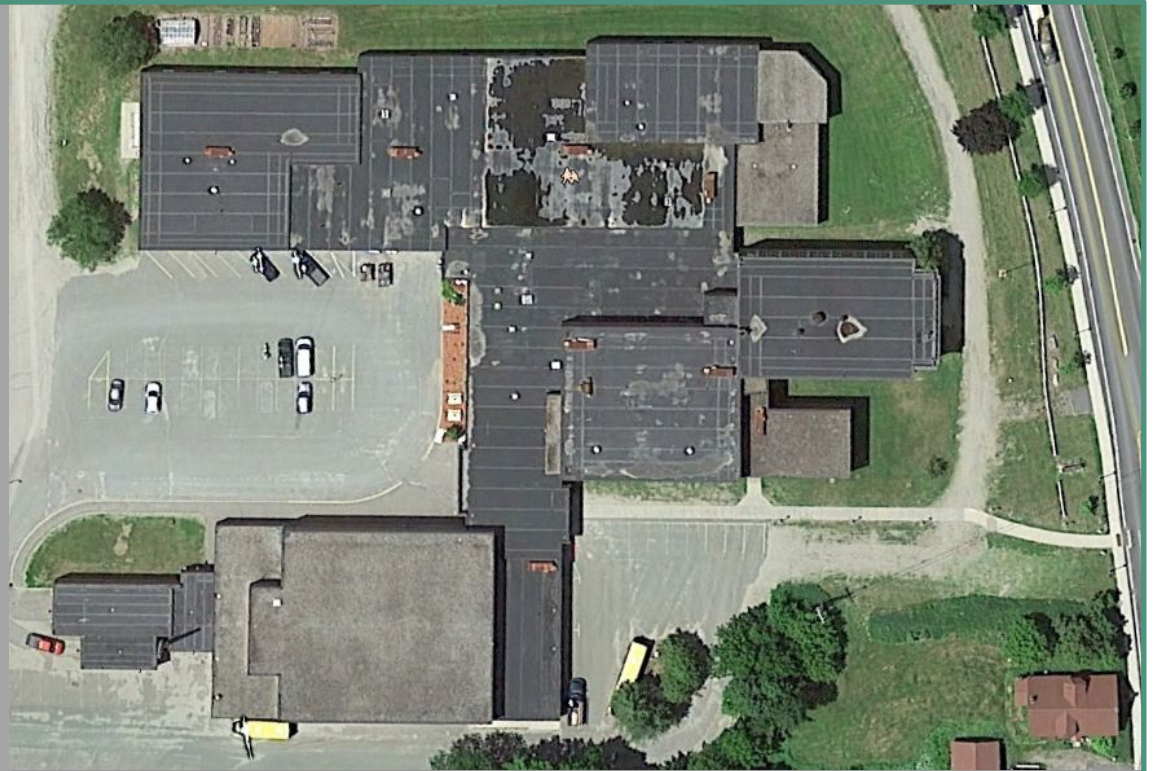
BUILDING ENVELOPE

- Ballasted Single-Ply Membrane:
 - 1989 Library/ Classroom
 - 1989 2-Story Addition
 - 1989 Gymnasium
- Single-Ply Membrane:
 - 1989 Other Areas
 - 2007 Woodchip
 - 1937 High School
 - 1957 Addition

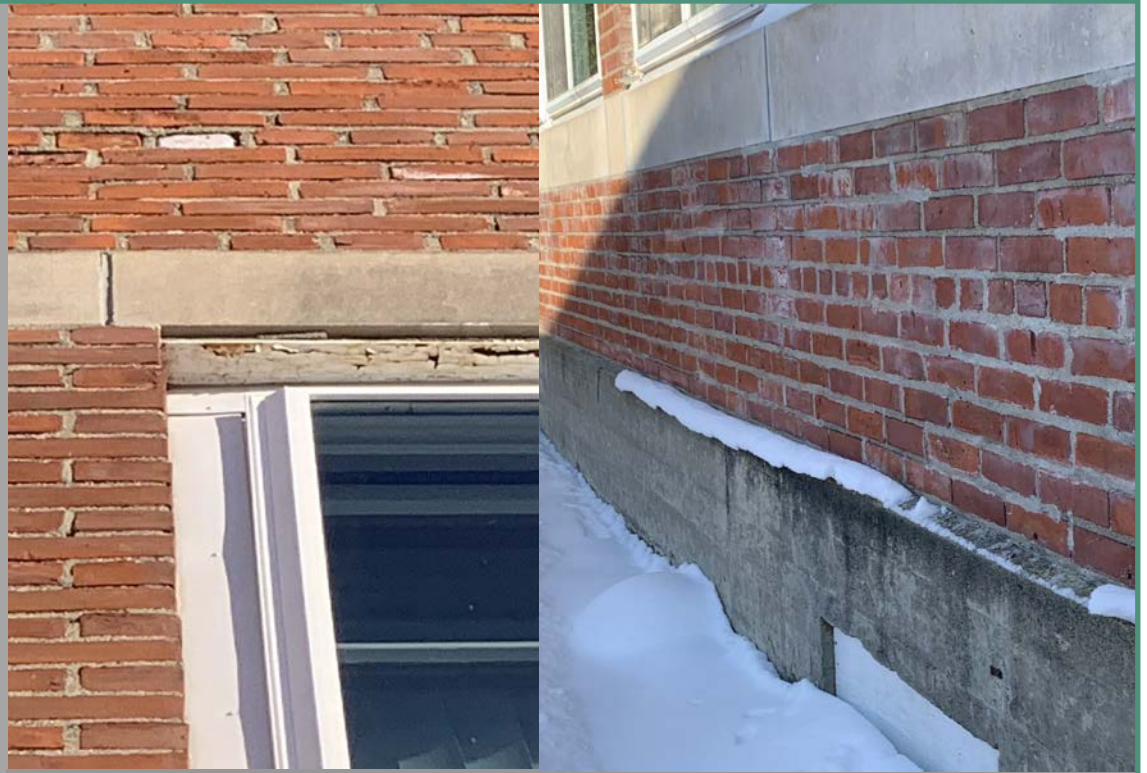
BUILDING ENVELOPE

- DETERIORATING MORTAR:
- *Previously noted as source of interior wall damage at 1937 Building*
- *Recommendation:
Full-building repointing at
1937 Building*

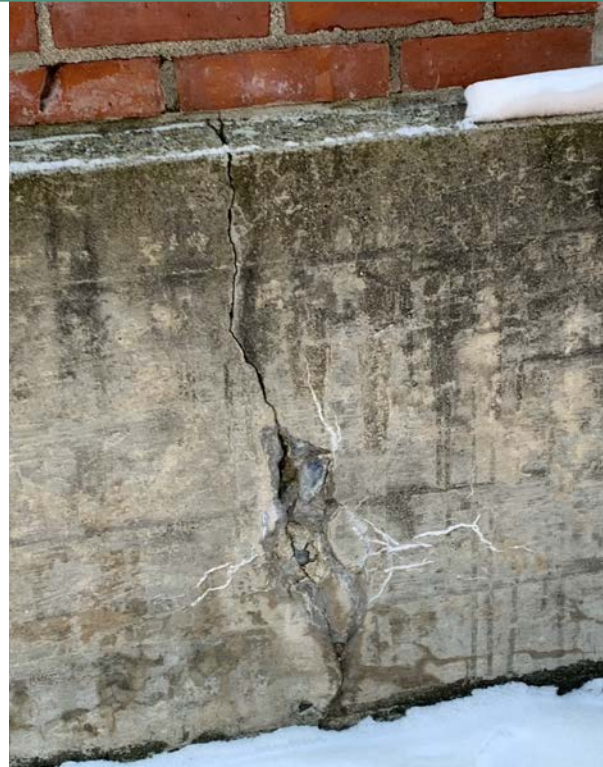
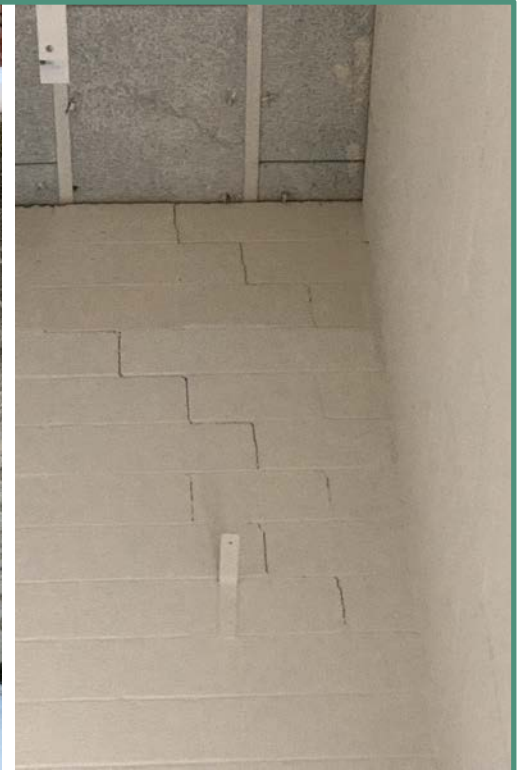
BUILDING ENVELOPE

- **STRUCTURAL CRACKING:**

- *Foundation Wall Cracks*

- *Cracking at Concrete Block (CMU) of Exterior Bearing Walls*

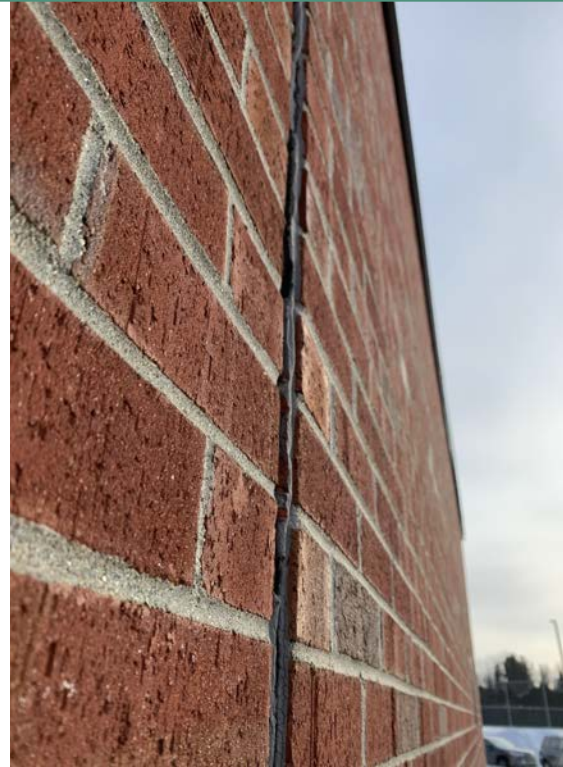
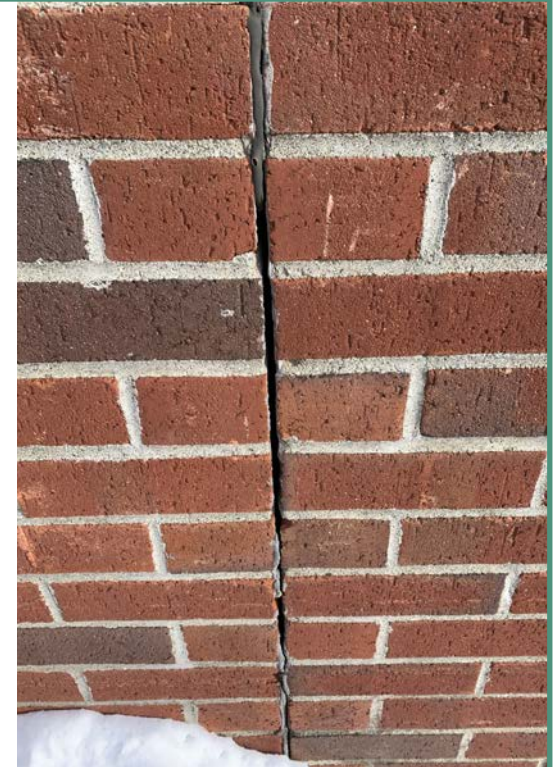
BUILDING ENVELOPE

- CONTROL JOINTS:
- *Failed Exterior Control Joints with water penetration to brick veneer cavity*
 - 1957
 - 1969
 - 1989

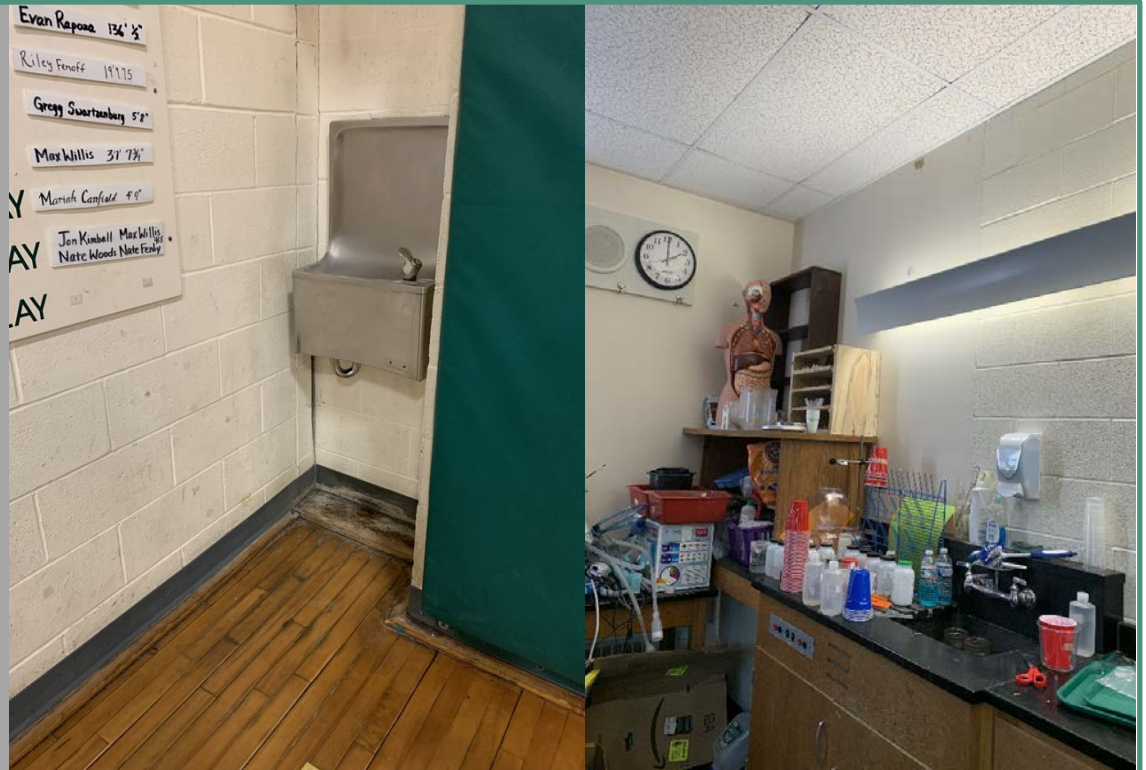
INTERIOR CONDITIONS

- **FLOORS:**

- *Replace aged, stained and worn **carpeting** throughout building*
- *Replace **wood sports floor** at Gymnasium*

- *Replace deteriorated casework/counters in areas slated for renewal/renovation*

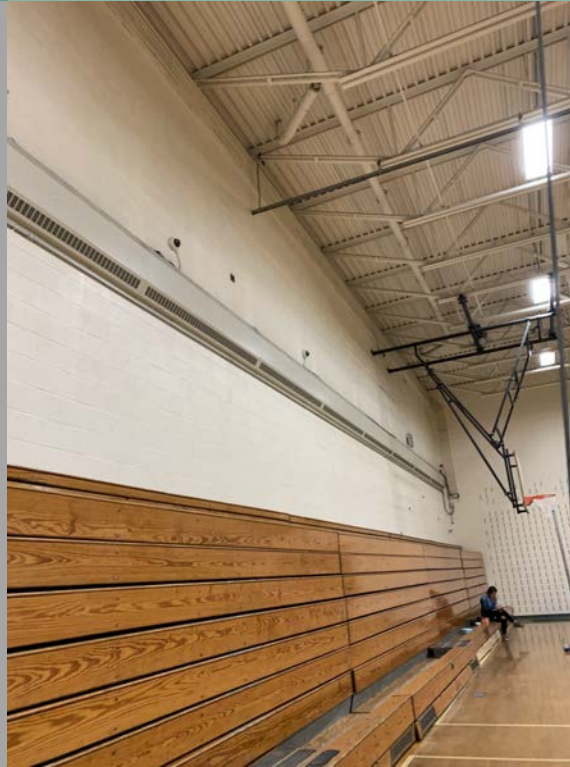
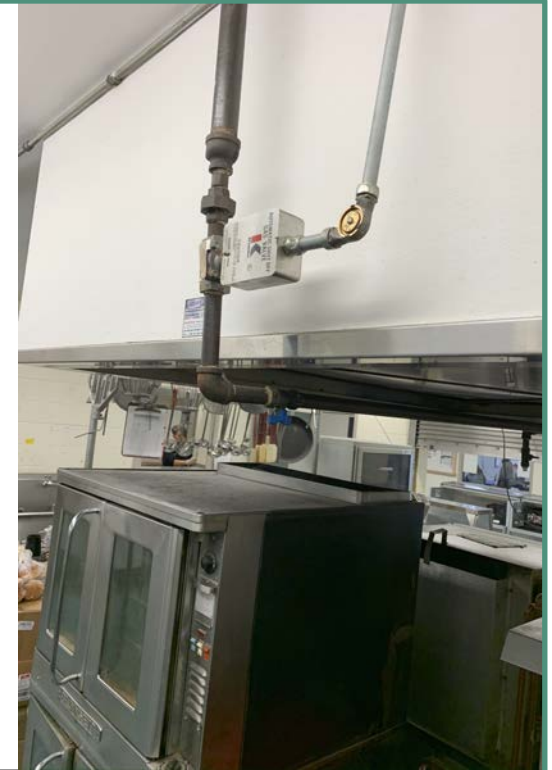
INTERIOR CONDITIONS

- **GYMNASIUM:**
- *Replace Retractable Bleacher seating system*
- *Renew or replace operable Basketball Backstops*
- **KITCHEN**
- *Infrastructure at end of useful life*
- *Replace all piping and waste lines under-slab*

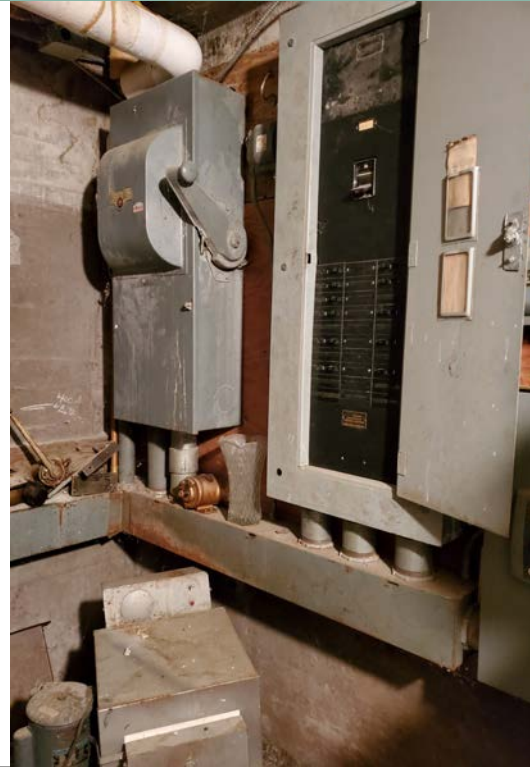
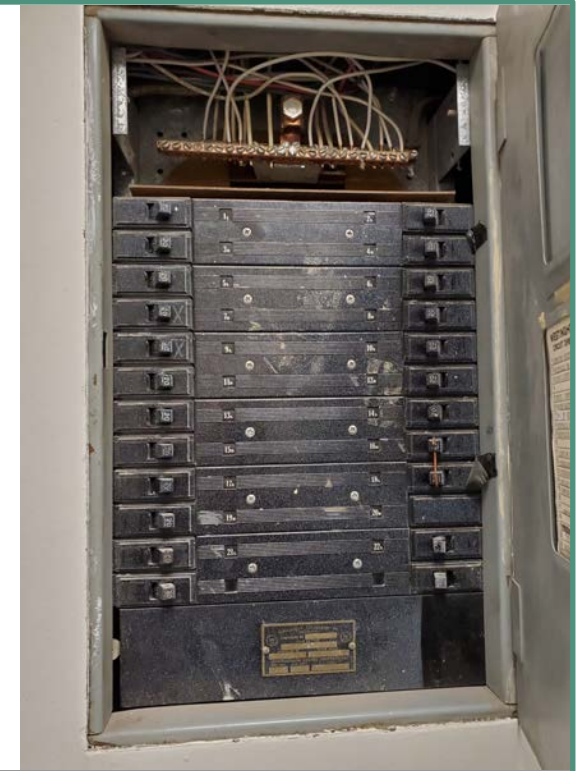
ELECTRICAL SYSTEMS

- **DISTRIBUTION:**
- *Electrical switchgear more than 50 years old. At the end of service life and oversized for current loads*
- *Electrical distribution panels in service date from 1937, 1957 & 1969. Beyond service life – some well beyond...*
 - *Replace outdated distribution gear and panels*

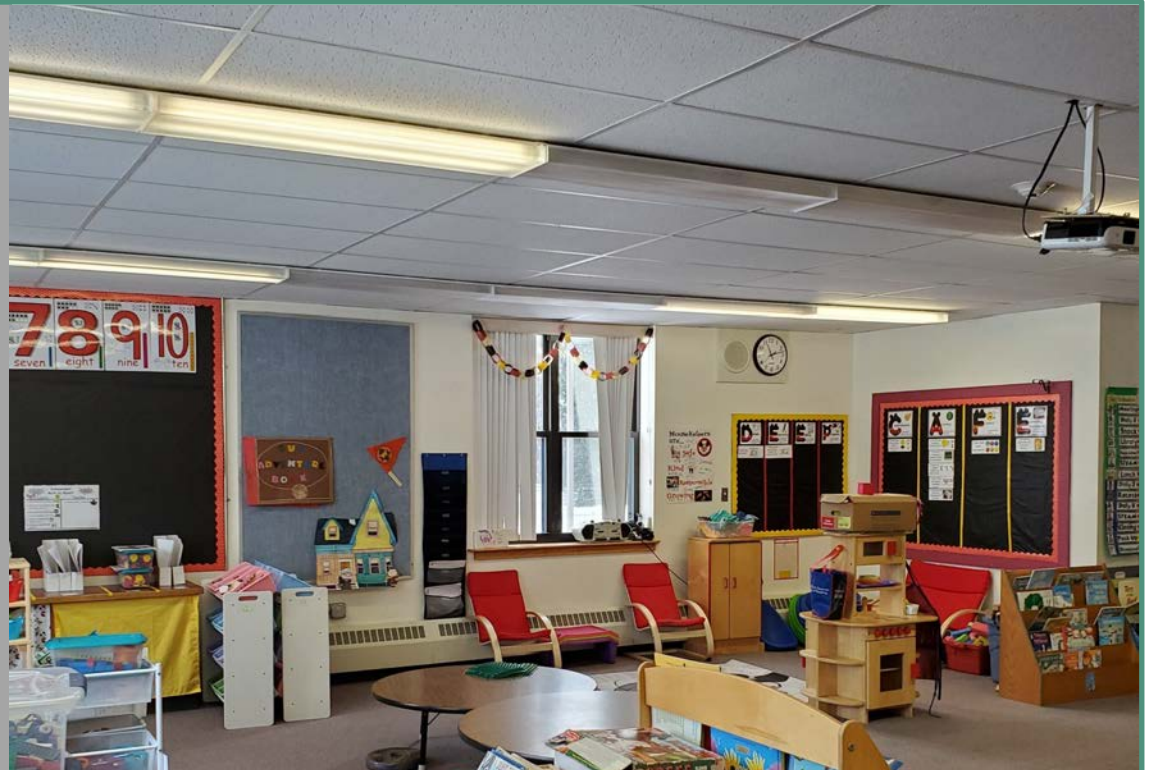
ELECTRICAL SYSTEMS

- **Lighting:**
- *Currently fluorescent technology with efficiency upgrades*
- *LED lighting technology offers controllability, better quality of light and energy savings – a next generation solution*
 - *Replace all lighting with LED lighting systems*

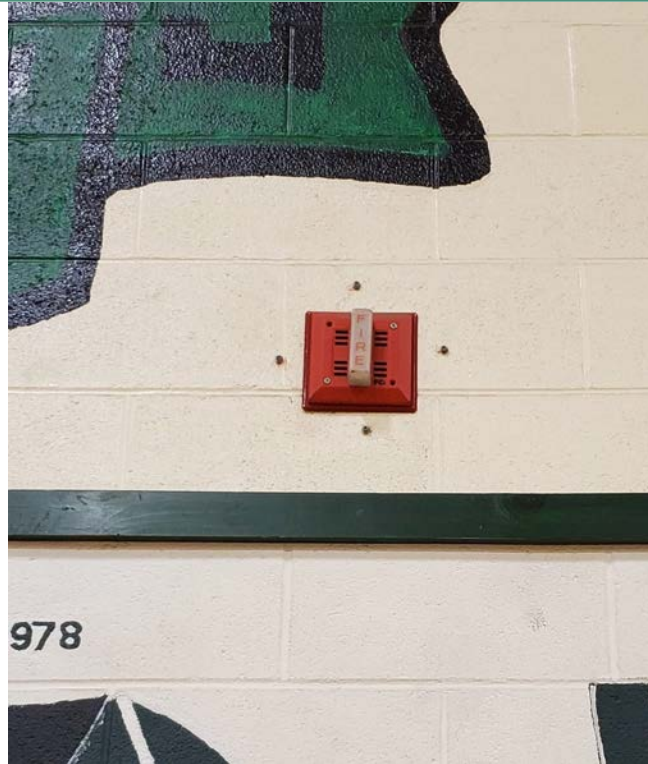
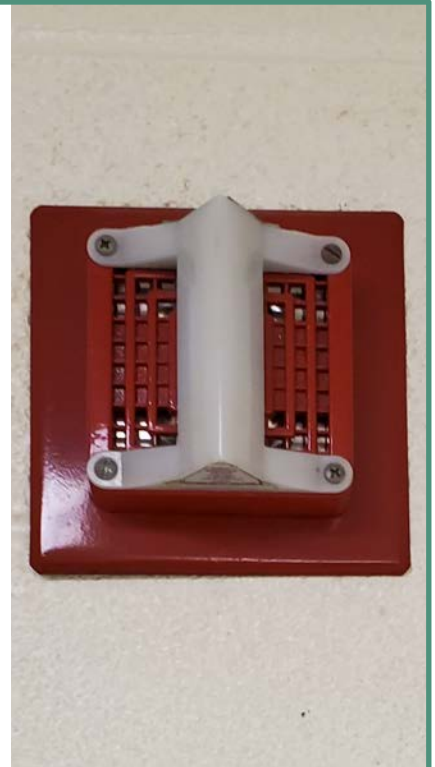
ELECTRICAL SYSTEMS

- **CODE ISSUES:**
- *Current system does not meet current code- not a Voice Evacuation System*
- *Outdated and ADA-non-compliant devices*
- *Heat/Smoke Detection incomplete ...required in non-fully sprinklered building*
 - *Provide code compliant alarm system*

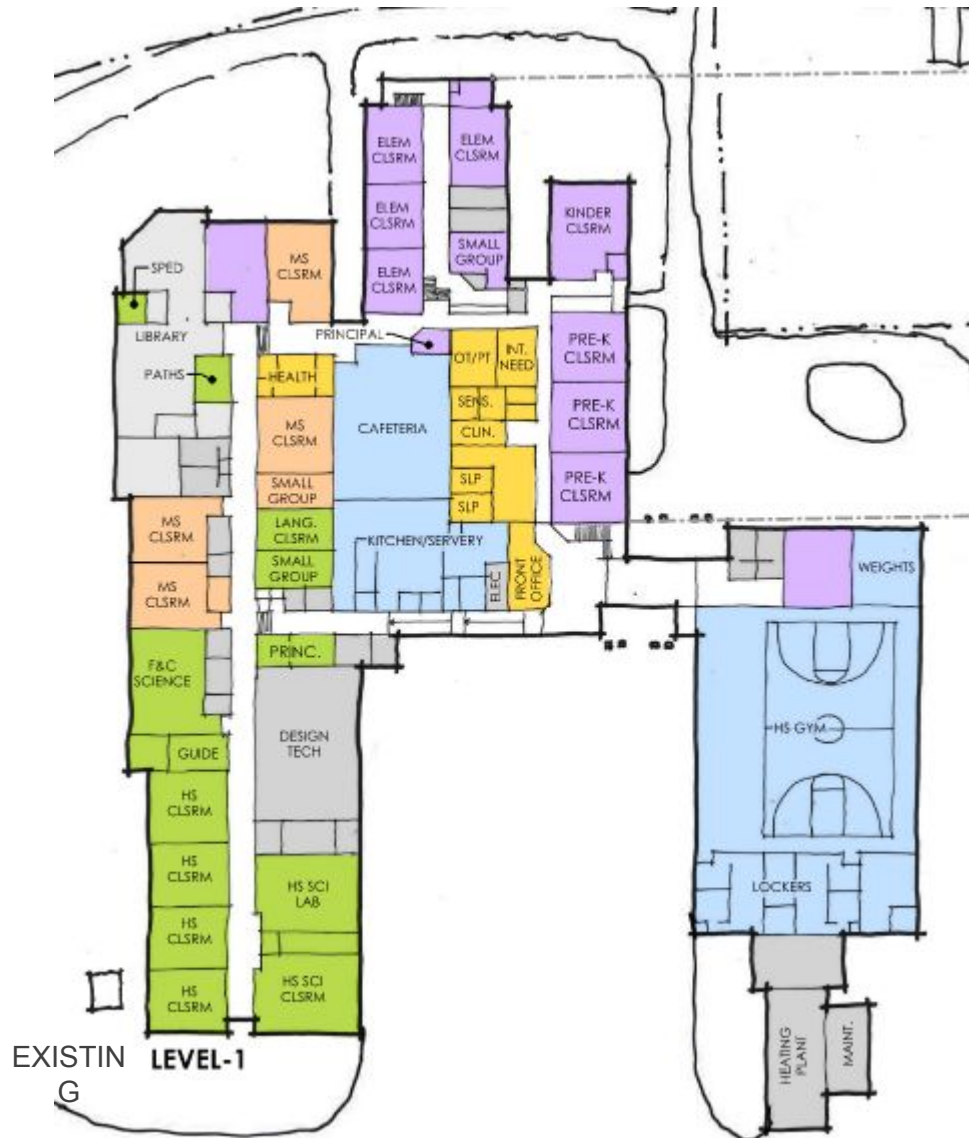
ALTERNATIVE OPTIONS – REDUCED PLAN

- Combined Cafeteria/Gym
- Reduced Auditorium
- Reduced demolition of existing
- Reduced new construction
- Increased areas of renovation
- Up to \$10 million in potential savings

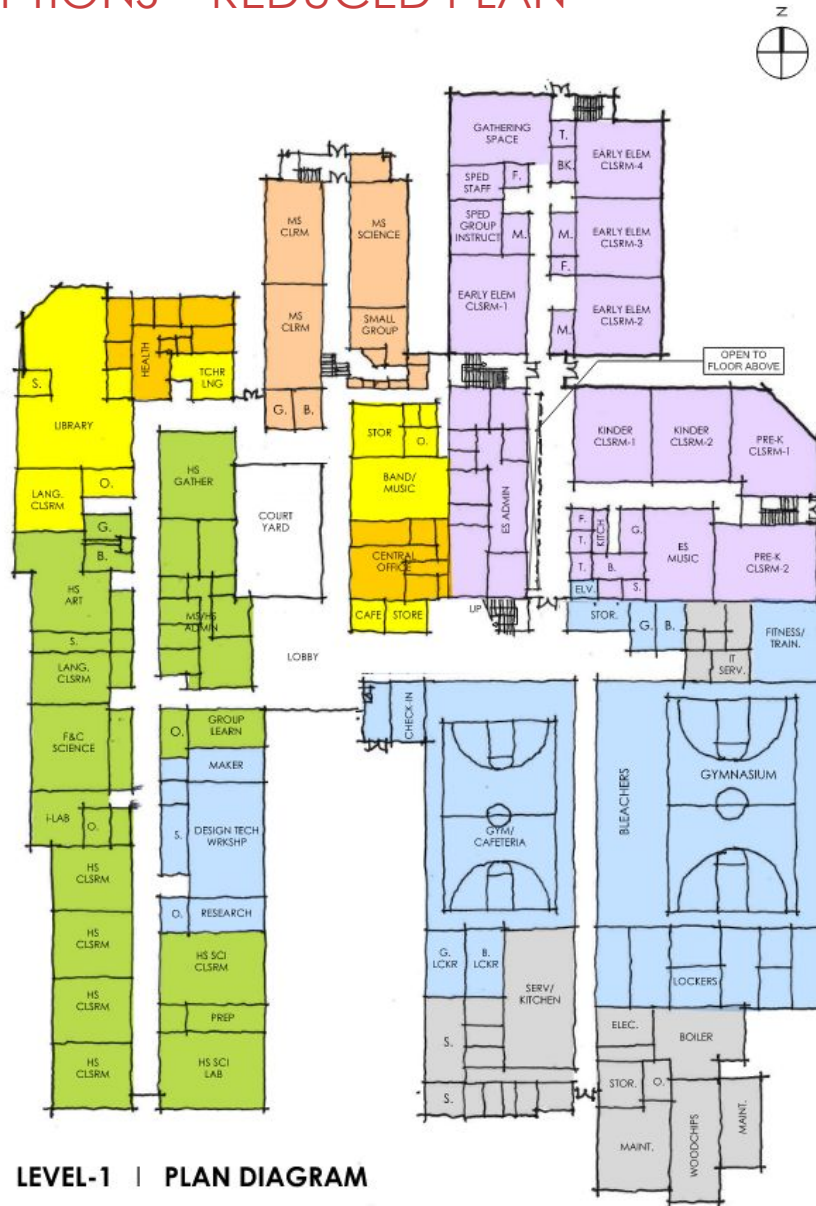
PROPOS ED LEVEL-1 | PLAN DIAGRAM

ALTERNATIVE OPTIONS – REDUCED PLAN
