# Report: The Death and Rebirth of Community Bridge

November 30, 2021 (revised 10/22)

## Report: The Death and Rebirth of Community Bridge

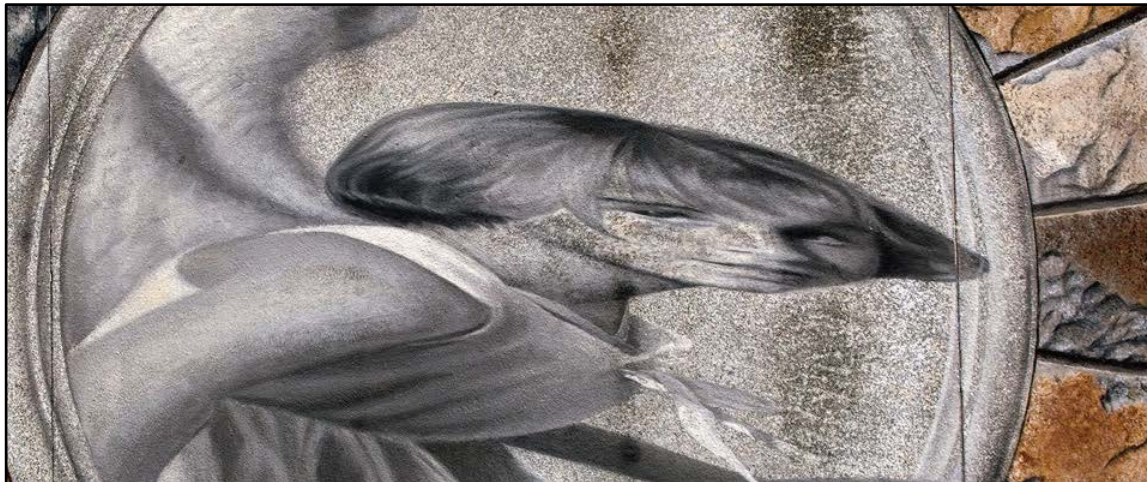
*Above: Advanced colonies of what are believed to be the cyanobacteria *Gloeocapsa Magma* feasting on the cement substrate just beneath the silicate mural surface.*

Unfortunately, the biological growths covering many Bridge surfaces for three years were more destructive than lichens or algae. They appear to have been *Gloeocapsa magma*, an aggressive cyanobacterium that creates all the damages itemized above, but also has two other characteristics that make it especially harmful.

First, *Gloeocapsa magma* consumes calcium carbonate in cement and concrete as food. Second, unlike most biological growths, *Gloeocapsa magma* grows a hard UV shield around it, giving it the unusual ability to thrive on surfaces exposed to direct sunlight.

The characteristic dark streaks seen in the photograph on the previous page are advanced colonies of *Gloeocapsa magma*. These colonies are pulled downward by gravity when they reach advanced stages of development. The bacterial infection also invisibly covers and damages the surface in the area between the dark streaks. These bacteria spread aggressively across all mural walls, north, south, east, and west. The cement surface had already suffered damage from prolonged moisture intrusion when these armored bacteria began feasting on the mural's substrates. They were sustained for at least three years by the high levels of moisture permeating the surfaces.

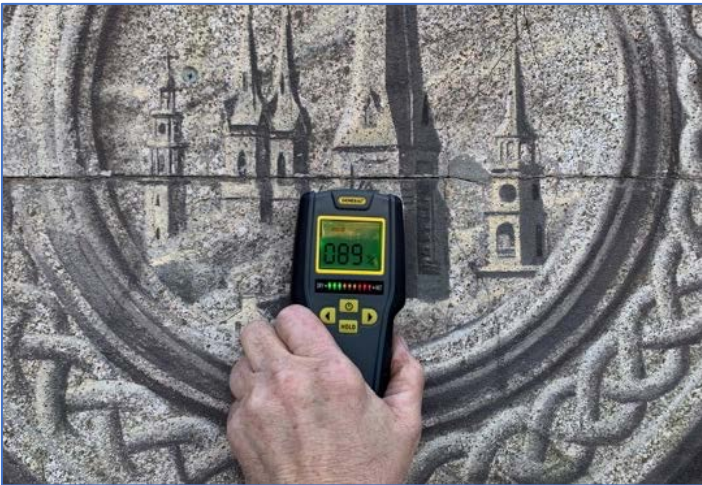
Concrete may look "hard as a rock," but it is an incredibly porous material that resembles a sponge on the inside. Twelve to eighteen percent of concrete are tiny open holes and tunnels. This network of tunnels rapidly conveys any moisture and contaminants throughout the concrete by **capillary action**, the term for how water transports quickly through concrete's tiny pores due to surface interactions between liquid and the pore wall that occur on a molecular level.

Moisture wicks throughout concrete and cement much faster than most people imagine, and often carries dissolved salts and other corrosives. Moisture intrusion is the **leading cause of concrete degradation worldwide**. Protecting concrete structures from moisture and salt incursion is a designer's primary responsibility.

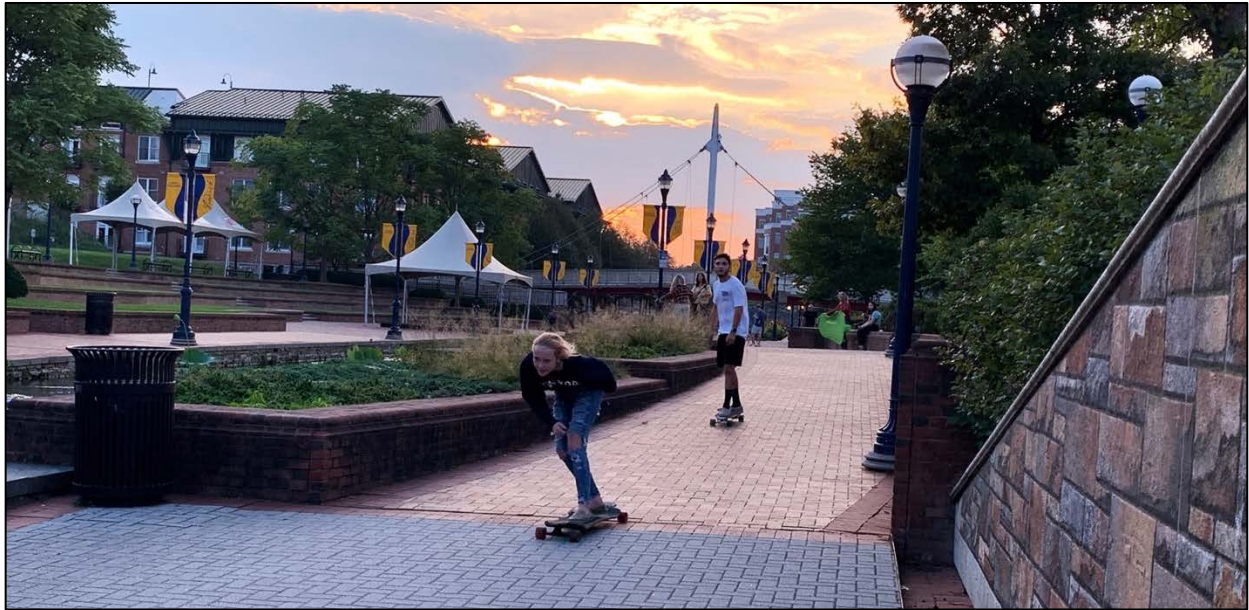
*Adjacent walkways and landscaping all slope downhill toward the low area around Community Bridge.*

The park and surrounding terrain now slope down to the bridge on all sides. Consequently, runoff from rain, snow, and irrigation moves downhill and becomes concentrated in the bridge area, where the sand bed beneath the pavers acts as a reservoir, a 5000-square-foot “wet blanket” that is continually replenished by precipitation and the park's irrigation systems. This “wet blanket” of sand-set pavers holds water in the liquid state against the concrete surface of the conduit and the base of all bridge walls, columns, and mural substrates for extended periods. It wicks moisture into all the concrete structures it touches.

The design of the park transformed the area under and around the Bridge into a bowl that, without commensurate drainage improvements, holds moisture and salts on a permanent basis.

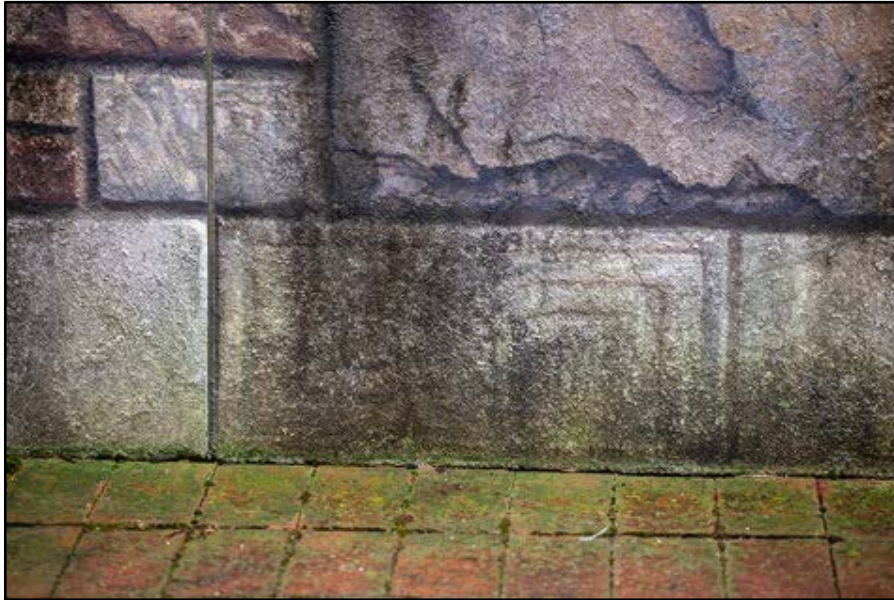
mural walls. Overspray from poorly positioned irrigation outlets in the planting beds has regularly wetted the wing walls and paver walkways, contributing significantly to the moisture problems. The longstanding presence of moss and lichens on the pavers is an unmistakable sign of the constant presence of water.

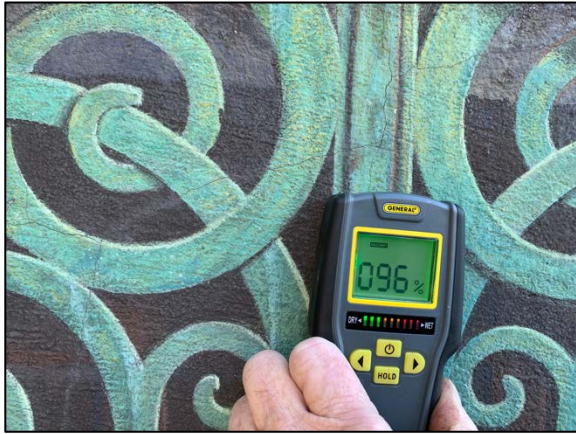
Mural surfaces and walkways alike have shown consistently high moisture readings, even weeks after rain. In the bridge area, the park became the equivalent of a marine environment.
