**REPORT ON  
RECYCLING AND WASTE DIVERSION PROGRAM EVALUATION  
FINAL – NOVEMBER 17, 2023  
SUBMITTED TO**

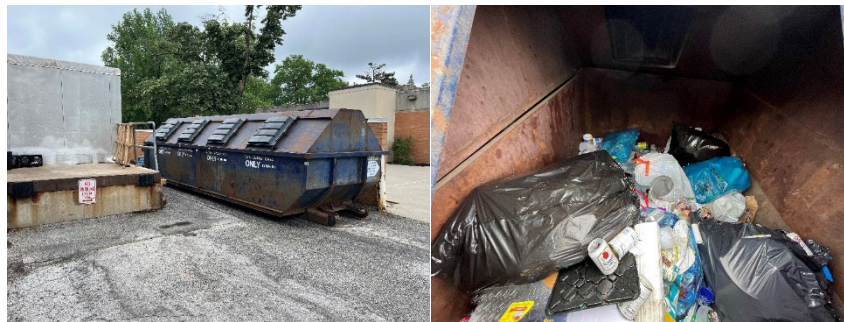
Users may perceive this location as being less accessible due to its location next to a loading dock. Contamination was relatively limited, which may be a function of the location being somewhat restricted. The posted instructions for use were not within line of sight when approaching and using the receptacles.

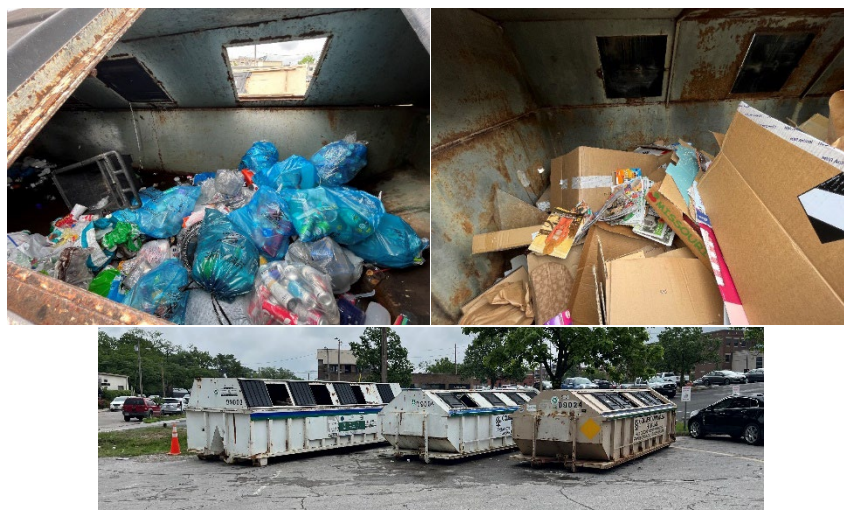
*Downtown (The Armory) – Along Park Ave, between 7<sup>th</sup> and 8<sup>th</sup> Street*

RRT observed this location to be busy with users. The receptacles are gable-top roll-offs for both streams. The site and the receptacles are out in the open. The receptacles were observed to be more contaminated than other sites, with bagged trash in both the container and fiber roll-offs, somewhat more so with the commingled containers. The recycling guidelines are posted directly on the roll-offs.

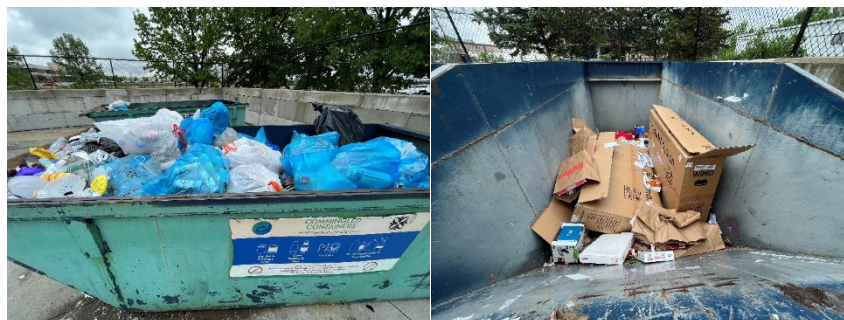
This site is a notably larger location. The containers are open top 8- to 12-cubic yard “dumpsters” with no closures. The site was observed to be clean and had minimal contamination in containers and fiber dumpsters, despite the wide-open access for users and being heavily screened from the street. This could have to do with the location being in a busy commercial and shopping area.

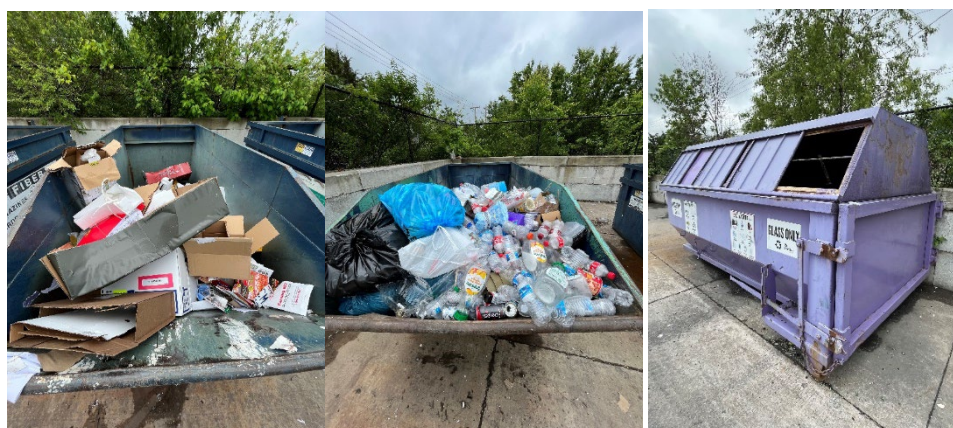
*State Farm Parkway – Near Grindstone, North of E. Nifong Blvd*

This site is another notably larger location. The containers are open top 8- to 12-cubic yard “dumpsters,” most without closures. This is the only drop-off center with a dedicated receptacle for glass. A City employee who happened to be on site noted this is the busiest location. The site was observed to be clean and had minimal contamination in containers and fiber dumpsters, despite the wide-open access for users, the somewhat secluded location, and being heavily screened from the street. There was minor contamination in the dumpsters from bagged trash, although much of the cardboard had Styrofoam inside of it and one of the fiber dumpsters had carpets placed inside of it.

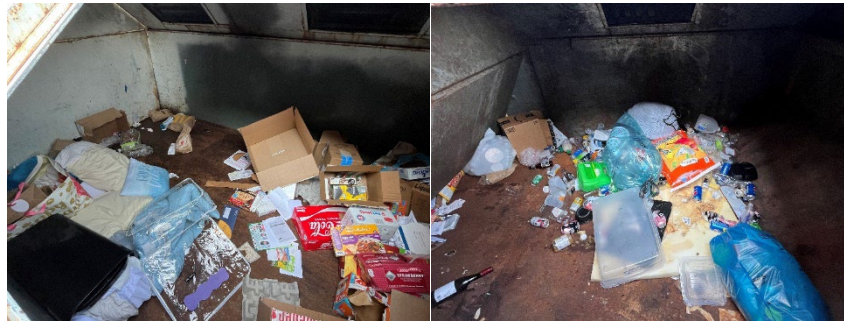
*University of Missouri (East Campus Plant Growth Facility) – Near East Campus Road and Ashland Road*

The site is adjacent to a residence hall on the Mizzou campus. The receptacles consist of gable-top roll-offs for both streams. The site had apparently been serviced relatively recently, but contamination in receptacles was already observed, including blankets, pillows, bulky plastic home goods, foam, crockery, film plastics, and cardboard in the wrong bin.
