**Subject:** 2025 Bridge Inspection Report to Council

2025 Bridge Inspections Summary PT NBIS(45) PCN 04N9

## CITY OF WATERTOWN | 2025 BRIDGE INSPECTIONS

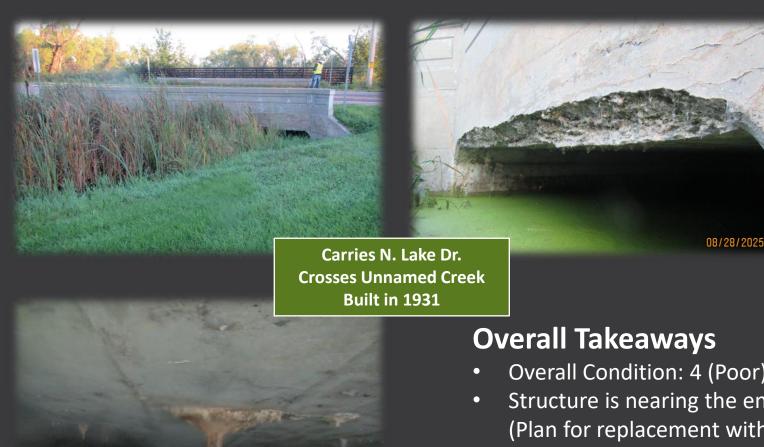
## Structure No. 15-141-139

- Overall Condition: 4 (Poor)
- Structure is nearing the end of its useful service life (Plan for replacement within next 5-10 years)
- Minor repair/maintenance recommendations.
- No load posting currently required.

Structure No.	Feature Carried	Feature Crossed	Inspection Date	Overall Condition	Current Posting	Recommended Posting	Recommended Repairs
15-141-139	North Lake Dr.	Unnamed Creek	8/28/2025	4	Not Posted	No Load Posting Required	Repairing the deteriorated areas of the barrel walls and top slab is not practical due to the age and condition of the structure.     Update the bridge railing to meet current standards.     This structure is nearing the end of its useful life and should be considered for replacement in the next 5-10 years.
15-158-185	17th Ave SW	Unnamed Creek	8/28/2025	7	Not Posted	No Load Posting Required	Replace missing hardware at SW sidewalk railing.     Remove moderate tree growth at SE corner of structure.
15-158-187	N Pelican Ln	Unnamed Creek	8/28/2025	8	Not Posted	No Load Posting Required	Repair undermining at SW sidewalk.
15-181-170	3rd Ave. NW	Big Sioux River	8/28/2025	7	Not Posted	No Load Posting Required	Clean and grout areas of honeycombing with exposed rebar on the underside of the concrete slab in center span.     Recommend application of an epoxy crack sealer at transverse and longitudinal cracking in deck over east and west piers.     Monitor sidewalk ends for vertical displacement advancement creating tripping hazards.     Paint areas of rusting in railing extensions at welded splices.

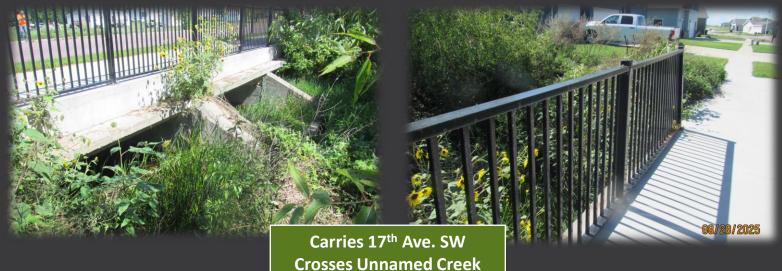
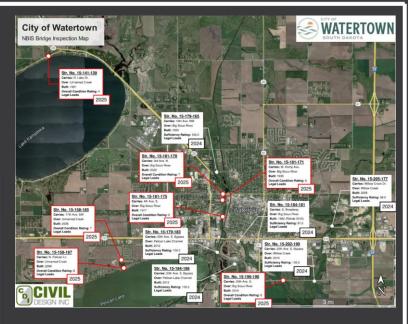
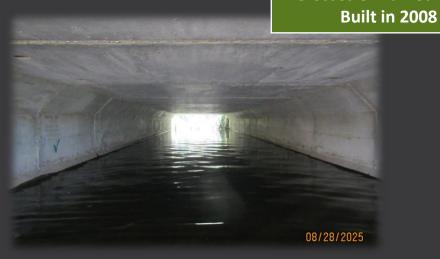
## Structure No. 15-158-185

- Overall Condition: 7 (Good)
- Structure added to NBIS Inventory (Initial Inspection)
- Minor repair/maintenance recommendations.
- No load posting required.

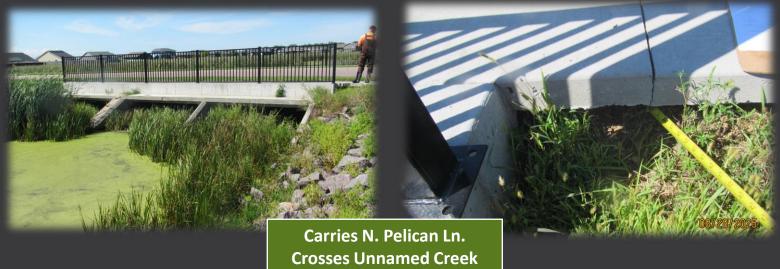
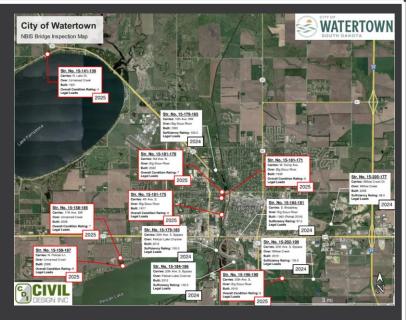
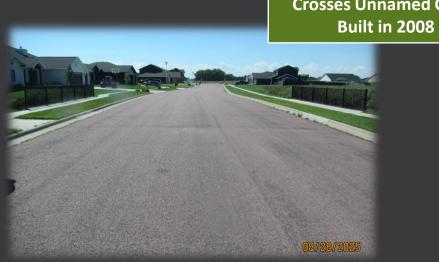
## Structure No. 15-158-187

- Overall Condition: 8 (Good)
- Structure added to NBIS Inventory (Initial Inspection)
- Minor undermining to SE Sidewalk.
- No load posting required.

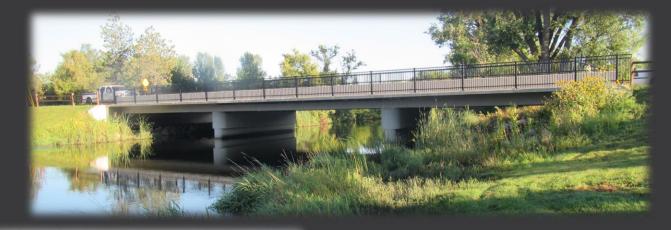
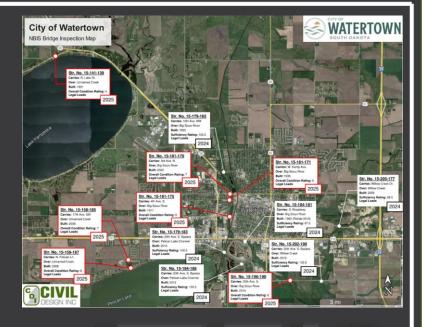
## Structure No. 15-181-170

Carries 3<sup>rd</sup> Ave. NW **Crosses Big Sioux River** Built in 2022

- Overall Condition: 7 (Good)
- Minor repair/maintenance recommendations.
- No load posting required.

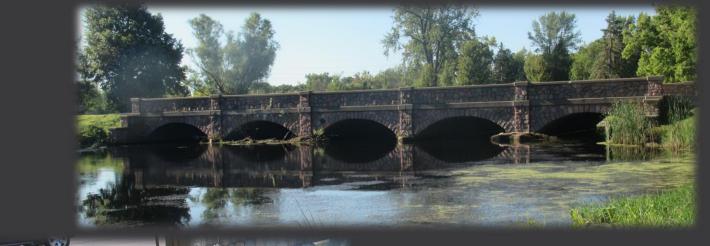
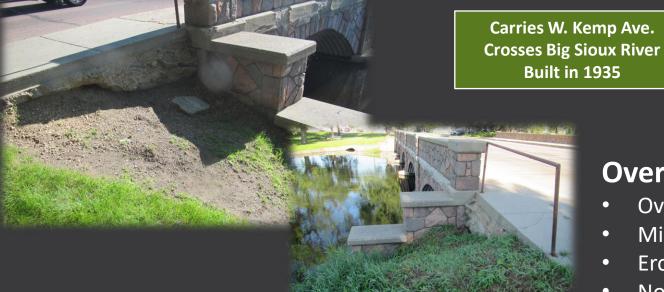
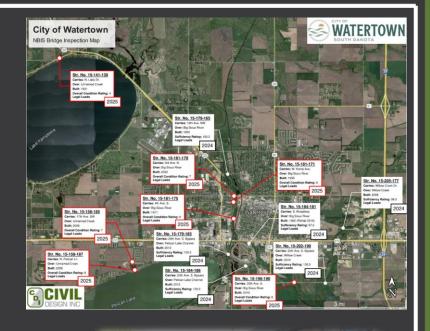
- Overall Condition: 6 (Fair)
- Minor repair/maintenance recommendations.
- Erosion & pedestrian safety related repairs.
- No load posting required.

15-181-171	W. Kemp Ave.	Big Sioux River	8/28/2025	6	Not Posted	No Load Posting Required	Extend the deck drain pipes on the underside of the arches.     Stabilize the erosion at all corners of the structure.     Clear the deck drains of debris.     Install chain link to railing extensions at SW and SE sidewalk approach corners for pedestrian safety.     Install railing extensions at NW and NE sidewalk approach corners.
15-181-175	4th Ave. SW	Big Sioux River	8/28/2025	6	Not Posted	No Load Posting Required	<ol> <li>Install a Type 3 object marker at all four (4) corner of the structure.</li> <li>Add chain link fence to the north pedestrian railing and paint railing or consider a railing retrofit.</li> <li>Riprap berm slopes in front of the east and west abutments.</li> <li>Consider an epoxy deck seal to extend the life of the concrete deck.</li> <li>Repair areas of delamination in the top surface of the concrete slab.</li> <li>Replace east and west approach concrete sidewalk panels with settlement and tripping hazards.</li> <li>Remove small tree growth under and around SW and SE corners of the structure.</li> <li>Cut old timber falsework pile putting pressure on bottom of slab under span #5. Consider cutting all falsework pile flush with ground.</li> </ol>

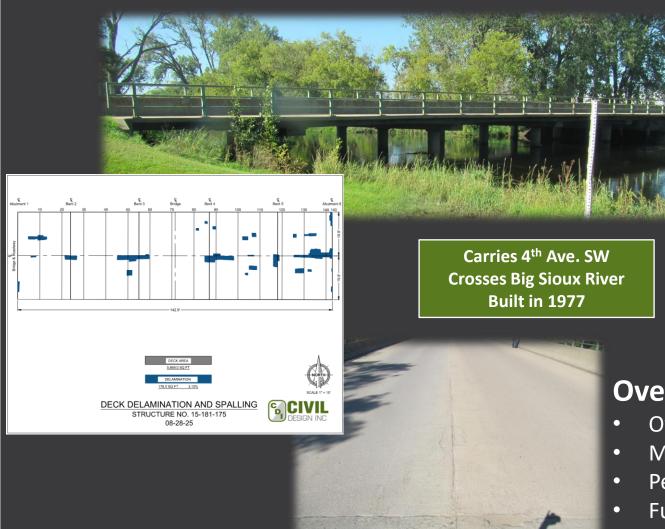
## Structure No. 15-181-175

- Overall Condition: 6 (Fair)
- Minor repair/maintenance recommendations.
- Pedestrian safety related repairs.
- Future deck repairs & polymer chip seal recommended.
- No load posting required.

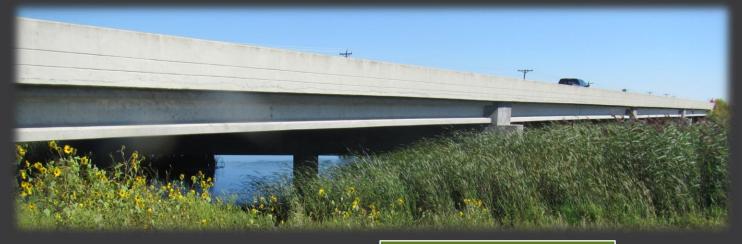
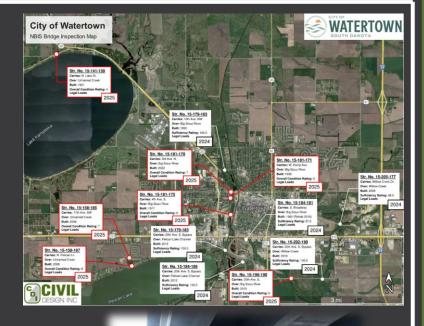
## Structure No. 15-196-190

- Overall Condition: 6 (Fair)
- Minor to moderate repair/maintenance recommendations.
- Arrest Bearing Pad Movement.
- Replace failed expansion joint filler at bridge ends.
- No load posting required.

15-196-190	20th Ave. SE	Big Sioux River	8/28/2025	6	Not Posted	No Load Posting Required	1. Install steel angle adjacent to neoprene bearing pad at girder #7, span #4 to prevent further movement. Alternatively reset neoprene bearing pad below girder to provide full bearing.  2. Replace failed expansion joint filler at east and west bridge ends.  3. Replace SW and NE object marker on ends of approach guardrails.  4. Replace the bent terminal post at the northwest guardrail end.  5. Install missing W-beam bolt on the northeast approach guardrail.  6. Routinely clean deck of debris to deter abrasive deterioration and to assist with the water flow. There are no drains on the structure with a minimal profile grade.  7. Consider installing deck drains at intermediate span locations where camber effect is noticeable.  8. Replace expansion filler joint material at all four (4) wingwalls of structure between wingwall and barrier rail.
