Pawleys Inlet Migration and Erosion Impacts – Preliminary Assessment

Prince George Community Shoreline

Georgetown County, South Carolina

**HISTORICAL CHANGES AT PAWLEYS INLET
AND A CONCEPTUAL PLAN FOR AN
INLET MANAGEMENT ZONE**

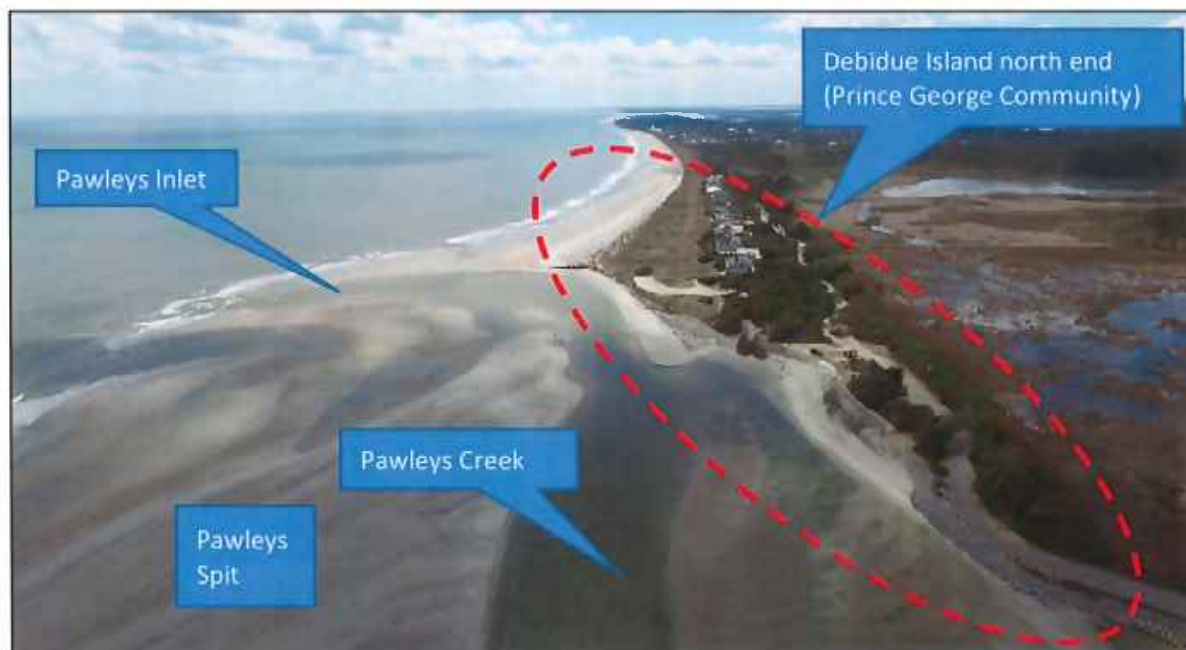
Figure 1. March 17, 2022 Oblique Aerial Imagery of Pawleys Inlet and Erosion along Study Area Shoreline along north end of Debidue Island (outlined in red)

Applied Technology and Management (ATM) has completed an assessment of the ongoing southern migration of Pawleys Inlet its associated erosion impacts in Georgetown County, South Carolina. The recent 2019/2020 Pawleys Island beach nourishment has dramatically increased the rate of southerly migration of the inlet which has exacerbated erosion on the northern end of Debidue Island along the Prince George Community shoreline. This observed pattern of increased inlet migration and accelerated erosion is already significantly affecting the northern Debidue Island shoreline and will continue to negatively impact several oceanfront lots in the Prince George Community neighborhood (see Figure 1). Roadways, utility lines, and other infrastructure are also at risk.

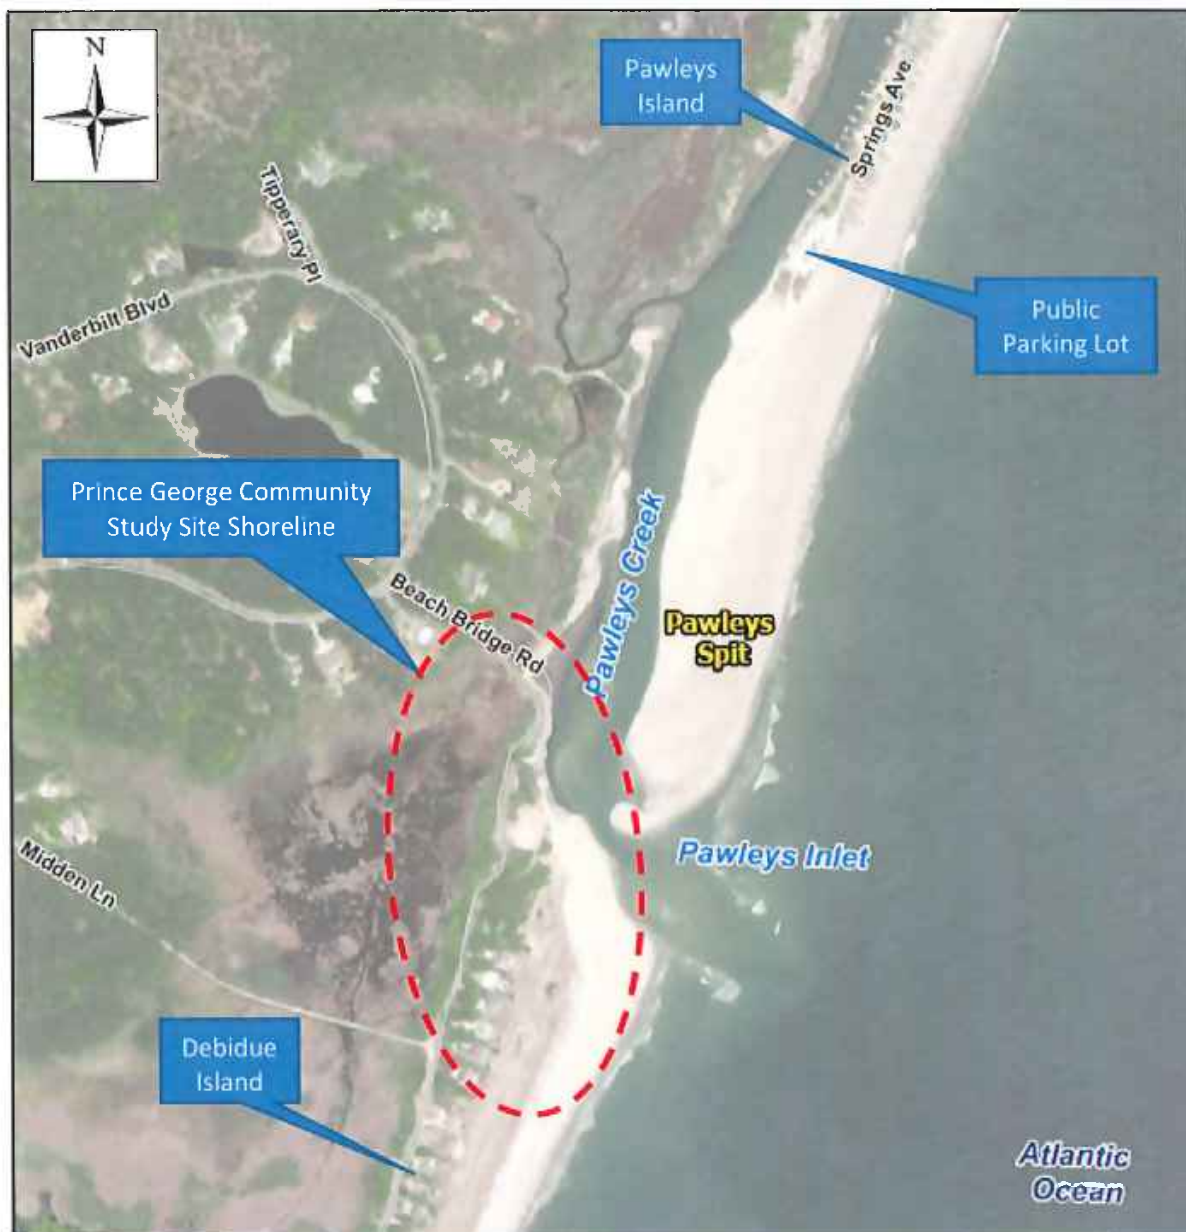
Figure 2. Study Area and Surrounding Features Overview (April 2021 Aerial Imagery).

Pawleys Inlet is an unstabilized inlet that separates Debidue Island, to the south, from Pawleys Island, to the north. Figure 2 presents an overview of the study area. The focus area for this assessment is on the affected shoreline along the backside of the inlet and the northern end of Debidue Island, within the Prince George Community neighborhood.

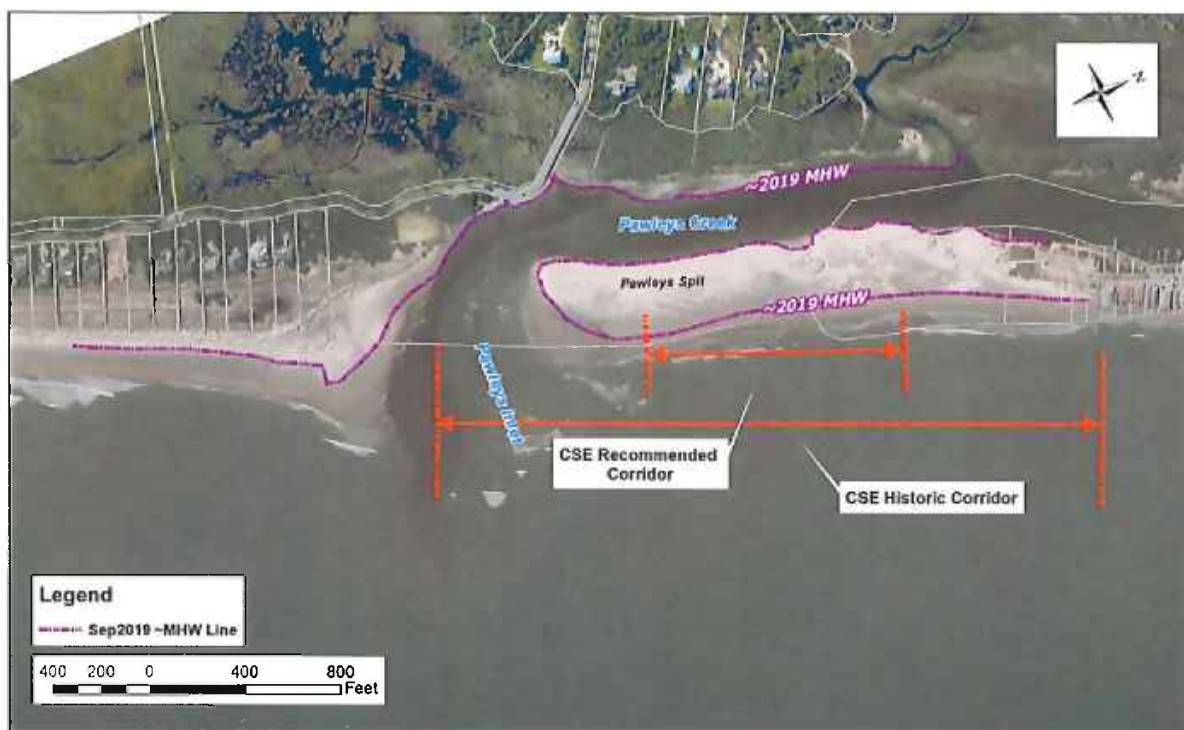
Figure 6: September 2019 Pre-Nourishment Aerial and MHW Line. CSE 2010 Historical and recommended inlet corridors also shown (refer to Figure 5 and Appendix B).

Figure 6 presents a September 2019 aerial and approximate mean high water (MHW) line showing pre-nourishment conditions around the inlet. The historic inlet corridor and the recommended inlet corridor from the 2010 CSE report are also shown for reference. As the 2019 aerial shows, the inlet was south of the recommended inlet corridor location but within the historical inlet corridor. Also note that Pawleys Spit is much more likely to breach (and shift the inlet north) in this pre-nourishment aerial when compared to post-nourishment aerials.

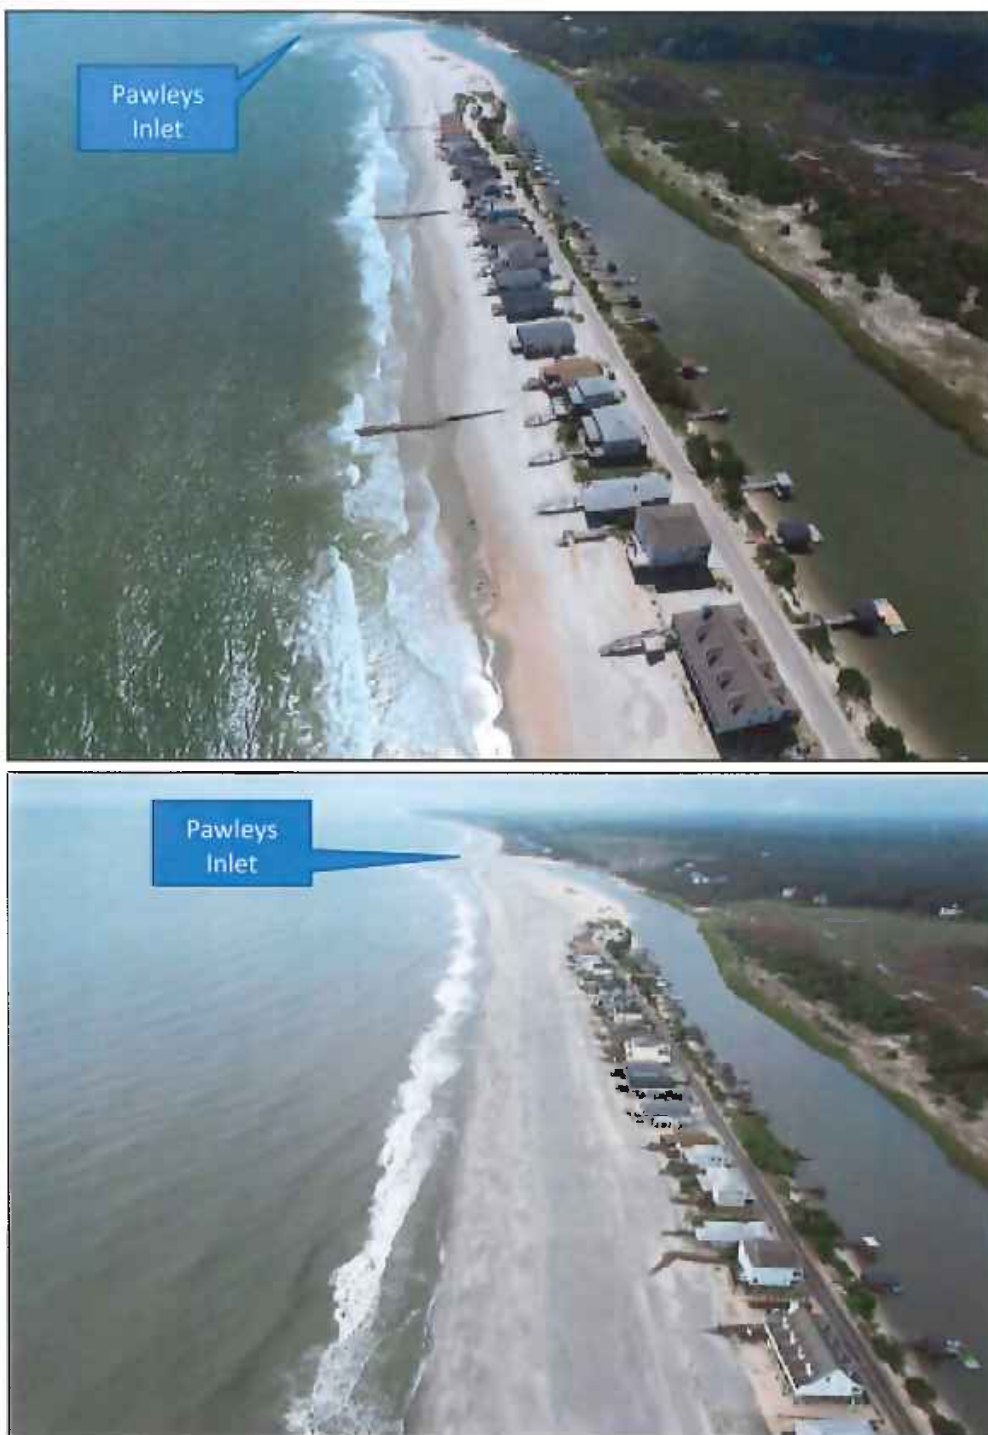
FIGURE B.1 (page 1 of 6). August 2019 [UPPER] and June 2021 [LOWER] images of Reach 1 at Pawleys Island (SC). Pawleys Inlet and Debidue Island are in the background. [all images taken by D. Giles]

Figure 7: Excerpt from CSE 1-yr post project monitoring report showing pre- and post-nourishment conditions along the southern end of Pawleys Island looking south towards Pawleys Inlet and Debidue Island. ~575,000 cy (~120 cy/ft on average) placed along the Reach 1 shoreline.

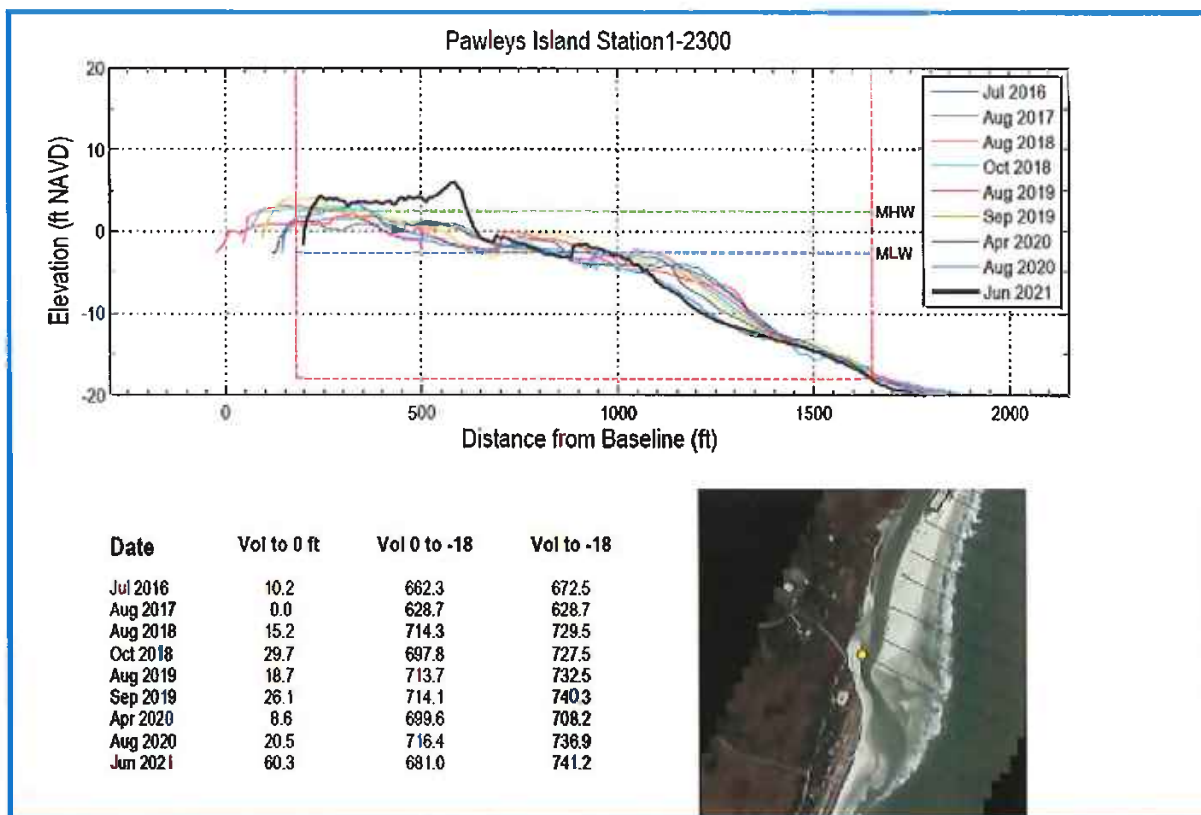
Figure 9: Excerpt from CSE 1-yr post project monitoring report showing the southernmost survey transect. Note Pawleys spit is clearly gaining material as the nourishment sand is moving south towards the inlet and Debidue Island.

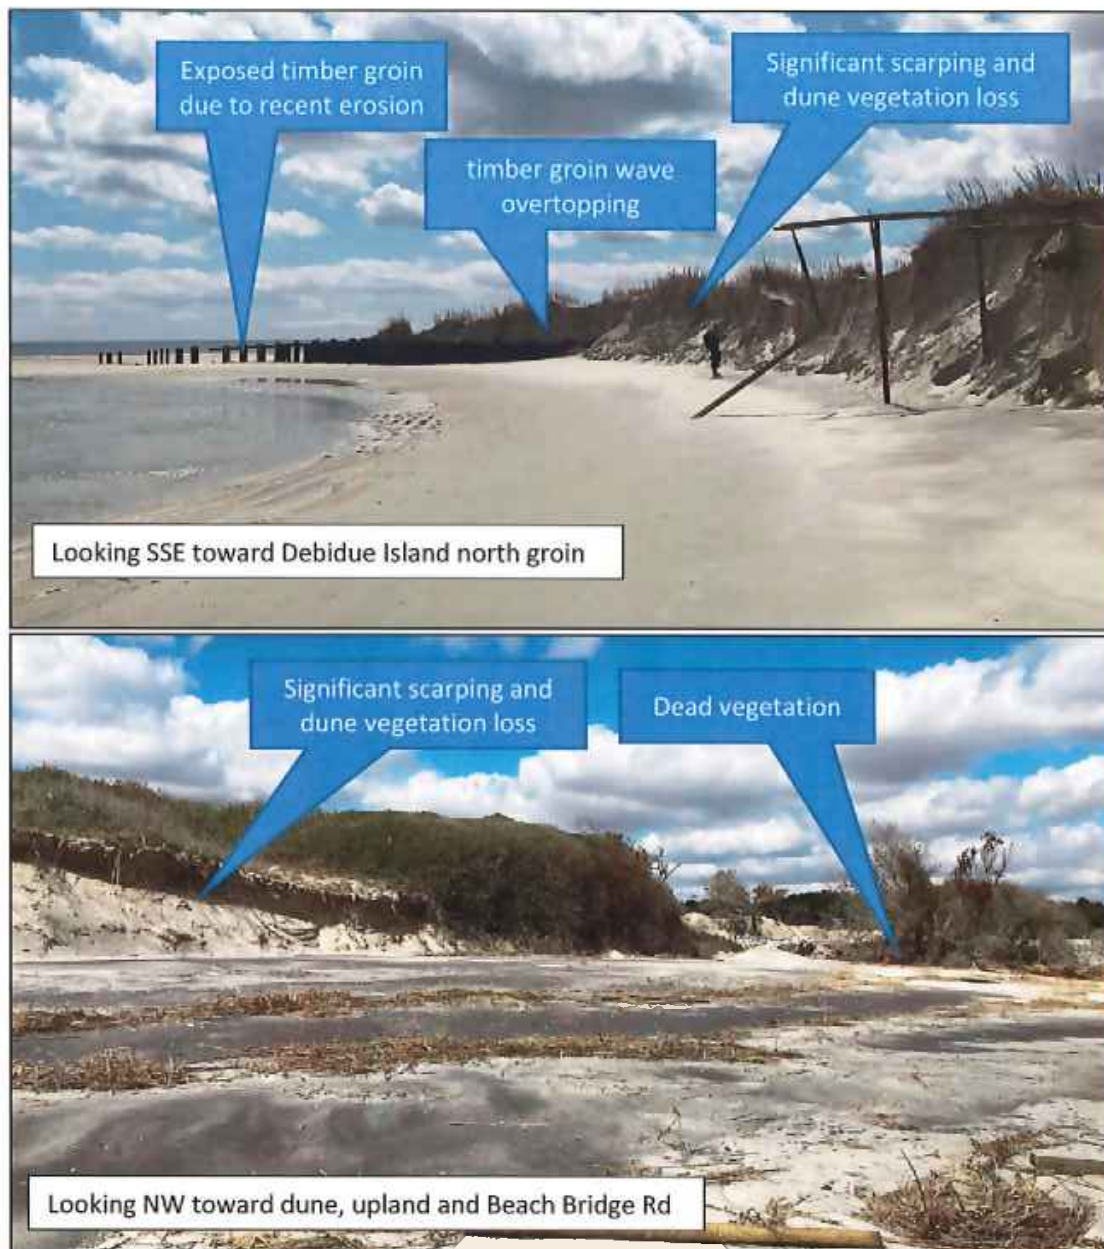
Figure 12: Site shoreline existing conditions along north end of Debidue Island (March 17, 2022). Note extreme scarping (8-10 ft high), vegetation loss, and exposed timber groin in marginal to poor condition.

Additionally, the northern-most groin on Debidue Island is now partially exposed at its seaward end due to this erosion (see photo and aerial). The exposed portions of the timber groin are in marginal to poor

condition and it is doing little to trap sand in place along the Prince George Community shoreline. It is anticipated with the continued erosion caused by the inlet this groin will soon be fully exposed, severely damaged, and become entirely non-functional.

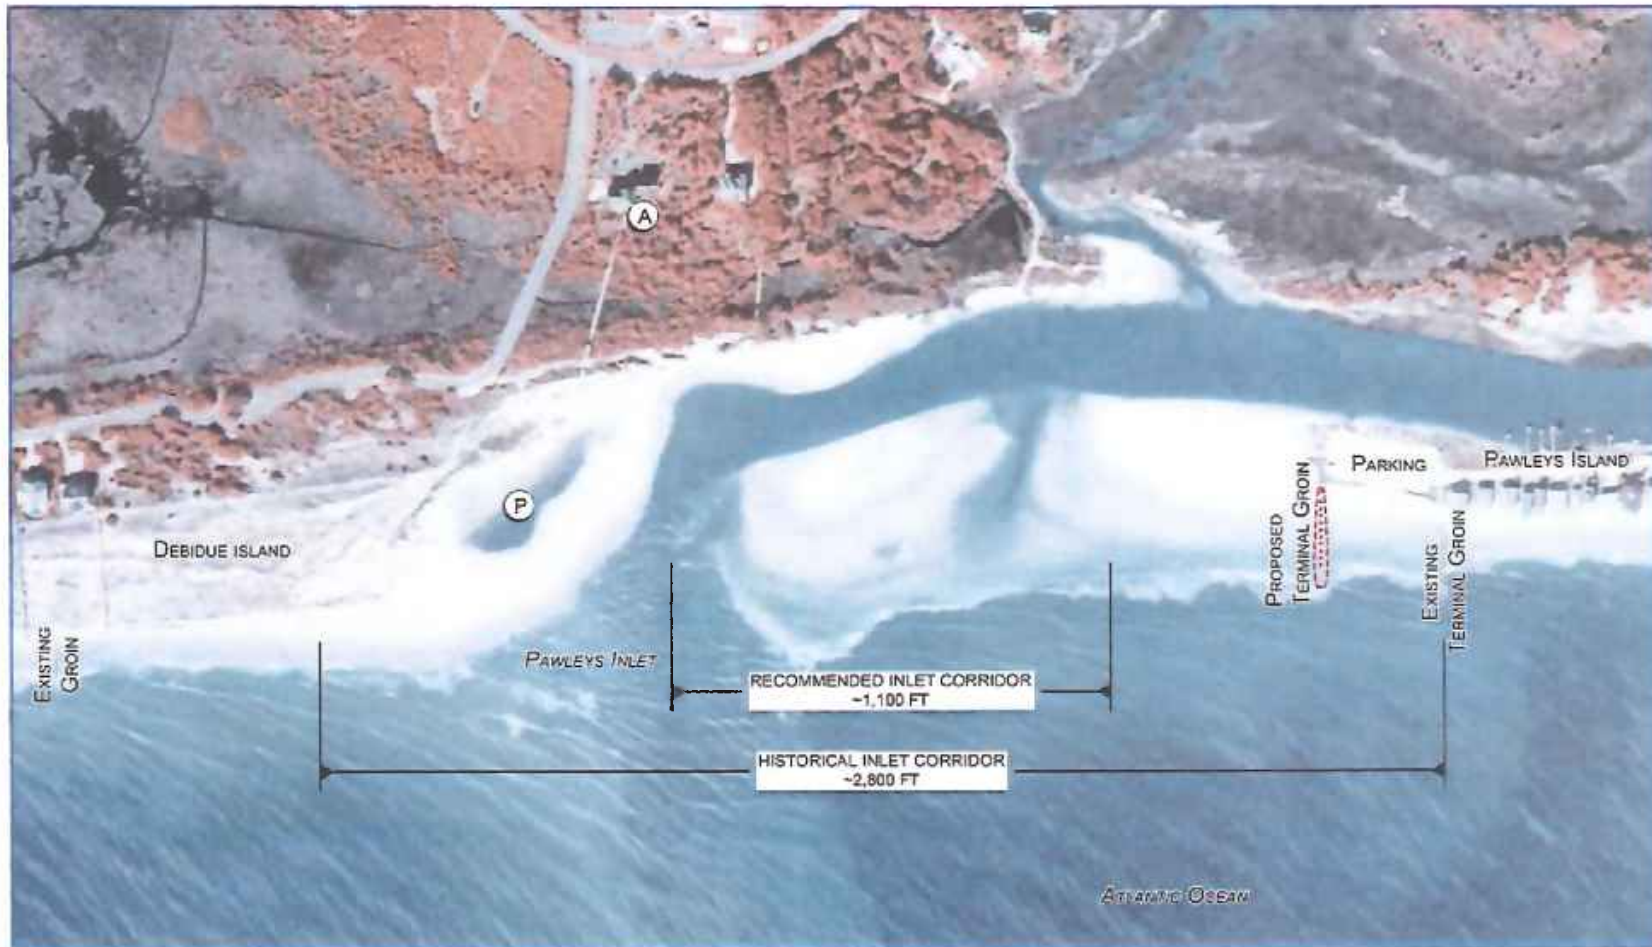
FIGURE 1. Pawleys Inlet in March 2006 showing the area from Groin #1 (labeled Existing Terminal Groin) to an existing groin at the northern end of Debidue Island. For the past 60 years, with one exception, the inlet has remained within the indicated historical corridor. Hurricane *Hugo* (September 1989) breached Pawleys spit 2,200 ft north of the terminal groin and shifted the inlet until it was closed in October 1989. CSE (letter from TW Kana to H Faison dated 4 September 2009) recommended a narrower inlet corridor be designated for purposes of avoiding encroachment on existing development. Area "P" is an abandoned former channel. An incipient channel through the spit is evident in the area above the word "corridor." (Photo courtesy of SCDNR)

Figure 13 illustrates what Pawleys Inlet would look like if the channel were maintained within the recommended ~1,100-ft corridor (see Fig 1). There would be at least 1,000 ft of dry beach between Groin #1 and the inlet. The downcoast beach at Prince George would similarly retain a buffer zone of at least 500 ft between the channel and community infrastructure.

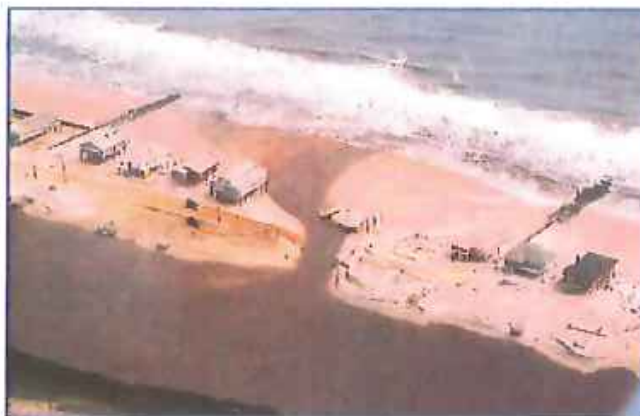
FIGURE 4.

Sketch map of Pawleys Inlet area after Hurricane *Hugo* (21 September 1989) prepared by Stauble et al (1991 – *Journal of Coastal Research*, Special Issue No 8, pg 147).

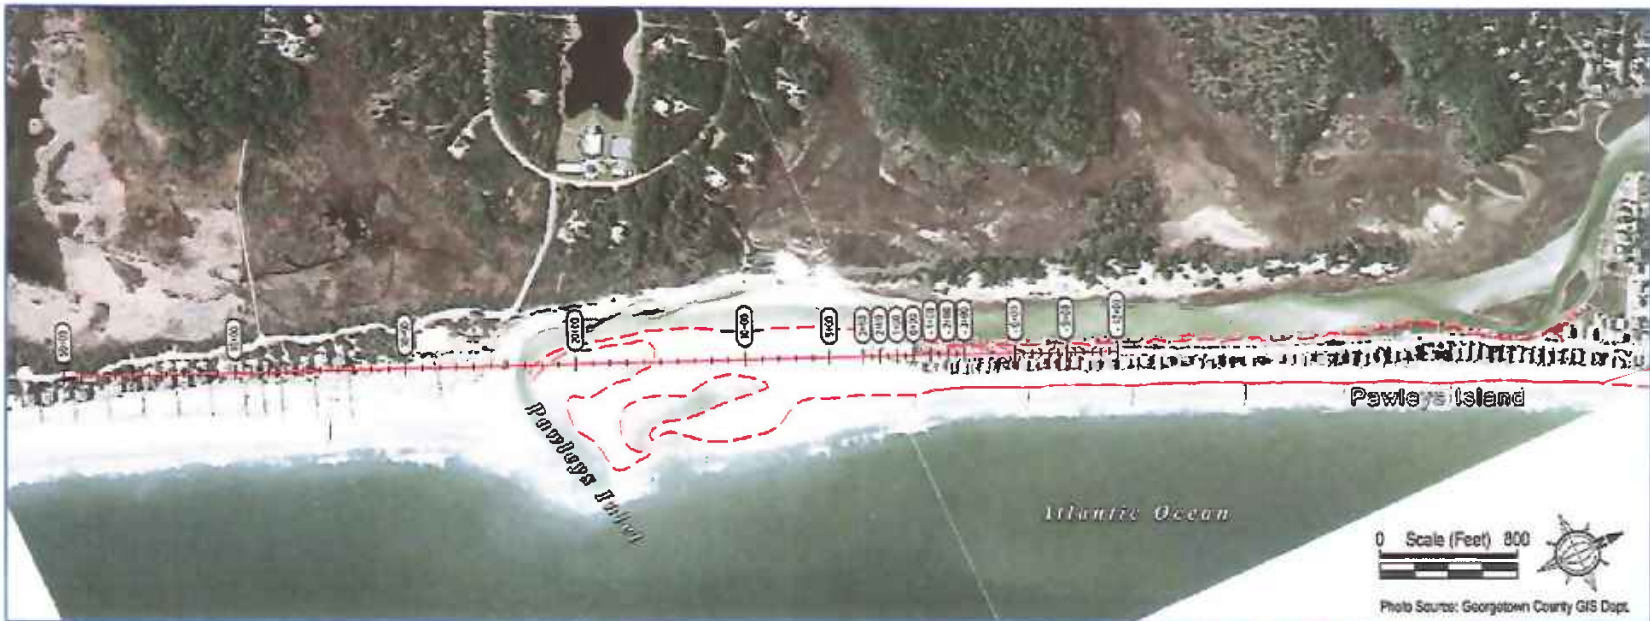
FIGURE 5. Most recent vertical aerial photograph showing position of Pawleys Inlet in March 2009 (courtesy of Georgetown County GIS Department). Note proximity to Beach Bridge Road, an access road within the Prince George community on the south side of the inlet. The PGCA installed emergency shore protection (buried) in August 2009 landward of jurisdictional setback lines to protect the road and utilities.

Figure 5 is the most recent vertical photo of the island, obtained from the Georgetown County GIS Department. Superimposed on the image is CSE's control line and stationing relative to Groin #1. [Note: Negative-numbered stations extending north from Groin #1 are not shown but are similarly referenced to Groin #1.]

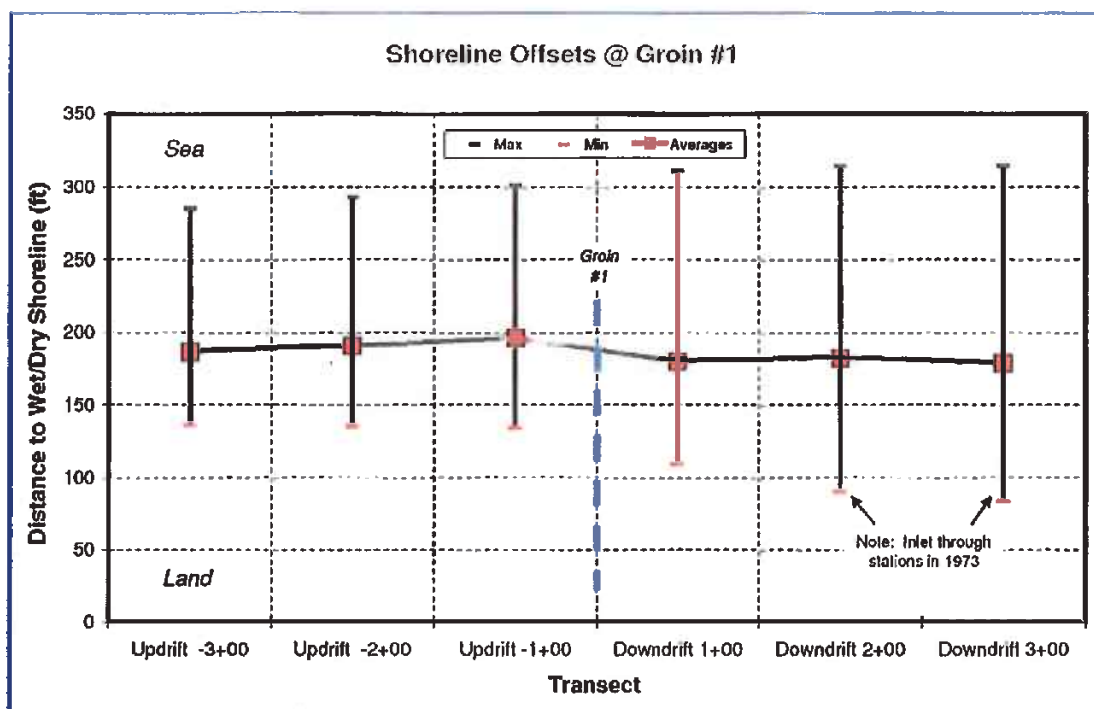
FIGURE 9. Maximum, minimum, and average shoreline positions north (updrift) and south (downdrift) of Groin #1 for available data spanning 1950 to 2009. Note relatively small average offset across the groin.

Figure 9 shows the maximum, minimum, and average shoreline positions around Groin #1 for available photos spanning 1950 to 2009. The small seaward inflection in the line from station -3+00 to station -1+00 reflects the "updrift fillet." (A fillet is a wedge of dry-sand beach that tends to accumulate on the north side of each groin at Pawleys Island after periods of waves from the north.) The maximum (seaward) shoreline position reflects onshore movement of sand bars during fair-weather conditions (producing a seaward shift of the high waterline). The minimum shoreline position generally reflects post-storm conditions and beach recession, such as the period after Pawleys Inlet shifted north in July 1969. The inlet channel encroached stations 2+00 and 3+00 (200-300 ft south of Groin #1) in the early 1970s.

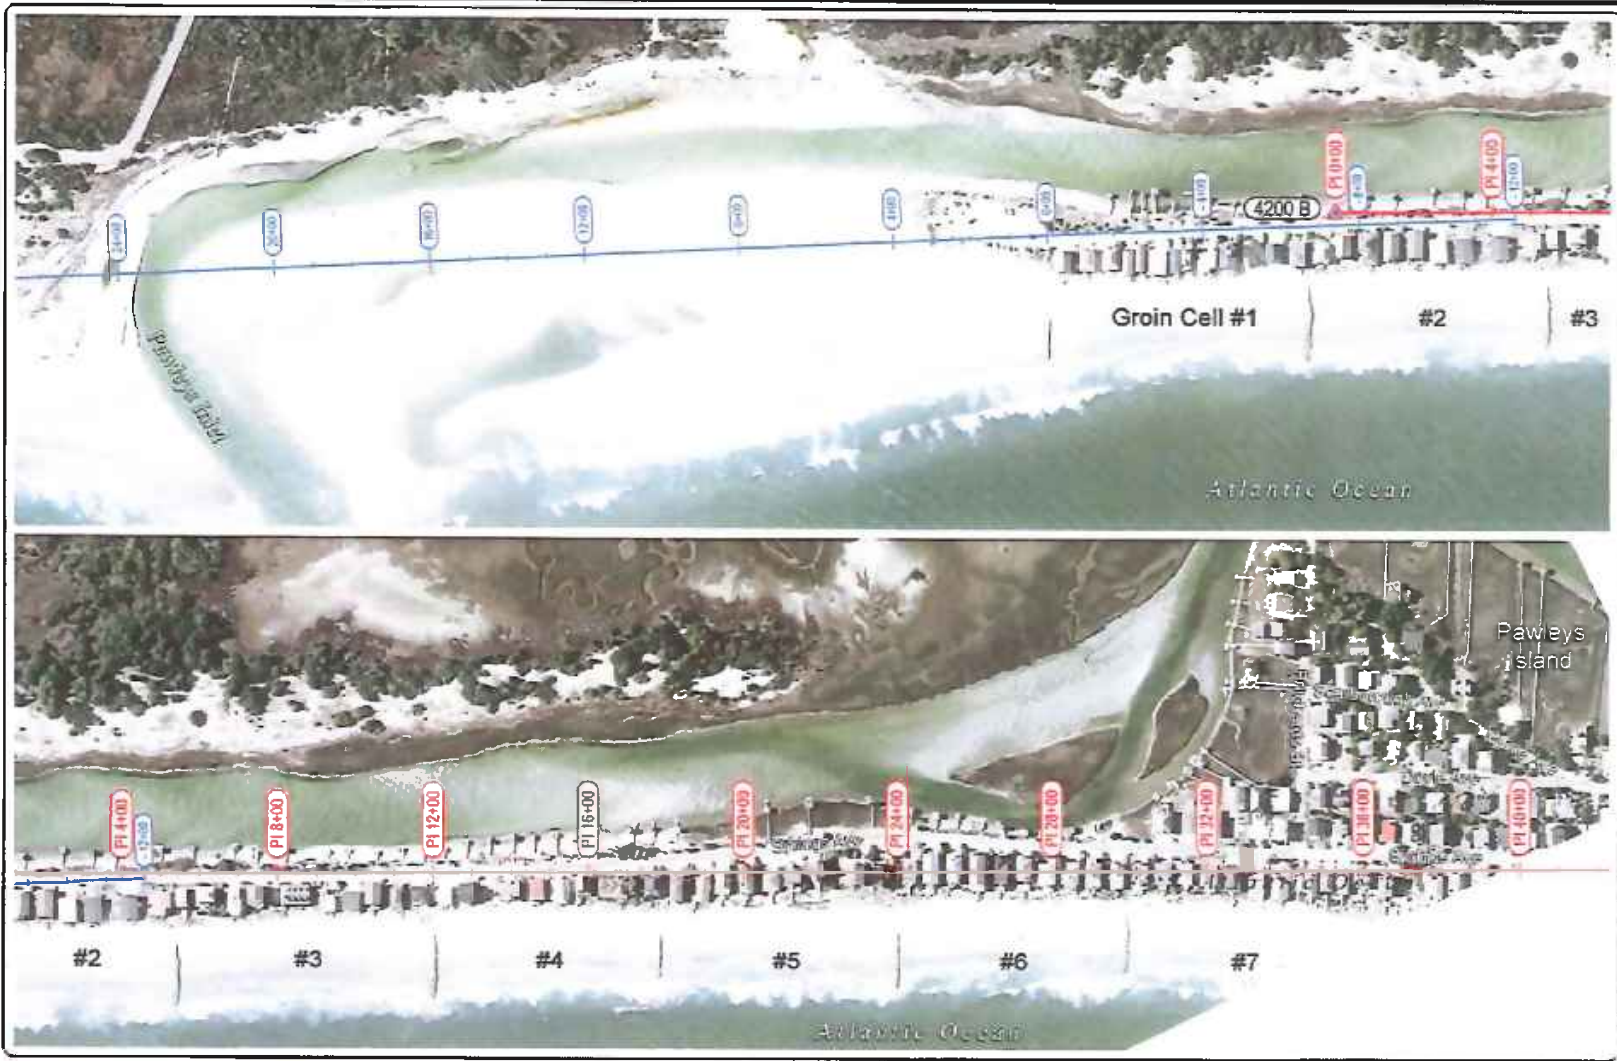
FIGURE 11. (following page) Pawleys Island spit in March 2009 showing general uniformity in width (~150-180 ft) between high water on the ocean side and Pawleys Creek. The majority of houses along the spit lack dune protection. The red reference line shows stations used during the 1999 beach restoration project. [Image courtesy of Georgetown County GIS Department]

Pawleys spit has generally uniform width and elevation from Pritchard Street to the inlet. Figure 11 shows conditions in 2009 within the groin field. The typical width of the spit from high water on the ocean side to high water on the creek side is 150-180 ft. Figure 12 illustrates how narrow the spit is, with little room for the main access road and one row of houses. The foredune tends to be low or non-existent in groin cells 1-6, making the spit vulnerable to breach events. A typical elevation across Pawleys spit is 7-8 ft NGVD. Ocean waves frequently run up to these elevations. The foredune (see Fig 12-lower) provides some protection during minor storm events but with a base less than 30 ft wide, it is inadequate for absorbing storm-wave energy. Once the foredune is eroded, storm waves tend to wash over the spit.

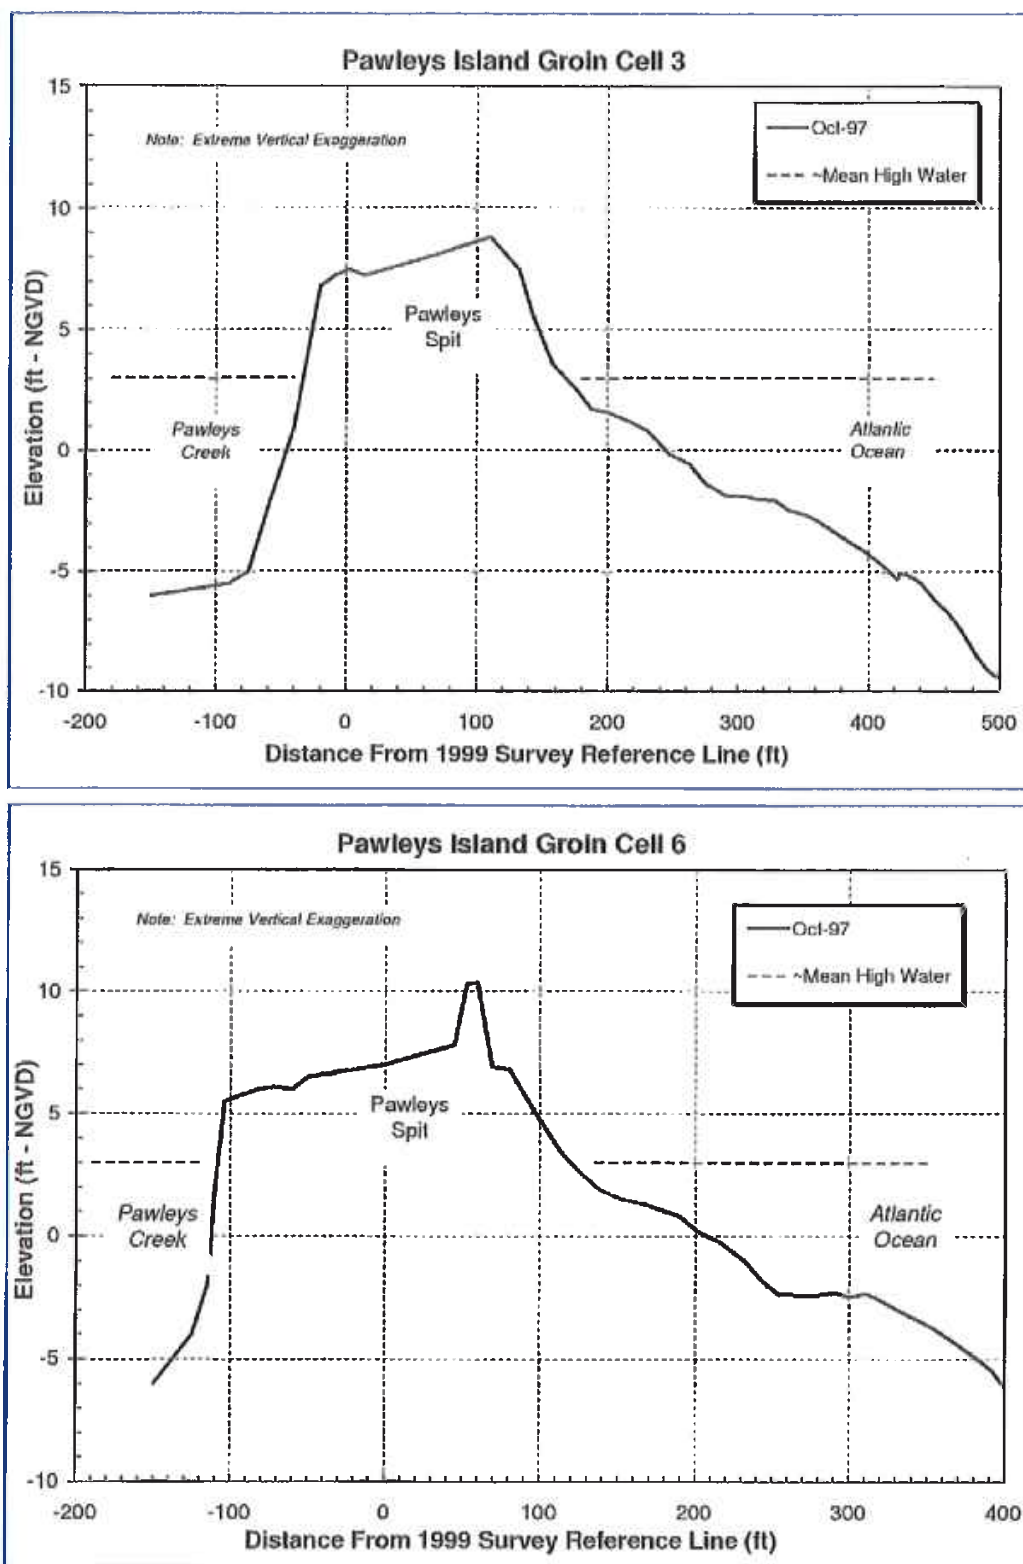
FIGURE 12. Typical sections through Pawleys spit (see Figure 11 for localities) showing low elevations relative to mean high water and narrow separation between Pawleys Creek and the ocean.

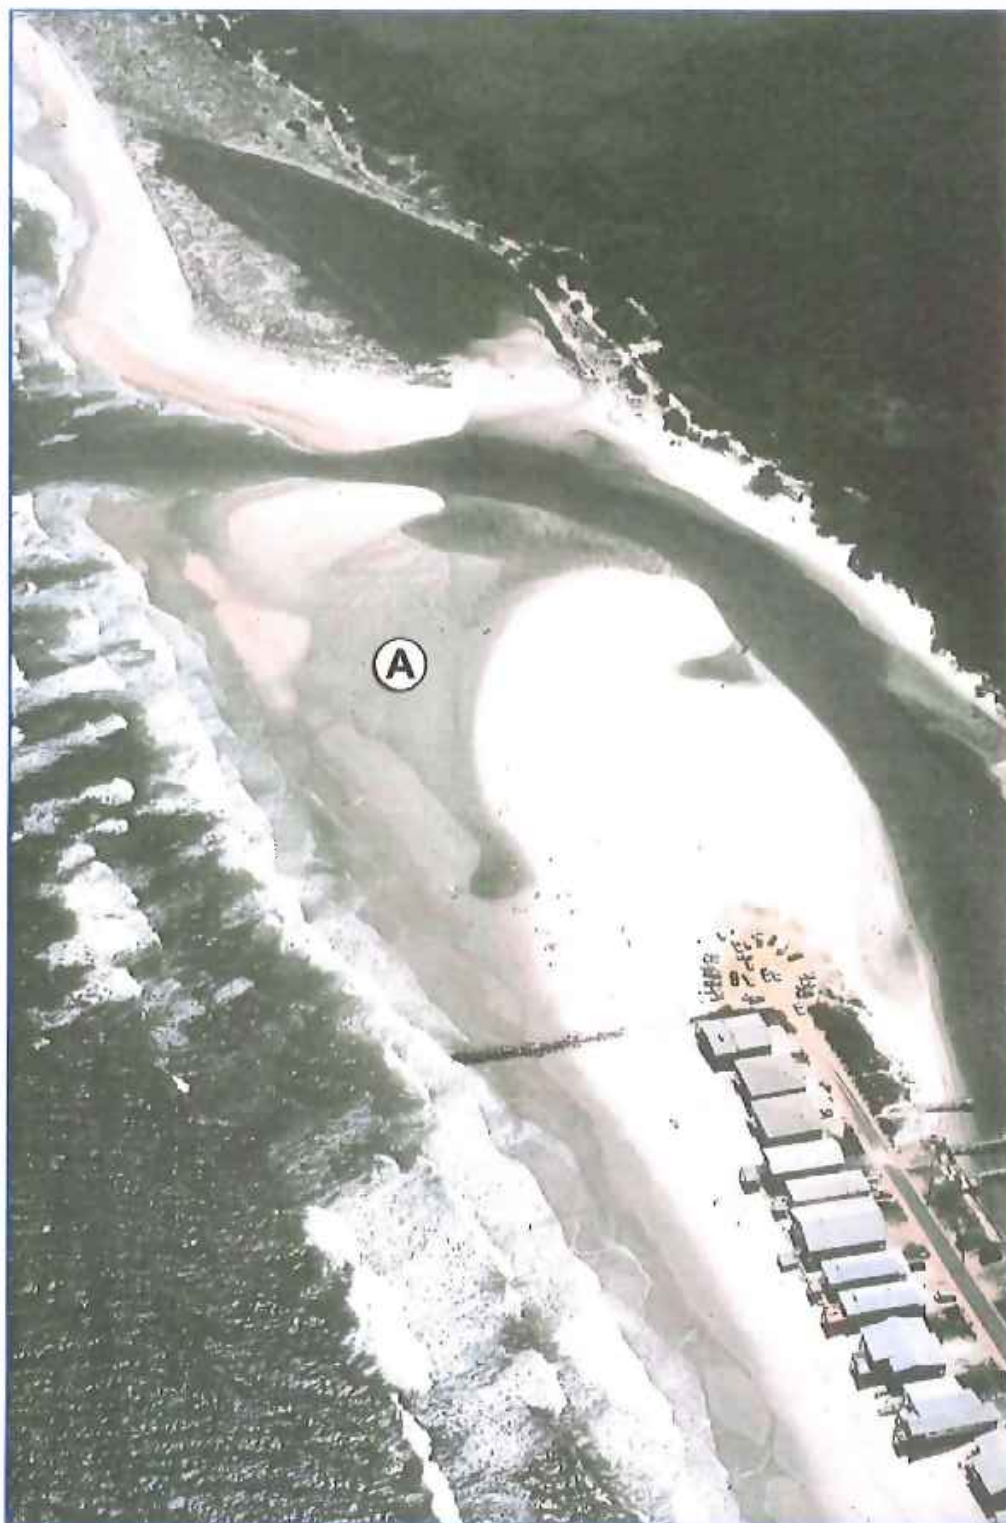
FIGURE 13. Pawleys Inlet at low tide on 15 May 1985 when the channel was positioned about 1,200 ft south of Groin #1 (visible near the lower center of the photo). Note the intertidal shoal platform (area A) on the updrift side of the inlet which acts as a fillet and helps maintain the spit. An abandoned channel ("cat-eye" pond) is at the top of the image.

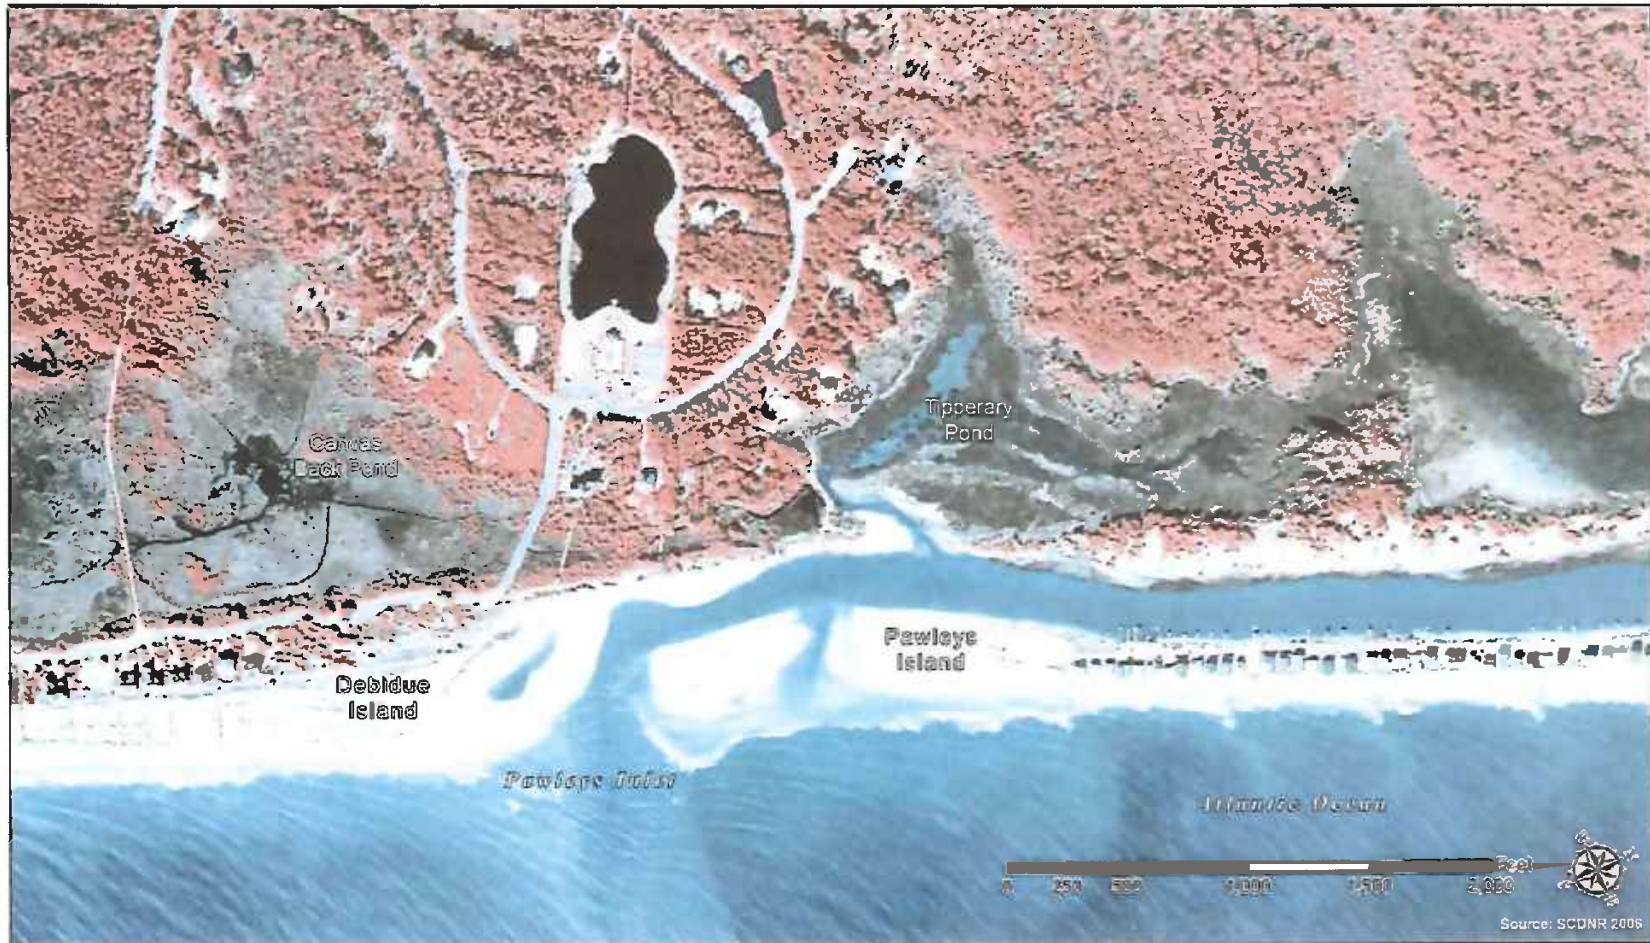
FIGURE 15. Pawleys Inlet in March 2006 showing (right to left) an incipient channel through the end of Pawleys spit at ~1,000 ft south of Groin #1, the main entrance channel ~2,000 ft south of Groin #1, and a remnant channel ("cat-eye" pond) on the Debidue Island side of the inlet. Note the breach of the mainland shoreline north of Pawleys spit (dry-sand area). The breach channel has created a connection with the large brackish water impoundment, Tipperary Pond. Continued southerly migration of Pawleys Inlet increases the likelihood of a breach into Canvasback Pond, which contains extensive fresh-water wetlands.
