**FINAL REPORT
NATURAL BRIDGE INVESTIGATION**

*Frontispiece/*Figure 1: False-color point-cloud image of Natural Bridge,
Rockbridge County, Virginia.

April 2018
(VTRC 99584)

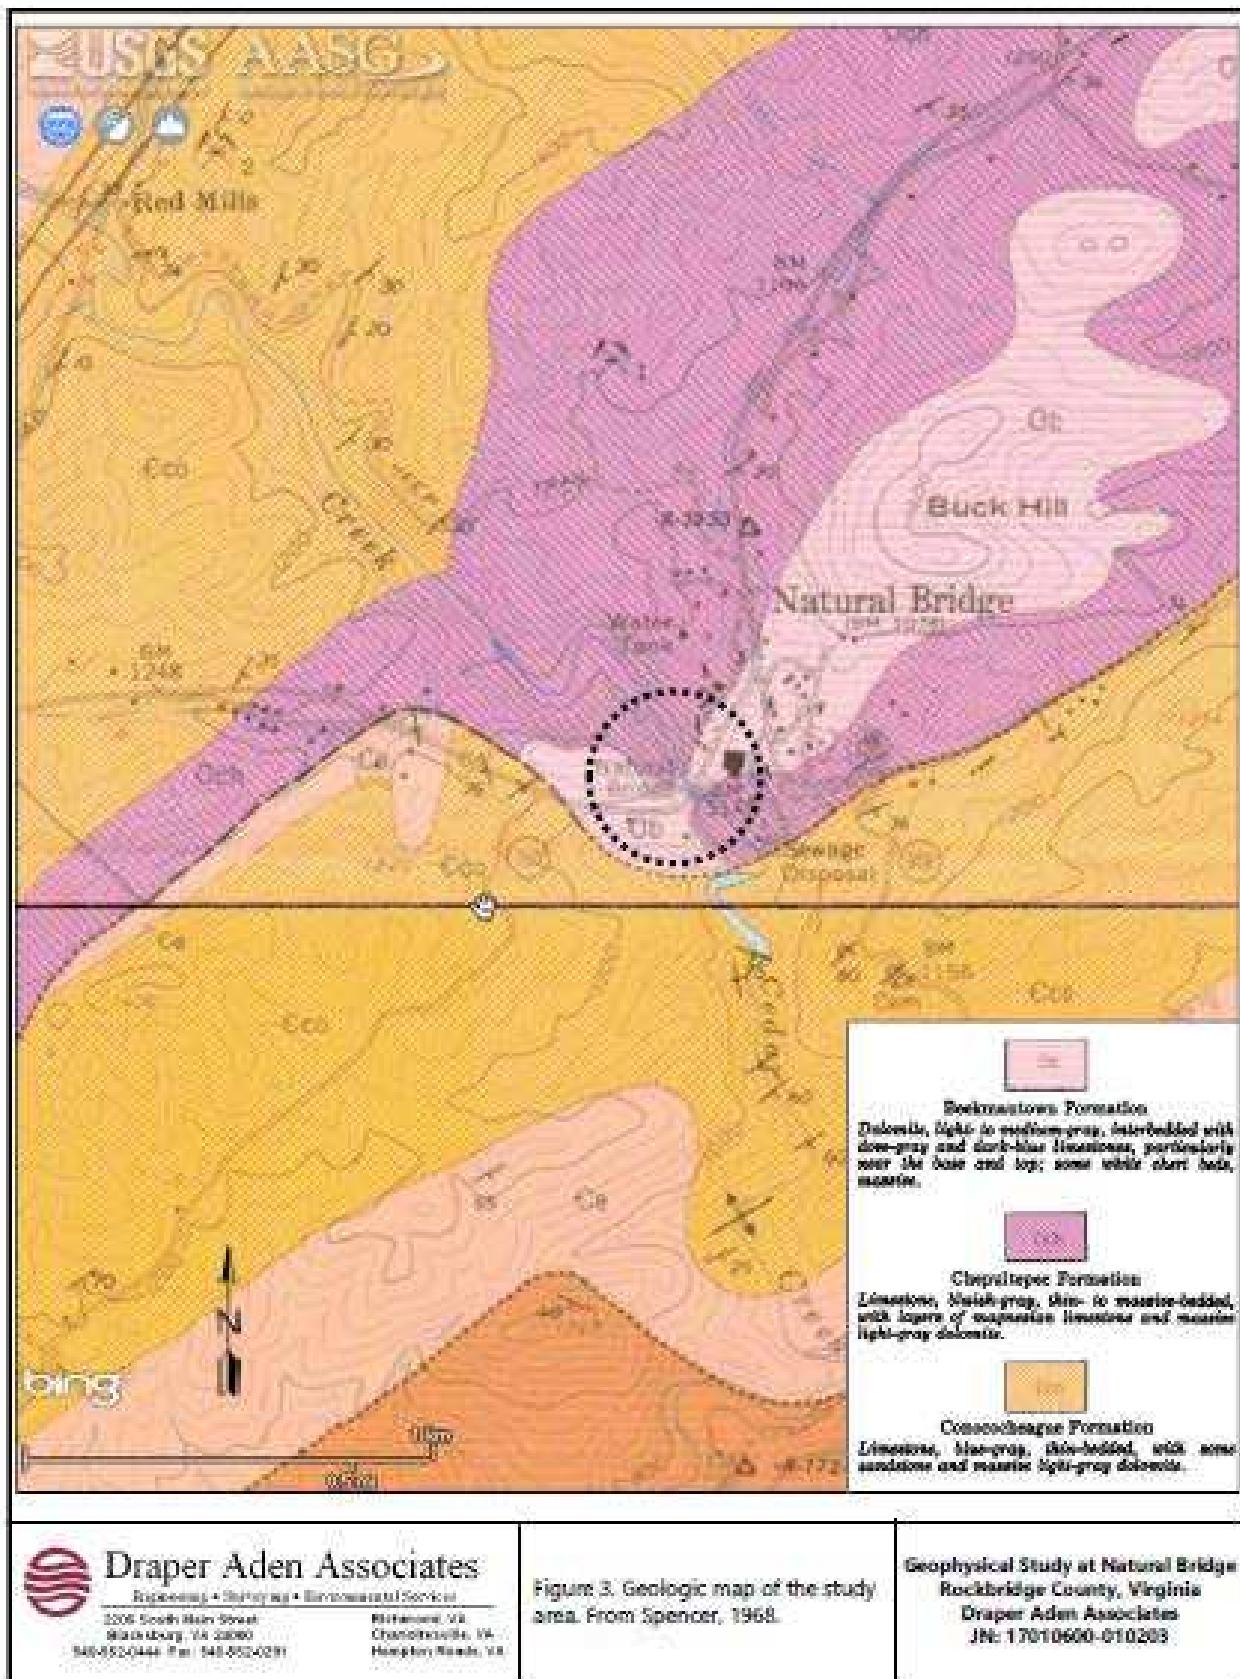
Figure 2: Geological map of Natural Bridge and vicinity. From Draper Aden, 2017; Spencer, 1968

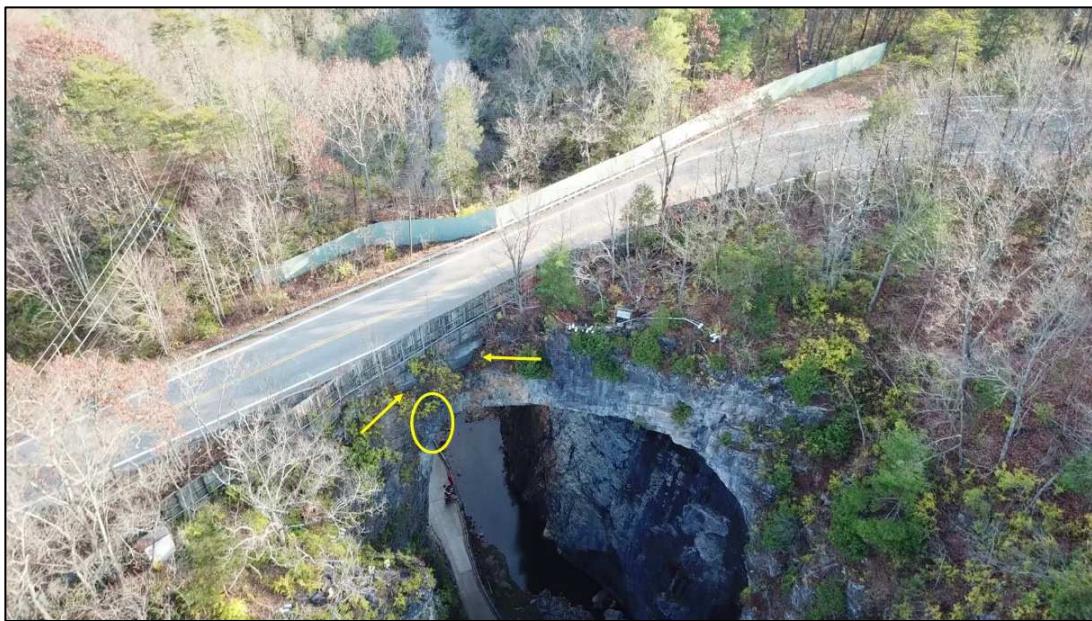
General photography and videography from the air can often be both revealing and dramatic. Figure 6 is a still image captured from high definition video of a mission flying downstream toward Natural Bridge. It shows how Route 11 crosses the rock formation at an angle, bringing the pavement very close to one of the most sensitive parts of the structure. A sensitive rock feature called “The Old Man” is circled. Above it are the concrete buttresses, marked by arrows, placed in 2000 to reduce undermining and erosion beneath the pavement.

Figure 6. Still image from RU UAS video looking downstream from the north. Shows orientation of Route 11 crossing Natural Bridge at oblique angle and proximity to sensitive features. "Old Man" structure is circled. Arrows indicate concrete buttresses placed in 2000 to reduce erosion and undermining beneath the pavement.

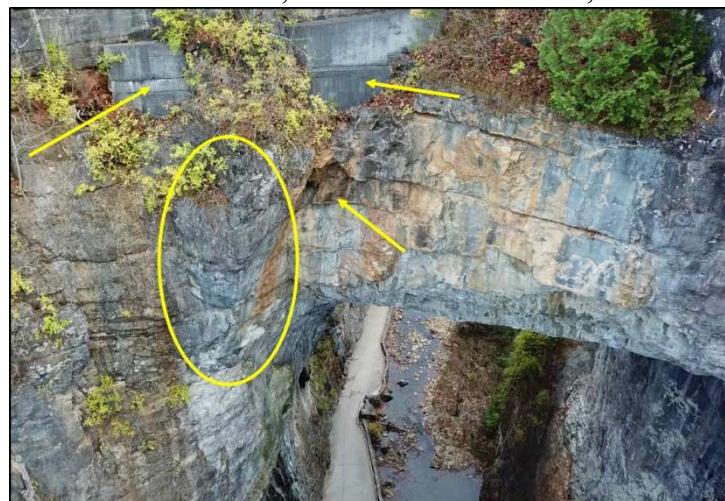
Figure 7 shows a close-up of the Old Man structure, the concrete buttresses, and an opening to one of the solution voids revealed by the electrical resistivity and GPR imaging. Figure 8 shows a close-up of a similar sensitive area on the downstream side of the rock formation.

Figure 7. Still image from RU UAS video. Close-up of sensitive areas of rock structure below the roadway. "Old Man" structure is circled. Arrows indicate solution void opening and concrete buttresses placed in 2000 to reduce erosion and undermining beneath the pavement.

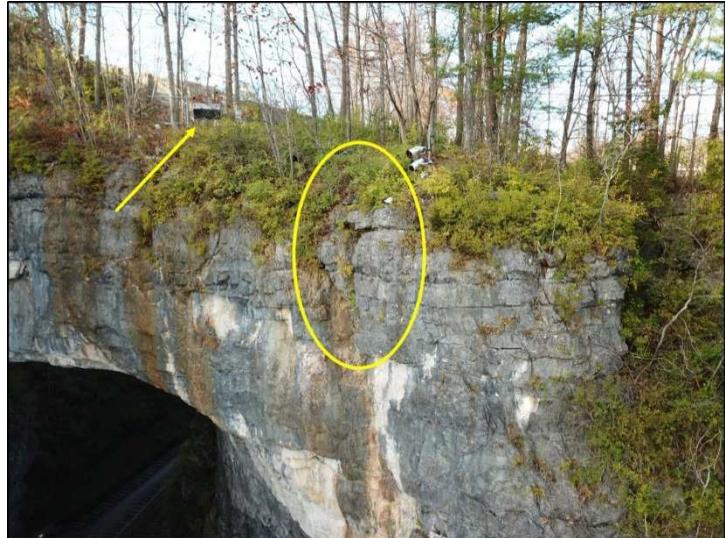
Figure 8. Still image from RU UAS video. Close-up of sensitive area of rock on the downstream-side of the rock formation. Low safety factor block is circled. Arrow indicates loudspeaker used during nightly sound-and-light shows.

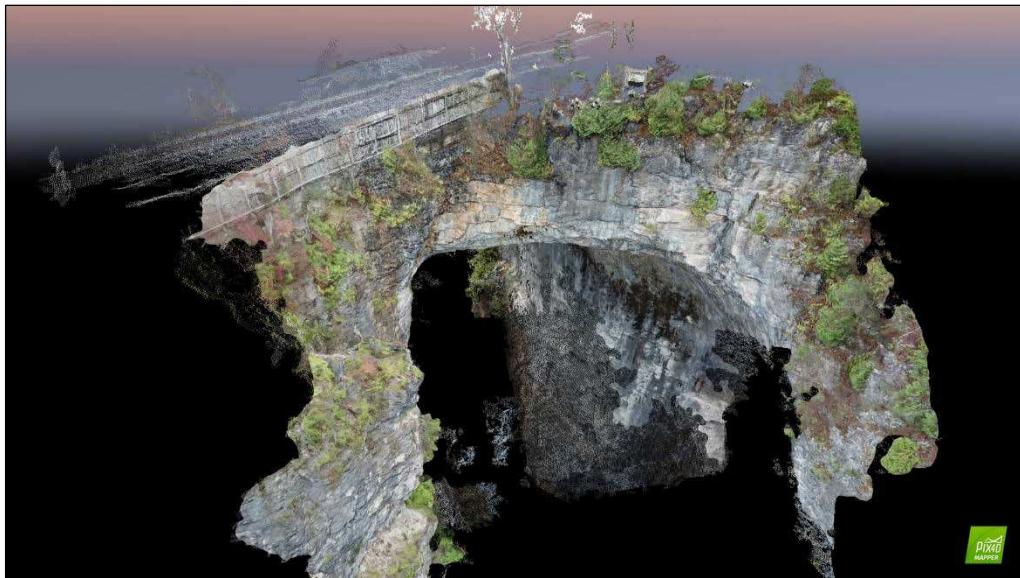
The digital point clouds, triangle meshes, and data extracted from them are depicted in the following figures and plots. Figure 9 is a still image captured from a point cloud animation video showing the overall upstream-side point cloud. Figure 10 is an enlarged view and depicts the Old Man structure, the adjacent void opening, a through-cutting fracture, and the concrete buttresses beneath the pavement.

Figure 9. A still image taken from a point cloud animation of the upstream-side of Natural Bridge. Point clouds like this are georeferenced allowing for quantitative measurements to be made, including discontinuity orientations for stability analyses.

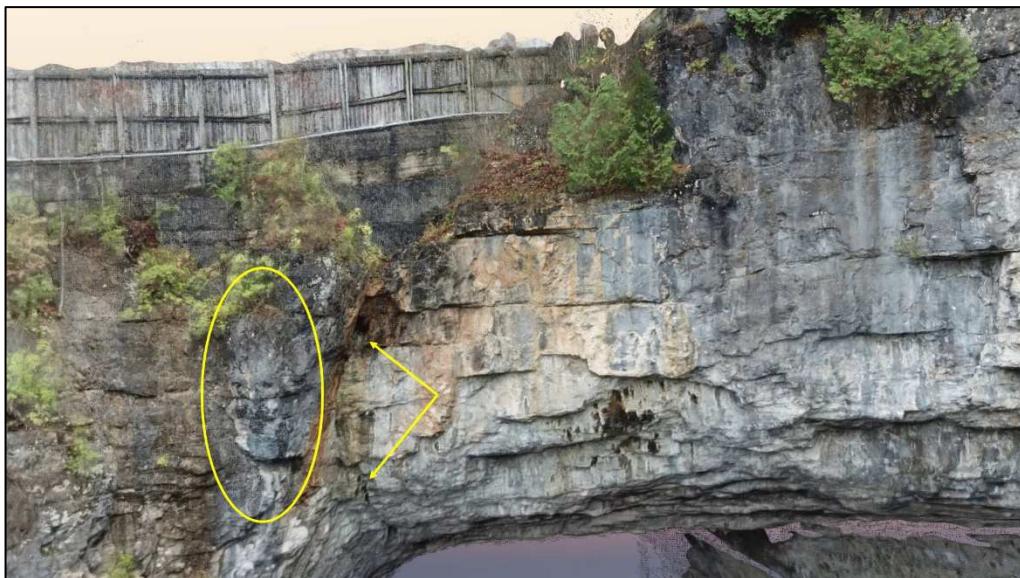
Figure 10. An enlarged view of the upstream-side of Natural Bridge, taken from the point cloud animation depicted above. The sensitive Old Man structure is circled. Arrows point to solution openings aligned with a through-cutting fracture. Point clouds like this are georeferenced allowing for quantitative measurements to be made, including discontinuity orientations for stability analyses.

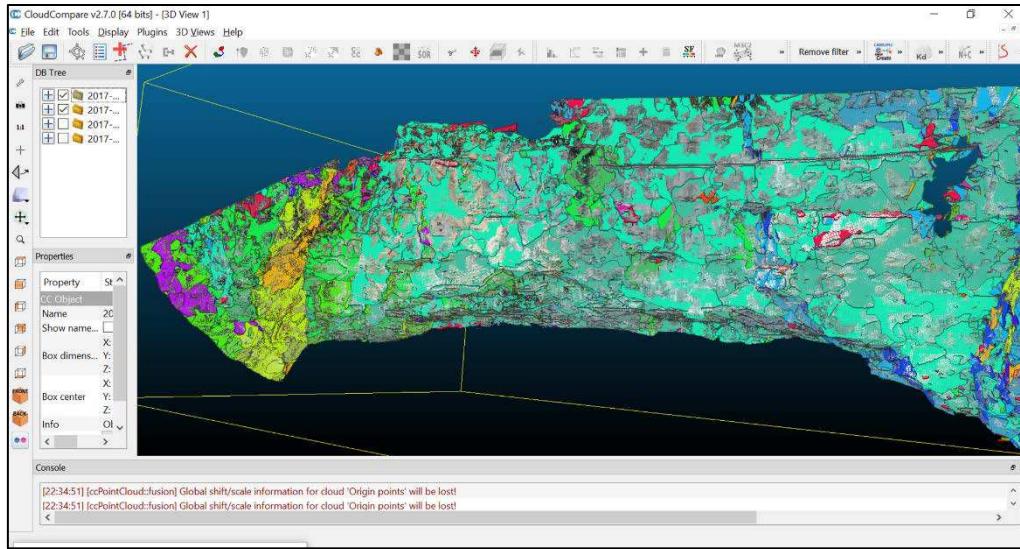
Figure 11 depicts the discontinuity facets detected by the *CloudCompare* software and extracted from the point cloud of Figures 9 and 10, for stereonet plotting and stability analyses. This method of collecting geological structure data from point clouds reduces the need to rappel down slopes.

Figure 11. The point cloud shown in Figures 9 and 10 processed in **CloudCompare** software to extract discontinuity orientation values for stability analyses. Different colored facets or patches represent different sets of discontinuity orientations.

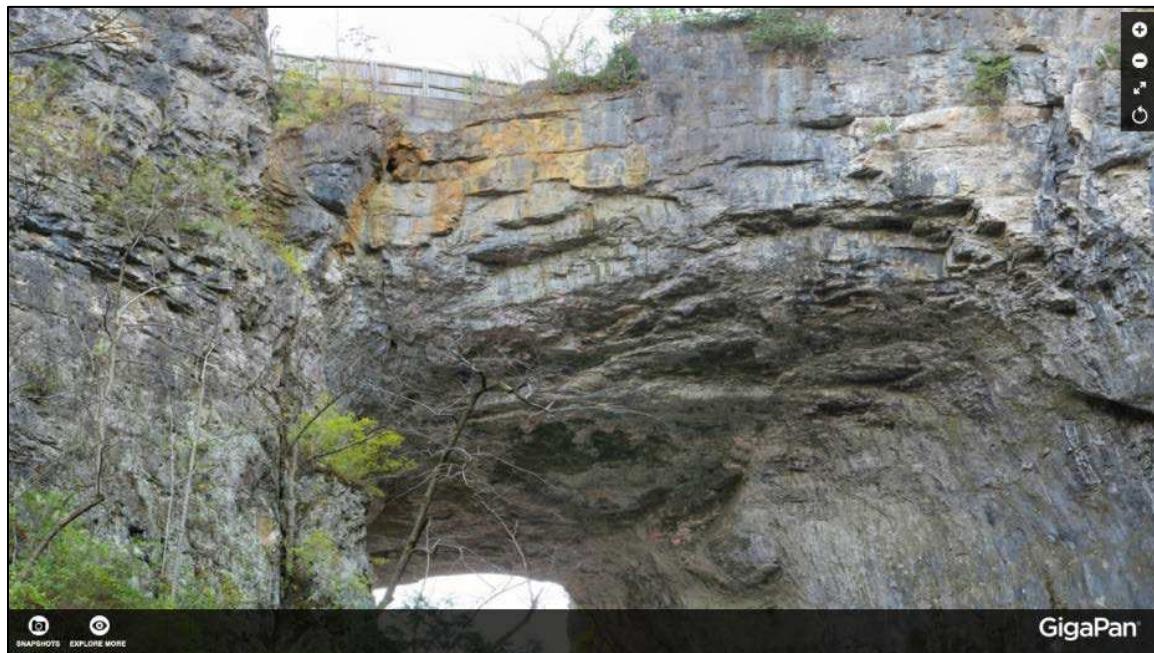
Figure 12. High resolution GigaPan image of the north side of Natural Bridge, normal zoom.

All of the GigaPan scans provide panoramic imagery of the formation in extraordinary detail. Figure 12 illustrates one of the most sensitive portions of the formation with regard to stability. Figure 13 is zoomed in to reveal greater detail of the through-cutting fracture surface to the side of the Old Man feature, including openings to the solution voids identified by the electrical resistivity imagery.

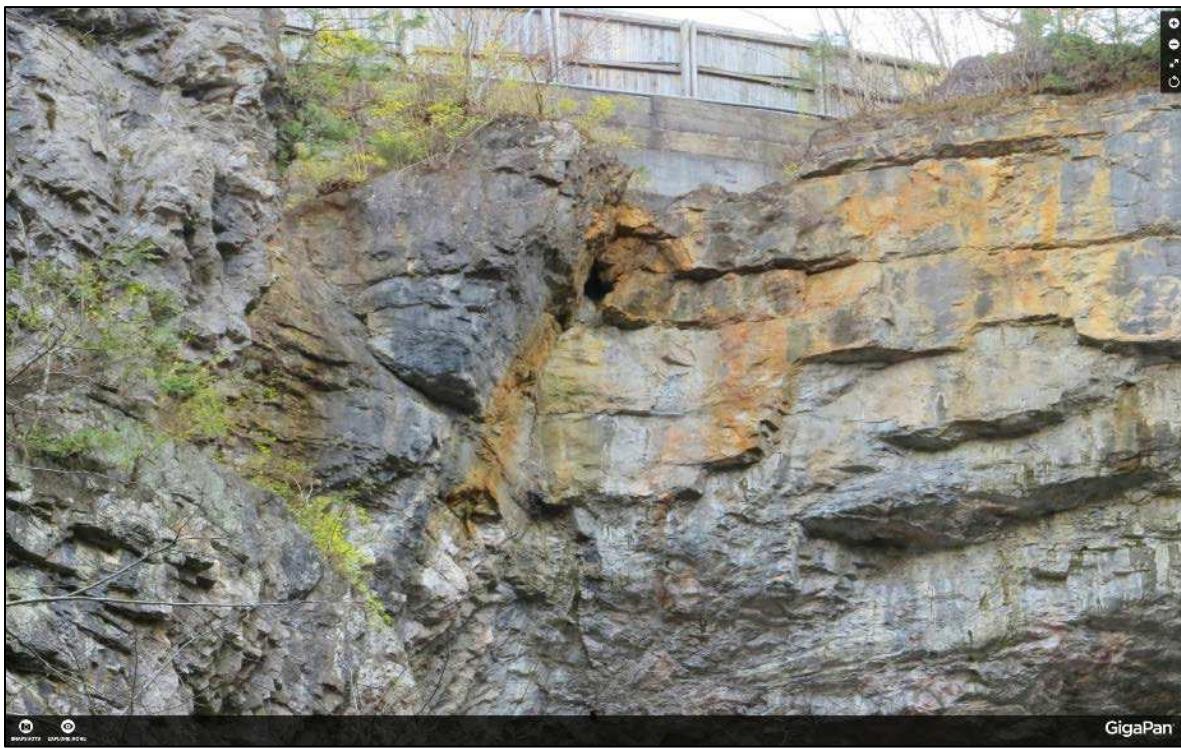
Figure 13. High resolution GigaPan image of the north side of Natural Bridge, zoomed in to show openings to solution voids.

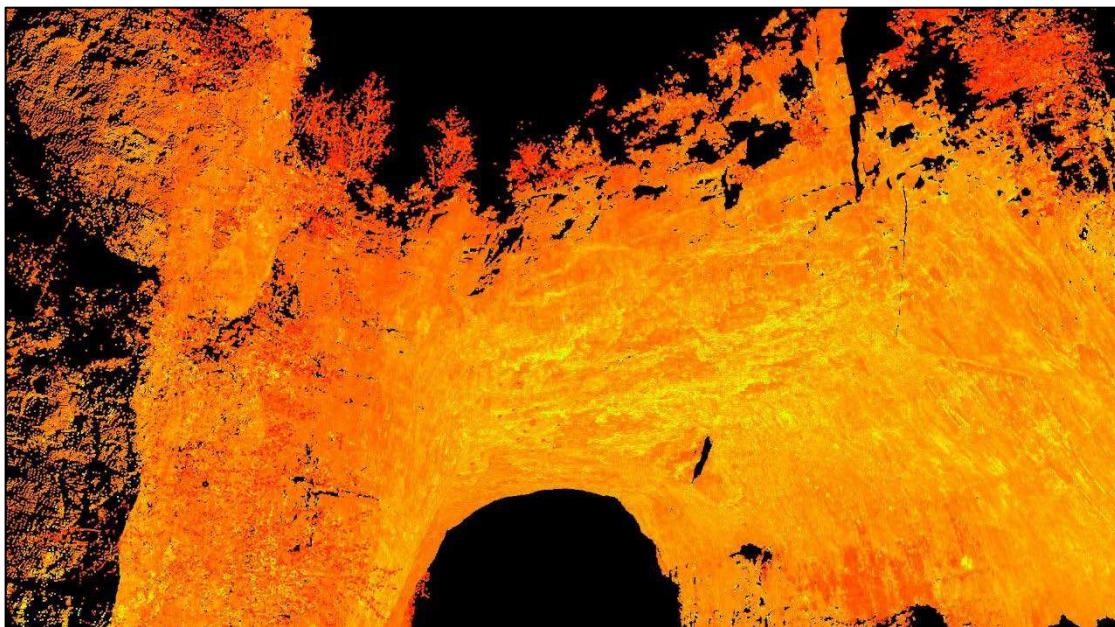
Figure 14. Example of LiDAR 3D point cloud generated by Radford University undergraduate researcher students.

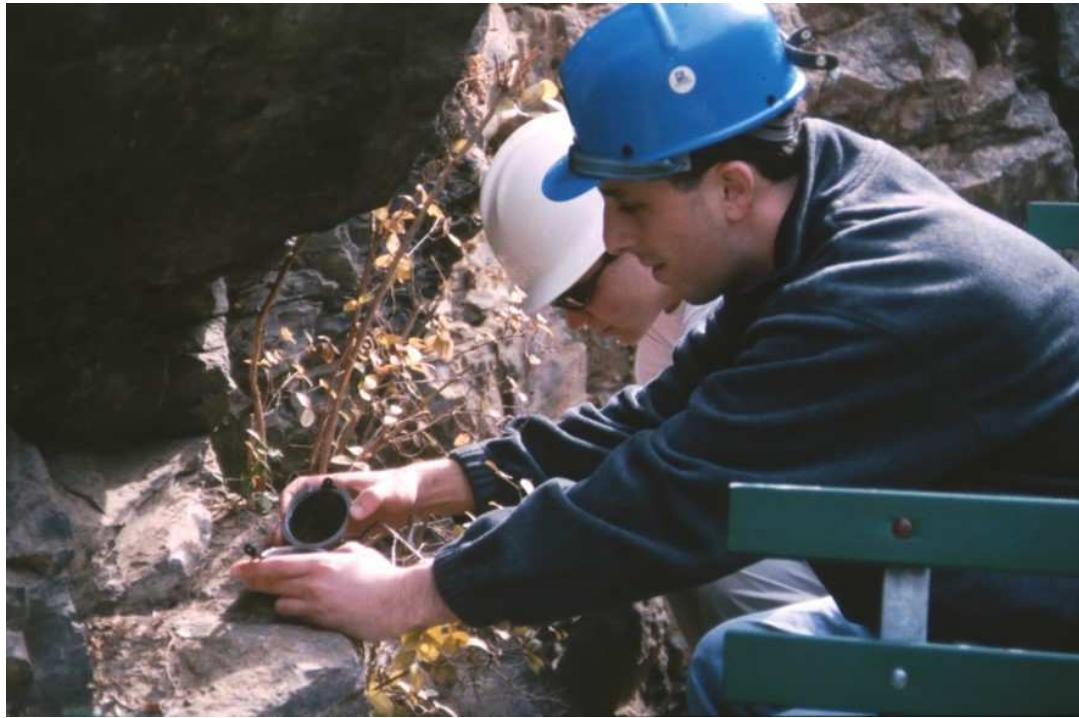
Manual collection of discontinuity orientation data (Figure 15) was the standard for decades prior to the development of the LiDAR and UAS technologies that make remotely acquired, georeferenced, point clouds possible today. Often, manual data collection involved the use of rappelling ropes and the geological transit compass for measuring the dip direction and the dip angle of these weaknesses in the rock masses.

Figure 15. Manual collection of discontinuity orientation data by Radford University graduate students at Natural Bridge in 2000.

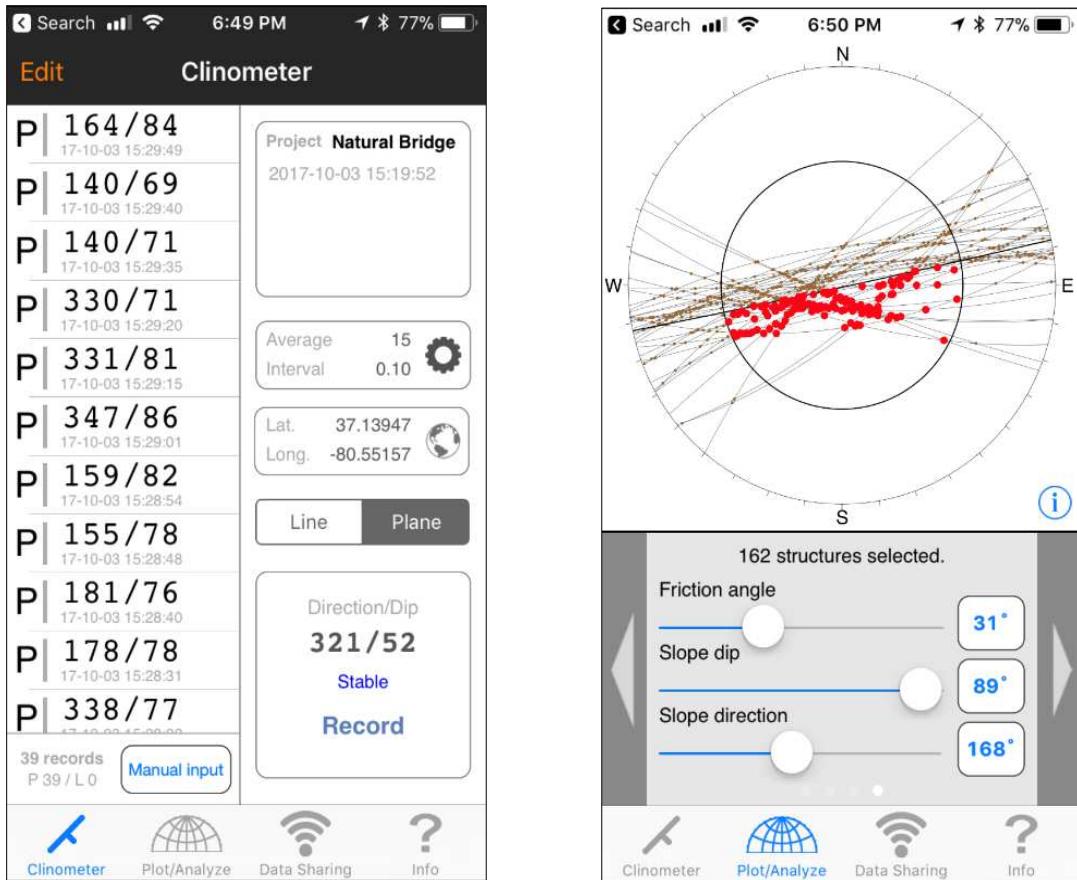
During this study, an iPhone app called *GeoID* (Figure 16) was used to manually collect discontinuity orientation data rapidly. Data collection with *GeoID* involves placing the device on a discontinuity surface, allowing internal accelerometers to stabilize for a second or two, and pressing the data record button. A traditional geological transit compass was also used to validate the *GeoID* data. Data were collected at a variety of locations around the rock formation that are structurally similar by visual inspection to rock structures above the trail and out of reach.

The screen on the left shows typical discontinuity planar orientation data (**P**) in the form of *direction of dip / dip angle*. The screen on the right shows a stereonet indicating that the weak structures controlling the shape and orientation of Natural Bridge have a strong east-west, slightly northeast-southwest orientation.

Figure 16. Sample screens from smart device application, GeolD, showing data collected at Natural Bridge in 2017.

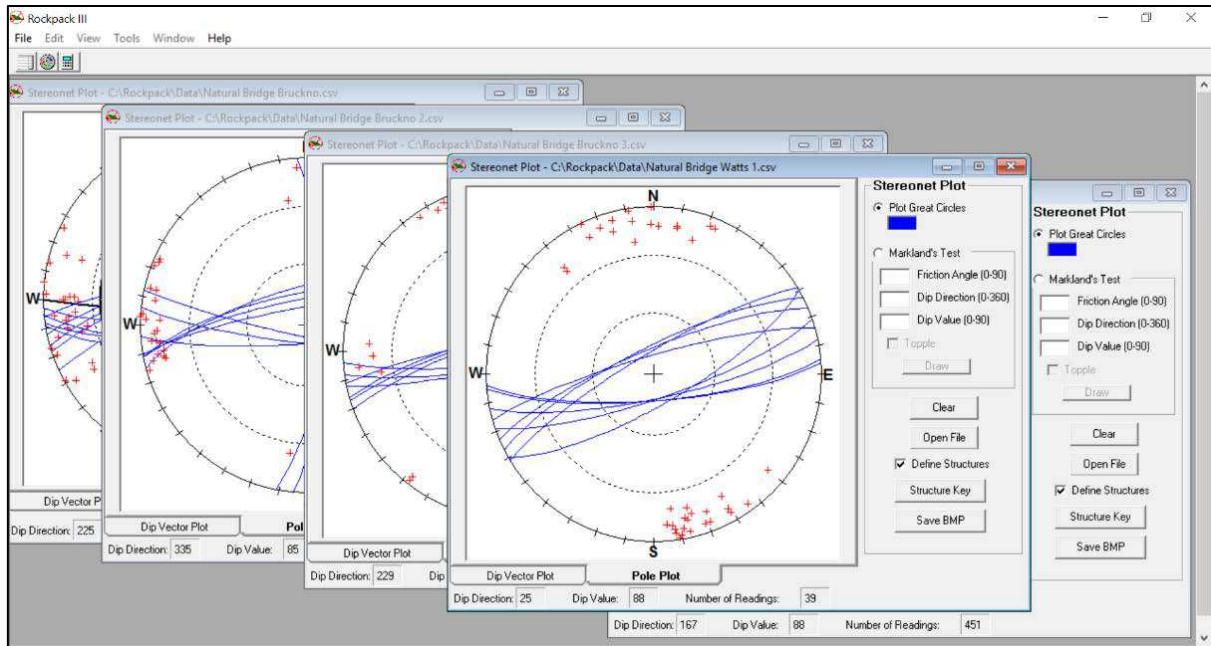
The simplest way to visualize discontinuity orientation data is to plot them on stereonets. In simplest form, stereonets may be thought of as compasses on which arcs representing planes of weakness may be plotted. The arcs are actually great circles. The alignment from end-to-end of the great circle on the compass corresponds to the real-world alignment of the weakness. And the straighter the great circle, the more steeply the weakness dips out of the rock mass. Conversely, the more curvature there is to the great circle, the less steeply the discontinuity dips out of the rock mass. Steep discontinuities are more dangerous than gently dipping discontinuities. Stereonet plots of the great circles, combined with representations of the slope geometry, allow for stability analyses to be performed. Figure 17 gives a sense of typical stereonets for Natural Bridge.

Figure 17. Sample stereonets for manually collected data from Natural Bridge in 2017.

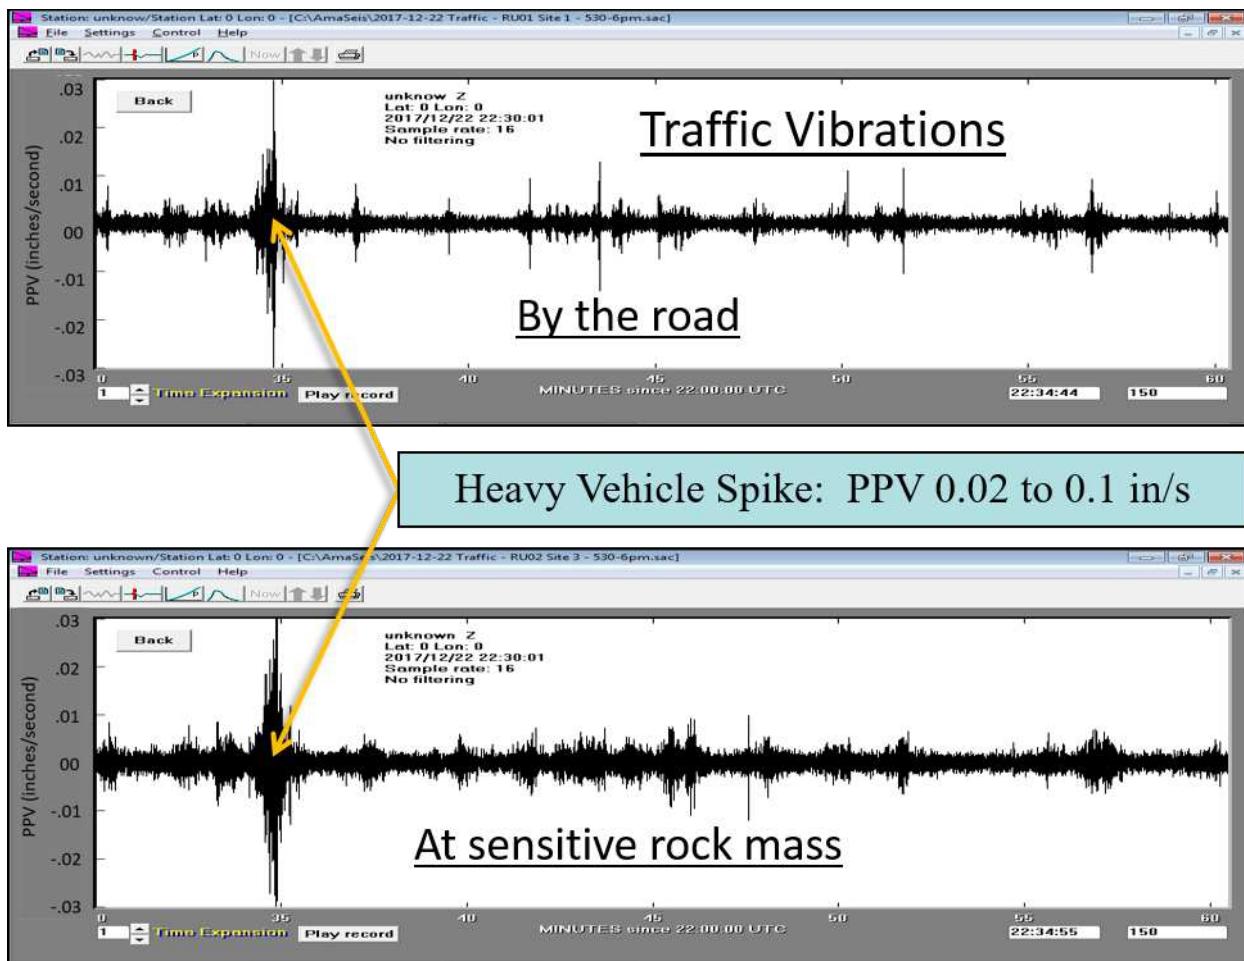
Figure 18. Typical traffic seismograms for a thirty-minute period at Natural Bridge during the evening of December 22, 2017. Top graph represents a seismometer next to the highway. Bottom graph represents a seismometer approximately 110 feet away from highway centerline, on a sensitive rock block. Sensitive rock masses appear to resonate for a longer period of time than the earth adjacent to the highway.

Figure 18 shows typical seismograms for normal traffic conditions. A spectral analysis of several seismograms for traffic at Natural Bridge reveals that the average frequencies are 6.46 Hz (cycles per second), with PPVs ranging from 0.028 inches/second to about 0.095 inches/second, or essentially 0.10 inches/second.

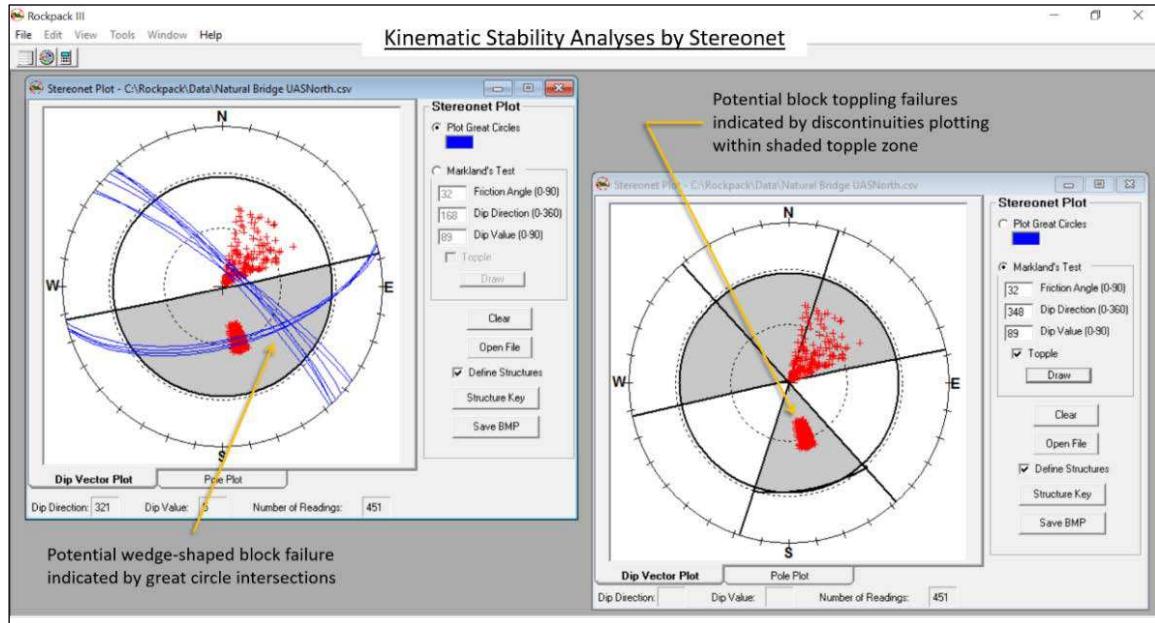
Figure 19. Examples of stereonets created as the first step in stability analyses at Natural Bridge. Plot on the left reveals the possibility of rock wedge failures on the south side of the bridge. Plot on the right reveals the possibility of toppling failures into the gorge on the on the north side of the formation.

Figure 19 shows just two examples of the dozens of stereonets that could be used to evaluate the stability of different portions of the rock faces that make up Natural Bridge. Very simply put, the kinematic stereonet analysis of Figure 19 compares the orientations of the discontinuity weaknesses, obtained by LiDAR, UAS 3D modeling, and manual data collection, with the actual physical geometry of the rock faces at Natural Bridge. The arrows point to stereonet indicators of potential rock wedge failures in the diagram on the left and potential rock toppling failures in the diagram on the right.

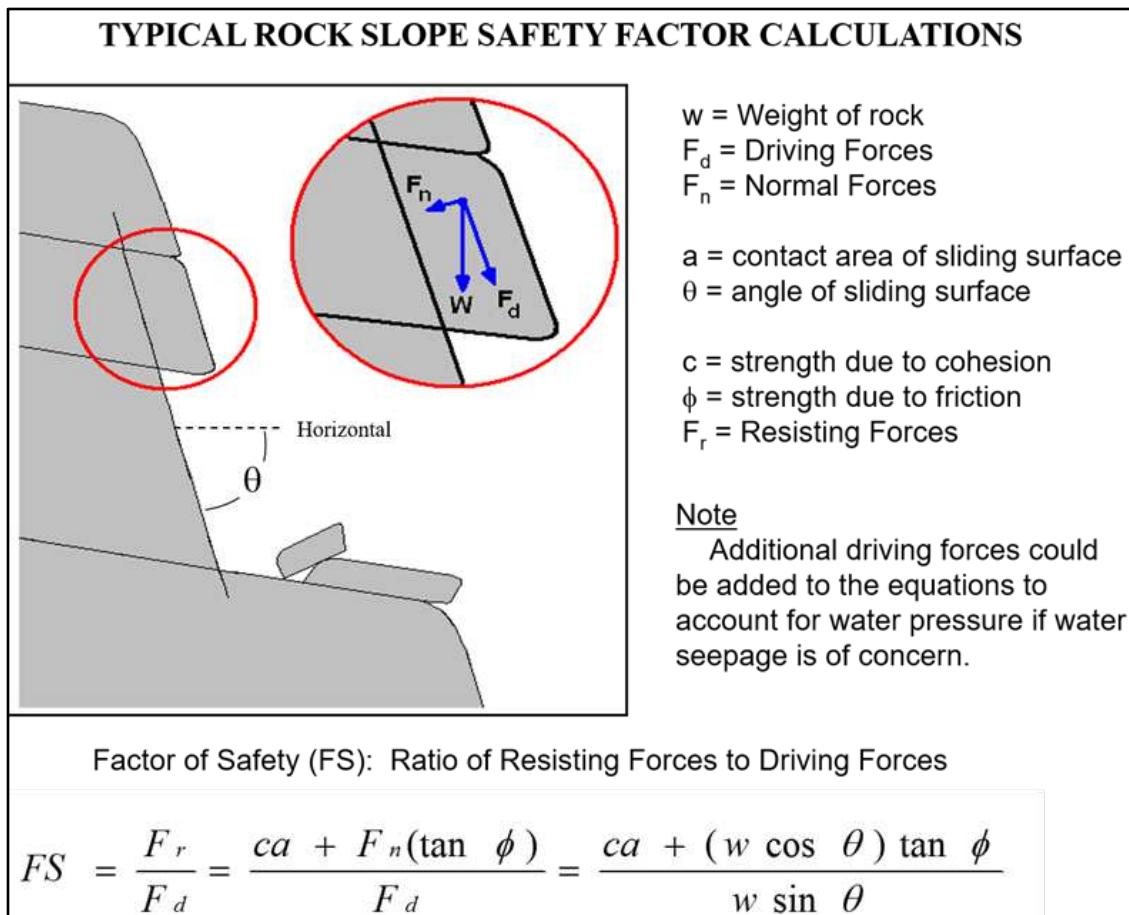
Figure 20. The general safety factor equation for rock slope stability (Watts, 2012). Neither the role of water nor the role of vibration as additional driving forces, are included in these sample equations.

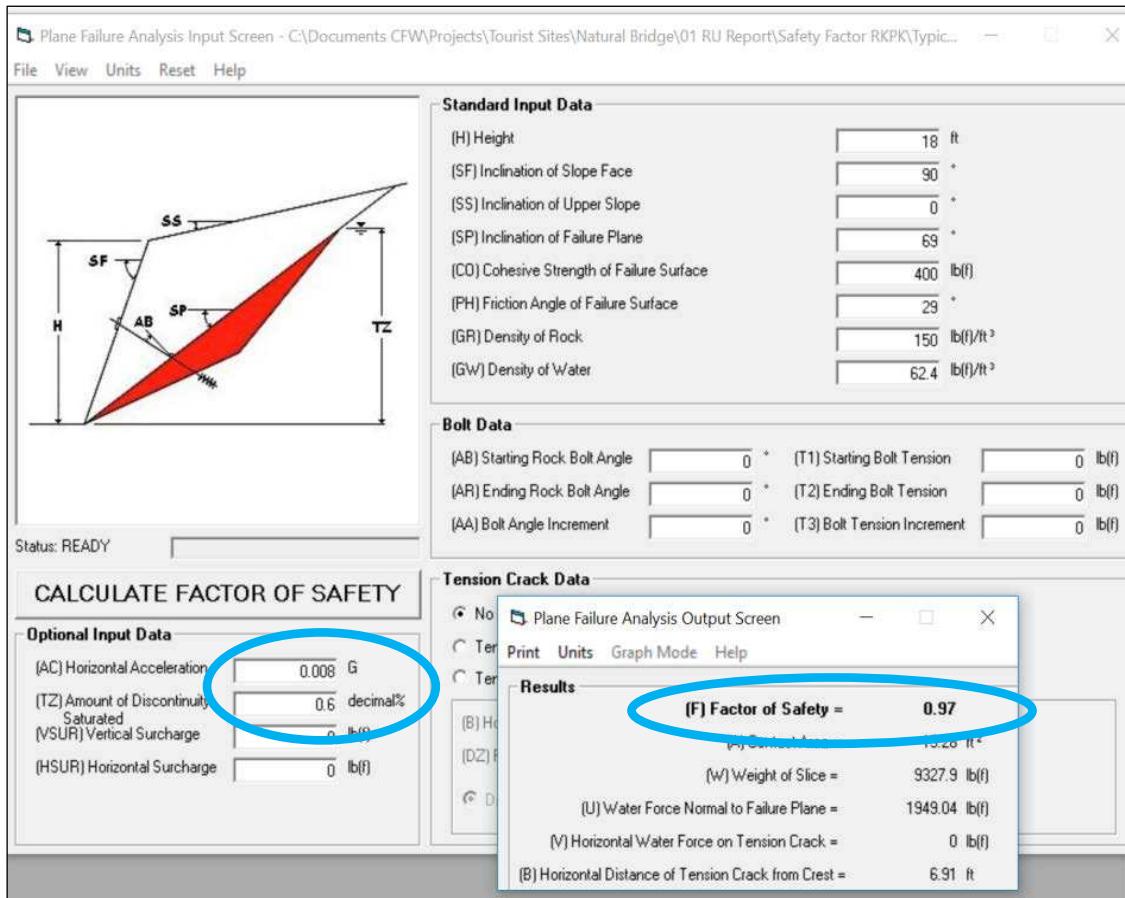
Figure 21 shows the final step in the stability analysis of a rock block in the vicinity of the Old Man structure on the north side of the rock formation showing the last step in a worst-case scenario; the Old Man is believed to be most sensitive of the sensitive structures.

Figure 21. Example of a safety factor calculation using RockPack III software from RockWare. Note that in this worst case scenario, a vibration of 0.008 G, while the weak discontinuity surface is partially saturated, causes the safety factor to drop below 1.0, to 0.97. This would most likely result in a rock fall.

In Step One of this worst-case or near-worst-case scenario, the factor of safety without vibrations or water seepage would be 1.1. That is theoretically safe, although very close to the equilibrium value of 1.0, making it a “sensitive” location. Adding vibration to the stability analysis as another driving force is straightforward as is adding water pressure as another driving force. For example, if a vibration of 0.008 G is added to this case, the local short-term safety factor drops to 1.09, which is even less stable than for the static condition. Greater vibrations would further lower the factors of safety. Finally, if the discontinuity becomes partially saturated, to 60% for the 0.008 G case, the safety factor drops below 1.0 to 0.97, suggesting that a rock fall would be imminent. It should be noted that most natural geological formations, such as rock and soil slopes, generally hover near a factor of safety of 1.0, and are therefore dynamic in nature and behavior, making Natural Bridge and its environs typical in this sense.
