Feasibility Study for the
Soldiers Monument at the Santa Fe Plaza - FINAL REPORT

December 5, 2025

Site and Monument Assessment

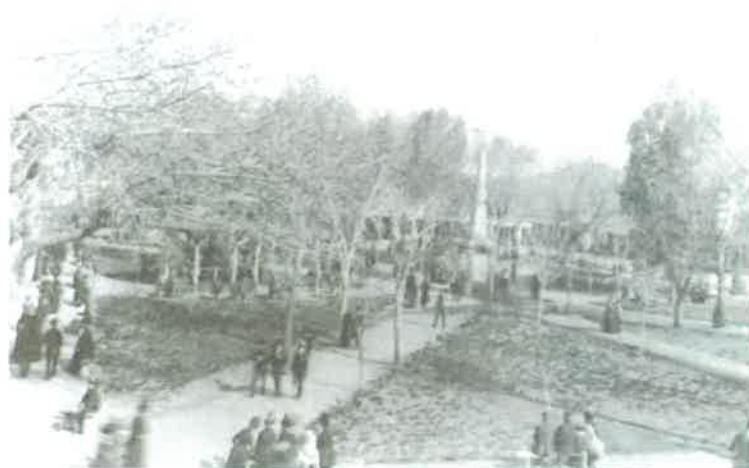
Late 19th century Santa Fe Plaza with radial pathways and the Soldiers' Monument at the center.

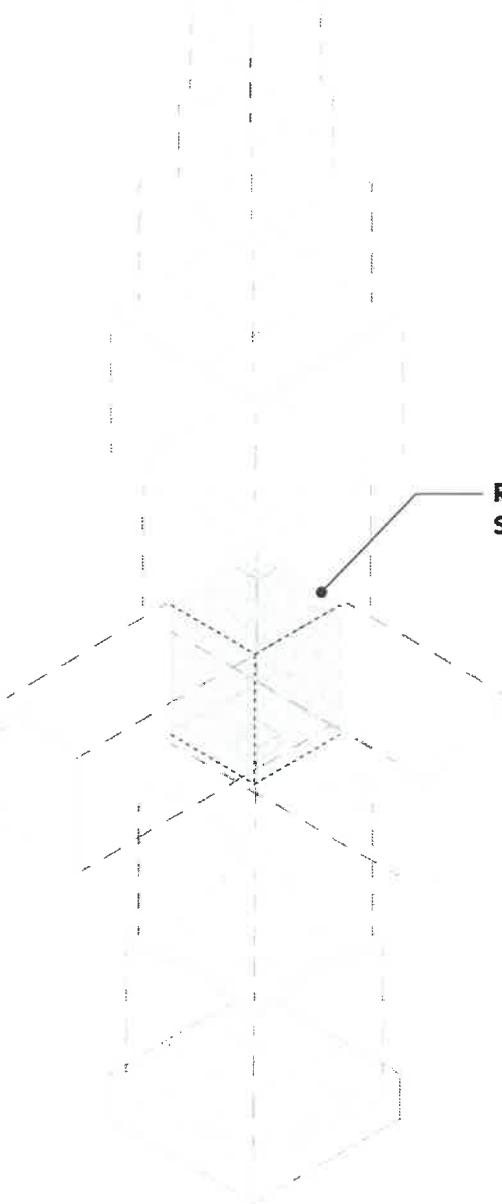
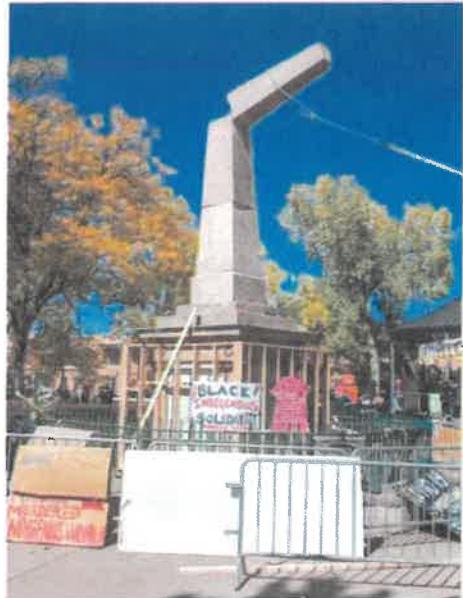
The following diagram shows an exploded isometric view of the existing monument as it still stands on the plaza.

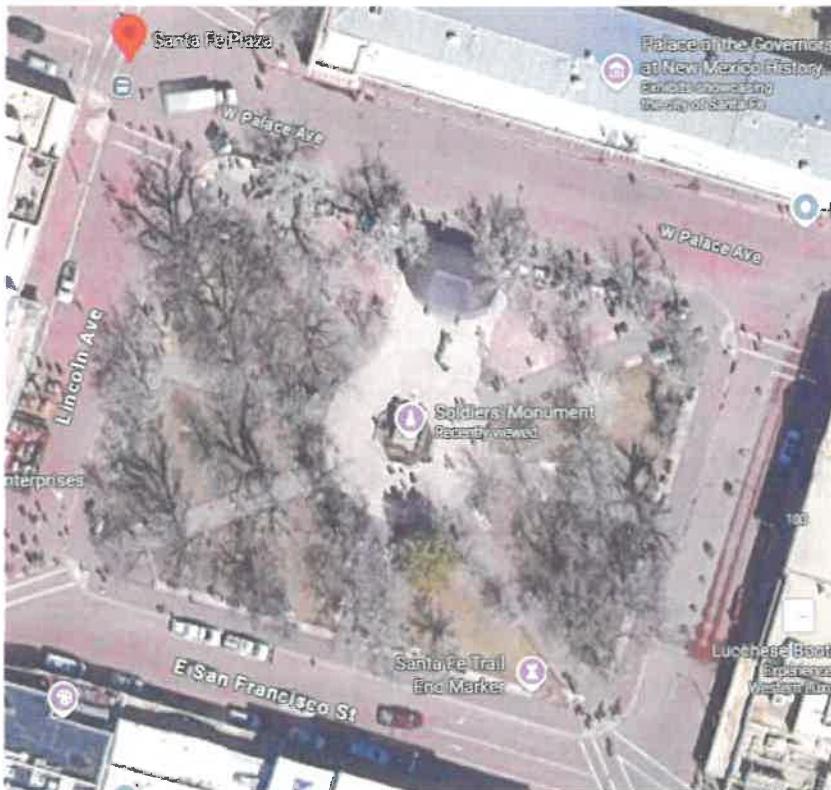
The Soldier's Monument is located within the Santa Fe Plaza in a fenced area consisting only of the historic cast stone and sandstone base with inscribed marble plaques on all four sides. A single stone remains on top where the obelisk used to rise. The remaining pieces of the obelisk are being stored at an undisclosed, secure site within Santa Fe.

It appears that the damage done during the 2020 protest included paint and other materials that were attempted to be removed/cleaned from the monument. Areas are scratched, gouged, and scarred.

The sandstone components show signs of freeze-thaw damage where water has penetrated cracks on the surface. Some spalling has occurred and several areas are fragile to the touch.

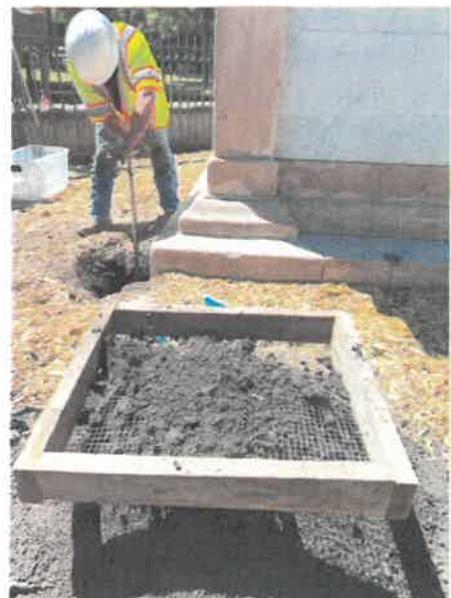
SOLDIER'S MONUMENT ELEVATIONS AS IT STAND TODAY

The monument's plinth is in fair to poor condition. The plinth appears to have a slight tilt to the southwest, but appears to be stable and unmoving. The bottom stones are slightly buried and continue below the grade at least 32". No visible sign of a footing was found when a small hole was dug to investigate it further. See structural report for more information.

The base is four-sided, approximately 8'0" x 8'-0" with stepped sandstone blocks, some bevelled and others straight cut, with four columns at the corners.

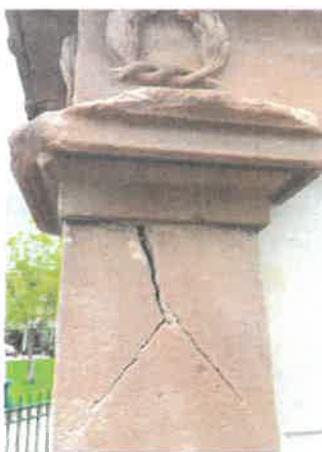
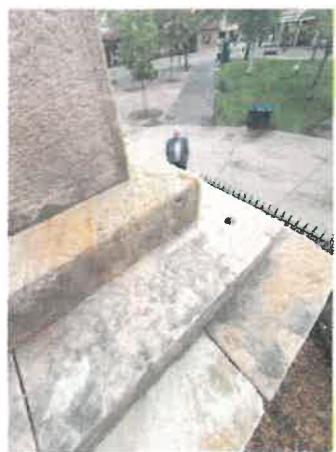
02.b.1.1 CAST STONE / SANDSTONE: It is presumed that there is a combination of historic cast stone and solid sandstone used for the monument. As each side of the monument exhibits duplicate intricate wreath designs, carving solid stone in such precise duality seems uncommon, but not unheard of among stone masons. The stone has weathered in time and is showing signs of moisture damage with mildew and lichen growth. This is typical of historic stone weathering.

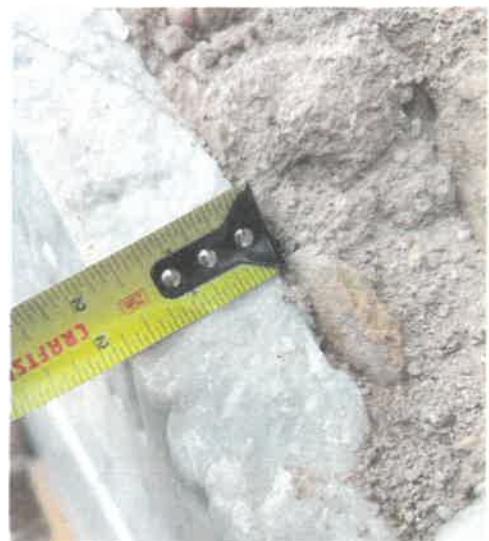
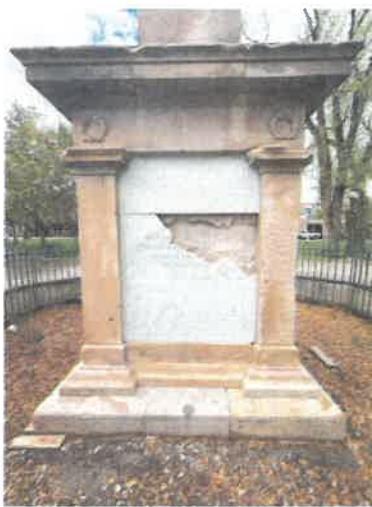
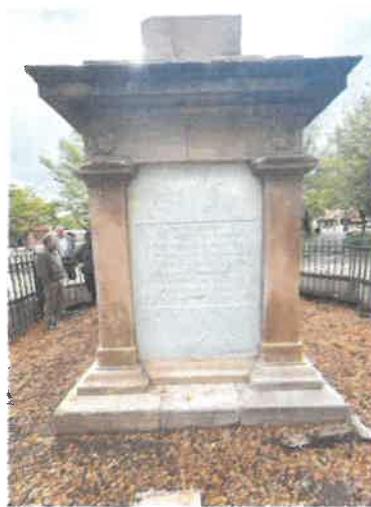
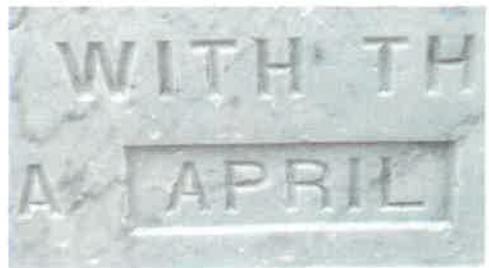
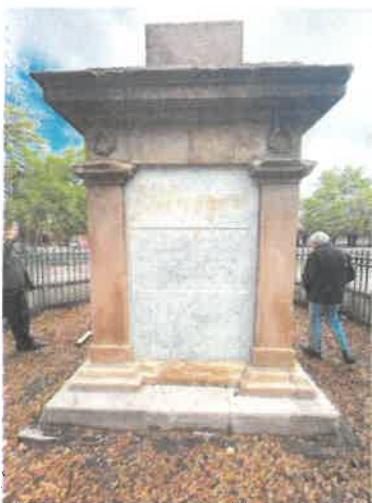
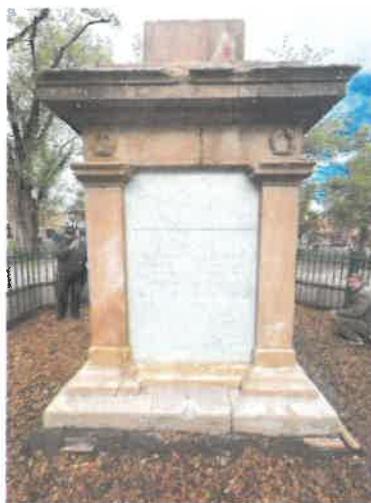
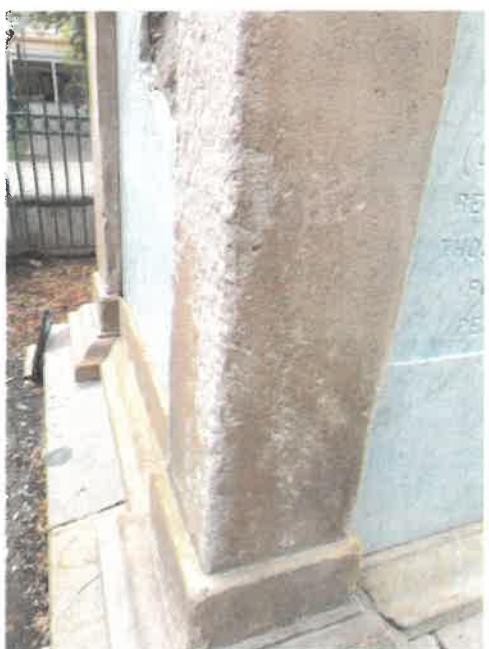
02.b.1.2 MARBLE: The marble is white, 1-3/4" or 2" thick panels installed vertically on all four sides. Inscriptions are complete with some typos or words removed, evident by the 1/4" indented inscription, highlighted in grey and others left unchecked, highlighted in yellow. They read as follows:

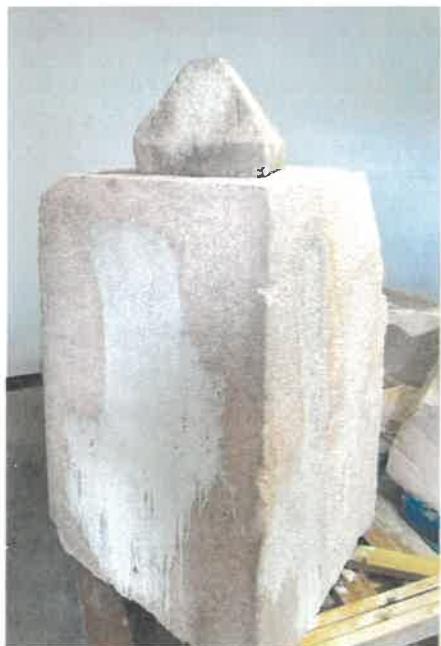
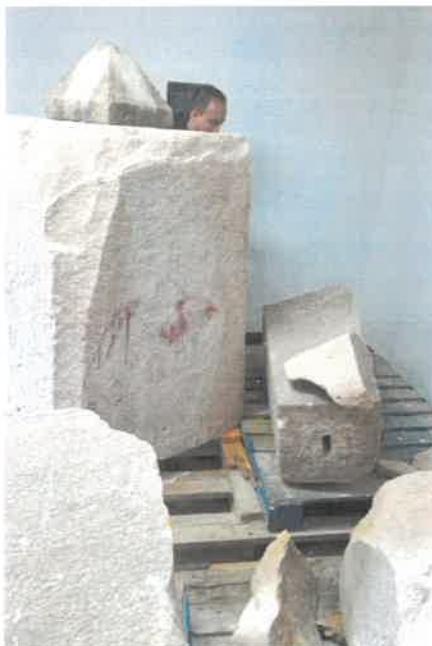
SIDE B

02.b.2.0 OBELISK: The obelisk was formed by stacking three four sided stone pieces atop the plinth with a capstone piece on top. The current remaining pieces of the obelisk are being stored in a secure location off-site on pallets. Most pieces appear to have included a slot for stacking and pinning pieces together. The recovered obelisk stone pieces have only slots. The original pins are missing. Not all of the broken obelisk pieces were recovered. Several large stones have been broken into smaller pieces. It is uncertain which pieces go together at this time. To fully assemble the obelisk will be similar to putting a three-dimensional puzzle together with missing pieces.

The largest base piece of the obelisk has the majority of graffiti and cleaning agent remaining on three of four faces. There are four holes at the base of this piece centered approximately 3" from the bottom. Some holes still contain a metal sleeve that was possibly used to lift the stone into place at installation. Now the hole is either empty or the metal sleeve has been crimped.

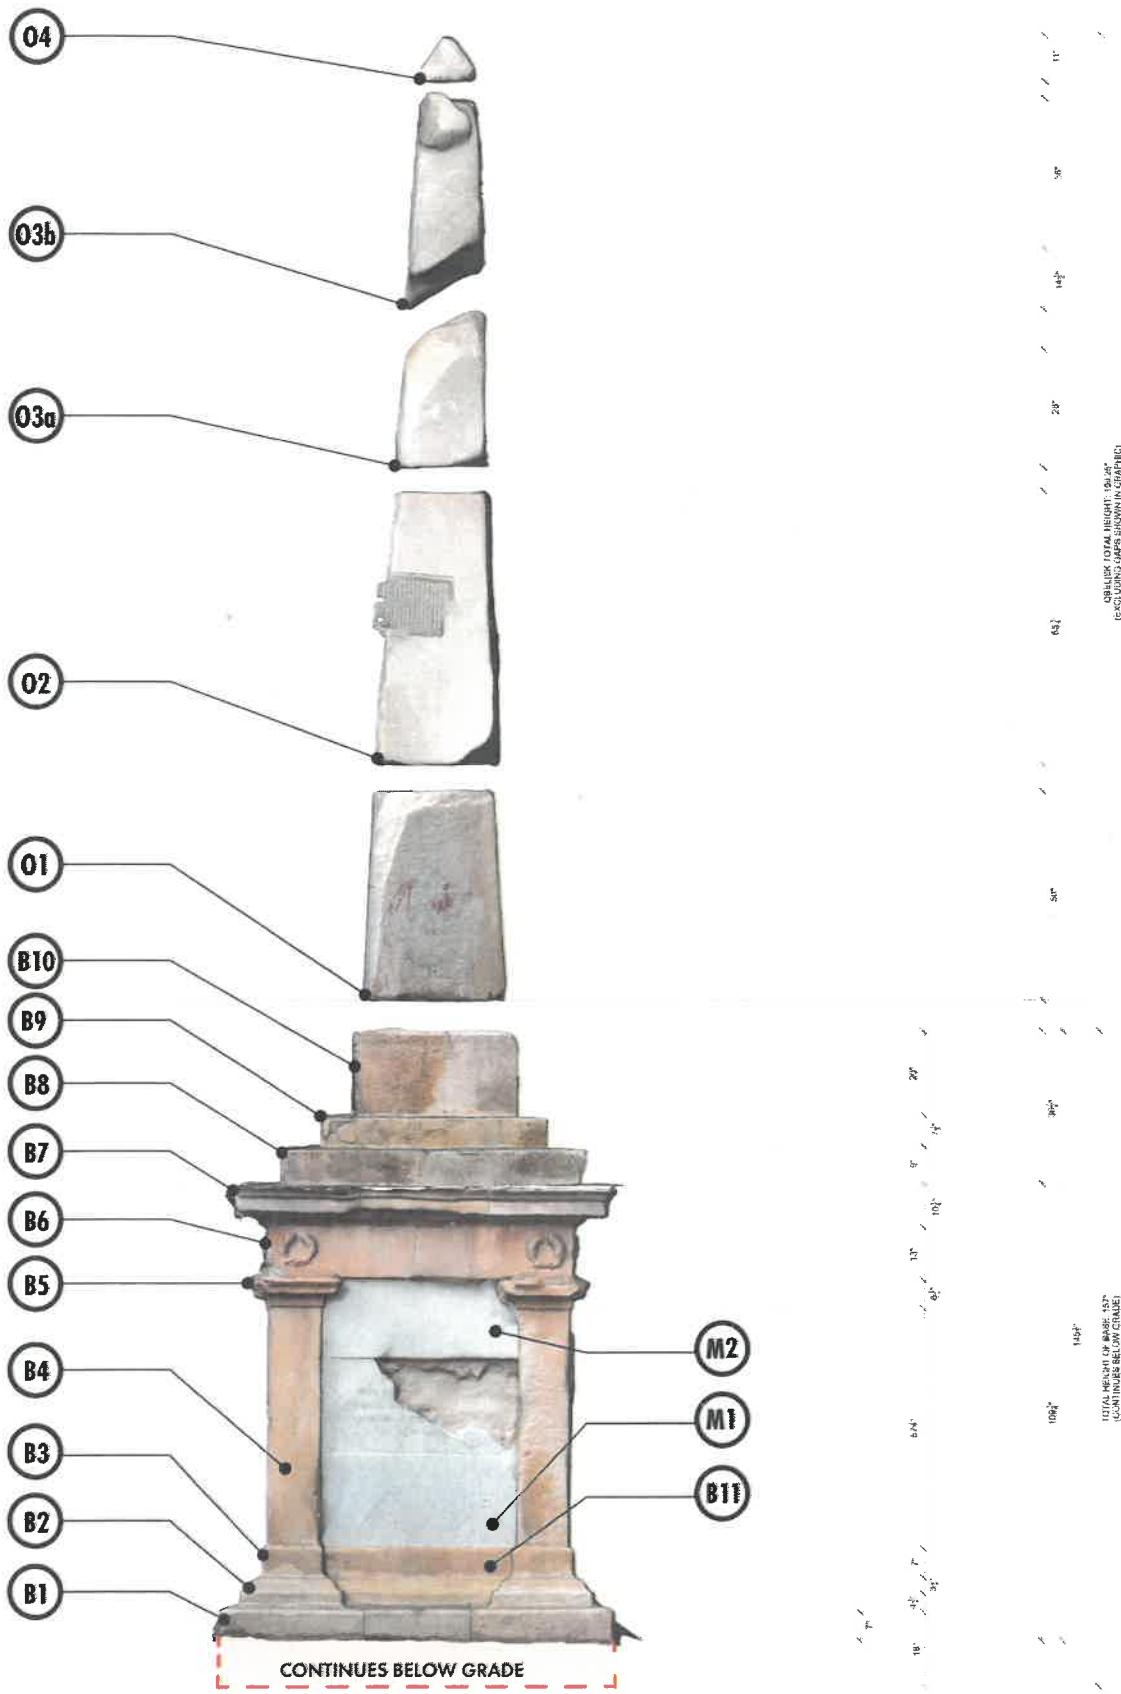
02.b.3.O COMPONENTS: *The components of the complete monument are labeled and dimensioned below.*

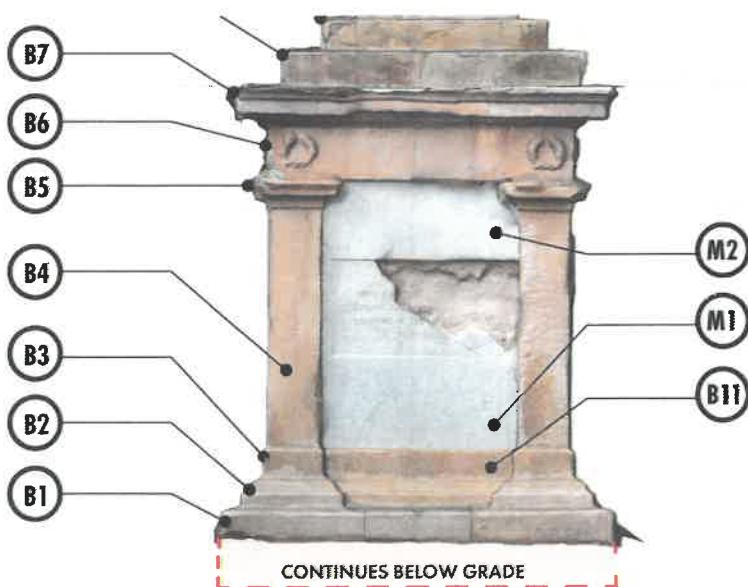
Resource Item #	Condition Indicator Assessed	Condition Status	Rationale & Key Points
B1	9 Base Stones - 7" above grade	Fair Condition	The base has 7" visible above grade, but 11" continue below grade. The top of the stone is delaminating in at the upper sloped surfaces on sides A, C, & D. Edges are chipped on all sides with a large chip on side D where the obelisk probably fell.
B2	4 Lower Column Bases	Fair to Poor Condition	The lower column base is beveled and stepped to meet the upper column base. The stone is delaminating and chipped on all sides. There is a large crack separating the base at side C and D. At side D this base has been shattered at the inner corner of the left column base. If this stone were to be moved, it would lose all integrity and would need to be replaced.
B3	4 Upper Column Bases	Fair to Poor Condition	The upper column base is a block slightly smaller than the lower base top step and larger than the column shaft above it. The stone is delaminating and chipped at the corners on all sides. At side D above the shattered base the lower inner corner of the left column base has been chipped away by some impact. It is not certain if this stone is cracked continuously through the block.

B4	4 Column Shafts	Fair to Poor Condition	The Column Shaft appears to be a solid block of stone, rectangular in shape and volume with a niche for the marble plaque to slide into place. Side A - Left Column has a vertical crack beginning at the top down two-thirds of the shaft. Right Column has been scraped heavily. Side B - Left Column has small residual scratches and pock marks. The top is cracked from possibly an impact point. Right Column has inner edges scraped. Side C - Left Column has a few chips and scrapes and a faded handprint from the painted graffiti. Right Column also has some chips and scrapes. Side D - Left and Right Columns have chips and scrapes.

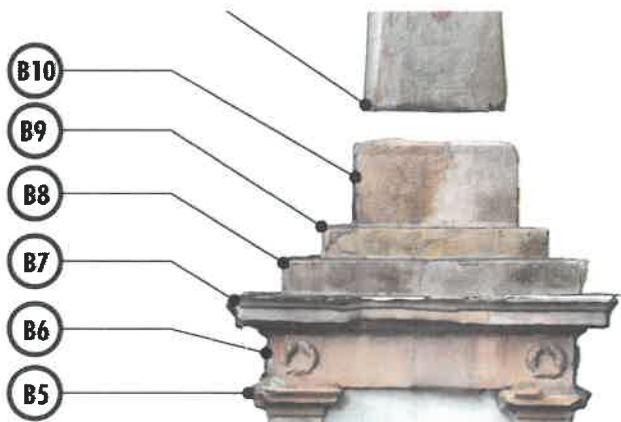
B5	4 Column Capitals	Fair to Poor Condition	The Capital appears to be a solid piece of stone with varying widths of square cap stones stacked from the column shaft, small to large with a slotted under side to allow for a drip edge. Side A - Left Capital is missing its left corner. Right Capital is missing the majority of its overhanging top layer, with considerable decay at the outer corners of the next lower overhang. Side B - Left Capital is missing the majority of its overhanging top layer, with the outer corner of the next layer chipped away. Right Capital is missing the outer corners of the top layer of the overhanging stone. Side C - Left Capital is missing the majority of its overhanging top layer, with considerable decay at the outer corners of the next lower overhang. Right Capital is missing the outer corners of the top layer of the overhanging stone and the outer corner of the next layer of stone. Side D - Left Capital is missing the inner corners of the top and second layers of stone. Right Capital is missing the inner corner of the top layer and the center of top layer is chipped. The next layer under is missing the outer corner.

B6	4 Capstones with "Open Wreaths"	Fair Condition	The Capstones include two "open wreaths" per side centered above the columns. All appear to be intact. The stones on Side A appear to have some water damage, but no delamination. On sides C & D show faded graffiti marks and slight water damage.
B7	9 Upper Cap Stones	Fair to Poor Condition	The upper cap consists of 9 stones that are almost a mirror image to the base stones but not as deep. The upper outer edge of the top is chipped on all sides. Side D has a large chip in the center where the obelisk coming down may have damaged it.
B8	Obelisk Wide Base	Fair Condition	The Obelisk Wide Base consists of 4 solid blocks of sandstone with a hole and metal sleeve at each corner when looking from the top. The top of stone shows signs of weathering with black lichen growing.
B9	Obelisk Middle Base	Fair Condition	The Obelisk Middle Base consists of 4 visible stones. At all sides, there are two holes on the vertical face at the corners with a metal sleeve inserted. Because of their regular placement it is thought that these were used to help lift the pieces in place during initial installation. Each of these stones has significant weathering and hairline cracks, some delamination, and lichen growth. Mortar between stones is missing in most areas.

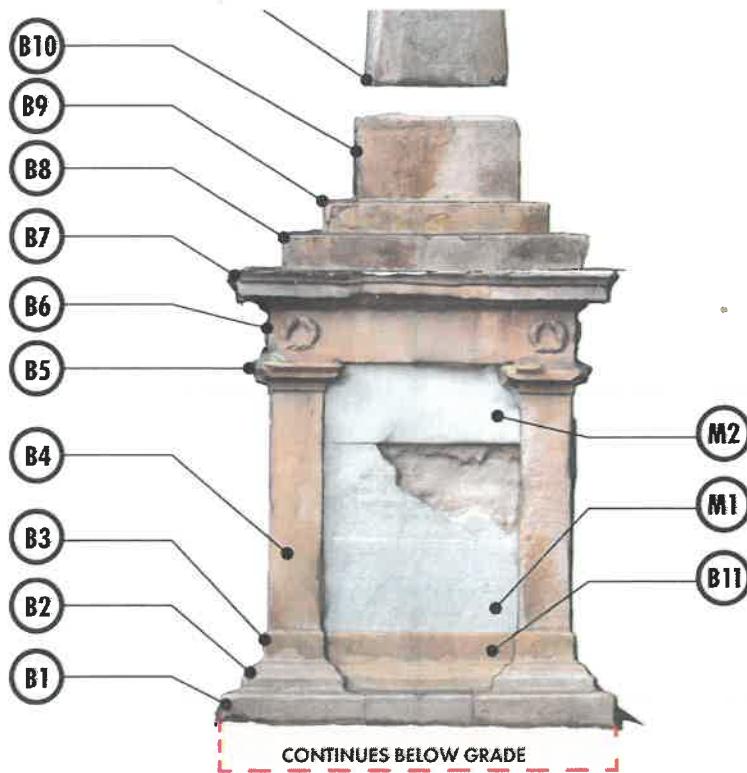
B10	Obelisk Upper Base	Fair Condition	The Obelisk Upper Base is one solid block of sandstone with a beveled top edge and a central slot on top. Side A has a chipped upper right corner with some residual paint that has left a white residue. Side B has a chipped upper left corner and chipped vertical right side; residual paint appears to have been washed off. Side C top edge is uneven and chipped left vertical side. Side D has residual red paint from graffiti. Mortar between this stone and the Obelisk Middle Base is present in two shades of gray possibly from original installation and a later repointing.
B11	Middle Plaque Base	Fair to Poor Condition	The Middle Plaque Base on Side A consists of 2 stones shaped to match the lower and upper column bases. The face and edges have some areas of delamination and small chips at the bottom edge. Side B is missing the upper plaque base and has similar delamination and small chips. Side C is missing the upper plaque base and has much more delamination and wear. Side D is missing the upper plaque base and has similar delamination as A & B with edges chipped and worn away.

M1	Bottom Marble Plaque	Poor Condition	This piece of marble has been damaged and a large triangular portion of the marble was removed. The piece missing is 1-3/4" thick.
M2	Top Marble Plaque	Good Condition	This 2" thick piece is still intact and undamaged.
M3	Marble Plaque, full height	Fair to Good Condition	Side B - appears to be intact with a brownish blotchy stain at the top. Uncertain if this can be cleaned. Side C - appears to be intact with a brownish blotchy stain at the top. Uncertain if this can be cleaned. Side D - appears to be intact with small chips around the "1866" date and near the bottom.

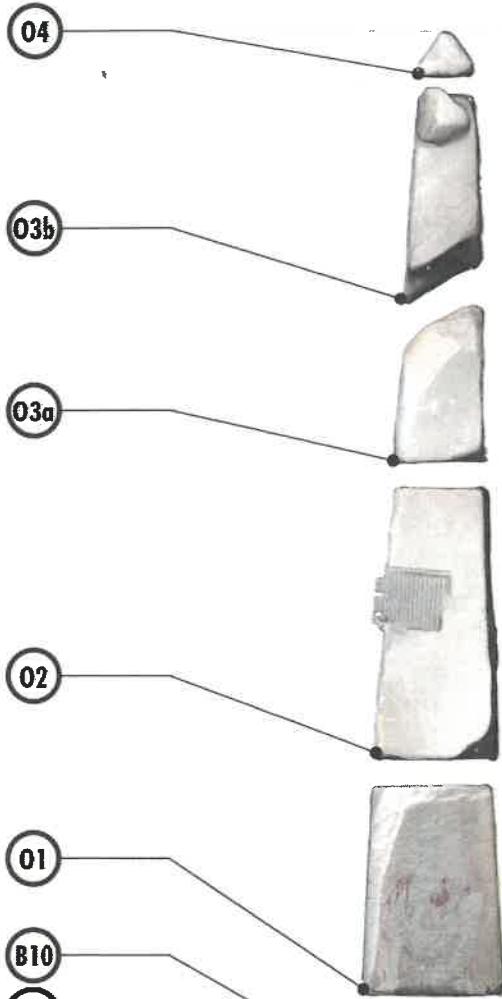
02.b.3.1.4 COMPONENT ASSESSMENT:

04	Capstone	Fair to Poor Condition	This four sided pyramidal shape is missing its point and has sides showing weathering with lichen growth and deterioration of the crisp edges. One bottom corner is missing. There is slot in the bottom of the Capstone approximately 1" x 3" which appears to be either a mortise for a tenon or an opening to receive a pin of some sort. The adjoining segment 03b also has a slot.
03b	Obelisk Upper Shaft part 2	Poor Condition	This four sided slanted shaft of the obelisk has a broken bottom end from the tearing down of the monument in 2020. The top has a slot approximately 1" x 3" to receive a pin for stacking the capstone to this piece. The pin is missing and it is unknown what material it was. This part of the shaft is sitting on its side in storage, so only 3 sides were visible. They all show signs of weathering with large chips at the edges where it fell on hard surfaces.

03a	Obelisk Upper Shaft part 1	Poor Condition	This four sided slanted shaft of the obelisk has a broken top end from the tearing down of the monument in 2020. This part is severely misshapen from large missing pieces sheared off when it fell. All three visible sides show signs of weathering with large chips at the edges and middle sides from impact. Flecks of green paint are visible from scraping the surrounding fence. There is no slot at the bottom end of this piece.
02	Obelisk Middle Shaft	Fair to Poor Condition	This four sided slanted shaft of the obelisk has a rough and sandy bottom and top end. All three visible sides show signs of weathering with large chips and a broken corner. The missing corner appears to be on site in storage and could be lifted to see that it fit. Flecks of green paint are visible from scraping the surrounding fence. Other scrape marks and chips are visible and residue from paint or a cleaning product are present.

01	Obelisk Bottom Shaft	Poor Condition	This four sided slanted Bottom Shaft of the obelisk has a rough and sandy top end with a visible slot. All four sides show signs of weathering with large stains from graffiti and the removal cleaning agent. Other scrape marks and chips are visible and several holes from either lifting mechanisms or maybe embedded bullets?

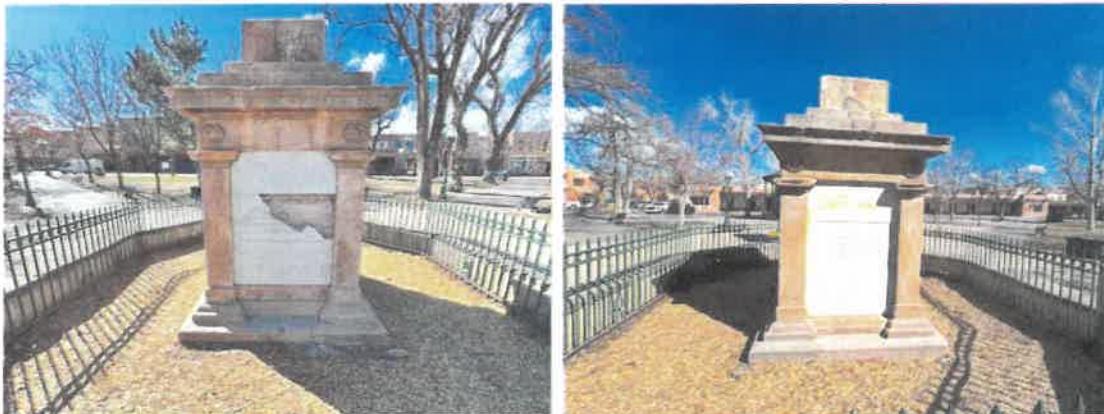
Existing Conditions - Foundation

- Excavation Summary
 - Excavation adjacent to the monument revealed a 22-inch thick sandstone base, embedded 14-inches below grade (8-inches exposed).
 - Excavations continued 18-inches below the sandstone base until refusal.
- Foundation Composition
 - The sandstone blocks span between large boulders, with soil filling the voids.
 - The extent and treatment of the boulders remain unknown.
- Other Observations
 - Concrete fragments found were likely remnants from past stabilizations during adjacent water line work. Not necessarily structural support but replacing soils lost during excavation.
 - Clay piping fragments, like historical water supply systems were discovered in the excavation.
- Overall Assessment
 - Buried boulders, not concrete, likely support the monument.
 - It is unclear whether the boulders were placed intentionally or are natural.

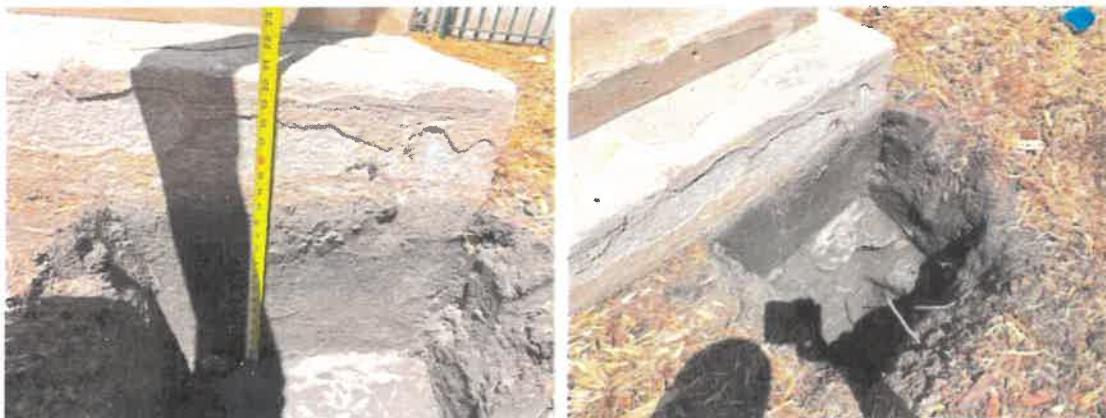
Existing Conditions - Plinth

- Monument Base
 - Composed of several sandstone block pieces; connections are unknown (dowels or keyed joints were not observed).
 - Masonry joints are in poor condition; sandstone blocks show deterioration (cracks, spalls, impact chips).
 - Joint gaps vary in width, suggesting block movement over time – could be caused by differential movement.
- Site Grading and Drainage
 - Poor grading around the monument was observed; a concrete banco and fence trap runoff, allowing water to infiltrate soils below.
 - The banco was likely installed during plaza drainage renovations, leaving the monument at the lowest elevation.
 - No drainage system exists within the banco area; soils experience wetting and drying cycles.
 - If the soils are moisture-sensitive, shrink-swell behavior may continue to damage the monument over time.

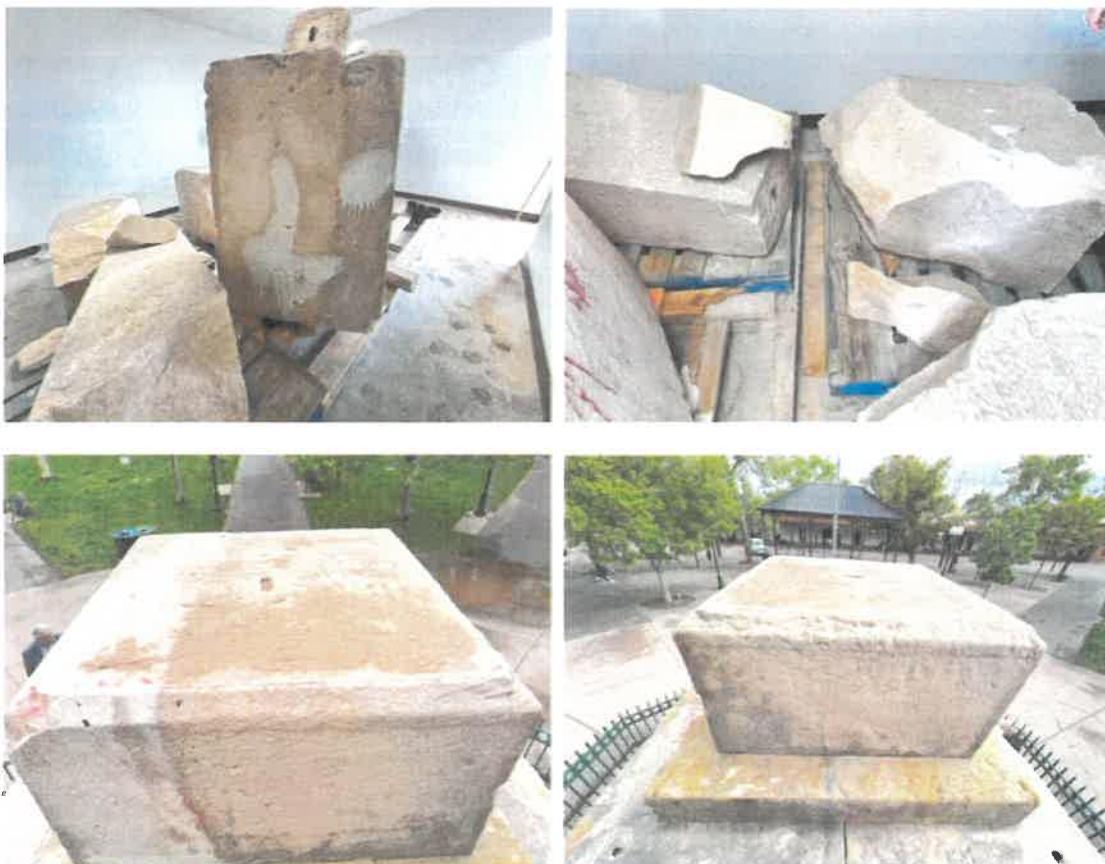
Existing Conditions - Obelisk

- Construction & Assembly
 - The pieces were inspected within a storage facility.
 - The obelisk is comprised of four separate stacked pieces, jointed with masonry joints.
 - Some pieces have holes or spaces possibly for dowels, but it is unclear if dowelling was used or if these features are original.
- Condition & Damage
 - Ends, corners, and edges of all pieces were severely damaged.
 - Most remaining pieces do not show cracks or punctures, except for one.
 - All pieces are weathered, chipped and dimpled.
- Plinth Connection
 - The top piece of the plinth is clean and has a hole, likely for doweling, lifting or erection.

Reassemble the obelisk using existing stones and keeping the current plinth and foundation.

Mechanically connect original stones and replace damaged ones with new material (using damaged historical stones as thinner face materials). Keep the current plinth and foundation.

Move the monument to a new site and rebuild with improved connections and new foundations.

Preferred option if the monument is moved. Relocation provides the greatest opportunity to strengthen and provide a new foundation support.

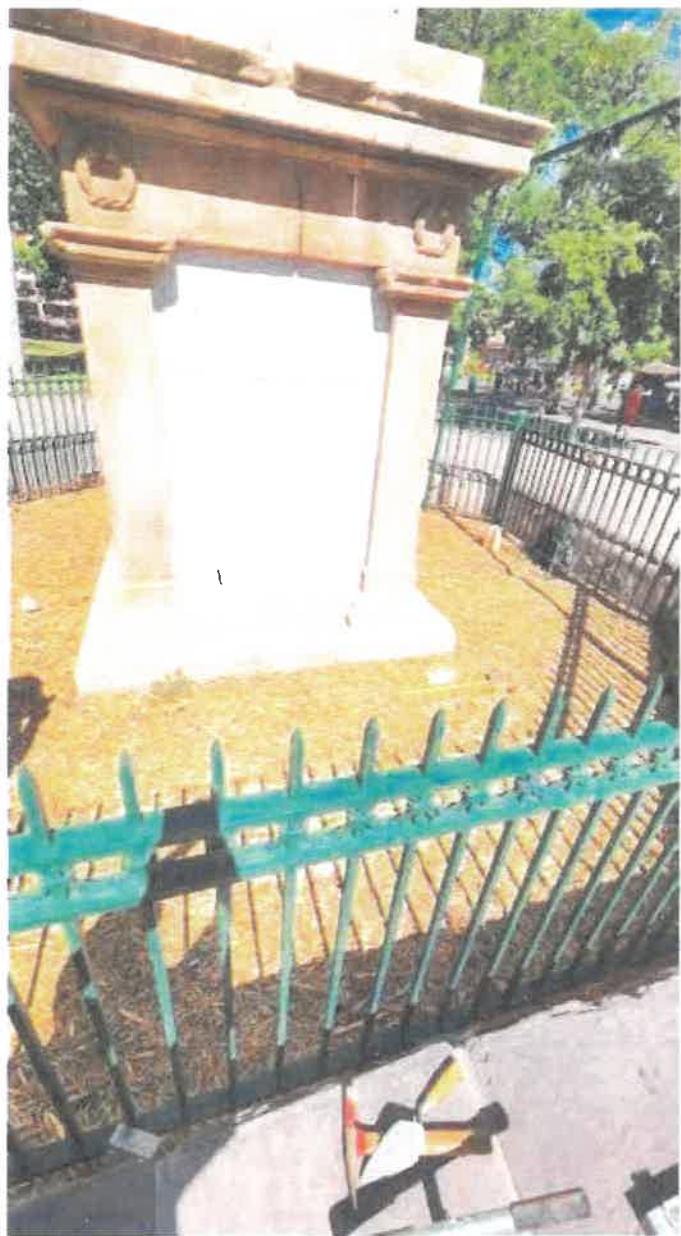
Figure 2. Soldier's Monument "Obelisk" site overview.

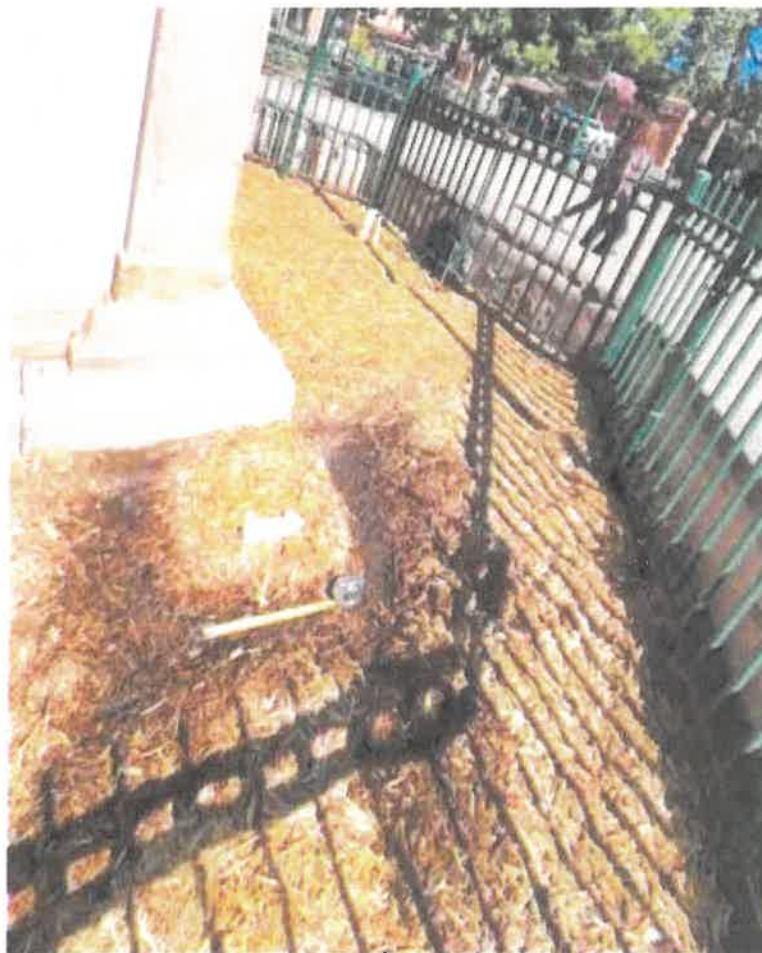
Figure 3. Begin assessment in the NE Corner.

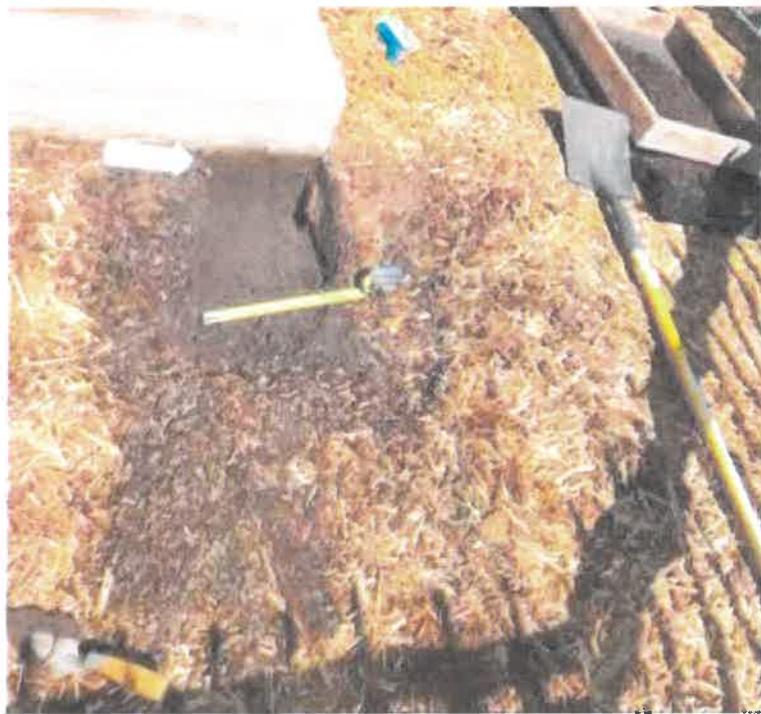
This initial assessment identified the presence of modern to historic trash debris consisting of fragmented glass, animal bone, plastic, copper pennies, Tewa Polychrome sherds, and metal artifacts. The soil generally comprises of an O, A, and R horizons but to what extent is unknown and further investigations is necessary to understand the depth of the granitic cobbles and boulders and what lies beneath the current foundation. It is recommended given the limited review and window in the northeast corner of the site that all further proposed ground disturbing work at a minimum be monitored by a qualified archaeologist listed on the City of Santa Fe's List of Approved Archaeologists and Historians for the Historic Downtown Archaeological Review District.

Figure 4. Levels 3 and 4 where the historic cultural materials were observed .

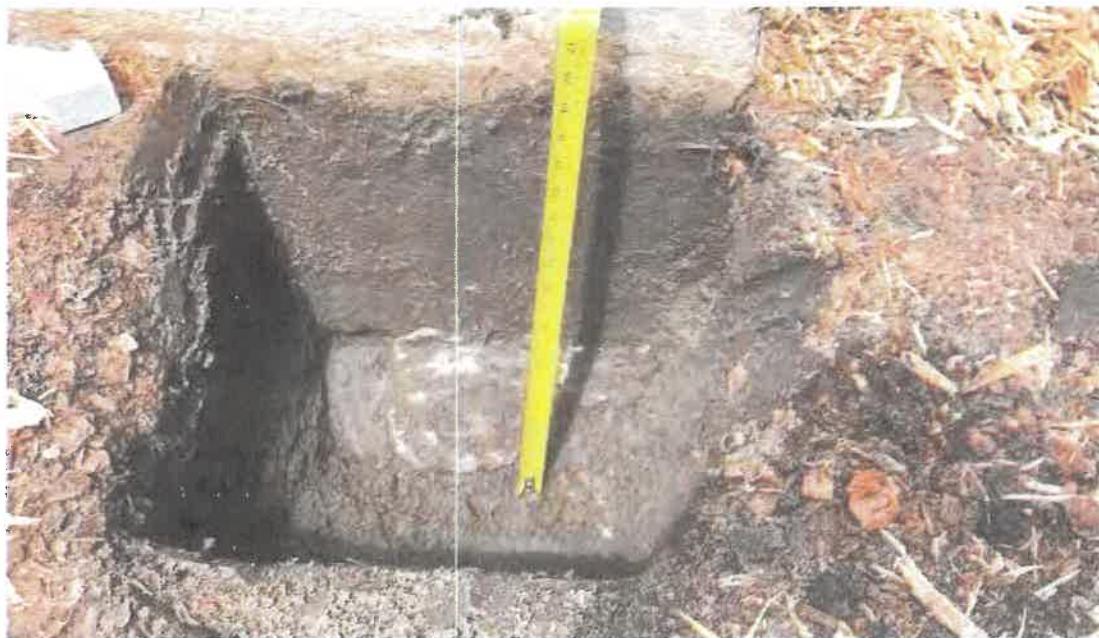
Figure 5. Top of the granitic rock.

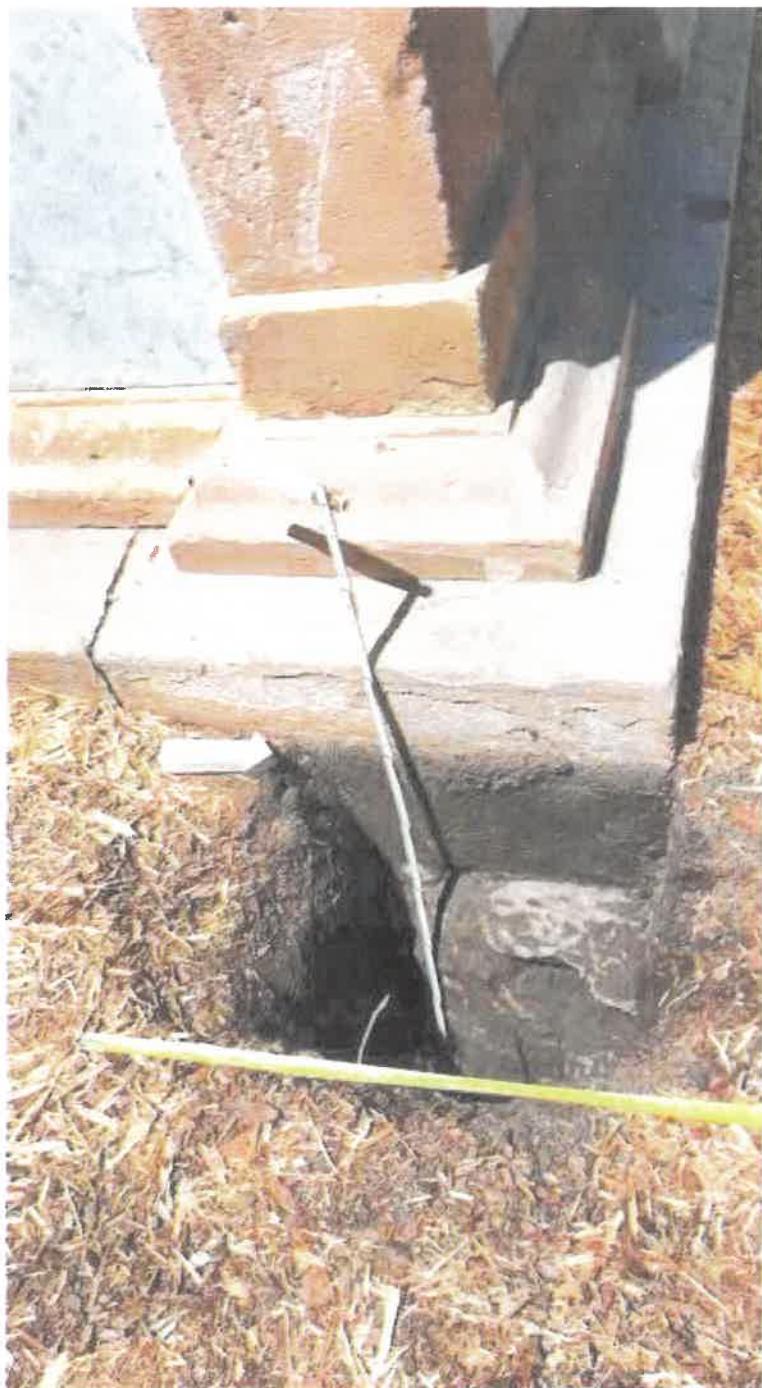
Figure 6. Bottom of excavation.

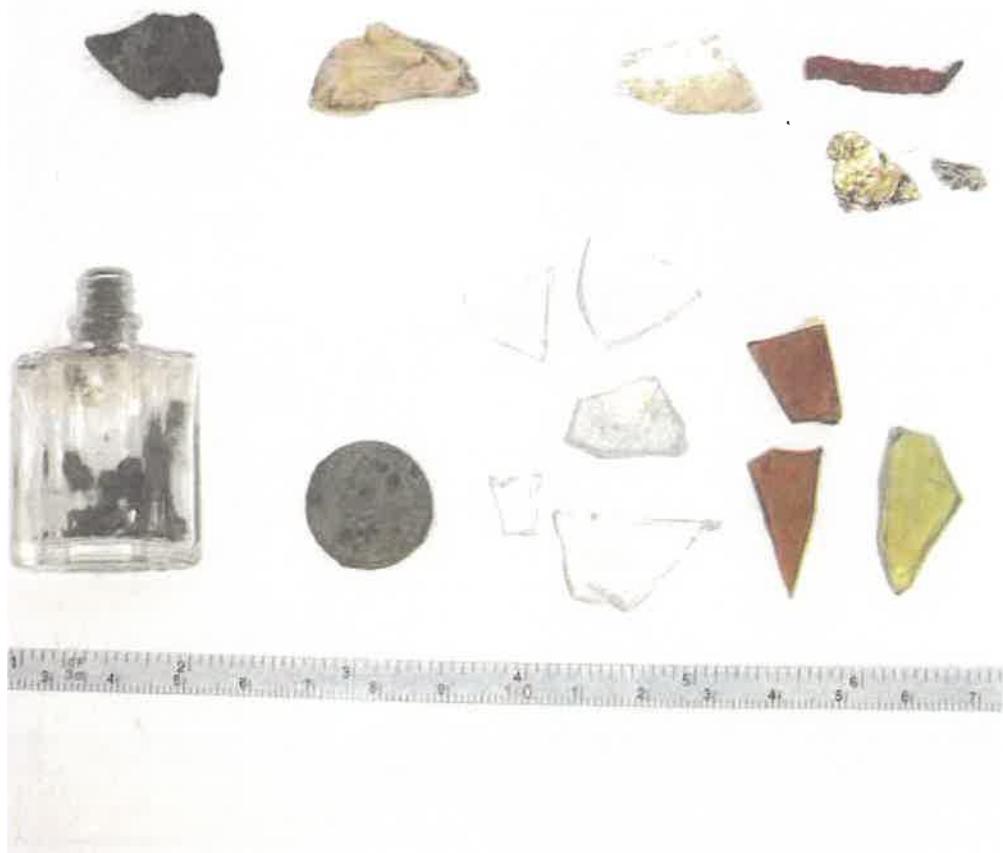
Figure 8. Historic and modern trash midden from Levels 3 and 4.

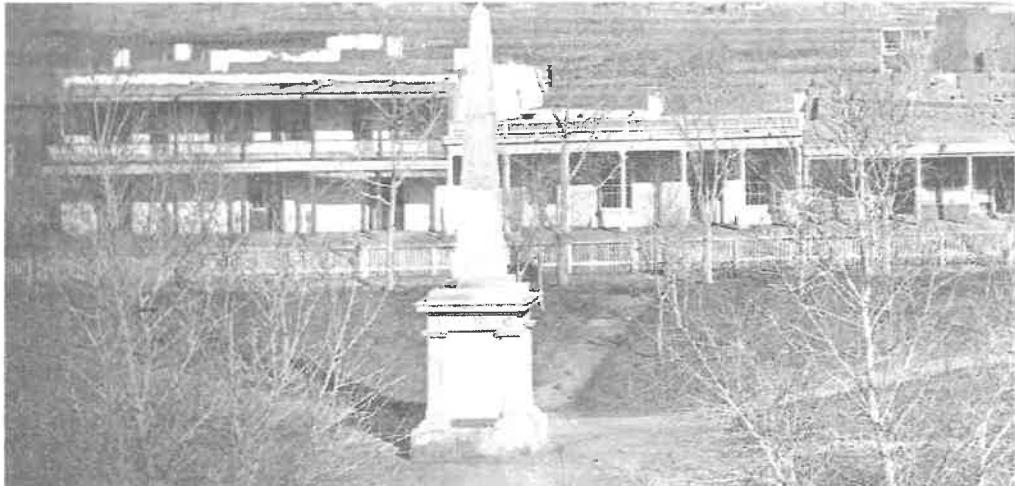
Figure 4: Early photograph of the Santa Fe Soldiers' Monument. This image is cropped from "East side of Plaza, Santa Fe, New Mexico," Nicholas Brown, ca. 1868-69, Negative No. 011252. Courtesy of Palace of the Governors Photo Archives, New Mexico History Museum.

By the end of May, the marble work was completed, and the Soldiers' Monument stood finished by the following month. A short article in the *New Mexican* praised the result as a "beautiful and chaste memento of the brave men who fell in New Mexico that the nation might live" (Fig. 4).⁴⁶

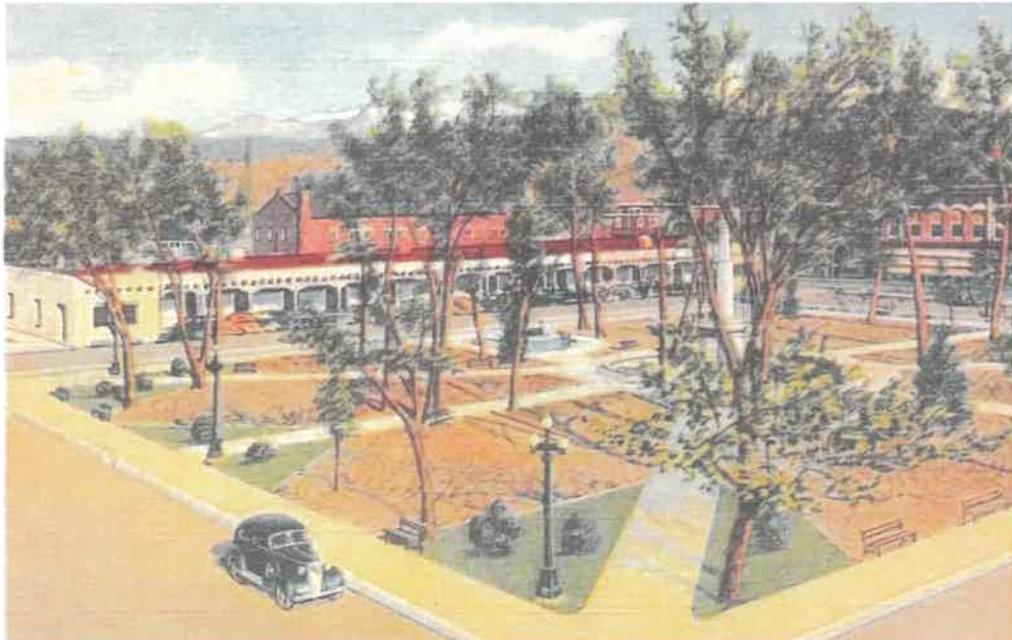
Figure 7: Ca. 1940s postcard of the Plaza showing 1935 New Deal improvements, including introduction of flagstone section and a circular wall around the Soldiers' Monument. Courtesy of Curt Teich Postcard Archives Collection.

Given that the project was funded by the Federal Emergency Relief Administration—precursor to the Works Progress Administration—it’s unlikely the federal government would have approved the destruction of a historic monument. Instead, the 1935 redesign enhanced the monument’s surroundings. Obtrusive metal lights attached to it were removed, a circular seating wall was added, and artist Will Shuster designed new lighting.⁵⁸ The landscaping improved radial walkways, added flagstone paving, cleared overgrowth, and planted evergreens around the structure (Fig. 7).⁵⁹

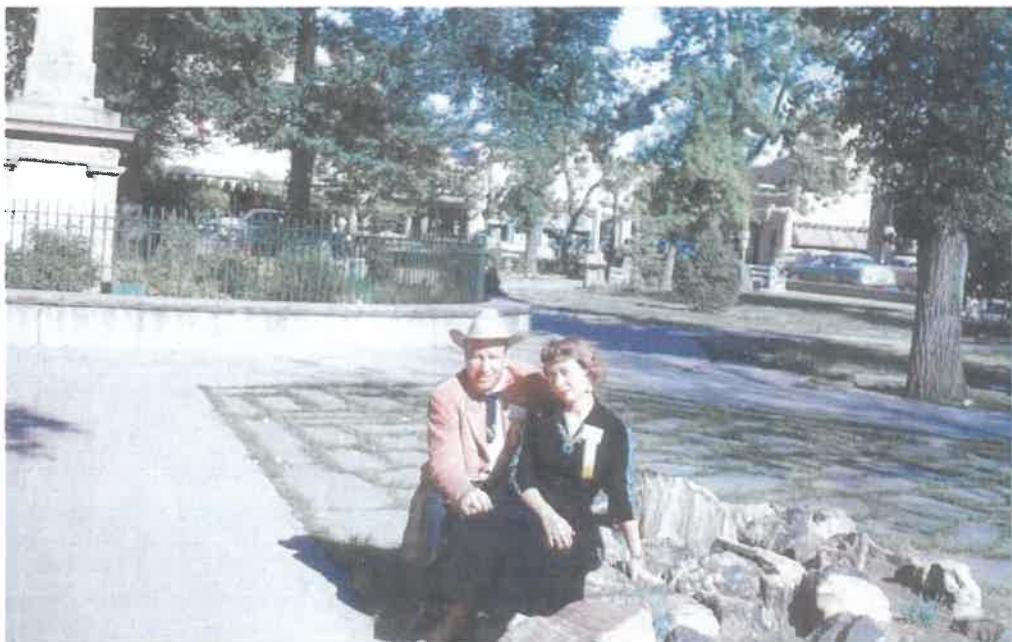
Figure 8: 1950s photograph of Santa Fe Plaza. Note steel fence. Courtesy of Medwick Closet.

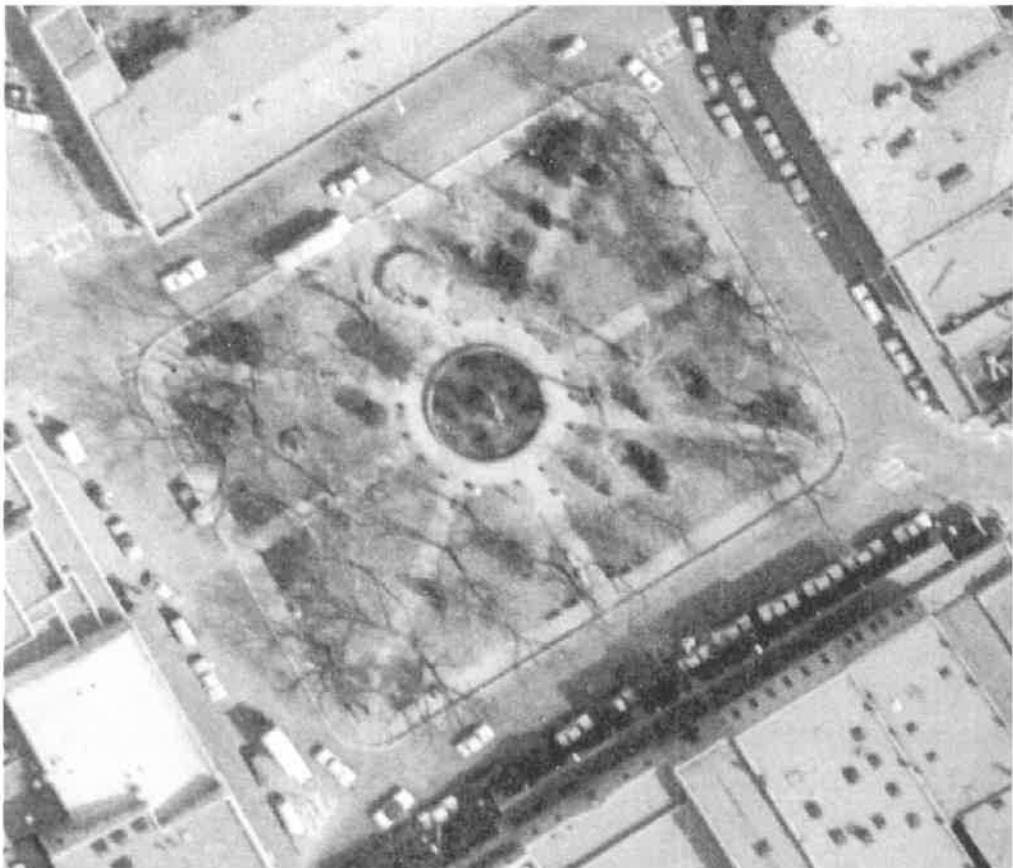
Figure 11: 1968 aerial photograph showing plantings and circular seating bench.
 Architect John Gaw Meem found this arrangement to be too cluttered. Courtesy of the
 New Mexico Department of Transportation.

For the second phase, Meem envisioned installing his long-desired bandstand at the Plaza's center, which would require the removal of the Soldiers' Monument. He believed both changes would help declutter and unify the Plaza's landscape (Fig. 11).⁷⁰ Meem proposed relocating the Soldiers' Monument to the new capitol grounds, as he and the city concluded it was a state-owned structure.
