Feasibility Study for the
Soldiers Monument at the Santa Fe Plaza - FINAL REPORT

December 5, 2025

Site and Monument Assessment

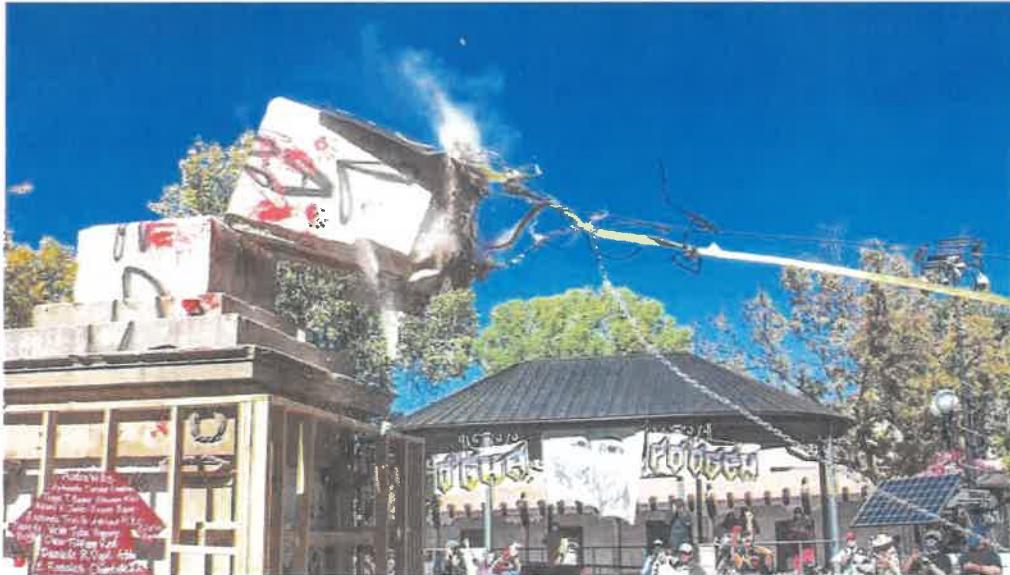
Figure 12: Last piece of four-part obelisk being torn down, Katherine Lewin, October 12, 2020. Courtesy of the Santa Fe Reporter.

Using multiple yellow hauling straps—some held by hand, others tied to a pickup truck—they pulled down the first section of the shaft, which fell into the fenced enclosure. They repeated the effort, ultimately bringing the remaining segments crashing to the ground (Figs. 12 & 13). As a final gesture, protestors climbed atop the now-empty monument base and unfurled a large black-and-white “Land Back” banner, signaling the end of the action.

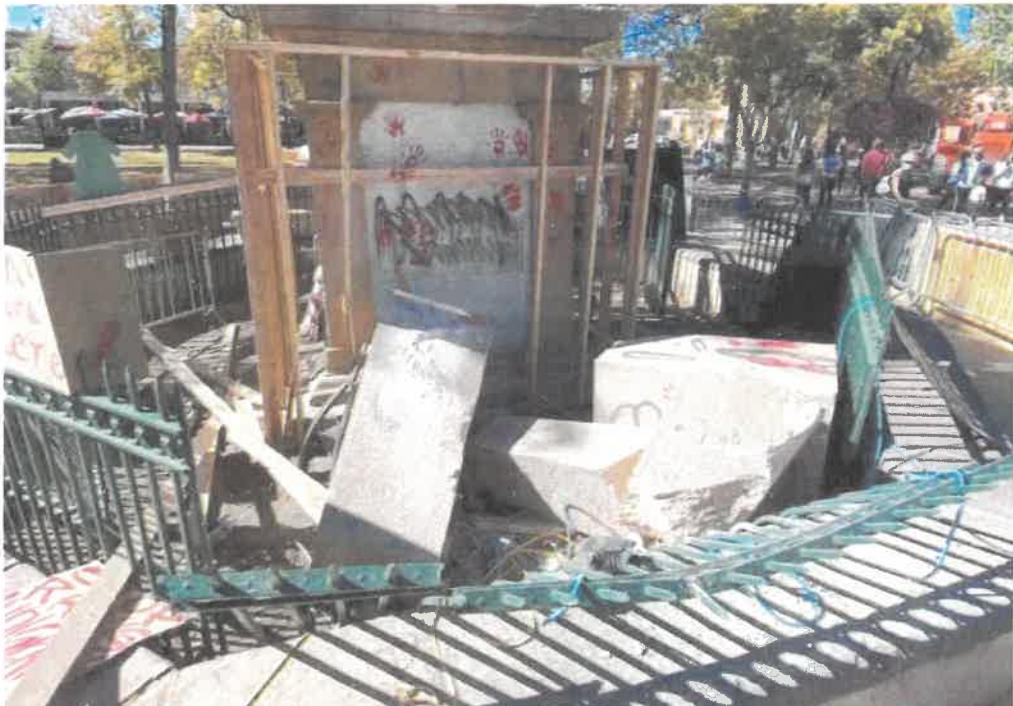
Figure 13: Toppled obelisk. Adrianna Vigil, October 12, 2020. Courtesy of Adrianna Vigil. See Figure 16.

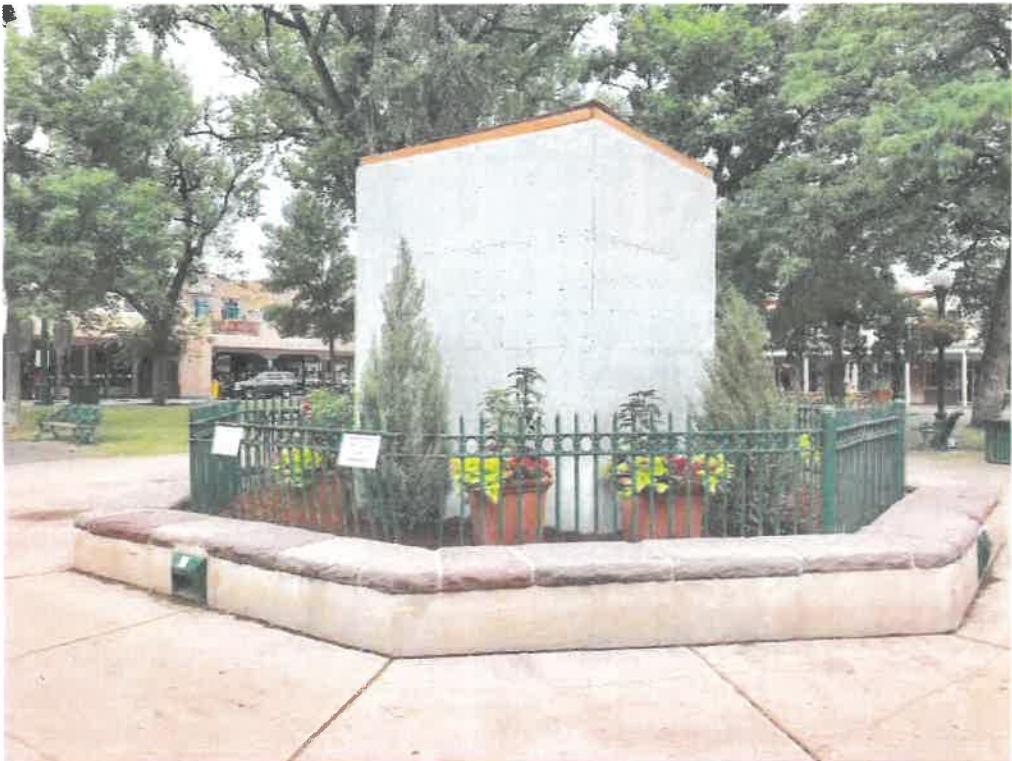
Figure 14: South and east elevations. John W. Murphey, June 28, 2021.

The city quickly enclosed the base of the monument in a protective plywood box, sheathed in cement board (Fig. 14), and later painted to resemble adobe. Potted plants were arranged inside the surrounding fence to soften the site’s appearance.

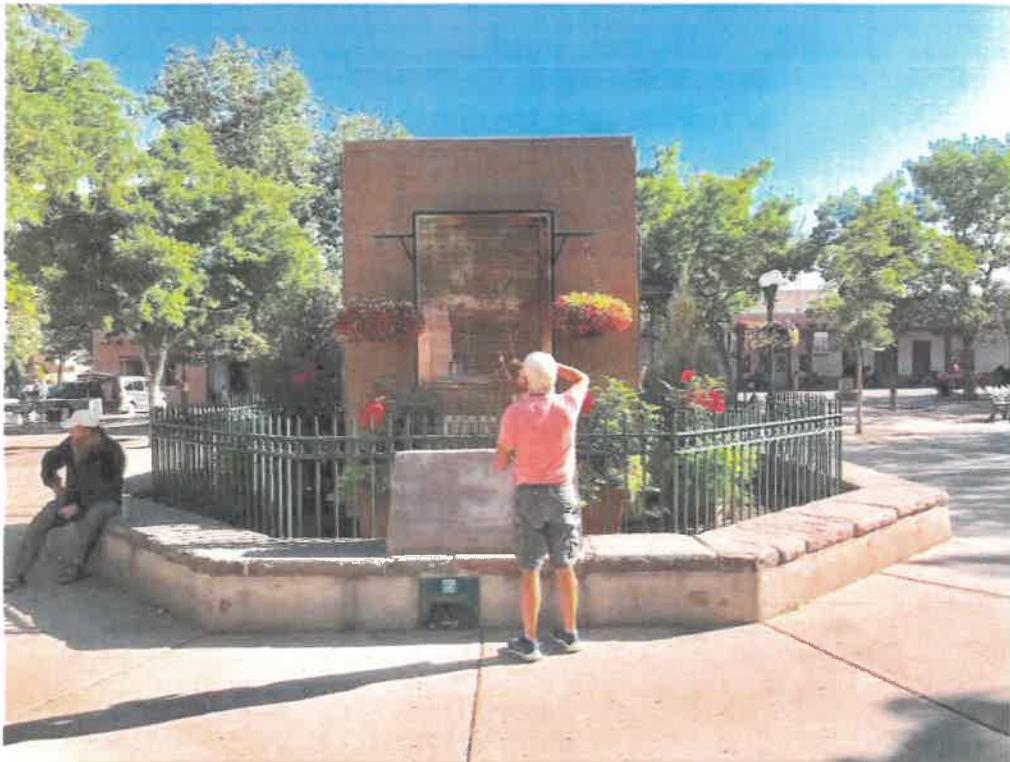
Figure 15: South elevation. John W. Murphey, July 18, 2021.

By the following year, a framed proclamation appeared on the monument’s south face, contextualizing the toppling and outlining the city’s CHART initiative—Culture, History, Art, Reconciliation, and Truth (Fig. 15). According to the city, the \$265,000 program was

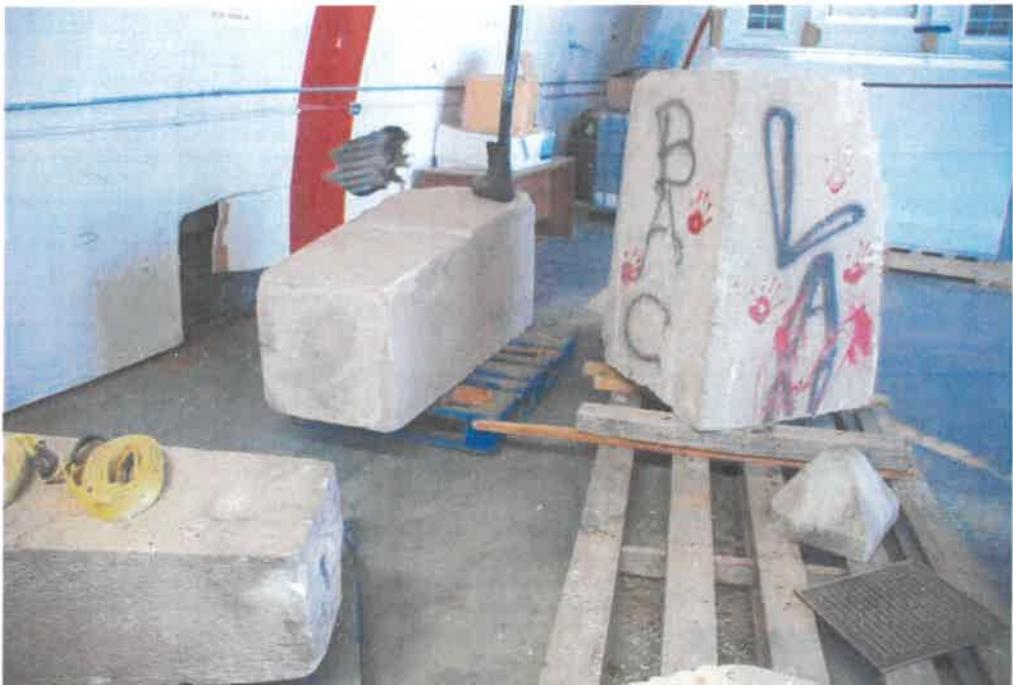
Figure 16: Four pieces of Santa Fe Soldiers' Monument obelisk in storage at the Santa Fe Regional Airport. David Rasch©, May 22, 2024. Courtesy of David Rasch.

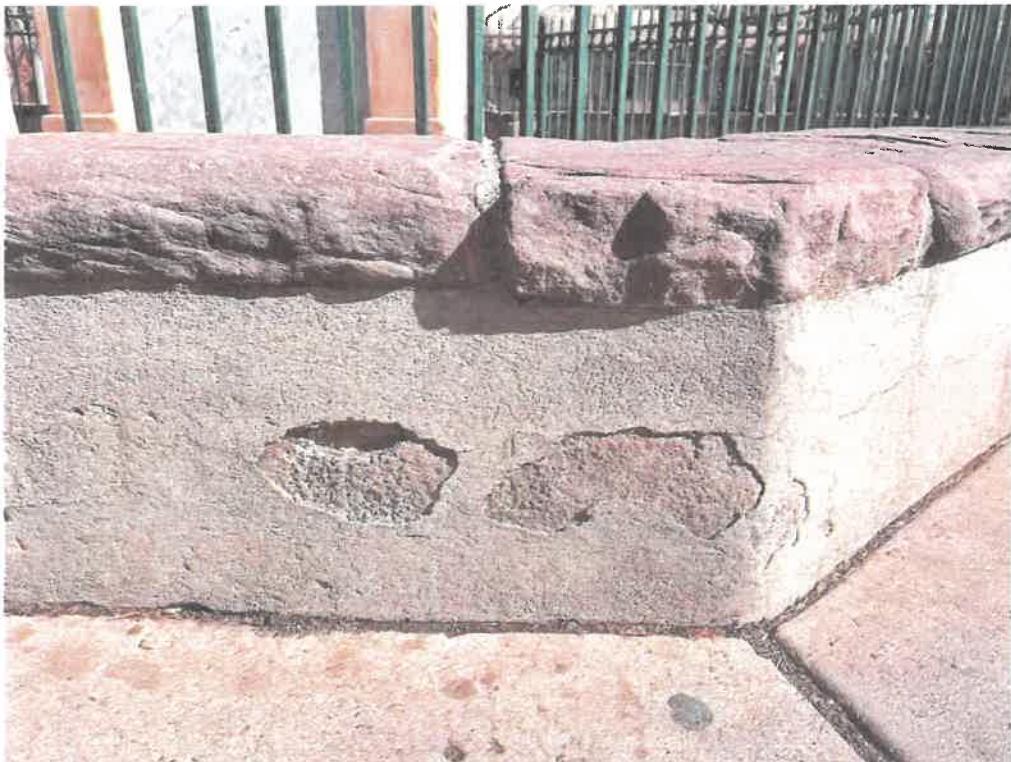
Photo 4: Seating wall. South elevation. Camera facing north. March 14, 2025.

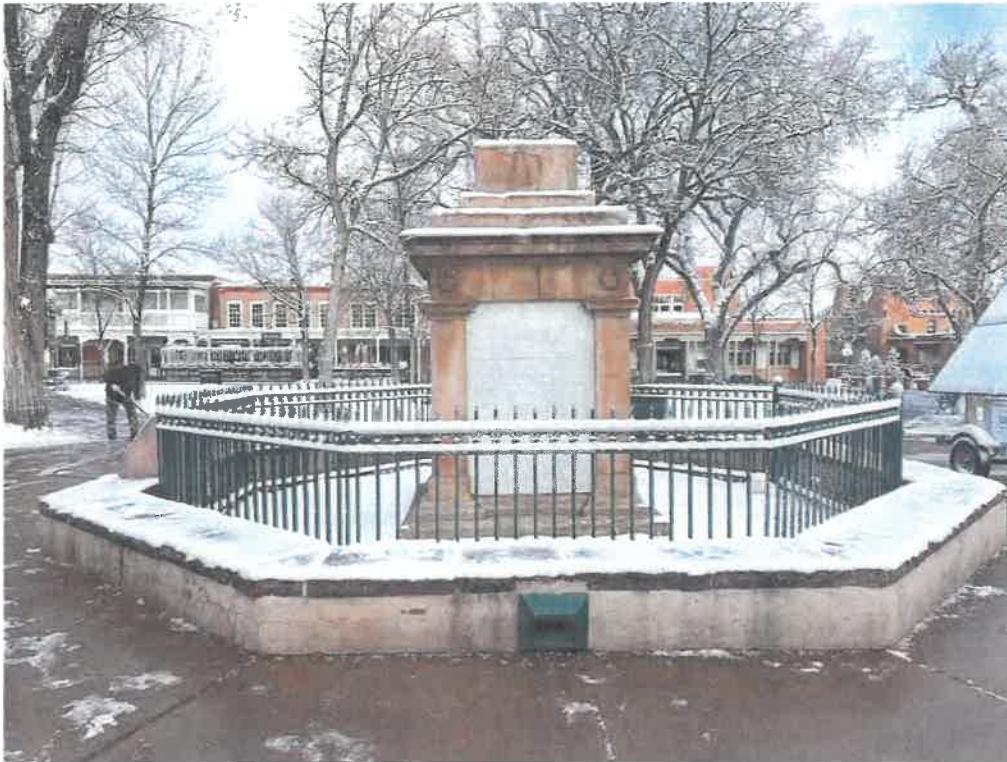
Photo 5: East elevation and picket fence. Camera facing west. March 7, 2025.

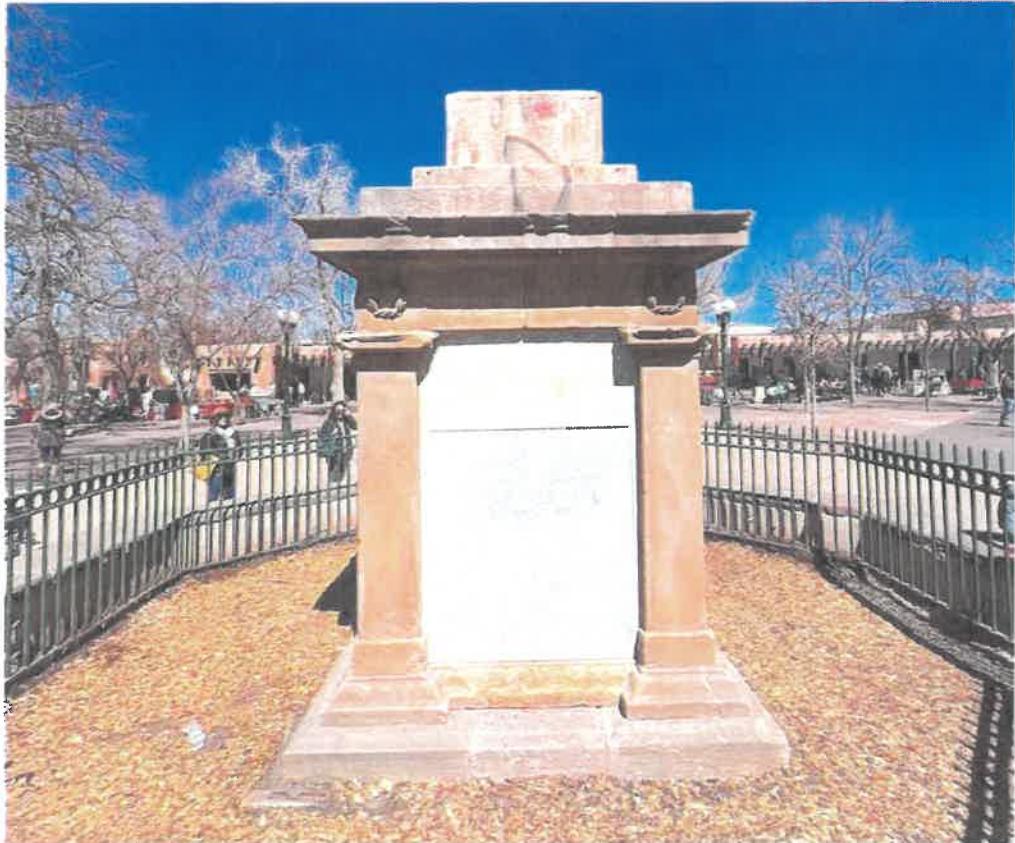
Photo 6: South elevation. Monument composition. Camera facing north. March 16, 2025.

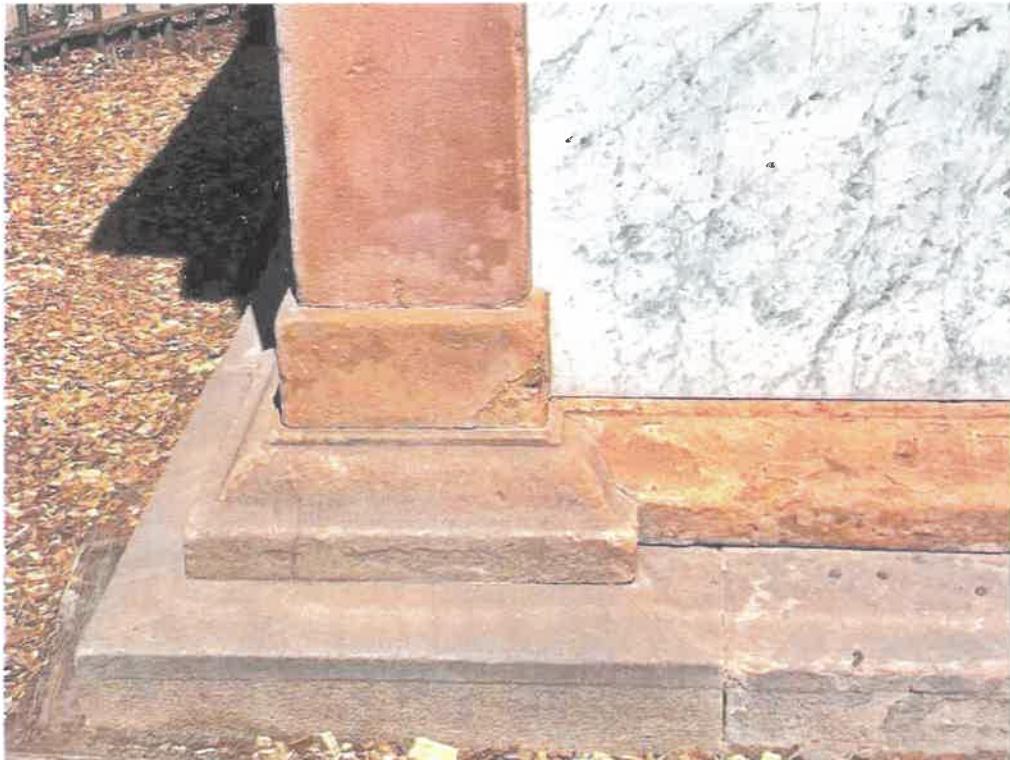
Photo 7: South elevation. Base. Camera facing down. March 16, 2025.

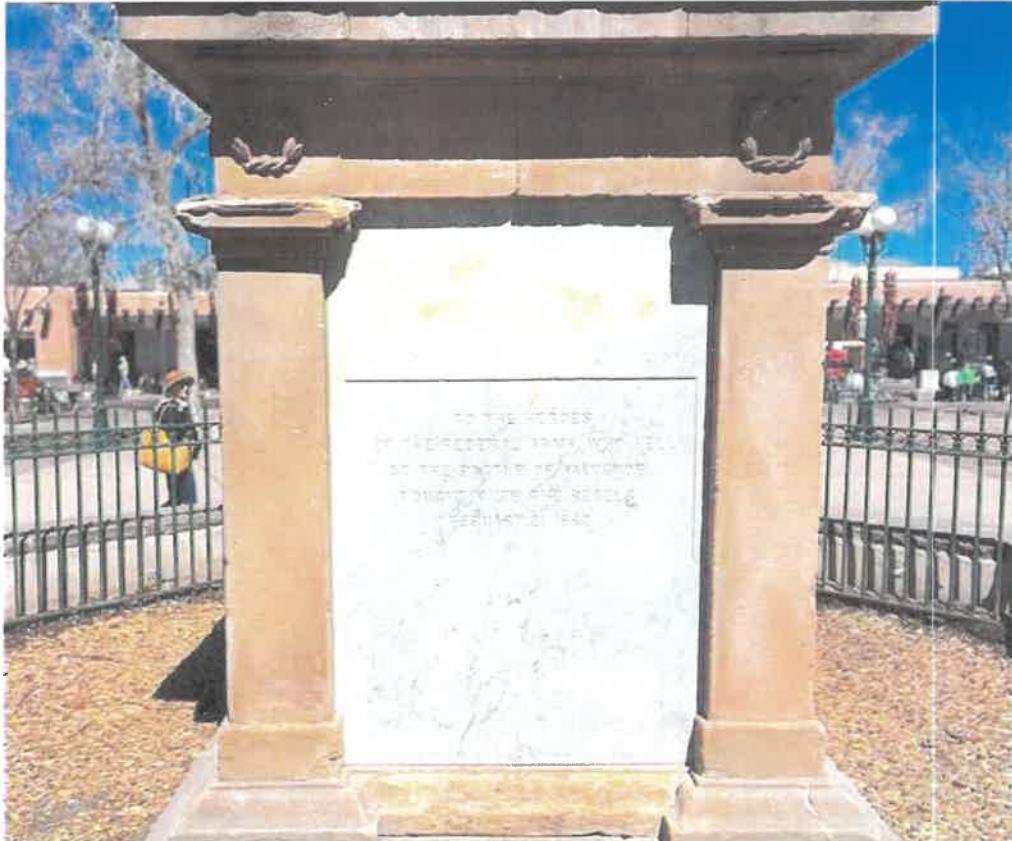
Photo 8: South elevation. Main shaft and tablet. March 16, 2025.

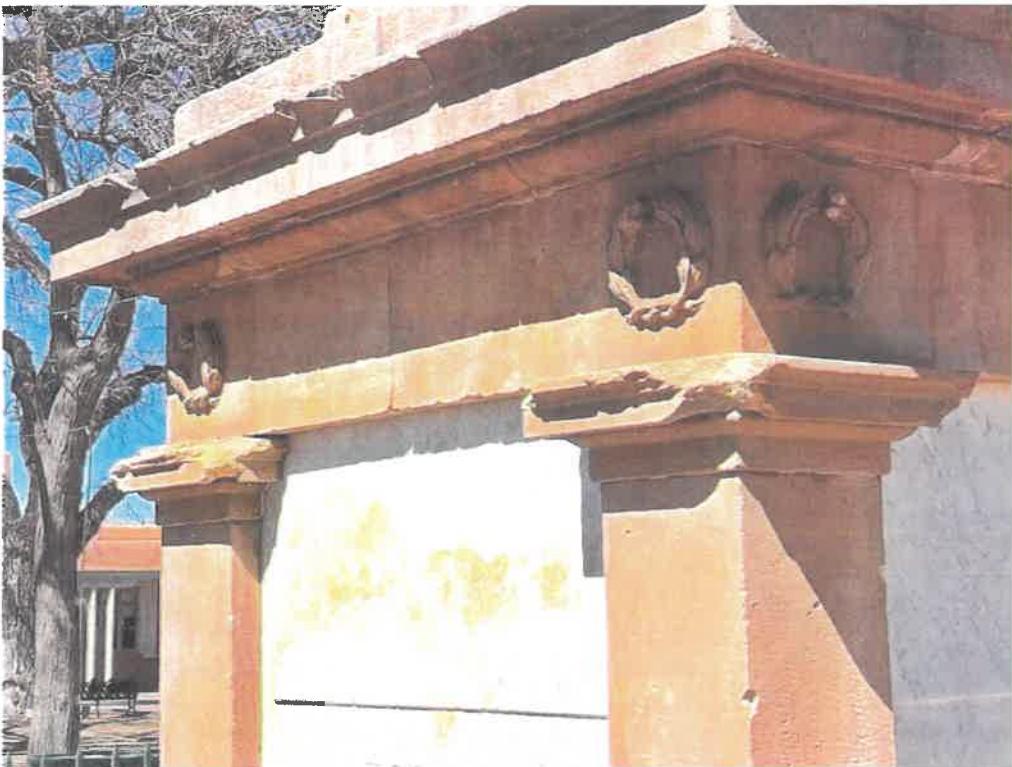
Photo 9: South elevation. Architrave. Camera facing northwest. March 16, 2025.

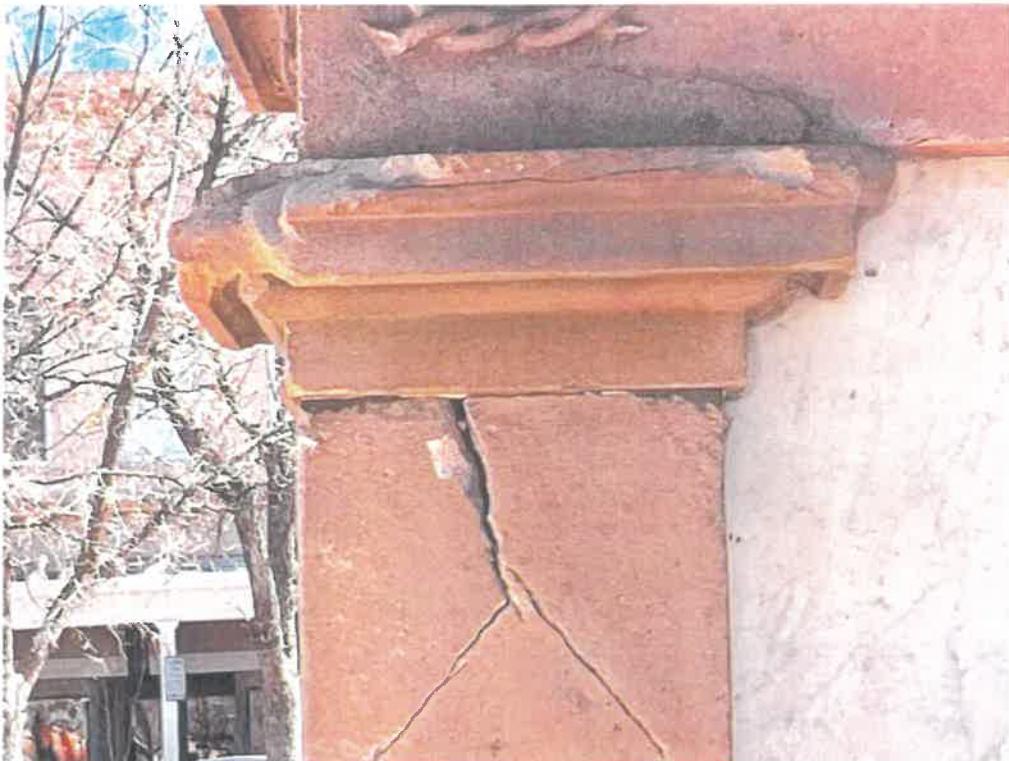
Photo 13: North elevation. Cracking of northwest pilaster. Camera facing south.
 March 16, 2025.

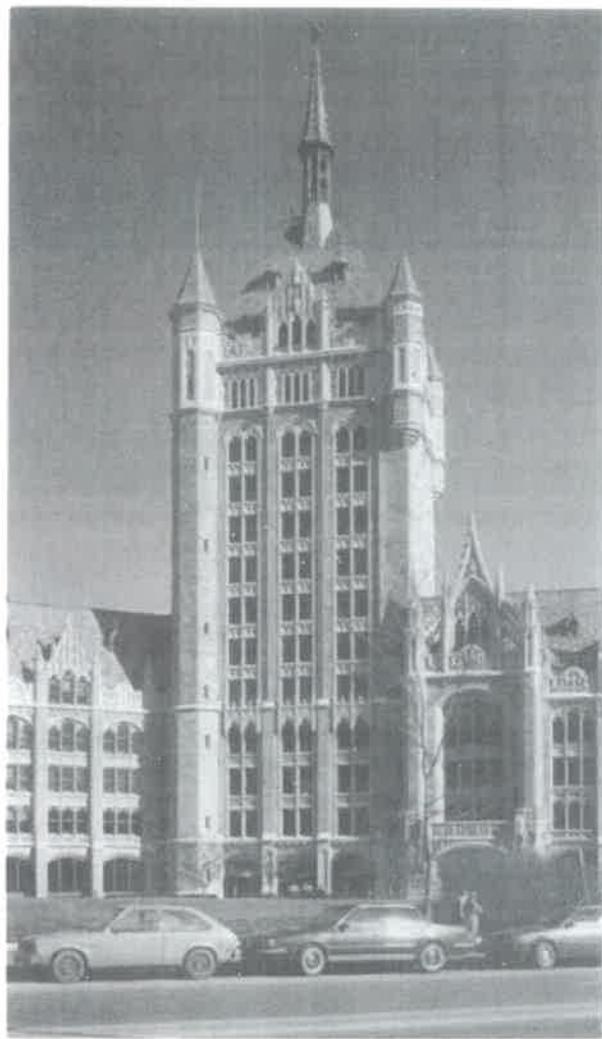
Figure 2. The prominent Delaware and Hudson Building in Albany, New York (1916) made extensive use of cast stone as trim combined with a random ashlar facing of natural granite. The elaborate gothic trim was produced by the Onondaga Litholite Company of Syracuse, New York.

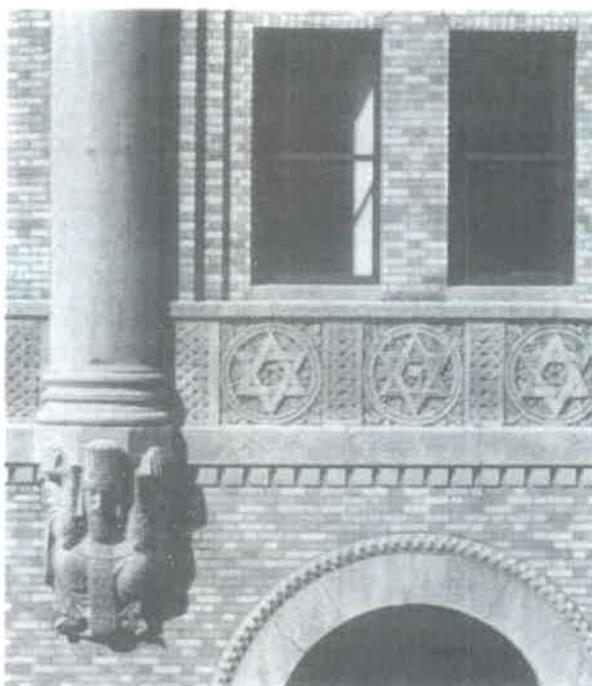
Figure 3. Sculptural ornament was frequently produced in cast stone. Repetitive detail, such as these banding course panels on the Level Club in New York City (1926), were produced much more economically than they could be in natural stone.

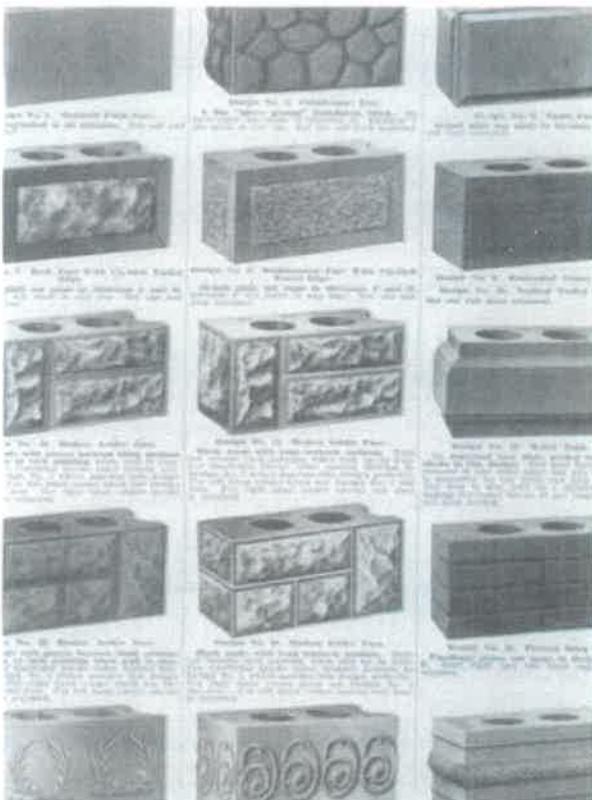
Figure 4. As shown in this Searl, Roebuck and Co. concrete machinery catalog, artistic concrete used standard concrete mixes to produce precast and cast-in-place concrete in molded forms, but made little effort to simulate natural stone.

States in the 19th century. These systems may be contrasted with "Artistic Concrete," decorative molded concrete construction, both precast and cast-in-place, which made little effort to simulate natural stone (Fig. 4).

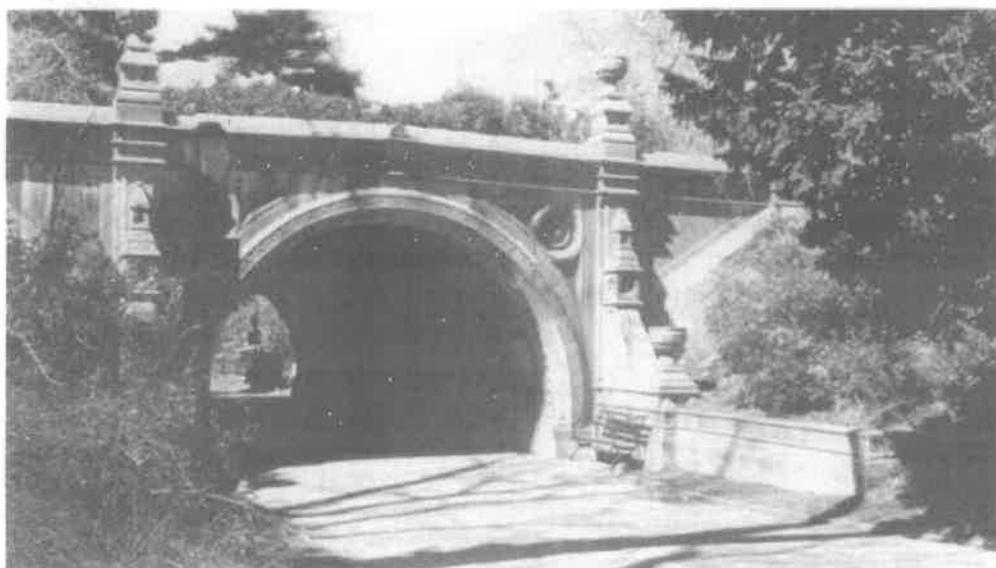
Figure 5. Constructed in 1868 of Beton Coignet, the Cleft Ridge Span in New York City's Prospect Park is one of the earliest extant cast stone structures in the United States.

the cast stone for one of the earliest extant cast stone structures in the United States, the Cleft Ridge Span in Prospect Park, Brooklyn, New York (Fig. 5).

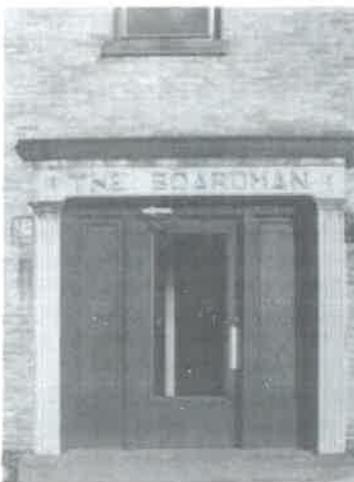
Figure 6. Cast stone was commonly used for molded trim in conjunction with brick or natural stone. This brick building in Rochester, New York, uses cast stone for the entry surround, and natural stone for unornamented window sills, thresholds, and water table units.

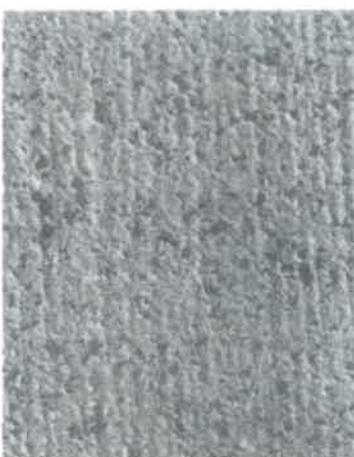
Figure 7. A combination of crushed white marble and black smelting slag was frequently used to give the appearance of a "white granite." The hammered finish on this early twentieth century cast stone would have been produced with a pneumatic chisel.

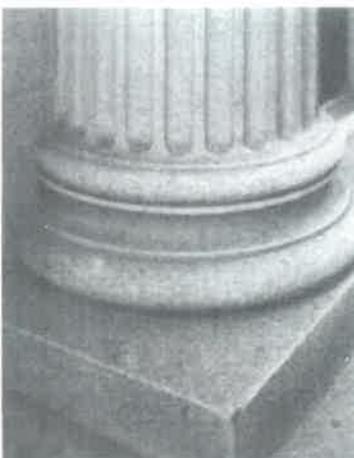
Figure 8. For this column, the appearance of a "pink granite" was simulated by using a pinkish matrix with white and black aggregate. Erosion of a tinted matrix results in a significant lightening of the cast stone surface.

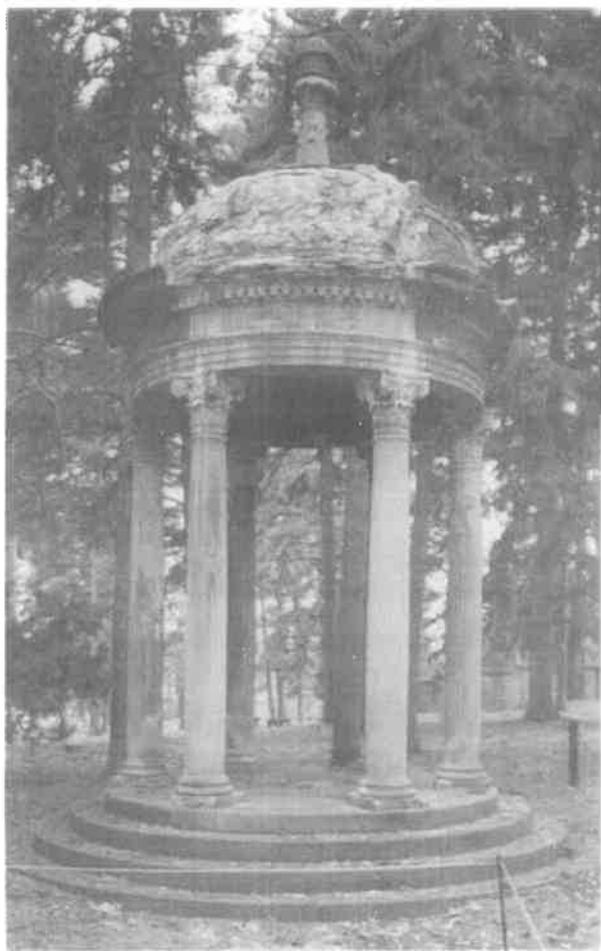
Figure 10. Scaling of cast stone units signals problems with the cementing mix and method of manufacture. Serious deterioration of cast stone, such as this, warrants replacement.

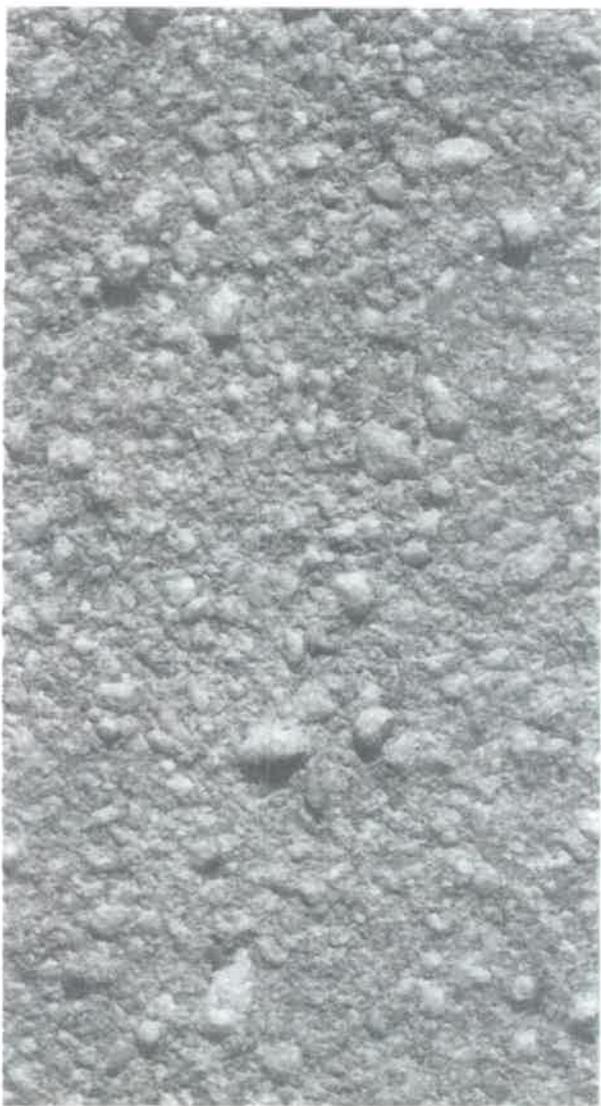
Figure 14. Sandblasting and wet grit blasting can seriously erode the surface and should not be used to clean cast stone surfaces.

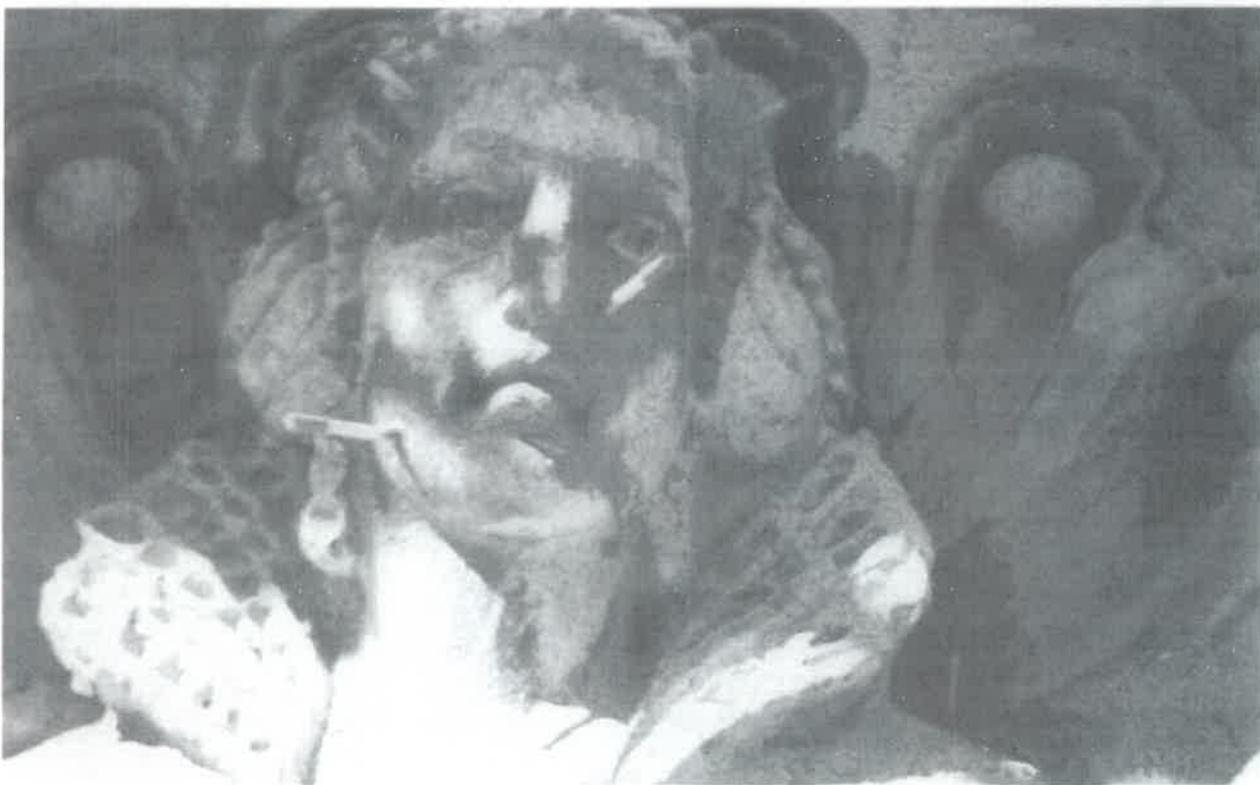
Figure 15. A delaminated layer of ornamental cast stone on the Orpheum Theater, San Francisco, California (1925), was successfully re-attached using epoxy. The multiple delivery ports for the epoxy are removed after treatment and the holes patched. Photo: David P. Wessell.

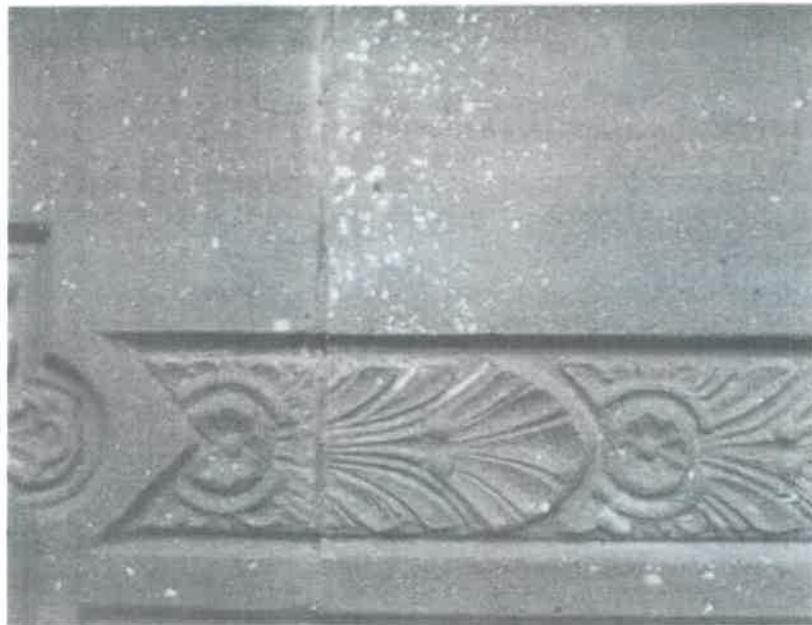
Figure 17. Unlike natural stone, cast stone generally may not be tooled in place to reduce lippage of uneven surfaces at joints. Tooling often exposes coarse aggregate from below the surface.

While re-tooling deteriorated natural stone may sometimes be appropriate, restoring the original appearance of cast stone where surface erosion has occurred is difficult or impossible. Tooling or grinding of the cast stone surface may expose coarse aggregate and will not, in any case, restore original patterned pigmentation that has weathered away (Fig. 17). Silicate paints or masonry stains may be applied in patterns to replicate the original appearance, but may not be durable or completely successful aesthetically.

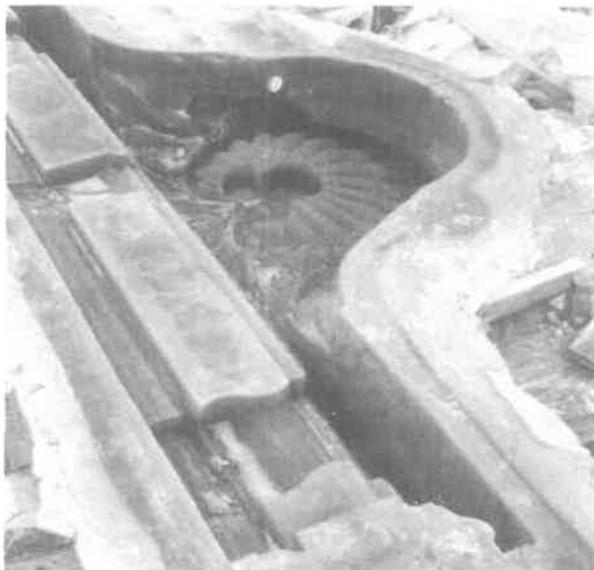
Figure 23. Production molds (left) made of durable rubbers backed with wood and plaster supports are used to fabricate new cast stone. Production molds may be made from original elements which have been repaired with epoxies and plaster, or from new plaster mockups. (below)

Surface rippling or irregularity. Production molds for fabrication are often made of rubber mold facings encased in larger "mother molds" of plaster and wood (Fig. 23). Vibration can loosen the rubber facing from the outer mold and result in rippling or irregularities on the surface of the finished casting (Fig. 24). Even when rippling is not noticeable, irregularity caused by mold movement can make it difficult to line up surfaces of adjacent units when assembling cast stone installations.

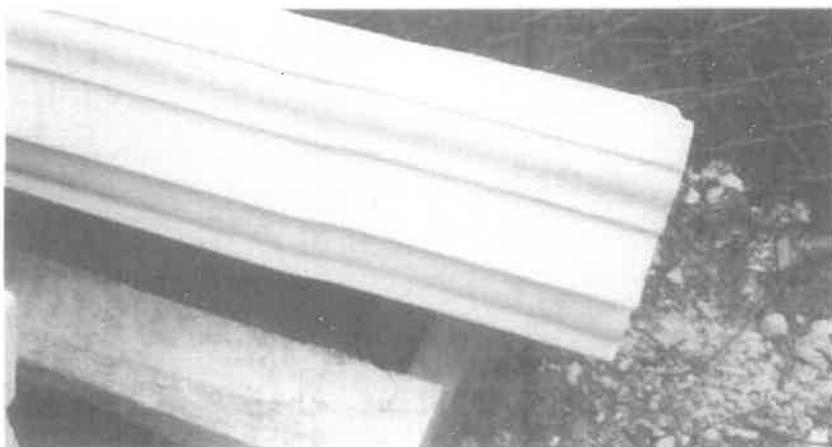
Figure 24. Separation of an interior rubber mold from a plaster master mold during casting may result in rippling or irregularity of the completed casting.

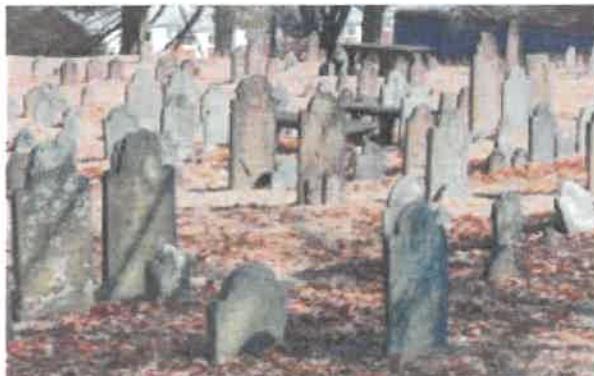
Figure 1. Sandstone and slate grave markers in the Ancient Burying Ground in New London, CT, display a variety of weathering conditions. Markers in the cemetery date from the mid-17th to the early 19th centuries. Photo: Jason Church.

While cemeteries are often considered to be perpetual, their most prominent feature—the grave markers—are not. They weather, naturally decay, often are poorly maintained and repaired and, on occasion, are vandalized (Fig. 1). Grave markers are usually noteworthy not only for their inscriptions but also for their craftsmanship. Exceptional markers are considered works of art.

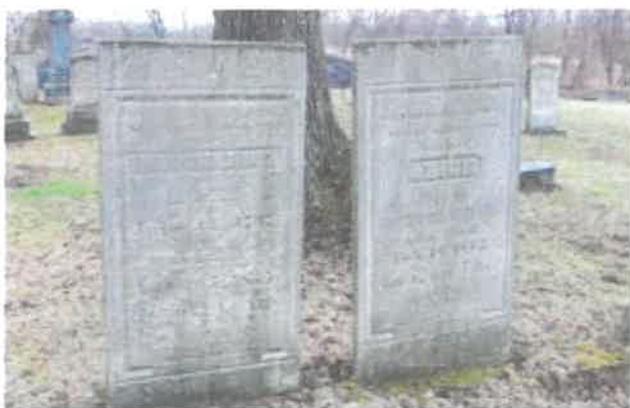
Figure 2. These mid-19th century, single-element stone grave markers in the Grove Cemetery in Bath, NY, are set in a vertical position. Photo: Jason Church.

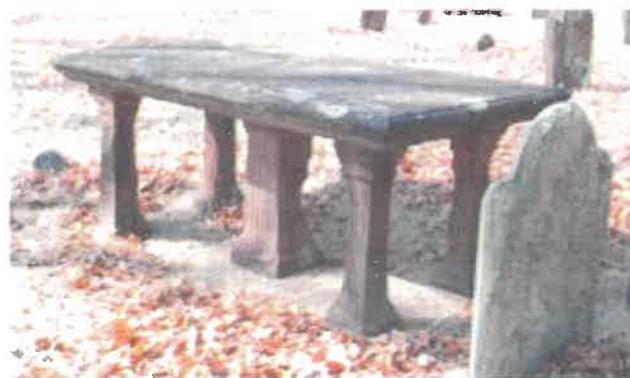
Figure 4. This sandstone table tomb, located in Cedar Grove Cemetery, New London, CT, is an engineered grave marker structure consisting of a horizontal stone tablet supported by four vertical table "legs" with and a central column. Photo: Jason Church.

Grave markers can also be engineered structures. Examples of grave marker structures include masonry arches, box tombs, table tombs, grave shelters, and mausoleums (Fig. 4). The box tomb is a rectangular structure built over the gravesite. The human remains are not located in the box itself as some believe, but

rather in the ground beneath the box structure. The table tomb is constructed of a horizontal stone tablet supported by small corner supports or columns. Grave shelters, also called grave houses, can be simple or elaborate wooden structures built over the gravesite. Mausoleums are above-ground buildings with compartments for multiple burials. Engineered structures also include hillside and underground tombs.

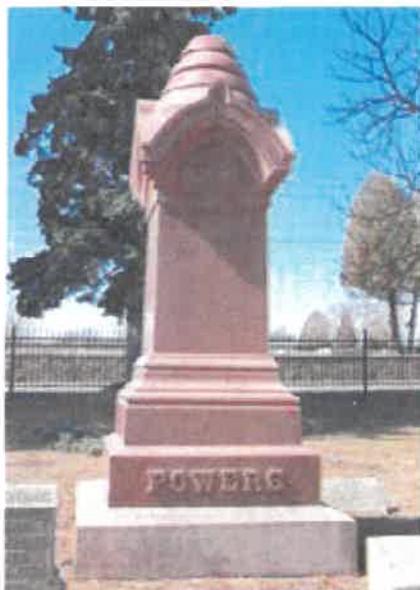
Figure 5. A variety of colors of natural stone are found in historic cemeteries, such as this pink granite marker in the Cedar Grove Cemetery, New London, CT. Photo: Jason Church.

Stone is a naturally occurring material with a wide range of properties and is available in a variety of colors (Fig. 5). Geologists classify stone according to the way in which it was formed with the three categories being igneous, sedimentary and metamorphic rock. Stone found in cemeteries is predominantly quarried, though the use of field stones is not uncommon. The mineralogy and chemical composition of stones vary. Some are composed primarily of silicate minerals; granites, sandstones, slate, and schist are examples. Other stones contain calcium carbonate with marble and limestone in this group. Mineralogy, chemical composition, and

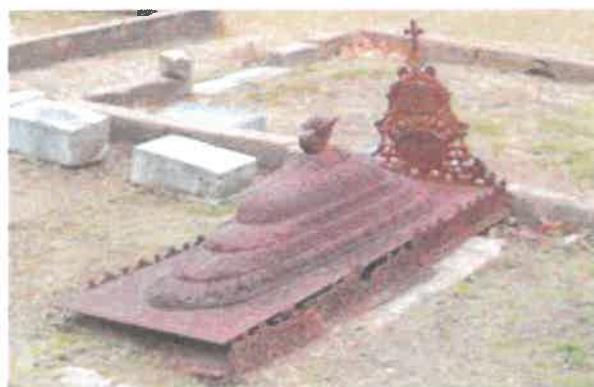
Figure 6. Decorative cast-iron grave markers like this late-19th century one in Oakland Cemetery in Shreveport, LA, are produced by heating the iron alloy and casting the liquid metal into a mold. Photo: Jason Church.

Metals are solid materials that are typically hard, malleable, fusible, ductile, and often shiny when new (Fig. 6). A metal alloy is a mixture or solid solution of two or more metals. Metals are easily worked and can be melted or fused, hammered into thin sheets, or

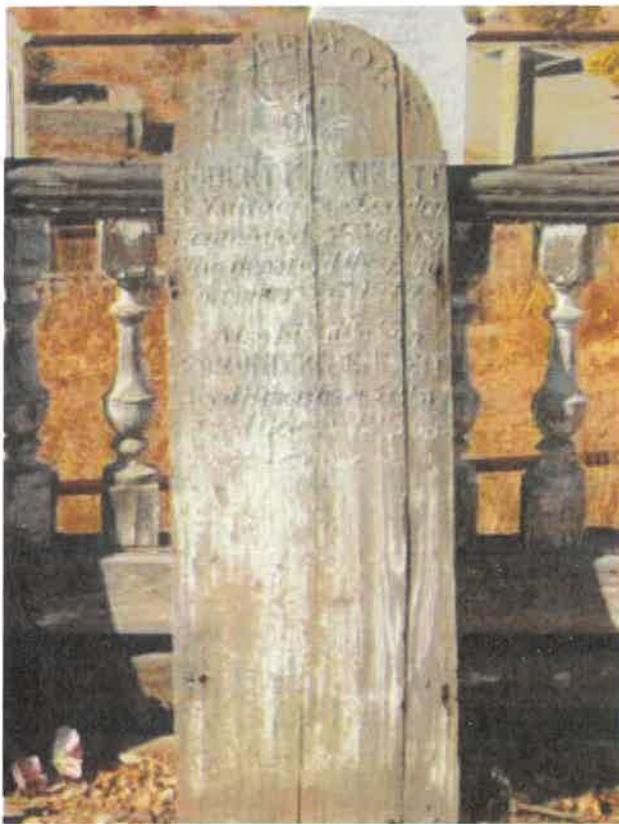
Figure 7. As shown by this 1877 marker in Silver Terrace Cemetery, Virginia City, NV, exposure to sunlight can damage wood grave markers, making the wood more susceptible to water damage and cracking. Photo: Jason Church.

and characteristics of these cells determine the wood's appearance and influence wood properties. Wood-cell walls and cavities contain moisture. Oven drying reduces the moisture content of wood. After the drying process, the wood continues to expand and contract with changes in moisture content. The loss of water from cell walls causes wood to shrink, sometimes distorting its original shape (Fig. 7).

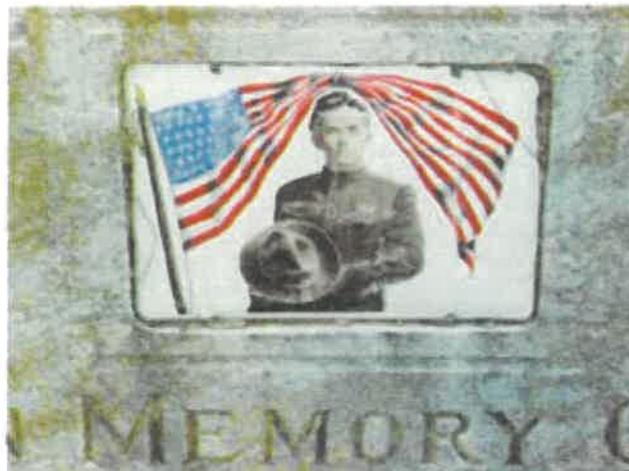
Figure 8. A fired ceramic, this cameo is set in a marble grave marker, located in Elmwood Cemetery, Memphis, TN. Different materials may require different conservation approaches. Photo: Mary Striegel.

Old cemeteries often include a wide variety of other materials not normally associated with contemporary grave markers, such as ceramics, stained glass, shells, and plastics (Fig. 8). As with masonry, metals, and wood, each has its own chemical and physical properties

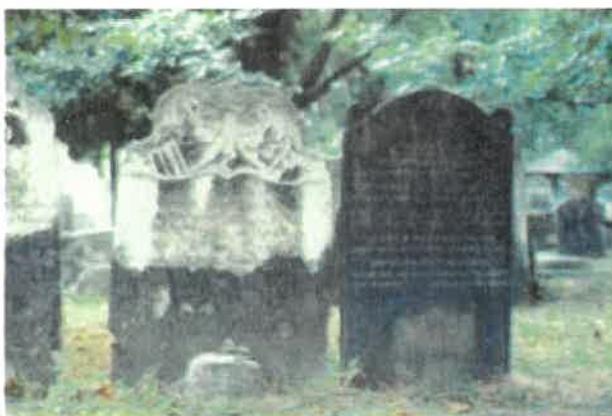
Figure 9. The limestone and sandstone grave markers in this historic cemetery have different weathering processes. On the left, the limestone shows surface loss in areas exposed to rainwater and gypsum crust formation below. The sandstone marker on the right displays uniform soiling, but surface hardening may be occurring. Photo: Fran Gale.

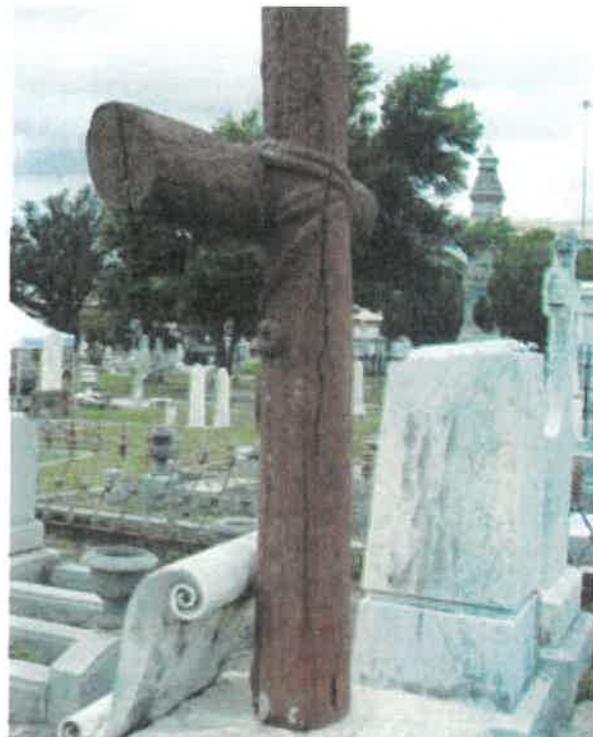
Figure 10. The sandstone cross (carved to look like wood) in this grave marker in St. Michael's Cemetery in Pensacola, FL, provides an example of inherent vice – the severe delamination affecting the sandstone has occurred along its natural bedding planes. Photo: Fran Gale.

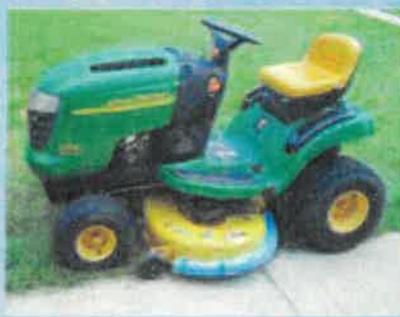
Figure B. A pool 'noodle' can be fitted to the deck of a lawnmower to prevent damage to grave markers. Photo: Debbie Dietrich Smith.

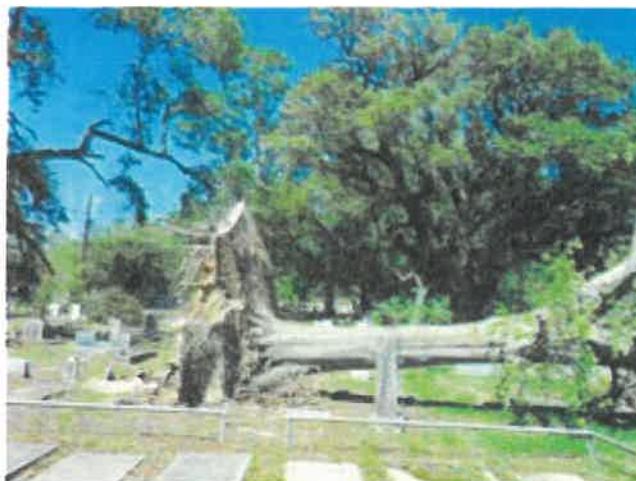
Figure 11. Woody vegetation can damage grave markers and pose a risk to visitors unless well managed and maintained. Photo: Jason Church.

Woody vegetation can damage grave markers in a variety of ways (Fig. 11). Trees, bushes, and vines can shade grave markers, extending the time that the markers are exposed to moisture. Tendrils and roots may burrow into mortar joints and openings, causing mechanical damage and large plants may lift up or shift markers. Even leaves and twigs, when allowed to collect on the ground near grave markers, can affect water drainage and evaporation (Fig. 12).

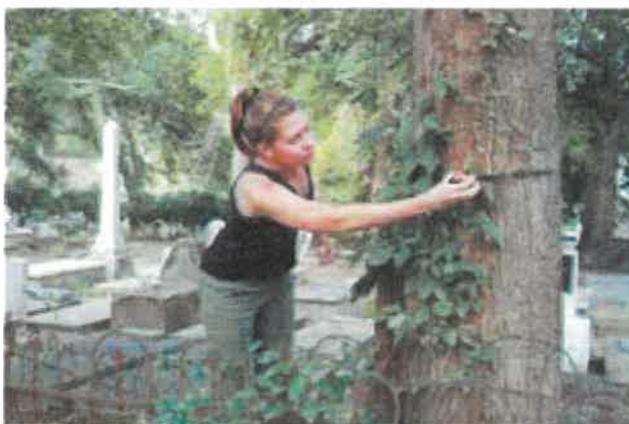
Figure 12. A cemetery professional undertakes a tree inventory in American Cemetery, Natchitoches, LA, to determine the health of trees in the cemetery. Management decisions for trimming or removal are based on the inventory. Photo: Debbie Dietrich Smith.

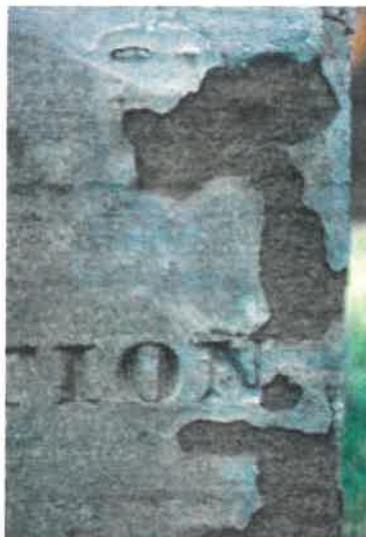
Figure 13. The impervious coating used to "protect" this sandstone grave marker trapped moisture within the stone, eventually resulting in deterioration and surface loss. Photo: Fran Gale.

Repointing masonry grave markers using Portland cement mortars that are harder than historic mortars often results in accelerated deterioration of the masonry material. Mortar should be softer than the adjacent masonry, enabling trapped moisture to migrate out, and serve as the sacrificial material when cracking occurs to relieve excessive stress. Problems also result when using impervious "protective" coatings that can trap moisture within the masonry, resulting in damage during wet/dry and freeze/thaw cycles (Fig. 13).

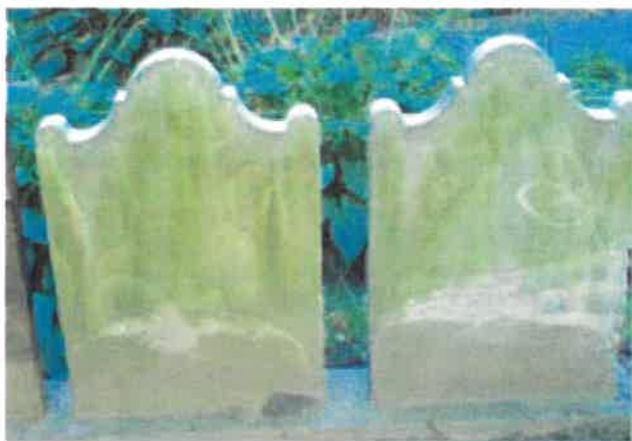
Figure 14. High-pressure water washing can damage grave markers. The photograph shows "wand marks" on the headstones produced by inappropriate pressure washing. Photo: Jason Church.
