Feasibility Study for the
Soldiers Monument at the Santa Fe Plaza - FINAL REPORT

December 5, 2025

Site and Monument Assessment

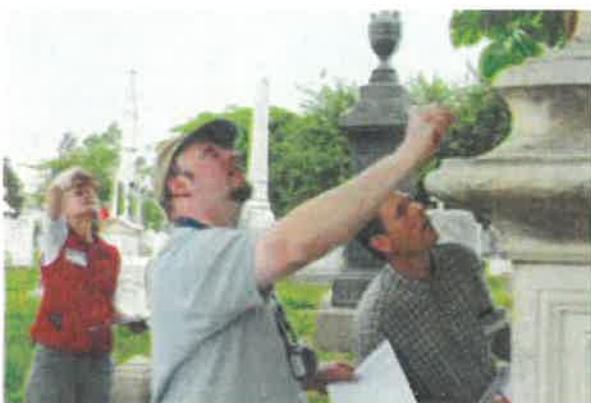
Figure 15a. Condition surveys are undertaken to document current conditions, determine safety issues, and plan both emergency stabilization and future treatment plans. There are a variety of survey forms available that can be tailored to the specific cemetery. Photo: Mary Striegel.

Depending upon the size of the cemetery and funding available, the initial assessment may be carried out by a team consisting of cemetery staff, a materials conservator, and, where necessary, an architect or structural engineer for cases involving large monuments and mausoleums (Figs. 15a and 15b). For smaller cemeteries without large monuments and mausoleums, and where funding is problematic, volunteers can be trained to prepare a condition assessment under the guidance of an experienced individual.

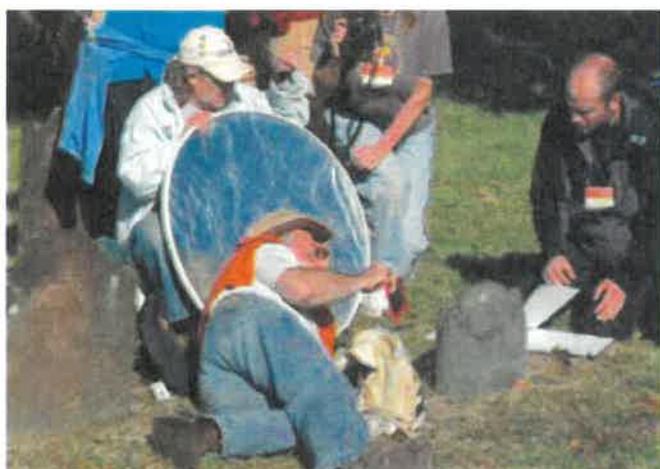
Figure 15b. Photographs are used to document the condition of the grave marker as part of a condition assessment. Photo: Fran Gale.

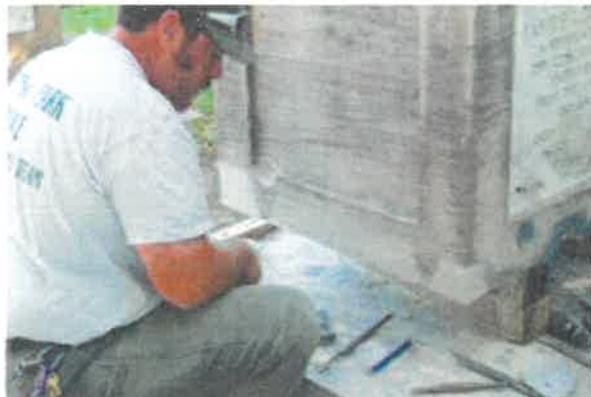
Figure 16. A professional mason works to insert a new piece of stone. Often referred to as a "dutchman", this repair technique requires replacing the deteriorated stone section with a new finished piece of the same size and material. Photo: Jason Church.

Some work is best done by specialists (Fig. 16). For example, unless there is a trained mason on staff, replacing deteriorated or missing mortar will require a skilled masonry contractor. Services of a conservator or trained cemetery specialist should be used for removing severe soiling and staining from grave markers and for carrying out adhesive repair work such as selectively replacing a piece of stone when a marker is damaged by mechanical equipment. Care should be taken to clearly define the scope of work when hiring a contractor. It is useful to reference guidelines and preservation standards, such as those provided by the Secretary of the Interior or the American Institute for Conservation, whenever possible.

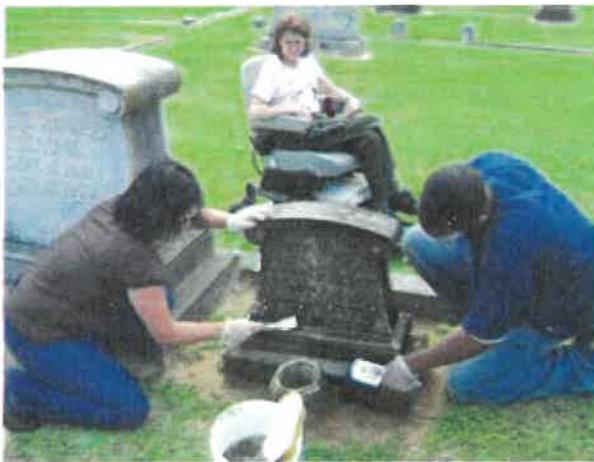
Figure 17. Volunteers can undertake cleaning of grave markers once they have received initial training. Cleaning methods may include wetting the stone, using a mild chemical cleaner, gently agitating the surface with a soft bristle brush, and thoroughly rinsing the marker with clean water. Photo: Jason Church.

Cleaning is carried out to remove soiling, staining, and contamination from grave markers (Fig. 17). Cleaning improves the visual appearance of the marker and sometimes reveals existing problems such as erosion and cracks. For various protective treatments, cleaning may be a necessary step in surface preparation.

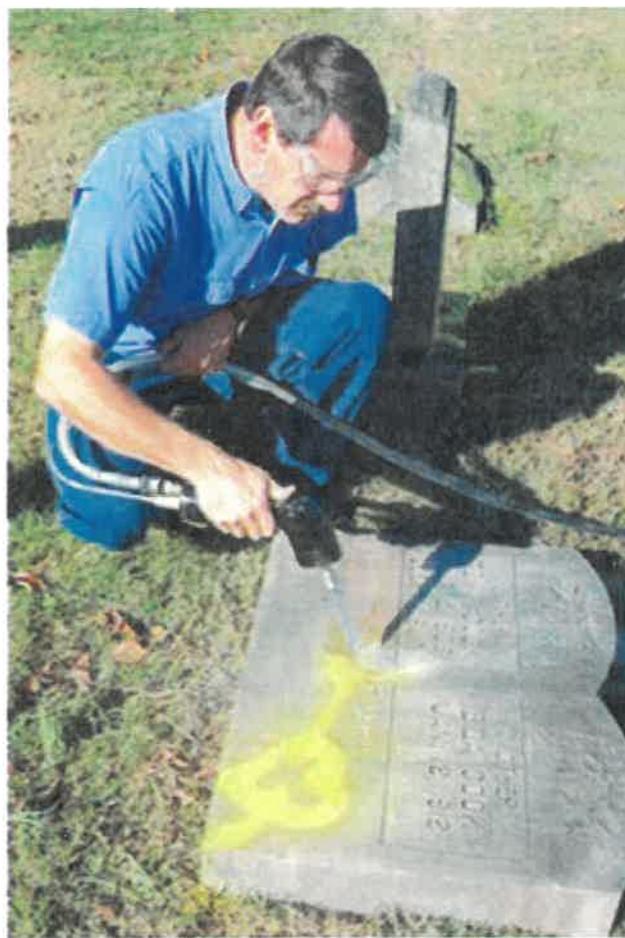
Figure 18. Graffiti is carefully removed using a low-pressure dry-ice misting instrument. Photo: Jason Church.

Markers with graffiti tend to be targets for further vandalism (Fig. 18). Timely removal helps deter future vandalism and improves the marker's appearance.

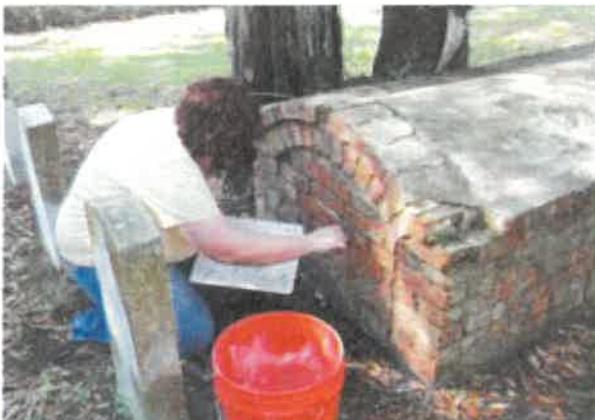
Figure 19. Masonry markers like this box tomb may require the repointing of mortar joints. It is important to use a mortar that is softer than the historic brick. In this case a conservator uses a lime putty-based mortar to repoint. Photo: Jason Church.

Missing and deteriorated mortar in old cemetery grave markers is a common condition, and the mortar should be replaced to prevent water intrusion and potential damage (Fig. 19). Several questions should be considered when selecting materials for repointing. Most importantly, what is the masonry substrate that

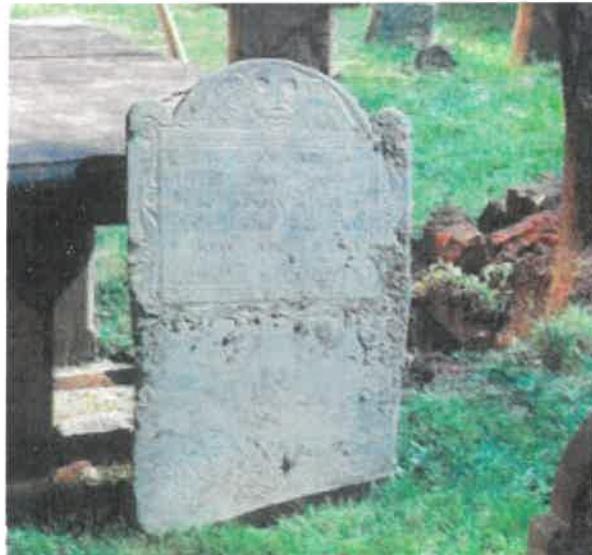
Figure 20a. This slate grave marker in the Ancient Burying Ground in Hartford, CT, is a ground-support stone. Resetting requires digging a hole that will hold the base of the stone and then compacting the soil at the bottom of the hole by hand. Photo: Fran Gale.

Resetting is recommended for grave markers when their foundations are unstable or out of plumb (Figs. 20a through 20c). This often complex activity involves lifting the grave marker, leveling its foundation, and returning the marker to its original upright position. Workers can be injured and the grave marker damaged if resetting is not carried out properly and safely.

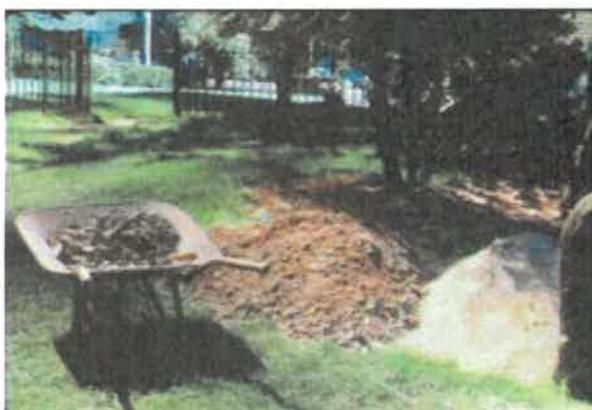
Figure 20b. To facilitate drainage, crushed stone, gravel, and sharp sand line the hole and are hand-tamped around the stone after placement. Photo: Fran Gale.

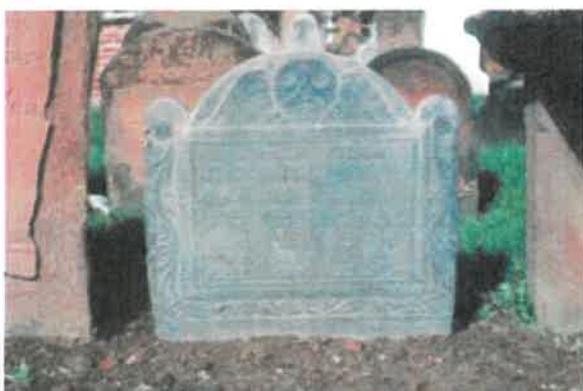
Figure 20c. The reset ground-supported grave marker should be level and plumb. Photo: Fran Gale.

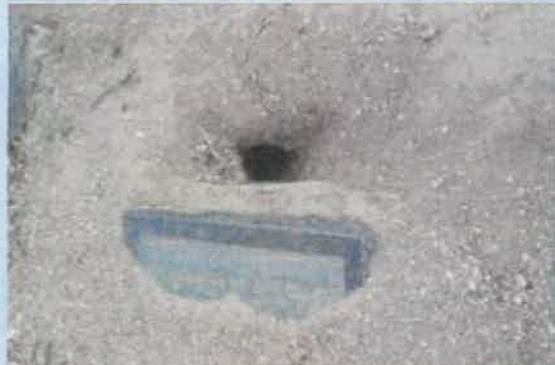
Figure C. Gophers and other burrowing animals produce uneven ground and holes that are trip and falling hazards to visitors and staff of historic cemeteries. Photo: Jason Church.

Trip and falling hazards include uneven ground, holes, open graves, toppled grave markers, fallen tree limbs, and other debris (Fig. C). Sitting, climbing, or standing on a grave marker should be avoided since the additional weight may cause

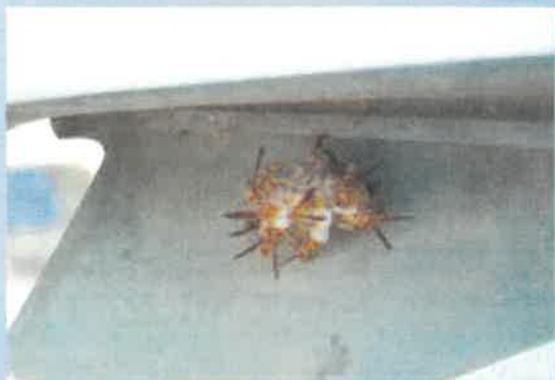
Figure D. Yellow jackets that are nesting below the projecting molding of this grave marker pose a hazard to visitors and staff because, if disturbed, they will vigorously defend their nest. Yellow jacket, paper wasp and hornet nests should be removed from grave markers by trained staff or specialists. Photo: Jason Church.

Snakes, wasps, and burrowing animals inhabit historic cemeteries (Fig. D). Snakes sun on warm stones and hide in holes and ledges, so it is important to be able to identify local venomous snakes. An appropriate venomous snake management plan should be in place, and

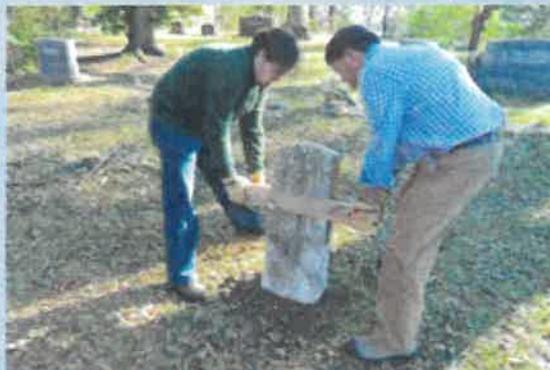
Figure E1. The simple wooden clamp system allows two people to safely lift a marble grave marker. Photo: Sarah Jackson.

lifting techniques. Lift equipment and ergonomically correct tools should be routinely used to lift heavy markers (for most people this includes markers that weight more than 50 pounds). For smaller grave markers, a simple wooden clamp system can be constructed for a two-person lift (Figs. E1 and E2).

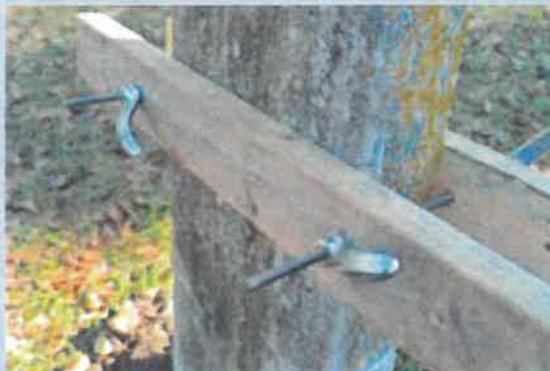
Figure E2. The clamp system is constructed from off-the-shelf wooden boards. Photo: Sarah Jackson.

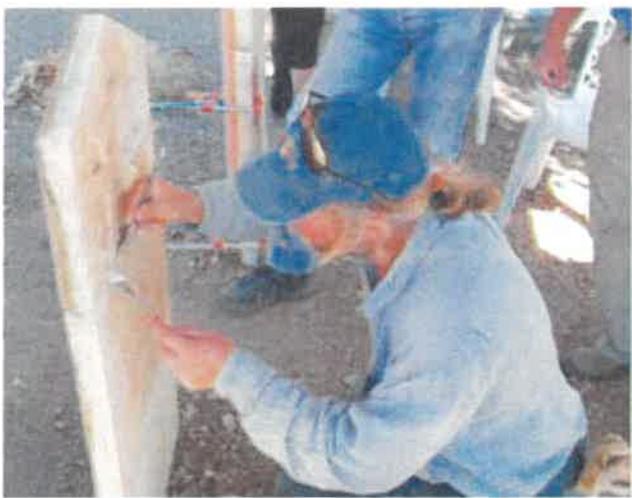
Figure 21. Cracks in a stone marker should be filled to keep water and debris out and prevent the crack from becoming larger. A patching mortar is designed to be used, in this case, with historic marble. Photo: Mary Striegel.

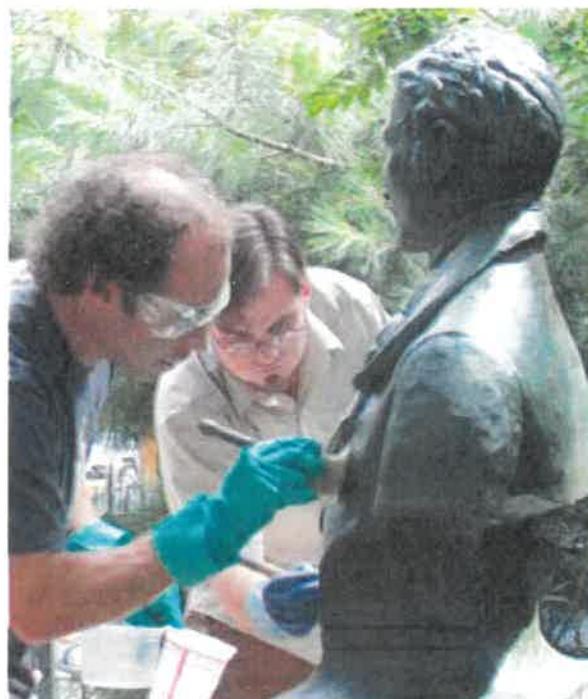
Figure 22. A protective coating must be maintained on metal elements. Wax or lacquer coatings help preserve the bronze patina and slow corrosion. Conservators apply a microcrystalline wax to this bust at St. Mark's Church in-the-Bowery, New York, NY.
Photo: John Scott.

Wax coatings are often used for bronze markers (Fig. 22). Wax provides a protective barrier against moisture, soiling, and graffiti. There are several steps in the wax application process. Where there is little corrosion, gentle cleaning of the marker is undertaken prior to applying the wax coating. Apply a thin layer of wax to the marker using a stencil brush or chip brush.

Mineral spirits can be added to the wax to facilitate brush application. A soft, clean cloth is used to remove excess wax and buff the surface. A second coat of wax is sometimes needed.

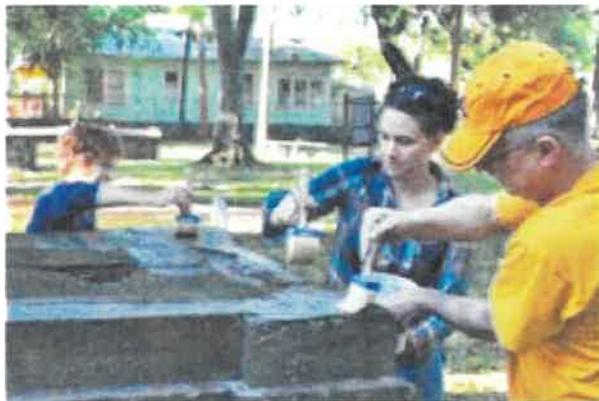
Figure 23. Limewash is a breathable coating sometimes used to protect the surface of the grave marker and provide a decorative finish. Limewash is applied by brush in five to eight thin coats (with each coat about the consistency of skim milk). The surface is allowed to slowly dry between coats. Sometimes the surface is covered by damp burlap to slow the drying process. Photo: Sarah Jackson.

Limewash is a traditional coating that brightens stucco-covered grave markers (Fig. 23). Like paint coatings, it needs to be periodically applied. Limewash is prepared with lime putty or hydrated lime and water. Curing begins following application. The lime putty or hydrated lime reacts with carbon dioxide in the air in a process called carbonation. This reaction eventually forms calcium carbonate, a stable hard coating. Limewash is a "green" coating with no volatile organic compound content and is "breathable," i.e., it allows for water vapor transmission. Although commonly white, limewash can be colored or tinted with alkali-stable pigments such as iron oxide.

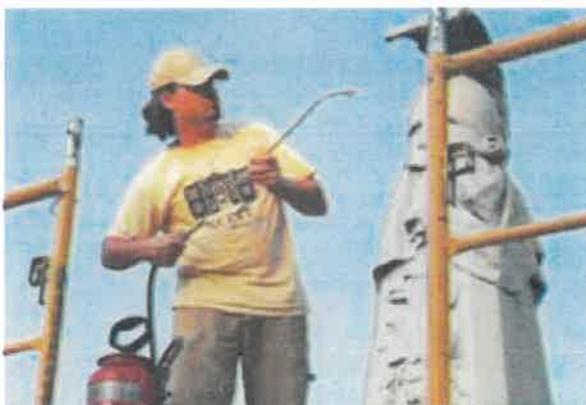
Figure 24. A severely deteriorating monument or grave marker can be treated with a stone consolidant. The treatment is usually applied using a spray system. The consolidant soaks into the stone and replaces mineral binders that hold the stone together. On-site and laboratory testing and evaluation are performed prior to using this non-reversible type of treatment. Photo: Lucas Flickinger.

When erosion is severe, consolidation treatments (e.g., ethyl silicate) have been used to replace mineral binders lost to weathering (Fig. 24). Because these treatments are not reversible, laboratory and on-site testing are essential. Application by a conservator or other experienced preservation professional is advised.
