Redevelopment and Operations Planning for the Midtown Performing Arts Center

Prepared for the
City of Santa Fe

January,
2026

Existing Conditions Assessment

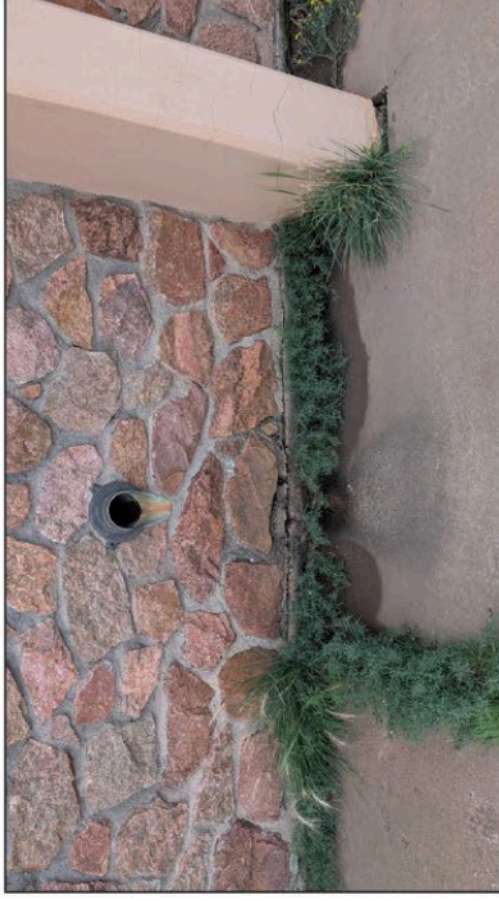
1) Roof Water Infiltration into Building Foundation

- There are missing splash blocks to direct water away from the building.
- There appears to be settling of the concrete slab under the roof drain outlet due to water infiltration against the building.
- It is recommended to direct roof drain outlets away from the building foundations to prevent damage to building foundations and exterior slabs.
- Concrete paving and sidewalks should be repaired / replaced as needed and planned in conjunction with other facility improvements.

- **Roofs/Roof Structure**
 - Add emergency overflow drains to the existing roof drains, and repair the existing roof drain pipes that are leaking.
 - Extend existing roof drains underground, and slope downhill to existing site landscaping areas.
 - Add-on option for a maximum 978 kwh/ day solar array added to roof areas shown on phase 1 plans. This number represents a maximum based only on square footage. further analysis will need to be conducted to determine solar array size, locations, and output.
 - Conduct a structural assessment of the existing roof structure and make any upgrades needed to support the weight of the optional solar array.
- **Site**
 - Inspect and repair any concrete sidewalks, steps, and ramps on site. Replace settled slabs due to roof water runoff.
 - Perform maintenance on existing site landscaping.

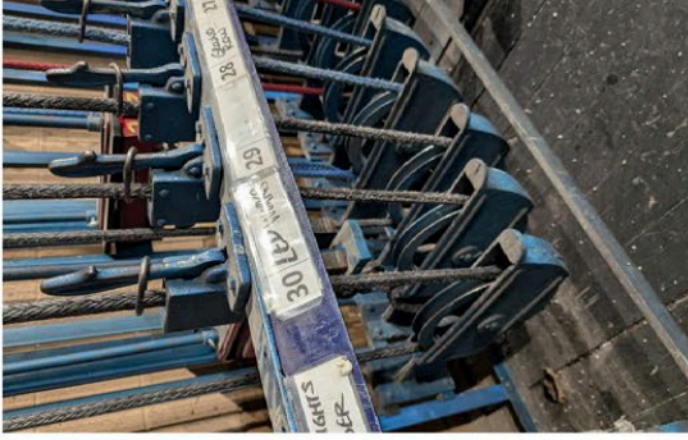
- The rigging system consists of a straight lift fire safety curtain, lattice track guided, counterweight line set located stage right.
- There are thirty one (31) single purchase, T-track guided, counterweight line sets.
- A loading gallery and a grid.
- There was a safety inspection report provided by Sapsis Rigging Inc. in 2016 that outlined existing conditions and issues/ items to be addressed.
- The fire curtain is paint encapsulated asbestos.
- Code states that the fire curtain be tested at least once every 30 performances, or but not less than once every 3 months.

- It is unknown when the last rigging inspection was conducted for the facility.
- A professional rigging inspection should be conducted on an annual basis. These inspections should be part of a larger well-documented ongoing maintenance program for all performance areas.
- It is unknown if any of the problems in the 2016 safety inspection report were addressed.
- There is no current fully documented maintenance plan in effect.
- It is recommended that there be an updated safety inspection report to address any new issues that may have arose since the 2016 report.
