# Road Safety Assessment Report

***Intersection of IL 32 and Bruce-Findlay/800  
North Road  
Moultrie County, Illinois***

Prepared by: IDOT Bureau of Safety Programs and Engineering  
12/19/2019

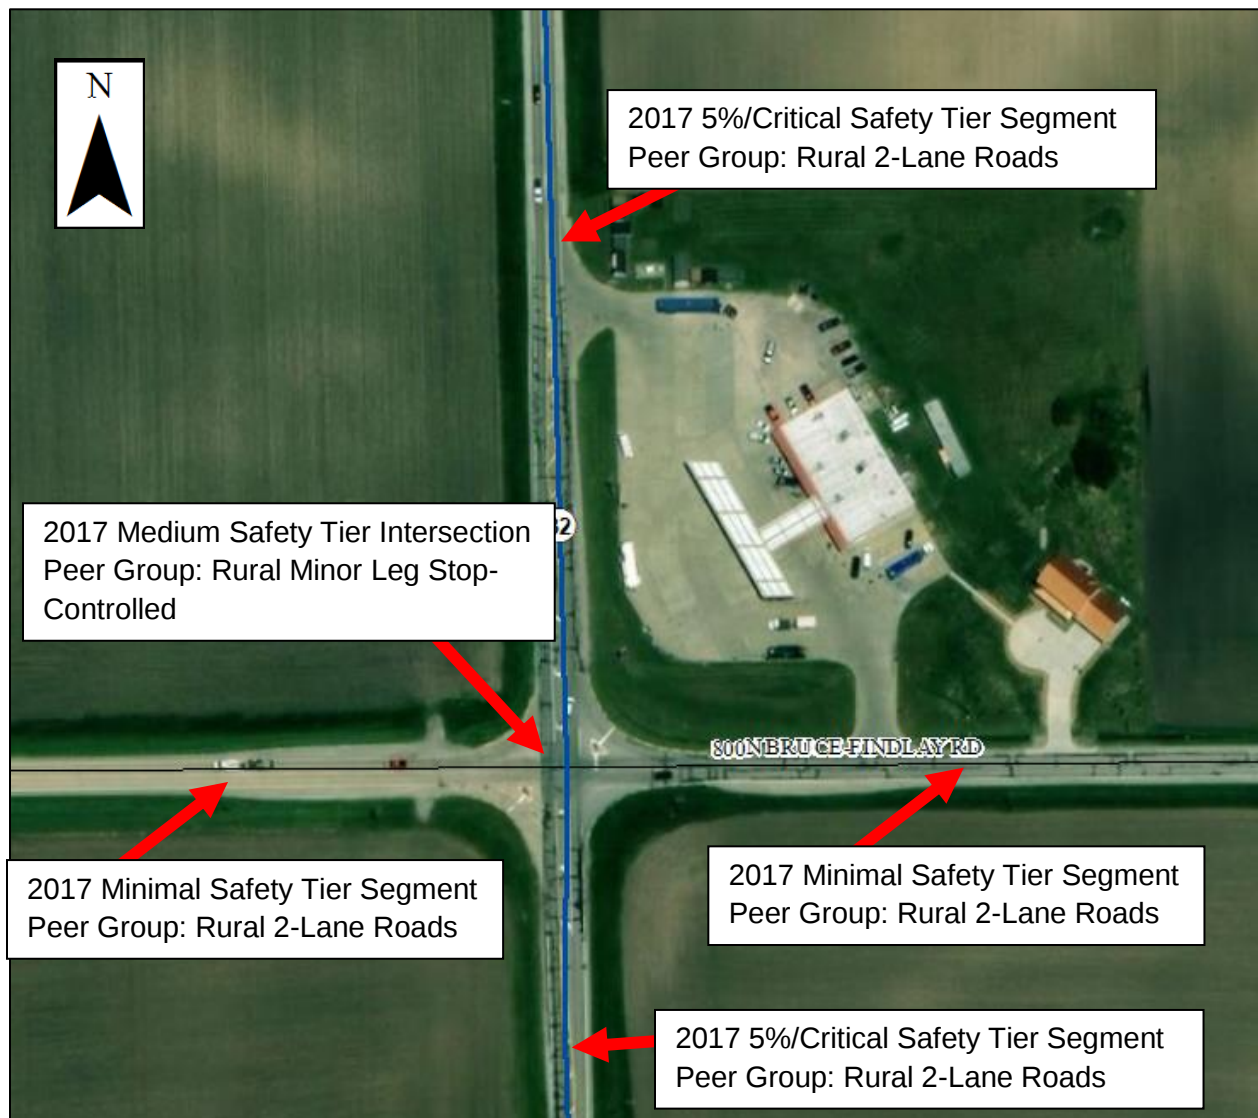
*Figure 4 - RSA LOCATION IN MOULTRIE COUNTY*

The intersection of IL 32 and Bruce-Findlay/800 North Road, as shown in Figure 4, is located just south of Sullivan, Illinois and to the east of Shelbyville Lake. Dedicated left turn lanes are present on the north and southbound approaches on IL 32. Right turn lanes are present on the west and east approaches on Bruce-Findlay/800 North Road. The minor approaches of Bruce-Findlay/800 North Road are stop-controlled while IL 32 is free flow with no stop control.

The RSA team discussed alternative intersection control types to the existing configuration (Figure 4). An Intersection Conflict Warning System (ICWS) was discussed. An ICWS reduces right angle crashes at rural intersection as its primary goal of the system and consists of three parts: static signing, detection, and dynamic elements. However, it was not recommended for this intersection as recent research indicates they are not effective (A study of the [Rural Intersection Conflict Warning System, MnDOT, 09/13/2019](#)). The RSA team discussed signalizing the intersection as an alternative solution but determined that federal warrants for traffic signals contained in the Manual on Uniform Traffic Control Devices (MUTCD) were not met. Therefore, this alternative was not recommended. Due to most of the crash types being angle and turning as well as looking at traffic volumes for all approaches of the intersection, the RSA team recommended two alternative intersection control designs, 4-way stop control and a roundabout design. Figure 13 shows an example of a roundabout design which can be found here: <https://safety.fhwa.dot.gov/intersection/innovative/roundabouts/>

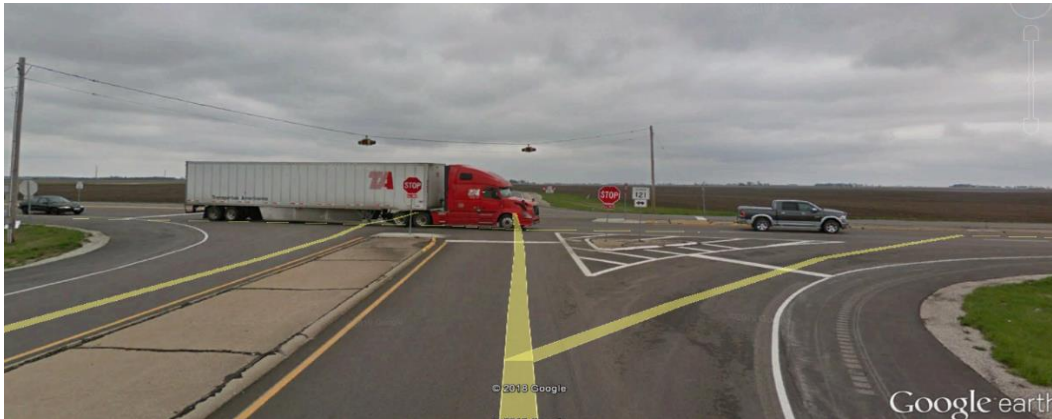
*Figure 14 - NORTHBOUND IL 128 AT FOUR-WAY STOP-CONTROLLED INTERSECTION WITH IL 121, NORTHWEST OF RSA LOCATION*

The other recommended alternative intersection design is converting the intersection into a four-way stop-controlled intersection. As noted later under Education, the RSA team noticed a pattern in the crash reports where drivers on Bruce-Findlay/800 North Road stopped but continued into the intersection believing cross traffic on IL 32 were required to stop as well. Only twenty miles northwest of the intersection, is a four-way stop-controlled intersection at IL 121 and IL 128 with only one minor injury crash and zero fatalities in the past five years. The northbound approach is shown below in Figure 14.

| Intermediate: | 4-way stop control |

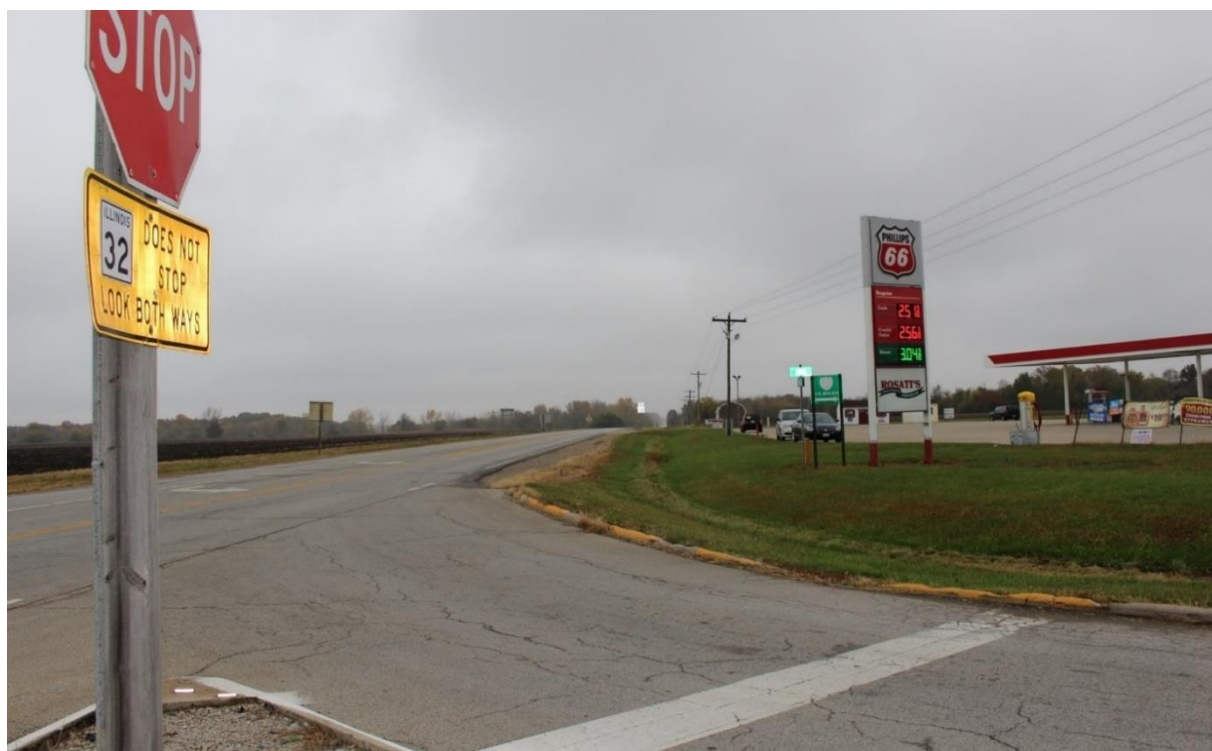
*Figure 15 - ON EAST LEG LOOKING NORTHBOUND FROM RIGHT TURN LANE*

As noted later in Pavement Markings, the RSA team observed that the right turn lane on both east and west approaches had a steep right turn angle approach causing motorist to have to excessively turn their heads to see if oncoming traffic is approaching. To improve the line of sight for the motorist, the RSA team recommends a re-design of the right turn lanes. Figure 15 illustrates the existing traditional right turn design. Figure 16 provides depictions of the existing design along with two modified designs to improve the line of sight angle

| Intermediate: | Redesign of the right turn lanes |

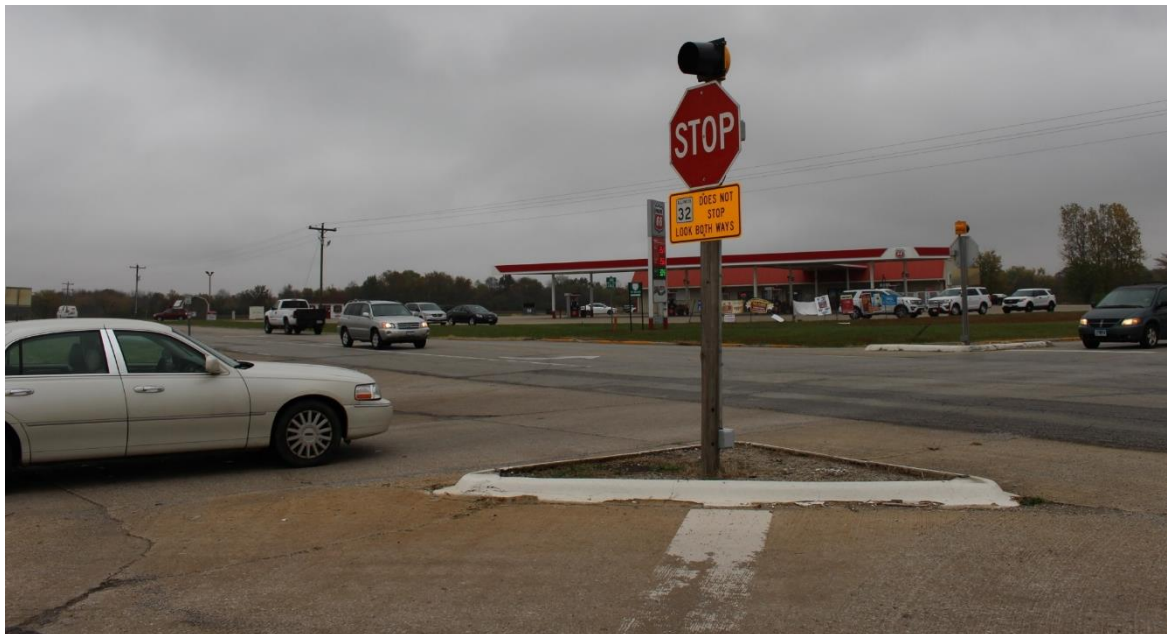
**Figure 19 - EXAMPLE OF DETERIORATING PAVEMENT MARKINGS AND NO STOP BAR PRESENT**

During the field visit the RSA team observed the pavement markings to be deteriorating or not visible as shown in Figure 19. On the West side of the intersection the pavement stop bar is not present for through traffic. The RSA team also noticed that the transverse rumble strips in the westbound lane on Bruce-Findlay 800 North Road approaching the intersection were worn and not as effective to warn the drivers of the intersection. Figure 20 illustrates what is remaining of the transverse rumble strips.

| Short-Term: | Add stop bar on west approach, add stop ahead pavement marking, stop marking at stop bar, square up right turn markings on east/west, re-cut transverse rumble strips |

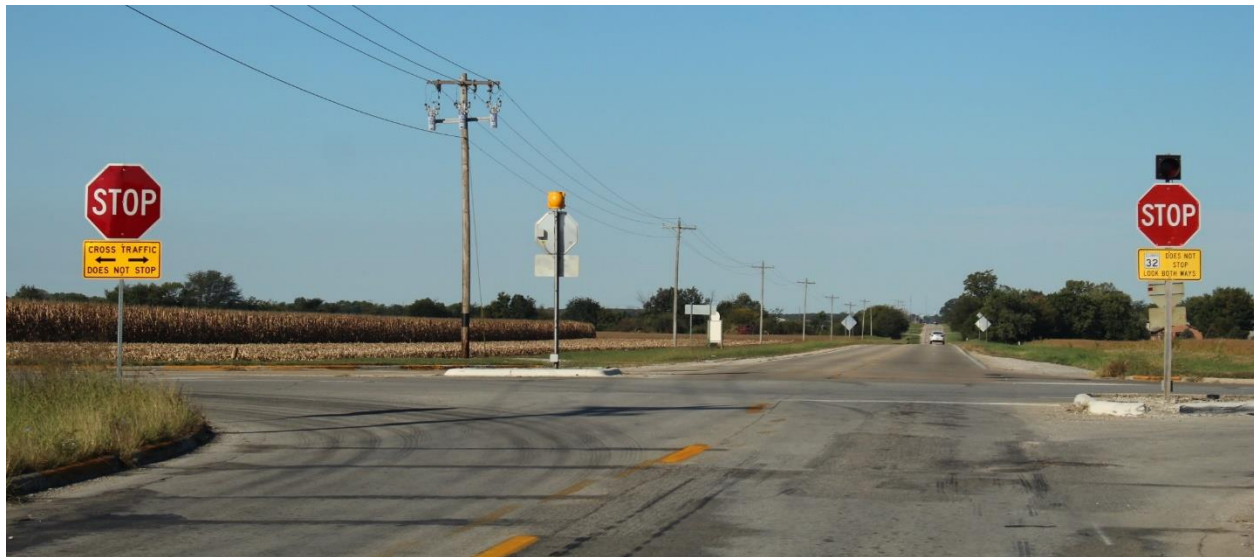
*Figure 21 - SIGNAGE ON BRUCE ROAD LOOKING WESTBOUND*

During the field visit, the RSA team observed several low-cost improvements already implemented by the owner such as: doubled up stop signs, advance warning signs, and “cross traffic does not stop” plaques below stop signs. There were some minor changes that the RSA team recommends supplementing the current signage in place. The stop sign assemblies are not consistent as the driver approaches the intersection as shown in Figure 21. The advance warning signs in Figure 22 are great countermeasures to alert drivers that they are approaching a stop-controlled intersection.

| Intermediate: | Remove blinking LED stop signs and install standard red flashing beacons on stop signs |

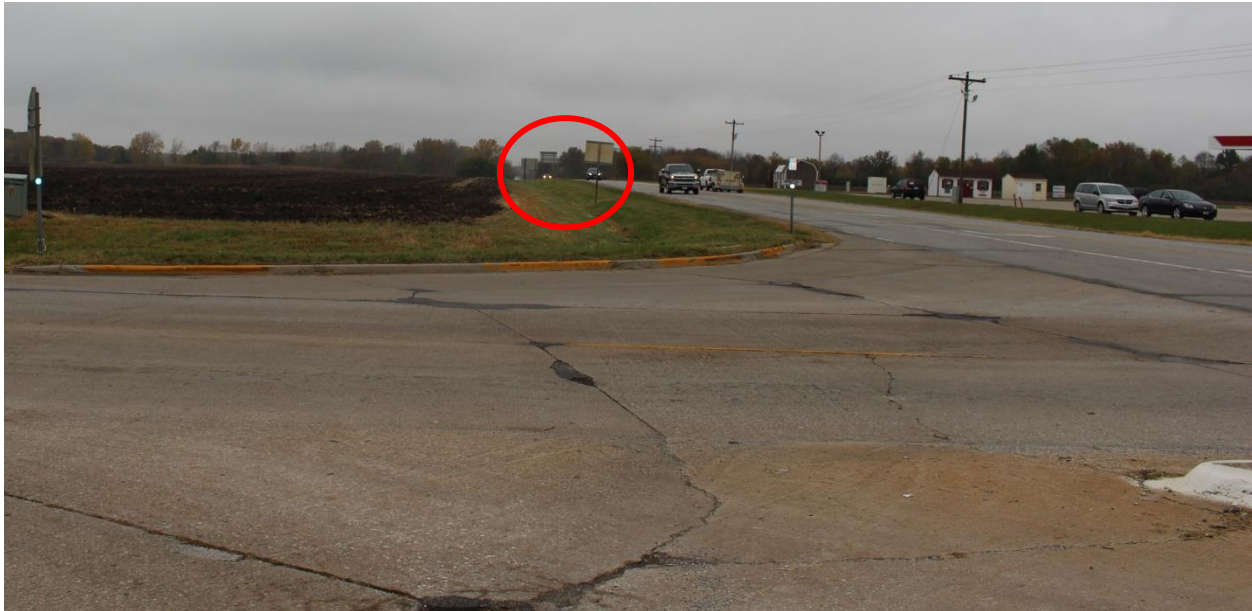
*Figure 23 - LOOKING NORTH AT GUIDE SIGNS FROM FINDLAY ROAD AND IL 32, ON FINDLAY/ 800 NORTH ROAD*

The RSA team looked at the guide signs on IL 32 to see if they would be obstructing sight distance for vehicles stopping on Bruce-Findlay North Road looking north. As shown in Figure 23 the guide signs do not appear to create a visibility issue, but some minor recommendations were provided to enhance the visibility of oncoming traffic.
