Historical Architectural Review Board

HBDO Preliminary Review Sheet

Address: 949-59 Hamilton Street

Proposal: Complete demolition of existing buildings; construct five-story hotel

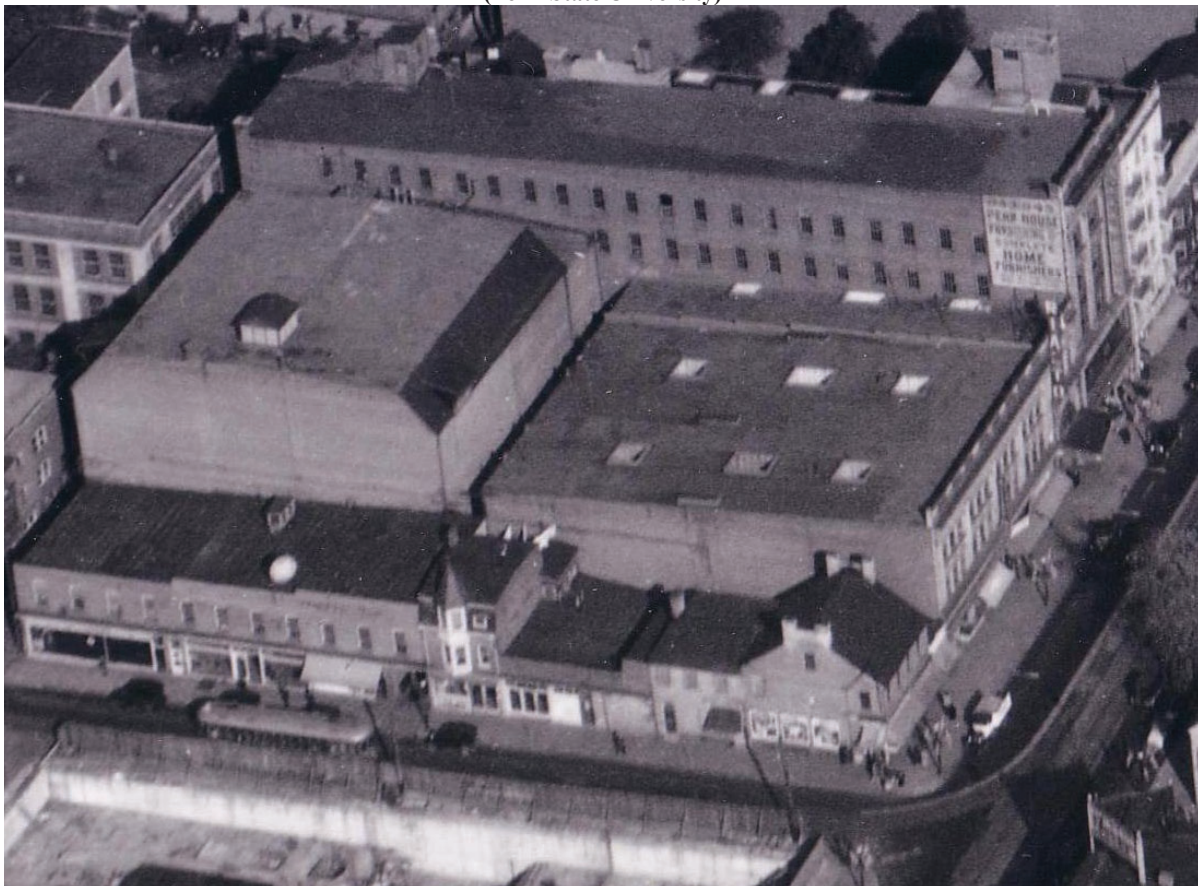
Fig. 4: Aerial image of the original Rialto Theater in 1930.
(Dallin Aerial Survey Company Photographs, Hagley Digital Archives)

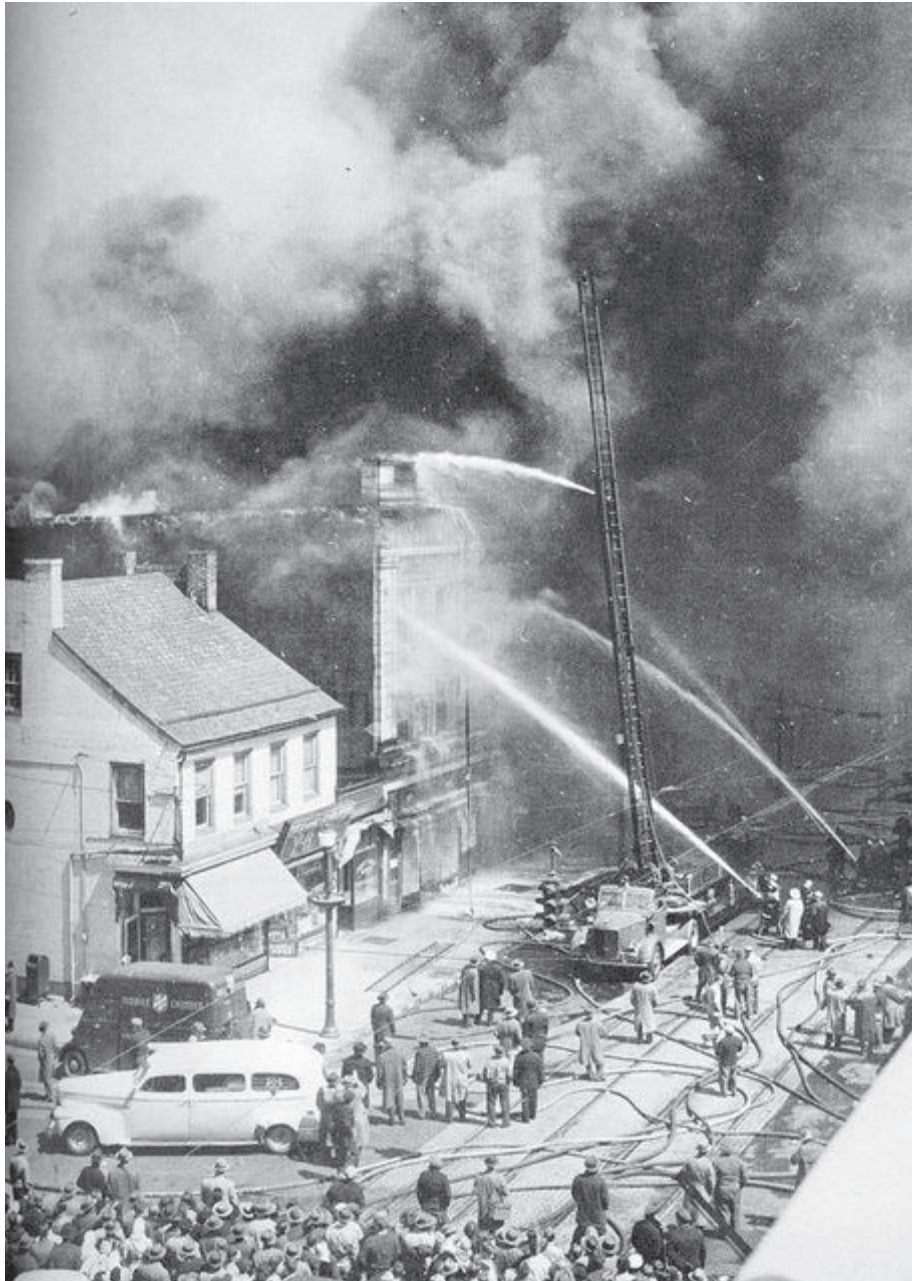
Fig. 5: Fire that destroyed the Rialto Theater lobby, 1946.
(cinematreasures.org)

Because of the quick construction of the lobby and delay in constructing the rear auditorium, the building maintained separation between the two structures. When the fire broke out in April 1949, only the building fronting Hamilton Street was destroyed (Figure 5). The auditorium sustained minor smoke and water damage but was otherwise unscathed. The limited damage to the auditorium necessitated the rushed rebuilding of the lobby to allow for the theater's reopening within the year following the fire. Once complete, the theater reopened for business in January 1947.

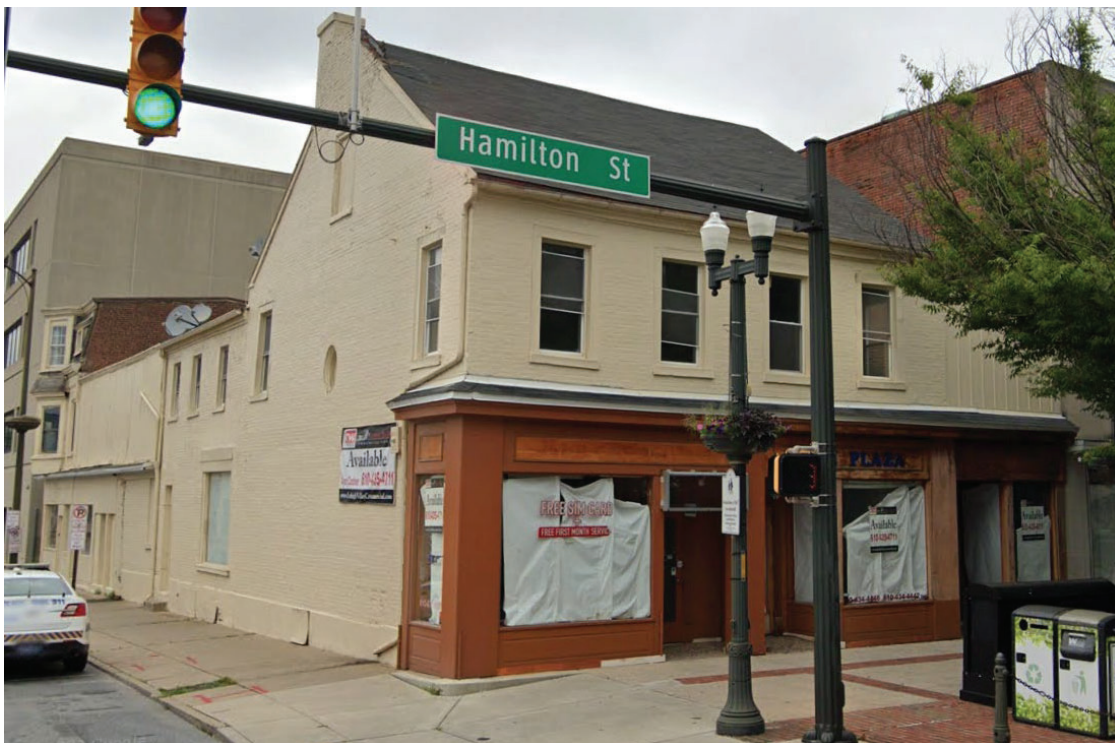
Fig. 6: Front and side elevations of the building at 10th and Hamilton Streets, 2019.
(Google StreetView)

The building located at the corner of 10th and Hamilton Streets was historically constructed as a twin building to house two commercial spaces and largely continued that function through the present day. It was built as a simple vernacular Federal-style structure, and its original form is maintained on Hamilton Street, with the original massing visible but extended on 10th Street. The storefront alteration occurred early in the building's history and has achieved some significance in its own right. Despite several alterations that include changes to the roofing material, replaced windows, capped window frames, partially demolished chimney and painted masonry, the building maintains some integrity. Staff notes that the building is vernacular rather than high style and functions as a historic anchor to the corner where it relates to other vernacular architecture similar in massing, size, scale, and proportion along Hamilton Street. It may be individually significant owing to its age and association with the earlier evolution of the Hamilton Street commercial corridor. The property continues to contribute to the streetscape and neighborhood. (Staff notes that the building is not individually referenced in the Hamilton Street Historic Structures Survey and is graded a "B" with the former Rialto Theater building).

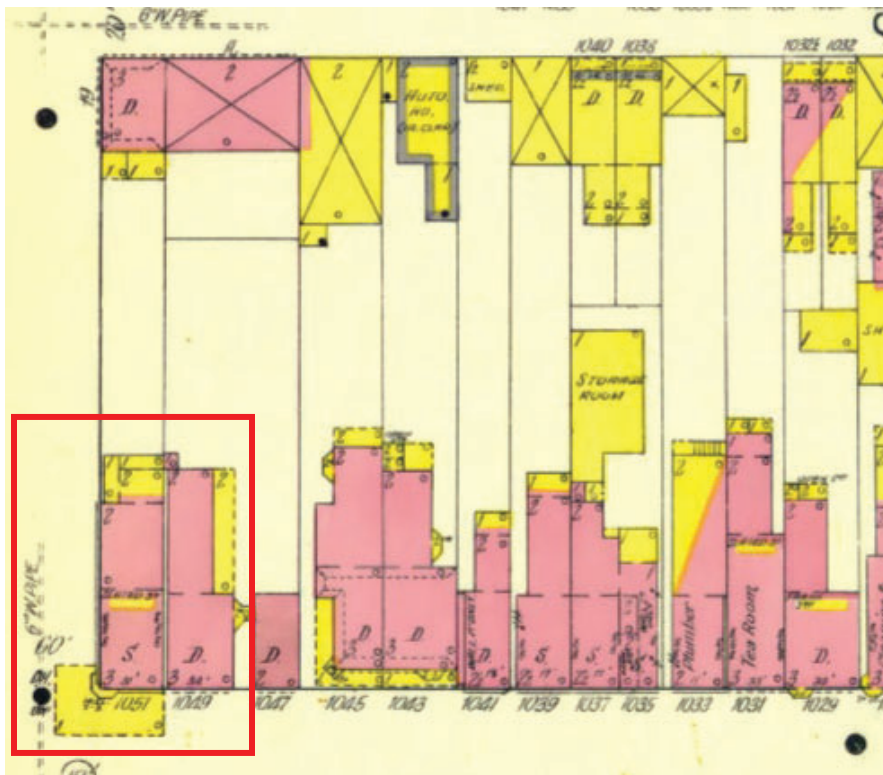
Fig. 10: 1911 Sanborn Map showing the twin building at the corner of 10th and Hamilton Streets.
(Penn State University)

The 10th Street elevation likely maintained its original configuration until the early twentieth century. The 1911 Sanborn map shows that the corner structure remained separate from the rear residential building fronting 10th Street (Figure 10). Only a minor frame addition was constructed onto the ell. By 1930, however, the two buildings had been connected. The 1930 aerial photograph shows that the infill was two stories in height and lacked fenestration at the second story (Figure 4). A series of storefront windows were inserted at the north end adjacent to the former residential building.

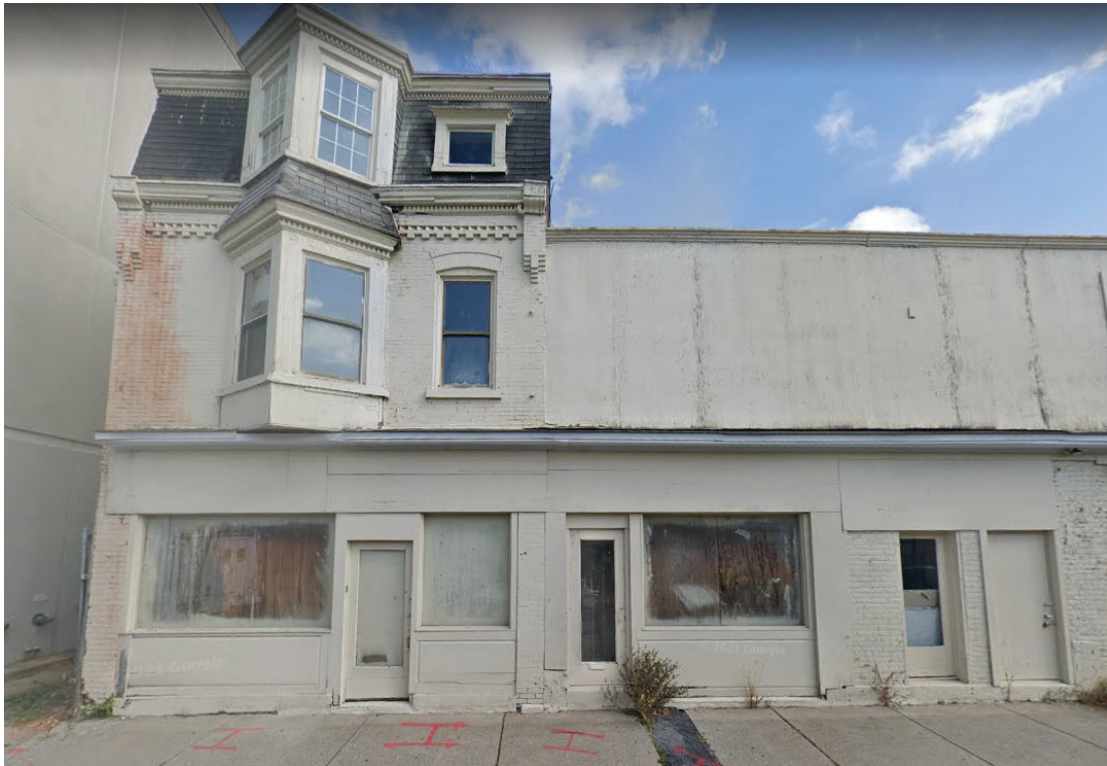
**Fig. 11: Front façade of the property fronting N. 10th Street, 2021.
(Google StreetView)**

This building constructed as a private residence in the Eastlake style has been heavily altered at the first story with the insertion of a storefront, likely early in the twentieth century. Unlike the neighboring building to the south, the storefront has not acquired its own significance, owing to more recent alterations. The building's integrity lies at the second and third stories of the front façade and is typical of the Eastlake style of architecture. More intact properties representative of the style remain throughout Allentown. (Staff notes that the building is not individually referenced in the Hamilton Street Historic Structures Survey and is graded a "B" with the former Rialto Theater building).

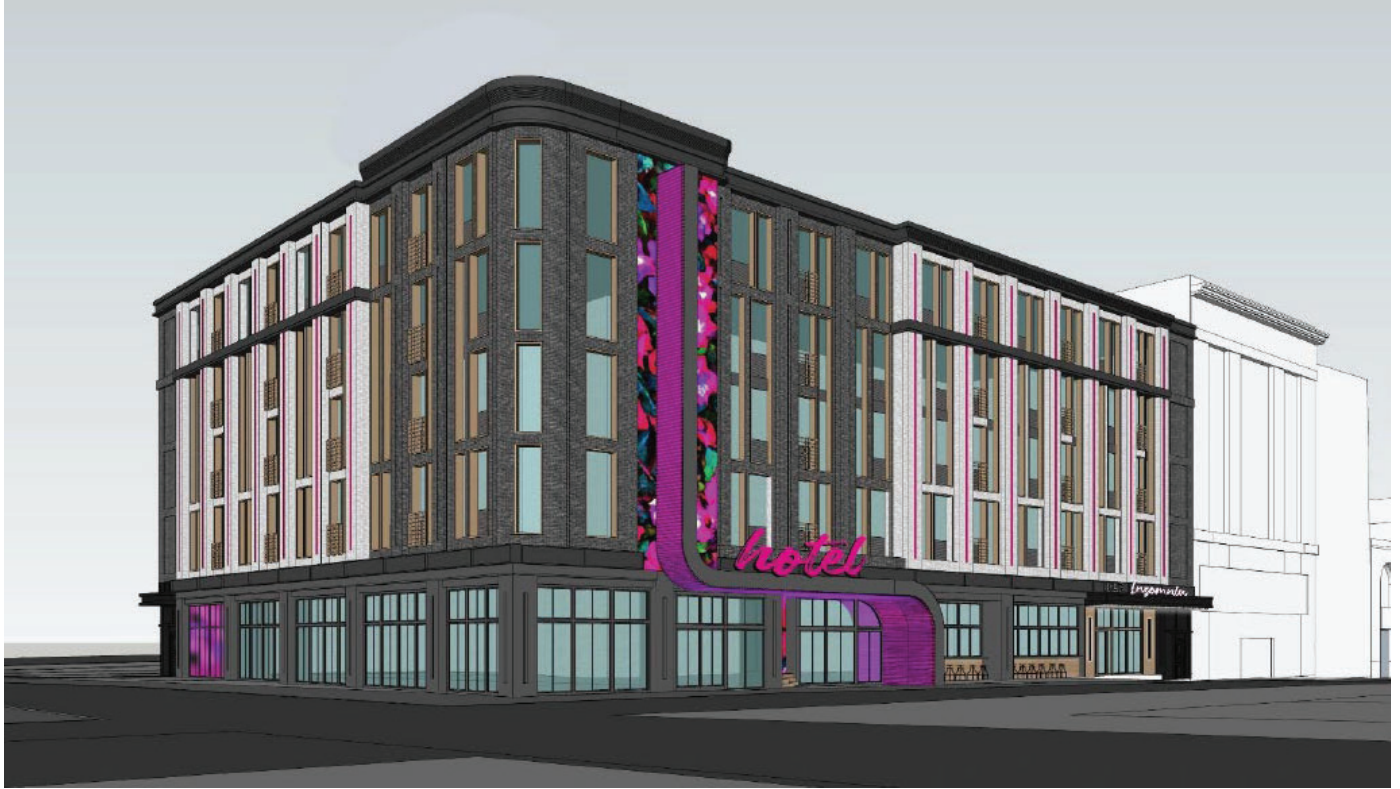
Rendering of proposed building viewed from 10th and Hamilton Streets.
(Applicant)

The design guidelines recommend that the height, massing, and scale of adjacent buildings be considered, but that a variety of heights should be incorporated to create visual interest. The proposed hotel development includes a five-story, 55,000-square-foot structure and would increase the size, scale, and massing of the corner; however, the building would relate to the existing structures to the east at 941 and 943 Hamilton Street, which are five and six stories in height. The rendering provided in the application shows that the new building would terminate at the lower line of the adjacent building's cornice, and 943 Hamilton Street would project several feet above the proposed building. Because the property would be located on the corner, the proposed height is appropriate.

Staff further suggests increasing the height of the corner pylon slightly to create verticality and to better meet the design guidelines' recommendation for varying heights of buildings. The proposed building is a large, horizontal mass. While the vertical piers provide some verticality, the horizontality is most prominent at the roofline.

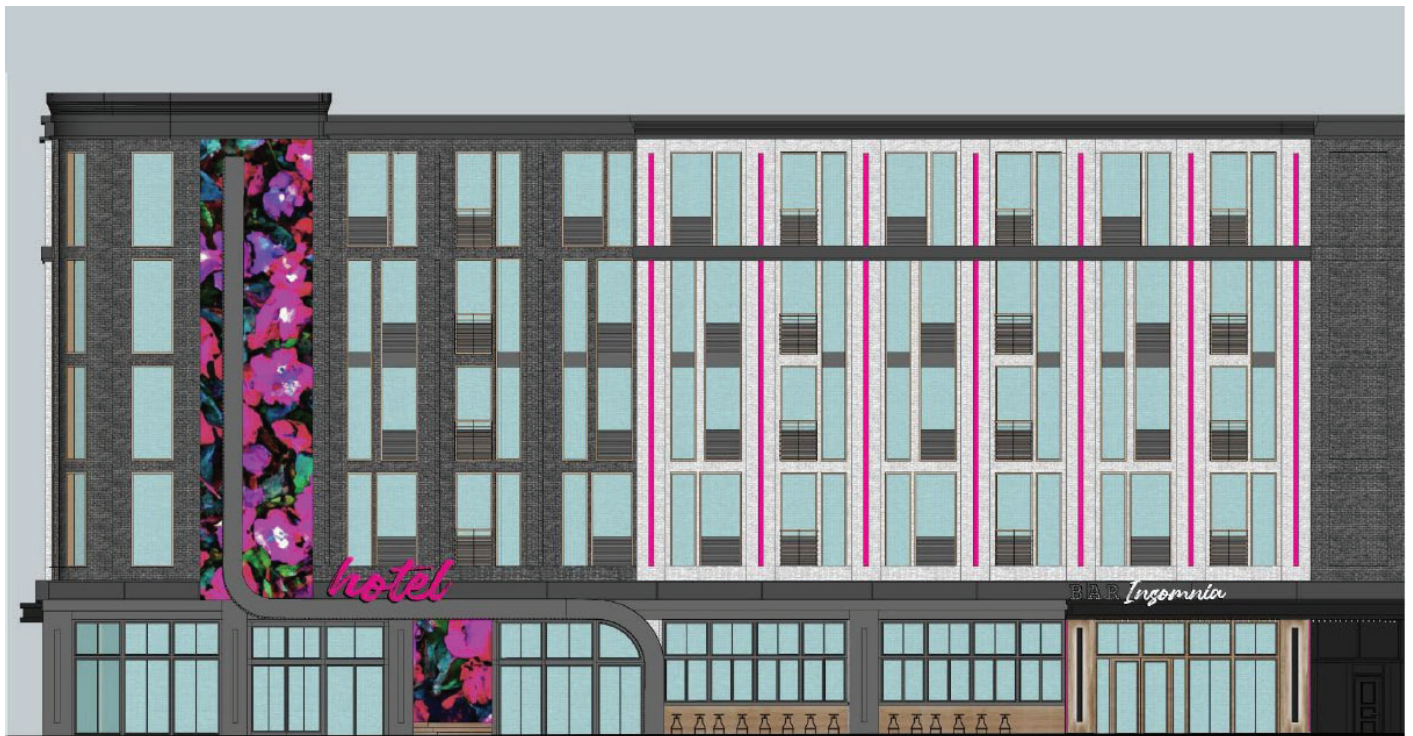
Rendering of Hamilton Street façade of proposed building.
(Applicant)

Staff suggests either eliminating the faux Juliet balconies on both the Hamilton and 10th Street facades or selecting a design that better relates to the historic metal detailing on nearby buildings. For example, the adjacent building at 943-45 Hamilton Street has traditional recessed panels between the third- and fourth-story window bays. The property at 948 Hamilton Street features a pressed copper bay with diamond designs.

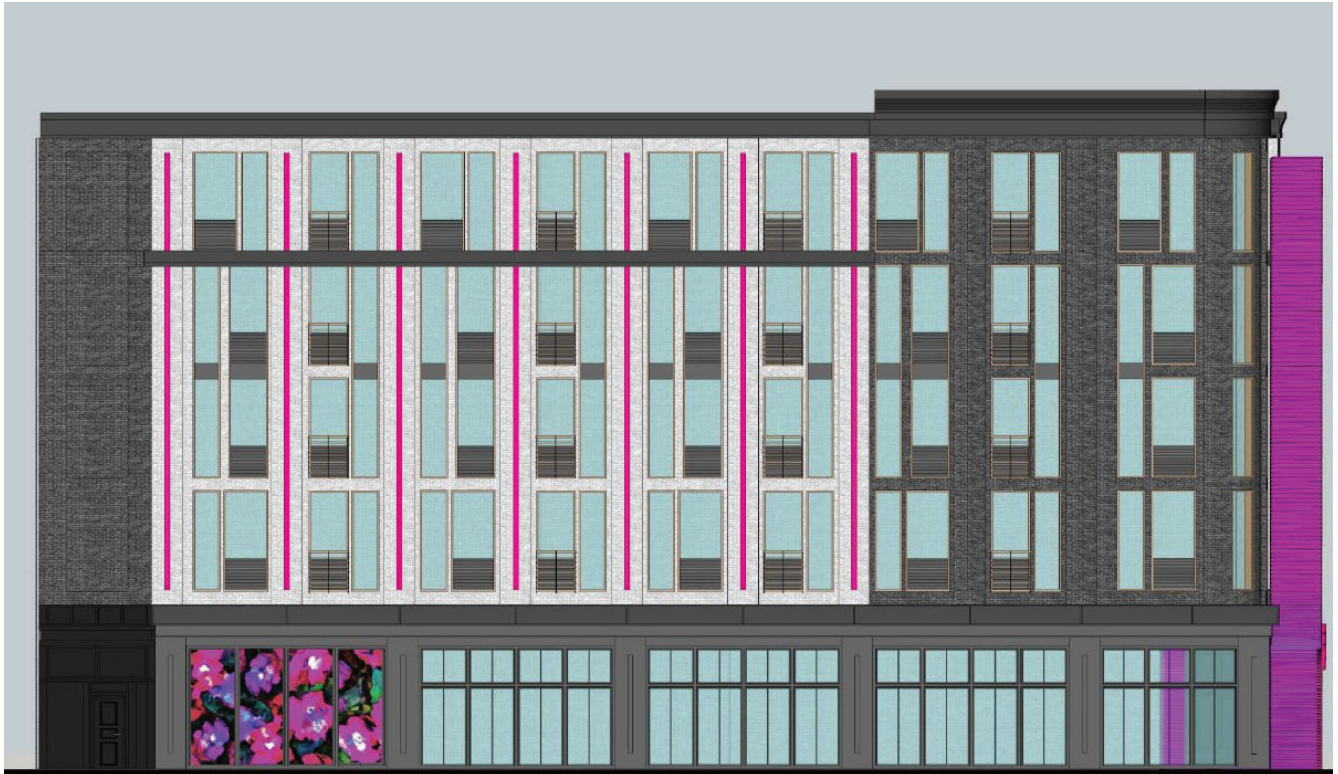
**Rendering of 10th Street façade of proposed building.
(Applicant)**

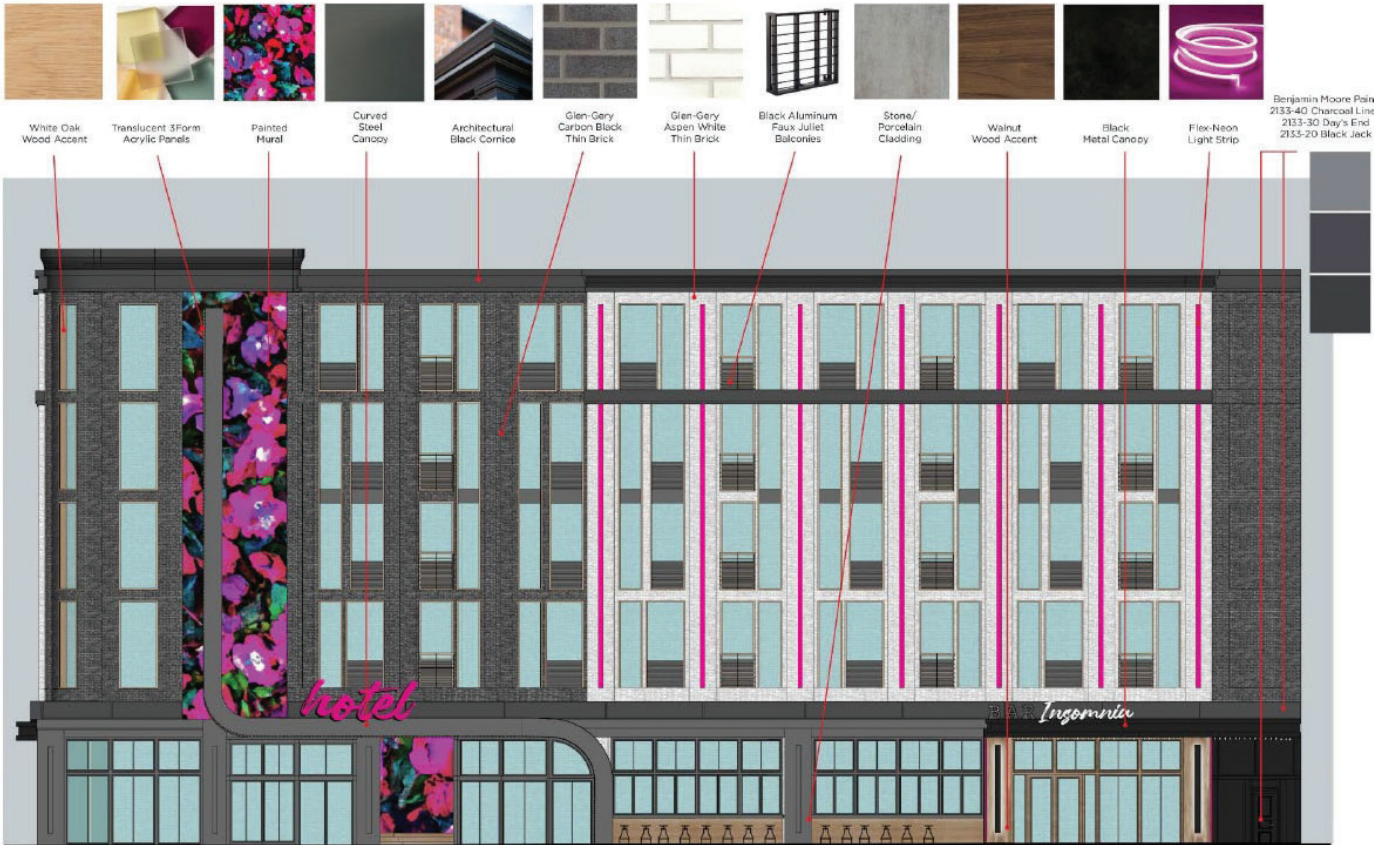
**Façade materials of proposed building.
(Applicant)**

The design guidelines advocate for appropriate materials. The proposed materials include brick cladding, wood, and stone/porcelain tiles, with metal and acrylic accents. The majority of the building would be clad in Glen-Gery Carbon Black Thin Brick, and the projecting piers would be clad in Glen-Gery Aspen White Thin Brick. Staff finds the use of the dark gray brick to be acceptable but recommends replacing the stark white brick with a light gray brick. Staff notes that white materials tend to weather poorly and are susceptible to unsightly soiling without regular cleaning. Staff also recommends using stone rather than porcelain at the façade to comply with the guidelines.

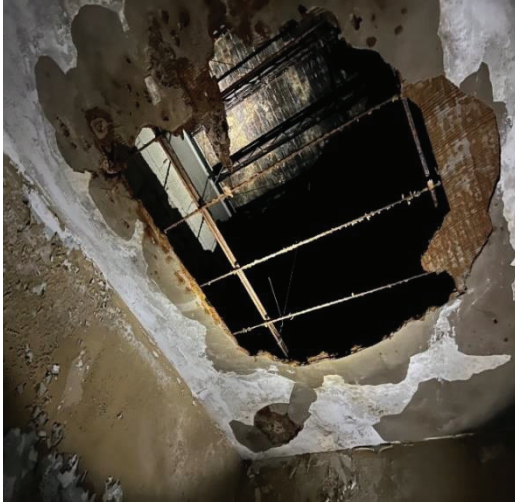
Photo #1 – Water Infiltration

While walking through the buildings there were several issues that arose and were a cause for immediate concern. There appears to be water infiltration issues throughout the entire space, which has caused most of the upstairs floor to become infiltrated with mold and materials have significantly deteriorated because of this. Most specifically, sections of the floor pose a safety concern for access due to obvious cupping of the floorboards under the carpet. Many areas are unsafe to walk on due to this deterioration. This was especially noticeable in the buildings of 961-965 Hamilton. Attached below (Photos #1, #3, #4) are pictures of the water damage and mold. In addition, most ceilings have collapsed due to water infiltration which you will find is pictured below (Photo #2).

Ultimately, there are a few key components that render these buildings unusable for future reuse. The water infiltration and mold require significant remediation and repair. The layouts and construction type of the buildings limit the ability to attract and accommodate prospective tenants. The buildings in general lack any architecturally desirable significance. Based on these items, no feasible alternatives exist other than demolition and the buildings

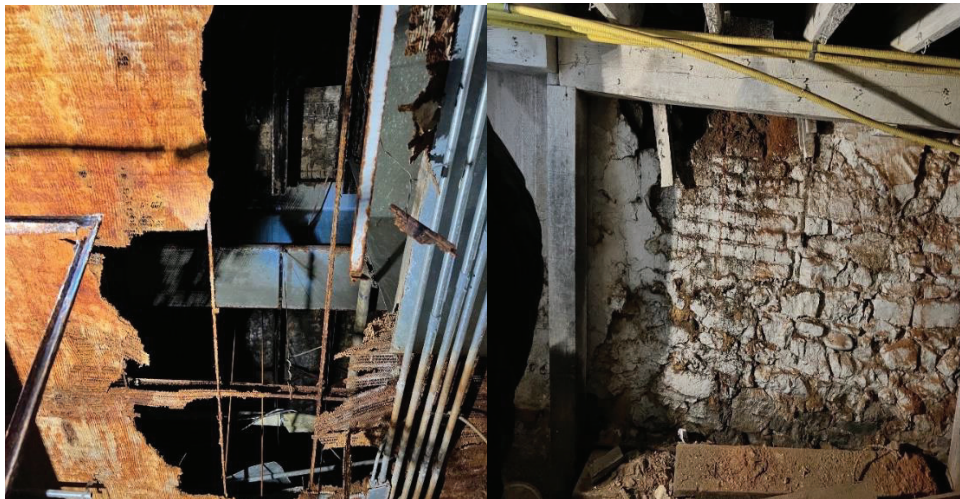
Photo #5 – Deterioration

The next area of focus/concern was the structural integrity of the buildings. The buildings at 949-959 Hamilton are cast in place concrete structures with formed concrete floors supported by steel beams, while the adjoining buildings at 961-963 Hamilton are cast stone with wood beams and floors. There were no immediate visual concerns about the foundations at 949-959, but the likelihood that these walls can still meet the load required of them today is unlikely.

Upon reviewing the basement of 961-965 Hamilton, a rather large concern arose surrounding the structural integrity of the wood used to support the floor above. Much of the wood is deteriorated and the floor joists do not have enough structural capacity to meet the floor load requirements today (Photo #5). When walking on the first floor above you could feel the floor giving way in certain areas to the small load being put upon it, this leads me to believe that these floors are not supported enough to hold the capacity necessary. There is also concern around what appears to be a deteriorating foundation wall (Photo #6). Debris has started to infiltrate through the wall or deteriorate from above. Significant rebuilding of these walls would need to occur for reuse. Concerns also arose regarding the steel beams that run through the ceilings and support the floors. There is noticeable rust on numerous beams, especially those exposed to the water damage. Further investigation of the structure would need to occur after the steel is exposed to see the level of rust that has occurred.

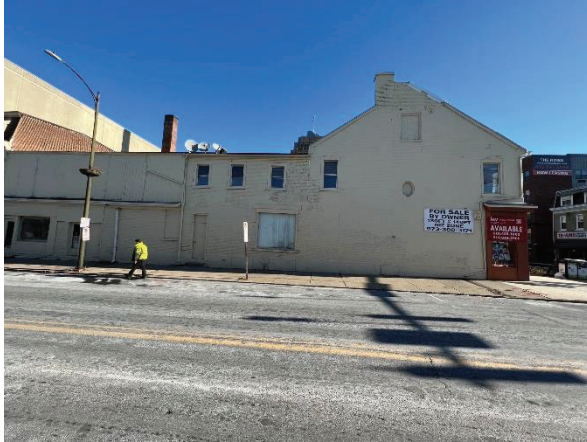
Photo #7 – 10th Street Façades

The architecture of the buildings appears to be insignificant based on my visit. The façade on the buildings closer to 10th street is not original and had been updated previously but is still dated and beginning to show significant wear (Photo #7). The facades along Hamilton Street are also dated and in need of total replacement due to age and weather damage (Photo #8) The floor heights of the two buildings are not even and creates a challenge when it comes to properly

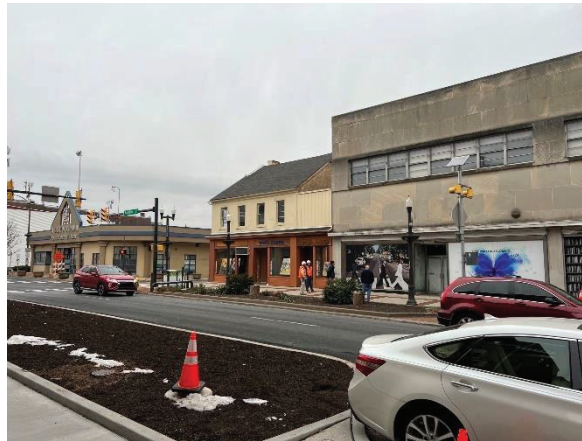
Photo #9 – Hamilton Street Façades

laying out large continuous floors, which is a key requirement for most users in today's market. (Photo #9).
