# Emissions Estimate Report

Chemtool Facility  
1165 Prairie Hill Road,  
Rockton, Illinois

Prepared for:  
Chemtool, Inc.

July 2022

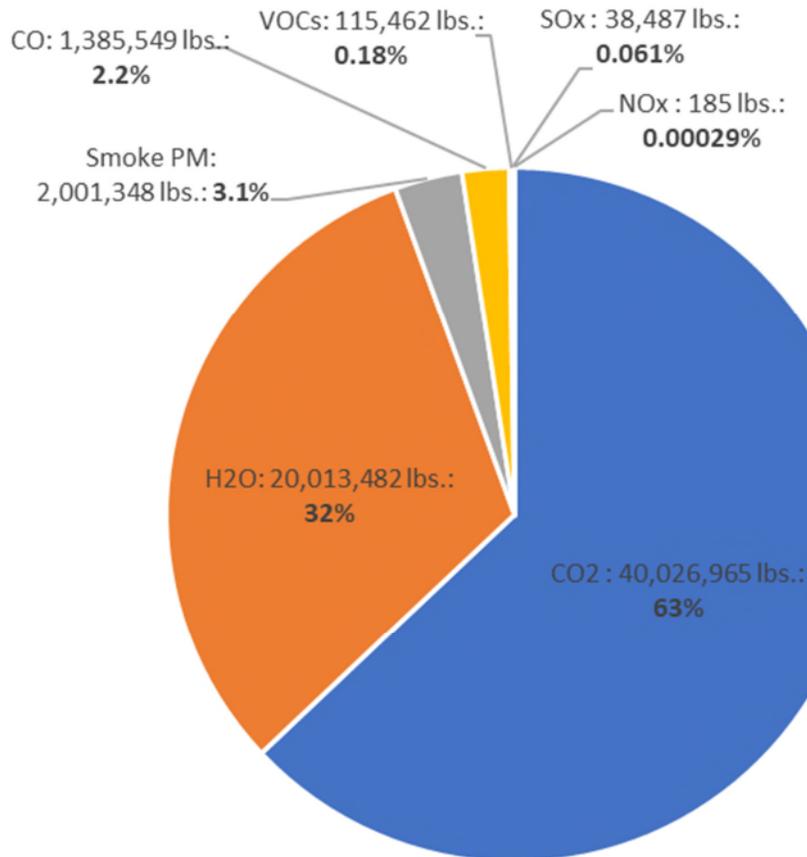
Using the preliminary estimate of product combusted in Step 1, EHS Support estimated the composition and quantity of emissions from the Fire based on literature-derived emission factors (**Section 7.1**) and Site-specific data (**Section 7.2** through **Section 7.4**). The emissions from the Fire were comprised of seven components:

The composition of the emissions by component was:

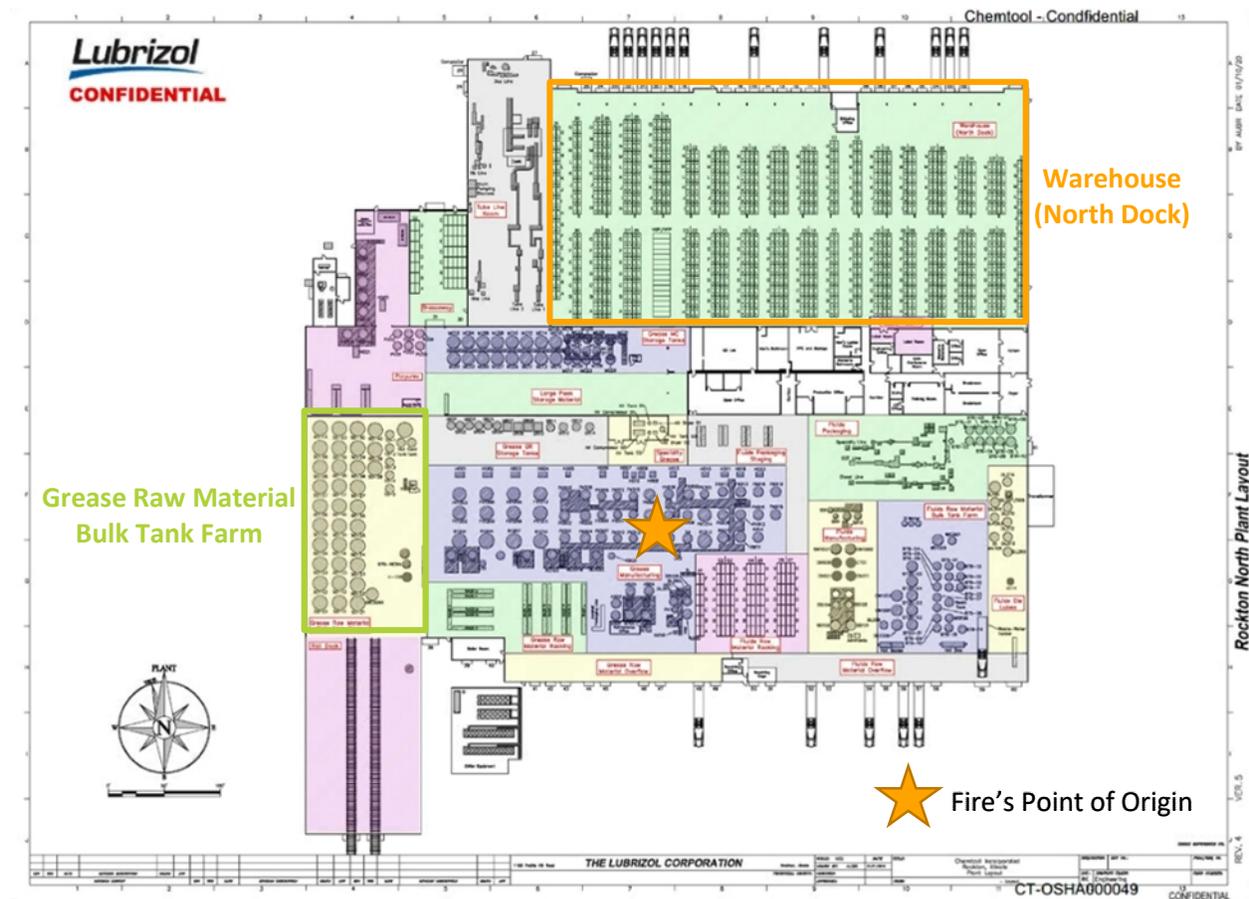
**Figure 2. Facility layout highlighting areas of significant product storage (Chemtool, 2021d).**

As detailed in **Figure 2**, the Facility consists of multiple operational areas. The Fire's point of origin in the **Grease Manufacturing** area of the Facility is identified in **Figure 2** by the orange star. Based on the information provided by Chemtool (Chemtool, 2021a; Chemtool, 2021b; Chemtool, 2021e; Chemtool, 2021f), there were 23.61 million (M) pounds (lbs.) of product (raw materials and finished goods) present throughout the Facility at the time of the Fire, with the majority of the inventory located in the **Warehouse (North Dock)** and **Grease Raw Material Bulk Tank Farm**.

<u>Location:</u>	<u>Quantity:</u>
• Warehouse (North Dock):	9.42 M lbs. (40%)
• Grease Raw Material Bulk Tank Farm: 7.07 M lbs. (30%)	7.07 M lbs. (30%)
• Various ( <b>Appendix A</b> ):	7.12 M lbs. (30%)
• <b>Inventory:</b>	<b>23.61 M lbs.</b>

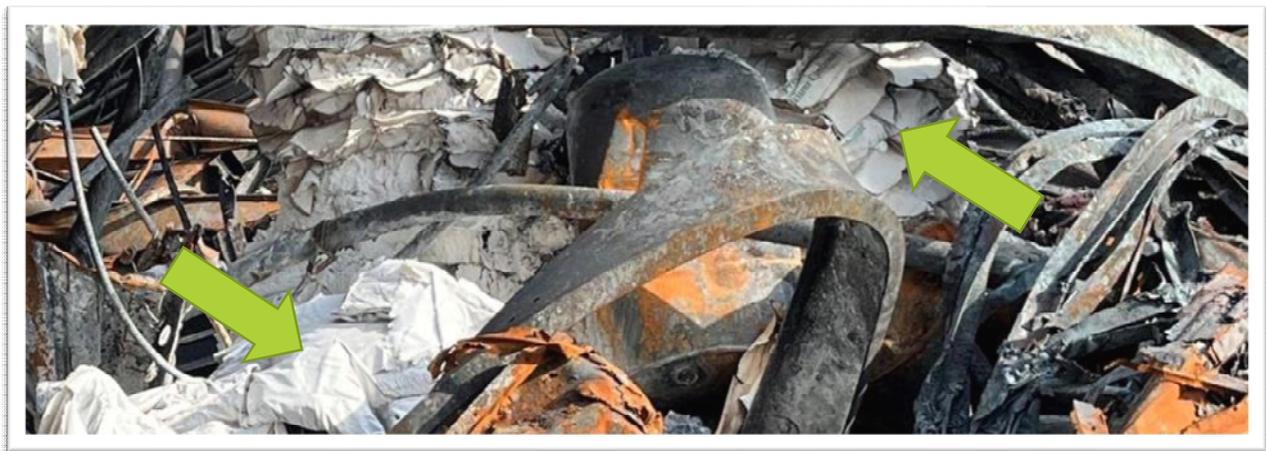
**Figure 3. Bags of calcium carbonate observed on March 2022 Site walk.**

Calcium carbonate, an example of a chemical that would not combust during the Fire, was observed on a post-Fire Site walk (March 17, 2022) in the Grease Raw Material Racking area of the Facility (**Figure 3**). The exclusion of non-combustible chemicals (1.81 M lbs.) from the total inventory (23.61 M lbs.) yields 21.80 M lbs. of potentially combustible product present throughout the Facility at the time of the Fire.

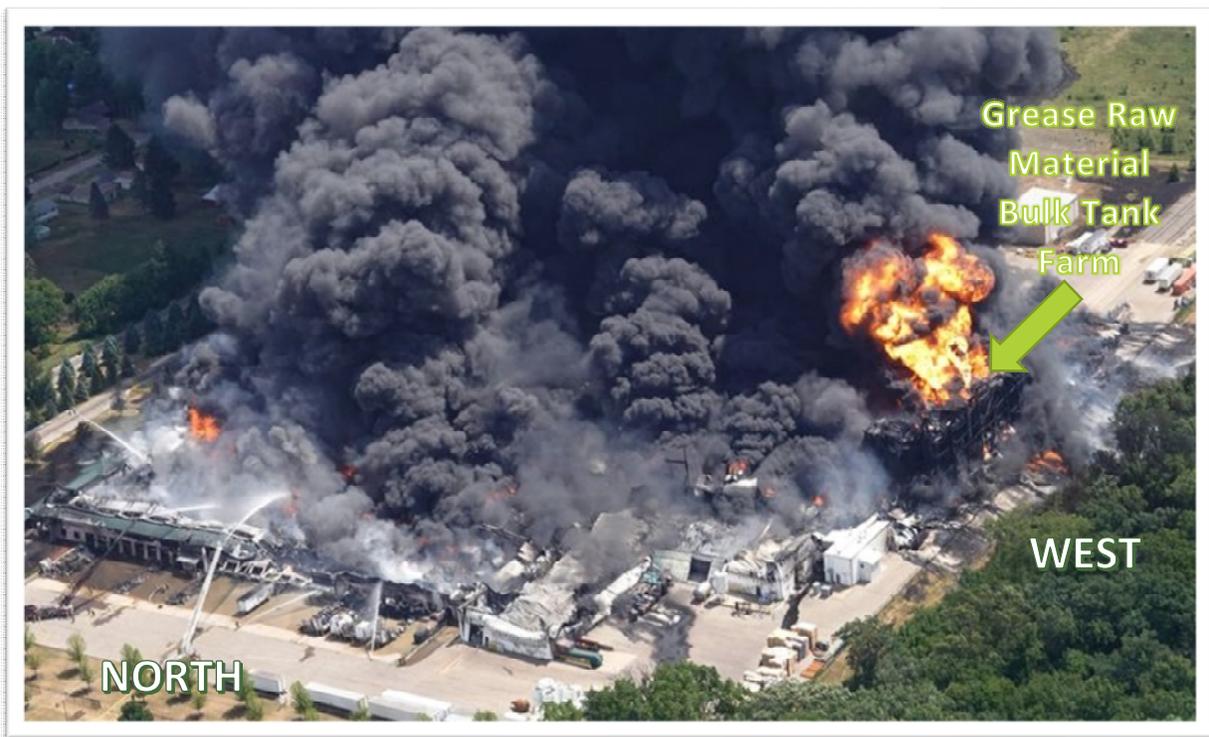
**Figure 4. A photograph of the Fire, as observed on June 14, 2021, showing discharges from the Grease Raw Material Bulk Tank Farm to the western side of the Facility (Chicago Tribune, 2021).**

Emergency response activities were initiated on June 14, 2021, immediately after the Fire started. Initially, fire suppression water and product pooled within the Facility's footprint and containment areas. Water and product were then observed to discharge from the western side of the Facility (near the **Grease Raw Material Bulk Tank Farm** [Figure 4]) as well as from the eastern side of the Facility. Chemtool recovered product from the Site by collecting product from product storage tanks (**Section 4.1**), collecting commingled fire suppression water and product (**Section 4.2**), and excavating visually impacted soils (**Section 4.3**). As of Fall 2021, the product recovery associated with the western side of the Site (**Grease Raw Material Bulk Tank Farm**) is 877,742 lbs. (approximately 12.7%<sup>4</sup> of the inventory in the **Grease Raw Material Bulk Tank Farm** at the time of the Fire) consisting of:

<sup>15</sup> Possible reasons that the **Warehouse (North Dock)** was less affected include: 1) distance from the Fire's point of origin; 2) proximity to sprinkler system; and 3) access by firefighters (**Figure 4**).

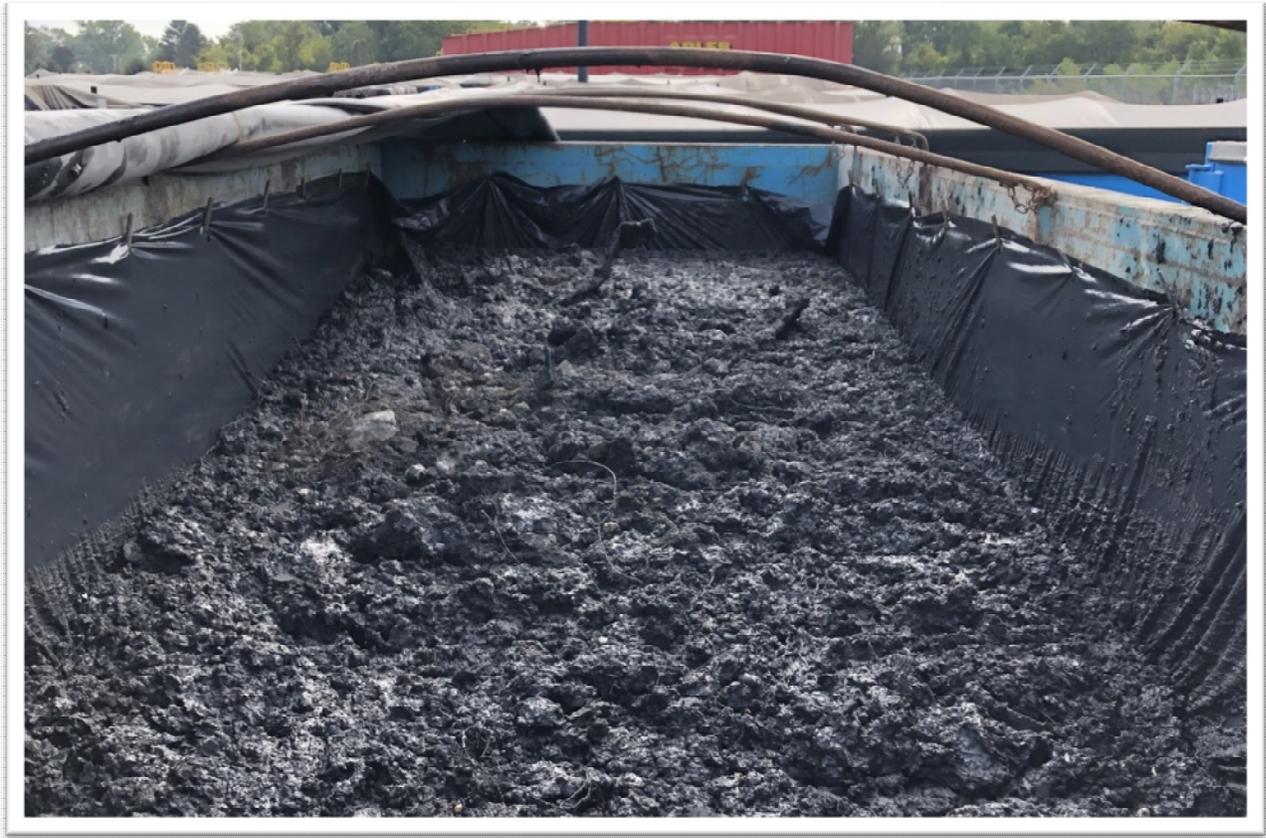
**Figure 5. A photograph of product saturated soil (“sludge”) contained in roll-off box SB1315.**

Similar to the recovered commingled fire suppression water and product (**Section 4.2**), the visually impacted soils from the western side of the Facility were likely sourced from the **Grease Raw Material Bulk Tank Farm**. As stated earlier, there were 697 cy of visually impacted soils; however, 117 cy of that amount was described as “sludge” (**Figure 5**). EHS Support calculated **93,162 lbs.** of product in the visually impacted soils based on an average/median TPH concentration of 48,500 milligrams per kilogram (mg/kg)<sup>9</sup> and a bulk density of 2,359.78 lbs./cy<sup>10</sup> for the 580 cy of visually impacted soils and a TPH concentration of 97,000 mg/kg<sup>11</sup> concentration for the 117 cy of “sludge.”

<sup>11</sup> Given that the “sludge” had product above residual saturation, the TPH concentration was estimated to be twice the concentration of visually impacted soils (97,000 mg/kg) (**Figure 5**).

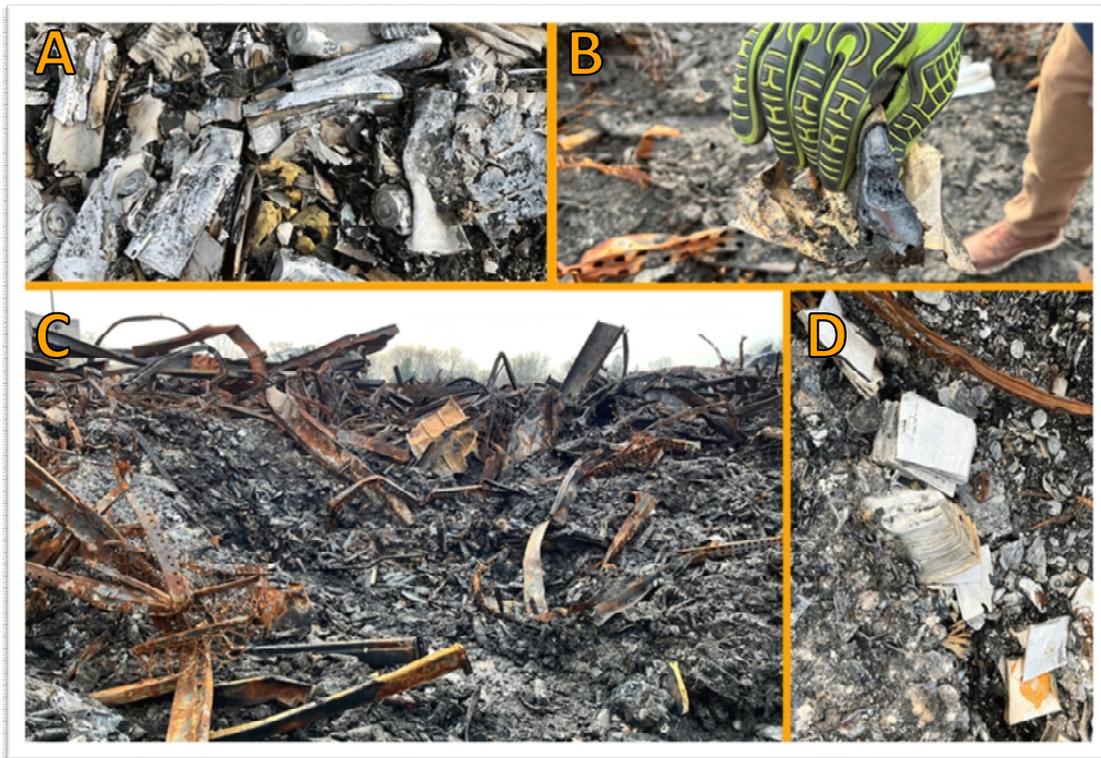
**Figure 6. Observations of the northwestern portion of the Warehouse (North Dock) during the March 2022 Site walk.**

During the March 2022 Site walk, it became evident that the **Warehouse (North Dock)** was less affected by the Fire than other areas of the Facility.<sup>15</sup> In the northwestern portion of the **Warehouse (North Dock)**, there were piles of cardboard tubes (**Figure 6A**); grease that visually appeared unaffected by the Fire (**Figure 6B**); commingled mounds of product,<sup>16</sup> packaging, and building materials that were more than 6 feet high (**Figure 6C**); and piles of papers (**Figure 6D**).

<sup>16</sup> A sample collected on April 19, 2022, in this portion of the **Warehouse (North Dock)** had a TPH (C10 – C34) concentration greater than 100,000 mg/kg confirming the presence of product.

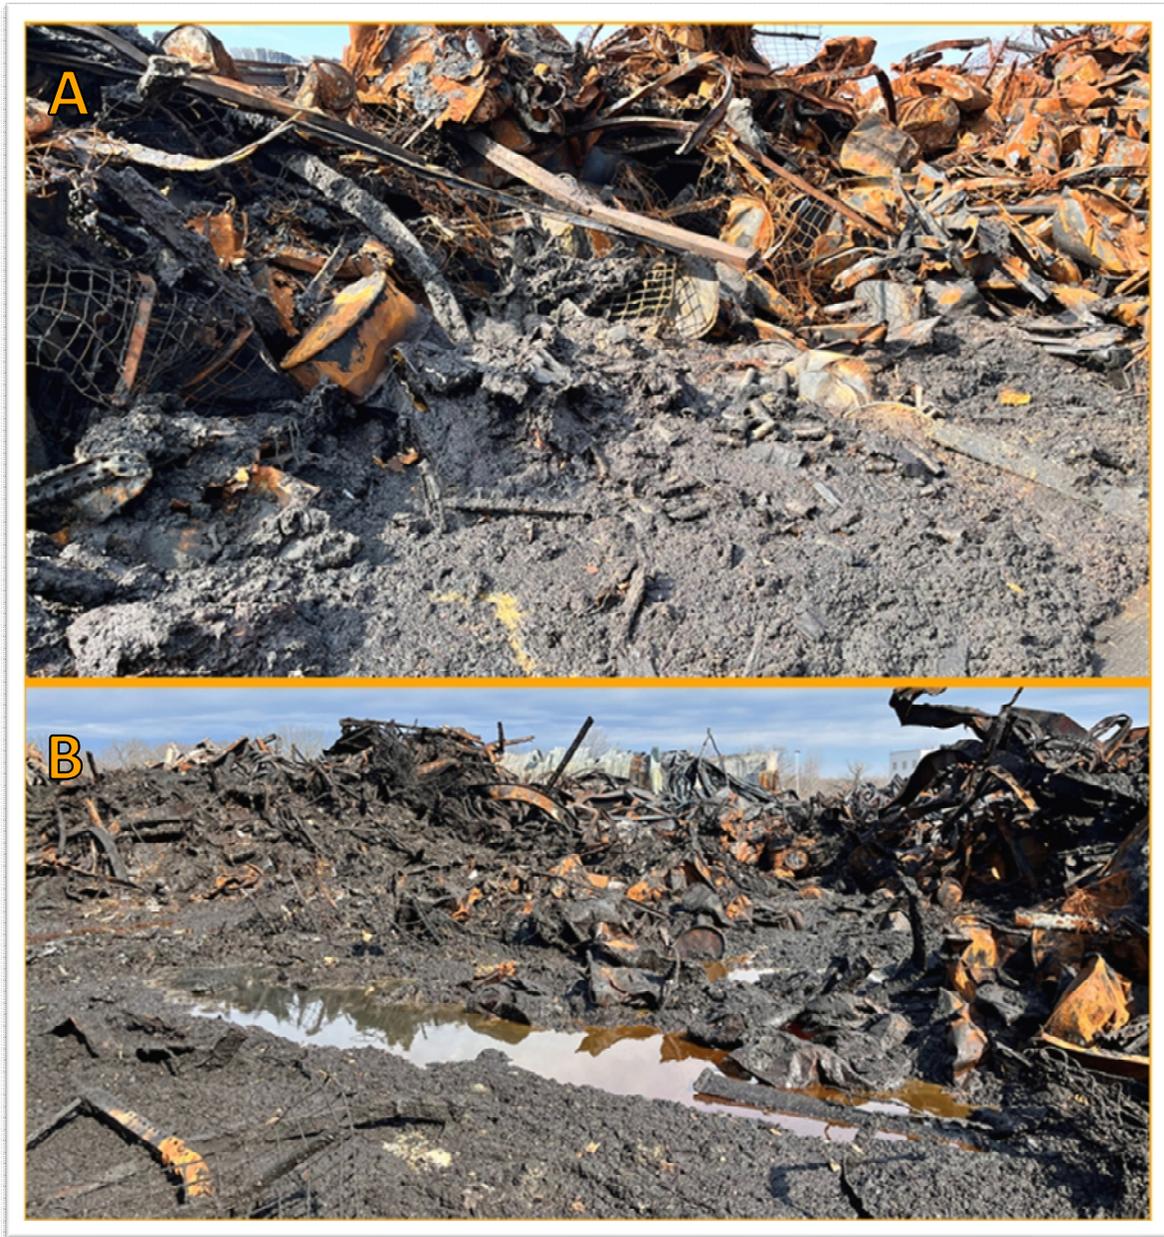
**Figure 7. Observations of the northeastern (A) and southern (B) portions of the Warehouse (North Dock) on March 2022 Site walk.**

Additional observations in the northeastern (**Figure 7A**) and southern (**Figure 7B**) portions of the **Warehouse (North Dock)** show appreciable quantities of product,<sup>17</sup> ranging from 0.5 feet thick in the former warehouse aisles to more than several feet thick in the former warehouse racks.

<sup>17</sup> Two samples collected on April 19, 2022, in these areas of the **Warehouse (North Dock)** have TPH (C10 – C34) concentrations greater than 100,000 mg/kg confirming the presence of product.

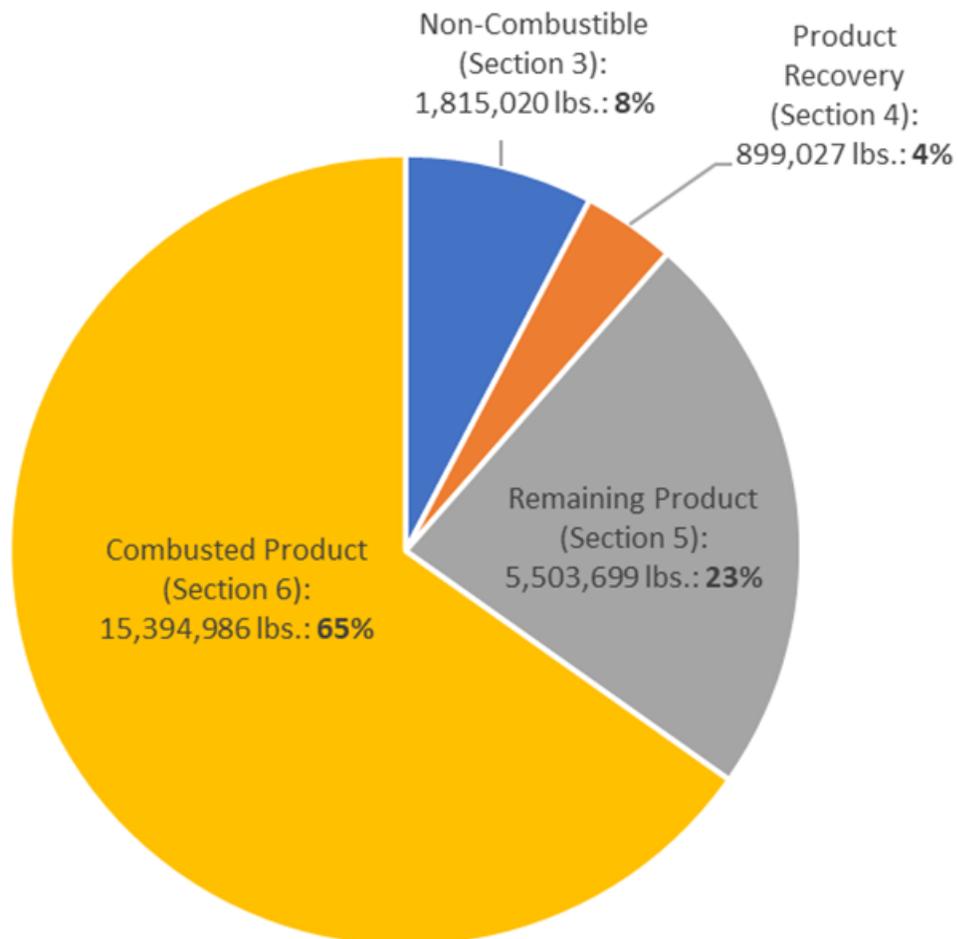
**Figure 8. Fate of product at the Facility.**

<b><u>Estimate:</u></b>	<b><u>Quantity:</u></b>
• Inventory ( <b>Section 2</b> ):	23,612,732 lbs.
• Non-Combustible ( <b>Section 3</b> ):	-1,815,020 lbs.
• Product Recovered ( <b>Section 4</b> ):	-899,027 lbs.
• Product Remaining ( <b>Section 5</b> ):	<u>-5,503,699 lbs.</u>
• <b>Product Combusted:</b>	<b>15,394,986 lbs.</b>

**Figure 8** summarizes the fate of product at the Facility.

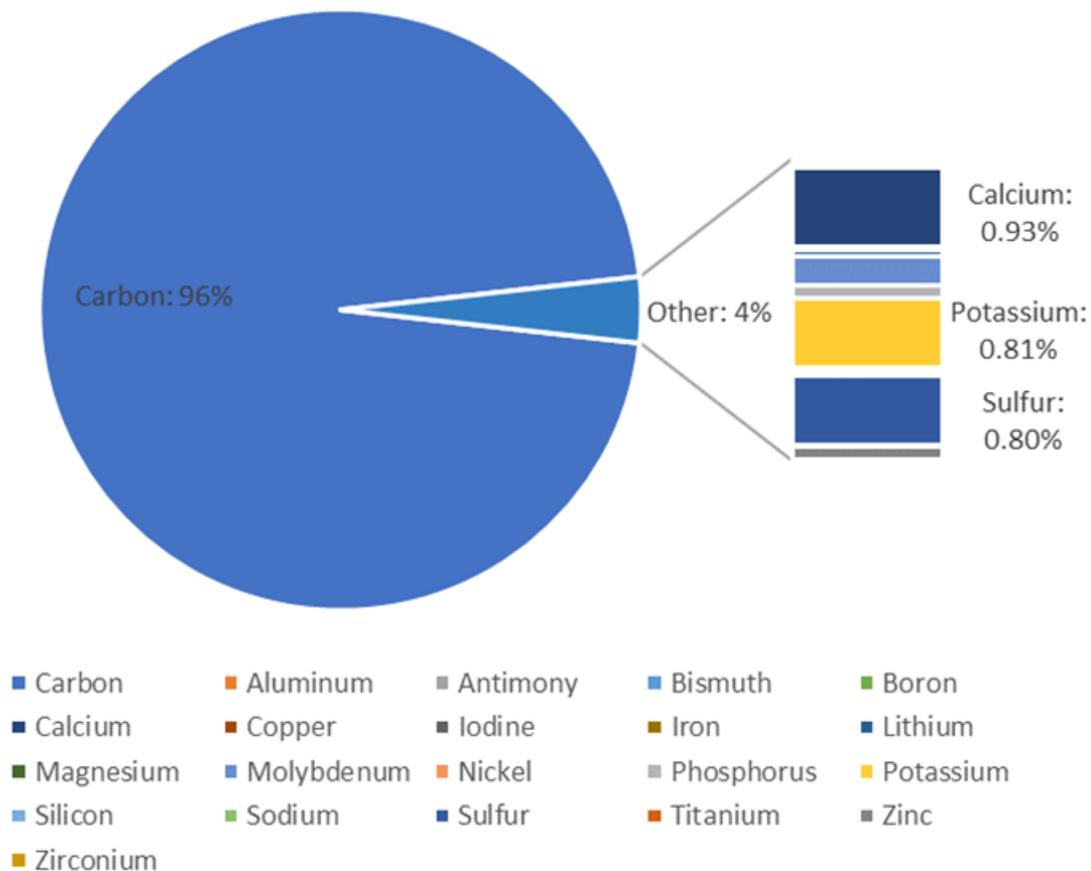
**Figure 9. Elemental composition of combustible products.**

Based on emission factors from Booher et al. (1997), approximately 2.0 M lbs. of smoke PM were potentially emitted during the Fire (**Table 1**). Determining the chemical composition of smoke PM requires Site-specific data. The National Guard collected ash samples from the Fire that were analyzed for metals by the Illinois Environmental Protection Agency (IEPA) (IEPA, 2022). According to IEPA (2022), **“all [ash] samples were non-detect or below threshold levels.”** The analytical results from the ash samples cannot be used to determine the composition of smoke PM because certain analytes were not considered (e.g., carbon). Instead of environmental data, product elemental compositions provided by Chemtool (Chemtool, 2021c) were used to determine the elemental composition<sup>26</sup> for the combustible products (**Figure 9**).

The majority of the elemental composition is carbon (96%), which is consistent with Booher et al. (1997).<sup>27</sup> After carbon, calcium and potassium are the most dominant elements (**Figure 9**), which is consistent with the analytical results from the ash samples (IEPA, 2021). Application of the elemental composition (**Figure 9**) to the 2.0 M lbs. of smoke PM (**Section 7.1**) results in an estimate of particulate emissions (**Table 2**).

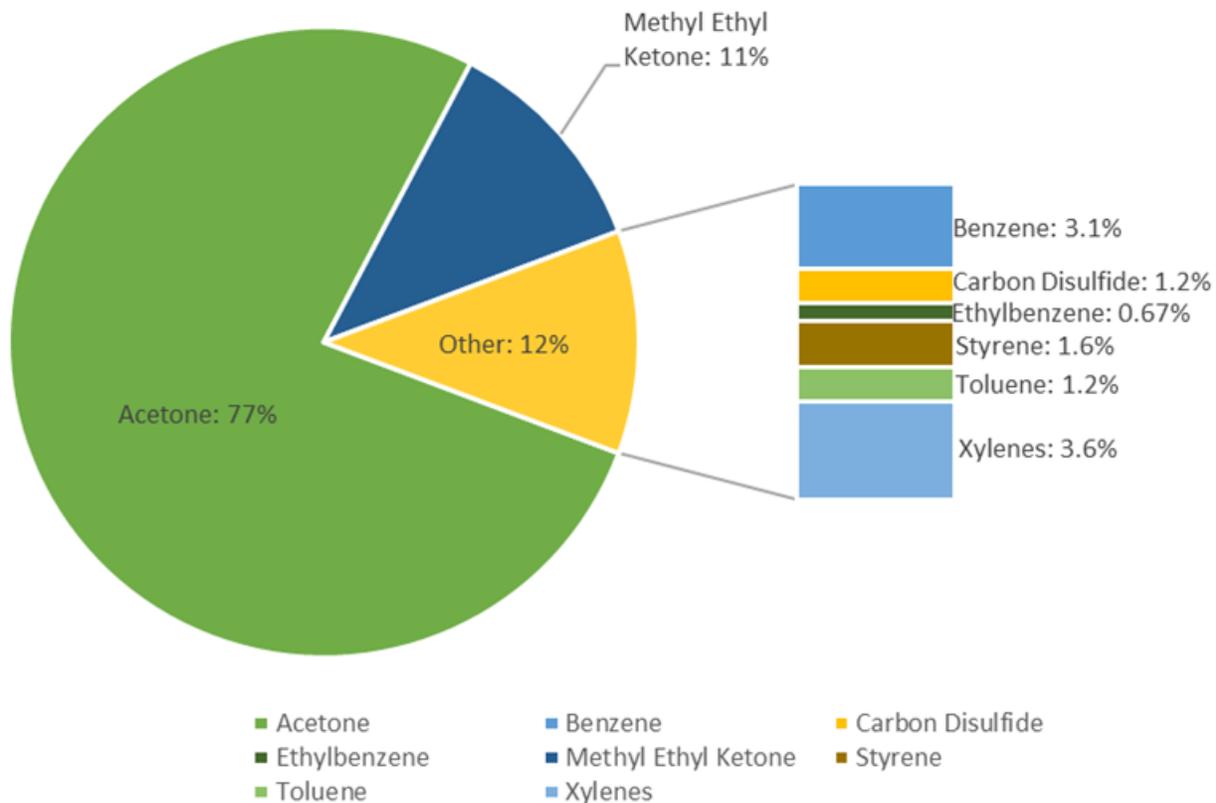
**Figure 10. VOC composition in recovered fire suppression water.**

background concentrations of VOCs<sup>28</sup> prevents the usage of the data in this Report. As an alternative, analytical data from the recovered fire suppression water,<sup>29</sup> which came into direct contact with VOC emissions from the Fire, was used to determine the emitted VOCs. Contribution from fire suppression water sourced from the Rock River has not been evaluated; therefore, the source of the detected VOCs was conservatively assumed to be from the Fire. **Figure 10** shows the composition of VOCs in the recovered fire suppression water.

Application of the elemental composition (**Figure 10**) to the 115,462 lbs. of VOCs (**Section 7.1**) results in an estimate of VOC emissions (**Table 3**).

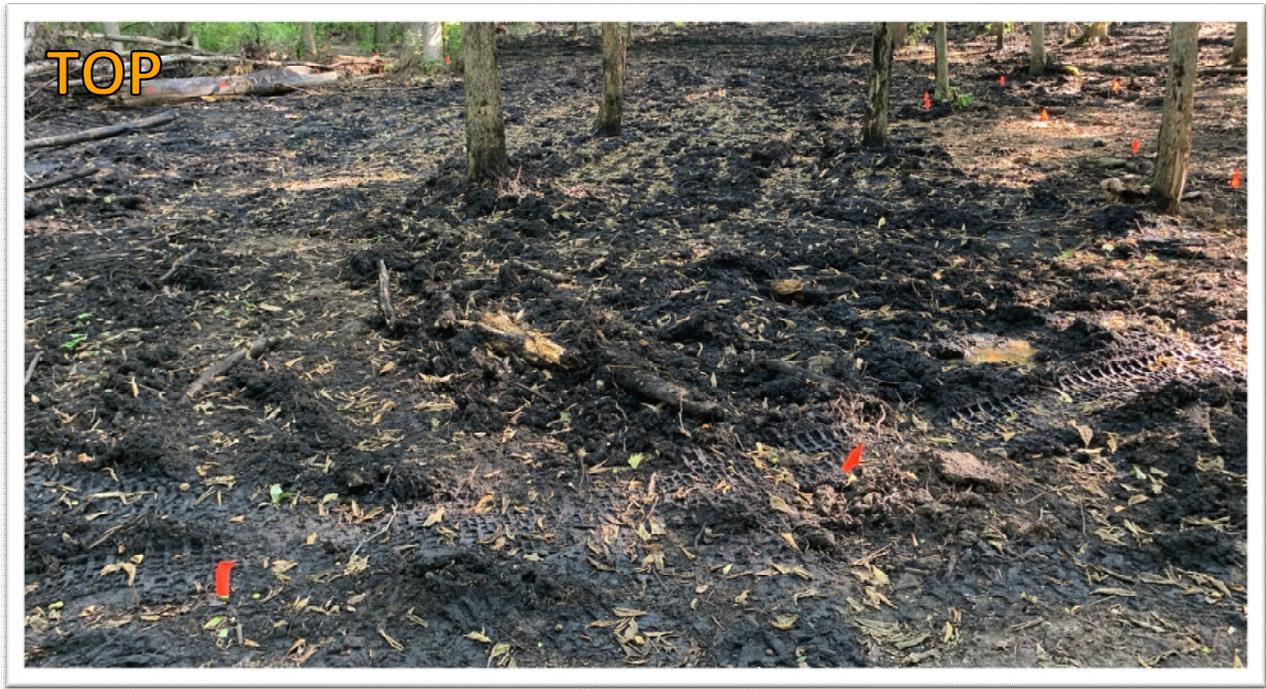
Photograph showing visually impacted soil between interceptor trenches 1 and 2.

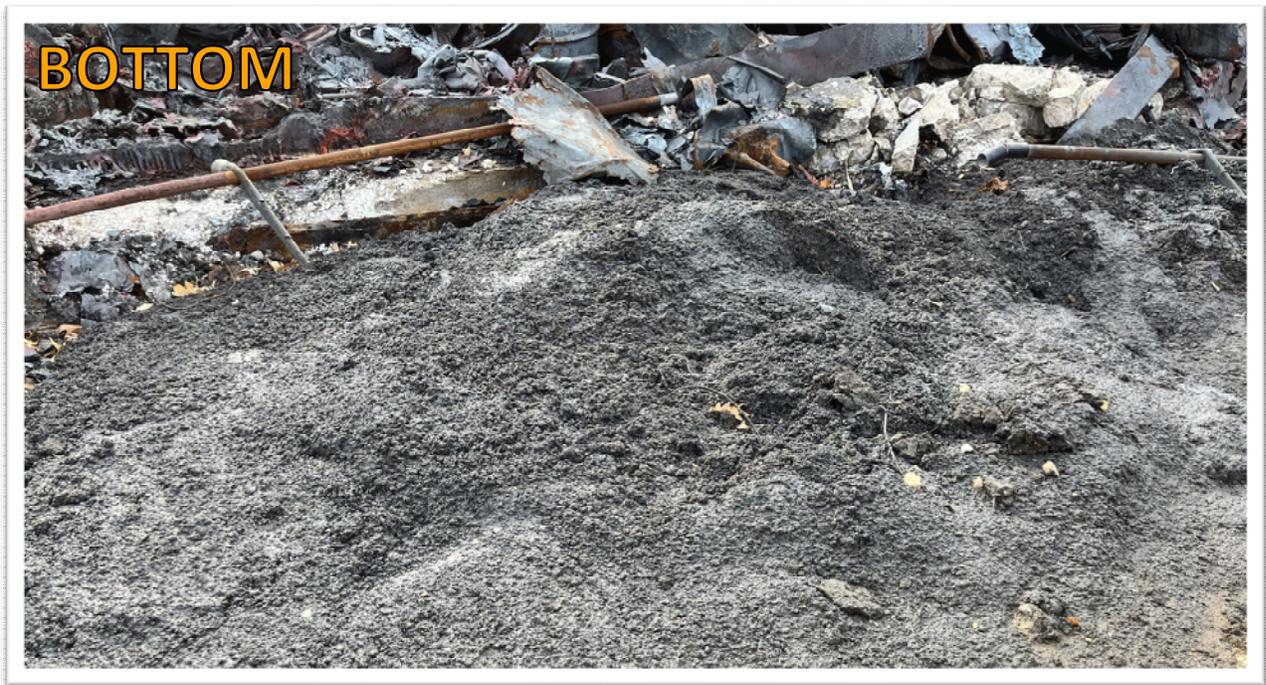
Photograph showing visually impacted soil adjacent to the western side of the Facility.
