STAFF REPORT

PROCEEDING NO. 20I-0437E

IN THE MATTER OF THE INVESTIGATION INTO THE HISTORY AND CONTINUING OPERATIONS OF THE PUBLIC SERVICE COMPANY OF COLORADO COMANCHE UNIT 3 GENERATING STATION PURSUANT TO DECISION NO. C20-0505.

March 1, 2021

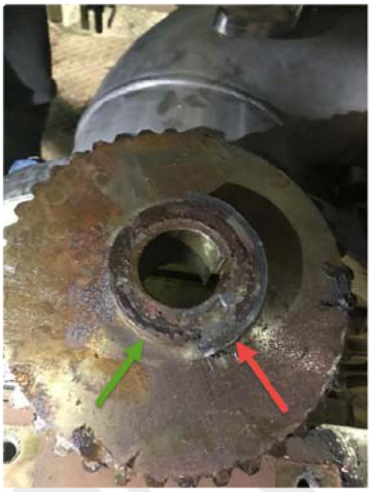
Figure 10(b) *Underside of gear.*[38]

Figure 10 (a) *Gear removed.*[37]

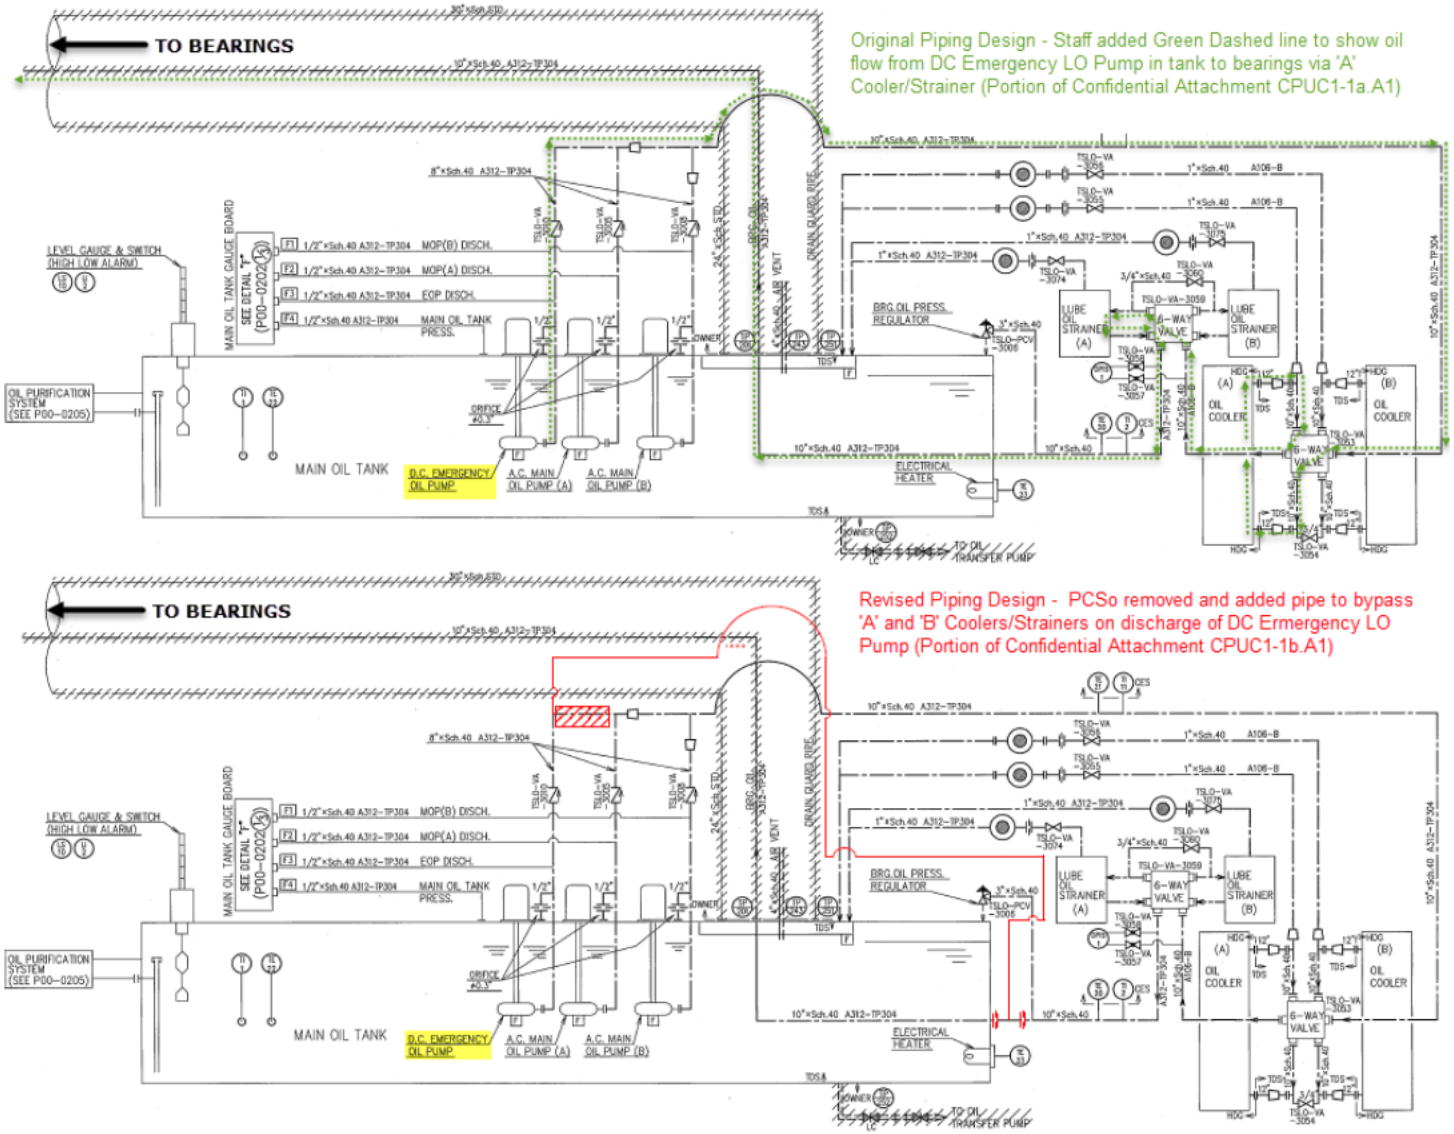
Figure 13. Original P&ID of lube oil system (top) vs. revised P&ID (bottom).

The Technical Design Team, as part of the TLO system corrective actions, removed a section of pipe and added additional piping allowing the DC emergency TLO pump to bypass cooler/filters and feed directly to bearings. Figure 13 illustrates the redlined piping and instrumentation diagram (P&ID) of the system.

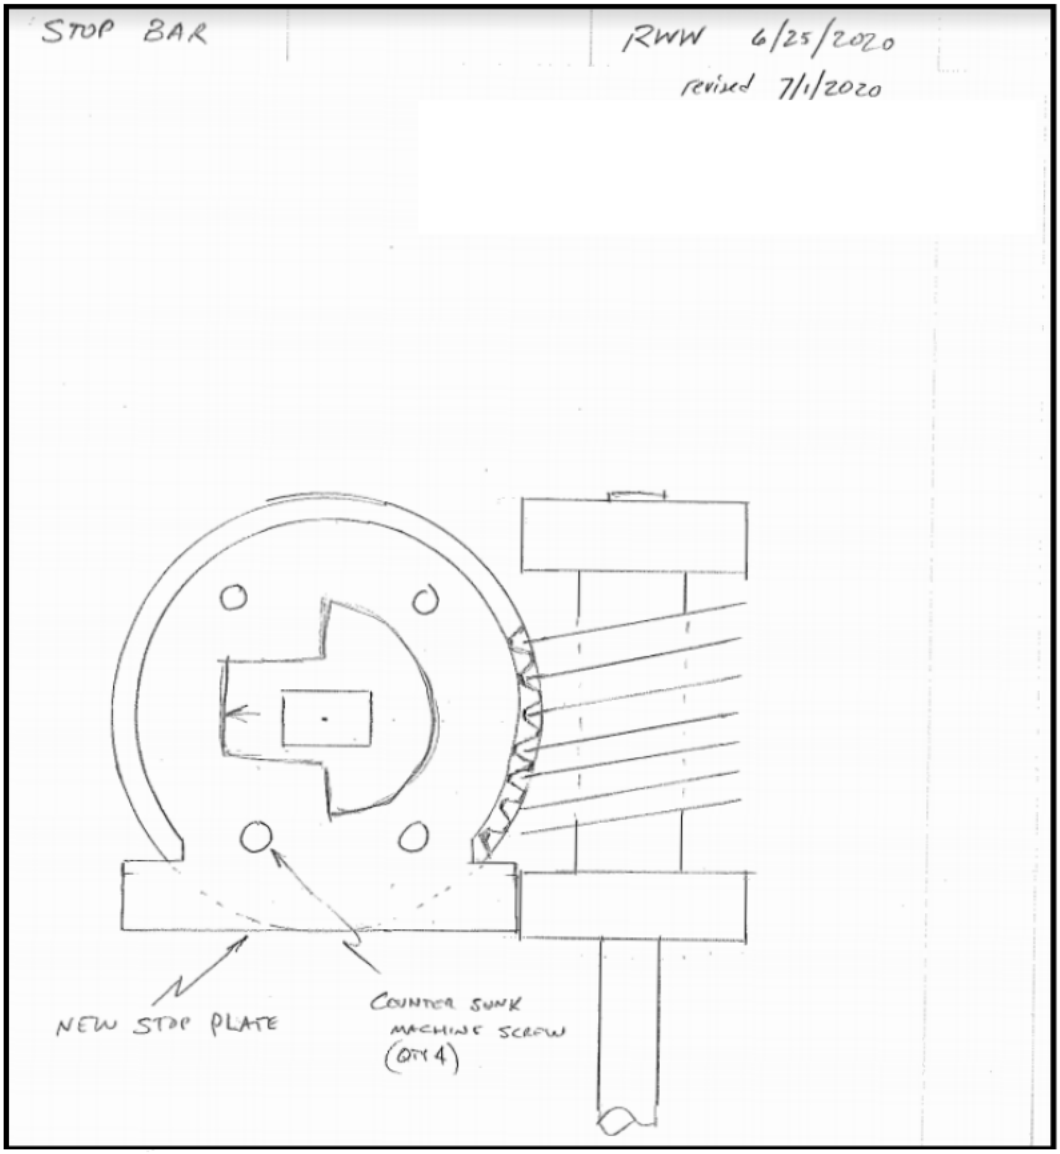
Figure 14. Valve sketch (1 of 2).

The Company's design modification drawings for the actuator modifications is provided below:[50]

It was noted that the drawings were created and signed by the Technical Improvement Team Lead, who also happens to be the Plant's Manager of Reliability. There was no secondary or independent signature that demonstrated that the design was reviewed or verified. As is apparent by the single signature, design changes appear to have been made also without independent verification. There was no indication of the materials used for the modifications to the valve. There is no discussion of why modifications were made necessary (e.g. the result of a previous incident or identified by a SPOF analysis). There is no indication of what service standard was used, nor was there any indication that the drawings were filed or input into the plant's drawing system for future reference or traceability.

While this is may be a minor design change, it is essential to create a record of what modifications were made and why.

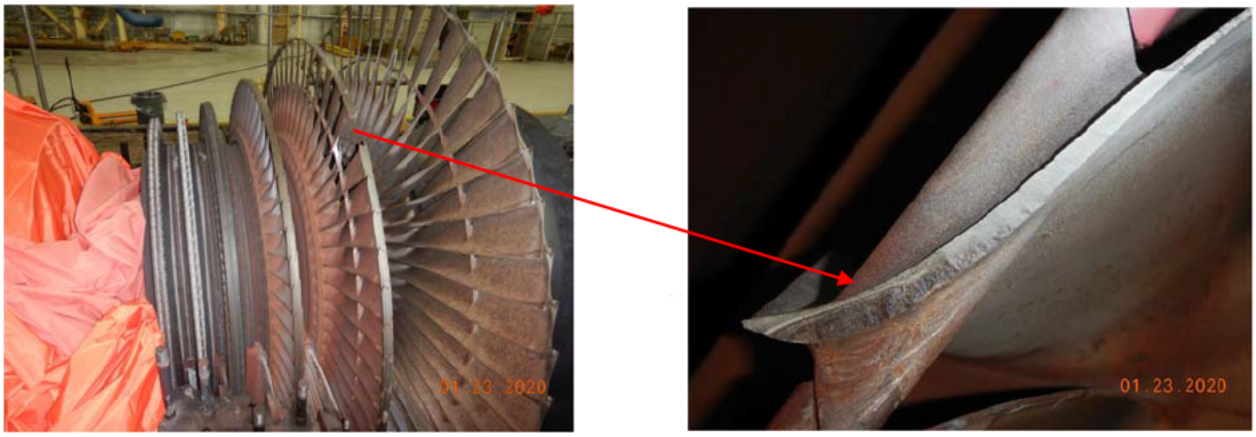
Figure 22. Blade damage.

The company also engaged a consultant to assess whether steam cycle chemistry contributed to the blade damage show in the figures below.[89] Key conclusions in the consultant's included: [redacted]"[90]

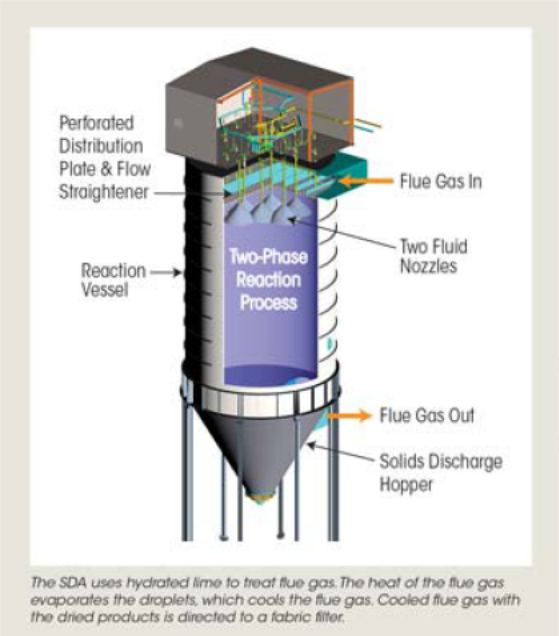
Figure 23. Typical SDA diagram.

This outage was caused by debris which plugged the gas dispersion. The debris was cleared from the gas disperser and bottom of the vessel during the outage.[95] Comanche 3 was in an outage state for 8 days returning to service on December 7, 2018. Replacement power costs for this outage were estimated at $1.4M.
