Saint Stanislaus Kostka Mission

CONDITION ASSESSMENT STUDY FINAL REPORT - DECEMBER 12, 2020

Executive Summary - December 12, 2020

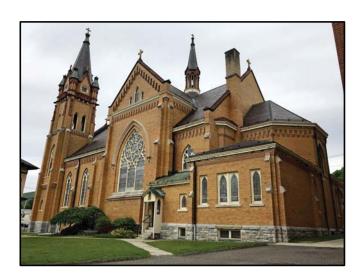
<u>Photo</u> <u>E02:</u> View of Church from southwest.

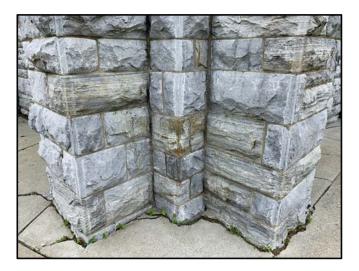
<u>Photo E03:</u> Typical condition at stone base. Minor mortar loss and staining present throughout.

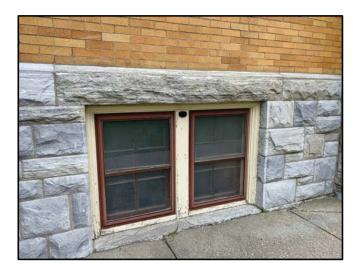
<u>Photo E04:</u> Typical dressed stone lintel at lower windows in acceptable condition.

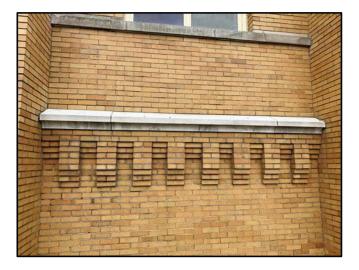
<u>Photo E05:</u> Typical condition at exterior yellow brick. Note lack of bonder bricks.

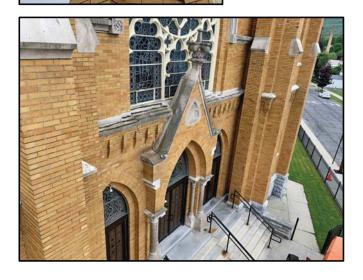
Photo E09: Condition of cast stone elements at north entrance.

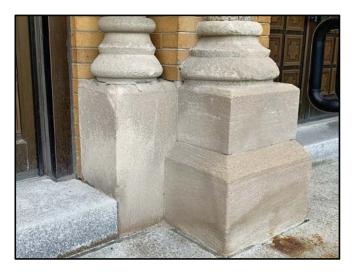
Photo E10: Cast stone column elements in acceptable condition at north entrance. Some water staining was present.

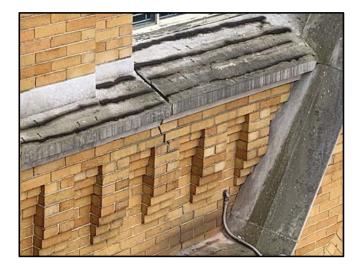
Photo E11: Water staining and early cracking at cast stone stringcourse above north entrance. Movement in cast stone elements beginning to crack brick dentils.

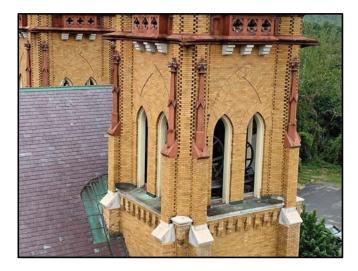
<u>Photo E14:</u> Typical brick and cast stone condition at top of buttresses and balcony at towers.

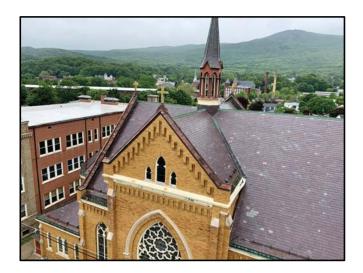
Photo E15: Cast stone stringcourse at west gable is covered with composite materials. Similar condition at west gable.

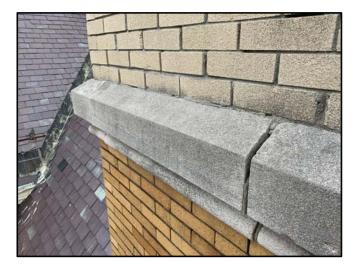
Photo E16: Mortar loss at cast stone stringcourse at chimney on south side of building. Mortar loss also present at the upper rebuilt section of chimney.

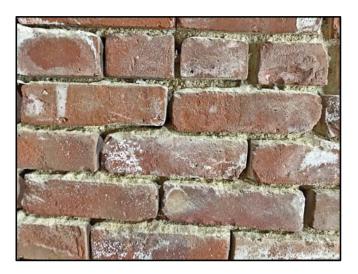
- 3. The red brick masonry backup is visible at the tower interiors. Due to moisture levels within the tower, the interior brick face of the masonry is beginning to flake and deteriorate.

<u>Photo T03:</u> Typical condition of brick masonry at interior face of tower above Level 2.

- 1. The interior of the masonry, above and below the belfry, should be regularly cleaned and treated with limewash. Limewash will help manage the moisture levels of the brick. Some repointing may be needed prior to limewash application. (M)

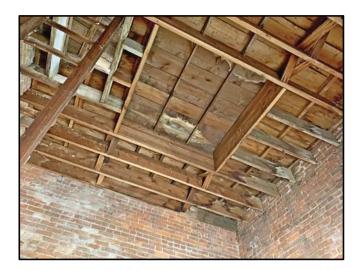
- 4. The framing at the first floor, balcony, and Tower Level 2 is concealed. Wood joist framing was observed and documented at the West Tower at the Belfry and at Tower Level 3. The exposed joists appear to be performing well but water damage was observed at some locations.

<u>Photo</u> <u>T04:</u> Belfry framing with moderate water damage at joist pockets into masonry walls.

- 2. The exposed wood joists should be regularly inspected as part of the Church's maintenance program. While the framing is performing well now, it is pocketed into the masonry bearing walls which regularly cycle between wet and dry conditions. Regular maintenance should account for treating water-damaged framing. The Church may need to cut back framing and install new pressure-treated ledgers in the future. (M)

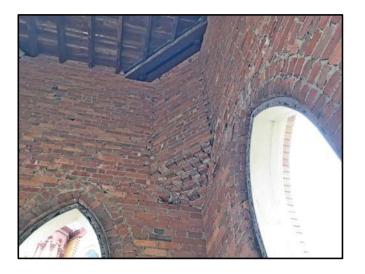
Photo T05: Brick masonry corner corbels at belfry for turrets. Also shown is typical double steel channel with hold-down rods for spires.

6. The steel lintels and hold-down rods for the spires should be wire-brushed cleaned and treated with a rust-inhibitive paint. (N)

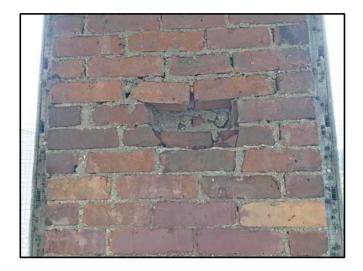
<u>Photo T06:</u> Brick removal observed at multiple locations showing composition and condition of tower masonry.

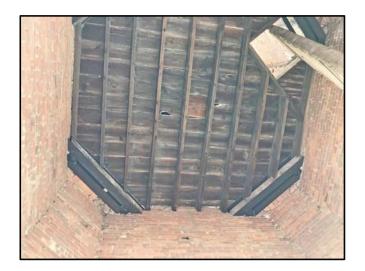
Photo T07: Wood framing for Tower Level 3 (highest level) with moderate decking deterioration.

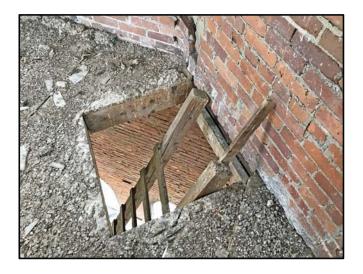
- 5. GNCB accessed the top level (06 Tower Level) of the West Tower via a wooden ladder. This ladder is in poor condition and not safely anchored to the structure. Bird excrement is present at the entire level.

<u>Photo T08:</u> Ladder to top Tower level should be replaced.

- 3. New OSHA-certified ladders should be installed to allow safe access to all levels of both towers. (N)
- 4. Bird excrement should be removed at the upper levels of the towers. This is an air-quality condition which may be hazardous for maintenance. Additionally, bird excrement will cause further damage to wood framing. (N)

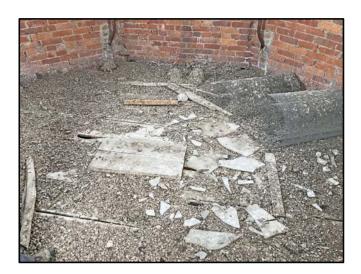
<u>Photo T09:</u> Debris and bird excrement at top Tower level should be removed.

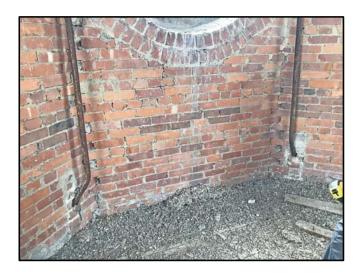
- 6. The wood spire framing is in generally acceptable condition although water damage was observed at roof sheathing.
- 7. The spire appears to be well-anchored against uplift. The eight hold-down rods and their connections to the wood hips and channel lintels do not show signs of significant deterioration. The steel channels and hold-down rods are not galvanized and have surface rust.

<u>Photo T10:</u> Metal hold-down rods at corners of spire anchor to double channels below.

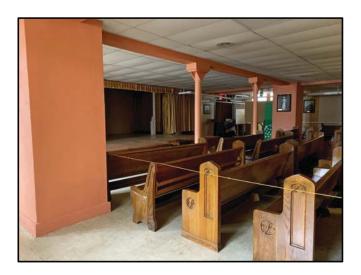
Photo BF02: Vies of basement below Sanctuary looking north showing steel columns with gussets, masonry piers, and dropped beams.

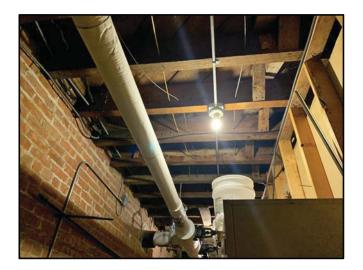
<u>Photo BF04:</u> Exposed first floor framing at south end of Sanctuary basement.

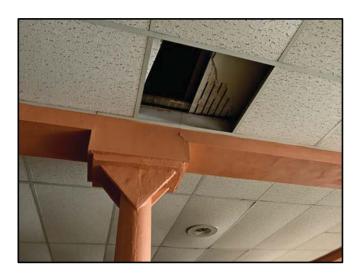
<u>Photo BF05:</u> Steel posts with gussets indicate removal of posts above up to balcony. Gussets support end of beams which are deflected, causing cracking in the plaster finishes.

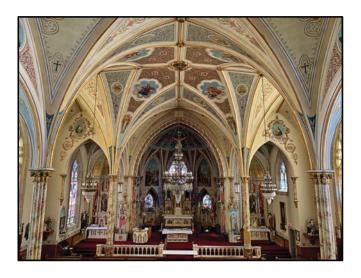
<u>Photo SC02:</u> View of transept and apse, looking south.

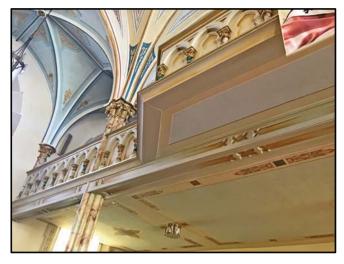
<u>Photo SC05:</u> Finishes on balcony spandrel may indicate previously removed post location.

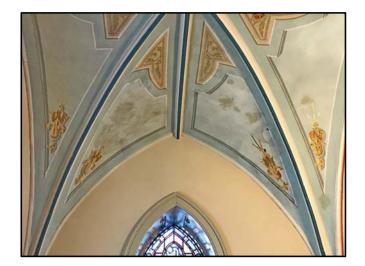
<u>Photo SC06:</u> Water damage observed at wall of west tower and ceiling beyond balcony. Damage indicates roofing issues.

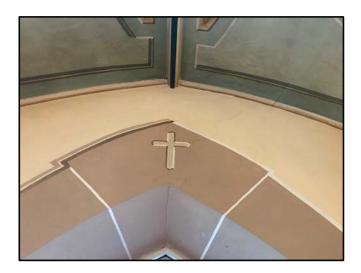
<u>Photo SC07:</u> Some cracking in plaster was observed at the apex of the window at the west side of the balcony. Brick masonry arch may be expanding and contracting.

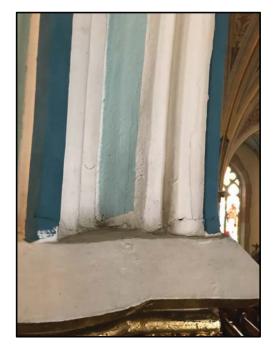
<u>Photo SC08:</u> Some cracking observed at the plaster corbels at the base of the ceiling ribs.

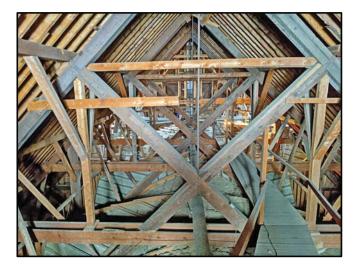
<u>Photo AR05:</u> View of attic looking south showing Typical Truss configuration.

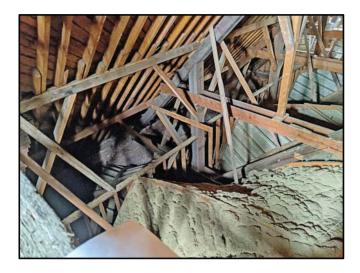
Photo AR06: Typical timber buttress frame at side aisle transfers Typical Truss thrust to outside masonry wall with masonry buttresses.

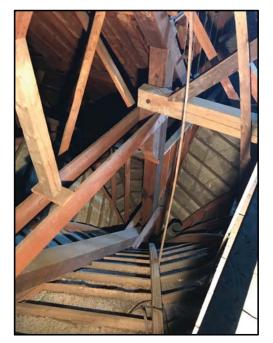
<u>Photo AR07:</u> Transept Truss sits on corbel at typical post. Connection requires improvement.

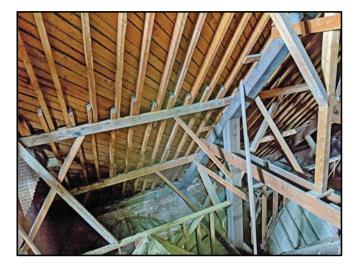
Photo AR09: Typical roof framing showing multiple purlins and simple span rafters. Purlins are partially supported with kickers which frame into the Typical Trusses. Roof decking consists of diagonal sheathing.

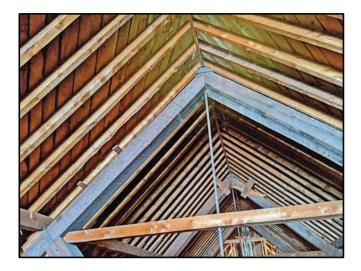
Photo AR10: Typical Trusses are not braced at the apex.

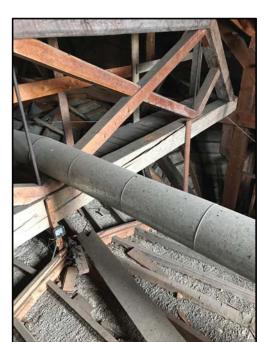
<u>Photo AR14:</u> Transept Truss at east side of attic with deep split initiating from significant rotational checking.

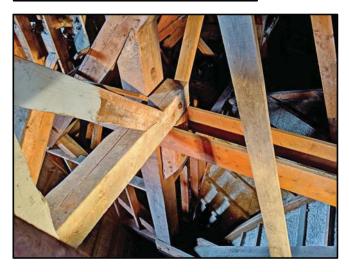
<u>Photo AR15:</u> View of Transept Truss sitting on corbel.

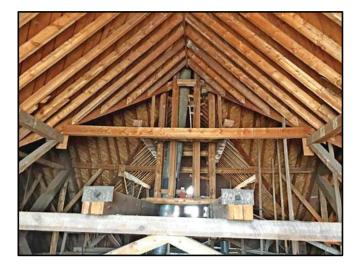
Photo AR16: Significantly deflected Upper Purlin crosses Transept and supports Transfer Beams and Upper Dunnage Beams. Cupola posts sit on lower dunnage beam spanning between Cupola Trusses.

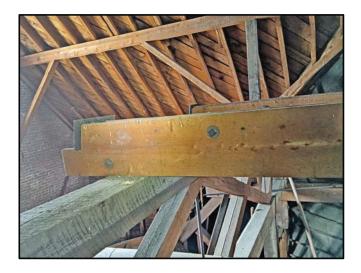
<u>Photo AR17:</u> End of Cupola Trusses (2) sit on Transept Truss at locations off of Transept Truss's panel points.

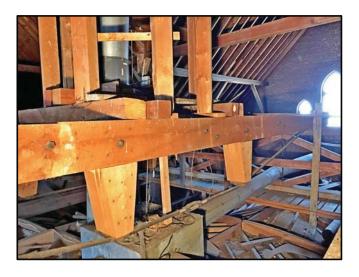
Photo AR18: Cupola Truss constructed of built-up members with vertical stubs and a high-load tension rod with turnbuckle.

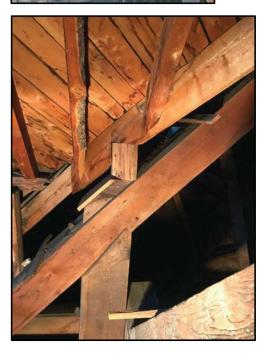
<u>Photo AR23:</u> Valley beams at west side of Transept are deeply notched and sit on blocking down to Typical Truss.

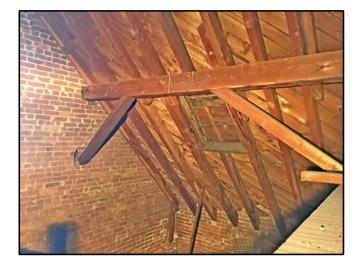
<u>Photo AR24:</u> Typical roof framing at bay adjacent to masonry wall. Purlins are moderately deflected and kicker pockets directly into masonry wall. Water damage observed at abandoned roof hatch at west side of Transept.

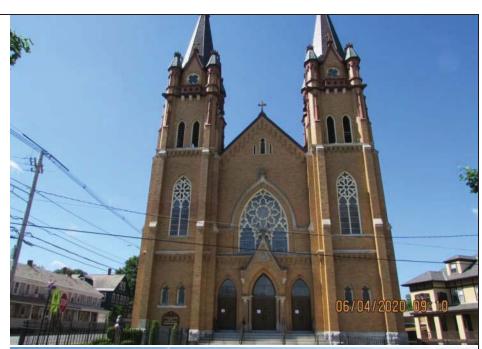
Photo 3:

- 2.1.1 The East and West Main Roofs as viewed from the ground are shown in Photos 3, 6, 11 and 12; some slate were visibly damaged. Note sections of the snow retention system or pipe snow guard fence at the north end of the West Main Roof were damaged. See Photo 5. The south end snow guard fence, Photo 6, was completely damaged.

View of the west main steep sloped slate roof at the north end as viewed from the ground. A large built-in gutter resides along the bottom. The outboard side was covered with an ornamental cover. Two (2) leaders provide drainage.

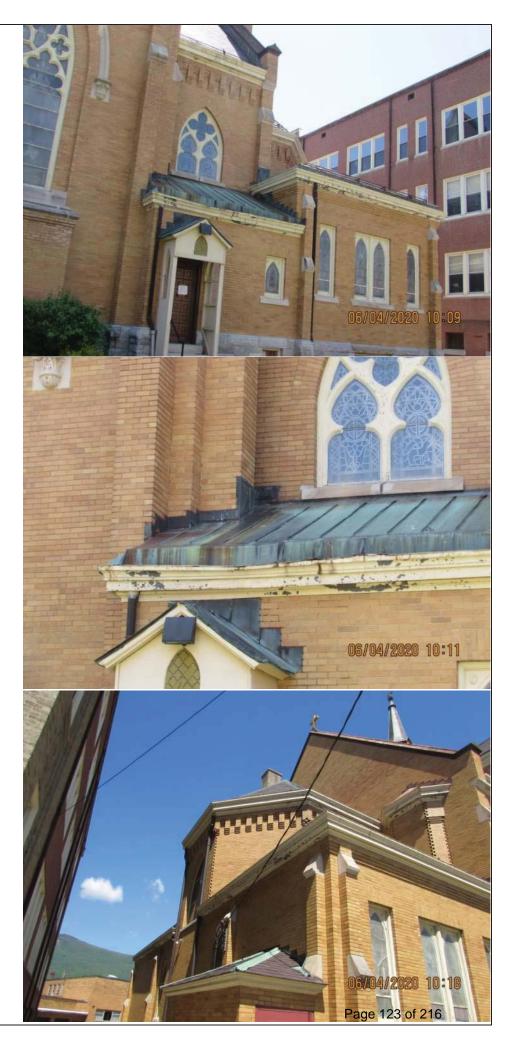
Photo 10:

General view of the east building elevation looking northwest.

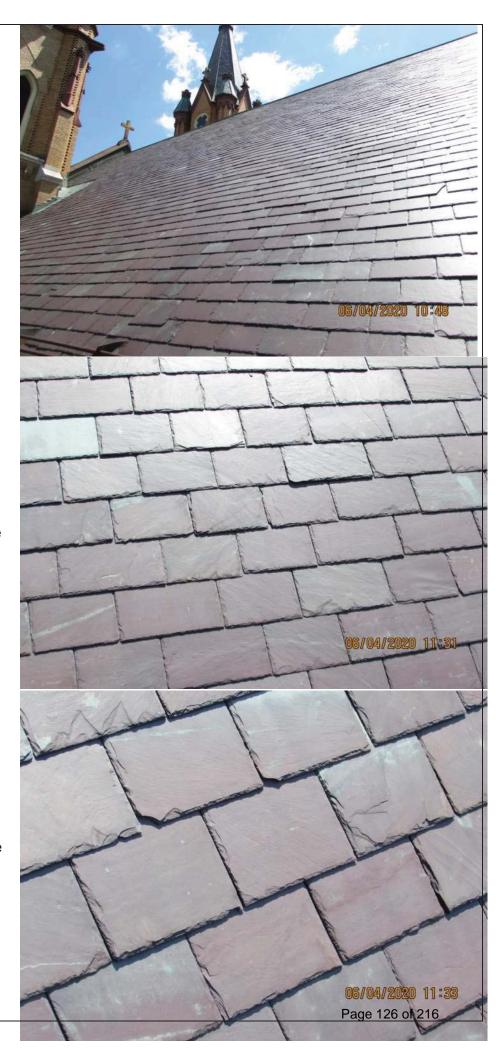
Photo 19:

View of another location on the west main steep sloped roof showing condition of the individual slate. The slate condition was good. The tapping method produced a solid tone.

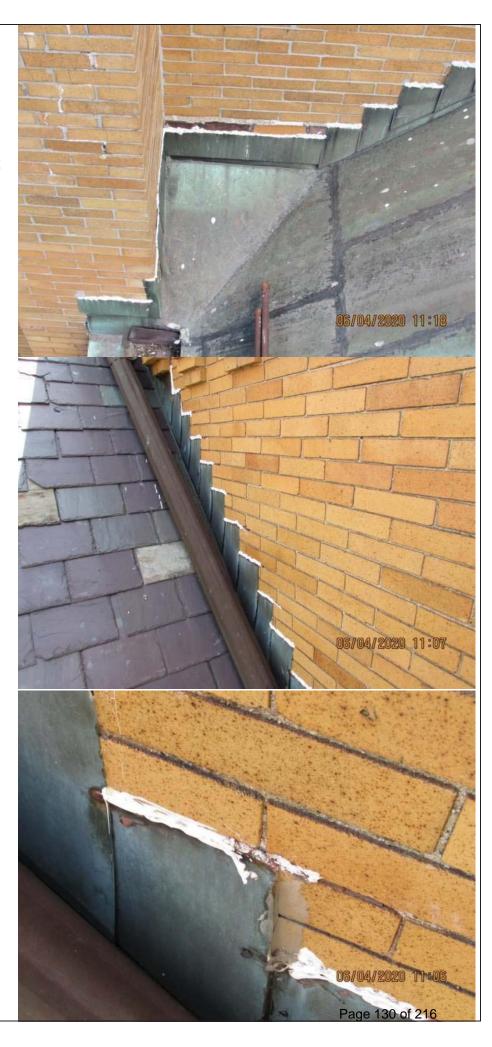
Photo 31:

- 2.2.7 Photos 31, 32, 33, 86, 111, 120, 128, 129 and 132 show decorative copper ridge rolls covering the ridge of the Main roofs and dormers; decorative covers were also installed covering the roof hips. The condition of the copper ridge and hips covers was generally fair. The copper ridge roll was retained in place with rusted exposed nail fasteners; the fasteners were not copper.

View looking southeast at the main roof ridge. The ridge was covered with a copper ridge roll.

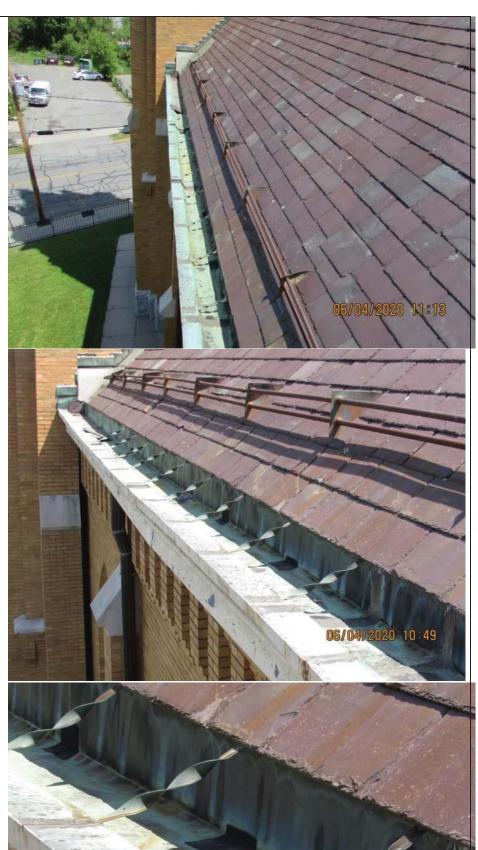
Photo 37:

- on the dormer roofs. See Photo 37. Note prior repairs of EPDM had been installed to the copper liners as shown in Photos 36 and 84. Other gutter liners exhibited damage resembling that from an impact. See Photos 43 and 55. The condition of the liners was less than fair

View of condition of one (1) of the copper liner solder joints. The solder joint contained no cracks.

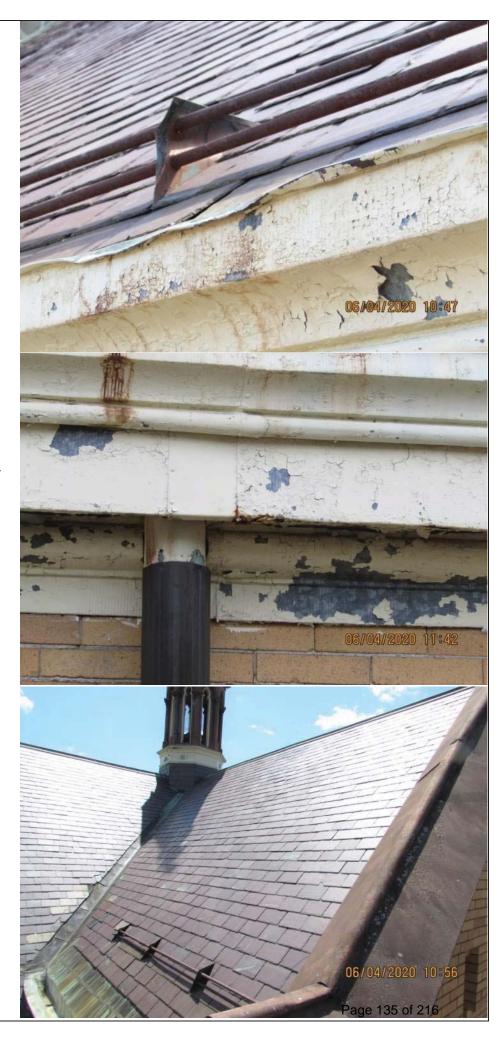
Photo 46:

View of condition of the mottled purple and green slate on the West Dormer north roof. The slate condition was good. The slate produced a solid tone during the tapping method.

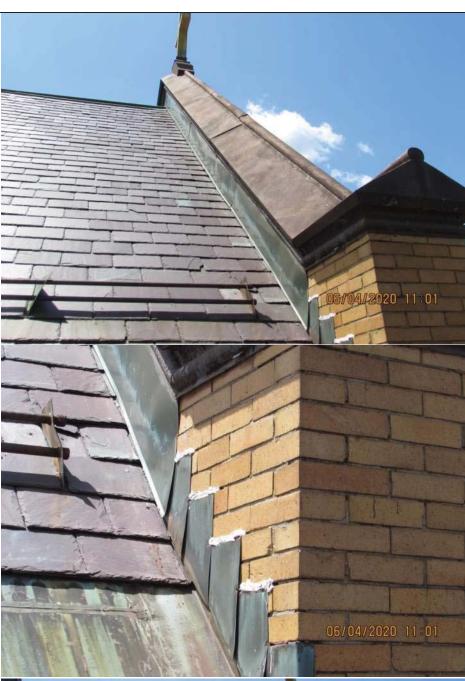
Photo 52:

- 83 and 93. Snow slides from the dormer roofs likely caused this damage.
- 2.2.4 Where the Main and dormer roofs interface the roof rake, knee wall parapets reside at these locations; the parapets were covered with terne metal copings. Copper base flashings that were incorporated with the metal copings and conceal the stepflashings of the slate roof are shown in Photos 27, 49 and 51; the copper flashings' condition was fair. The condition of the terne metal copings was generally less than fair. See Photos 52, 71, 72 and 94.

Another view of the terne metal coping condition.

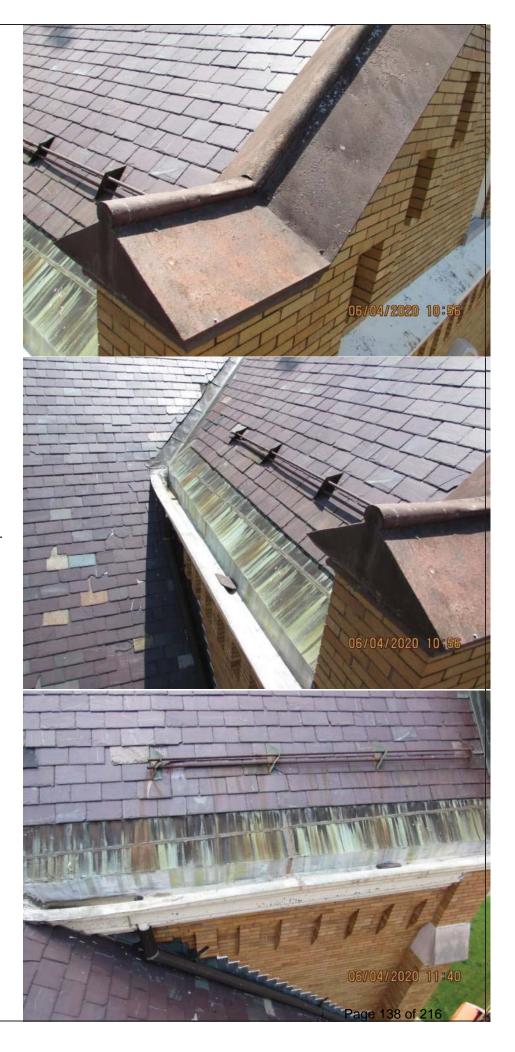
Photo 55:

View of the east end of the large built-in gutter. Note large area contains sealant below the valley.

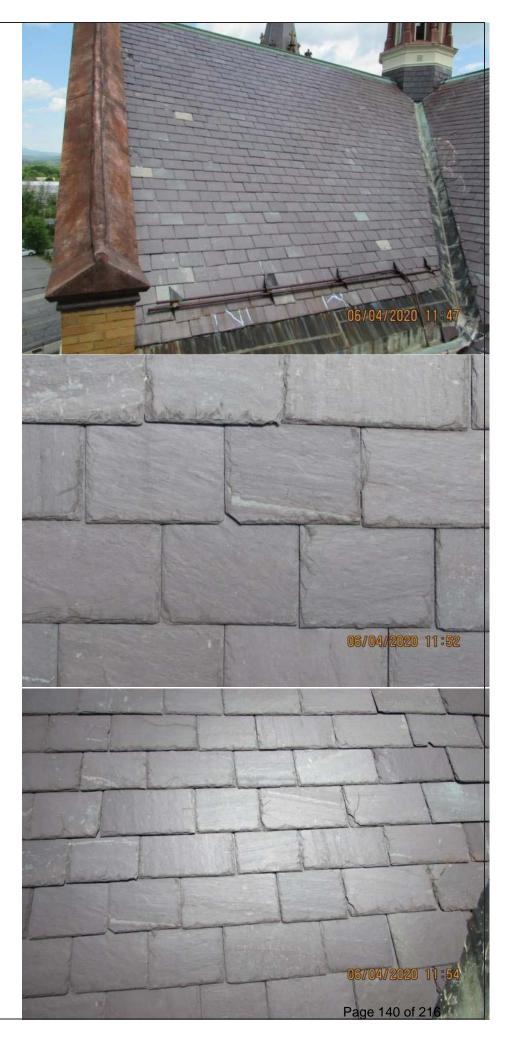
Photo 61:

- 2.2.1 Localized broken slate in the field of the Main and dormer roofs including the south hip roofs are shown in Photos 22, 25, 61, 62, 63, 80, 81, 82, 84, 98, 110, 128 and 130. Copper nails utilized to secure the slate were exposed at some of these locations. Water can enter.

View of few localized damaged slate in the field of the south dormer roof. Copper fasteners were exposed where the slate were damaged.

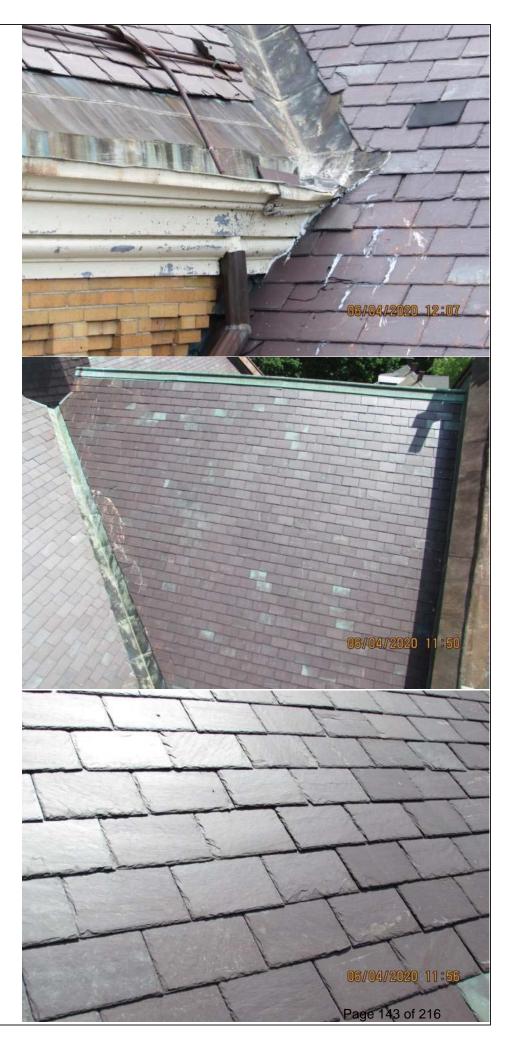
Photo 70:

View of condition of other slate. The two (2) green slate were from a prior repair.

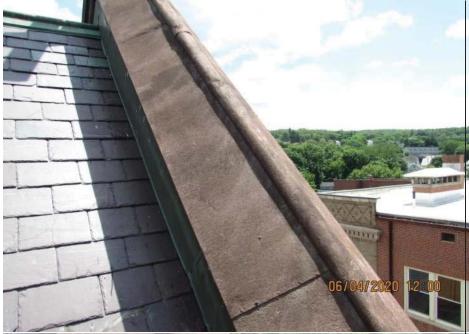
Photo 72:

Another view of the terne metal condition. Note nails secure the metal sections where they overlap one another.

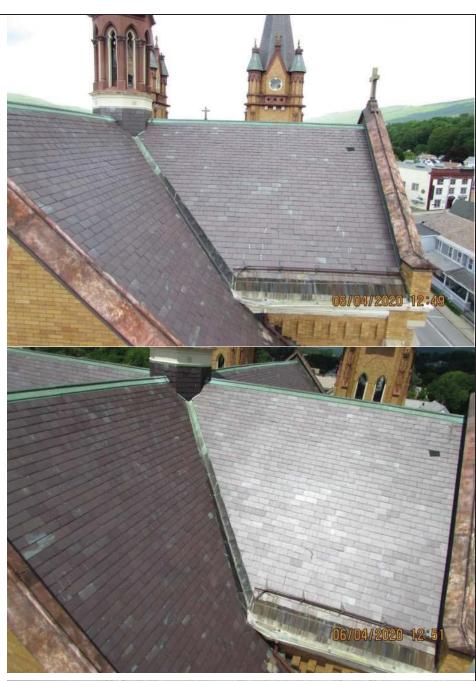
Photo 88:

- 2.2.2 Repairs to damaged slate utilizing copper bibs and sealant are shown in Photos 23, 24, 47, 48, 65, 88, 89, 90, 109 and 126. Some of these had failed exposing abandoned nail holes in the slate or copper fasteners. Water can enter.

View of prior sealant repairs made to several slate. One (1) slate was damaged.

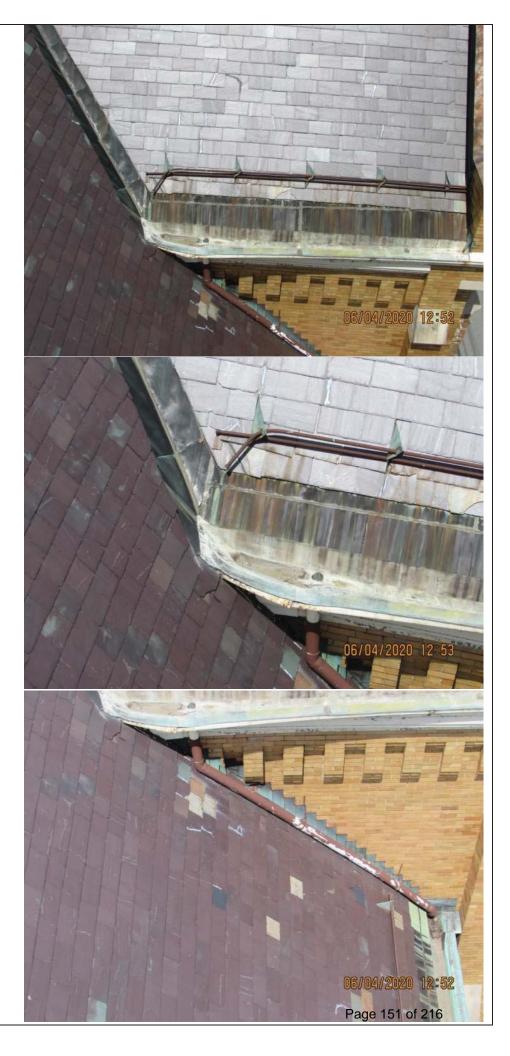
Photo 94:

View of condition of the terne metal rake parapet coping on the East Dormer roof. The coping condition was less than fair.

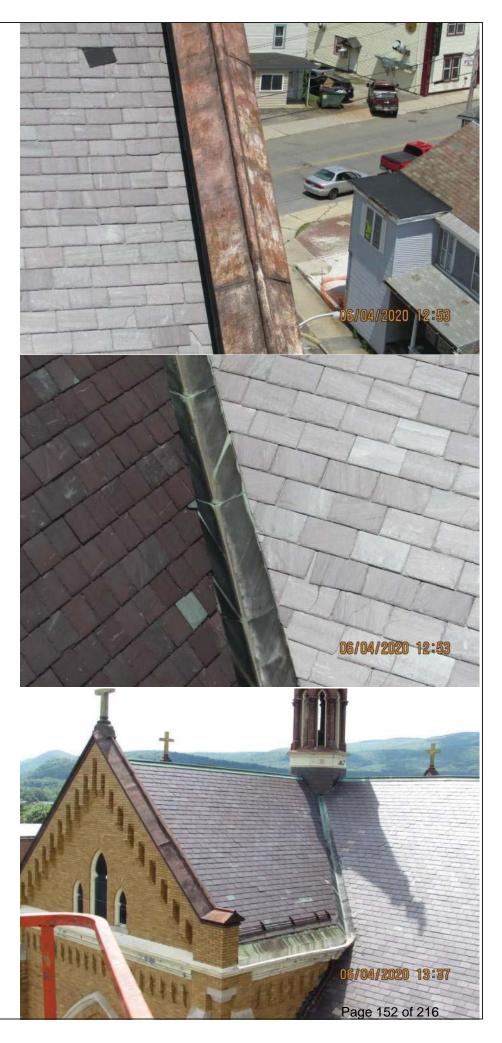
Photo 97:

- 2.2.8 The snow retention system or pipe snow guard fence, along the bottom of the Main and dormer roofs are shown in Photos 34, 38, 54, 64, 76, 91, 97, 107, 108, 113, 126 and 128. Various degrees of damage were observed to sections of the snow fence. See Photos 39, 40, 54, 64, 65, 66, 77, 78 and 92.

- 2.3.4 The painted galvanized ornamental covers of the built-in gutters of the slate and metal roofs are shown in Photos 41, 42, 54, 67, 75, 78, 97, 114 and 117. The outboard side of the copper liner was "locked" onto the cover. As noted, paint was peeling on many areas of the covers.

View of condition of the large built-in gutter and copper liner.

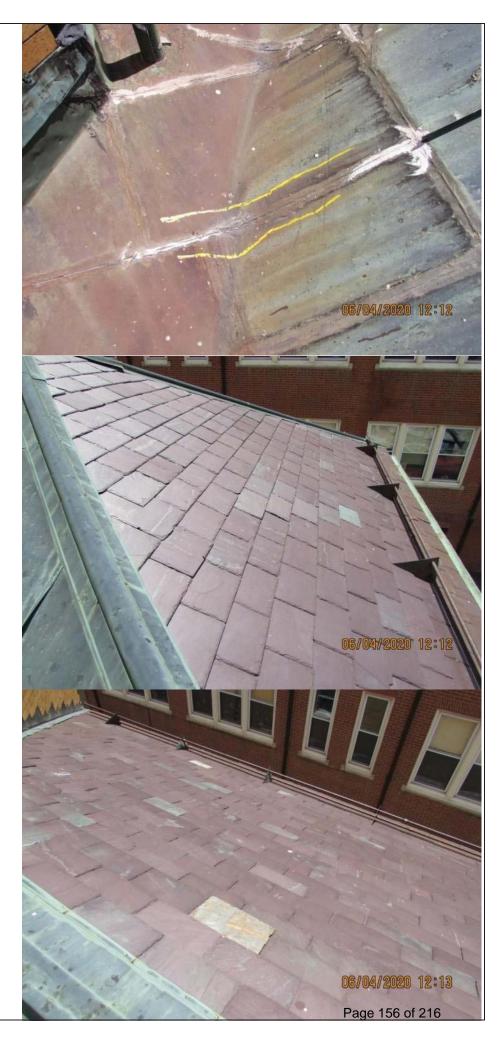
Photo 109:

View of one (1) of the sealant repaired slate. The repair was improper.

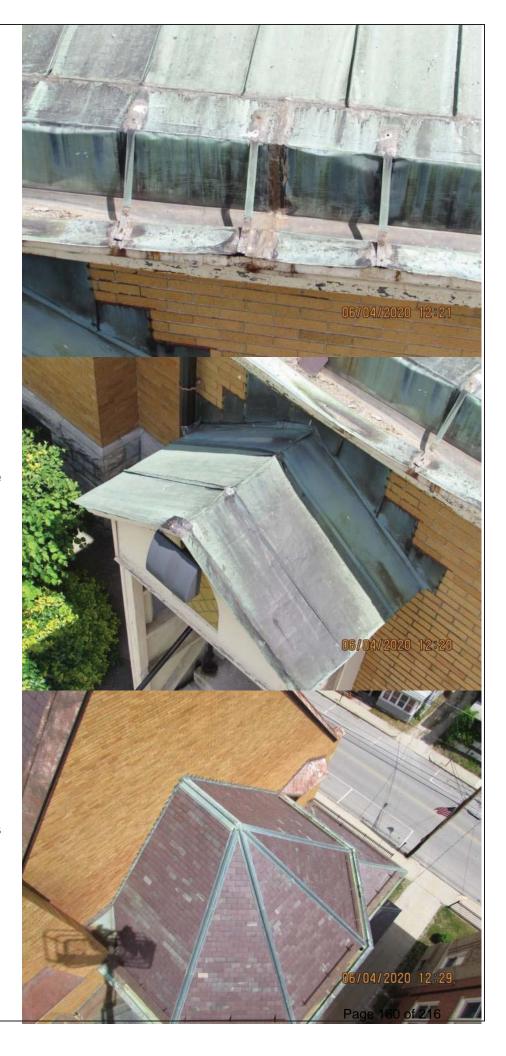
Photo 121:

View of condition of the mottled purple and green slate. The slate condition was fair to good. The slate produced a solid tone when tapped.

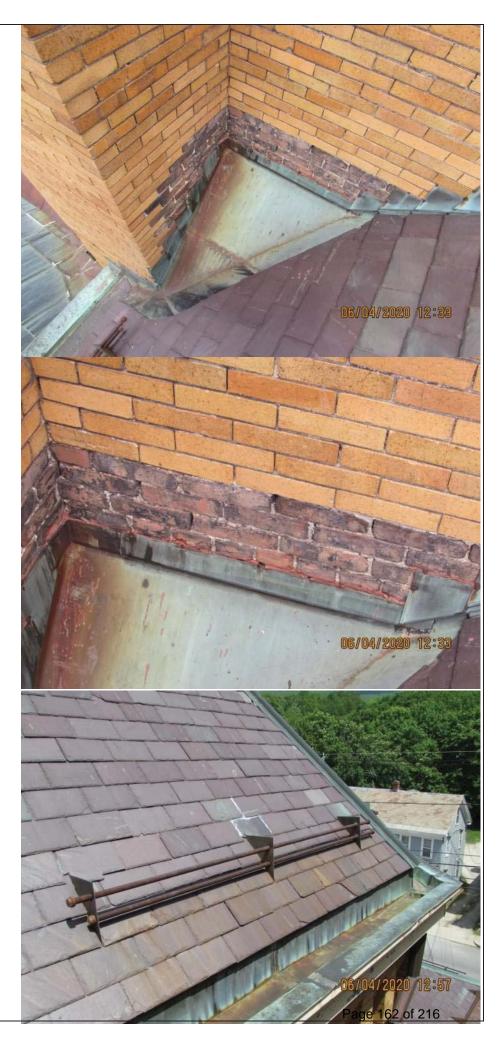
Photo 127:

View of condition of the copper liner. Prior bituminous repairs were made to the copper soldered joint. The repair was improper.

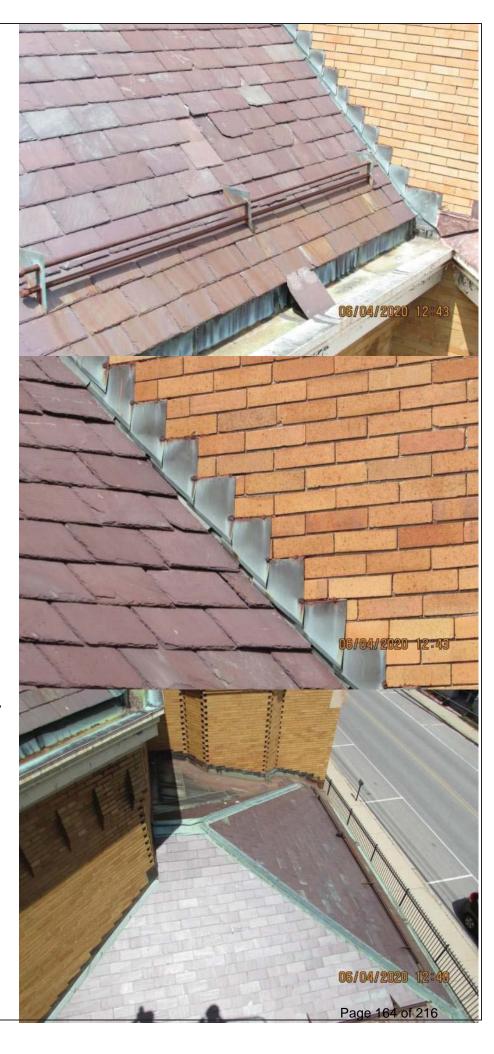
Photo 133:

View of the flat seam copper roof panels at the north end of the Southeast Lower Hip roof. Condition of the copper was less than fair. Note metal bib repairs on the north slate roof.

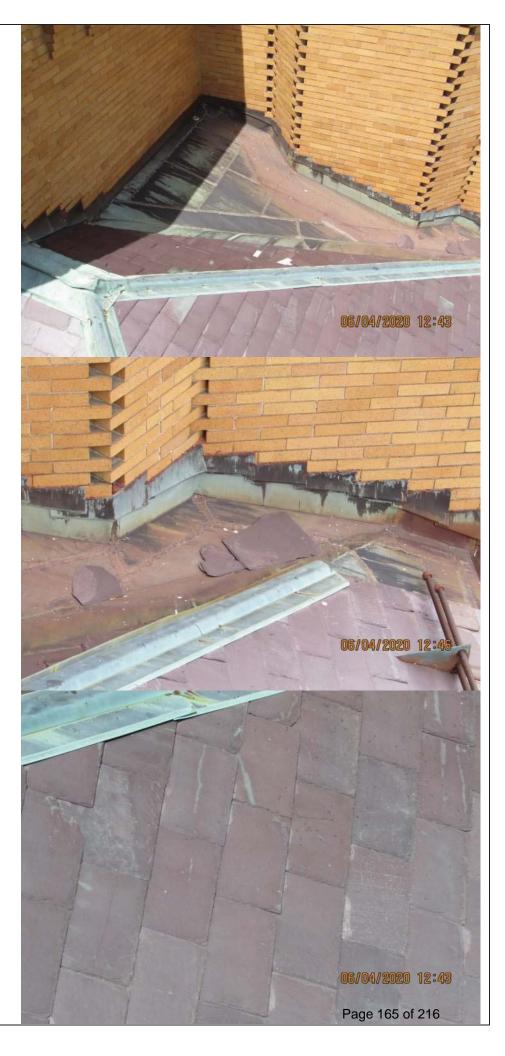
Photo 136:

View of condition of the mottled purple and green slate on the South Hip roof. The condition of these slate was good.

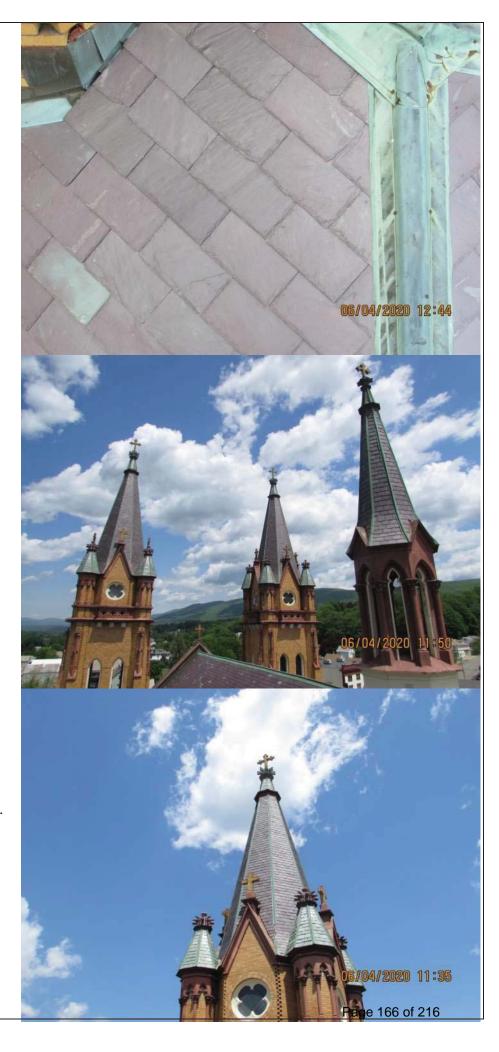
Photo 139:

- 4.1.2 Photos 139, 140 and 161 show localized damaged or cracked slate on the East and West Main Spire roofs.
 - 4.1.3 The corners or hips of the 8-sided main spire are shown in Photos 139 and 161; the hips were covered with individual copper covers. Note in Photo 141, one (1) of the copper covers was observed missing exposing wood. Water can enter.

Closer view of the slate and copper hip covers condition on the east side of the Main Spire roof. Note one (1) slate was damaged. Copper fasteners were exposed. Water can enter.

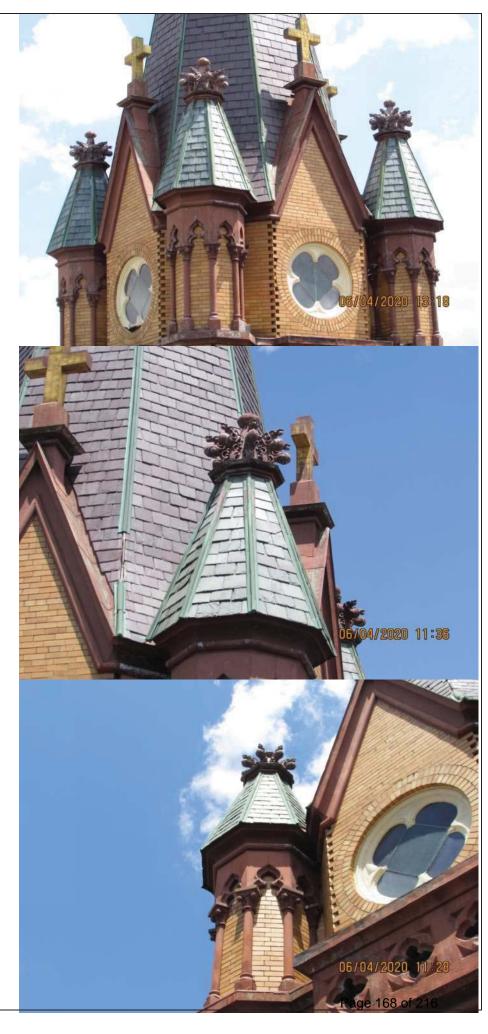
Photo 145:

- 4.1.6 Photos 145, 151, 162, 163, 164, 175 and 181 show ornate terne metal pilasters which were installed as part of the waterproofing of the small spire brick turrets; the ornate pilasters cover the pigeon hole construction of the brick. The visual condition of these ornate pilasters was less than fair. Several were observed missing.

View of condition of the ornate terne metal pilasters and architrave at the southeast brick turret. The metal condition was generally poor to less than fair.

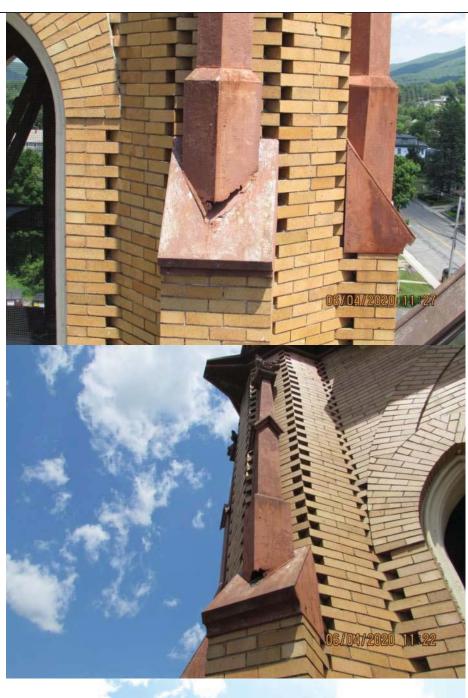
Photo 151:

- 4.1.8 The East and West towers' four (4) ornate terne metal balconies are shown in Photos 151, 157, 162, 166 and 175. Their visual condition was failed to less than fair. Some of the balconies' underside were observed corroded. See Photos 150, 152, 153, 158, 167, 178, 179 and 180. At one (1) location, wood was exposed. Water can enter.

View of the east side ornate balcony.

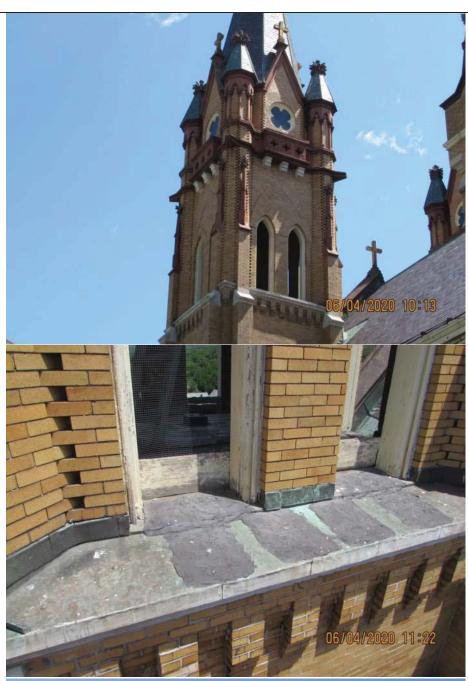
Photo 157:

View of the brick turrets, the ornate terne metal architrave, pilasters, upper and lower ledge, and the ornate balcony on the Tower north side.

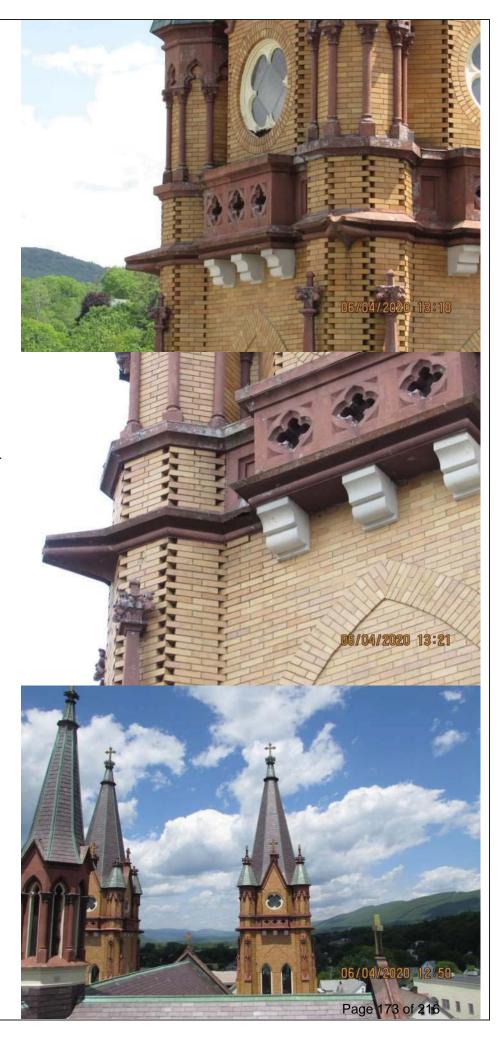
Photo 160:

- 4.1.1 Photos 138, 139, 140, 160, 161 and 174 show the slate on the east and west main spire roofs; the slate were also the mottled purple and green. The smaller roofs on the top of the main spires were green slate. The visual condition of the slate was good.

View of condition of the mottled purple and green slate on the south Main Spire and the green slate on the small spires. Their visual condition was good.

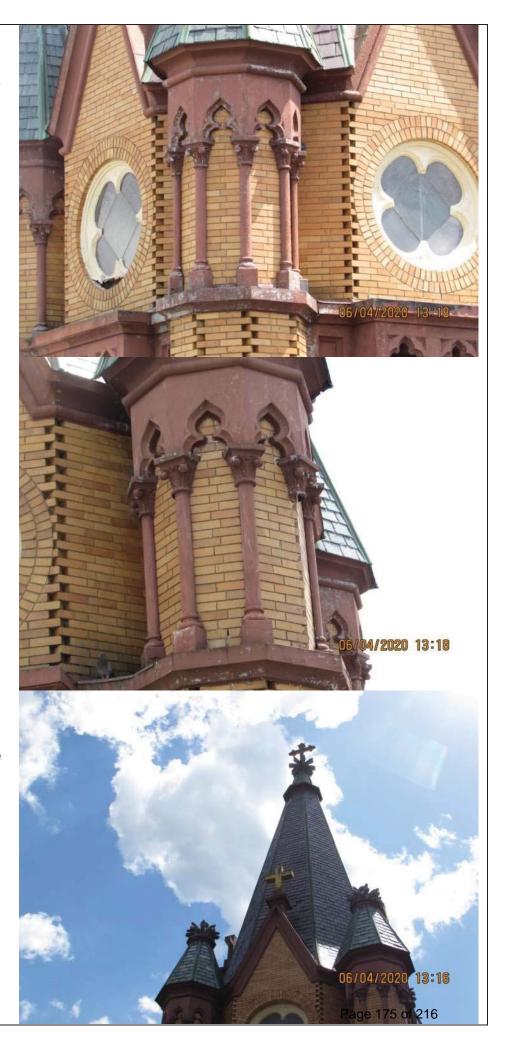
Photo 166:

View of the north side ornate balcony.

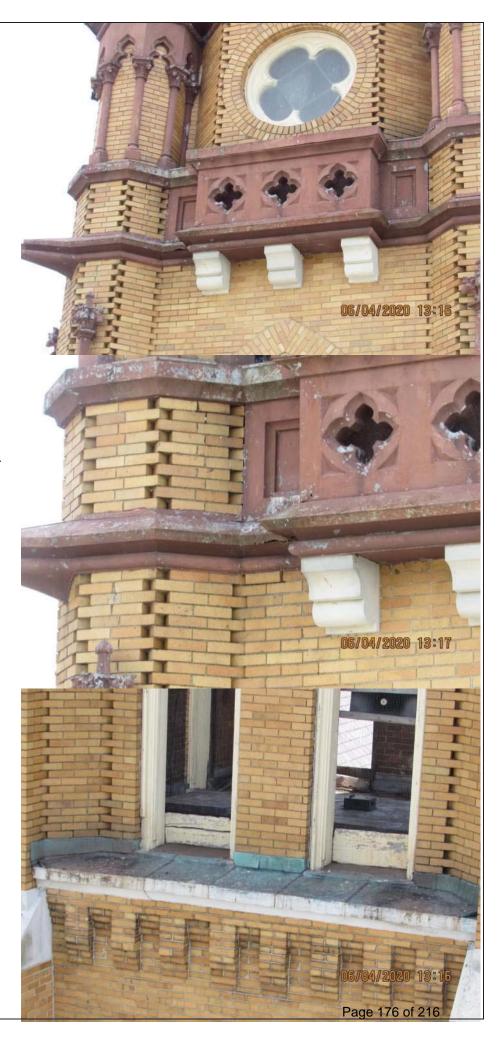
Photo 169:

View of the ornate metal pilaster at the northeast brick turret.

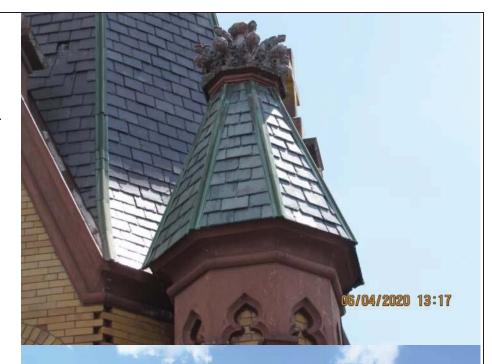
Photo 172:

View of the northwest small spire roof. The visual condition of slate was good.

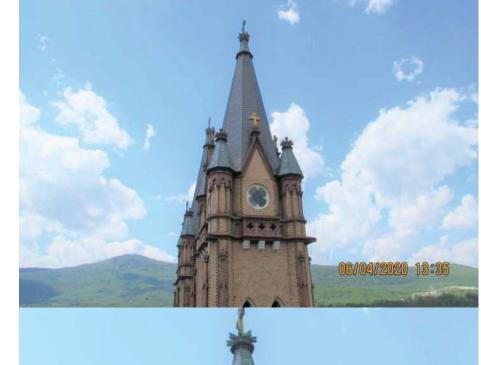
Photo 173:

View of the east side of the East Tower.

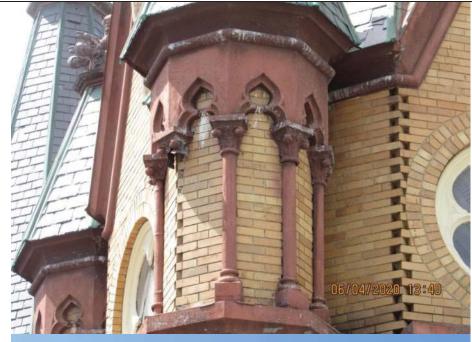
Photo 181:

View of condition of the southeast brick turret ornate terne metal pinnacles. One (1) was missing. Note slate missing at bottom of the Main Spire roof above.

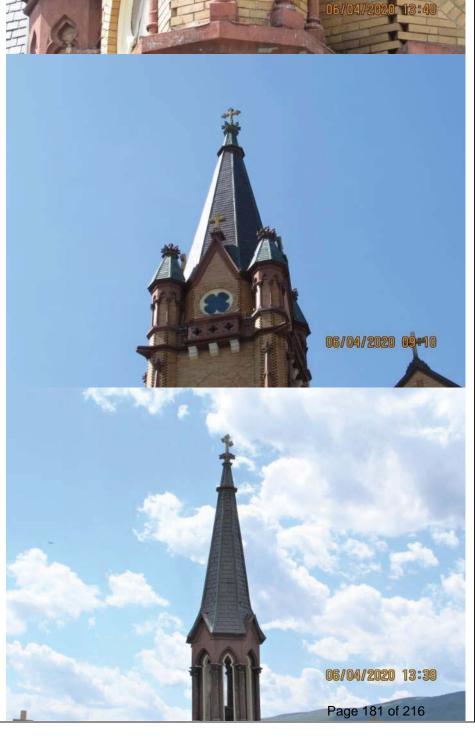
Photo 183:

View of the Center Tower.

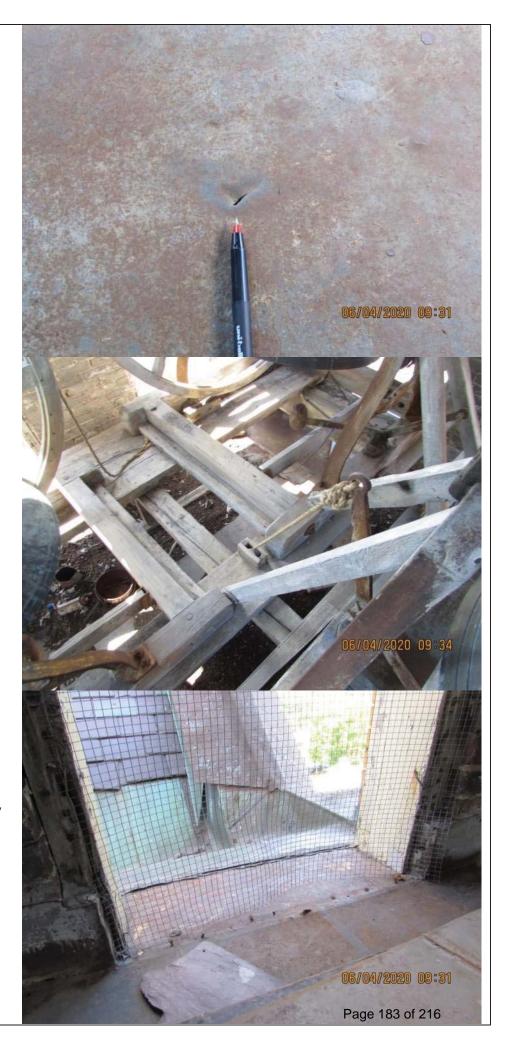
Photo 189:

- 5.1.3 The Belfry roofs were sloped to the four (4) sides which contained large openings for drainage. Screens had been installed over these openings and were attached to wood blocking or directly into the terne metal roof panels. See Photos 189, 191, 192, 200 and 201. Note that wood blocking obstructed drainage.

View of one (1) of the drainage openings within the Belfry. Note the screen installed covering the Belfry opening had pulled out of the metal causing holes.

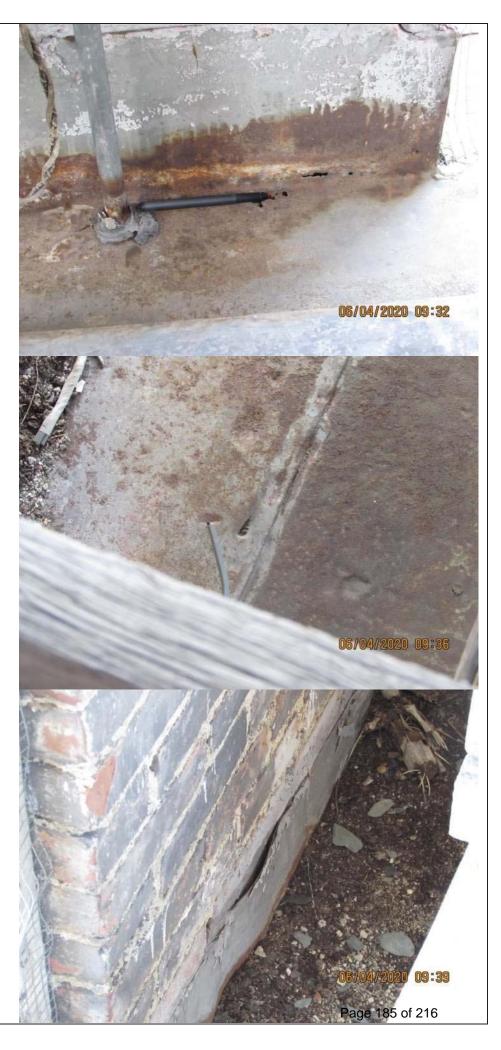
Photo 195:

View of metal base flashing which had pulled away from the brick wall. Water can enter.

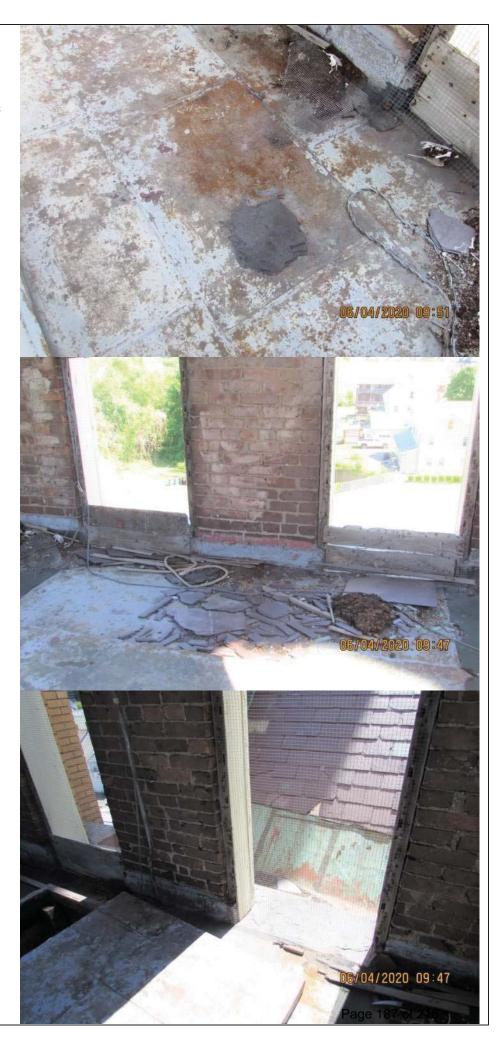
Photo 201:

View of separate opening on the east side within the Belfry. Water drains onto the copper covered cornice and valley of the slate roof.

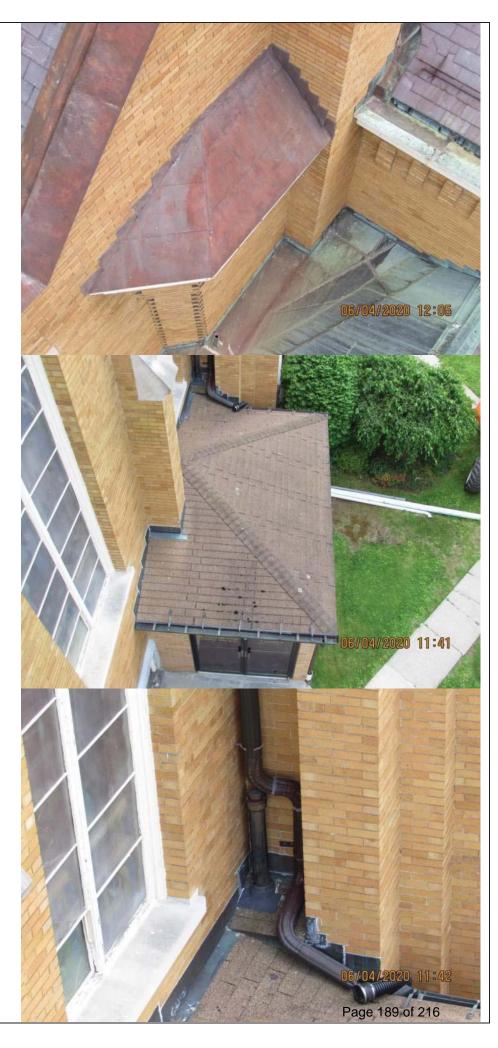
Photo 207:

View of leader pipe from the upper Main Roof large built-in gutter that drains onto this roof. Note the original cast iron drain line had been capped.
