Saint Stanislaus Kostka Mission

CONDITION ASSESSMENT STUDY FINAL REPORT - DECEMBER 12, 2020

Executive Summary - December 12, 2020

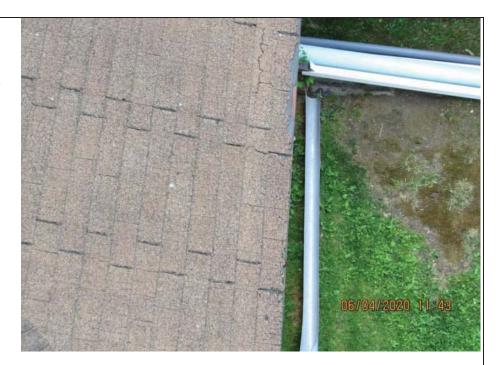
Photo 208:

6.1 The west side entry shallow sloped roof is shown in Photo 206; the roof was shallow in slope and consisted of No Cut-Out organic shingles. The condition of the shingles was poor. See Photo 208.

View of condition of the No-Cut Out shingles along the bottom. The shingles were decayed and dry rotted. Some along the edge were broken.
