## *Existing Tree Inventory and Assessment Report*

***DAVID C. HAWKINS, CONSULTING ARBORIST***  
***URBAN FORESTRY SOLUTIONS, INC.***

Thirteen trees in Pittsfield's Park Square were assessed for health, risk and safe useful lifespan after a November 8, 2022, onsite meeting with James McGrath from Pittsfield Community Development Office, members of Pittsfield's Park's Department and a representative of Pittsfield Beautiful. In addition to the tree assessment, there were discussions on the future plans for this park including a suitable replacement elm for the center of the park, a permanent versus temporarily annual Christmas tree, possible transplanting of two weeping cherries from the west section of the park to the east garden area, a suitable crabapple variety for the eastern most section of the park's 'tear drop' design (see Site Illustrations Page 4), and the benefits of installing composted woodchip mulch around the base of the larger shade trees. These topics, in addition to the assessment data are included in this report.

# Pittsfield Park Square

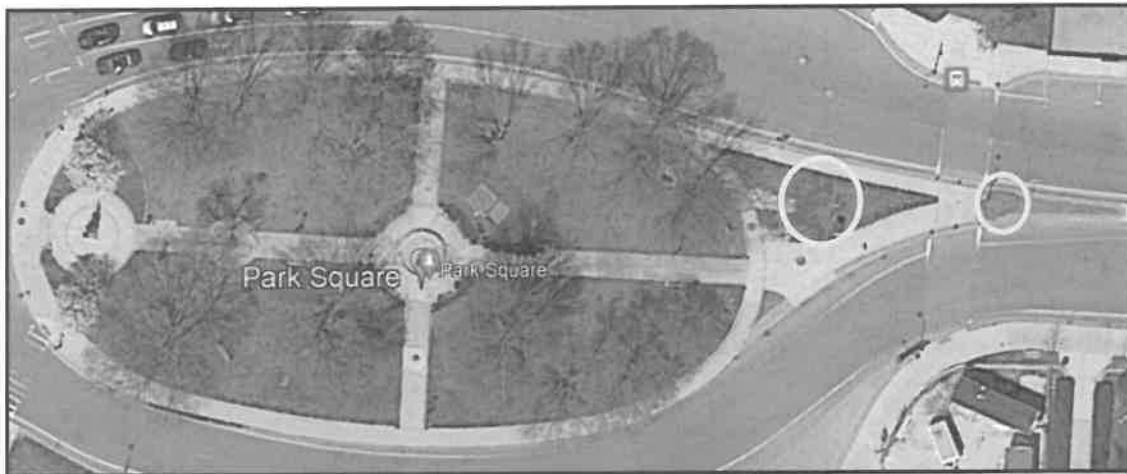
Google Earth Aerial Image (2014) showing the current park configuration. The east garden area and proposed crabapple locations are circled.

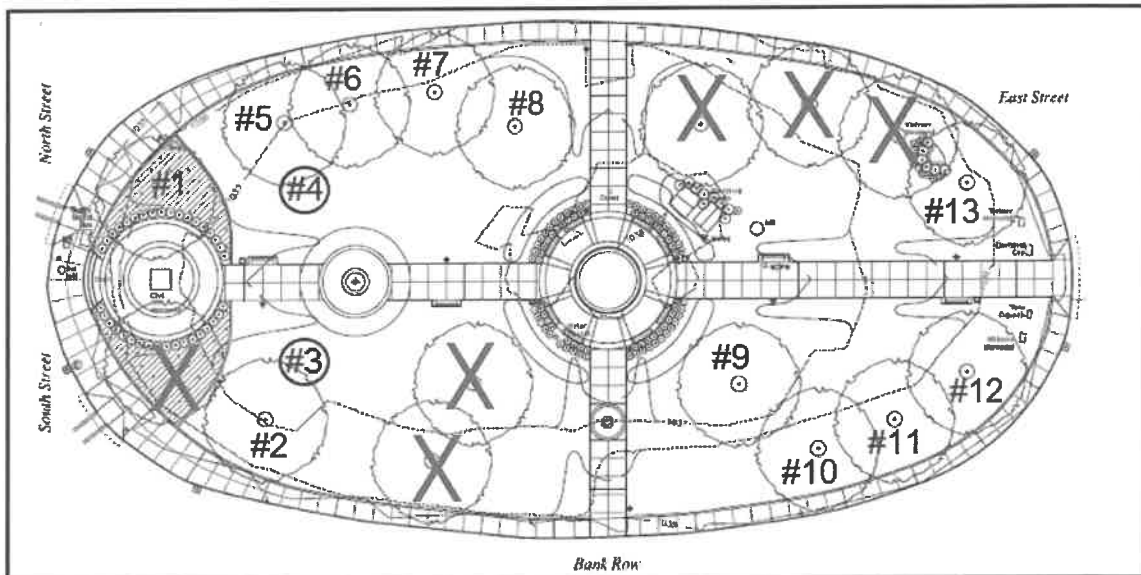
Base plan (1999) provided by Berkshire Design with trees located. The 'X' trees have subsequently been removed. The existing trees are numbered in the sequence they were assessed.

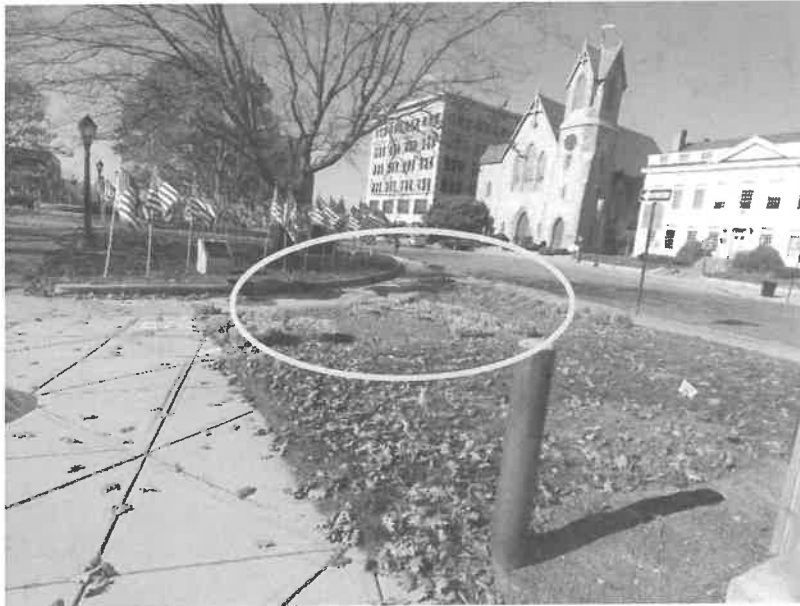
East garden area and proposed cherry transplant location

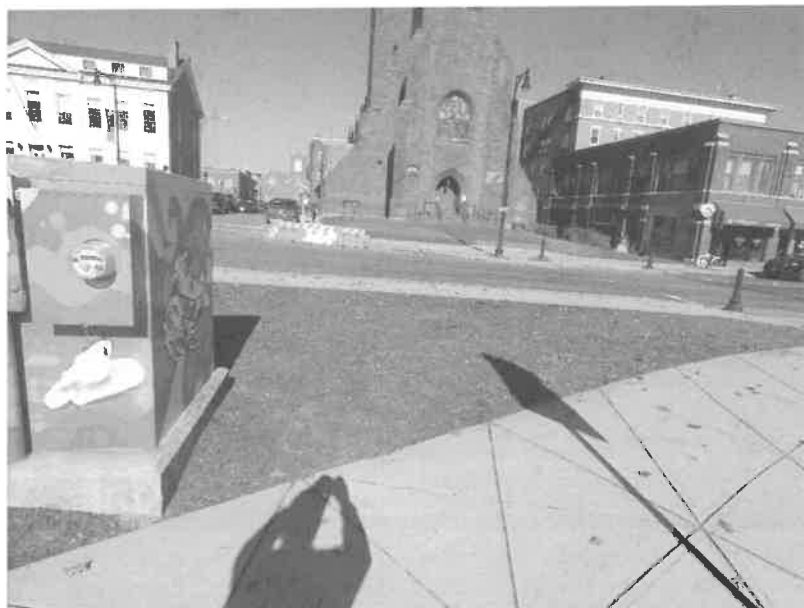
East 'tear drop' area and proposed location for the crabapple.
